# PRES Cycle 6

## Final Report

### Road Inventory and Condition Assessment of Paved Routes Presidio of San Francisco

**Report Date: August 2015**

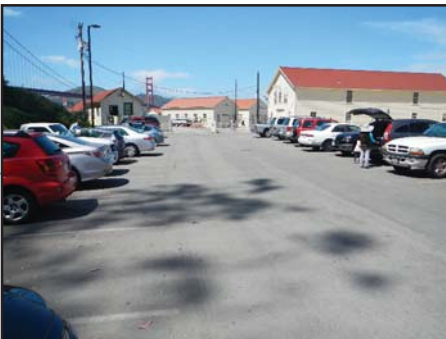
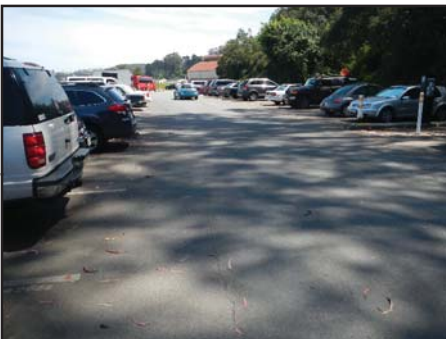
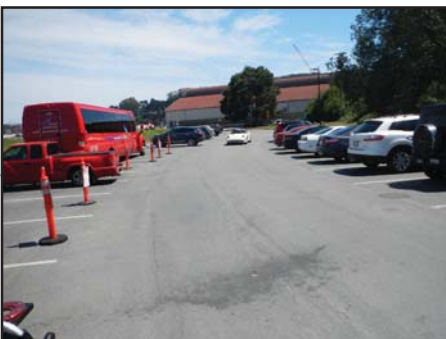
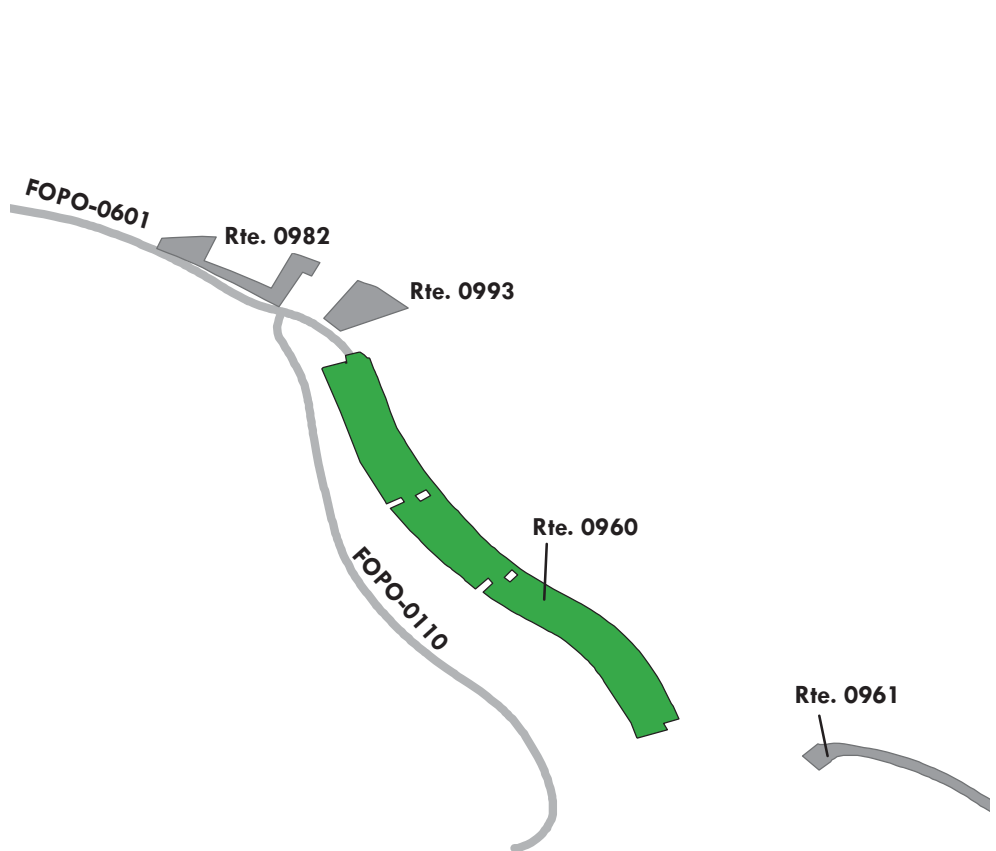
Inspection Date	FMSS Number	User Access	Surface Type
5/1/2014	38190	PUBLIC	ASPHALT
Area (Sq. Ft.)	Lane Miles (11' Widths)	Curb Reveal (Inches)	Curb Recommendation
51,558	0.888	4	DO NOTHING
Curb Type		Curb & Gutter Type	
ASPHALT		CONCRETE	
Pavement Recommendation		Condition Rating / PCR	
PREVENTIVE MAINTENANCE		GOOD / 90

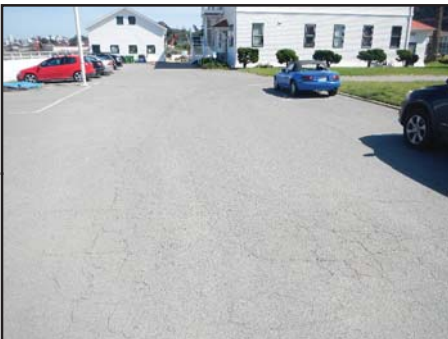
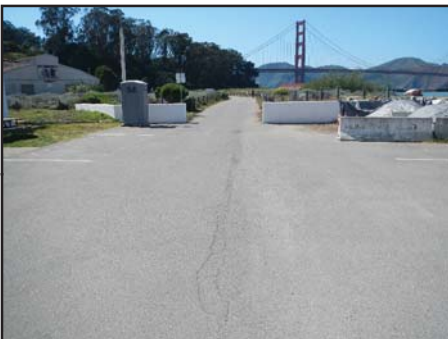
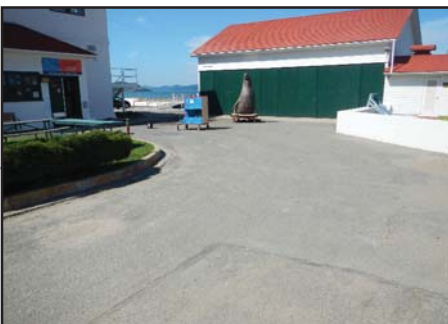
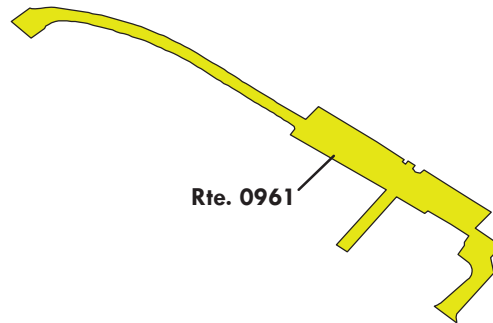
## ROUTE 0961: CRISSY FIELD OLD COAST GUARD STATION PARKING LOT

Inspection Date	FMSS Number	User Access	Surface Type
5/1/2014	80728	NONPUBLIC	ASPHALT
Area (Sq. Ft.)	Lane Miles (11' Widths)	Curb Reveal (Inches)	Curb Recommendation
24,986	0.43	1	MODERATE REPAIR
Curb Type		Curb & Gutter Type	
CONCRETE		CONCRETE	
Pavement Recommendation		Condition Rating / PCR	
LIGHT 3R TREATMENTS		FAIR / 73

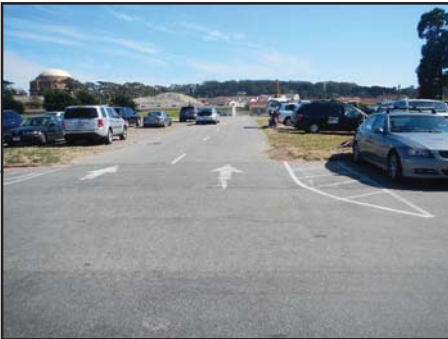
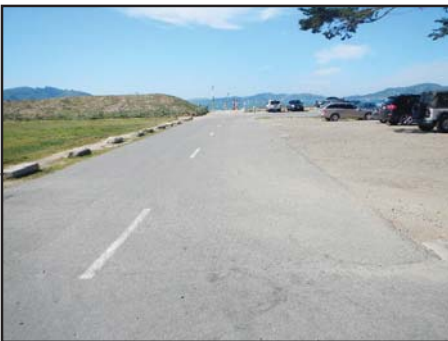
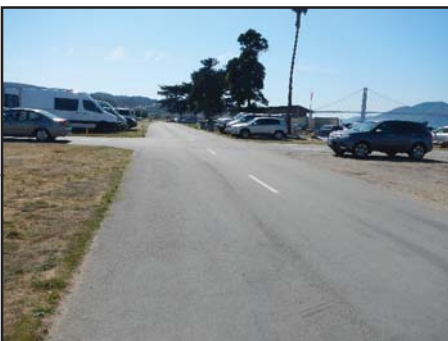
## ROUTE 0962: CRISSY FIELD PROMENADE PARKING EAST BEACH LOT

Inspection Date	FMSS Number	User Access	Surface Type
5/1/2014	38189	PUBLIC	ASPHALT
Area (Sq. Ft.)	Lane Miles (11' Widths)	Curb Reveal (Inches)	Curb Recommendation
104,329	1.796	4	LIGHT REPAIR
Curb Type		Curb & Gutter Type	
CONCRETE		NO CURB AND GUTTER	
Pavement Recommendation		Condition Rating / PCR	
PREVENTIVE MAINTENANCE		GOOD / 90

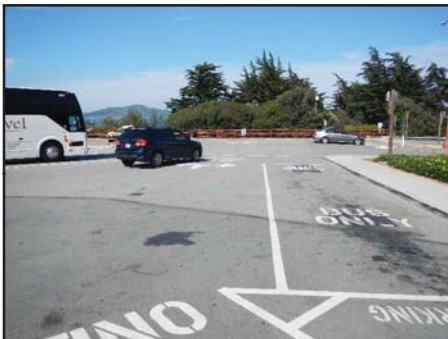
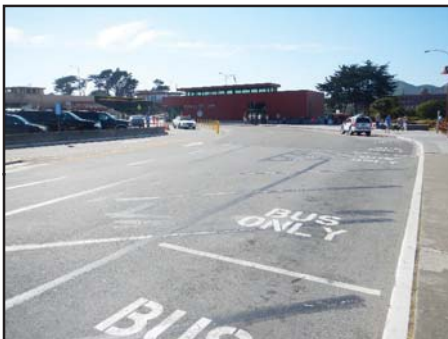
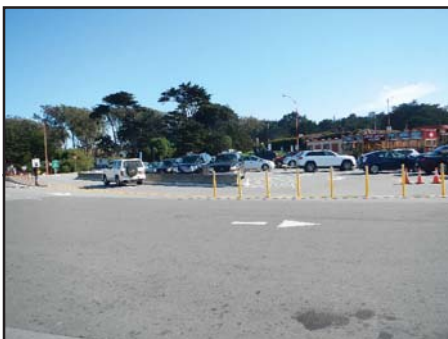
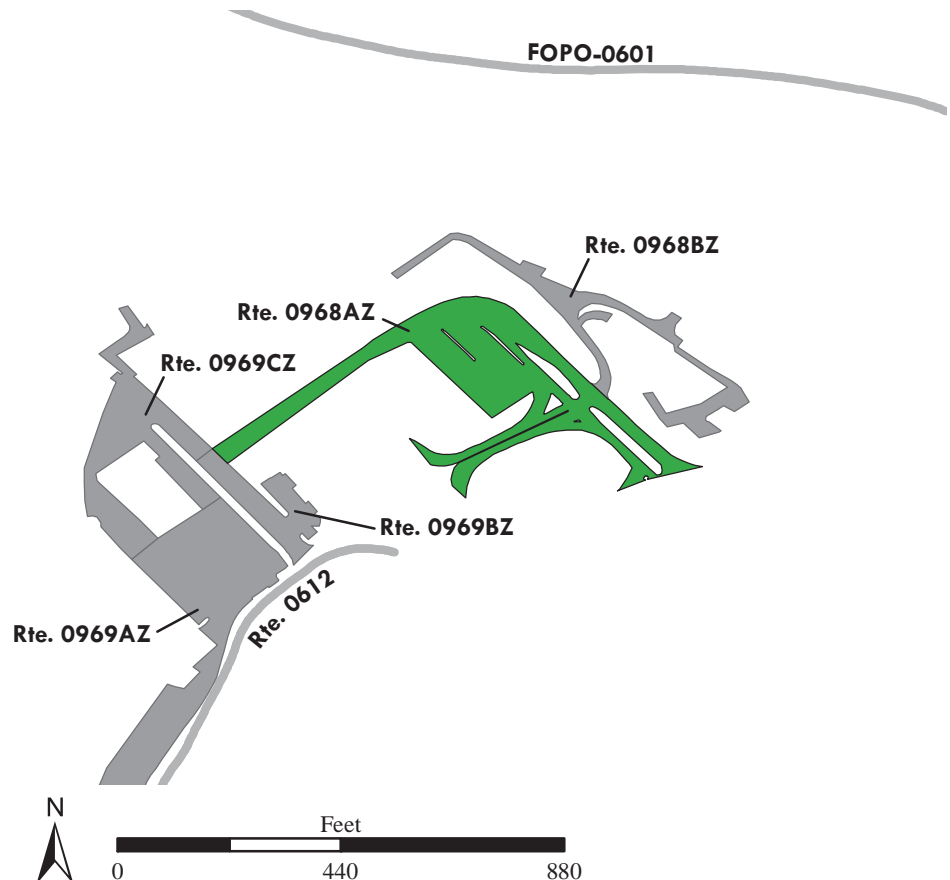
## ROUTE 0968AZ: GOLDEN GATE BRIDGE NORTHEAST PARKING LOT A

Inspection Date	FMSS Number	User Access	Surface Type
5/1/2014	104003	PUBLIC	ASPHALT
Area (Sq. Ft.)	Lane Miles (11' Widths)	Curb Reveal (Inches)	Curb Recommendation
69,400	1.195	4	DO NOTHING
Curb Type		Curb & Gutter Type	
CONCRETE		CONCRETE	
Pavement Recommendation		Condition Rating / PCR	
PREVENTIVE MAINTENANCE		GOOD / 90

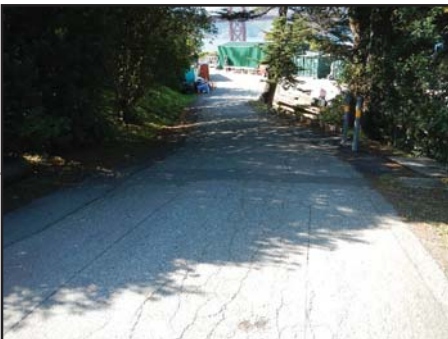
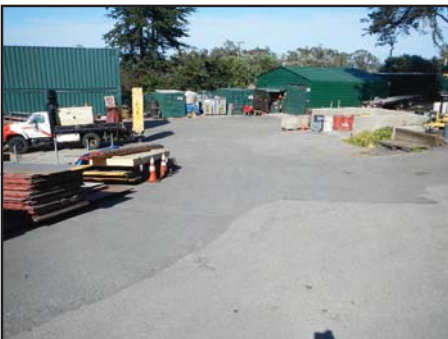
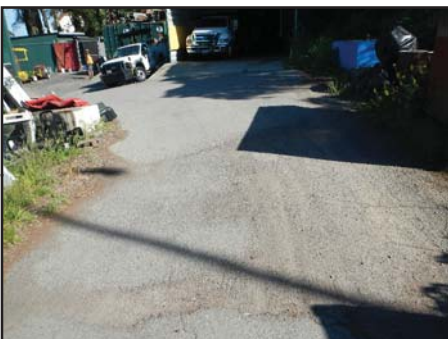
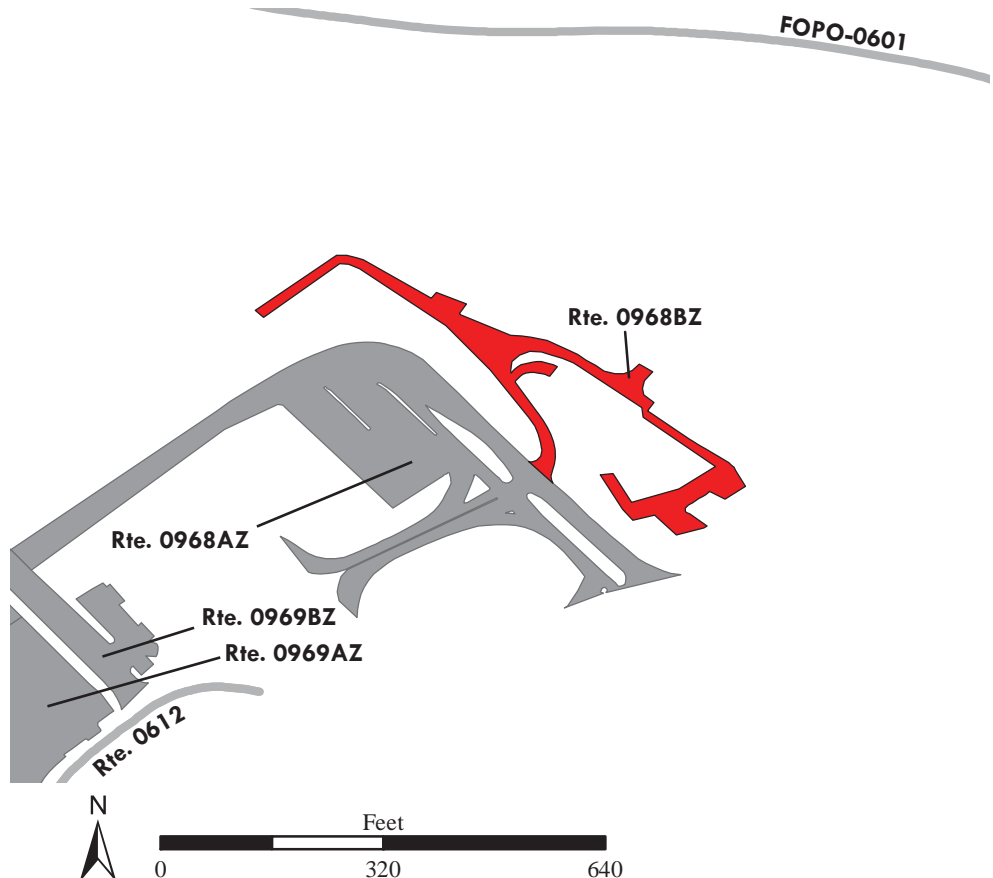
## ROUTE 0968BZ: GOLDEN GATE BRIDGE NORTHEAST PARKING LOT B

Inspection Date	FMSS Number	User Access	Surface Type
5/1/2014	104003	PUBLIC	ASPHALT
Area (Sq. Ft.)	Lane Miles (11' Widths)	Curb Reveal (Inches)	Curb Recommendation
22,388	0.385	NOT APPLICABLE	NOT APPLICABLE
Curb Type		Curb & Gutter Type	
NO CURB		NO CURB AND GUTTER	
Pavement Recommendation		Condition Rating / PCR	
HEAVY 3R TREATMENTS		POOR / 53

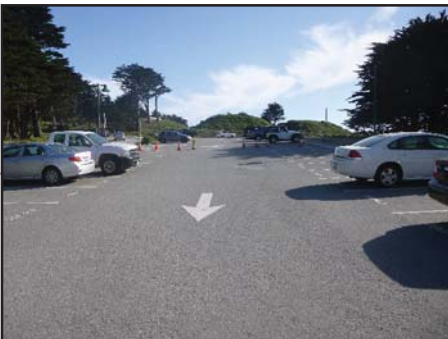
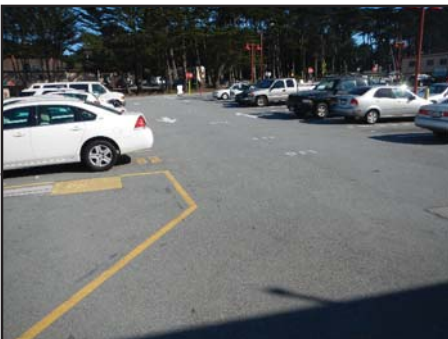
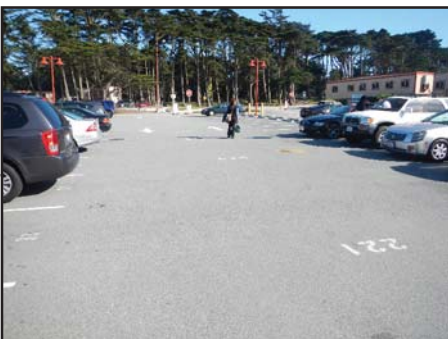
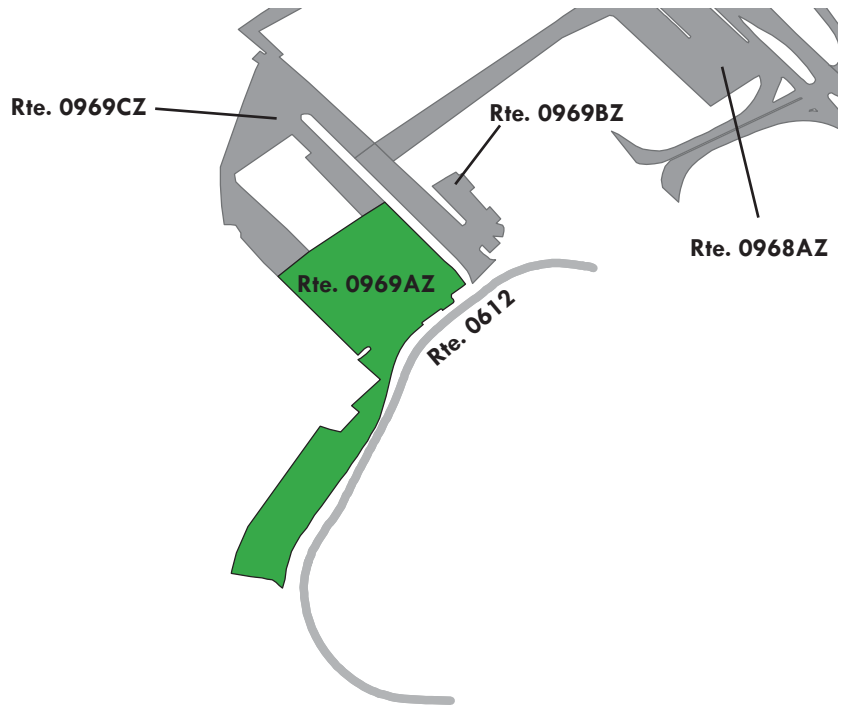
## ROUTE 0969AZ: GOLDEN GATE BRIDGE SOUTHWEST PARKING LOT A

Inspection Date	FMSS Number	User Access	Surface Type
5/1/2014	104004	PUBLIC	ASPHALT
Area (Sq. Ft.)	Lane Miles (11' Widths)	Curb Reveal (Inches)	Curb Recommendation
55,776	0.96	5	LIGHT REPAIR
Curb Type		Curb & Gutter Type	
CONCRETE		NO CURB AND GUTTER	
Pavement Recommendation		Condition Rating / PCR	
PREVENTIVE MAINTENANCE		GOOD / 90

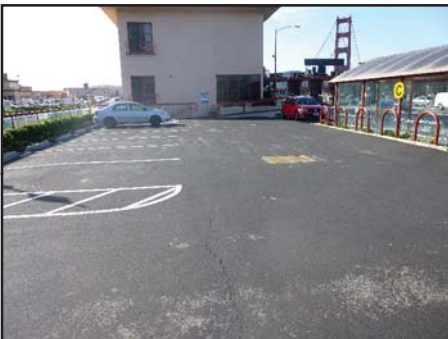
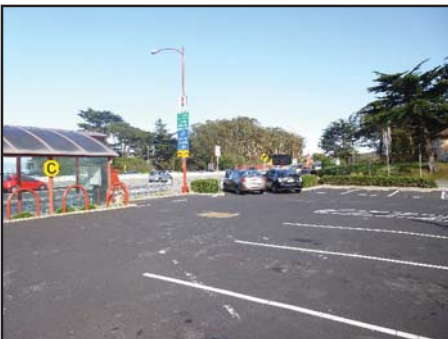
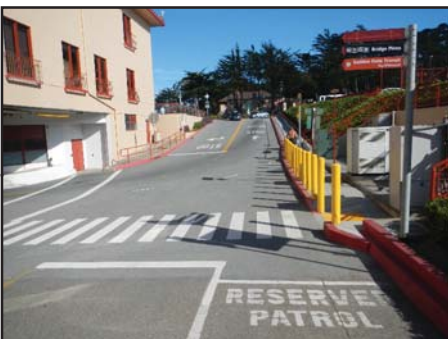
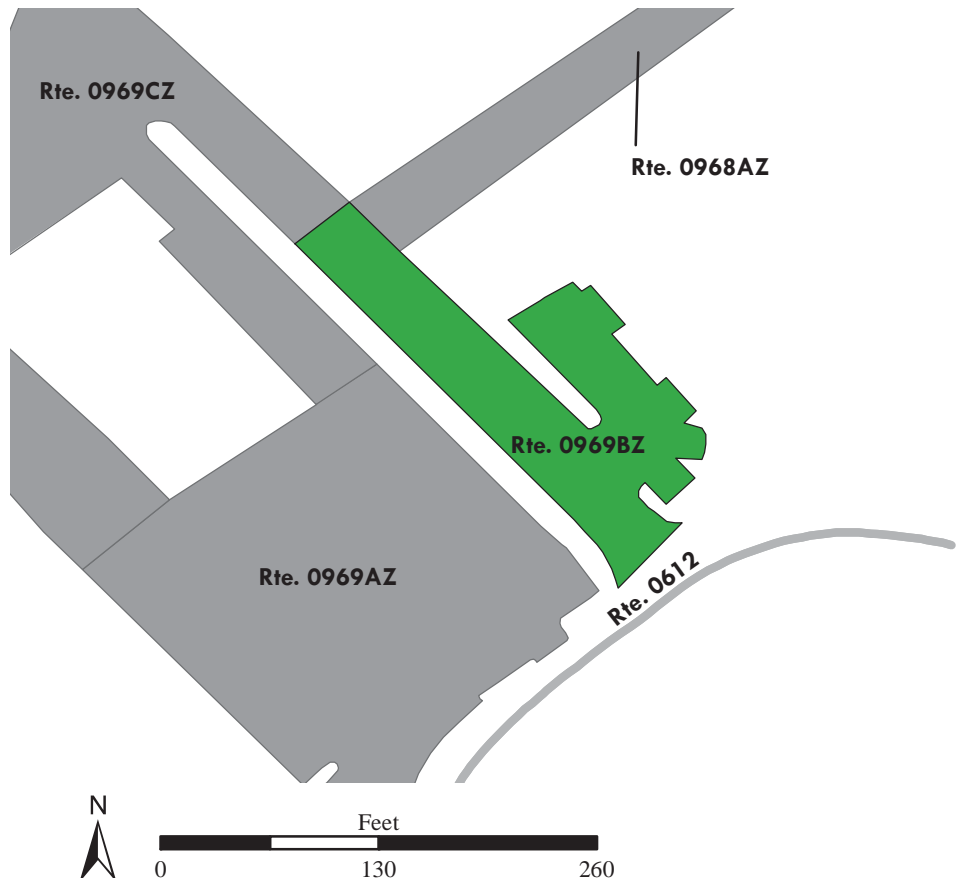
## ROUTE 0969BZ: GOLDEN GATE BRIDGE SOUTHWEST PARKING LOT B

Inspection Date	FMSS Number	User Access	Surface Type
5/1/2014	104004	PUBLIC	ASPHALT
Area (Sq. Ft.)	Lane Miles (11' Widths)	Curb Reveal (Inches)	Curb Recommendation
14,240	0.245	3	LIGHT REPAIR
Curb Type		Curb & Gutter Type	
CONCRETE		NO CURB AND GUTTER	
Pavement Recommendation		Condition Rating / PCR	
PREVENTIVE MAINTENANCE		GOOD / 90

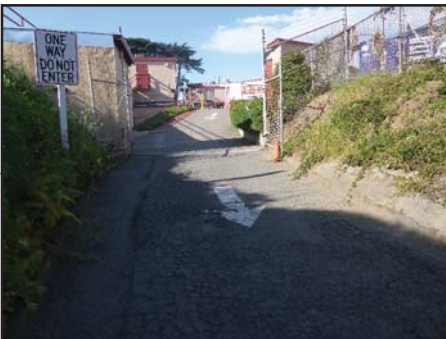
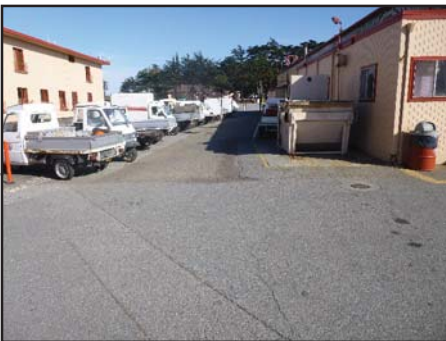
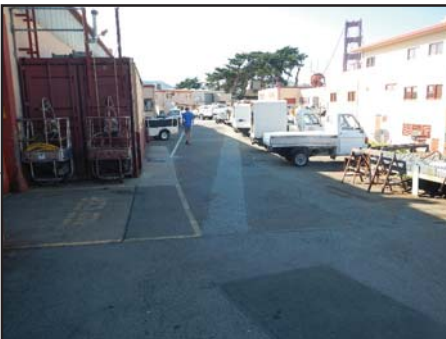
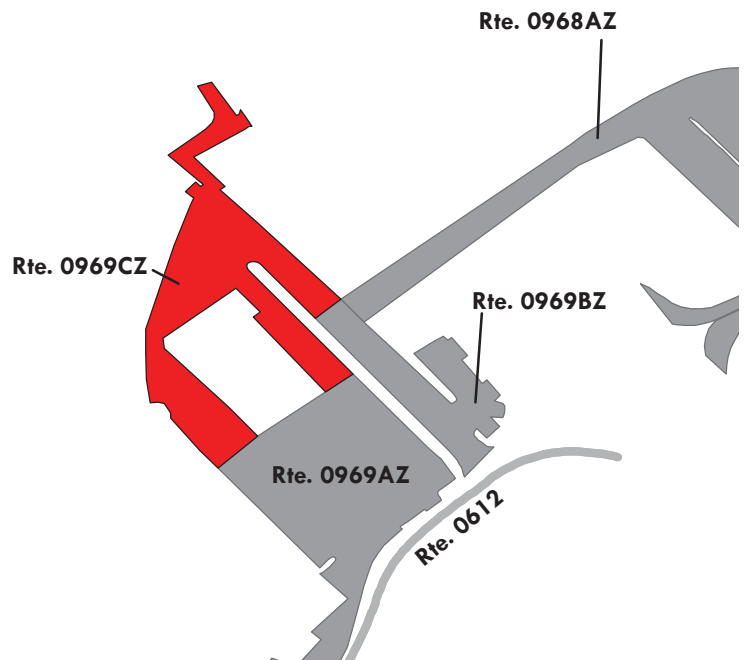
## ROUTE 0969CZ: GOLDEN GATE BRIDGE SOUTHWEST PARKING LOT C

Inspection Date	FMSS Number	User Access	Surface Type
5/1/2014	104004	PUBLIC	ASPHALT
Area (Sq. Ft.)	Lane Miles (11' Widths)	Curb Reveal (Inches)	Curb Recommendation
33,448	0.576	5	LIGHT REPAIR
Curb Type		Curb & Gutter Type	
CONCRETE		NO CURB AND GUTTER	
Pavement Recommendation		Condition Rating / PCR	
HEAVY 3R TREATMENTS		POOR / 53

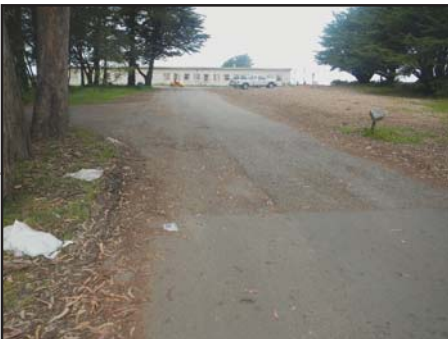
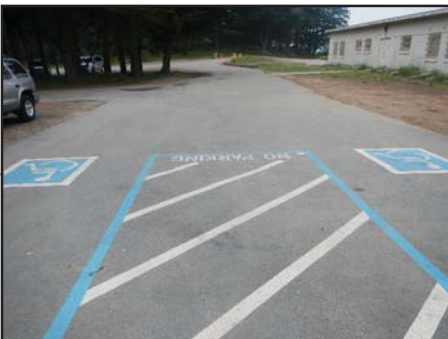
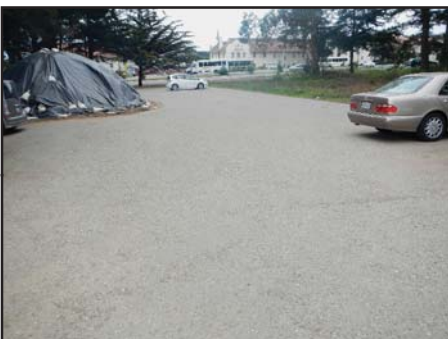
## ROUTE 0970: LANGDON COURT PARKING LOT

Inspection Date	FMSS Number	User Access	Surface Type
5/2/2014	92547	PUBLIC	ASPHALT
Area (Sq. Ft.)	Lane Miles (11' Widths)	Curb Reveal (Inches)	Curb Recommendation
20,105	0.346	6	DO NOTHING
Curb Type		Curb & Gutter Type	
WOOD		NO CURB AND GUTTER	
Pavement Recommendation		Condition Rating / PCR	
RECONSTRUCTION		POOR / 30

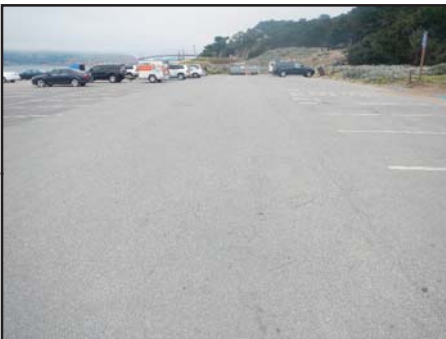
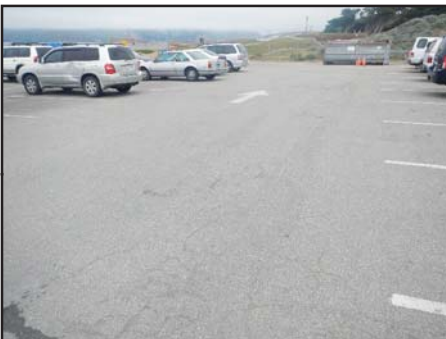
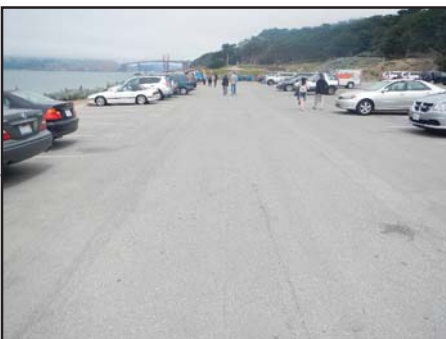
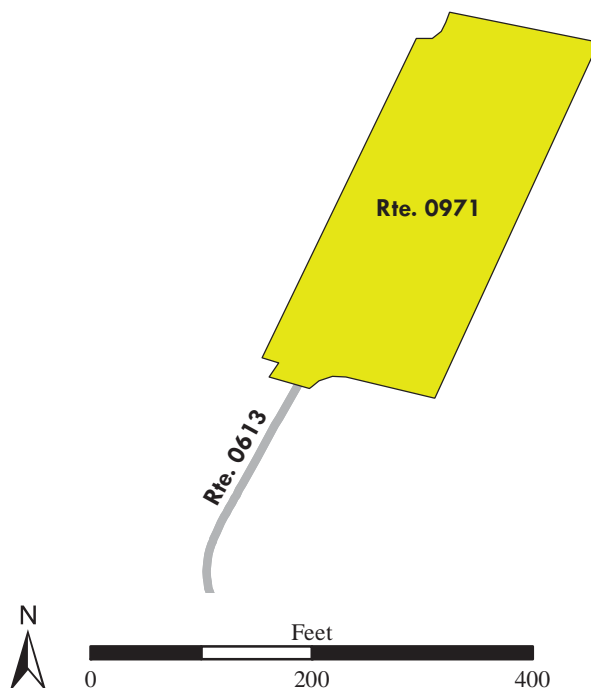
## ROUTE 0971: BAKER BEACH NORTH PARKING LOT

Inspection Date	FMSS Number	User Access	Surface Type
5/2/2014	38166	PUBLIC	ASPHALT
Area (Sq. Ft.)	Lane Miles (11' Widths)	Curb Reveal (Inches)	Curb Recommendation
42,999	0.74	NOT APPLICABLE	DO NOTHING
Curb Type		Curb & Gutter Type	
NO CURB		CONCRETE	
Pavement Recommendation		Condition Rating / PCR	
LIGHT 3R TREATMENTS		FAIR / 73

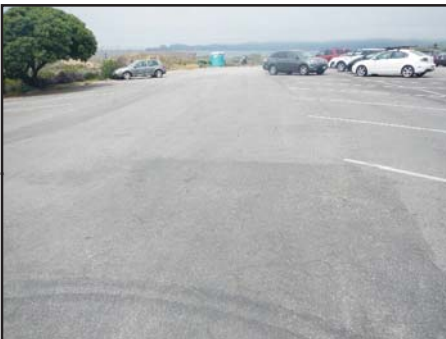
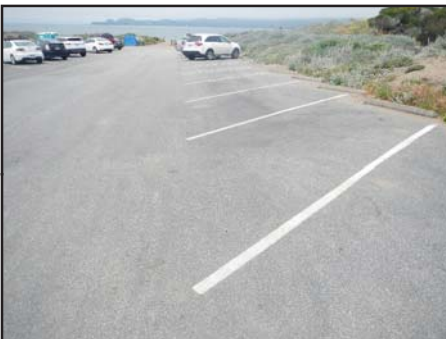
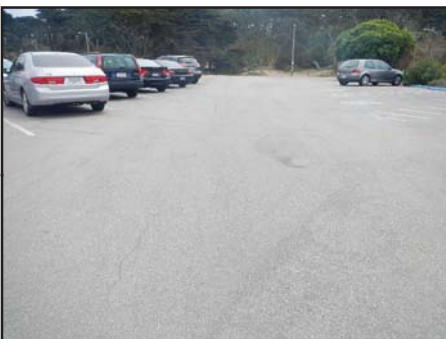
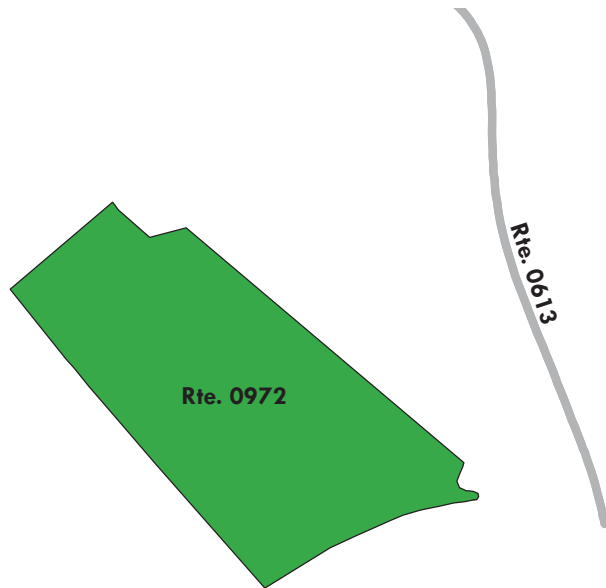
## ROUTE 0972: BAKER BEACH SOUTH PARKING LOT

Inspection Date	FMSS Number	User Access	Surface Type
5/2/2014	38168	PUBLIC	ASPHALT
Area (Sq. Ft.)	Lane Miles (11' Widths)	Curb Reveal (Inches)	Curb Recommendation
25,999	0.448	NOT APPLICABLE	NOT APPLICABLE
Curb Type		Curb & Gutter Type	
NO CURB		NO CURB AND GUTTER	
Pavement Recommendation		Condition Rating / PCR	
PREVENTIVE MAINTENANCE		GOOD / 90

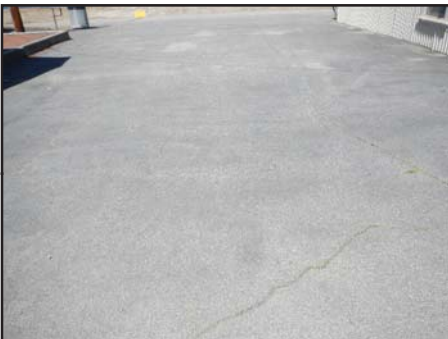
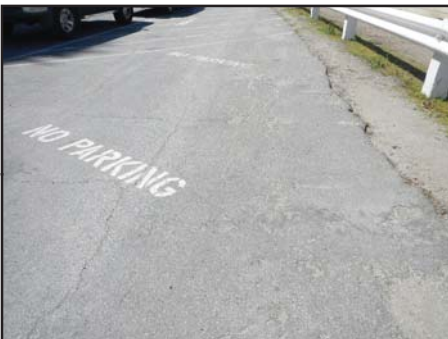
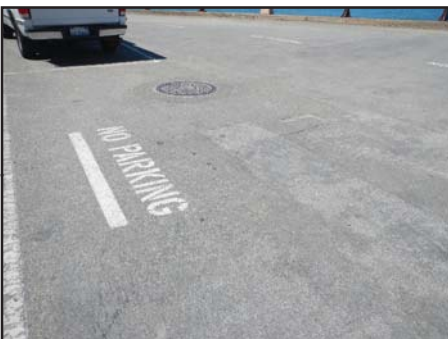
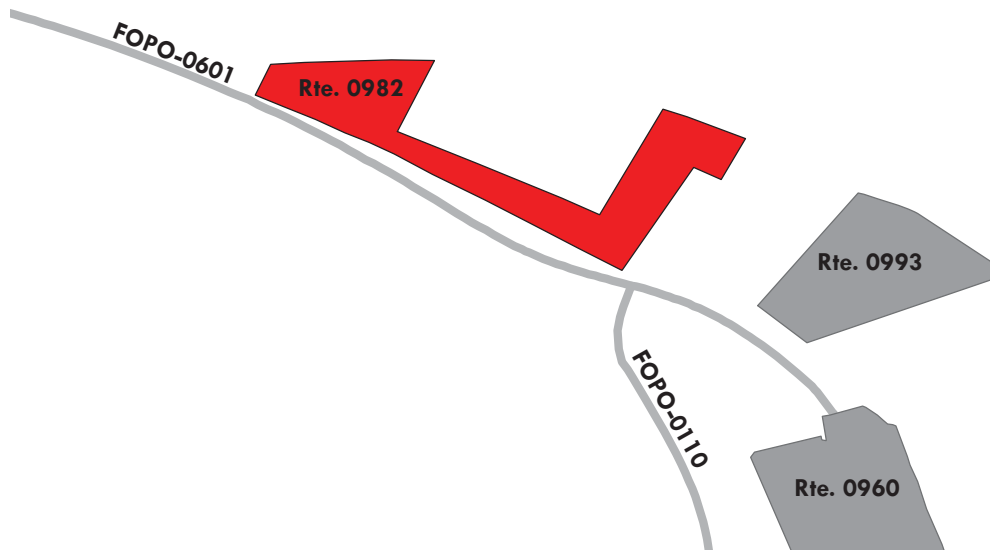
## ROUTE 0982: BUILDING 989 PARKING LOT

Inspection Date	FMSS Number	User Access	Surface Type
5/1/2014	38221	PUBLIC	ASPHALT
Area (Sq. Ft.)	Lane Miles (11' Widths)	Curb Reveal (Inches)	Curb Recommendation
6,916	0.119	NOT APPLICABLE	NOT APPLICABLE
Curb Type		Curb & Gutter Type	
NO CURB		NO CURB AND GUTTER	
Pavement Recommendation		Condition Rating / PCR	
HEAVY 3R TREATMENTS		POOR / 53

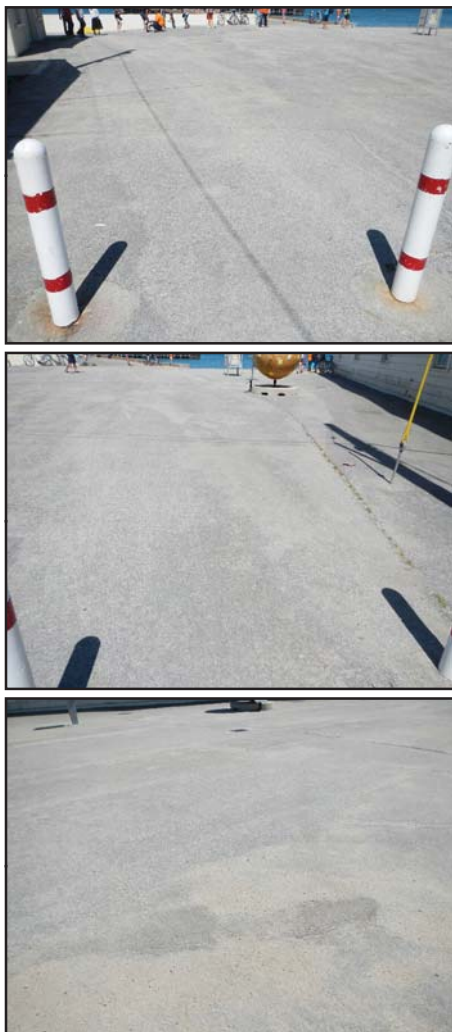
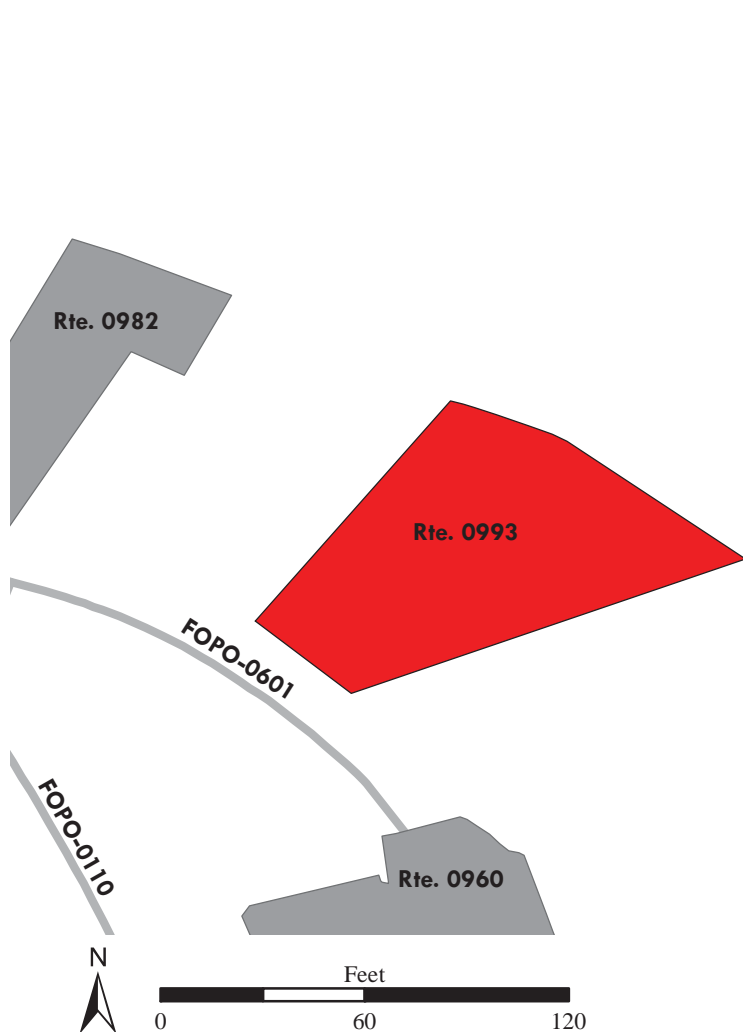
## ROUTE 0993: WARMING HUT PARKING LOT

Inspection Date	FMSS Number	User Access	Surface Type
5/1/2014	80725	NONPUBLIC	ASPHALT
Area (Sq. Ft.)	Lane Miles (11' Widths)	Curb Reveal (Inches)	Curb Recommendation
4,898	0.084	NOT APPLICABLE	NOT APPLICABLE
Curb Type		Curb & Gutter Type	
NO CURB		NO CURB AND GUTTER	
Pavement Recommendation		Condition Rating / PCR	
HEAVY 3R TREATMENTS		POOR / 53
