ROCA Cycle 6

Final Report

Road Inventory and Condition Assessment of Paved Routes Roosevelt Campobello International Park

Report Date: November 2020

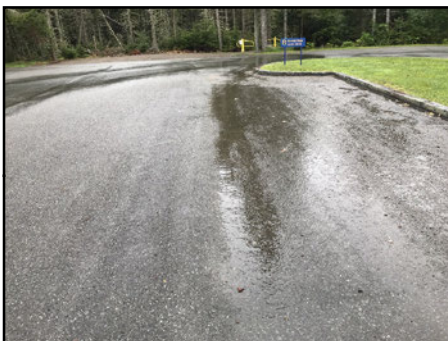
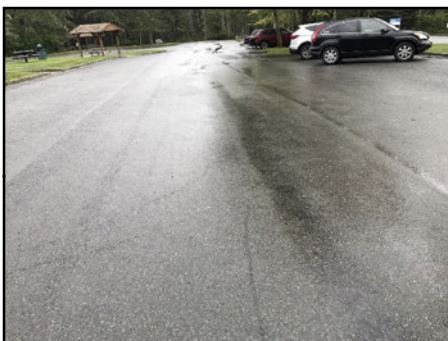
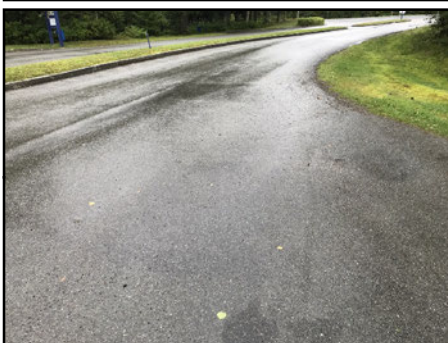
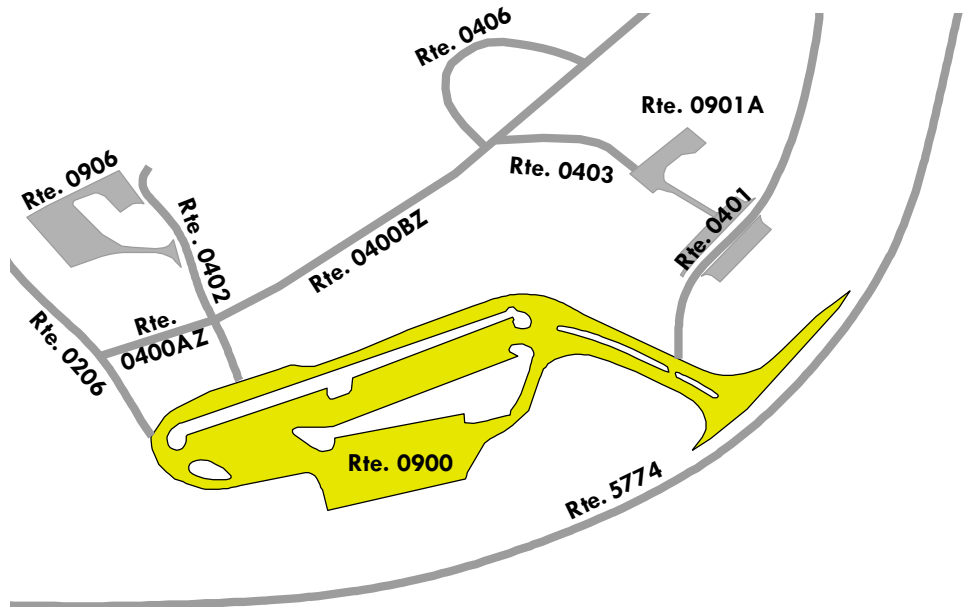
Inspection Date	FMSS Number	User Access	Surface Type
9/11/2019	N/A	PUBLIC	ASPHALT
Area (Sq. Ft.)	Lane Miles (11' Widths)	Curb Reveal (Inches)	Curb Recommendation
82,102	1.414	5	DO NOTHING
Curb Type		Curb & Gutter Type	
STONE		NO CURB AND GUTTER	
Pavement Recommendation		Condition Rating / PCR	
LIGHT 3R TREATMENTS		FAIR / 73

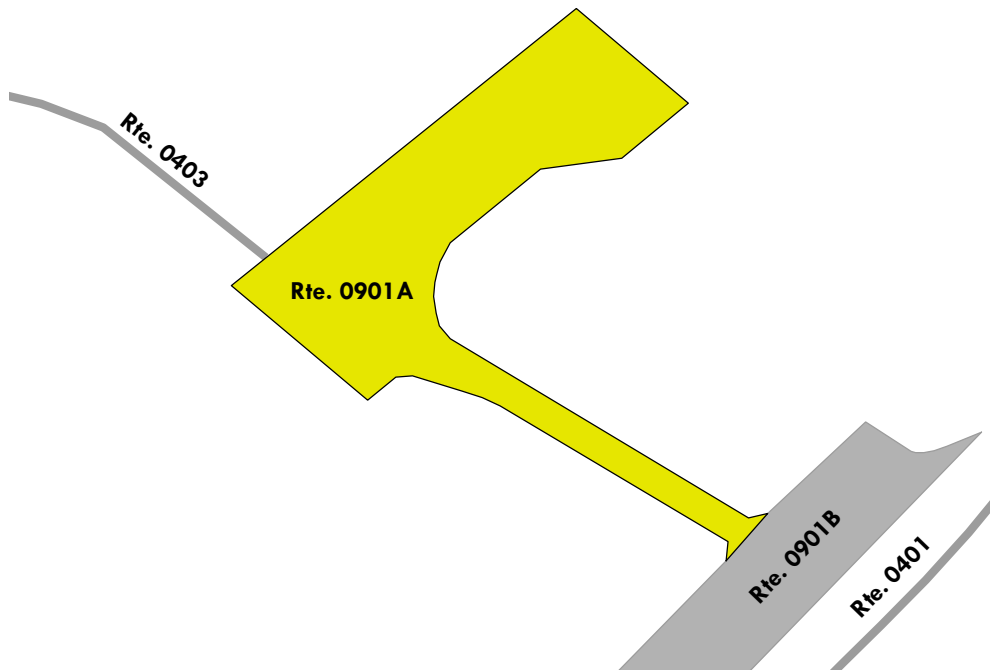
ROUTE 0901A: STAFF PARKING A

Inspection Date	FMSS Number	User Access	Surface Type
9/11/2019	N/A	NONPUBLIC	ASPHALT
Area (Sq. Ft.)	Lane Miles (11' Widths)	Curb Reveal (Inches)	Curb Recommendation
3,676	0.063	4	LIGHT REPAIR
Curb Type		Curb & Gutter Type	
CONCRETE		NO CURB AND GUTTER	
Pavement Recommendation		Condition Rating / PCR	
LIGHT 3R TREATMENTS		FAIR / 73

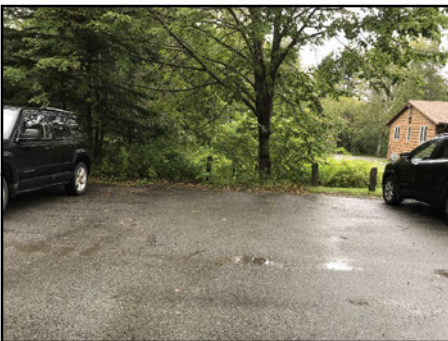
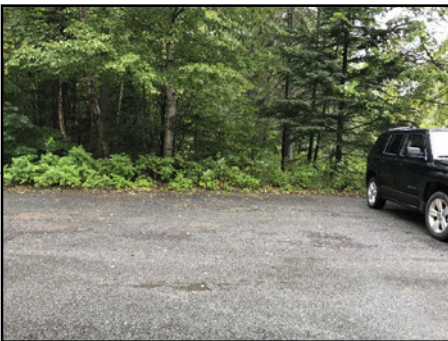
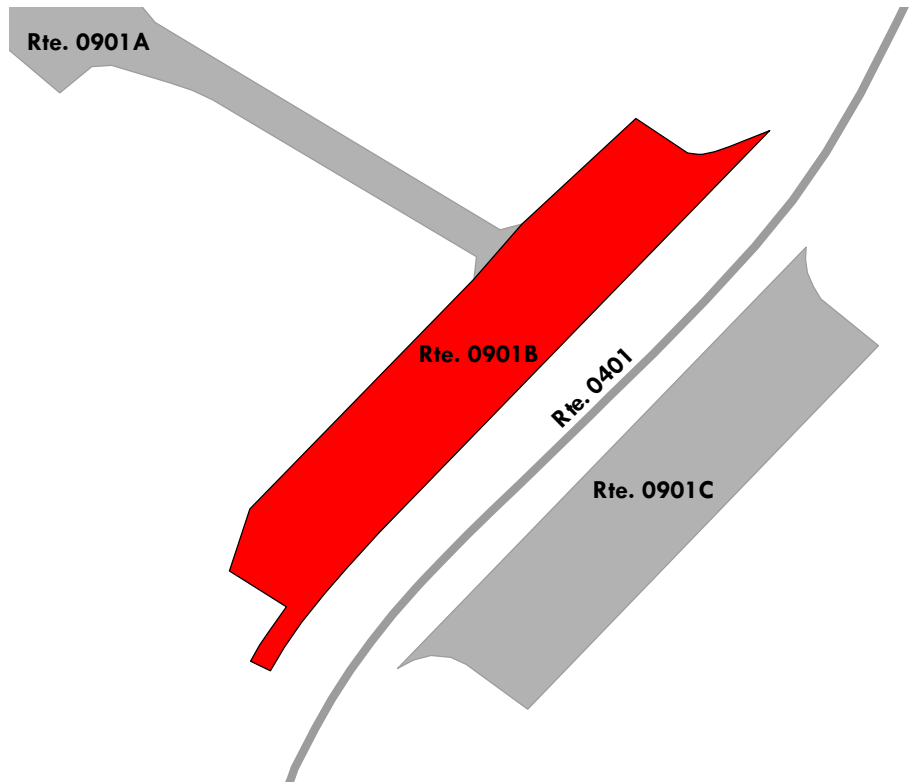
ROUTE 0901B: STAFF PARKING B

Inspection Date	FMSS Number	User Access	Surface Type
9/11/2019	N/A	NONPUBLIC	ASPHALT
Area (Sq. Ft.)	Lane Miles (11' Widths)	Curb Reveal (Inches)	Curb Recommendation
2,608	0.045	4	DO NOTHING
Curb Type		Curb & Gutter Type	
CONCRETE		NO CURB AND GUTTER	
Pavement Recommendation		Condition Rating / PCR	
HEAVY 3R TREATMENTS		POOR / 53

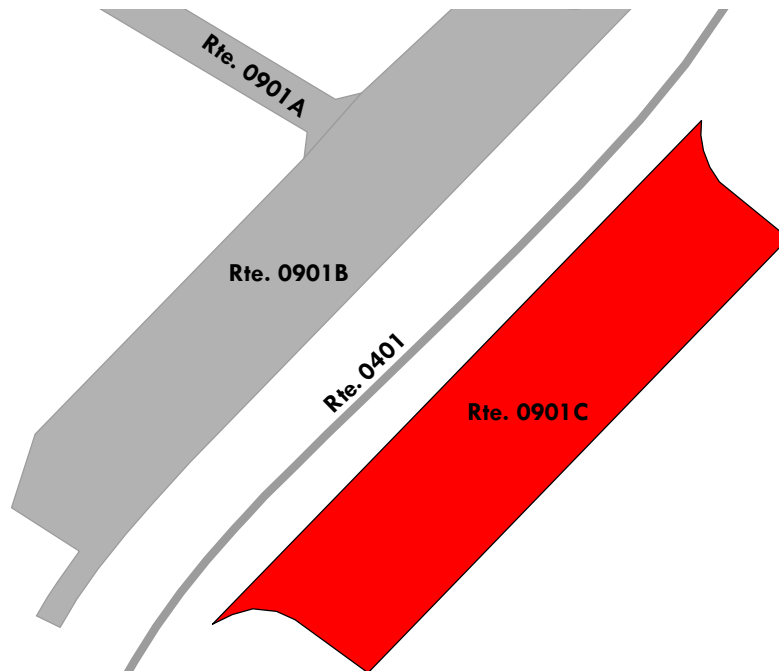
ROUTE 0901C: STAFF PARKING C

Inspection Date	FMSS Number	User Access	Surface Type
9/11/2019	N/A	NONPUBLIC	ASPHALT
Area (Sq. Ft.)	Lane Miles (11' Widths)	Curb Reveal (Inches)	Curb Recommendation
2,392	0.041	NOT APPLICABLE	NOT APPLICABLE
Curb Type		Curb & Gutter Type	
NO CURB		NO CURB AND GUTTER	
Pavement Recommendation		Condition Rating / PCR	
HEAVY 3R TREATMENTS		POOR / 53

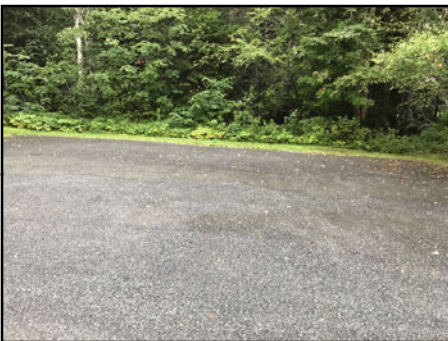
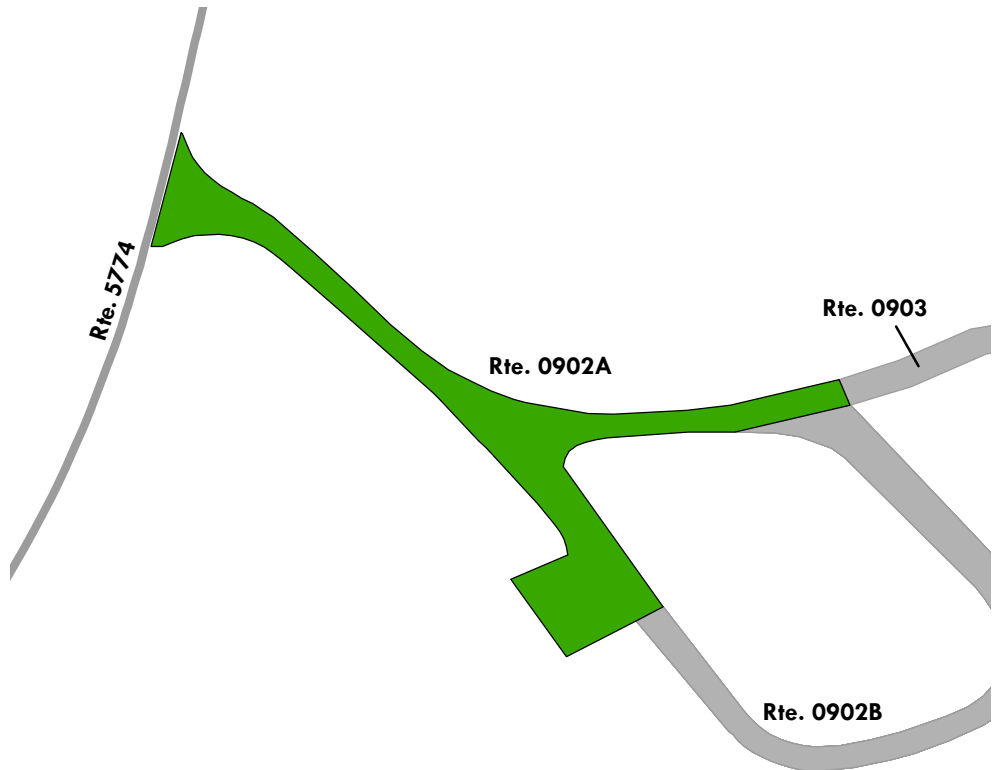
ROUTE 0902A: JOHNSTON COTTAGE PARKING

Inspection Date	FMSS Number	User Access	Surface Type
9/11/2019	N/A	PUBLIC	ASPHALT
Area (Sq. Ft.)	Lane Miles (11' Widths)	Curb Reveal (Inches)	Curb Recommendation
8,837	0.152	NOT APPLICABLE	NOT APPLICABLE
Curb Type		Curb & Gutter Type	
NO CURB		NO CURB AND GUTTER	
Pavement Recommendation		Condition Rating / PCR	
PREVENTIVE MAINTENANCE		GOOD / 90

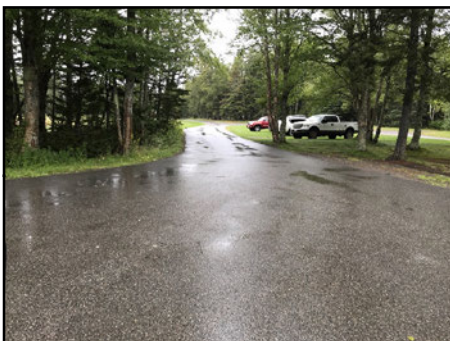
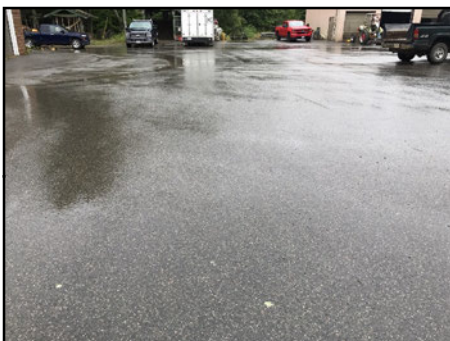
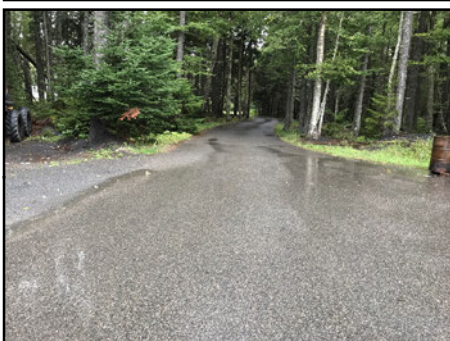
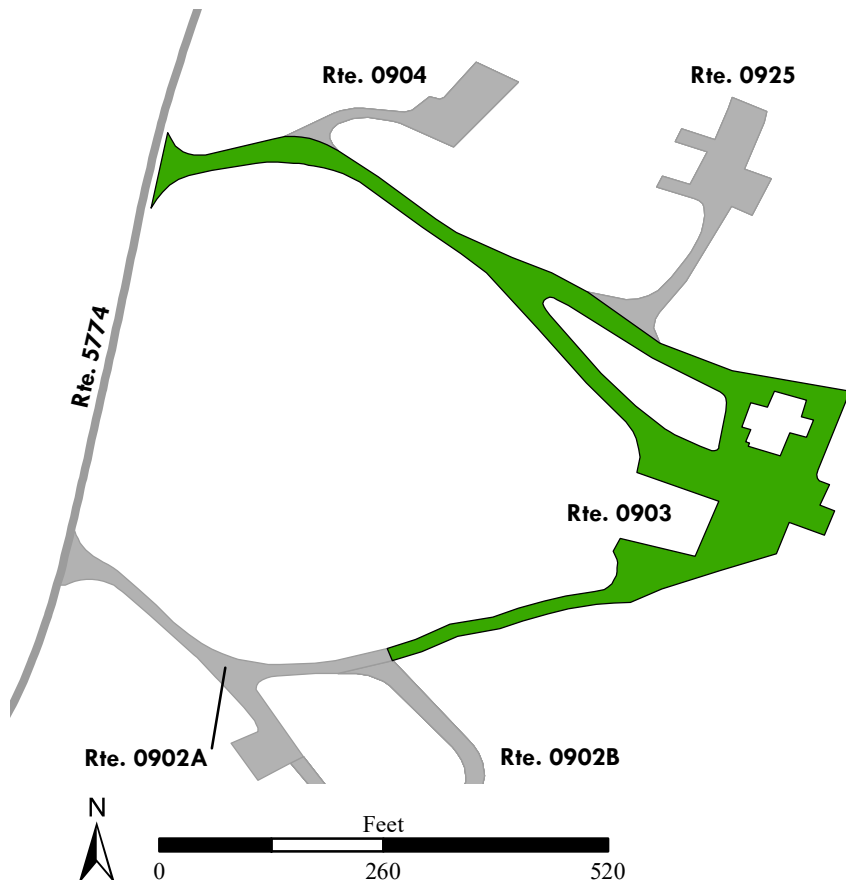
ROUTE 0903: MAINTENANCE AREA PARKING

Inspection Date	FMSS Number	User Access	Surface Type
9/11/2019	N/A	NONPUBLIC	ASPHALT
Area (Sq. Ft.)	Lane Miles (11' Widths)	Curb Reveal (Inches)	Curb Recommendation
42,508	0.732	NOT APPLICABLE	NOT APPLICABLE
Curb Type		Curb & Gutter Type	
NO CURB		NO CURB AND GUTTER	
Pavement Recommendation		Condition Rating / PCR	
PREVENTIVE MAINTENANCE		GOOD / 90

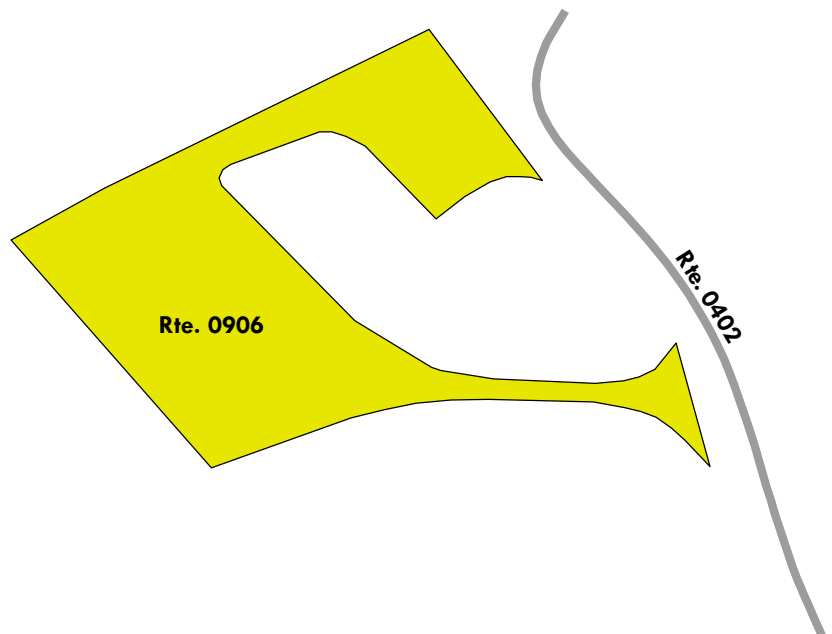
ROUTE 0906: PRINCE COTTAGE PARKING

Inspection Date	FMSS Number	User Access	Surface Type
9/11/2019	N/A	PUBLIC	ASPHALT
Area (Sq. Ft.)	Lane Miles (11' Widths)	Curb Reveal (Inches)	Curb Recommendation
8,913	0.153	NOT APPLICABLE	NOT APPLICABLE
Curb Type		Curb & Gutter Type	
NO CURB		NO CURB AND GUTTER	
Pavement Recommendation		Condition Rating / PCR	
LIGHT 3R TREATMENTS		FAIR / 73

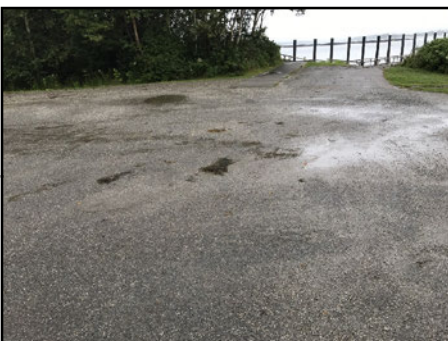
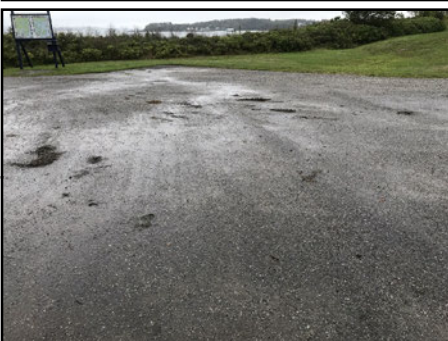
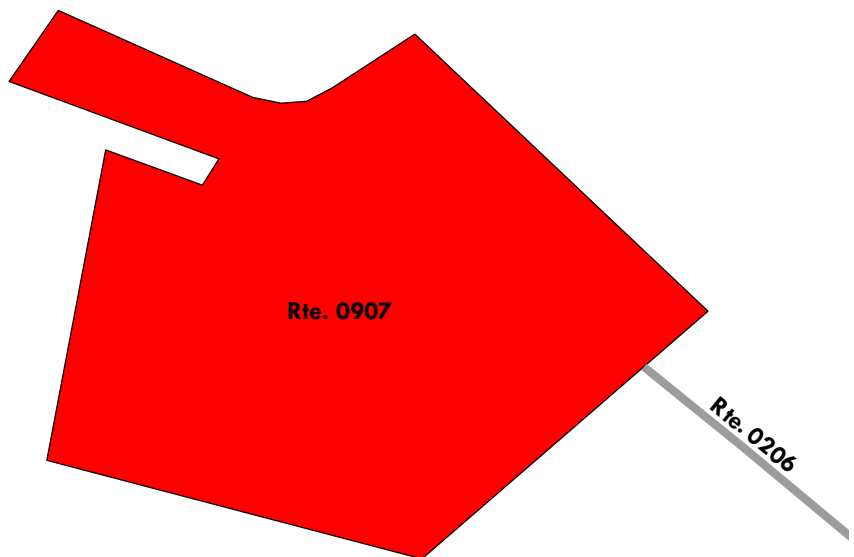
ROUTE 0907: DOCK PARKING

Inspection Date	FMSS Number	User Access	Surface Type
9/11/2019	N/A	PUBLIC	ASPHALT
Area (Sq. Ft.)	Lane Miles (11' Widths)	Curb Reveal (Inches)	Curb Recommendation
6,200	0.107	NOT APPLICABLE	NOT APPLICABLE
Curb Type		Curb & Gutter Type	
NO CURB		NO CURB AND GUTTER	
Pavement Recommendation		Condition Rating / PCR	
HEAVY 3R TREATMENTS		POOR / 53

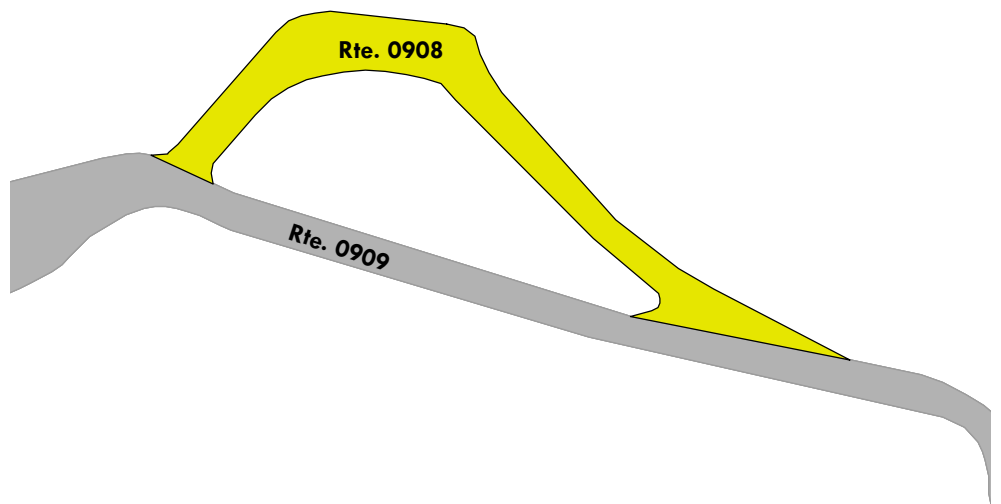
ROUTE 0908: FRIARS HEAD HANDICAPPED PARKING

Inspection Date	FMSS Number	User Access	Surface Type
9/11/2019	N/A	PUBLIC	ASPHALT
Area (Sq. Ft.)	Lane Miles (11' Widths)	Curb Reveal (Inches)	Curb Recommendation
6,442	0.111	NOT APPLICABLE	NOT APPLICABLE
Curb Type		Curb & Gutter Type	
NO CURB		NO CURB AND GUTTER	
Pavement Recommendation		Condition Rating / PCR	
LIGHT 3R TREATMENTS		FAIR / 73

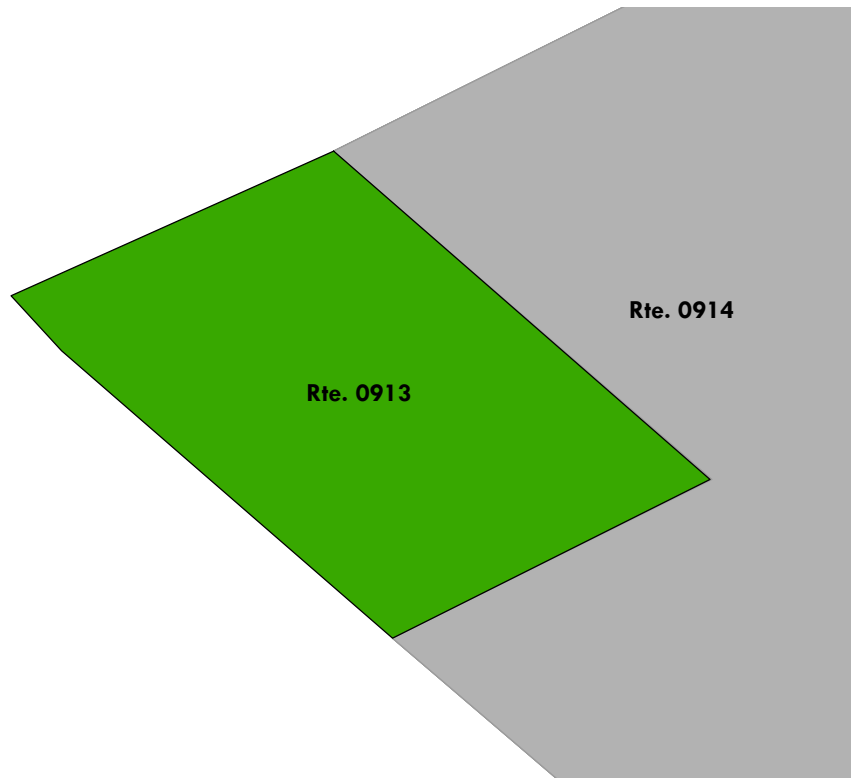
ROUTE 0913: EAGLE BOG HANDICAPPED PARKING

Inspection Date	FMSS Number	User Access	Surface Type
9/11/2019	N/A	PUBLIC	ASPHALT
Area (Sq. Ft.)	Lane Miles (11' Widths)	Curb Reveal (Inches)	Curb Recommendation
1,342	0.023	NOT APPLICABLE	NOT APPLICABLE
Curb Type		Curb & Gutter Type	
NO CURB		NO CURB AND GUTTER	
Pavement Recommendation		Condition Rating / PCR	
PREVENTIVE MAINTENANCE		GOOD / 90

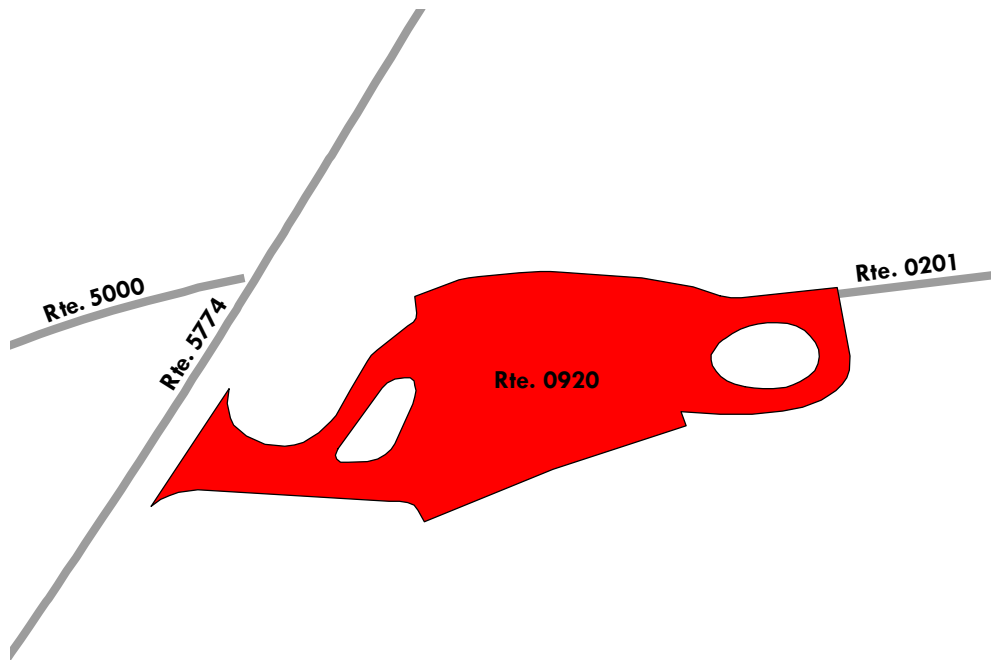
ROUTE 0920: ADVENTURE CENTER PARKING

Inspection Date	FMSS Number	User Access	Surface Type
9/11/2019	N/A	PUBLIC	ASPHALT
Area (Sq. Ft.)	Lane Miles (11' Widths)	Curb Reveal (Inches)	Curb Recommendation
24,733	0.426	NOT APPLICABLE	NOT APPLICABLE
Curb Type		Curb & Gutter Type	
NO CURB		NO CURB AND GUTTER	
Pavement Recommendation		Condition Rating / PCR	
HEAVY 3R TREATMENTS		POOR / 53
