SAAN Cycle 6

Final Report

Road Inventory and Condition Assessment of Paved Routes San Antonio Missions National Historical Park

Report Date: May 2017

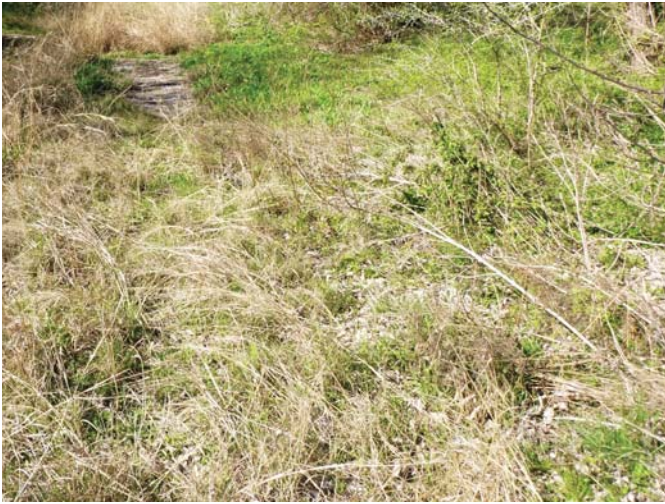
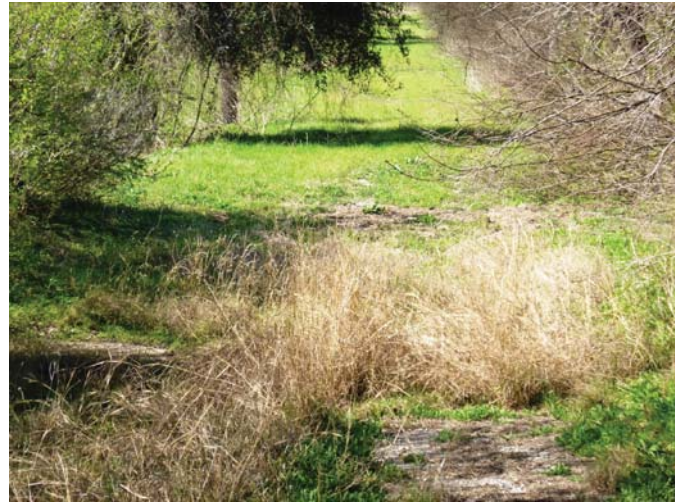
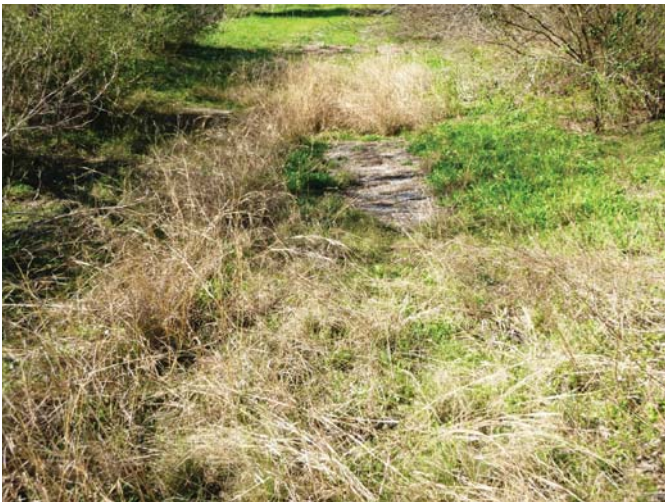
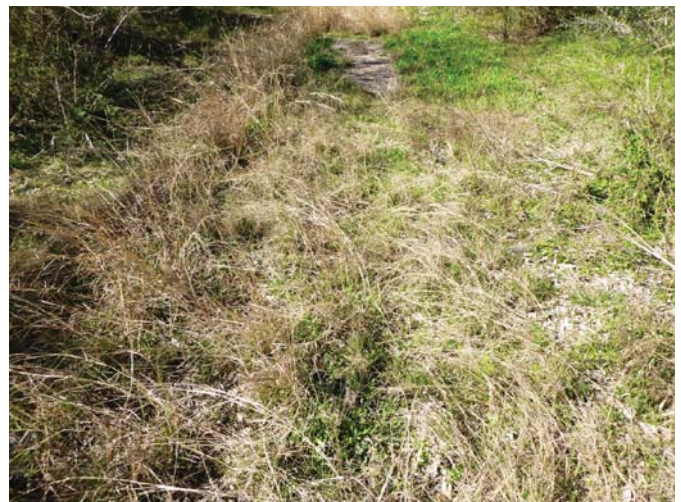
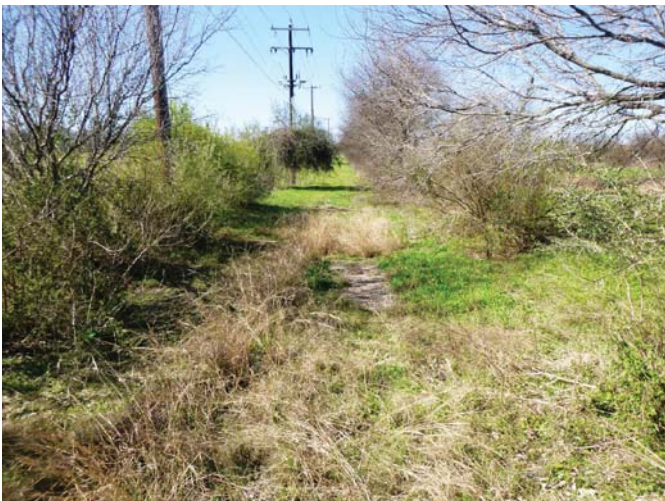
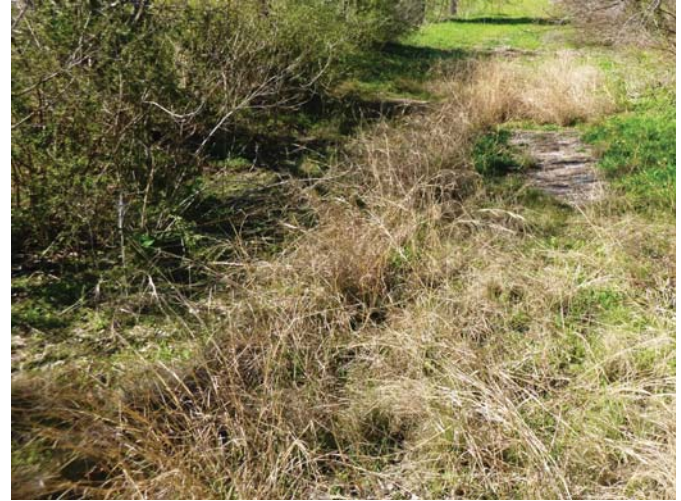
ROUTE 0406: FINLEY ROAD

NOTE: Route is in very poor condition and covered by overgrown grass.
