# SACN Cycle 6

## Final Report

### Road Inventory and Condition Assessment of Paved Routes St. Croix National Scenic Riverway

**Report Date: August 2019**

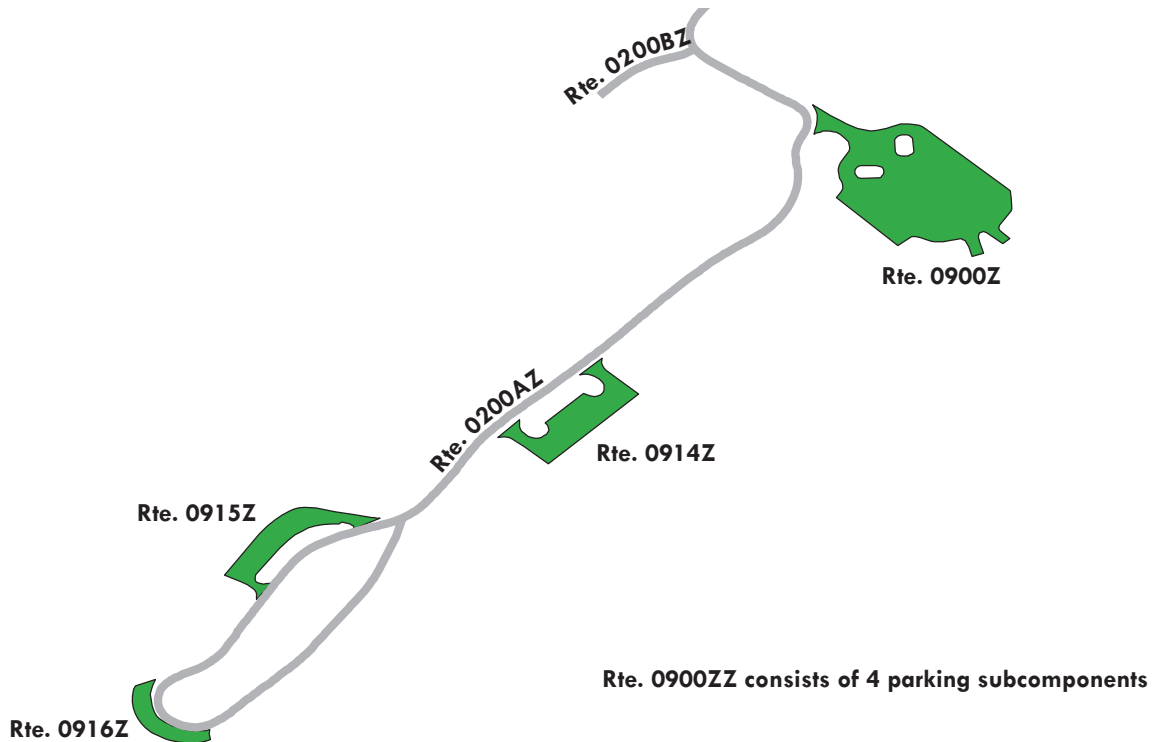
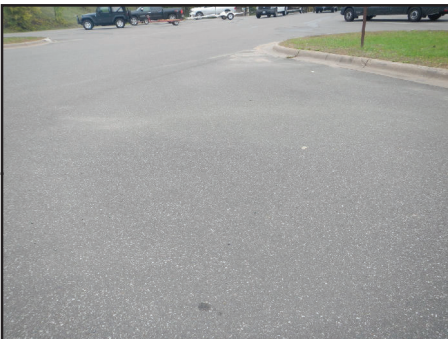
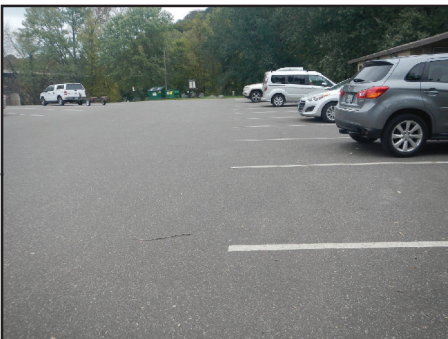
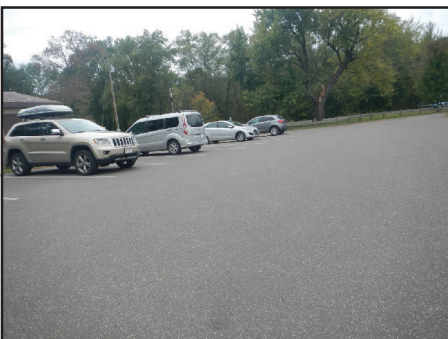
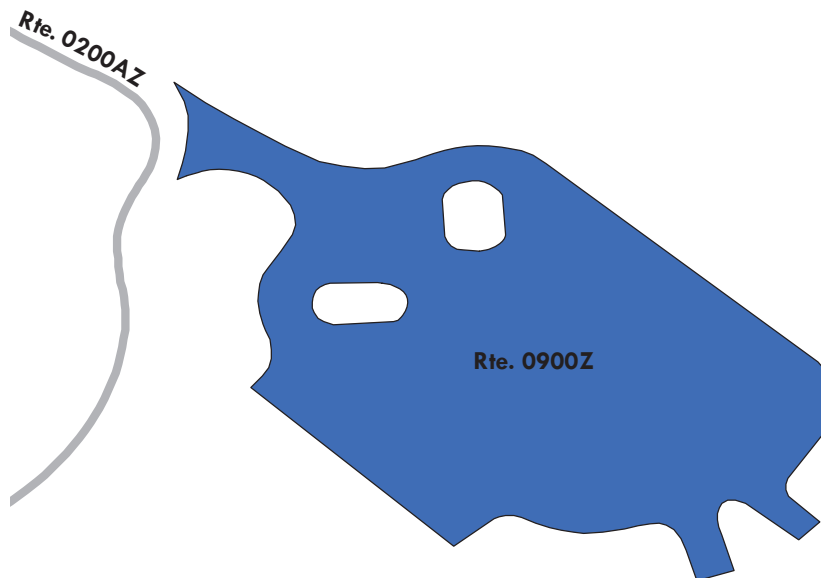
## ROUTE 0900Z: OSCEOLA LANDING MAIN PARKING

Inspection Date	FMSS Number	User Access	Surface Type
9/30/2018	24192	PUBLIC	ASPHALT
Area (Sq. Ft.)	Lane Miles (11' Widths)	Curb Reveal (Inches)	Curb Recommendation
42,185	0.726	6	DO NOTHING
Curb Type		Curb & Gutter Type	
ASPHALT		CONCRETE	
Pavement Recommendation		Condition Rating / PCR	
DO NOTHING		EXCELLENT / 97

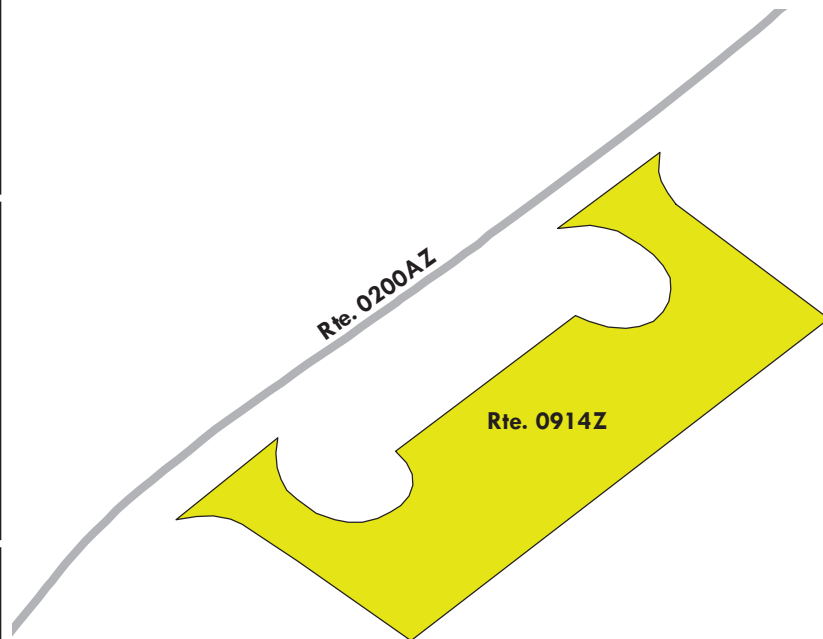
## ROUTE 0914Z: OSCEOLA SHELTER 1 PARKING

Inspection Date	FMISS Number	User Access	Surface Type
9/30/2018	24192	PUBLIC	ASPHALT
Area (Sq. Ft.)	Lane Miles (11' Widths)	Curb Reveal (Inches)	Curb Recommendation
11,440	0.197	NOT APPLICABLE	NOT APPLICABLE
Curb Type		Curb & Gutter Type	
NO CURB		NO CURB AND GUTTER	
Pavement Recommendation		Condition Rating / PCR	
LIGHT 3R TREATMENTS		FAIR / 73

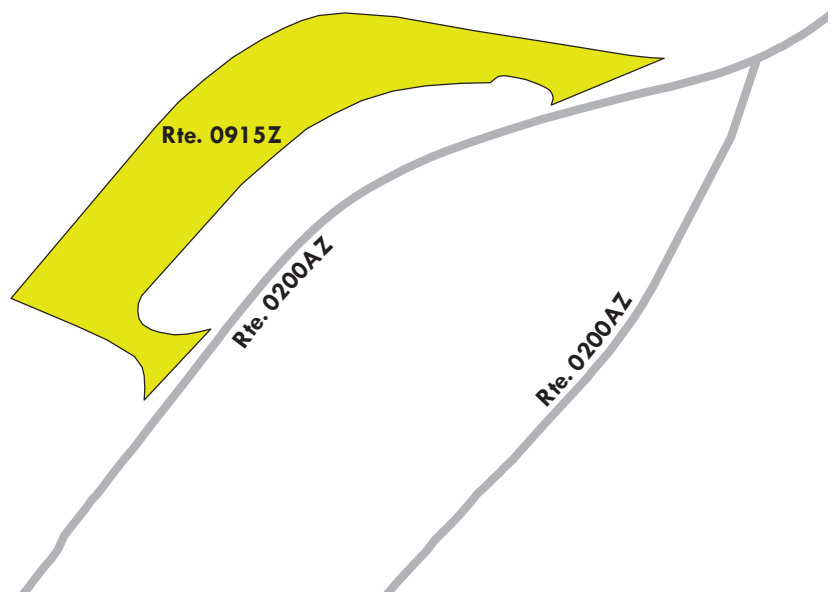
## ROUTE 0915Z: OSCEOLA BEACH PARKING

Inspection Date	FMSS Number	User Access	Surface Type
9/30/2018	24192	PUBLIC	ASPHALT
Area (Sq. Ft.)	Lane Miles (11' Widths)	Curb Reveal (Inches)	Curb Recommendation
9,303	0.16	NOT APPLICABLE	NOT APPLICABLE
Curb Type		Curb & Gutter Type	
NO CURB		NO CURB AND GUTTER	
Pavement Recommendation		Condition Rating / PCR	
LIGHT 3R TREATMENTS		FAIR / 73

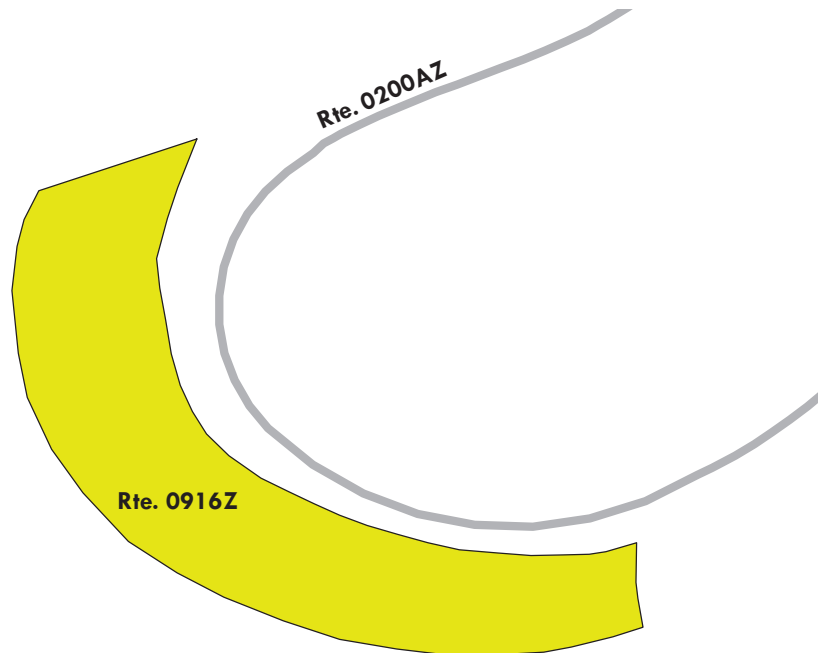
## ROUTE 0916Z: OSCEOLA SHELTER 2 PARKING

Inspection Date	FMISS Number	User Access	Surface Type
9/30/2018	24192	PUBLIC	ASPHALT
Area (Sq. Ft.)	Lane Miles (11' Widths)	Curb Reveal (Inches)	Curb Recommendation
4,434	0.076	NOT APPLICABLE	NOT APPLICABLE
Curb Type		Curb & Gutter Type	
NO CURB		NO CURB AND GUTTER	
Pavement Recommendation		Condition Rating / PCR	
LIGHT 3R TREATMENTS		FAIR / 73

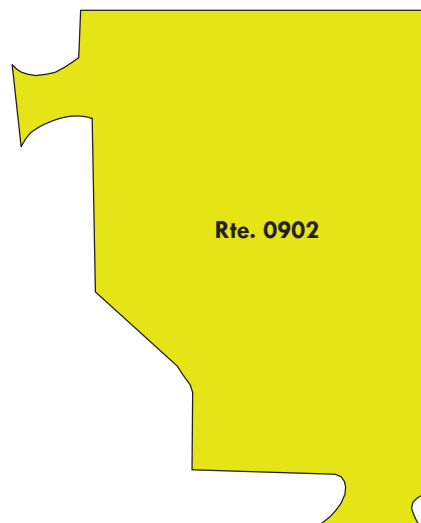
## ROUTE 0902: HEADQUARTERS PARKING

Inspection Date	FMSS Number	User Access	Surface Type
9/30/2018	23819	PUBLIC	ASPHALT
Area (Sq. Ft.)	Lane Miles (11' Widths)	Curb Reveal (Inches)	Curb Recommendation
27,316	0.47	NOT APPLICABLE	NOT APPLICABLE
Curb Type		Curb & Gutter Type	
NO CURB		NO CURB AND GUTTER	
Pavement Recommendation		Condition Rating / PCR	
LIGHT 3R TREATMENTS		FAIR / 73

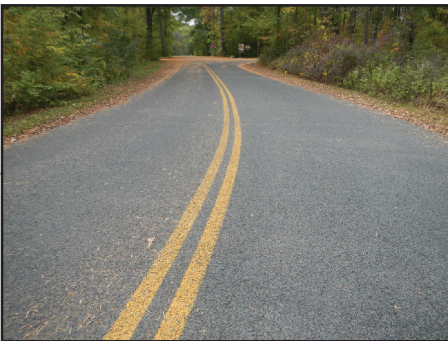
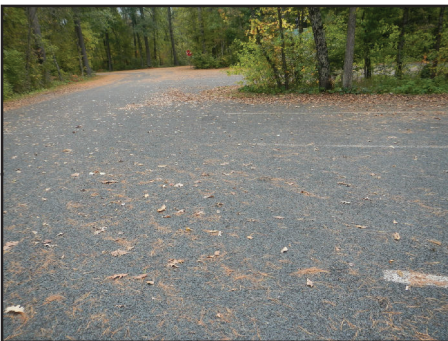
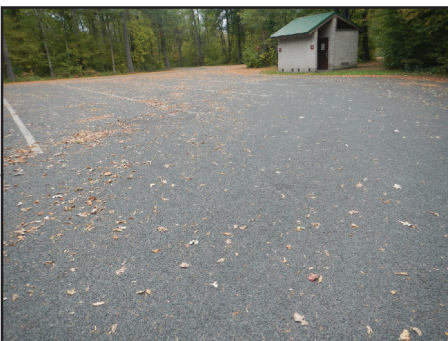
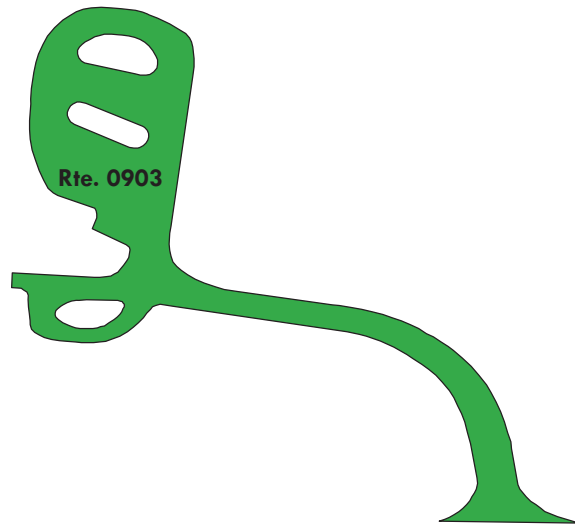
## ROUTE 0903: HIGHWAY 70 NORTH LANDING PARKING

Inspection Date	FMSS Number	User Access	Surface Type
9/30/2018	23878	PUBLIC	ASPHALT
Area (Sq. Ft.)	Lane Miles (11' Widths)	Curb Reveal (Inches)	Curb Recommendation
31,941	0.55	NOT APPLICABLE	NOT APPLICABLE
Curb Type		Curb & Gutter Type	
NO CURB		NO CURB AND GUTTER	
Pavement Recommendation		Condition Rating / PCR	
PREVENTIVE MAINTENANCE		GOOD / 90

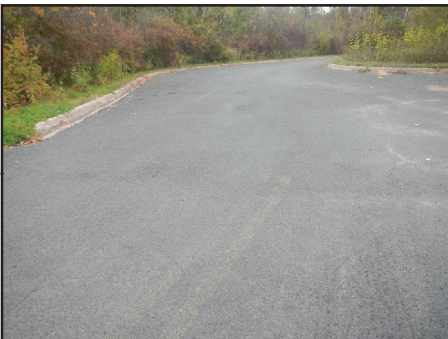
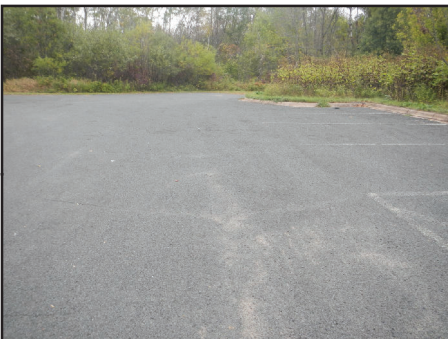
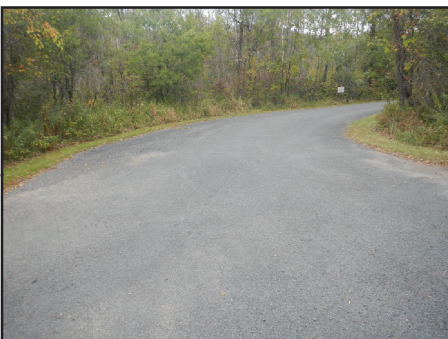
## ROUTE 0904: MARSHLAND PAVED PARKING

Inspection Date	FMSS Number	User Access	Surface Type
9/30/2018	24085	PUBLIC	ASPHALT
Area (Sq. Ft.)	Lane Miles (11' Widths)	Curb Reveal (Inches)	Curb Recommendation
14,697	0.253	NOT APPLICABLE	LIGHT REPAIR
Curb Type		Curb & Gutter Type	
NO CURB		CONCRETE	
Pavement Recommendation		Condition Rating / PCR	
LIGHT 3R TREATMENTS		FAIR / 73

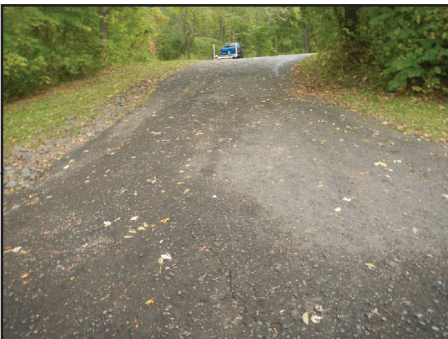
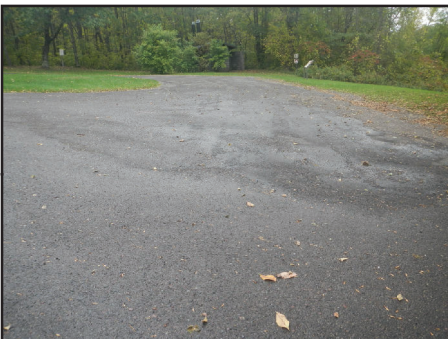
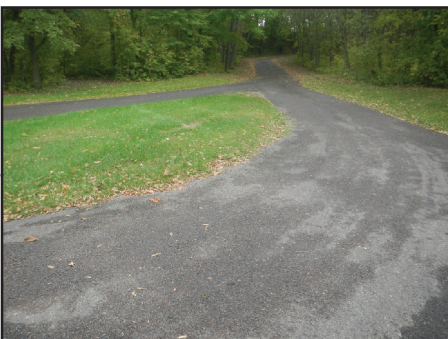
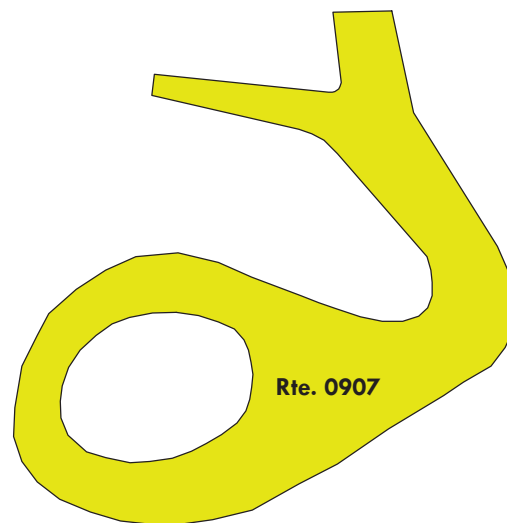
## ROUTE 0907: NORWAY POINT LANDING PARKING

Inspection Date	FMSS Number	User Access	Surface Type
10/1/2018	25704	PUBLIC	ASPHALT
Area (Sq. Ft.)	Lane Miles (11' Widths)	Curb Reveal (Inches)	Curb Recommendation
5,748	0.099	NOT APPLICABLE	NOT APPLICABLE
Curb Type		Curb & Gutter Type	
NO CURB		NO CURB AND GUTTER	
Pavement Recommendation		Condition Rating / PCR	
LIGHT 3R TREATMENTS		FAIR / 73
