SAGA Cycle 6

Final Report

Road Inventory and Condition Assessment for Saint-Gaudens National Historical Park

Report Date: September 2020

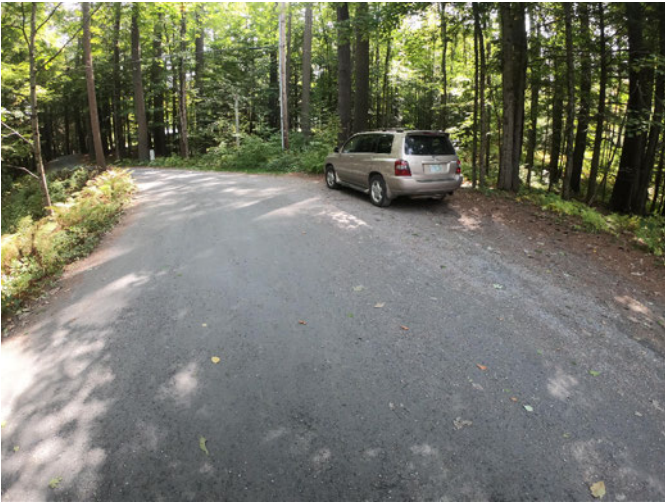
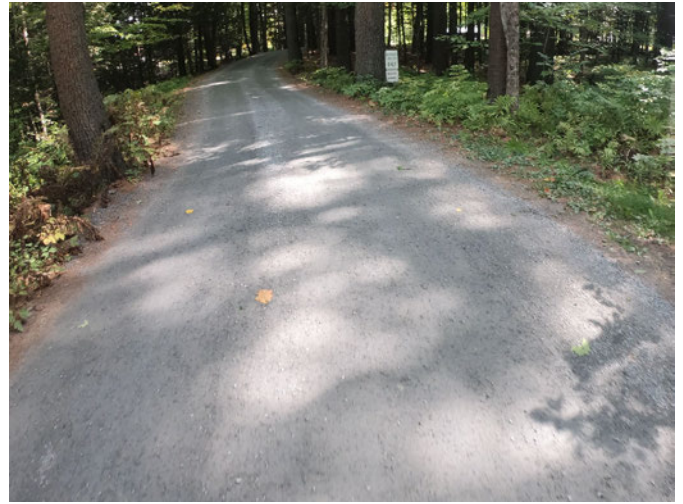
ROUTE 0401: MAINTENANCE ACCESS ROAD

Begin MP	End MP	Section Length	# of Lanes	Lane Width	Road Width	Treatment Recommendation	Treatment Cost	Unpaved Rating (Paser +)	Crown Severity	Drainage Severity	Rutting, Washboard Severity	Potholes / Loose Aggregate Severity
0.00	0.07	0.07	1	12.0	12.0	Routine Maintenance	\$700	4	Low	Med	Med	Med
Route Level Data:		0.07	1	12.0	12.00	Routine Maintenance	\$700	4	Low	Med	Med	Med

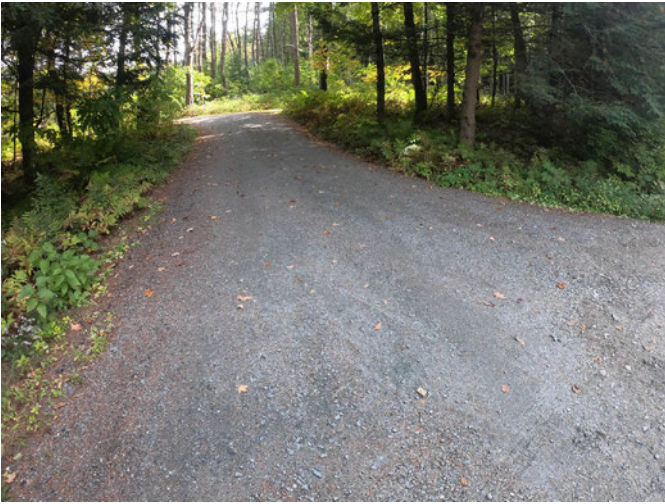
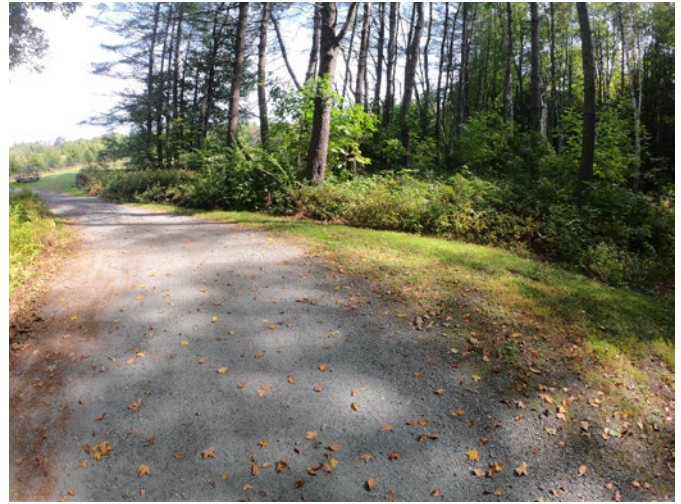
ROUTE 0403: FARM FIELD ACCESS ROAD

Begin MP	End MP	Section Length	# of Lanes	Lane Width	Road Width	Treatment Recommendation	Treatment Cost	Unpaved Rating (Paser +)	Crown Severity	Drainage Severity	Rutting, Washboard Severity	Potholes / Loose Aggregate Severity
0.00	0.08	0.08	1	12.0	12.0	Heavy Rehabilitation	\$12,320	2	High	Med	High	Med
Route Level Data:		0.08	1	12.0	12.00	Heavy Rehabilitation	\$12,320	2	High	Med	High	Med

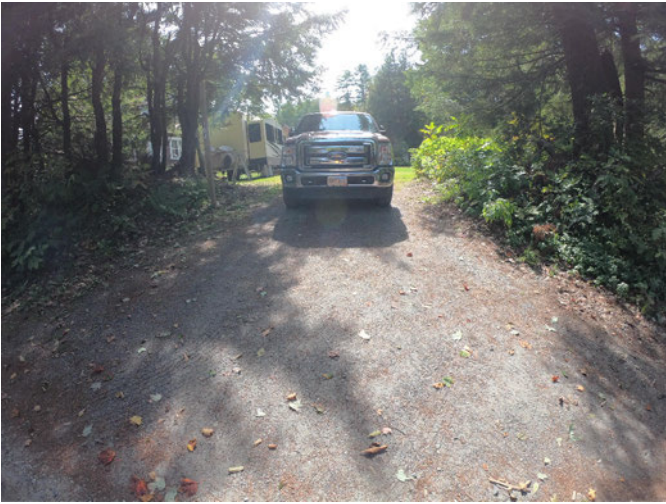
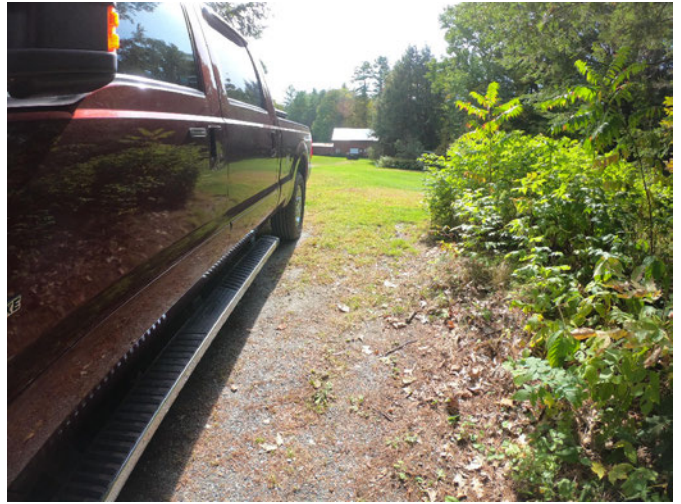
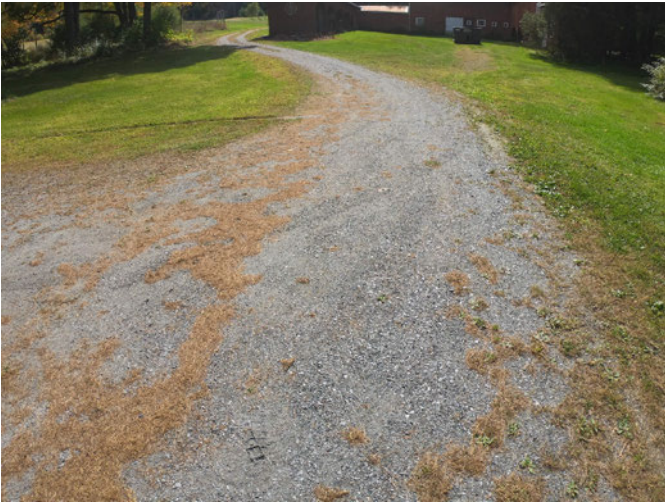
ROUTE 0404: SAINT GAUDENS FARM PROPERTY ROAD

Begin MP	End MP	Section Length	# of Lanes	Lane Width	Road Width	Treatment Recommendation	Treatment Cost	Unpaved Rating (Paser +)	Crown Severity	Drainage Severity	Rutting, Washboard Severity	Potholes / Loose Aggregate Severity
0.00	0.04	0.04	1	9.0	9.0	Limited Local Maintenance	\$0	5	Low	Low	Low	Low
Route Level Data:		0.04	1	9.0	9.00	Limited Local Maintenance	\$0	5	Low	Low	Low	Low

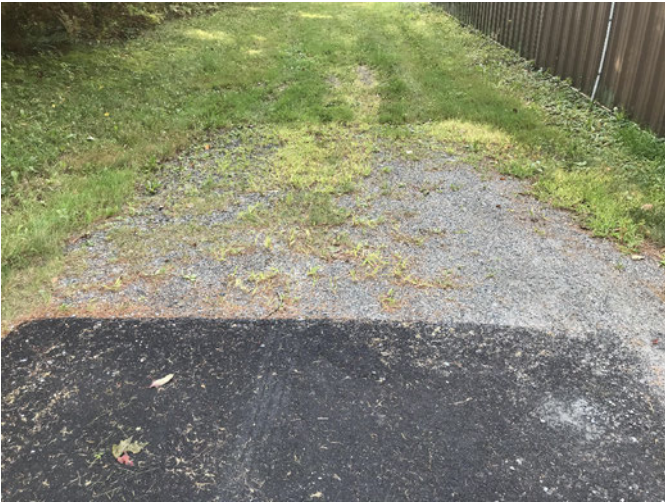
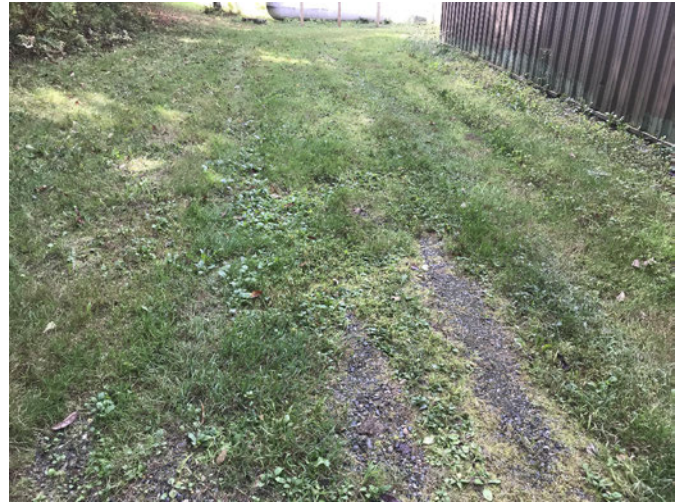
ROUTE 0405: NURSERY ROAD

Begin MP	End MP	Section Length	# of Lanes	Lane Width	Road Width	Treatment Recommendation	Treatment Cost	Unpaved Rating (Paser +)	Crown Severity	Drainage Severity	Rutting, Washboard Severity	Potholes / Loose Aggregate Severity
0.00	0.02	0.02	1	9.0	9.0	Routine Maintenance	\$34	3	Med	Med	Med	Low
Route Level Data:		0.02	1	9.0	9.00	Routine Maintenance	\$34	3	Med	Med	Med	Low

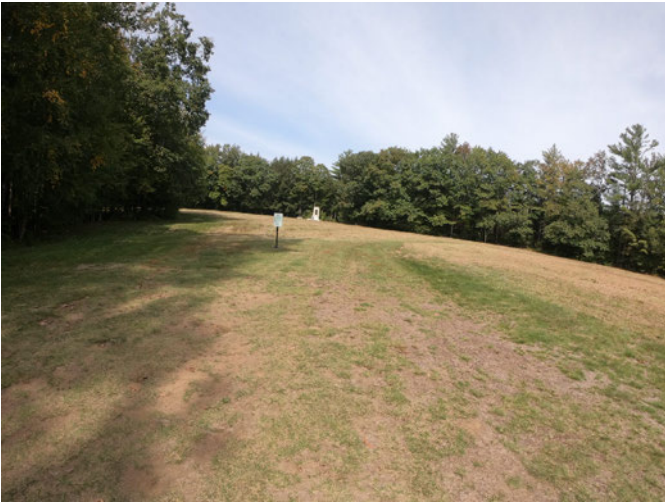
ROUTE 0406: CART PATH ROAD

Begin MP	End MP	Section Length	# of Lanes	Lane Width	Road Width	Treatment Recommendation	Treatment Cost	Unpaved Rating (Paser +)	Crown Severity	Drainage Severity	Rutting, Washboard Severity	Potholes / Loose Aggregate Severity
0.00	0.08	0.08	1	9.0	9.0	Heavy Rehabilitation	\$3,000	1	High	High	High	High
Route Level Data:		0.08	1	9.0	9.00	Heavy Rehabilitation	\$3,000	1	High	High	High	High

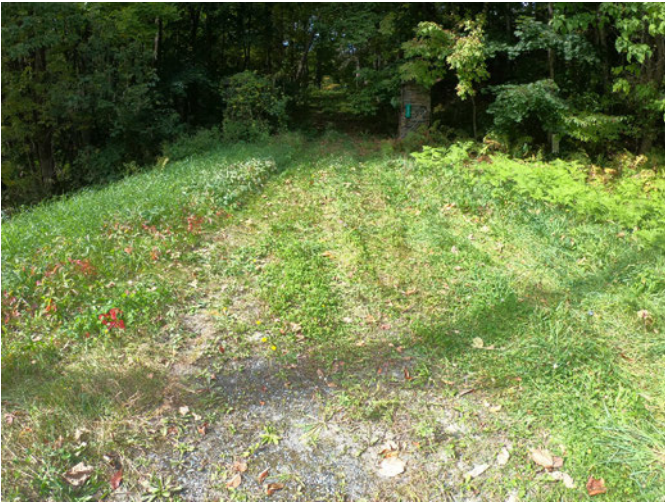
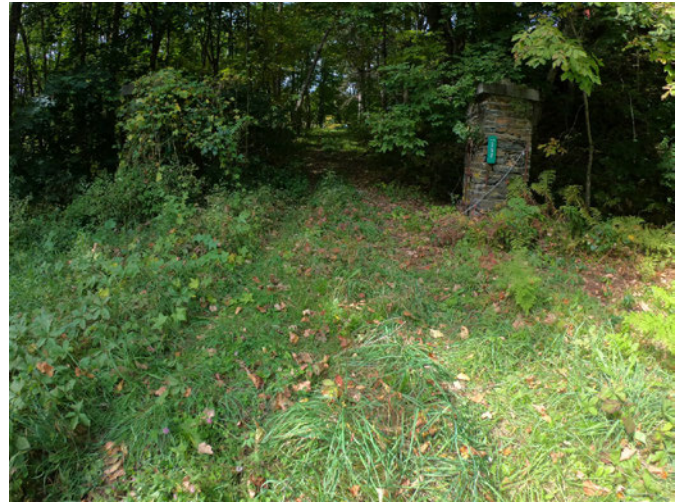
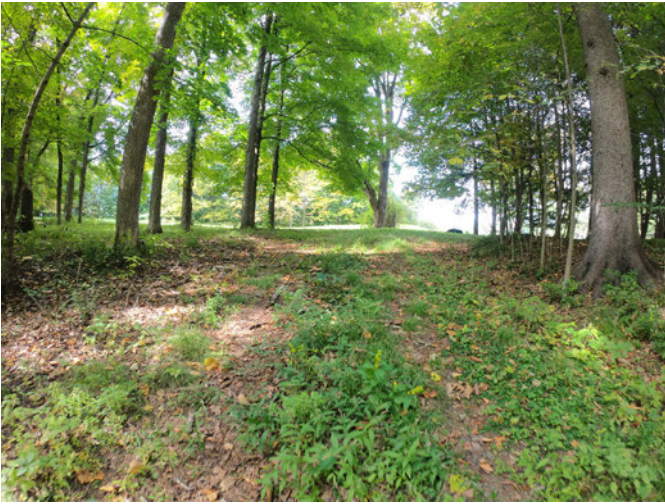
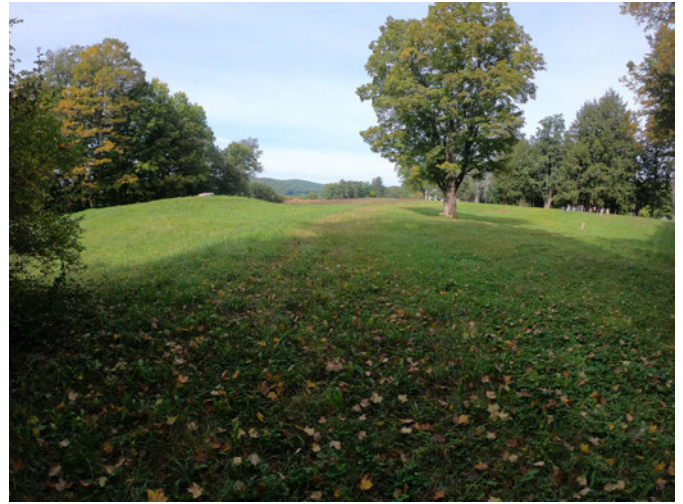
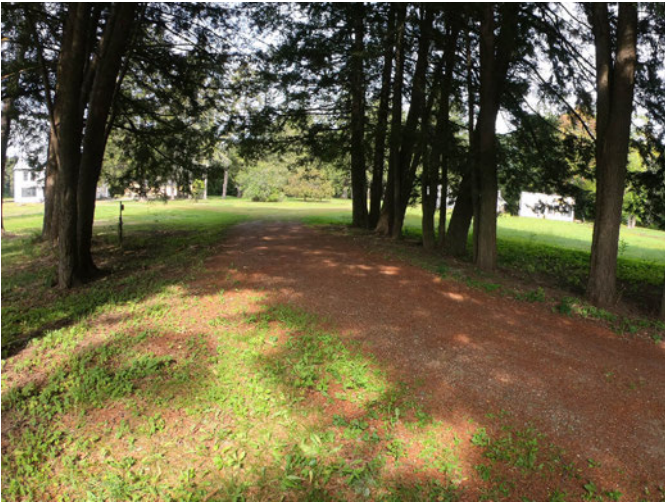
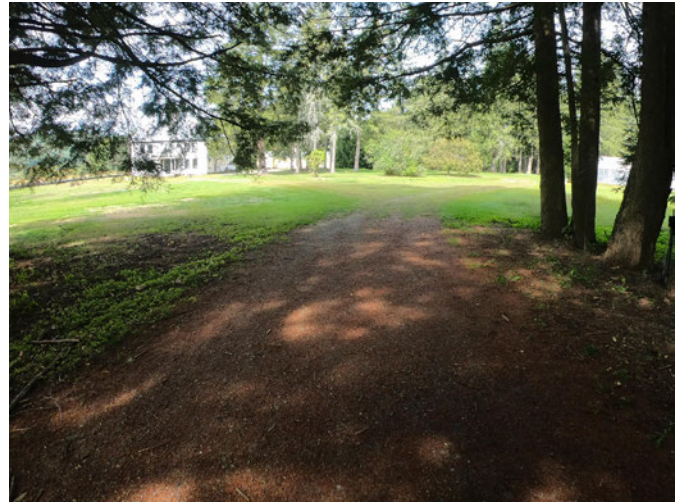
ROUTE 0410AZ: BEAMAN FARM SOUTH ROAD

Begin MP	End MP	Section Length	# of Lanes	Lane Width	Road Width	Treatment Recommendation	Treatment Cost	Unpaved Rating (Paser +)	Crown Severity	Drainage Severity	Rutting, Washboard Severity	Potholes / Loose Aggregate Severity
0.00	0.21	0.21	1	11.0	11.0	Reconstruction	\$51,500	1	Med	High	High	High
Route Level Data:		0.21	1	11.0	11.00	Reconstruction	\$51,500	1	Med	High	High	High

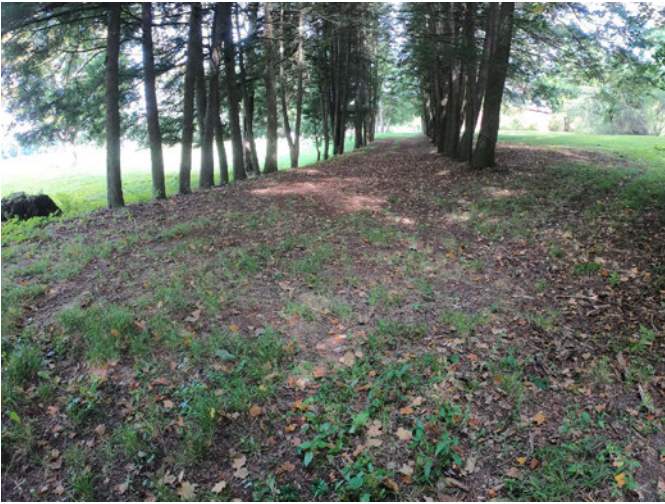
SAGA_0410BZ_0.001_REPORT.jpg

Begin MP	End MP	Section Length	# of Lanes	Lane Width	Road Width	Treatment Recommendation	Treatment Cost	Unpaved Rating (Paser +)	Crown Severity	Drainage Severity	Rutting, Washboard Severity	Potholes / Loose Aggregate Severity
0.00	0.05	0.05	1	12.0	12.0	Reconstruction	\$12,500	1	High	High	Med	High
Route Level Data:		0.05	1	12.0	12.00	Reconstruction	\$12,500	1	High	High	Med	High

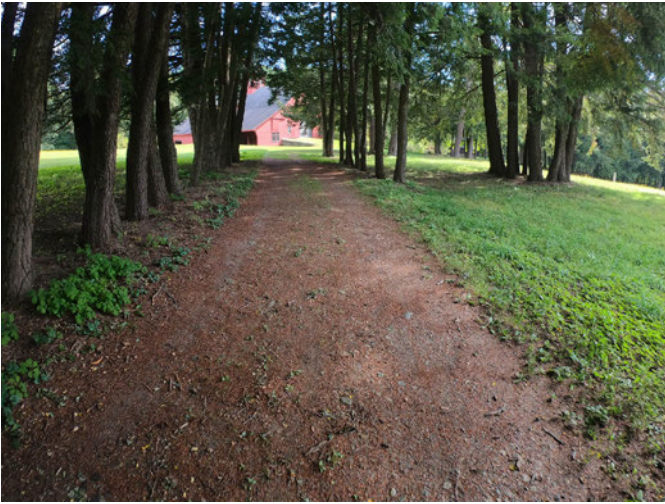
SAGA_0410CZ_0.004_REPORT.jpg

Begin MP	End MP	Section Length	# of Lanes	Lane Width	Road Width	Treatment Recommendation	Treatment Cost	Unpaved Rating (Paser +)	Crown Severity	Drainage Severity	Rutting, Washboard Severity	Potholes / Loose Aggregate Severity
0.00	0.08	0.08	1	9.0	9.0	Reconstruction	\$19,750	1	High	High	High	High
Route Level Data:		0.08	1	9.0	9.00	Reconstruction	\$19,750	1	High	High	High	High

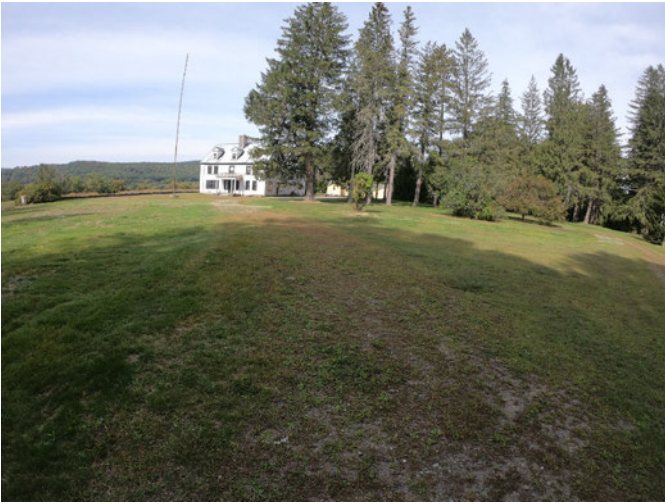
SAGA_0410DZ_0.001_REPORT.jpg

Begin MP	End MP	Section Length	# of Lanes	Lane Width	Road Width	Treatment Recommendation	Treatment Cost	Unpaved Rating (Paser +)	Crown Severity	Drainage Severity	Rutting, Washboard Severity	Potholes / Loose Aggregate Severity
0.00	0.03	0.03	1	8.0	8.0	Reconstruction	\$7,000	1	High	High	High	High
Route Level Data:		0.03	1	8.0	8.00	Reconstruction	\$7,000	1	High	High	High	High

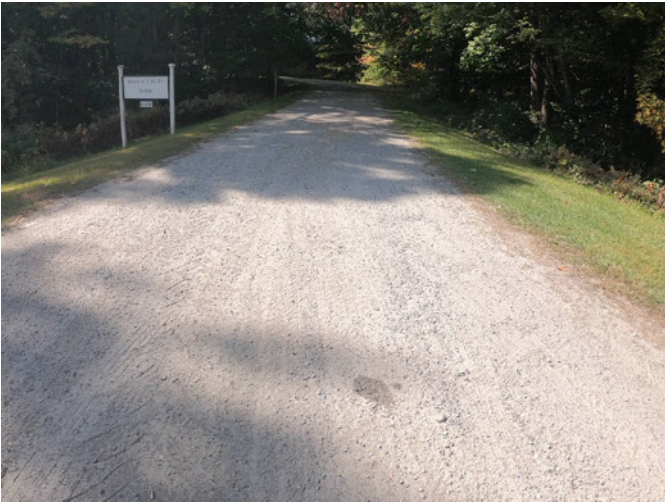
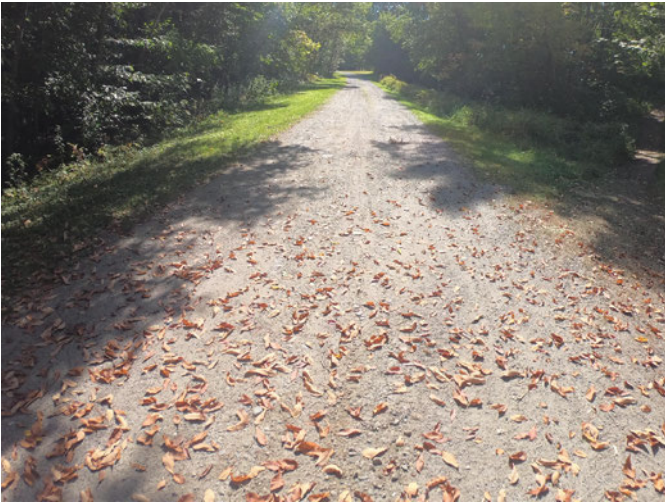
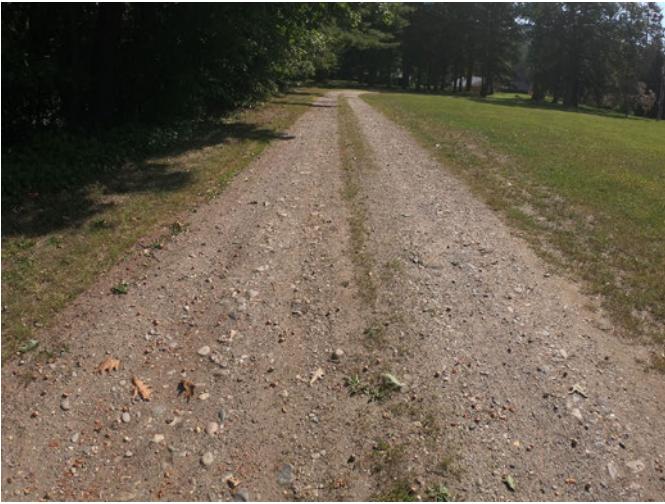
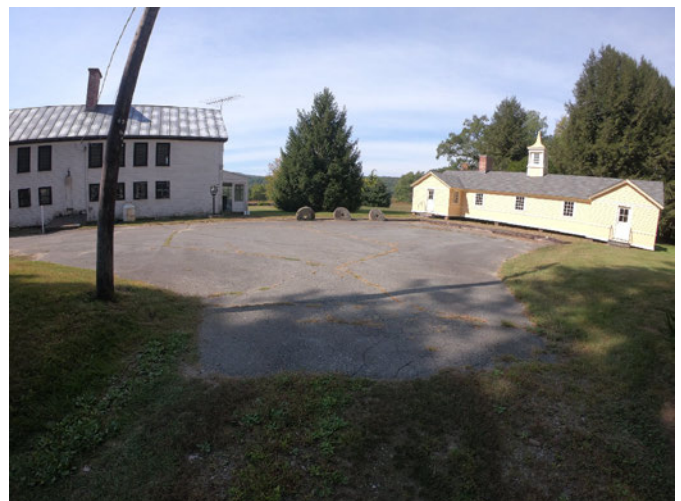
Begin MP	End MP	Section Length	# of Lanes	Lane Width	Road Width	Treatment Recommendation	Treatment Cost	Unpaved Rating (Paser +)	Crown Severity	Drainage Severity	Rutting, Washboard Severity	Potholes / Loose Aggregate Severity
0.00	0.25	0.25	2	7.6	13.2	Routine Maintenance	\$2,500	4	Med	Low	Med	Med
Route Level Data:		0.25	2	7.6	13.20	Routine Maintenance	\$2,500	4	Med	Low	Med	Med

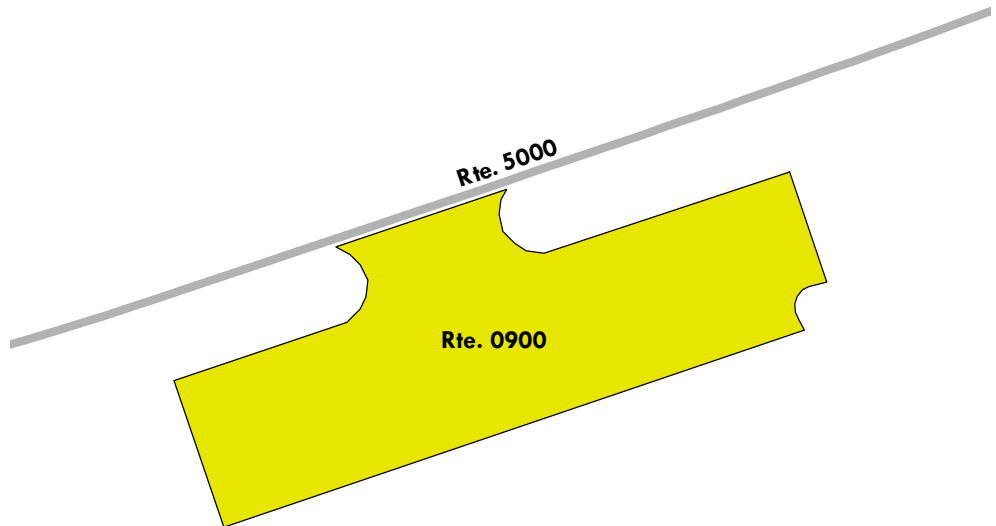
Inspection Date	FMSS Number	User Access	Surface Type
9/22/2019	102729	PUBLIC	ASPHALT
Area (Sq. Ft.)	Lane Miles (11' Widths)	Curb Reveal (Inches)	Curb Recommendation
4,318	0.074	NOT APPLICABLE	NOT APPLICABLE
Curb Type		Curb & Gutter Type	
NO CURB		NO CURB AND GUTTER	
Pavement Recommendation		Condition Rating / PCR	
LIGHT 3R TREATMENTS		FAIR / 73

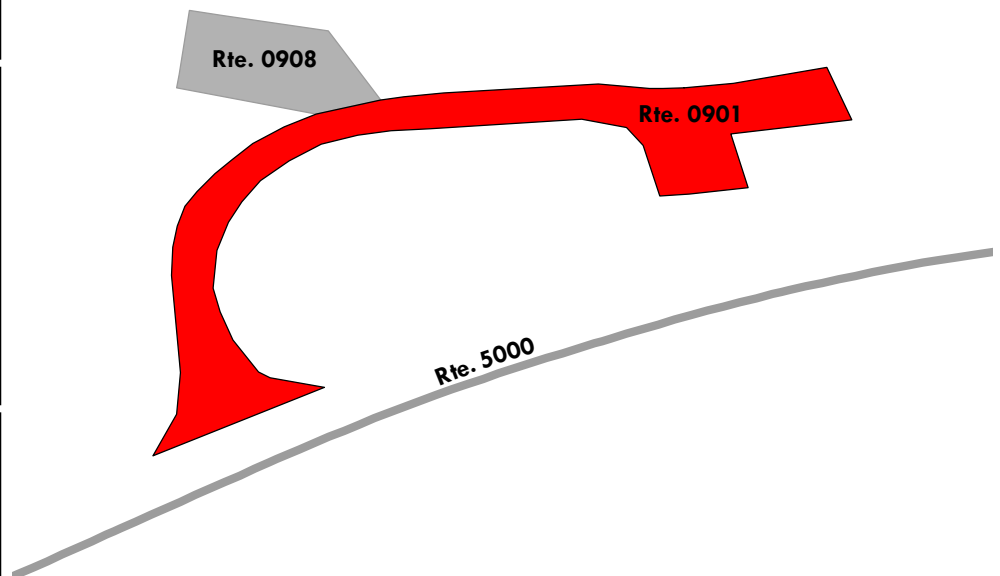
ROUTE 0901: VISITOR CENTER DRIVE PARKING

Inspection Date	FMSS Number	User Access	Surface Type
9/22/2019	102730	PUBLIC	ASPHALT
Area (Sq. Ft.)	Lane Miles (11' Widths)	Curb Reveal (Inches)	Curb Recommendation
5,134	0.088	NOT APPLICABLE	NOT APPLICABLE
Curb Type		Curb & Gutter Type	
NO CURB		NO CURB AND GUTTER	
Pavement Recommendation		Condition Rating / PCR	
HEAVY 3R TREATMENTS		POOR / 53

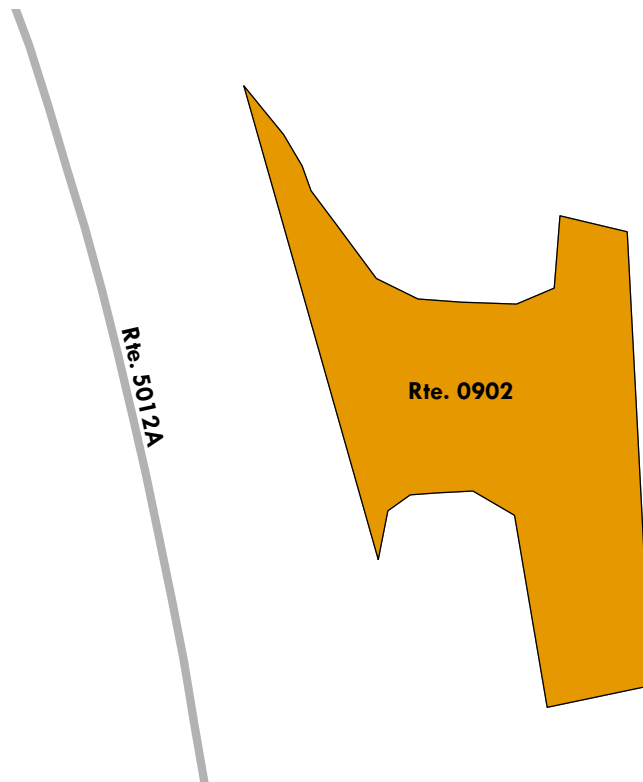
ROUTE 0902: MILL PARKING

Inspection Date	FMSS Number	User Access	Surface Type
9/22/2019	102732	PUBLIC	GRAVEL
Area (Sq. Ft.)	Lane Miles (11' Widths)	Curb Reveal (Inches)	Curb Recommendation
2,877	0.05	NOT APPLICABLE	NOT APPLICABLE
Curb Type		Curb & Gutter Type	
NO CURB		NO CURB AND GUTTER	
Treatment Recommendation		Condition Rating	
HEAVY REHABILITATION		2
