SAGU Cycle 6

Final Report

Road Inventory and Condition Assessment of Paved Routes Saguaro National Park

Report Date: May 2017

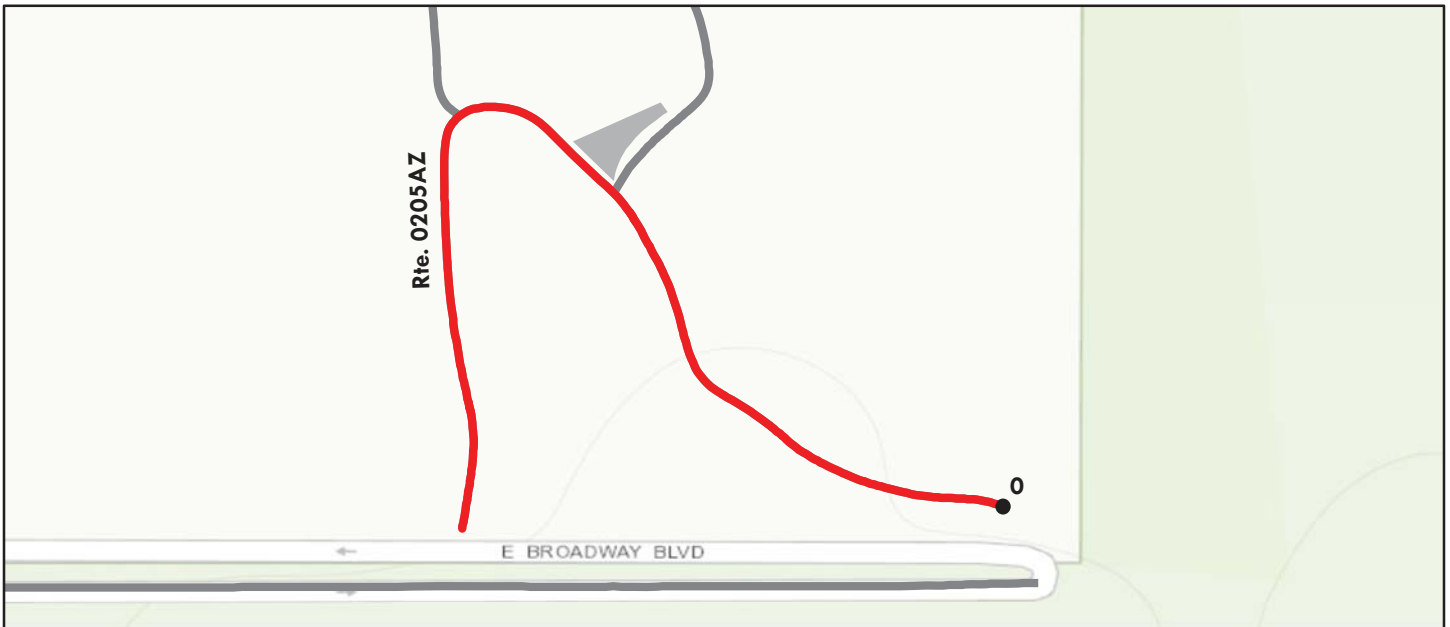
Subcomponent of Route SAGU-0205ZZ
Data Collection Vehicle (DCV) Rating

Badly degraded Asphalt.

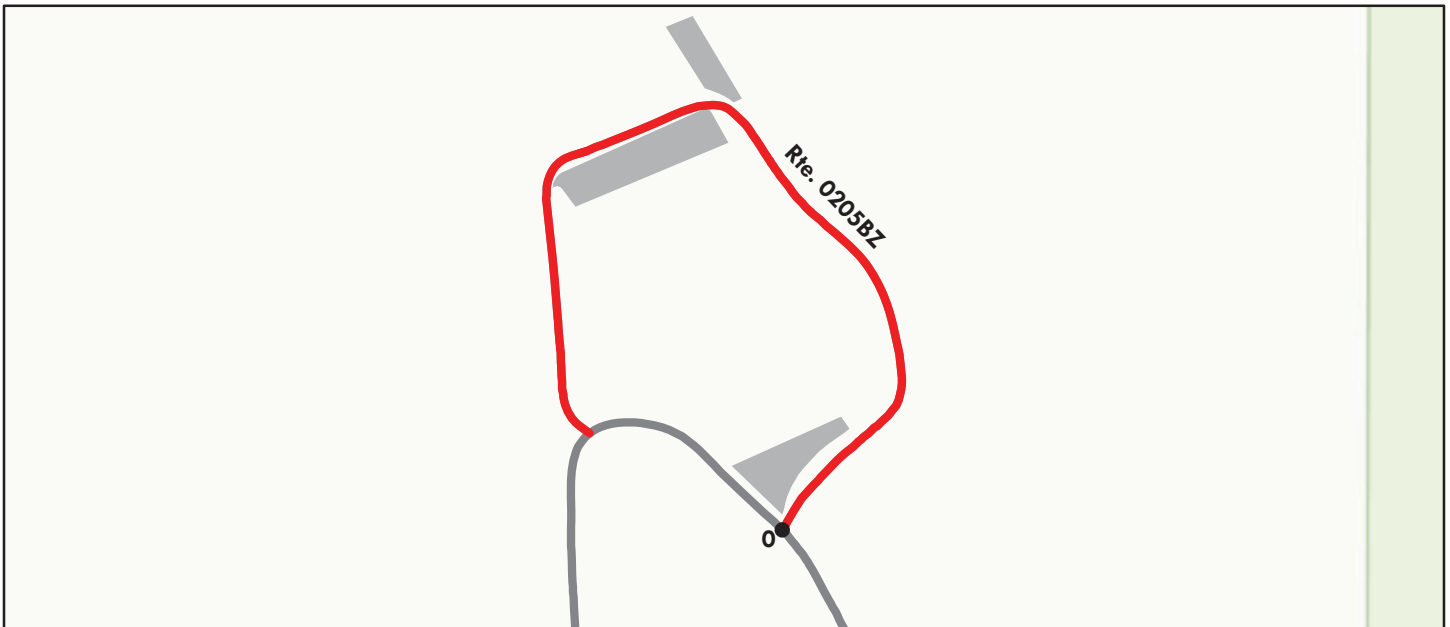
Subcomponent of Route SAGU-0205ZZ
Data Collection Vehicle (DCV) Rating

Badly degraded Asphalt.

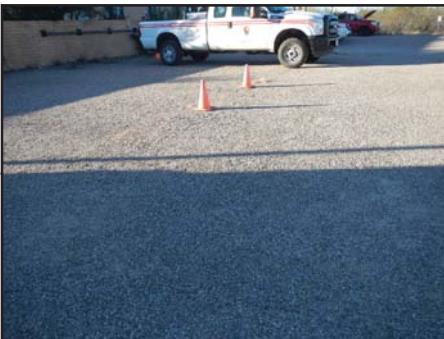
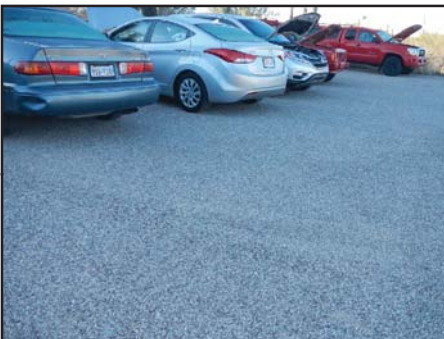
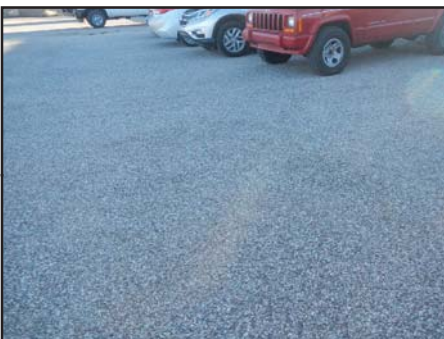
Asphalt has deteriorated to the point where only traces remain. Parking area appears to be mostly unpaved.

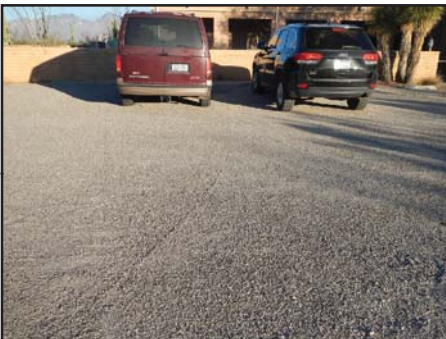
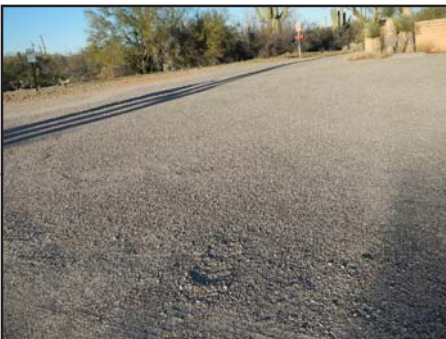
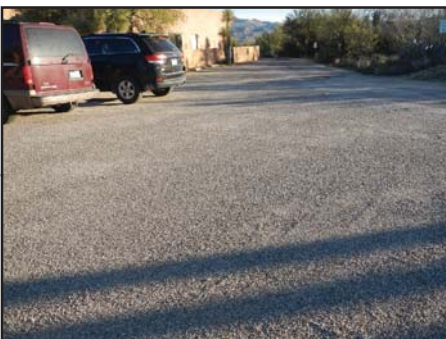
Asphalt has deteriorated to the point where only traces remain. Parking area appears to be mostly unpaved.
