Final Report

Road Inventory and Condition Assessment of Paved Routes Sagamore Hill National Historic Site

**Federal Lands Highway
Road Inventory Program**

Report Date: January 2022

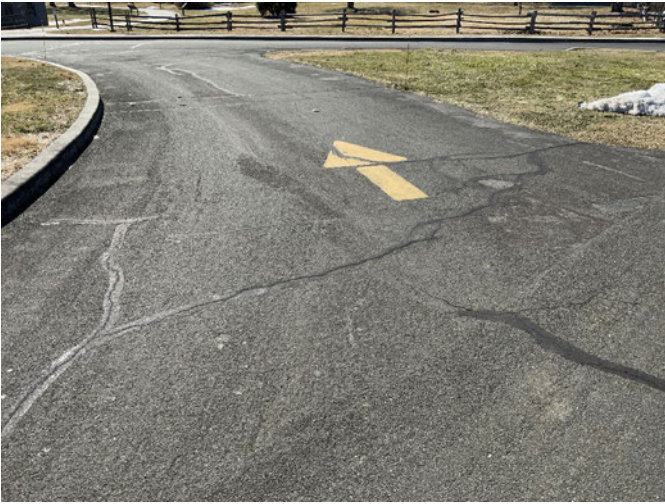
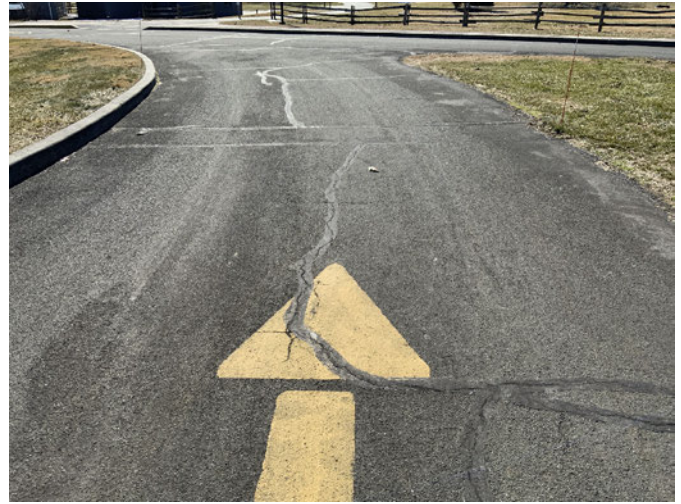
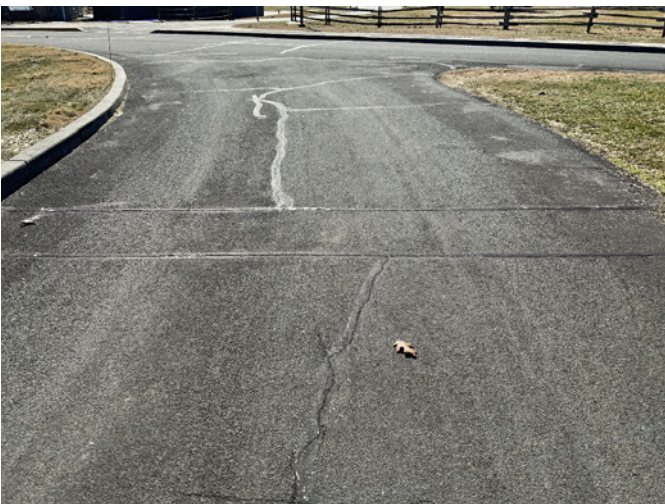
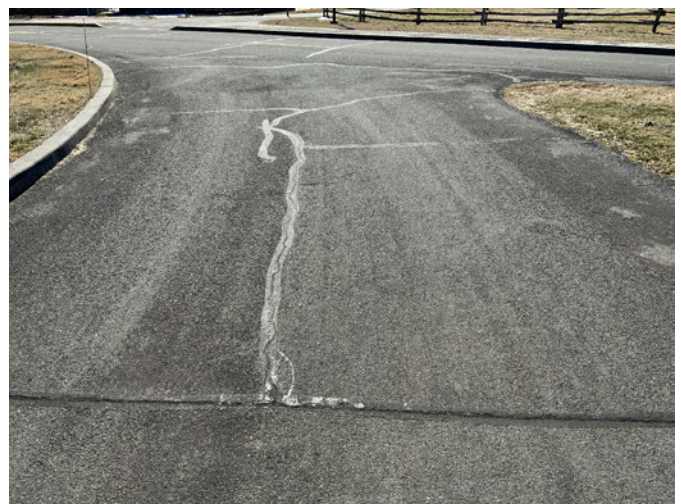
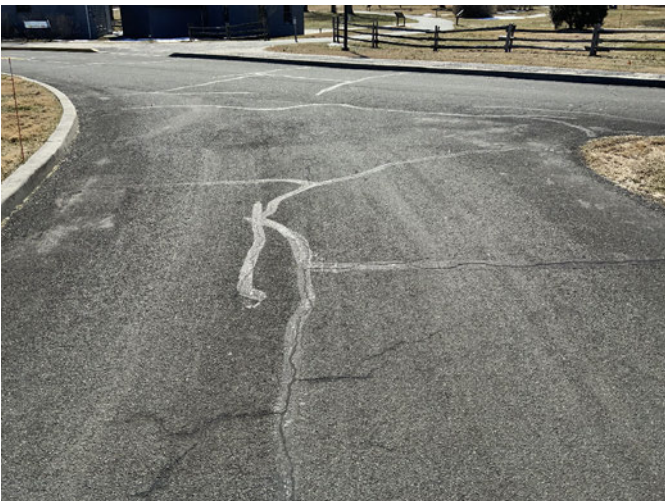
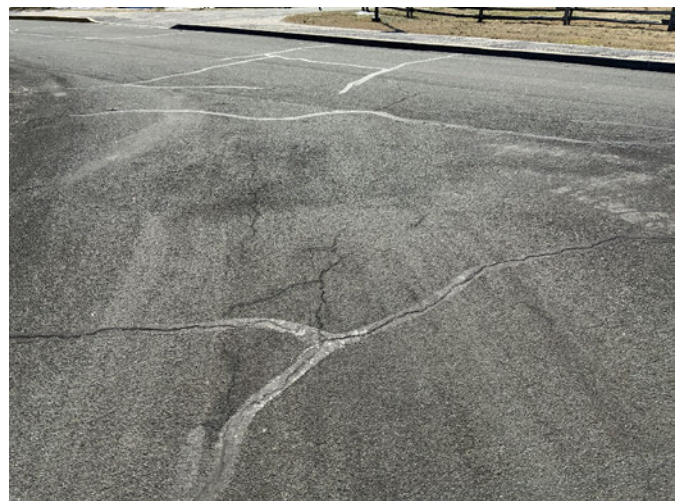
Route Condition Legend – Pavement Condition Rating (PCR)						
Poor (0 - 60)	Fair (61- 84)	Good (85 - 94)	Excellent (95 - 100)	Not Rated		
See Appendix for definitions and formulas						
Inspection Date: 3/2/2021	Beginning Section MP	0.00				
Paved Length (Miles): 0.02	Section Length (MI)	0.02				
Surface Type: ASPHALT	Route Summary					
Roadway Condition Information						
Pavement Condition Rating (PCR)	82	82				
Surface Condition Rating (SCR)	82	82				
Roughness Condition Index (RCI)	N/A	N/A				
Distress Index Values						
Structural Crack Index	83	83				
Alligator Crack Index	100	100				
Longitudinal Crack Index	83	83				
Transverse Cracking Index	82	82				
Patching Index	100	100				
Rutting Index	100	100				
International Roughness Index (IRI)	N/A	N/A				
Lane & Width Information						
Number of Lanes	2	2				
Paved Width (ft)	17	17				
Lane Width (ft)	8.5	8.5

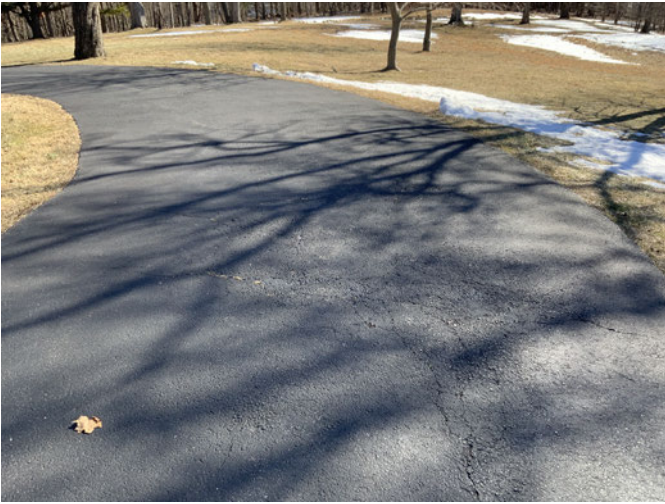
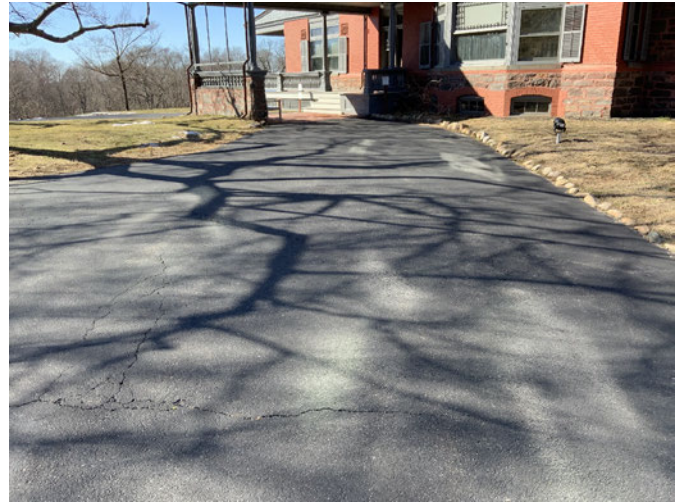
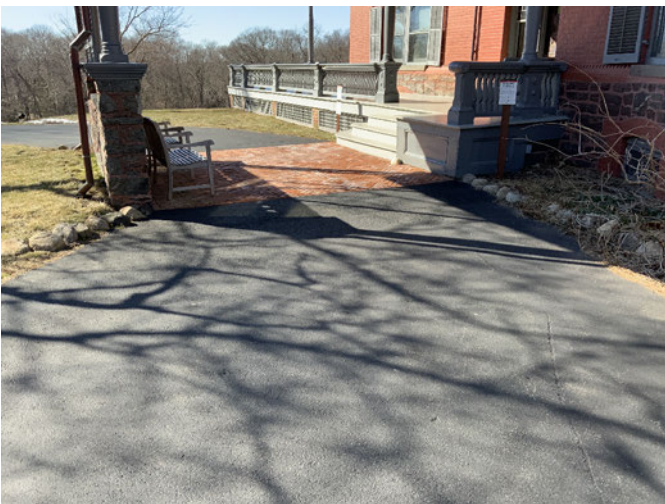
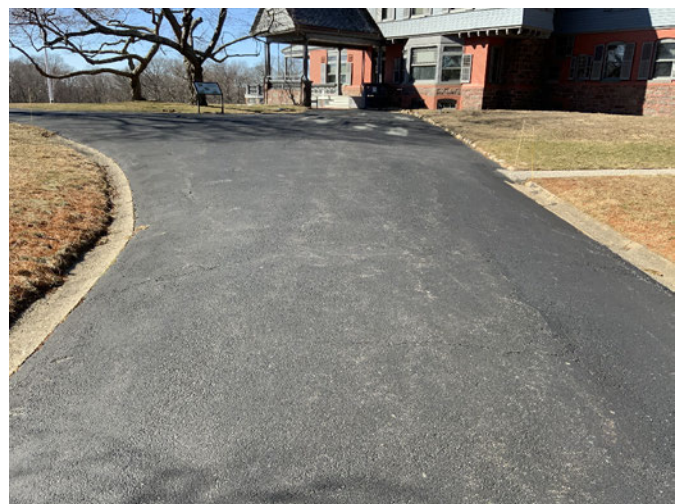
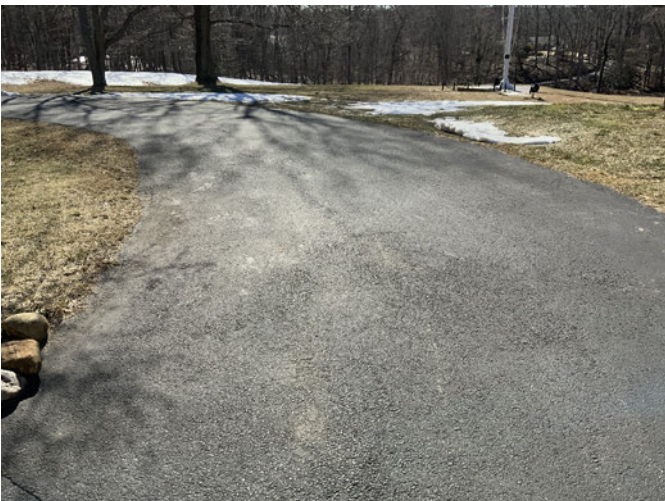
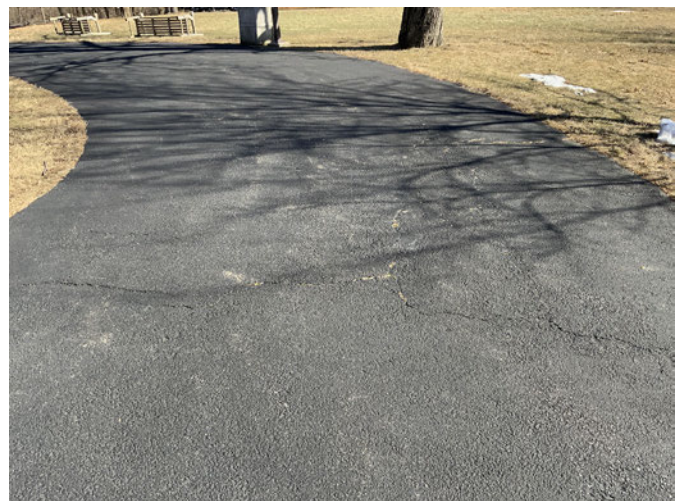
ROUTE 0106: HOUSE ENTRANCE ROAD

Route Condition Legend – Pavement Condition Rating (PCR)						
Poor (0 - 60)	Fair (61- 84)	Good (85 - 94)	Excellent (95 - 100)	Not Rated		
See Appendix for definitions and formulas						
Inspection Date: 3/2/2021	Beginning Section MP	0.00				
Paved Length (Miles): 0.07	Section Length (MI)	0.07				
Surface Type: ASPHALT	Route Summary					
Roadway Condition Information						
Pavement Condition Rating (PCR)	78	78				
Surface Condition Rating (SCR)	78	78				
Roughness Condition Index (RCI)	N/A	N/A				
Distress Index Values						
Structural Crack Index	78	78				
Alligator Crack Index	85	85				
Longitudinal Crack Index	93	93				
Transverse Cracking Index	98	98				
Patching Index	99	99				
Rutting Index	100	100				
International Roughness Index (IRI)	N/A	N/A				
Lane & Width Information						
Number of Lanes	2	2				
Paved Width (ft)	24	24				
Lane Width (ft)	12	12

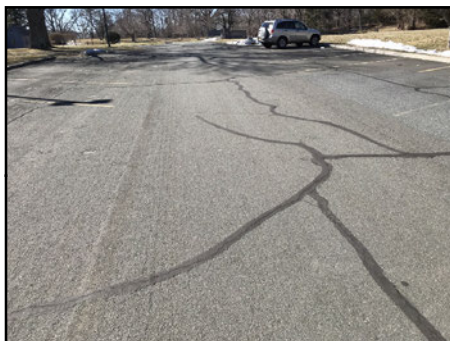
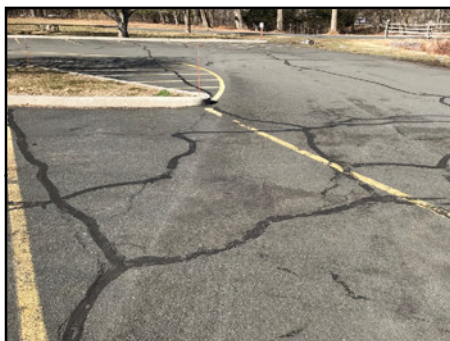
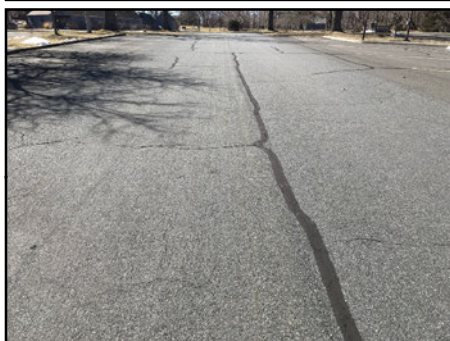
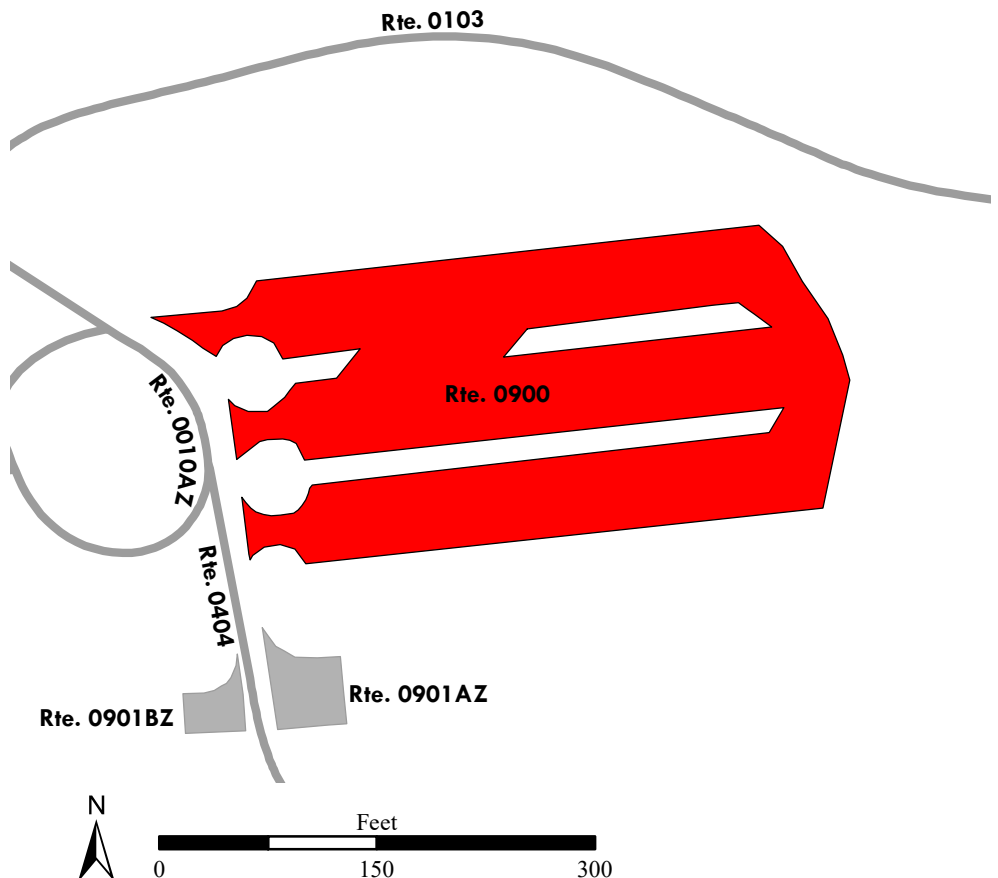
Inspection Date	FMSS Number	User Access	Surface Type
3/2/2021	47509	PUBLIC	ASPHALT
Area (Sq. Ft.)	Lane Miles (11' Widths)	Curb Reveal (Inches)	Curb Recommendation
51,215	0.882	6	DO NOTHING
Curb Type		Curb & Gutter Type	
CONCRETE		NO CURB AND GUTTER	
Pavement Recommendation		Condition Rating / PCR	
HEAVY 3R TREATMENTS		POOR / 53

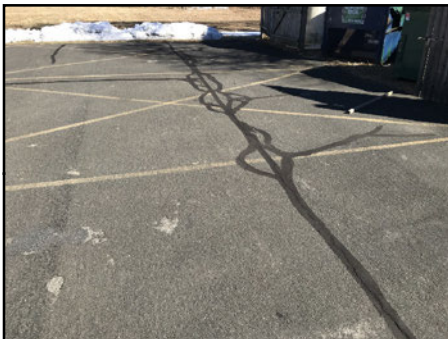
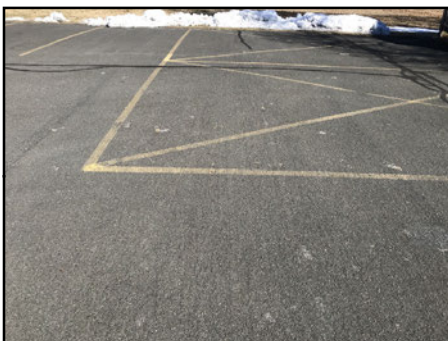
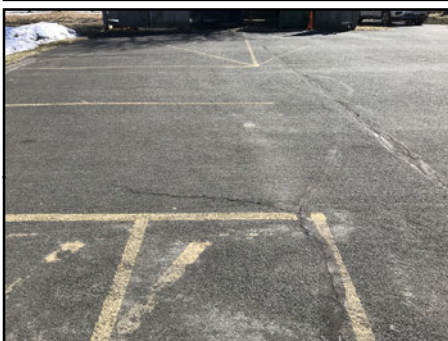
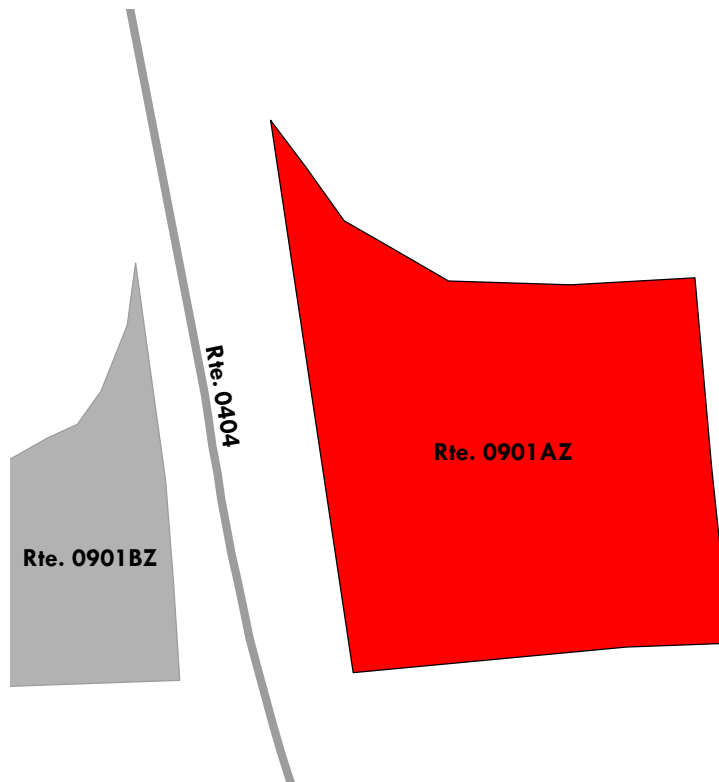
ROUTE 0901AZ: BARN PARKING A

Inspection Date	FMSS Number	User Access	Surface Type
3/2/2021	104625	NONPUBLIC	ASPHALT
Area (Sq. Ft.)	Lane Miles (11' Widths)	Curb Reveal (Inches)	Curb Recommendation
1,894	0.033	NOT APPLICABLE	NOT APPLICABLE
Curb Type		Curb & Gutter Type	
NO CURB		NO CURB AND GUTTER	
Pavement Recommendation		Condition Rating / PCR	
HEAVY 3R TREATMENTS		POOR / 53

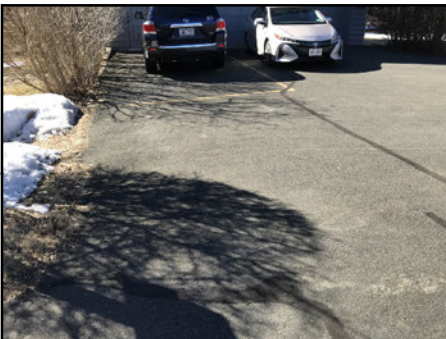
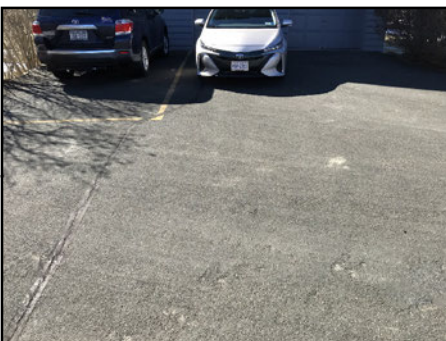
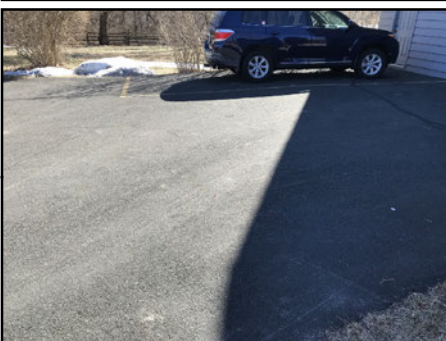
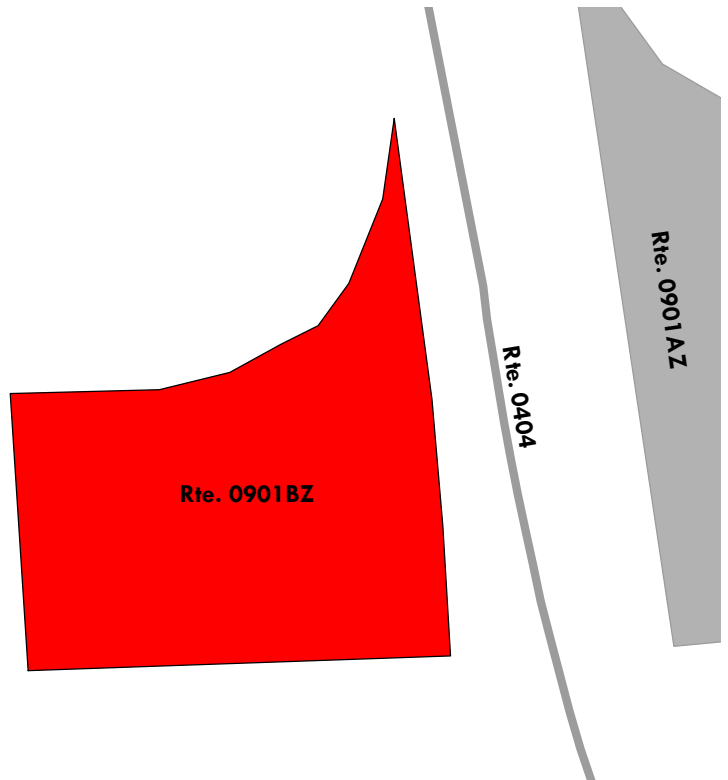
ROUTE 0901BZ: BARN PARKING B

Inspection Date	FMSS Number	User Access	Surface Type
3/2/2021	104625	NONPUBLIC	ASPHALT
Area (Sq. Ft.)	Lane Miles (11' Widths)	Curb Reveal (Inches)	Curb Recommendation
992	0.017	3	DO NOTHING
Curb Type		Curb & Gutter Type	
CONCRETE		NO CURB AND GUTTER	
Pavement Recommendation		Condition Rating / PCR	
HEAVY 3R TREATMENTS		POOR / 53

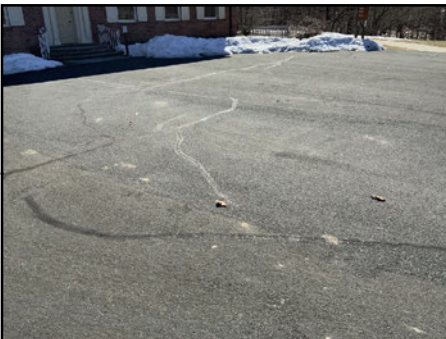
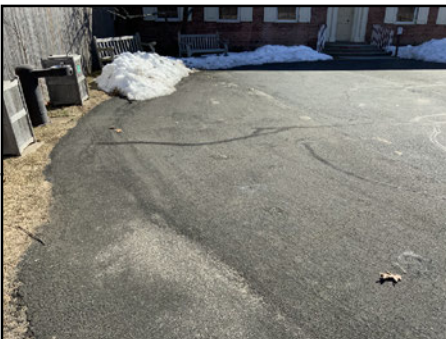
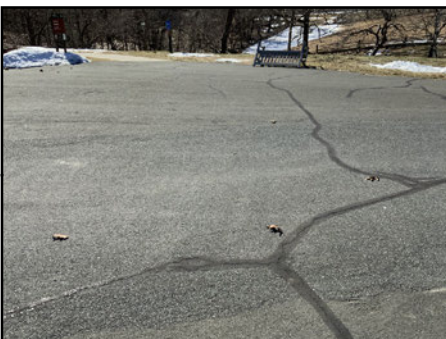
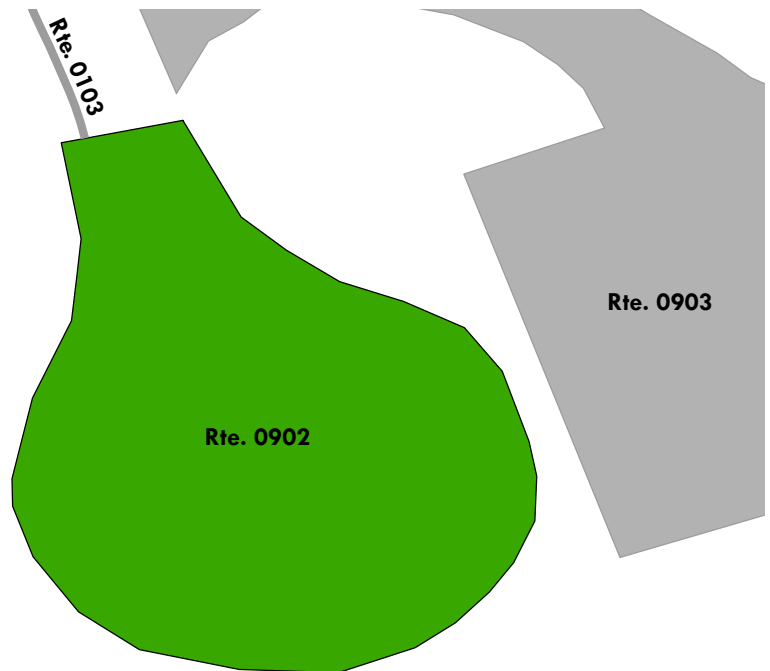
ROUTE 0902: THEODORE ROOSEVELT MUSEUM PARKING

Inspection Date	FMSS Number	User Access	Surface Type
3/2/2021	104655	PUBLIC	ASPHALT
Area (Sq. Ft.)	Lane Miles (11' Widths)	Curb Reveal (Inches)	Curb Recommendation
3,700	0.064	NOT APPLICABLE	NOT APPLICABLE
Curb Type		Curb & Gutter Type	
NO CURB		NO CURB AND GUTTER	
Pavement Recommendation		Condition Rating / PCR	
PREVENTIVE MAINTENANCE		GOOD / 90

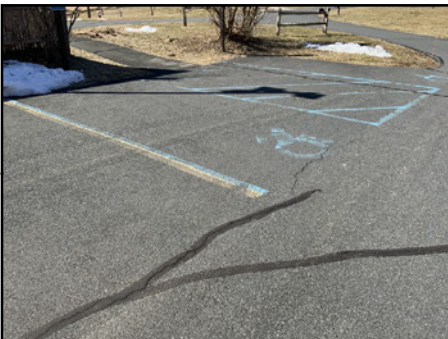
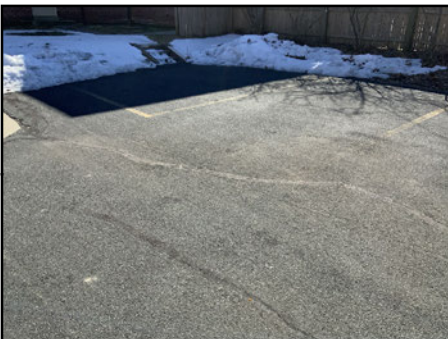
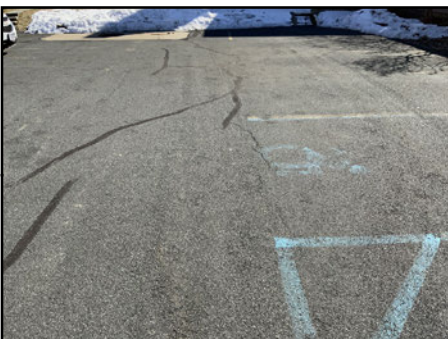
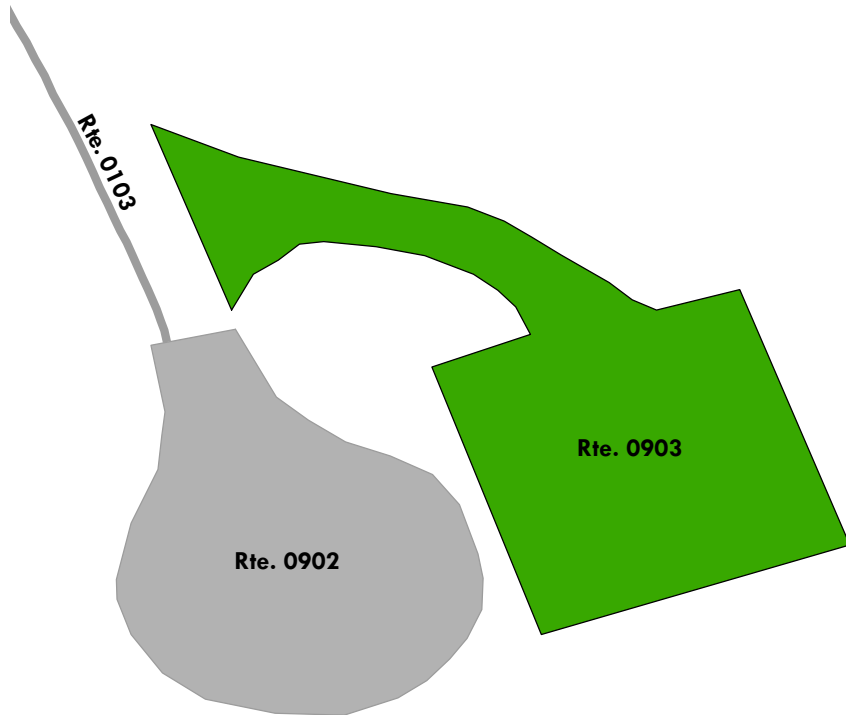
ROUTE 0903: ADMINISTRATIVE AND HANDICAP PARKING

Inspection Date	FMSS Number	User Access	Surface Type
3/2/2021	104640	PUBLIC	ASPHALT
Area (Sq. Ft.)	Lane Miles (11' Widths)	Curb Reveal (Inches)	Curb Recommendation
4,890	0.084	NOT APPLICABLE	NOT APPLICABLE
Curb Type		Curb & Gutter Type	
NO CURB		NO CURB AND GUTTER	
Pavement Recommendation		Condition Rating / PCR	
PREVENTIVE MAINTENANCE		GOOD / 90

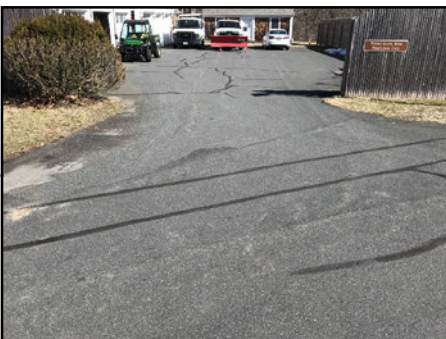
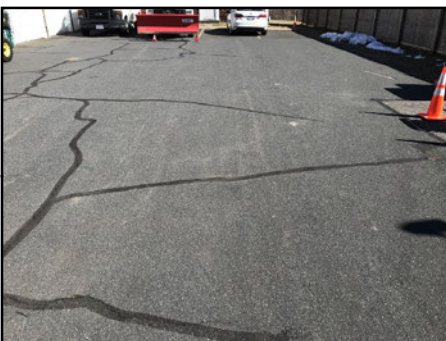
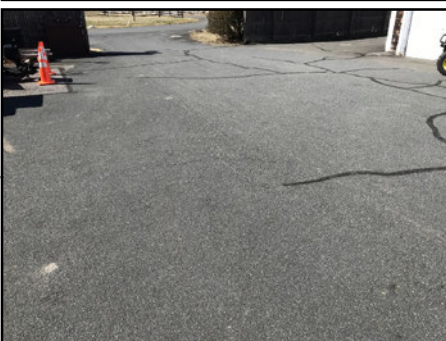
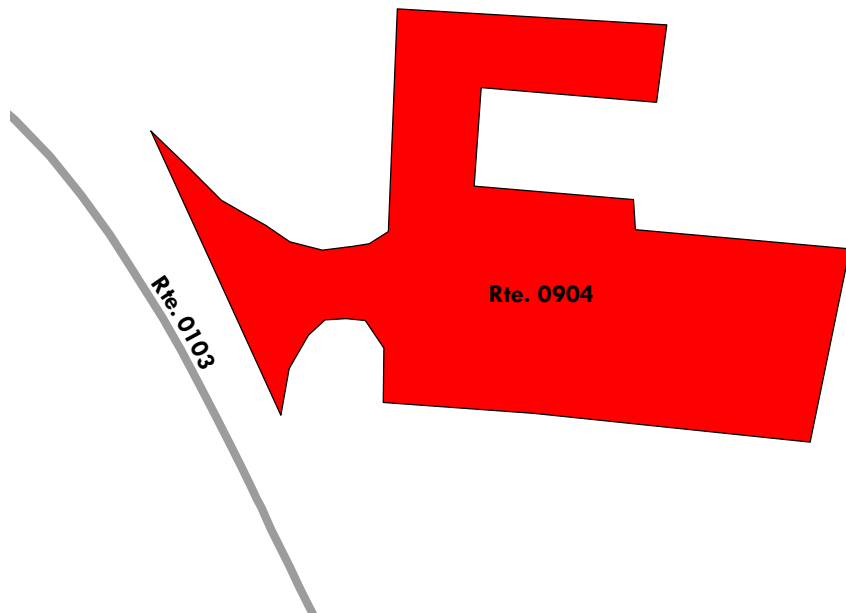
ROUTE 0904: MAINTENANCE AREA PARKING

Inspection Date	FMSS Number	User Access	Surface Type
3/2/2021	104660	NONPUBLIC	ASPHALT
Area (Sq. Ft.)	Lane Miles (11' Widths)	Curb Reveal (Inches)	Curb Recommendation
4,731	0.081	6	DO NOTHING
Curb Type		Curb & Gutter Type	
CONCRETE		NO CURB AND GUTTER	
Pavement Recommendation		Condition Rating / PCR	
HEAVY 3R TREATMENTS		POOR / 53

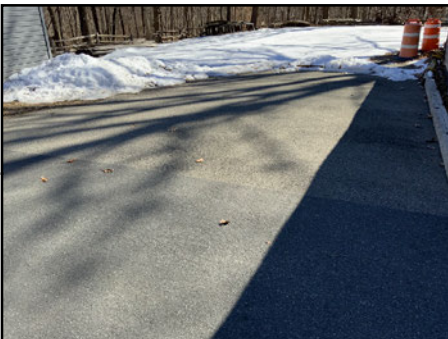
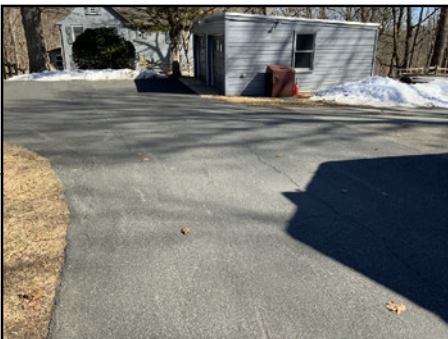
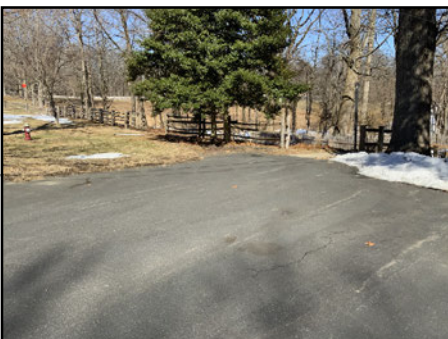
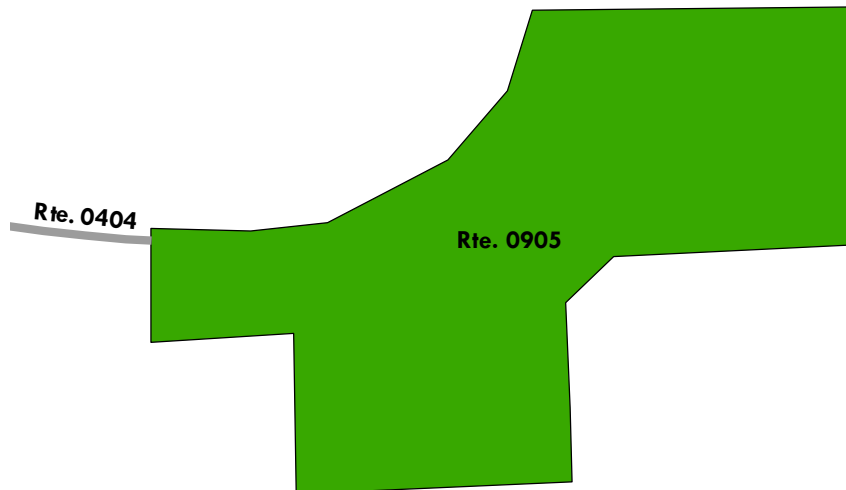
ROUTE 0905: EQUIPMENT STORAGE PARKING

Inspection Date	FMSS Number	User Access	Surface Type
3/2/2021	104687	NONPUBLIC	ASPHALT
Area (Sq. Ft.)	Lane Miles (11' Widths)	Curb Reveal (Inches)	Curb Recommendation
3,135	0.054	NOT APPLICABLE	NOT APPLICABLE
Curb Type		Curb & Gutter Type	
NO CURB		NO CURB AND GUTTER	
Pavement Recommendation		Condition Rating / PCR	
PREVENTIVE MAINTENANCE		GOOD / 90
