# SAJU Cycle 6

## Final Report

### Road Inventory and Condition Assessment of Paved Routes San Juan National Historic Site

**Report Date: August 2022**

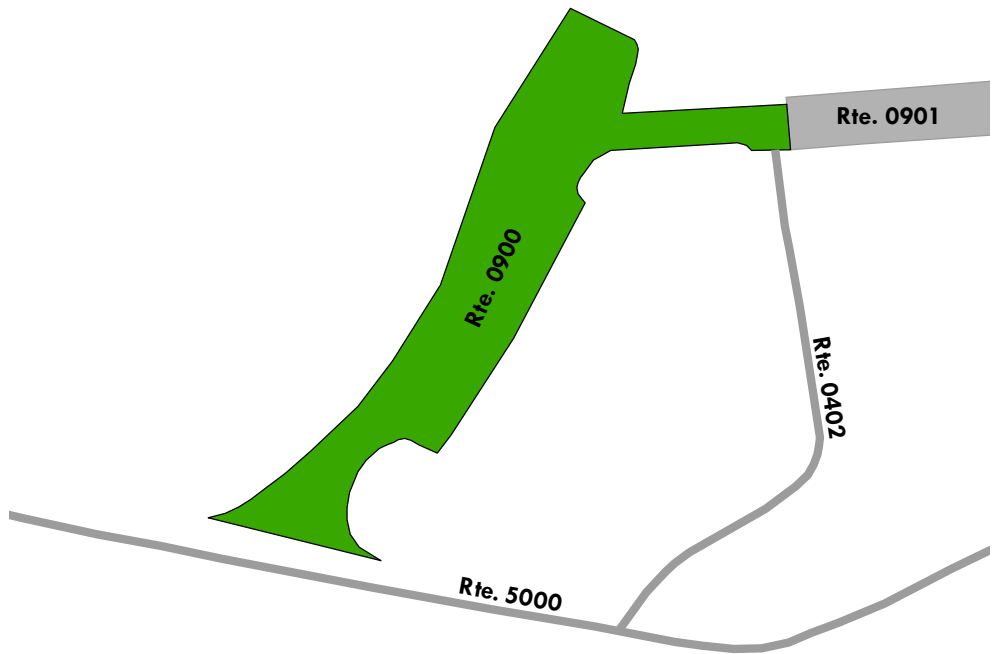
Inspection Date	FMSS Number	User Access	Surface Type
3/18/2022	103448	PUBLIC	CONCRETE
Area (Sq. Ft.)	Lane Miles (11' Widths)	Curb Reveal (Inches)	Curb Recommendation
16,963	0.292	7	DO NOTHING
Curb Type		Curb & Gutter Type	
CONCRETE		NO CURB AND GUTTER	
Pavement Recommendation		Condition Rating / PCR	
PREVENTIVE MAINTENANCE		GOOD / 90

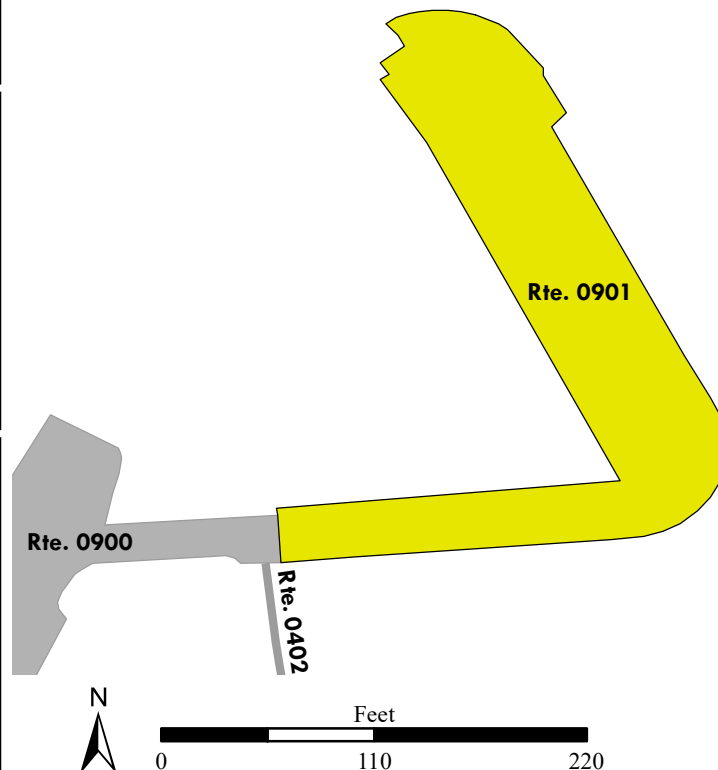
## ROUTE 0901: VISITOR CENTER ADMINISTRATIVE PARKING

Inspection Date	FMSS Number	User Access	Surface Type
3/18/2022	103445	NONPUBLIC	CONCRETE
Area (Sq. Ft.)	Lane Miles (11' Widths)	Curb Reveal (Inches)	Curb Recommendation
21,992	0.379	NOT APPLICABLE	NOT APPLICABLE
Curb Type		Curb & Gutter Type	
NO CURB		NO CURB AND GUTTER	
Pavement Recommendation		Condition Rating / PCR	
LIGHT 3R TREATMENTS		FAIR / 73

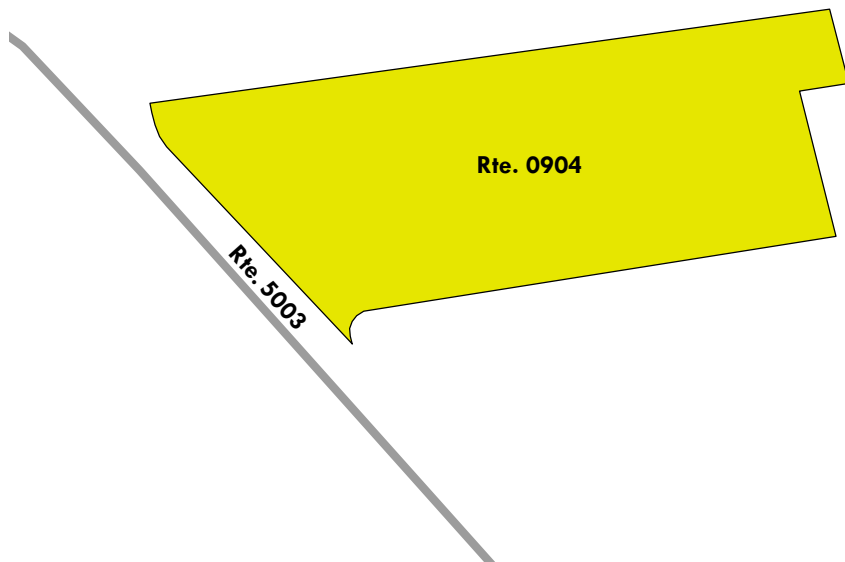
## ROUTE 0904: SANTA ELENA POWDER MAGAZINE PARKING

Inspection Date	FMSS Number	User Access	Surface Type
3/18/2022	114027	NONPUBLIC	BRICK PAVERS
Area (Sq. Ft.)	Lane Miles (11' Widths)	Curb Reveal (Inches)	Curb Recommendation
5,464	0.094	NOT APPLICABLE	NOT APPLICABLE
Curb Type		Curb & Gutter Type	
NO CURB		NO CURB AND GUTTER	
Pavement Recommendation		Condition Rating / PCR	
LIGHT 3R TREATMENTS		FAIR / 73
