# SAMO Cycle 6

## Final Report

### Road Inventory and Condition Assessment of Paved Routes Santa Monica Mountains National Recreation Area

Federal Highway Administration  
Eastern Federal Lands Highway Division  
Road Inventory Program (RIP)

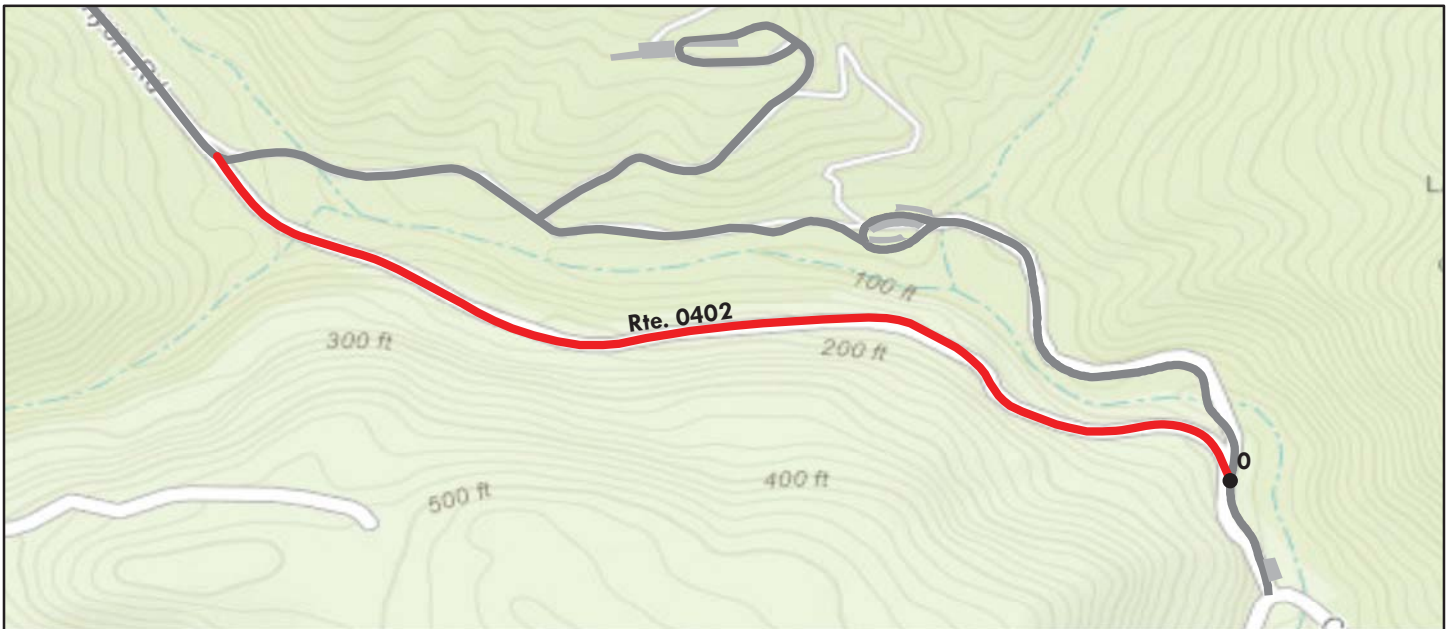
Route Condition Legend – Pavement Condition Rating (PCR)						
Poor (0 - 60)	Fair (61- 84)	Good (85 - 94)	Excellent (95 - 100)	Not Rated		
See Appendix for definitions and formulas						
<b>Inspection Date:</b> 3/2/2015	<b>Beginning Section MP</b>	0.00				
<b>Paved Length (Miles):</b> 0.51	<b>Section Length (MI)</b>	0.51				
<b>Surface Type:</b> ASPHALT	<b>Route Summary</b>					
<b>Roadway Condition Information</b>						
Pavement Condition Rating (PCR)	0	0				
Surface Condition Rating (SCR)	0	0				
Roughness Condition Index (RCI)	N/A	N/A				
<b>Distress Index Values</b>						
Structural Crack Index	N/A	N/A				
Alligator Crack Index	N/A	N/A				
Longitudinal Crack Index	N/A	N/A				
Transverse Cracking Index	N/A	N/A				
Patching Index	N/A	N/A				
Rutting Index	N/A	N/A				
International Roughness Index (IRI)	N/A	N/A				
<b>Lane &amp; Width Information</b>						
Number of Lanes	1	1				
Paved Width (ft)	16	16				
Lane Width (ft)	16	16

Route was given a PCR of 0 rating because it is in very poor condition, and individual distress indices could not be determined (due to the excessive distress quantity).

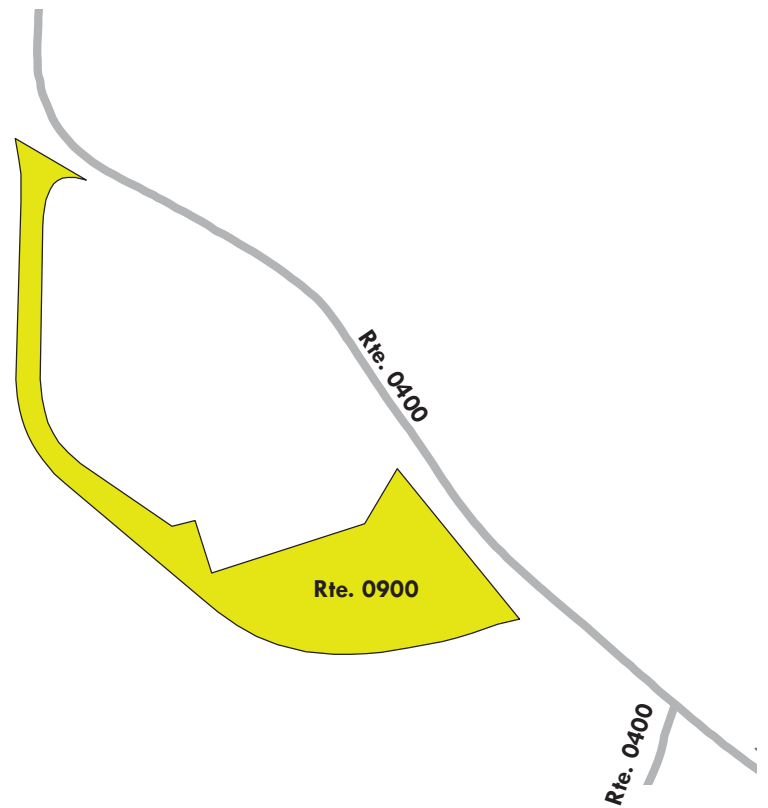
Inspection Date	FMSS Number	User Access	Surface Type
3/2/2015	102684	NONPUBLIC	ASPHALT
Area (Sq. Ft.)	Lane Miles (11' Widths)	Curb Reveal (Inches)	Curb Recommendation
13,696	0.236	4	DO NOTHING
Curb Type		Curb & Gutter Type	
ASPHALT		NO CURB AND GUTTER	
Pavement Recommendation		Condition Rating / PCR	
LIGHT 3R TREATMENTS		FAIR / 73

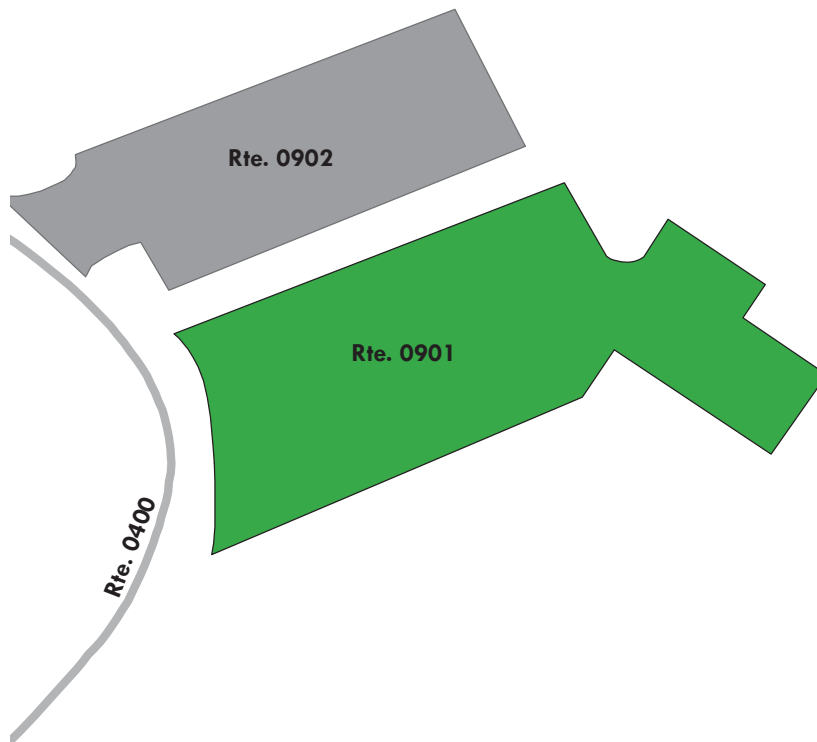
Inspection Date	FMSS Number	User Access	Surface Type
3/2/2015	17251	NONPUBLIC	ASPHALT
Area (Sq. Ft.)	Lane Miles (11' Widths)	Curb Reveal (Inches)	Curb Recommendation
9,876	0.17	NOT APPLICABLE	NOT APPLICABLE
Curb Type		Curb & Gutter Type	
NO CURB		NO CURB AND GUTTER	
Pavement Recommendation		Condition Rating / PCR	
PREVENTIVE MAINTENANCE		GOOD / 90
