SLBE Cycle 6

Final Report

Road Inventory and Condition Assessment of Paved Routes Sleeping Bear Dunes National Lakeshore

Report Date: August 2019

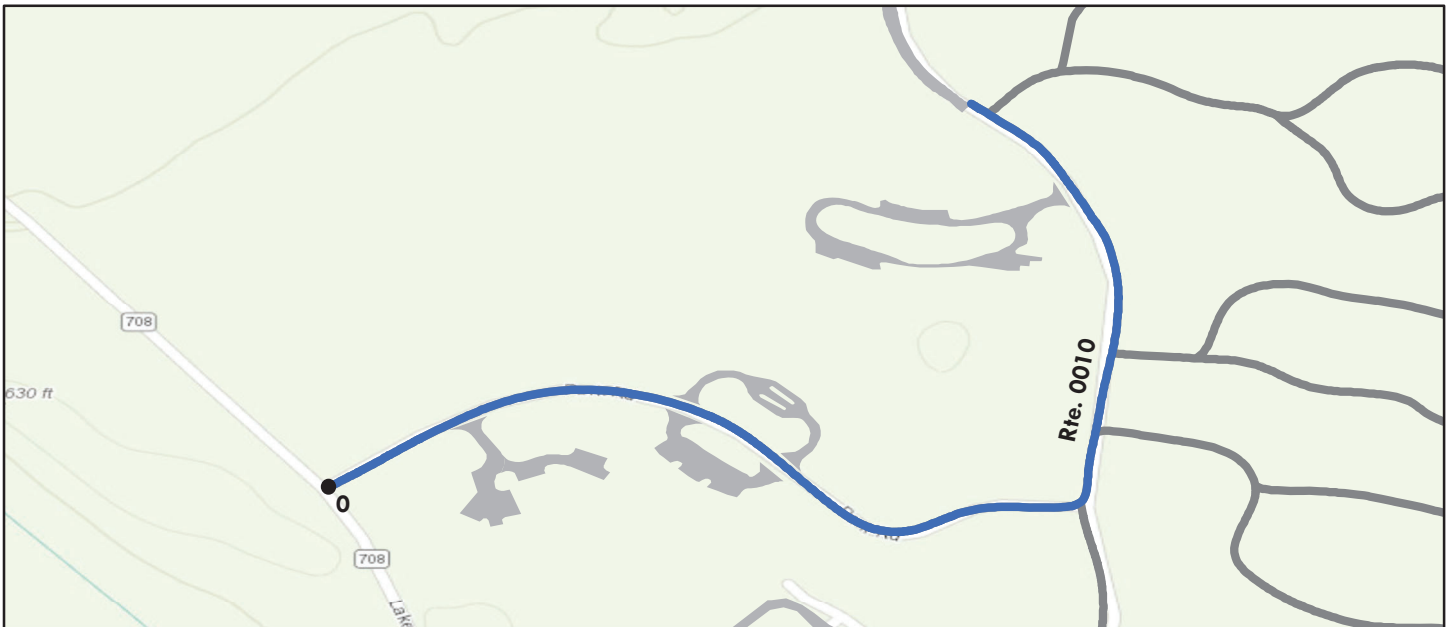
Data Collection Vehicle (DCV) Rating

Inspection Date:	10/16/2018	Beginning Section MP	0				
Paved Length (Miles):	0.44	Section Length (MI)	0.44				
Surface Type:	ASPHALT	Route Summary					
Roadway Condition Information							
Pavement Condition Rating (PCR)	98	98					
Surface Condition Rating (SCR)	98	98					
Roughness Condition Index (RCI)	N/A	N/A					
Distress Index Values							
Structural Crack Index	100	100					
Alligator Crack Index	100	100					
Longitudinal Crack Index	100	100					
Transverse Cracking Index	99	99					
Patching Index	100	100					
Rutting Index	98	98					
International Roughness Index (IRI)	N/A	N/A					
Lane & Width Information							
Number of Lanes	2	2					
Paved Width (ft)	27.4	27.4					
Lane Width (ft)	10.7	10.7

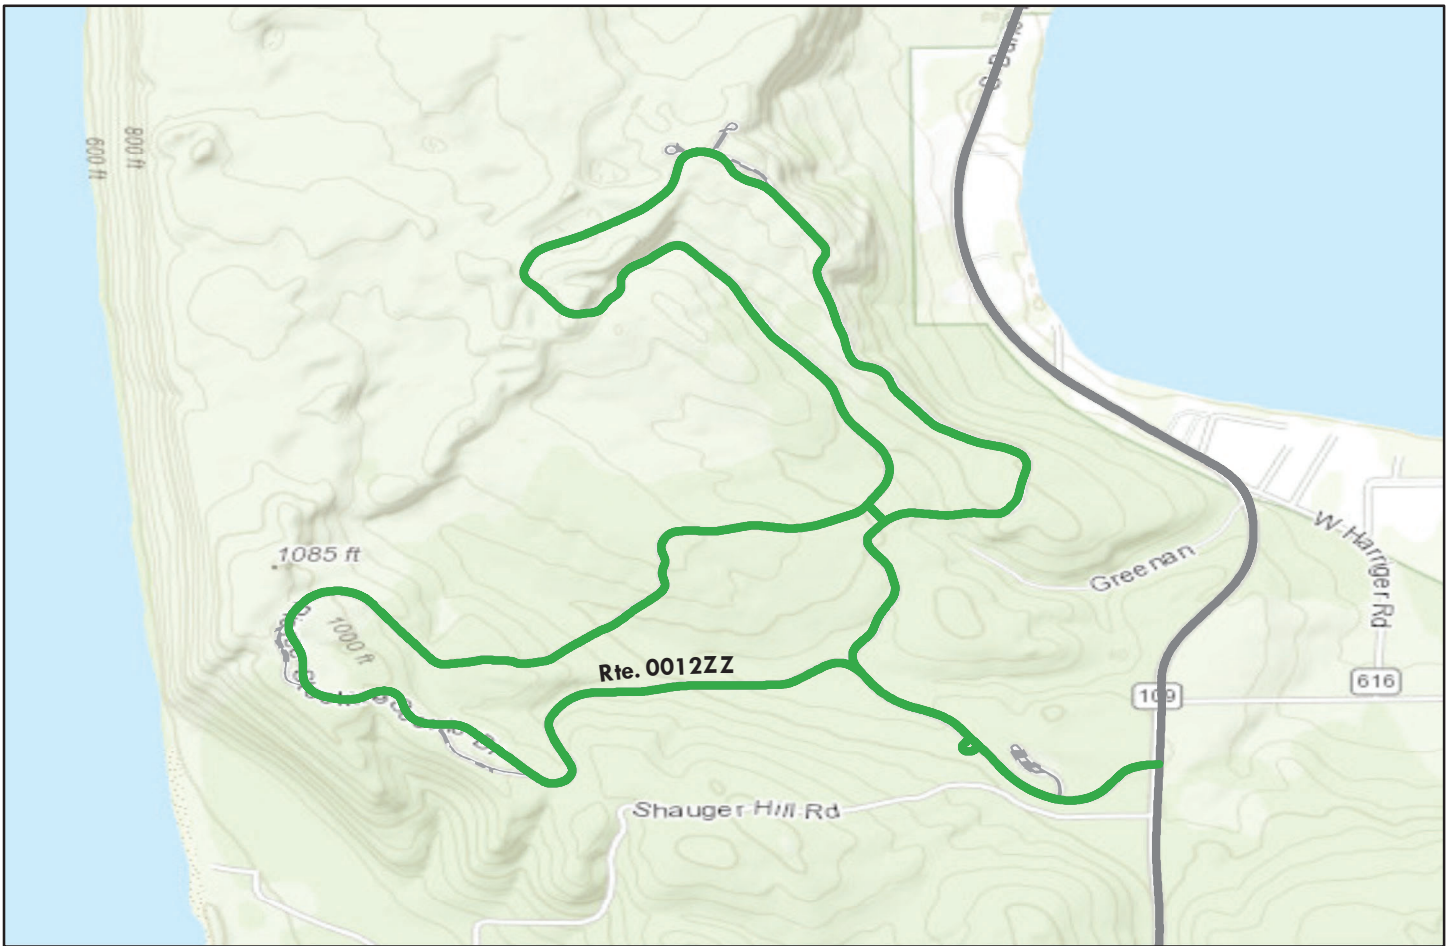
Summary Route

Route Condition Legend – Pavement Condition Rating (PCR)						
Poor (0 - 60)	Fair (61- 84)	Good (85 - 94)	Excellent (95 - 100)	Not Rated		
See Appendix for definitions and formulas						
Inspection Date:	10/16/2018					
Paved Length (Miles):	6.6					
Surface Type:	ASPHALT	Route Summary				
Roadway Condition Information						
Pavement Condition Rating (PCR)	90					
Lane & Width Information						
Number of Lanes	2					
Paved Width (ft)	19.7					
Lane Width (ft)	11.7

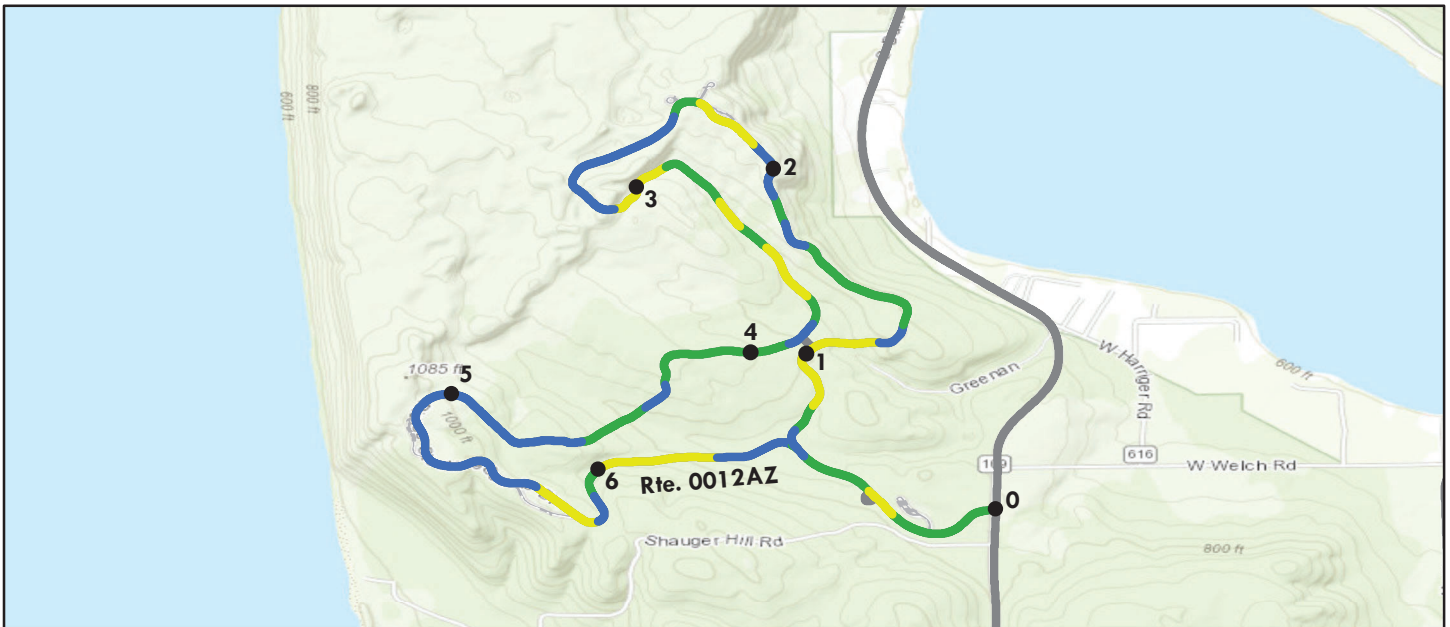
Data Collection Vehicle (DCV) Rating

Inspection Date:	10/16/2018	Beginning Section MP	0	1	2	3	4
Paved Length (Miles):	6.51	Section Length (MI)	1	1	1	1	1
Surface Type:	ASPHALT	Route Summary					
Roadway Condition Information							
Pavement Condition Rating (PCR)	90	87	88	93	88	95	
Surface Condition Rating (SCR)	87	85	87	92	83	92	
Roughness Condition Index (RCI)	95	91	90	94	96	100	
Distress Index Values							
Structural Crack Index	100	100	100	100	100	100	
Alligator Crack Index	100	100	100	100	100	100	
Longitudinal Crack Index	100	100	100	100	100	100	
Transverse Cracking Index	100	100	100	100	100	100	
Patching Index	100	100	100	100	100	100	
Rutting Index	87	85	87	92	83	92	
International Roughness Index (IRI)	128	138	142	130	125	108	
Lane & Width Information							
Number of Lanes	1	2	1	1	1	1	
Paved Width (ft)	19.8	29.8	18.3	17.8	17.8	17.5	
Lane Width (ft)	11.7	11.7	12.2	11.6	11.5	11.4

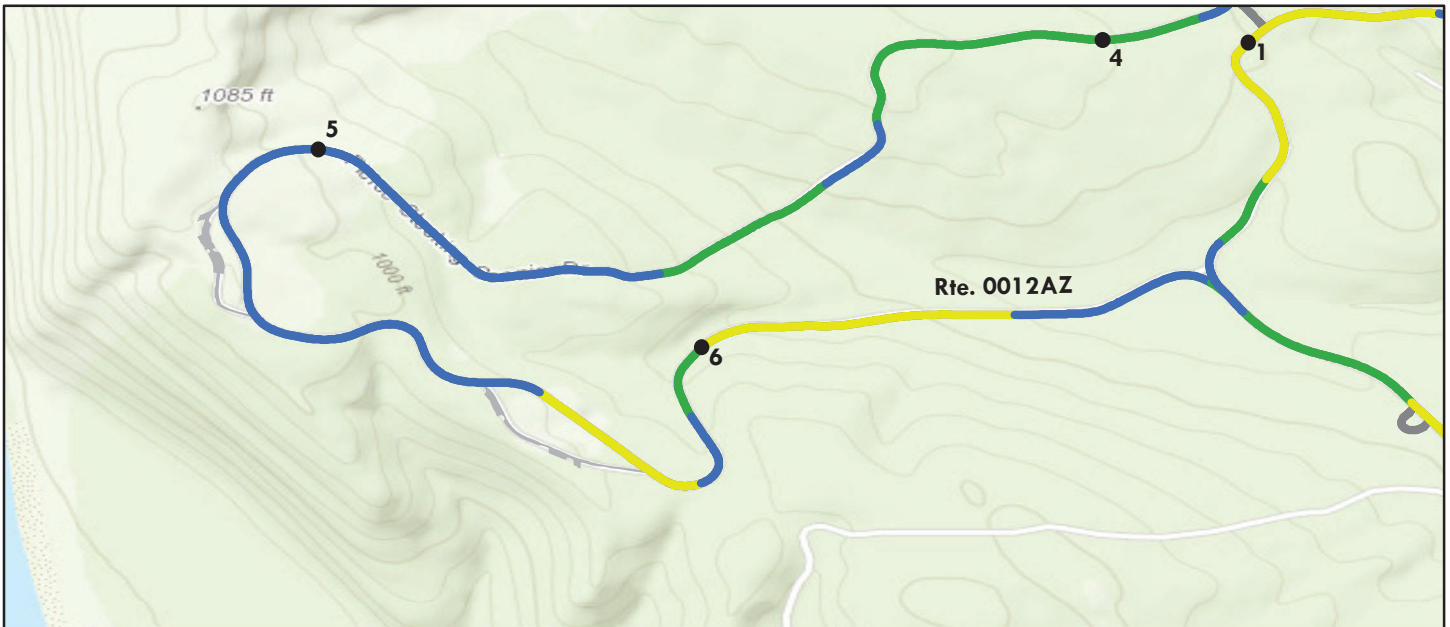
Data Collection Vehicle (DCV) Rating

Inspection Date:	10/16/2018	Beginning Section MP	5	6			
Paved Length (Miles):	6.51	Section Length (MI)	1	0.51			
Surface Type:	ASPHALT	Route Summary					
Roadway Condition Information							
Pavement Condition Rating (PCR)	90	92	88				
Surface Condition Rating (SCR)	87	90	85				
Roughness Condition Index (RCI)	95	96	93				
Distress Index Values							
Structural Crack Index	100	100	100				
Alligator Crack Index	100	100	100				
Longitudinal Crack Index	100	100	100				
Transverse Cracking Index	100	100	100				
Patching Index	100	100	100				
Rutting Index	87	90	85				
International Roughness Index (IRI)	128	124	133				
Lane & Width Information							
Number of Lanes	1	1	1				
Paved Width (ft)	19.8	18.1	18.8				
Lane Width (ft)	11.7	11.9	11.9

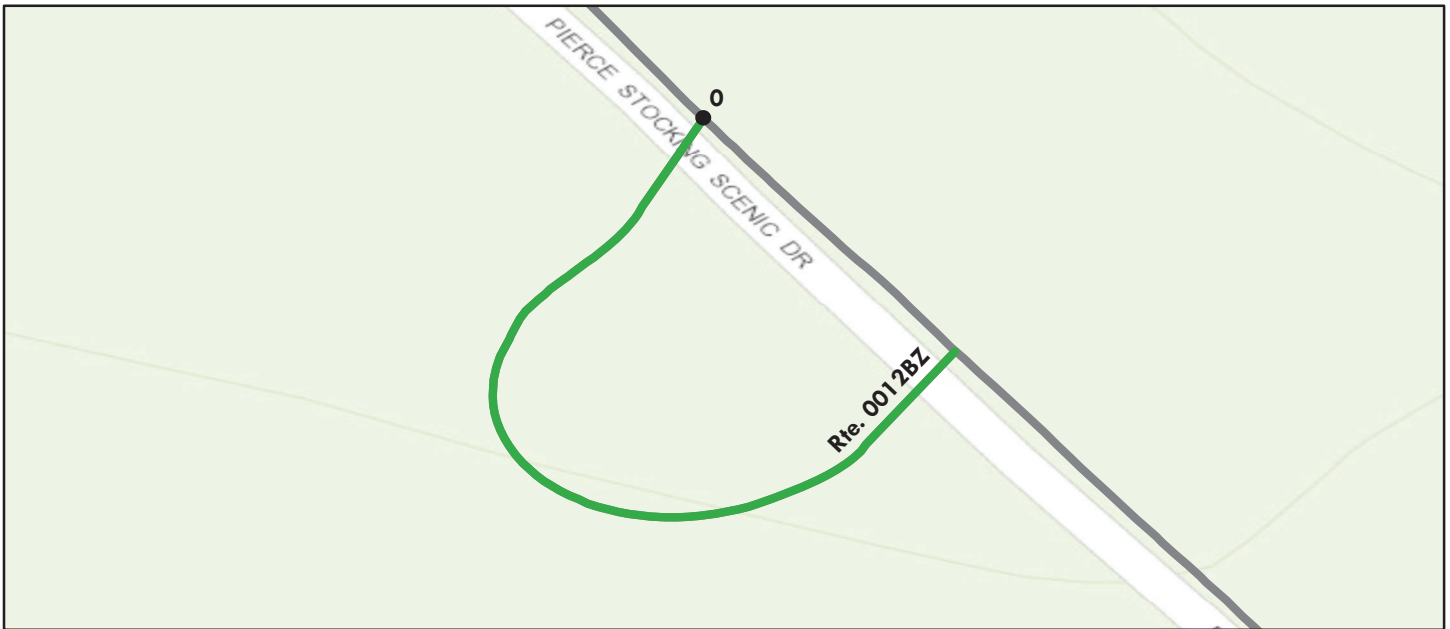
Data Collection Vehicle (DCV) Rating

Inspection Date: 10/16/2018	Beginning Section MP	0				
Paved Length (Miles): 0.05	Section Length (MI)	0.05				
Surface Type: ASPHALT	Route Summary					
Roadway Condition Information						
Pavement Condition Rating (PCR)	93	93				
Surface Condition Rating (SCR)	93	93				
Roughness Condition Index (RCI)	N/A	N/A				
Distress Index Values						
Structural Crack Index	100	100				
Alligator Crack Index	100	100				
Longitudinal Crack Index	100	100				
Transverse Cracking Index	100	100				
Patching Index	100	100				
Rutting Index	93	93				
International Roughness Index (IRI)	N/A	N/A				
Lane & Width Information						
Number of Lanes	1	1				
Paved Width (ft)	15.2	15.2				
Lane Width (ft)	15.2	15.2

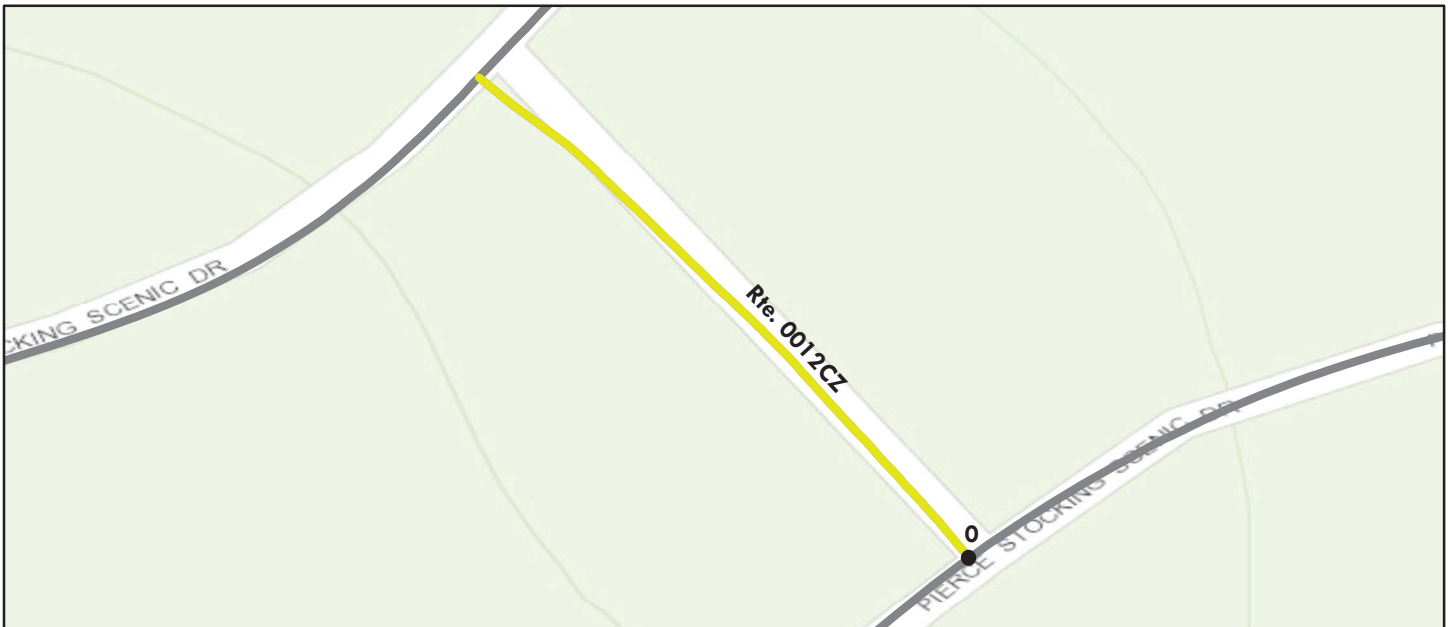
Data Collection Vehicle (DCV) Rating

Inspection Date: 10/16/2018	Beginning Section MP	0				
Paved Length (Miles): 0.05	Section Length (MI)	0.04				
Surface Type: ASPHALT	Route Summary					
Roadway Condition Information						
Pavement Condition Rating (PCR)	83	83				
Surface Condition Rating (SCR)	83	83				
Roughness Condition Index (RCI)	N/A	N/A				
Distress Index Values						
Structural Crack Index	100	100				
Alligator Crack Index	100	100				
Longitudinal Crack Index	100	100				
Transverse Cracking Index	100	100				
Patching Index	100	100				
Rutting Index	83	83				
International Roughness Index (IRI)	N/A	N/A				
Lane & Width Information						
Number of Lanes	2	2				
Paved Width (ft)	17.2	17.2				
Lane Width (ft)	8.6	8.6

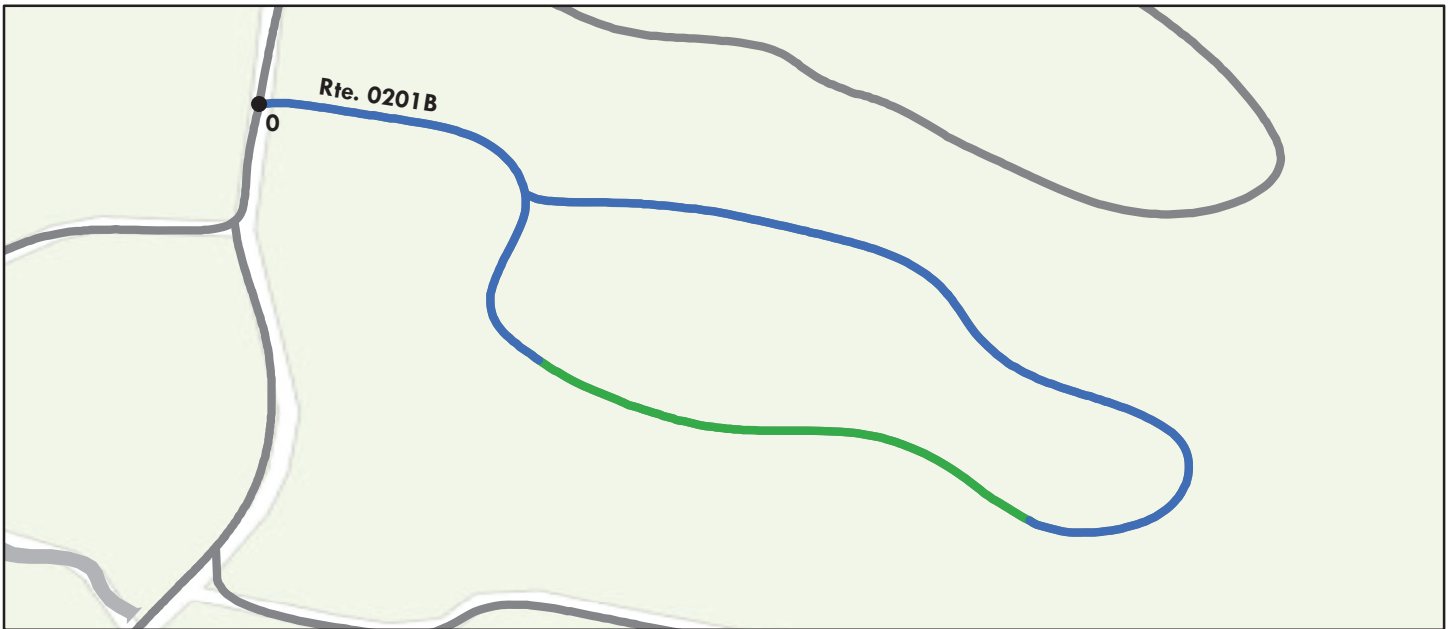
Data Collection Vehicle (DCV) Rating

Inspection Date:	10/16/2018	Beginning Section MP	0				
Paved Length (Miles):	0.38	Section Length (MI)	0.38				
Surface Type:	ASPHALT	Route Summary					
Roadway Condition Information							
Pavement Condition Rating (PCR)	97	97					
Surface Condition Rating (SCR)	97	97					
Roughness Condition Index (RCI)	N/A	N/A					
Distress Index Values							
Structural Crack Index	100	100					
Alligator Crack Index	100	100					
Longitudinal Crack Index	100	100					
Transverse Cracking Index	100	100					
Patching Index	100	100					
Rutting Index	97	97					
International Roughness Index (IRI)	N/A	N/A					
Lane & Width Information							
Number of Lanes	1	1					
Paved Width (ft)	16.5	16.5					
Lane Width (ft)	13.5	13.5

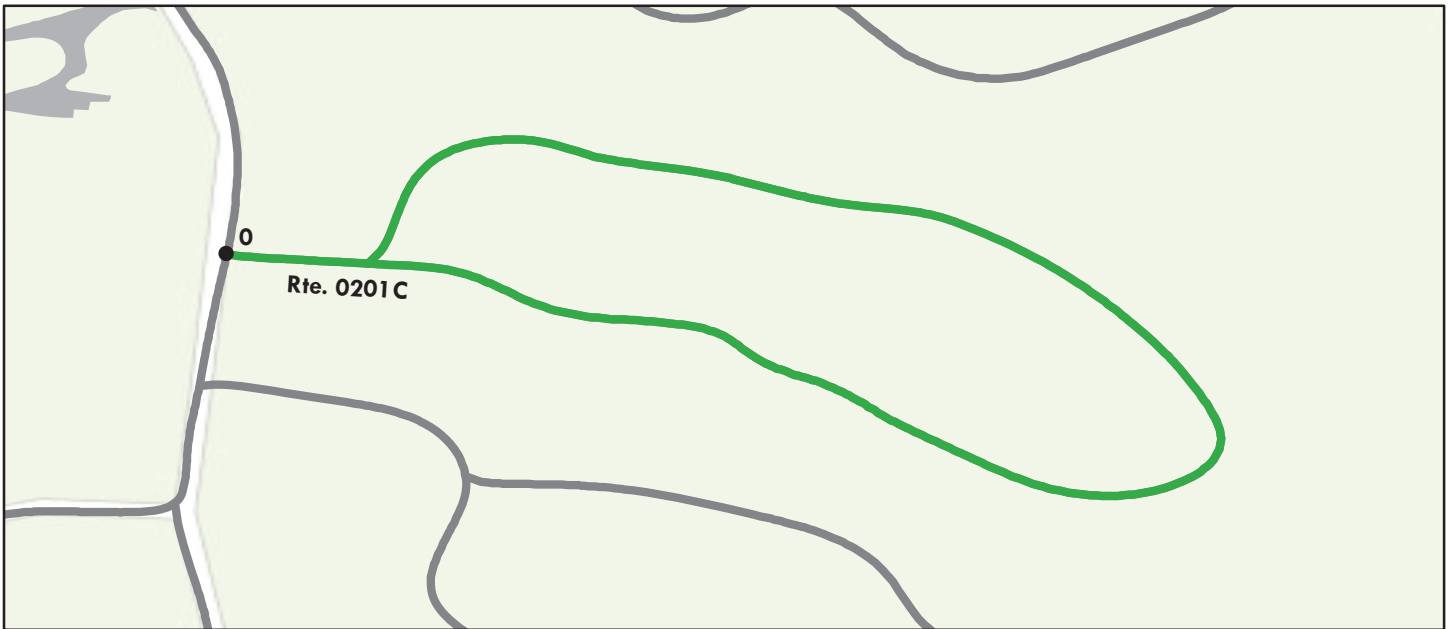
Data Collection Vehicle (DCV) Rating

Inspection Date:	10/16/2018	Beginning Section MP	0				
Paved Length (Miles):	0.39	Section Length (MI)	0.39				
Surface Type:	ASPHALT	Route Summary					
Roadway Condition Information							
Pavement Condition Rating (PCR)	90	90					
Surface Condition Rating (SCR)	90	90					
Roughness Condition Index (RCI)	N/A	N/A					
Distress Index Values							
Structural Crack Index	100	100					
Alligator Crack Index	100	100					
Longitudinal Crack Index	100	100					
Transverse Cracking Index	100	100					
Patching Index	100	100					
Rutting Index	90	90					
International Roughness Index (IRI)	N/A	N/A					
Lane & Width Information							
Number of Lanes	1	1					
Paved Width (ft)	17.2	17.2					
Lane Width (ft)	12.9	12.9
