STE Cycle 6

Final Report

Road Inventory and Condition Assessment of Paved Routes Steamtown National Historic Site

Steamtown National Historic Site in Pennsylvania

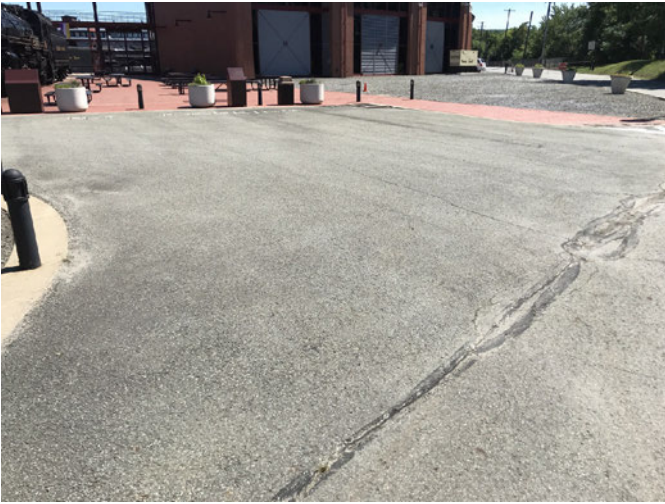
STEA_0400BZ_1.JPG

Inspection Date: 8/20/2020	Beginning Section MP	0.00				
Paved Length (Miles): 0.03	Section Length (MI)	0.03				
Surface Type: ASPHALT	Route Summary					
Roadway Condition Information						
Pavement Condition Rating (PCR)	54	54				
Surface Condition Rating (SCR)	54	54				
Roughness Condition Index (RCI)	N/A	N/A				
Distress Index Values						
Structural Crack Index	54	54				
Alligator Crack Index	100	100				
Longitudinal Crack Index	54	54				
Transverse Cracking Index	55	55				
Patching Index	94	94				
Rutting Index	100	100				
International Roughness Index (IRI)	N/A	N/A				
Lane & Width Information						
Number of Lanes	1	1				
Paved Width (ft)	14	14				
Lane Width (ft)	14	14

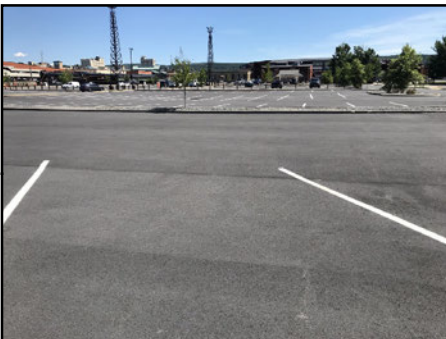
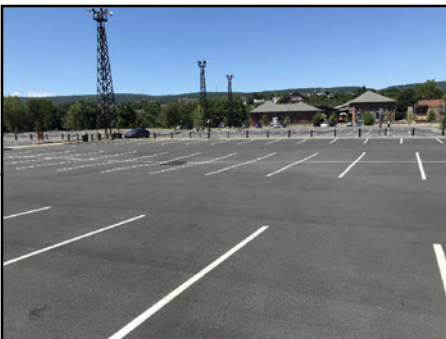
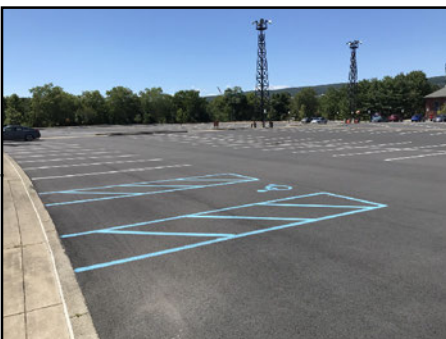
Inspection Date	FMSS Number	User Access	Surface Type
8/20/2020	00002041	PUBLIC	ASPHALT
Area (Sq. Ft.)	Lane Miles (11' Widths)	Curb Reveal (Inches)	Curb Recommendation
151,851	2.615	4	LIGHT REPAIR
Curb Type		Curb & Gutter Type	
CONCRETE		NO CURB AND GUTTER	
Pavement Recommendation		Condition Rating / PCR	
PREVENTIVE MAINTENANCE		GOOD / 90

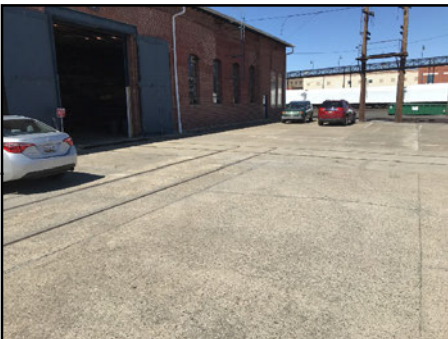
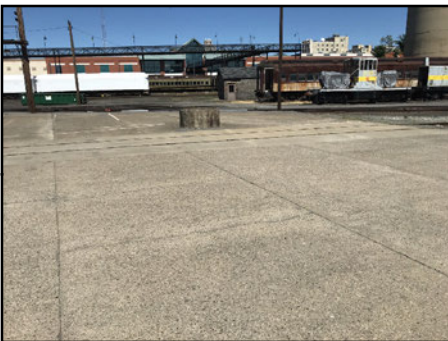
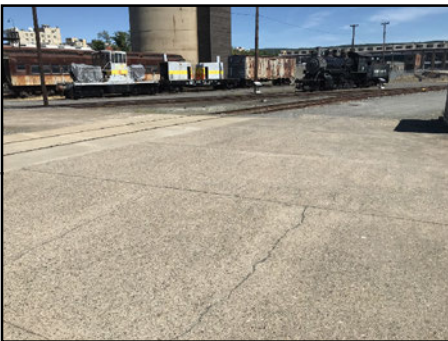
ROUTE 0902: LOCOMOTIVE SHOP EMPLOYEE PARKING

Inspection Date	FMSS Number	User Access	Surface Type
8/20/2020	61113	NONPUBLIC	CONCRETE
Area (Sq. Ft.)	Lane Miles (11' Widths)	Curb Reveal (Inches)	Curb Recommendation
10,065	0.173	NOT APPLICABLE	NOT APPLICABLE
Curb Type		Curb & Gutter Type	
NO CURB		NO CURB AND GUTTER	
Pavement Recommendation		Condition Rating / PCR	
HEAVY 3R TREATMENTS		POOR / 53

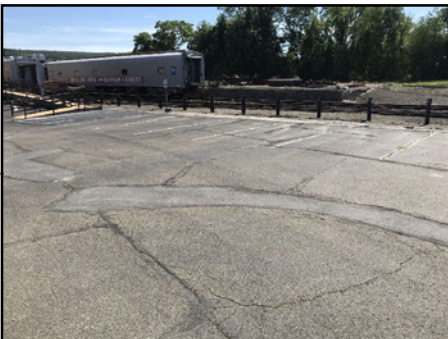
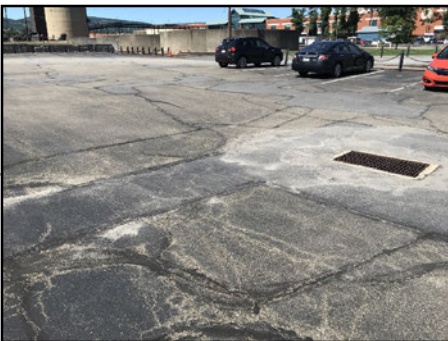
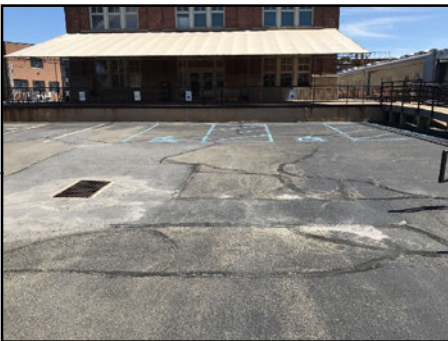
ROUTE 0906AZ: OFFICE AND STORAGE BUILDING PARKING A

Inspection Date	FMSS Number	User Access	Surface Type
8/20/2020	61119	NONPUBLIC	ASPHALT
Area (Sq. Ft.)	Lane Miles (11' Widths)	Curb Reveal (Inches)	Curb Recommendation
9,718	0.167	NOT APPLICABLE	NOT APPLICABLE
Curb Type		Curb & Gutter Type	
NO CURB		NO CURB AND GUTTER	
Pavement Recommendation		Condition Rating / PCR	
HEAVY 3R TREATMENTS		POOR / 53

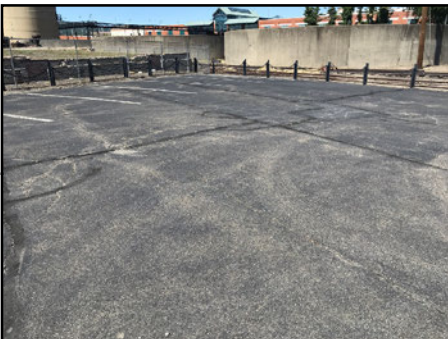
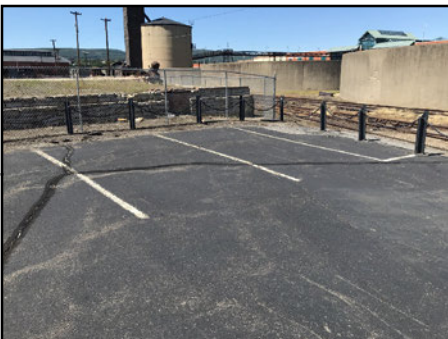
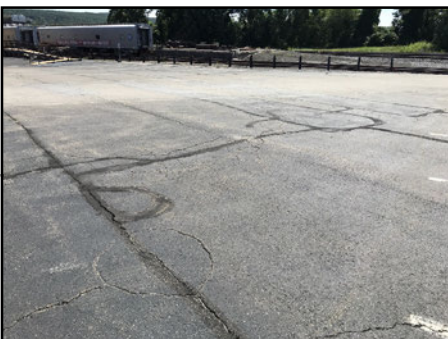
ROUTE 0906BZ: OFFICE AND STORAGE BUILDING PARKING B

Inspection Date	FMSS Number	User Access	Surface Type
8/20/2020	61119	NONPUBLIC	ASPHALT
Area (Sq. Ft.)	Lane Miles (11' Widths)	Curb Reveal (Inches)	Curb Recommendation
4,497	0.077	NOT APPLICABLE	NOT APPLICABLE
Curb Type		Curb & Gutter Type	
NO CURB		NO CURB AND GUTTER	
Pavement Recommendation		Condition Rating / PCR	
HEAVY 3R TREATMENTS		POOR / 53

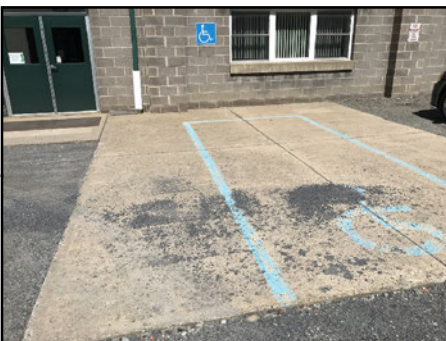
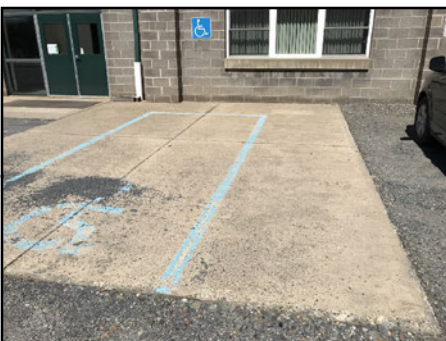
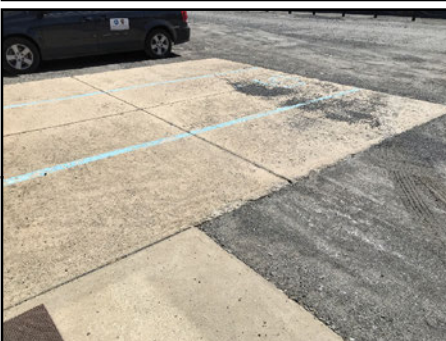
ROUTE 0908: MAINTENANCE AREA HANDICAPPED PARKING

Inspection Date	FMSS Number	User Access	Surface Type
8/20/2020	61121	NONPUBLIC	CONCRETE
Area (Sq. Ft.)	Lane Miles (11' Widths)	Curb Reveal (Inches)	Curb Recommendation
356	0.006	NOT APPLICABLE	NOT APPLICABLE
Curb Type		Curb & Gutter Type	
NO CURB		NO CURB AND GUTTER	
Pavement Recommendation		Condition Rating / PCR	
HEAVY 3R TREATMENTS		POOR / 53
