SUIT Cycle 6

Final Report

Road Inventory and Condition Assessment of Paved Routes Suitland Parkway *Part of the National Capital Parks - East*

Report Date: November 2019

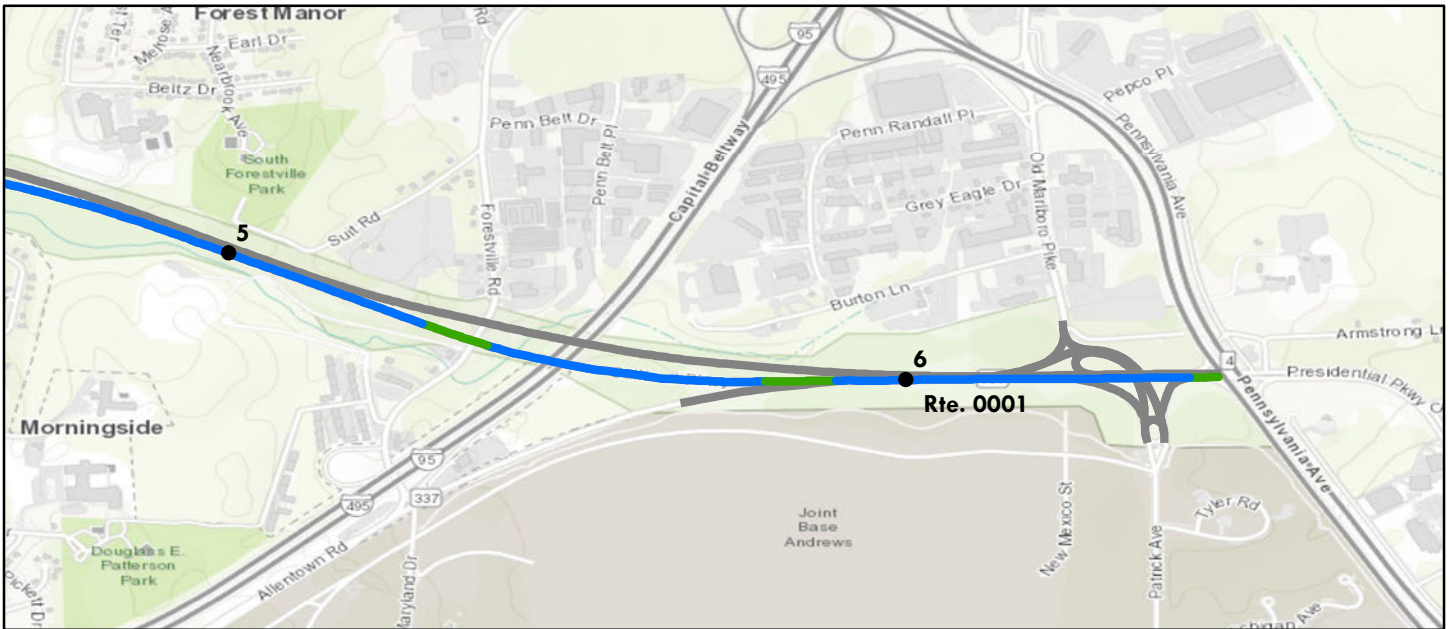
Data Collection Vehicle (DCV) Rating

Inspection Date: 3/24/2018	Beginning Section MP	5	6			
Paved Length (Miles): 6.44	Section Length (MI)	1	0.44			
Surface Type: ASPHALT	Route Summary					
Roadway Condition Information						
Pavement Condition Rating (PCR)	98	95	97			
Surface Condition Rating (SCR)	96	92	95			
Roughness Condition Index (RCI)	100	100	100			
Distress Index Values						
Structural Crack Index	96	100	99			
Alligator Crack Index	100	100	100			
Longitudinal Crack Index	96	100	99			
Transverse Cracking Index	98	100	99			
Patching Index	100	100	100			
Rutting Index	97	92	95			
International Roughness Index (IRI)	82	89	84			
Lane & Width Information						
Number of Lanes	2	2	2			
Paved Width (ft)	30.5	33.3	31.1			
Lane Width (ft)	13	13.7	13.8

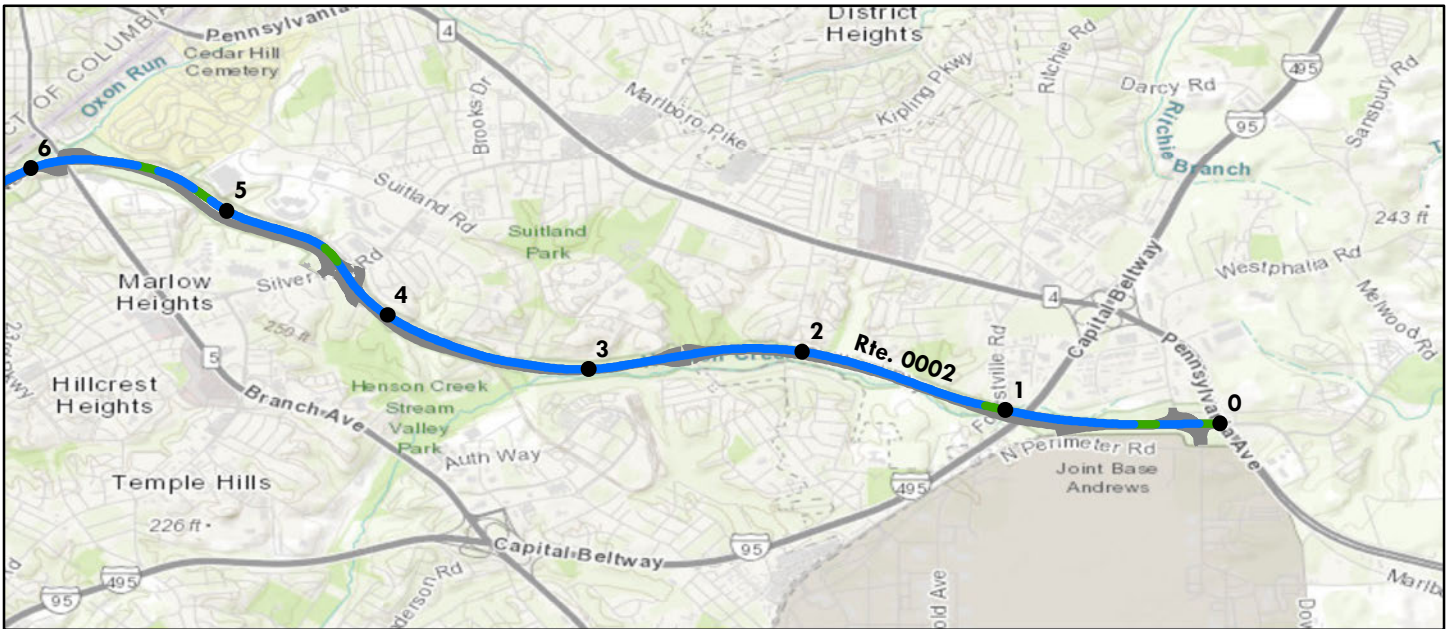
Data Collection Vehicle (DCV) Rating

Inspection Date: 3/24/2018	Beginning Section MP	0	1	2	3	4
Paved Length (Miles): 6.43	Section Length (MI)	1	1	1	1	1
Surface Type: ASPHALT	Route Summary					
Roadway Condition Information						
Pavement Condition Rating (PCR)	99	99	99	100	100	96
Surface Condition Rating (SCR)	98	98	99	100	100	93
Roughness Condition Index (RCI)	100	100	100	100	100	100
Distress Index Values						
Structural Crack Index	99	98	99	100	100	98
Alligator Crack Index	100	100	100	100	100	100
Longitudinal Crack Index	99	98	99	100	100	98
Transverse Cracking Index	98	99	100	100	100	93
Patching Index	100	100	100	100	100	100
Rutting Index	99	99	99	100	100	100
International Roughness Index (IRI)	65	79	56	54	52	74
Lane & Width Information						
Number of Lanes	2	2	2	2	2	2
Paved Width (ft)	30.5	31.6	29.6	29.9	32.5	30.9
Lane Width (ft)	12.9	13.8	12.2	12.9	11.8	14

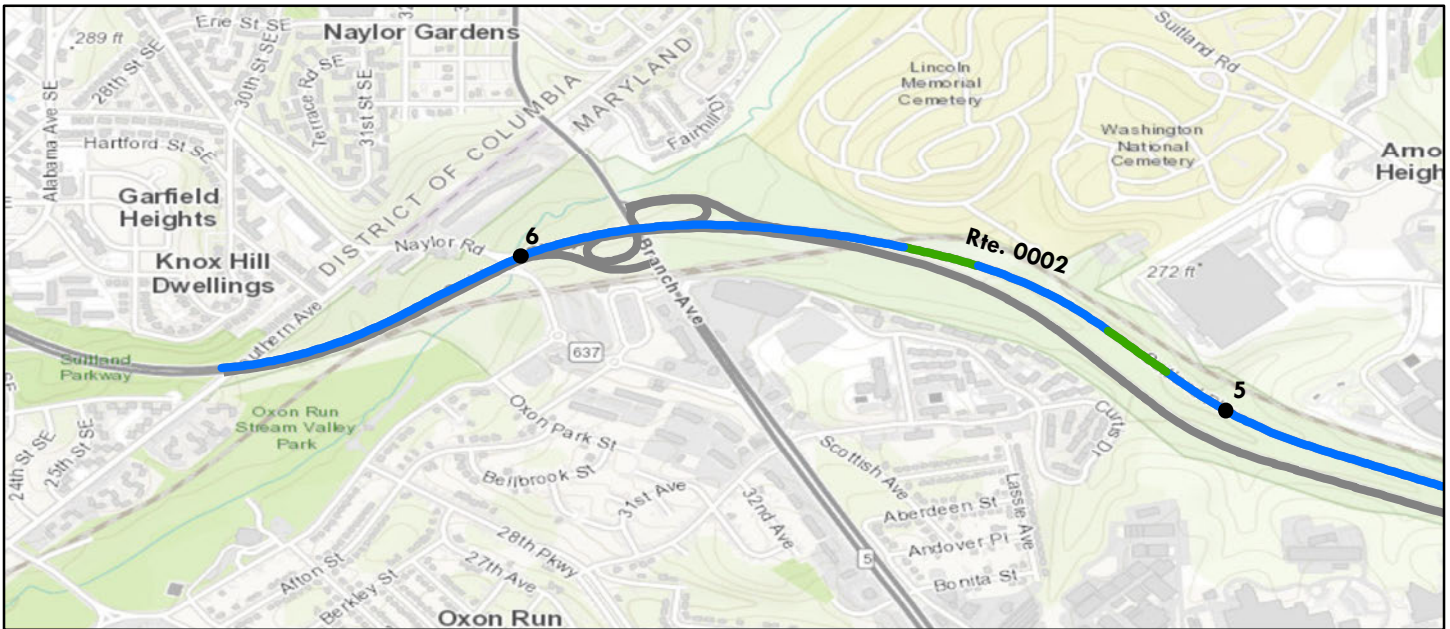
Data Collection Vehicle (DCV) Rating

Inspection Date: 3/24/2018	Beginning Section MP	5	6			
Paved Length (Miles): 6.43	Section Length (MI)	1	0.43			
Surface Type: ASPHALT	Route Summary					
Roadway Condition Information						
Pavement Condition Rating (PCR)	99	96	99			
Surface Condition Rating (SCR)	98	93	98			
Roughness Condition Index (RCI)	100	100	100			
Distress Index Values						
Structural Crack Index	99	99	98			
Alligator Crack Index	100	100	100			
Longitudinal Crack Index	99	99	98			
Transverse Cracking Index	98	93	98			
Patching Index	100	100	100			
Rutting Index	99	99	99			
International Roughness Index (IRI)	65	70	74			
Lane & Width Information						
Number of Lanes	2	2	2			
Paved Width (ft)	30.5	30.5	26.9			
Lane Width (ft)	12.9	13.1	11.9

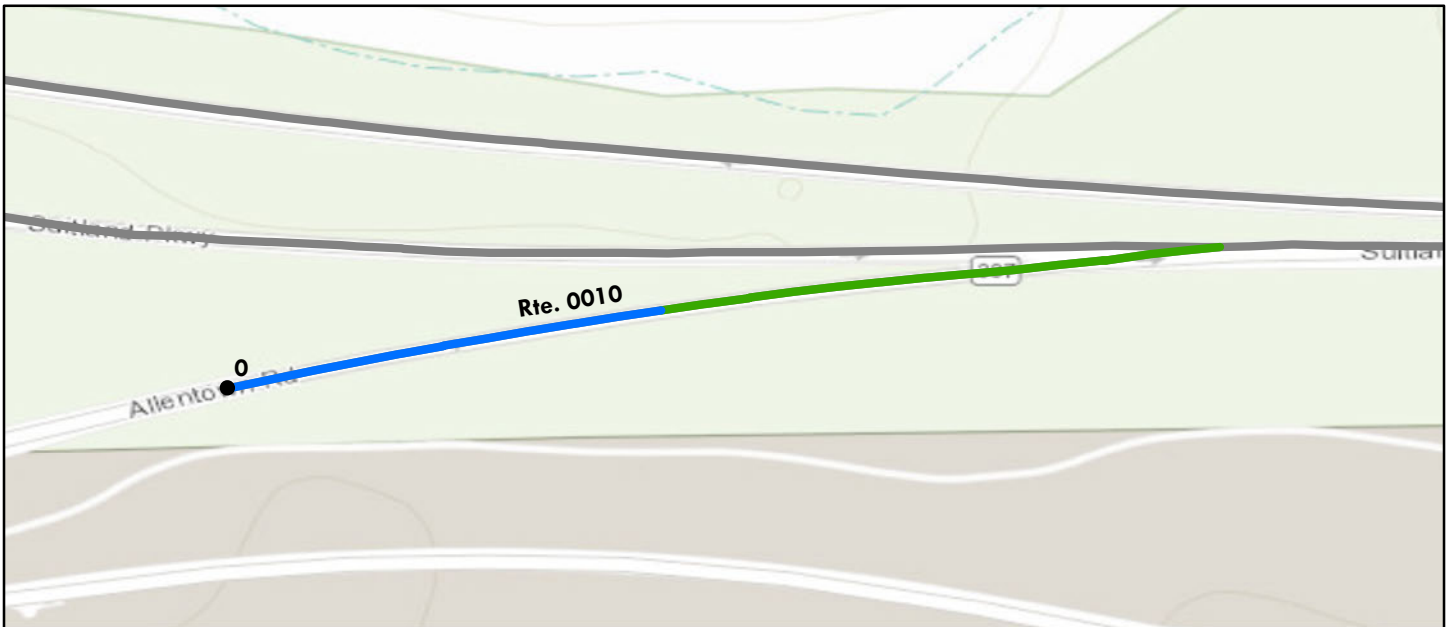
Data Collection Vehicle (DCV) Rating

Inspection Date: 3/24/2018	Beginning Section MP	0				
Paved Length (Miles): 0.22	Section Length (MI)	0.22				
Surface Type: ASPHALT	Route Summary					
Roadway Condition Information						
Pavement Condition Rating (PCR)	95	95				
Surface Condition Rating (SCR)	95	95				
Roughness Condition Index (RCI)	N/A	N/A				
Distress Index Values						
Structural Crack Index	99	99				
Alligator Crack Index	100	100				
Longitudinal Crack Index	99	99				
Transverse Cracking Index	100	100				
Patching Index	100	100				
Rutting Index	95	95				
International Roughness Index (IRI)	N/A	N/A				
Lane & Width Information						
Number of Lanes	1	1				
Paved Width (ft)	16.7	16.7				
Lane Width (ft)	15.5	15.5

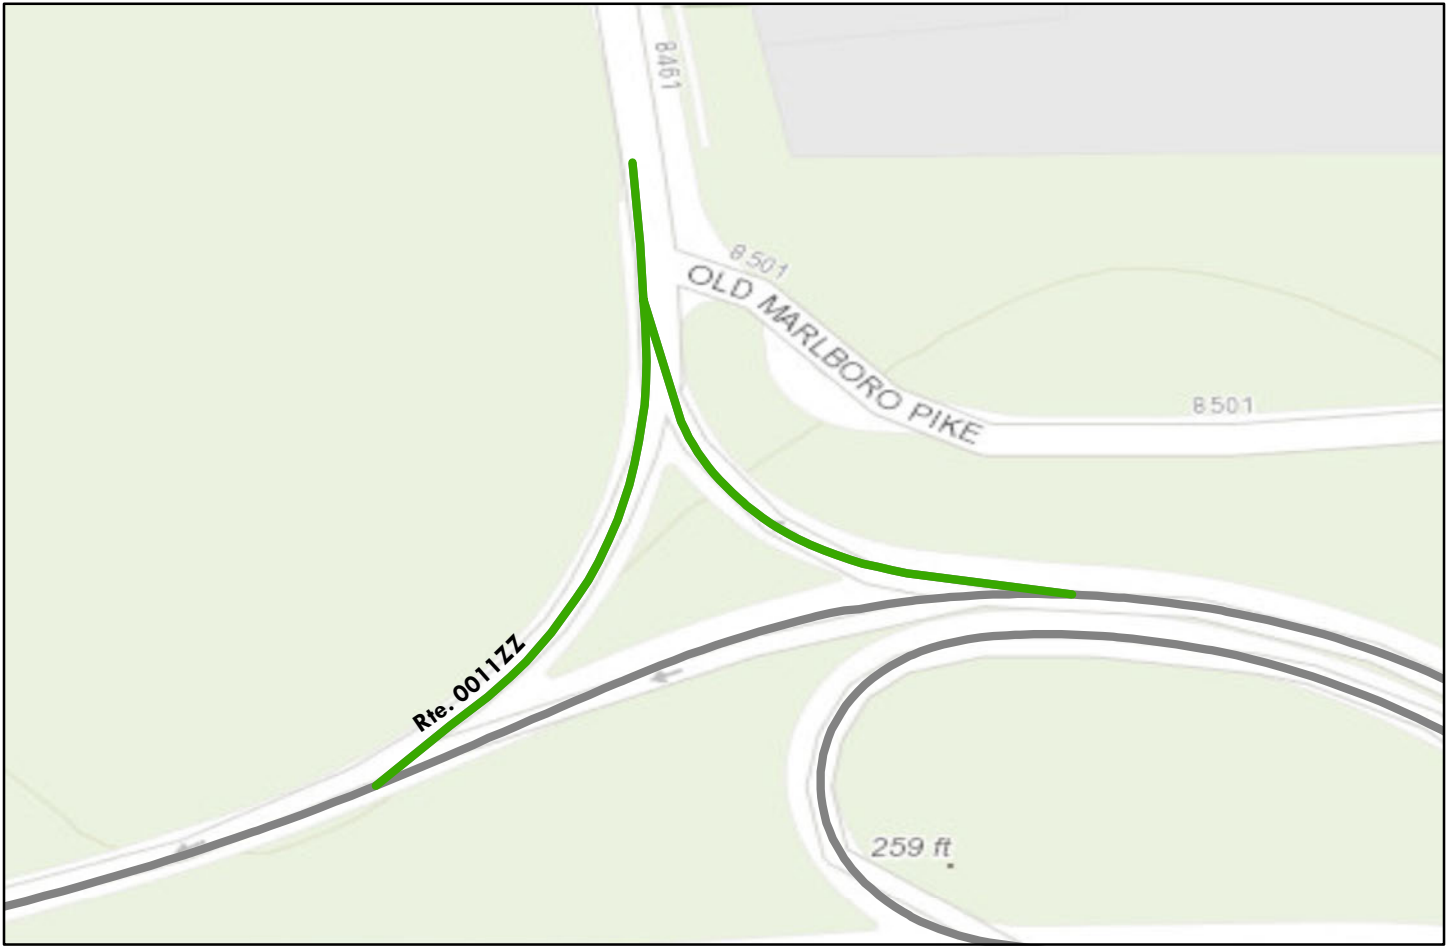
Summary Route

Route Condition Legend – Pavement Condition Rating (PCR)						
Poor (0 - 60)	Fair (61- 84)	Good (85 - 94)	Excellent (95 - 100)	Not Rated		
See Appendix for definitions and formulas						
Inspection Date:	3/24/2018					
Paved Length (Miles):	0.11					
Surface Type:	ASPHALT	Route Summary				
Roadway Condition Information						
Pavement Condition Rating (PCR)	92					
Lane & Width Information						
Number of Lanes	1					
Paved Width (ft)	18.3					
Lane Width (ft)	16.5

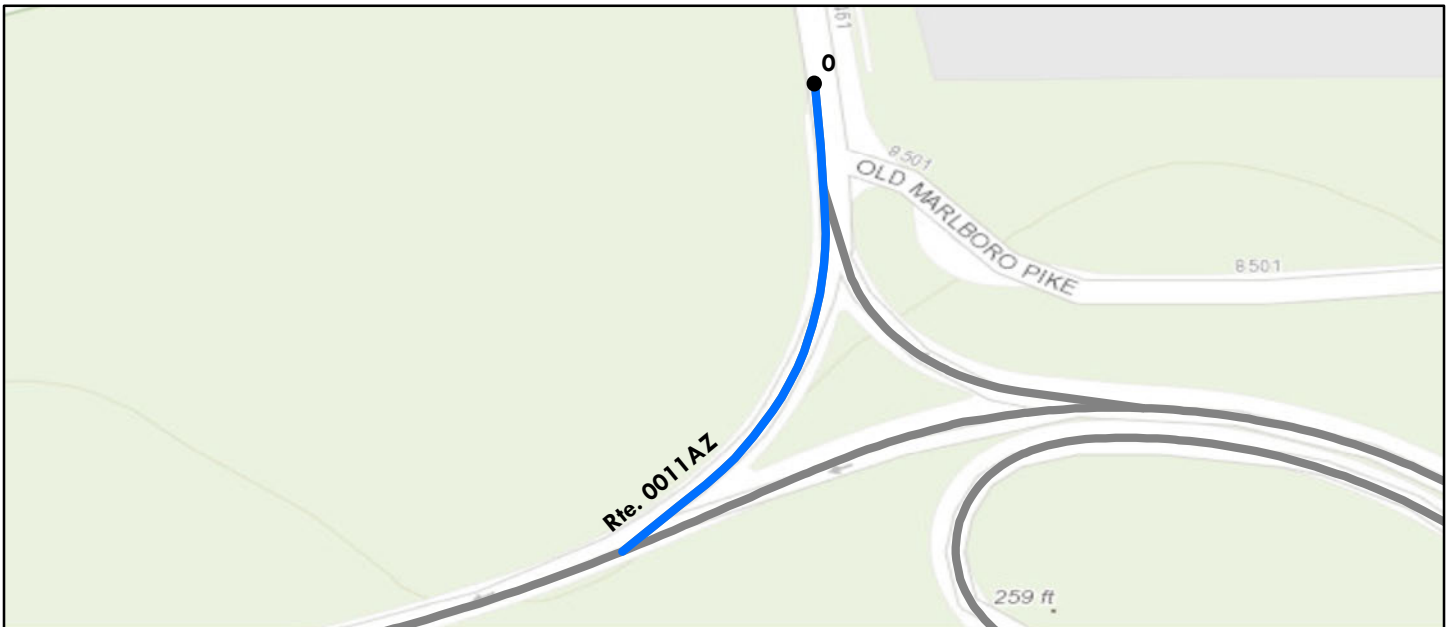
Subcomponent of Route SUIT-0011ZZ
 Data Collection Vehicle (DCV) Rating

Inspection Date: 3/24/2018	Beginning Section MP	0				
Paved Length (Miles): 0.08	Section Length (MI)	0.08				
Surface Type: ASPHALT	Route Summary					
Roadway Condition Information						
Pavement Condition Rating (PCR)	98	98				
Surface Condition Rating (SCR)	98	98				
Roughness Condition Index (RCI)	N/A	N/A				
Distress Index Values						
Structural Crack Index	100	100				
Alligator Crack Index	100	100				
Longitudinal Crack Index	100	100				
Transverse Cracking Index	100	100				
Patching Index	98	98				
Rutting Index	99	99				
International Roughness Index (IRI)	N/A	N/A				
Lane & Width Information						
Number of Lanes	1	1				
Paved Width (ft)	16.4	16.4				
Lane Width (ft)	14.5	14.5

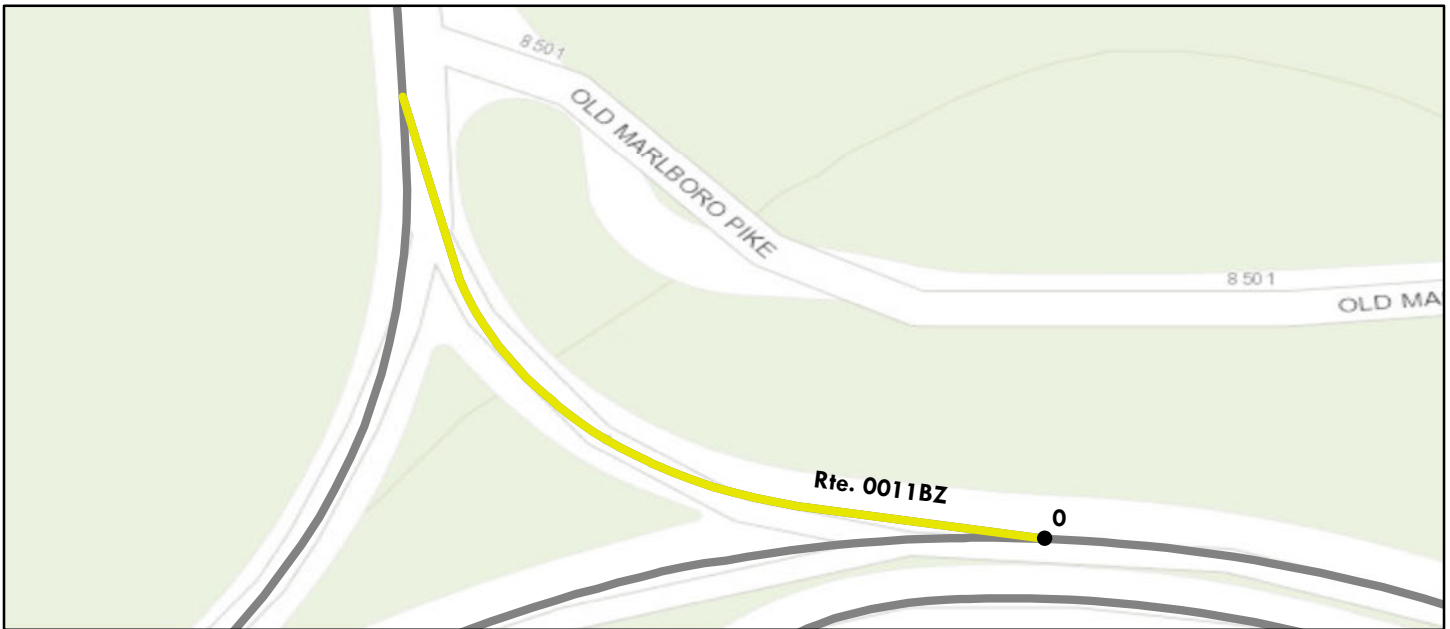
Subcomponent of Route SUIT-0011ZZ
 Data Collection Vehicle (DCV) Rating

Inspection Date: 3/24/2018	Beginning Section MP	0				
Paved Length (Miles): 0.03	Section Length (MI)	0.03				
Surface Type: ASPHALT	Route Summary					
Roadway Condition Information						
Pavement Condition Rating (PCR)	83	83				
Surface Condition Rating (SCR)	83	83				
Roughness Condition Index (RCI)	N/A	N/A				
Distress Index Values						
Structural Crack Index	100	100				
Alligator Crack Index	100	100				
Longitudinal Crack Index	100	100				
Transverse Cracking Index	100	100				
Patching Index	100	100				
Rutting Index	83	83				
International Roughness Index (IRI)	N/A	N/A				
Lane & Width Information						
Number of Lanes	1	1				
Paved Width (ft)	22.8	22.8				
Lane Width (ft)	21.3	21.3
