VAFO Cycle 6

Final Report

Road Inventory and Condition Assessment of Paved Routes Valley Forge National Historical Park

**Federal Highway Administration
Eastern Federal Lands Highway Division
Road Inventory Program (RIP)**

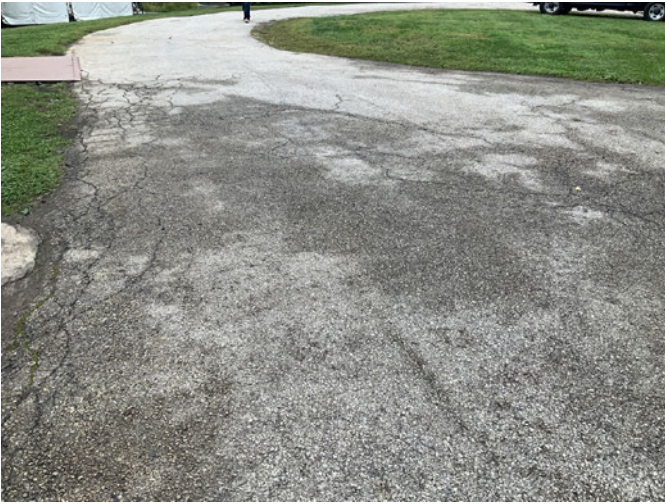
VAFO_0102BZ_1.jpg

Inspection Date:	9/27/2020	Beginning Section MP	0.00				
Paved Length (Miles):	0.03	Section Length (MI)	0.03				
Surface Type:	ASPHALT	Route Summary					
Roadway Condition Information							
Pavement Condition Rating (PCR)	73	73					
Surface Condition Rating (SCR)	73	73					
Roughness Condition Index (RCI)	N/A	N/A					
Distress Index Values							
Structural Crack Index	N/A	N/A					
Alligator Crack Index	73	73					
Longitudinal Crack Index	90	90					
Transverse Cracking Index	90	90					
Patching Index	97	97					
Rutting Index	90	90					
International Roughness Index (IRI)	N/A	N/A					
Lane & Width Information							
Number of Lanes	1	1					
Paved Width (ft)	12	12					
Lane Width (ft)	12	12

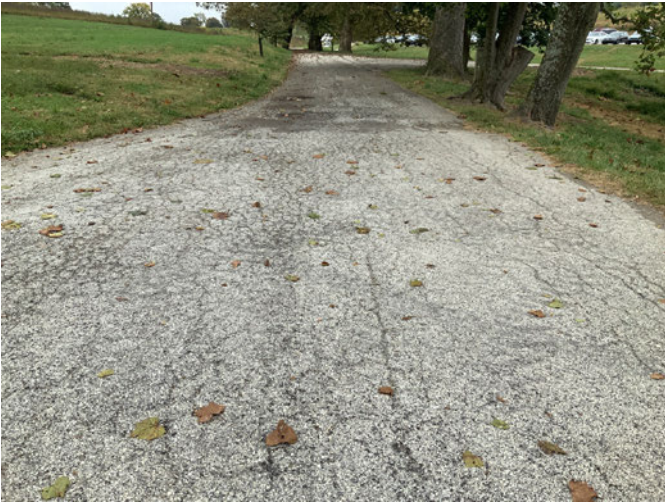
VAFO_0103_1.jpg

Route Condition Legend – Pavement Condition Rating (PCR)						
Poor (0 - 60)	Fair (61- 84)	Good (85 - 94)	Excellent (95 - 100)	Not Rated		
See Appendix for definitions and formulas						
Inspection Date: 9/27/2020	Beginning Section MP	0.00				
Paved Length (Miles): 0.18	Section Length (MI)	0.18				
Surface Type: ASPHALT	Route Summary					
Roadway Condition Information						
Pavement Condition Rating (PCR)	73	73				
Surface Condition Rating (SCR)	73	73				
Roughness Condition Index (RCI)	N/A	N/A				
Distress Index Values						
Structural Crack Index	N/A	N/A				
Alligator Crack Index	73	73				
Longitudinal Crack Index	90	90				
Transverse Cracking Index	90	90				
Patching Index	90	90				
Rutting Index	73	73				
International Roughness Index (IRI)	N/A	N/A				
Lane & Width Information						
Number of Lanes	1	1				
Paved Width (ft)	10	10				
Lane Width (ft)	10	10
