# VAMA Cycle 6

### Road Inventory and Condition Assessment of Paved Routes Vanderbilt Mansion National Historic Site

**Federal Highway Administration  
Eastern Federal Lands Highway Division  
Road Inventory Program (RIP)**

**Report Date: June 2021**

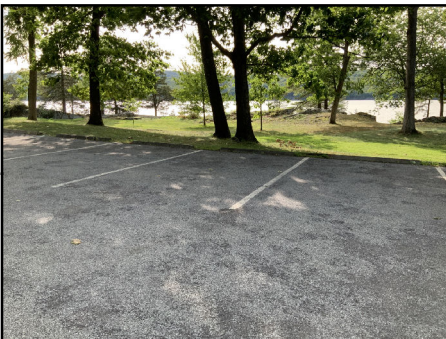
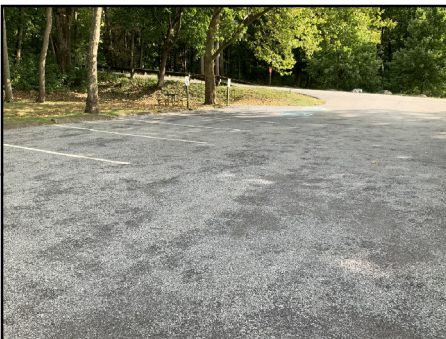
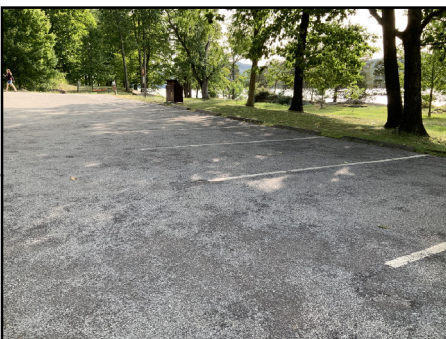
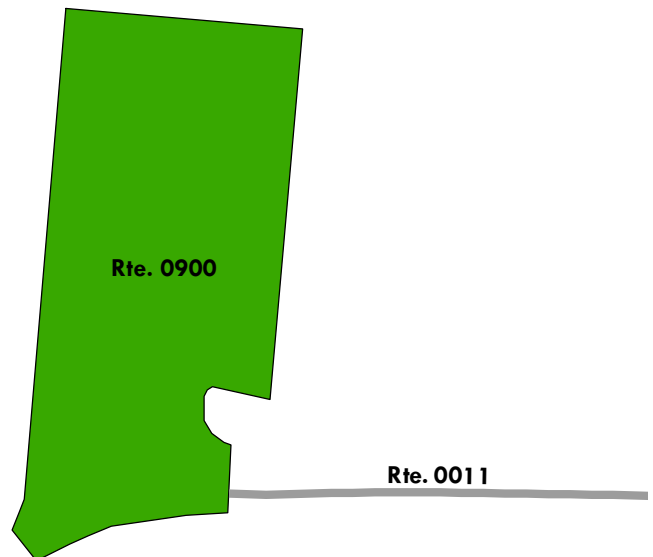
Inspection Date	FMSS Number	User Access	Surface Type
9/14/2020	103112	PUBLIC	ASPHALT
Area (Sq. Ft.)	Lane Miles (11' Widths)	Curb Reveal (Inches)	Curb Recommendation
7,899	0.136	NOT APPLICABLE	NOT APPLICABLE
Curb Type		Curb & Gutter Type	
NO CURB		NO CURB AND GUTTER	
Pavement Recommendation		Condition Rating / PCR	
PREVENTIVE MAINTENANCE		GOOD / 90

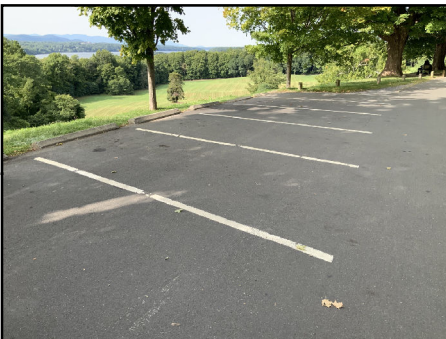
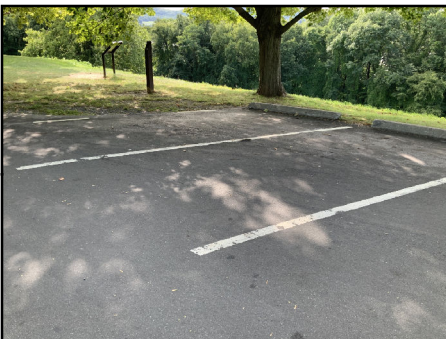
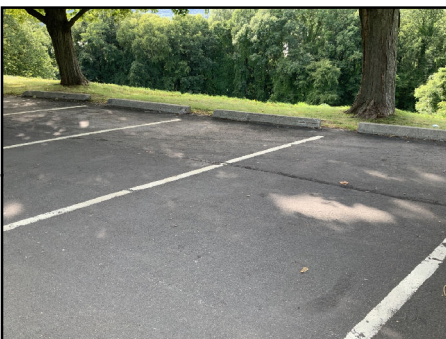
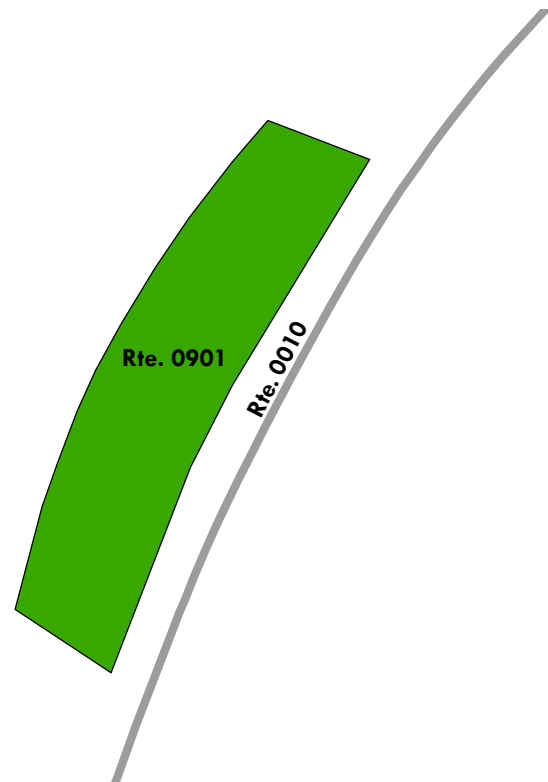
## ROUTE 0901: OVERLOOK PARKING

Inspection Date	FMSS Number	User Access	Surface Type
9/14/2020	103114	PUBLIC	ASPHALT
Area (Sq. Ft.)	Lane Miles (11' Widths)	Curb Reveal (Inches)	Curb Recommendation
1,928	0.033	NOT APPLICABLE	NOT APPLICABLE
Curb Type		Curb & Gutter Type	
NO CURB		NO CURB AND GUTTER	
Pavement Recommendation		Condition Rating / PCR	
PREVENTIVE MAINTENANCE		GOOD / 90

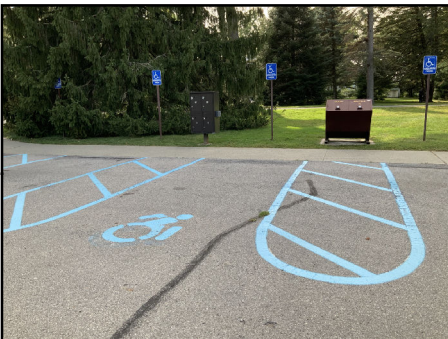
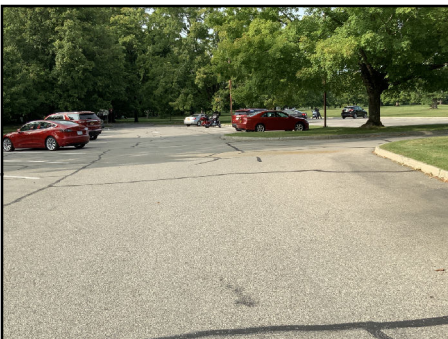
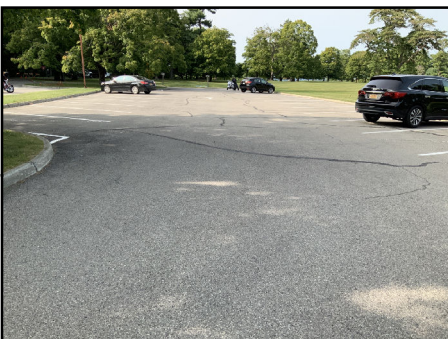
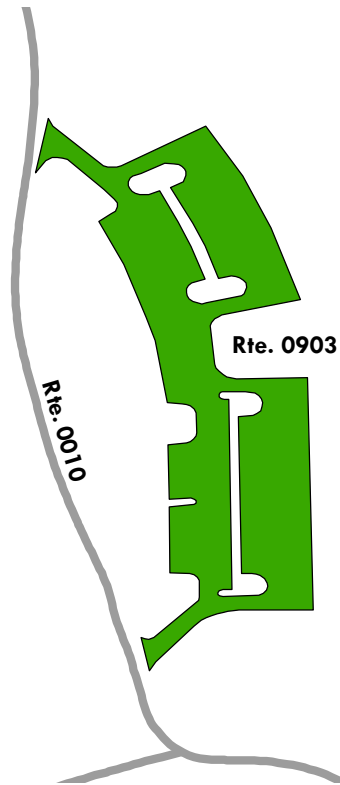
## ROUTE 0903: MANSION PARKING

Inspection Date	FMSS Number	User Access	Surface Type
9/14/2020	103117	PUBLIC	ASPHALT
Area (Sq. Ft.)	Lane Miles (11' Widths)	Curb Reveal (Inches)	Curb Recommendation
51,100	0.88	6	LIGHT REPAIR
Curb Type		Curb & Gutter Type	
CONCRETE		NO CURB AND GUTTER	
Pavement Recommendation		Condition Rating / PCR	
PREVENTIVE MAINTENANCE		GOOD / 90

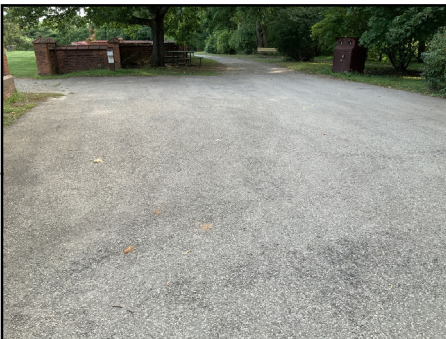
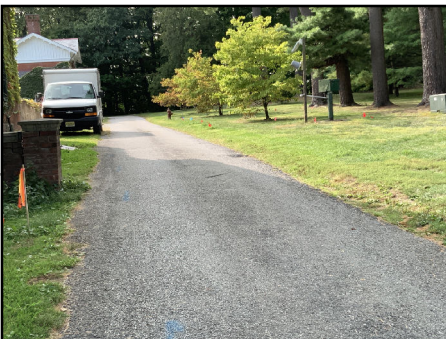
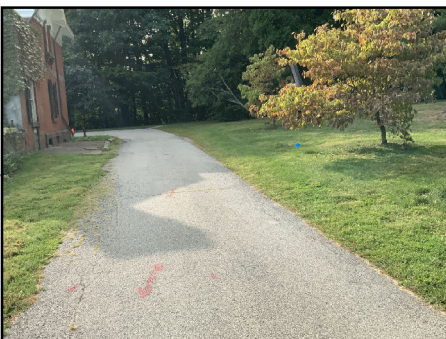
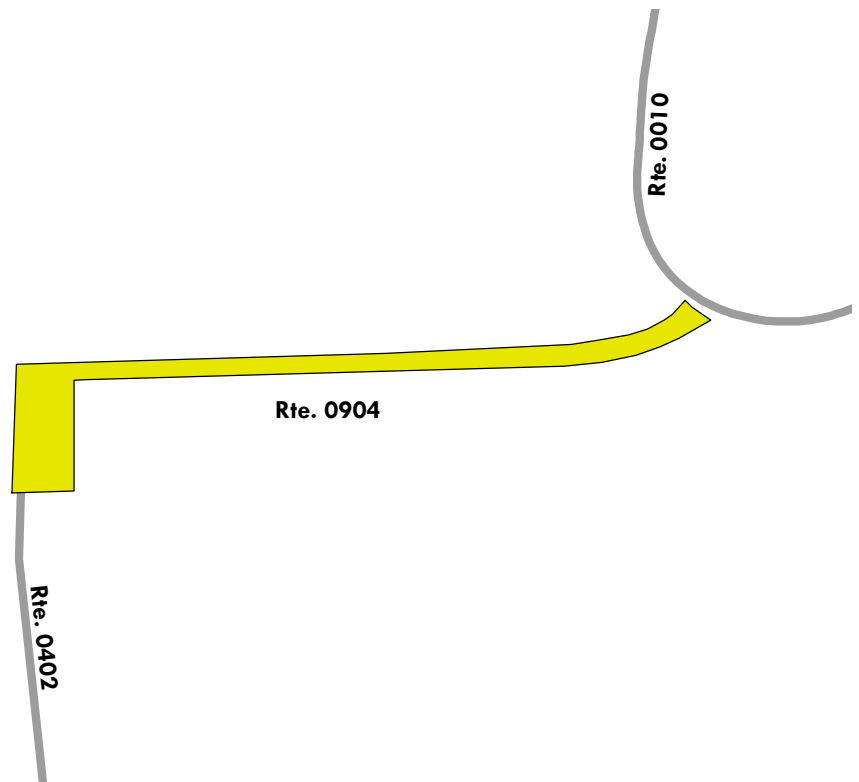
## ROUTE 0904: GARDEN ACCESS PARKING

Inspection Date	FMSS Number	User Access	Surface Type
9/14/2020	103109	PUBLIC	ASPHALT
Area (Sq. Ft.)	Lane Miles (11' Widths)	Curb Reveal (Inches)	Curb Recommendation
5,107	0.088	NOT APPLICABLE	NOT APPLICABLE
Curb Type		Curb & Gutter Type	
NO CURB		NO CURB AND GUTTER	
Pavement Recommendation		Condition Rating / PCR	
LIGHT 3R TREATMENTS		FAIR / 73

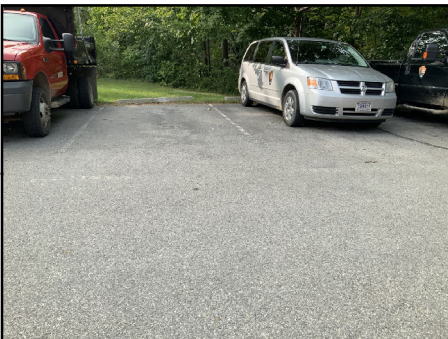
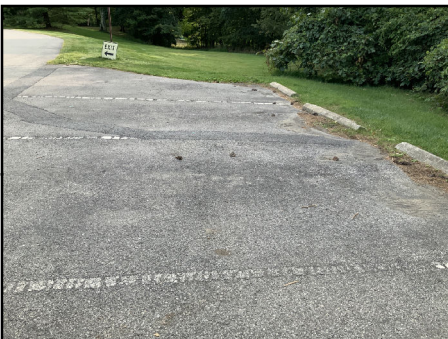
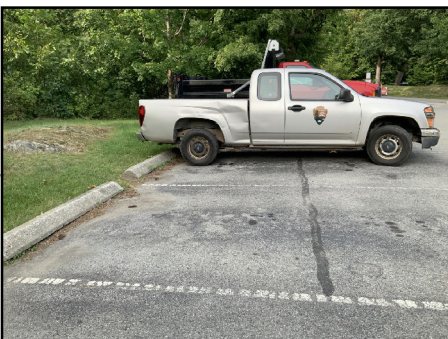
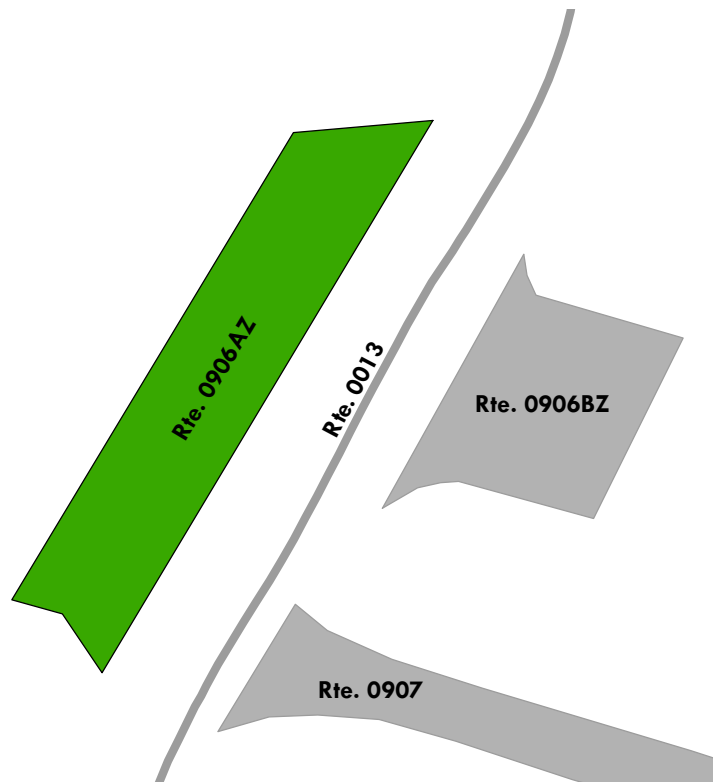
## ROUTE 0906AZ: COACH HOUSE PARKING A

Inspection Date	FMSS Number	User Access	Surface Type
9/14/2020	103105	PUBLIC	ASPHALT
Area (Sq. Ft.)	Lane Miles (11' Widths)	Curb Reveal (Inches)	Curb Recommendation
2,300	0.04	NOT APPLICABLE	NOT APPLICABLE
Curb Type		Curb & Gutter Type	
NO CURB		NO CURB AND GUTTER	
Pavement Recommendation		Condition Rating / PCR	
PREVENTIVE MAINTENANCE		GOOD / 90

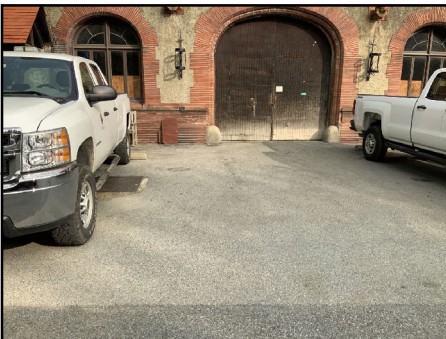
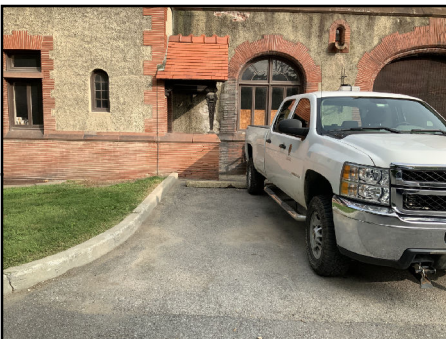
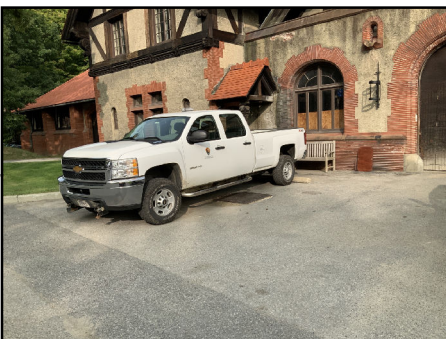
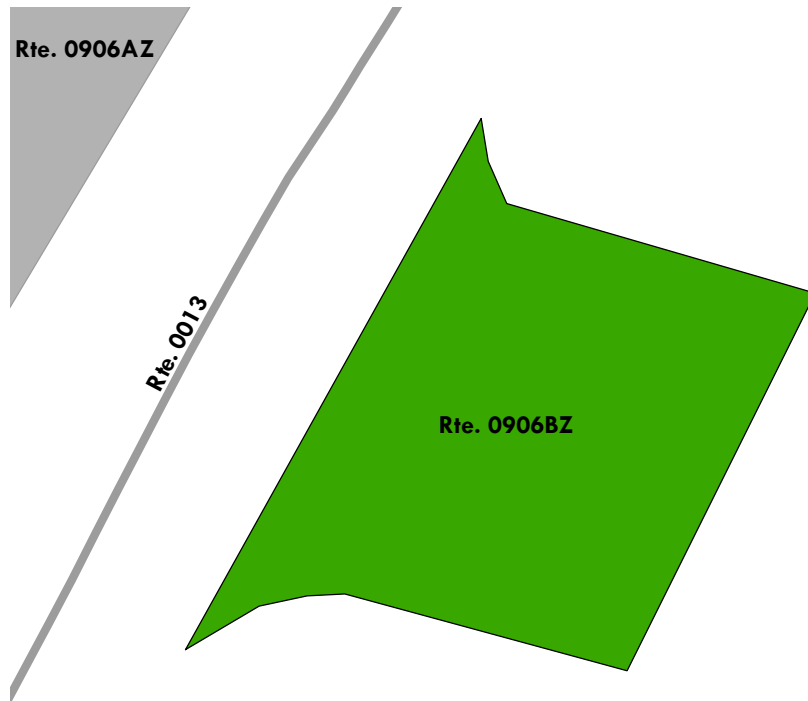
## ROUTE 0906BZ: COACH HOUSE PARKING B

Inspection Date	FMSS Number	User Access	Surface Type
9/14/2020	103105	PUBLIC	ASPHALT
Area (Sq. Ft.)	Lane Miles (11' Widths)	Curb Reveal (Inches)	Curb Recommendation
1,358	0.023	6	DO NOTHING
Curb Type		Curb & Gutter Type	
CONCRETE		NO CURB AND GUTTER	
Pavement Recommendation		Condition Rating / PCR	
PREVENTIVE MAINTENANCE		GOOD / 90
