VIIS Cycle 6

Final Report

Road Inventory and Condition Assessment of Paved Routes Virgin Islands National Park

Report Date: February 2023

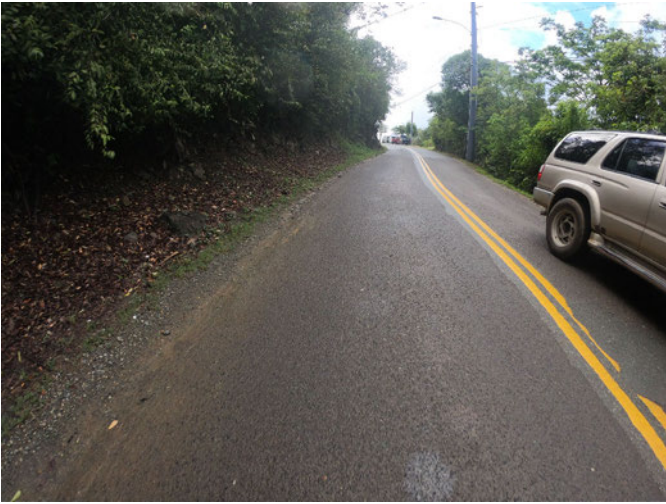
VIIS_0010B_0.413.jpg

Route Condition Legend – Pavement Condition Rating (PCR)						
Poor (0 - 60)	Fair (61- 84)	Good (85 - 94)	Excellent (95 - 100)	Not Rated		
See Appendix for definitions and formulas						
Inspection Date: 3/21/2022	Beginning Section MP	5.00	5.50			
Paved Length (Miles): 5.93	Section Length (MI)	0.50	0.43			
Surface Type: ASPHALT	Route Summary					
Roadway Condition Information						
Pavement Condition Rating (PCR)	49	53	53			
Surface Condition Rating (SCR)	49	53	53			
Roughness Condition Index (RCI)	N/A	N/A	N/A			
Distress Index Values						
Structural Crack Index	N/A	N/A	N/A			
Alligator Crack Index	49	53	53			
Longitudinal Crack Index	67	53	53			
Transverse Cracking Index	85	73	73			
Patching Index	63	73	73			
Rutting Index	73	73	73			
International Roughness Index (IRI)	N/A	N/A	N/A			
Lane & Width Information						
Number of Lanes	2	2	2			
Paved Width (ft)	21.5	21.1	21.1			
Lane Width (ft)	8.8	8.7	8.7

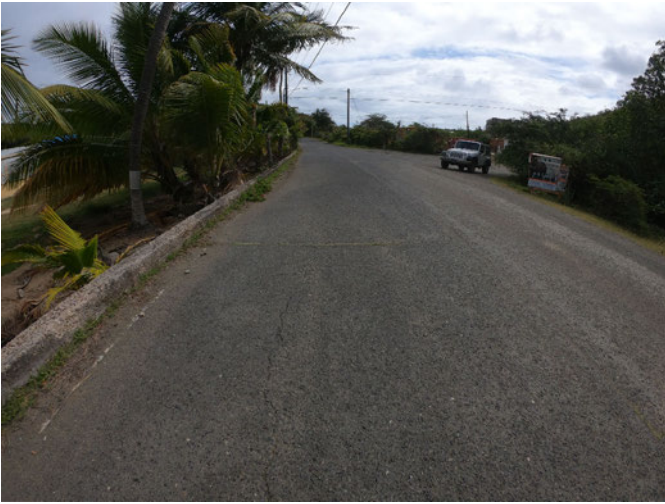
VIIS_0010D_0.074.jpg

Route Condition Legend – Pavement Condition Rating (PCR)						
Poor (0 - 60)	Fair (61- 84)	Good (85 - 94)	Excellent (95 - 100)	Not Rated		
See Appendix for definitions and formulas						
Inspection Date:	3/22/2022	Beginning Section MP	2.50			
Paved Length (Miles):	2.88	Section Length (MI)	0.38			
Surface Type:	ASPHALT	Route Summary				
Roadway Condition Information						
Pavement Condition Rating (PCR)	53	30				
Surface Condition Rating (SCR)	53	30				
Roughness Condition Index (RCI)	N/A	N/A				
Distress Index Values						
Structural Crack Index	N/A	N/A				
Alligator Crack Index	53	30				
Longitudinal Crack Index	53	53				
Transverse Cracking Index	79	73				
Patching Index	60	53				
Rutting Index	73	73				
International Roughness Index (IRI)	N/A	N/A				
Lane & Width Information						
Number of Lanes	2	2				
Paved Width (ft)	21.3	20.9				
Lane Width (ft)	9.9	10.2

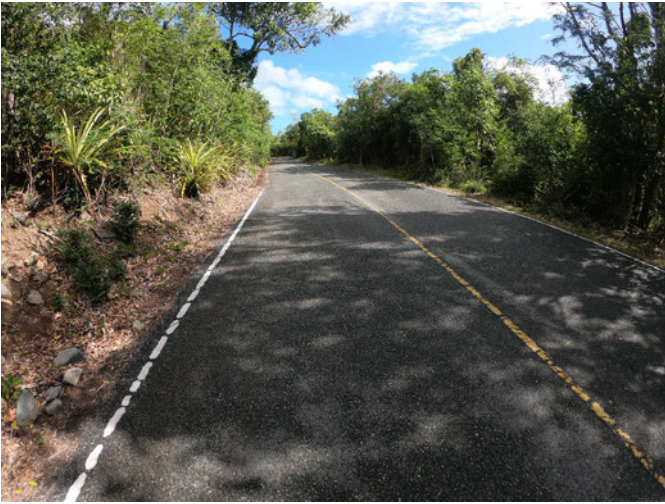
VIIS_0011_0.024.jpg

Route Condition Legend – Pavement Condition Rating (PCR)						
Poor (0 - 60)	Fair (61- 84)	Good (85 - 94)	Excellent (95 - 100)	Not Rated		
See Appendix for definitions and formulas						
Inspection Date: 3/23/2022	Beginning Section MP	0.00	0.50			
Paved Length (Miles): 0.58	Section Length (MI)	0.50	0.08			
Surface Type: ASPHALT	Route Summary					
Roadway Condition Information						
Pavement Condition Rating (PCR)	73	73	73			
Surface Condition Rating (SCR)	73	73	73			
Roughness Condition Index (RCI)	N/A	N/A	N/A			
Distress Index Values						
Structural Crack Index	N/A	N/A	N/A			
Alligator Crack Index	73	73	73			
Longitudinal Crack Index	90	90	90			
Transverse Cracking Index	90	90	90			
Patching Index	90	90	90			
Rutting Index	90	90	90			
International Roughness Index (IRI)	N/A	N/A	N/A			
Lane & Width Information						
Number of Lanes	2	2	2			
Paved Width (ft)	20.3	20.3	20.3			
Lane Width (ft)	8.9	8.9	8.9

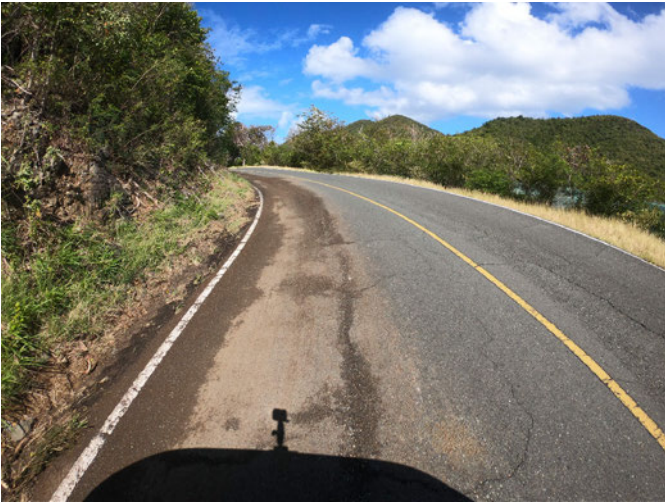
VIIS_0012_0.030.jpg

Inspection Date:	3/23/2022	Beginning Section MP	0.00				
Paved Length (Miles):	0.44	Section Length (MI)	0.44				
Surface Type:	ASPHALT	Route Summary					
Roadway Condition Information							
Pavement Condition Rating (PCR)	73	73					
Surface Condition Rating (SCR)	73	73					
Roughness Condition Index (RCI)	N/A	N/A					
Distress Index Values							
Structural Crack Index	N/A	N/A					
Alligator Crack Index	73	73					
Longitudinal Crack Index	73	73					
Transverse Cracking Index	90	90					
Patching Index	90	90					
Rutting Index	90	90					
International Roughness Index (IRI)	N/A	N/A					
Lane & Width Information							
Number of Lanes	2	2					
Paved Width (ft)	19	19					
Lane Width (ft)	7.8	7.8

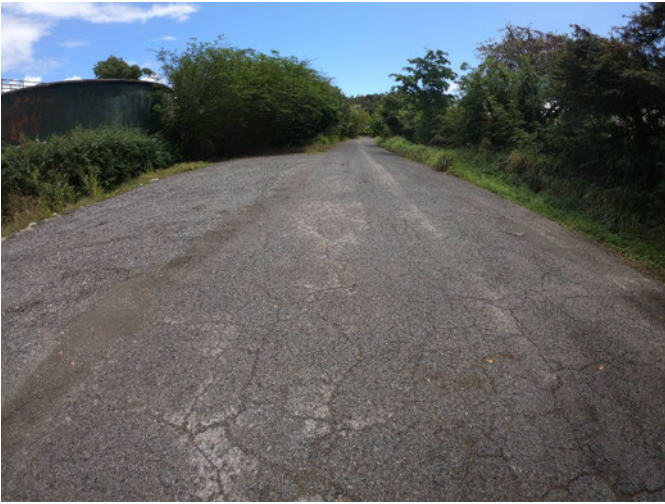
VIIS_0014AZ_0.026.jpg

Inspection Date:	3/21/2022	Beginning Section MP	0.00	0.50			
Paved Length (Miles):	0.54	Section Length (MI)	0.50	0.04			
Surface Type:	ASPHALT	Route Summary					
Roadway Condition Information							
Pavement Condition Rating (PCR)	30	30	30				
Surface Condition Rating (SCR)	30	30	30				
Roughness Condition Index (RCI)	N/A	N/A	N/A				
Distress Index Values							
Structural Crack Index	N/A	N/A	N/A				
Alligator Crack Index	30	30	30				
Longitudinal Crack Index	90	90	90				
Transverse Cracking Index	90	90	90				
Patching Index	90	90	90				
Rutting Index	53	53	53				
International Roughness Index (IRI)	N/A	N/A	N/A				
Lane & Width Information							
Number of Lanes	2	2	2				
Paved Width (ft)	21.3	21.3	21.3				
Lane Width (ft)	10.6	10.6	10.6

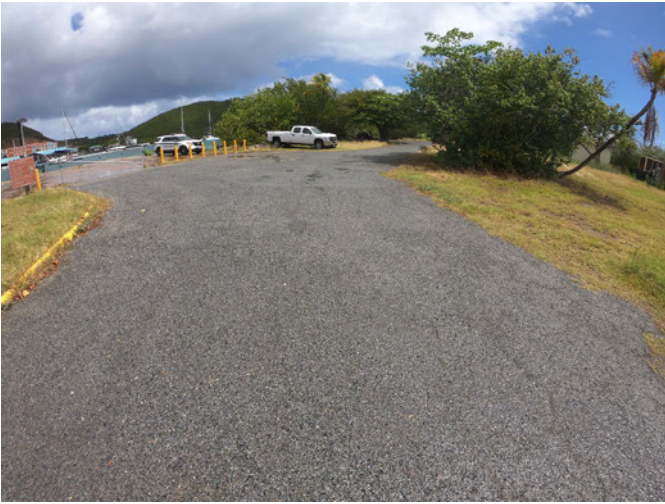
VIIS_0014BZ_0.006.jpg

Inspection Date: 3/21/2022	Beginning Section MP	0.00				
Paved Length (Miles): 0.03	Section Length (MI)	0.03				
Surface Type: ASPHALT	Route Summary					
Roadway Condition Information						
Pavement Condition Rating (PCR)	30	30				
Surface Condition Rating (SCR)	30	30				
Roughness Condition Index (RCI)	N/A	N/A				
Distress Index Values						
Structural Crack Index	N/A	N/A				
Alligator Crack Index	30	30				
Longitudinal Crack Index	90	90				
Transverse Cracking Index	90	90				
Patching Index	90	90				
Rutting Index	90	90				
International Roughness Index (IRI)	N/A	N/A				
Lane & Width Information						
Number of Lanes	2	2				
Paved Width (ft)	15.1	15.1				
Lane Width (ft)	7.5	7.5

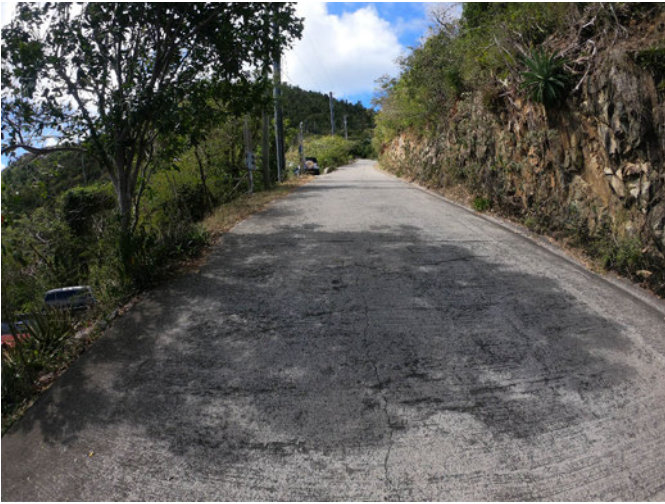
VIIS_0017_0.051.jpg

Concrete Distress Indices: Slab Cracking (73), Surface Delamination and Popouts (53), Joint Distress (73), Joint Faulting (73), Patches (90).

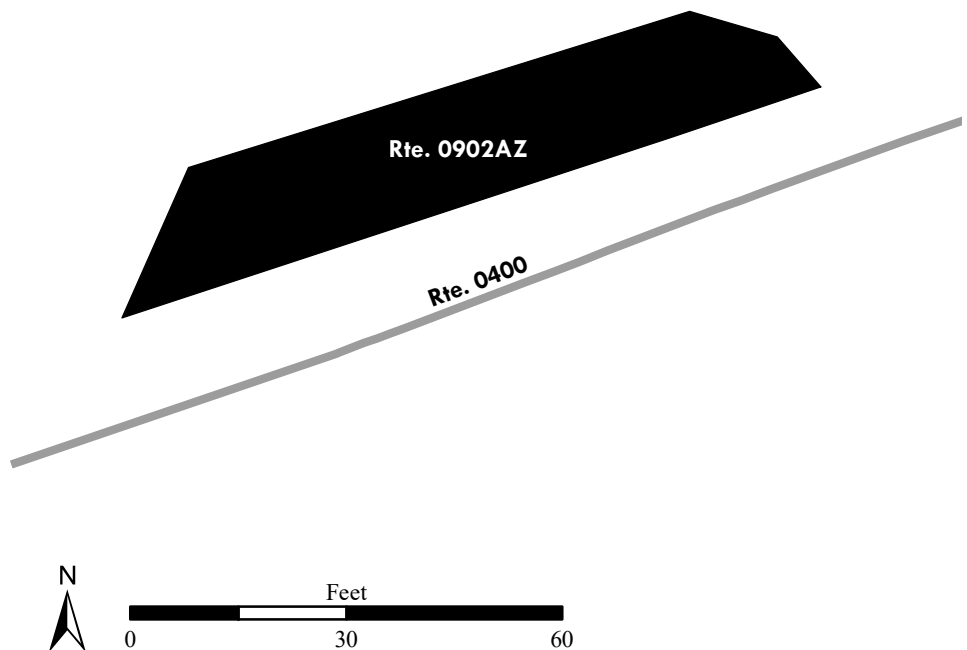
Note: Parking area was covered with debris since the area is under Construction.
