VOYA Cycle 6

Final Report

Road Inventory and Condition Assessment of Paved Routes Voyageurs National Park

**Federal Highway Administration
Eastern Federal Lands Highway Division
Road Inventory Program (RIP)**

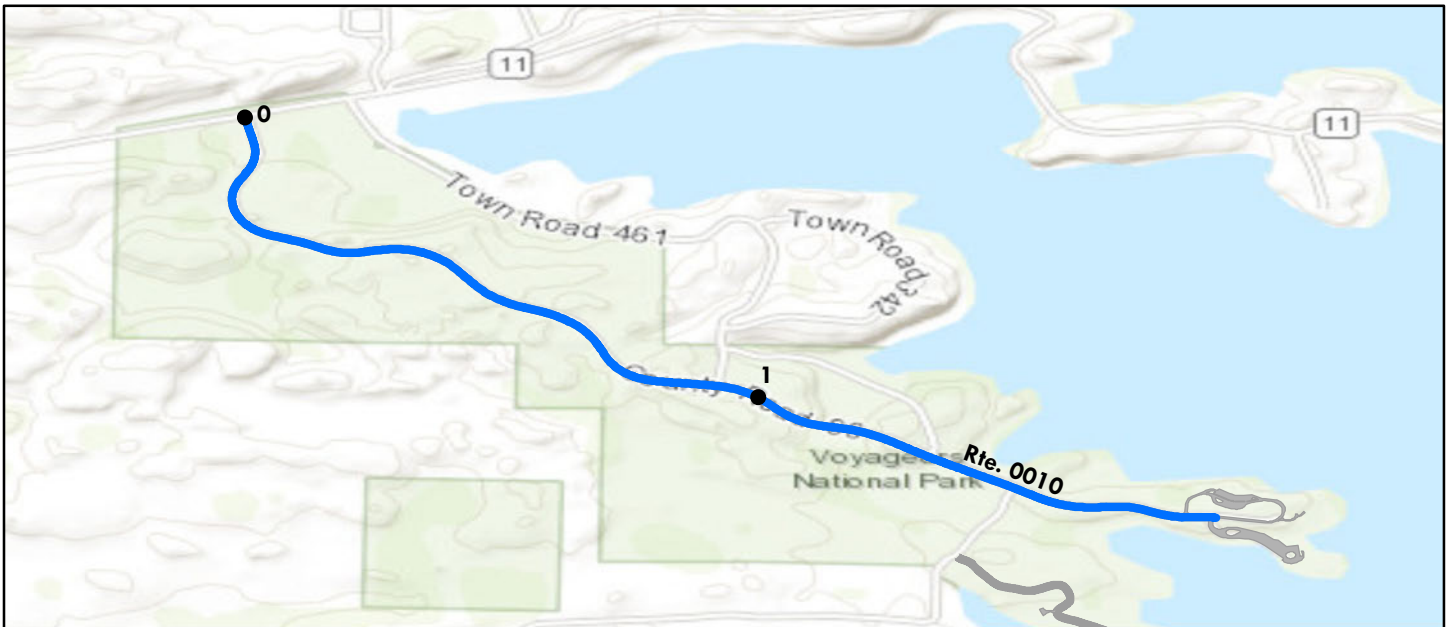
ROUTE 0010: RAINY LAKE VISITOR CENTER ACCESS ROAD

Inspection Date:	6/22/2019	Beginning Section MP	0	1			
Paved Length (Miles):	1.64	Section Length (MI)	1	0.64			
Surface Type:	ASPHALT	Route Summary					
Roadway Condition Information							
Pavement Condition Rating (PCR)	98	96	98				
Surface Condition Rating (SCR)	96	94	97				
Roughness Condition Index (RCI)	100	100	100				
Distress Index Values							
Structural Crack Index	100	100	99				
Alligator Crack Index	100	100	100				
Longitudinal Crack Index	100	100	99				
Transverse Cracking Index	96	94	97				
Patching Index	100	100	100				
Rutting Index	100	100	100				
International Roughness Index (IRI)	65	62	70				
Lane & Width Information							
Number of Lanes	2	2	2				
Paved Width (ft)	25.2	24.9	25.8				
Lane Width (ft)	10.9	10.7	11.2

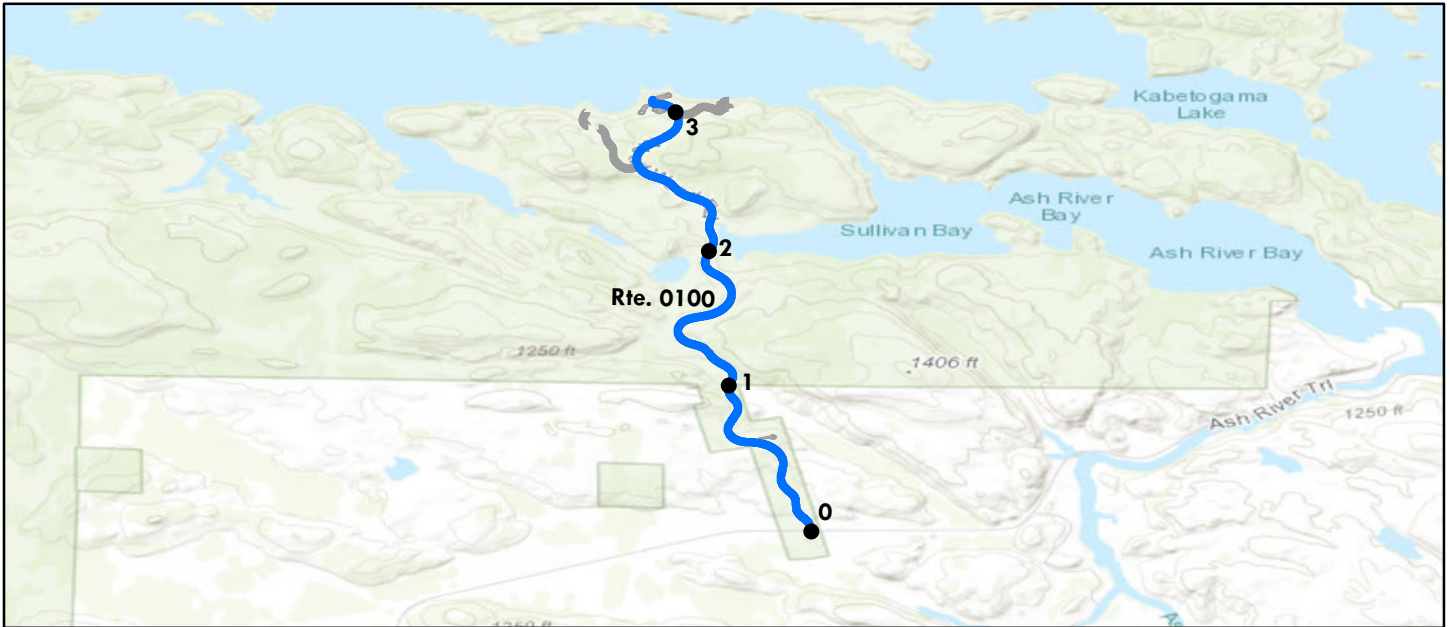
ROUTE 0100: ASH RIVER VISITOR CENTER ACCESS ROAD

Route Condition Legend – Pavement Condition Rating (PCR)						
Poor (0 - 60)	Fair (61- 84)	Good (85 - 94)	Excellent (95 - 100)	Not Rated		
Colors on map represent condition scores at 0.10-mile intervals. See Appendix for definitions and formulas.						
Inspection Date: 6/22/2019	Beginning Section MP	0	1	2	3	
Paved Length (Miles): 3.13	Section Length (MI)	1	1	1	0.13	
Surface Type: ASPHALT	Route Summary					
Roadway Condition Information						
Pavement Condition Rating (PCR)	98	98	98	97	98	
Surface Condition Rating (SCR)	96	96	96	95	96	
Roughness Condition Index (RCI)	100	100	100	100	100	
Distress Index Values						
Structural Crack Index	100	100	100	100	100	
Alligator Crack Index	100	100	100	100	100	
Longitudinal Crack Index	100	100	100	100	100	
Transverse Cracking Index	96	96	96	95	96	
Patching Index	100	100	100	100	100	
Rutting Index	100	100	100	100	99	
International Roughness Index (IRI)	57	55	57	59	68

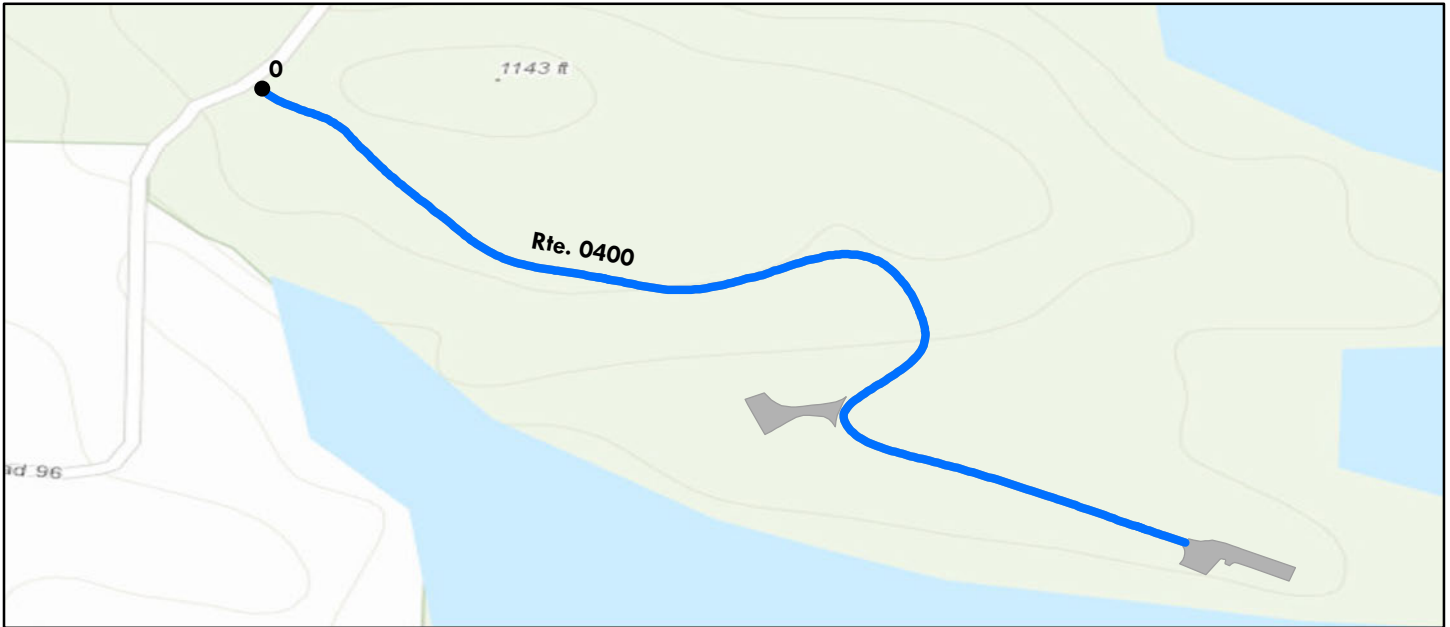
ROUTE 0400: RAINY LAKE MAINTENANCE AREA ACCESS ROAD

Inspection Date: 6/22/2019	Beginning Section MP	0				
Paved Length (Miles): 0.31	Section Length (MI)	0.31				
Surface Type: ASPHALT	Route Summary					
Roadway Condition Information						
Pavement Condition Rating (PCR)	98	98				
Surface Condition Rating (SCR)	98	98				
Roughness Condition Index (RCI)	N/A	N/A				
Distress Index Values						
Structural Crack Index	99	99				
Alligator Crack Index	100	100				
Longitudinal Crack Index	99	99				
Transverse Cracking Index	98	98				
Patching Index	99	99				
Rutting Index	100	100				
International Roughness Index (IRI)	N/A	N/A				
Lane & Width Information						
Number of Lanes	1	1				
Paved Width (ft)	11.9	11.9				
Lane Width (ft)	11.9	11.9

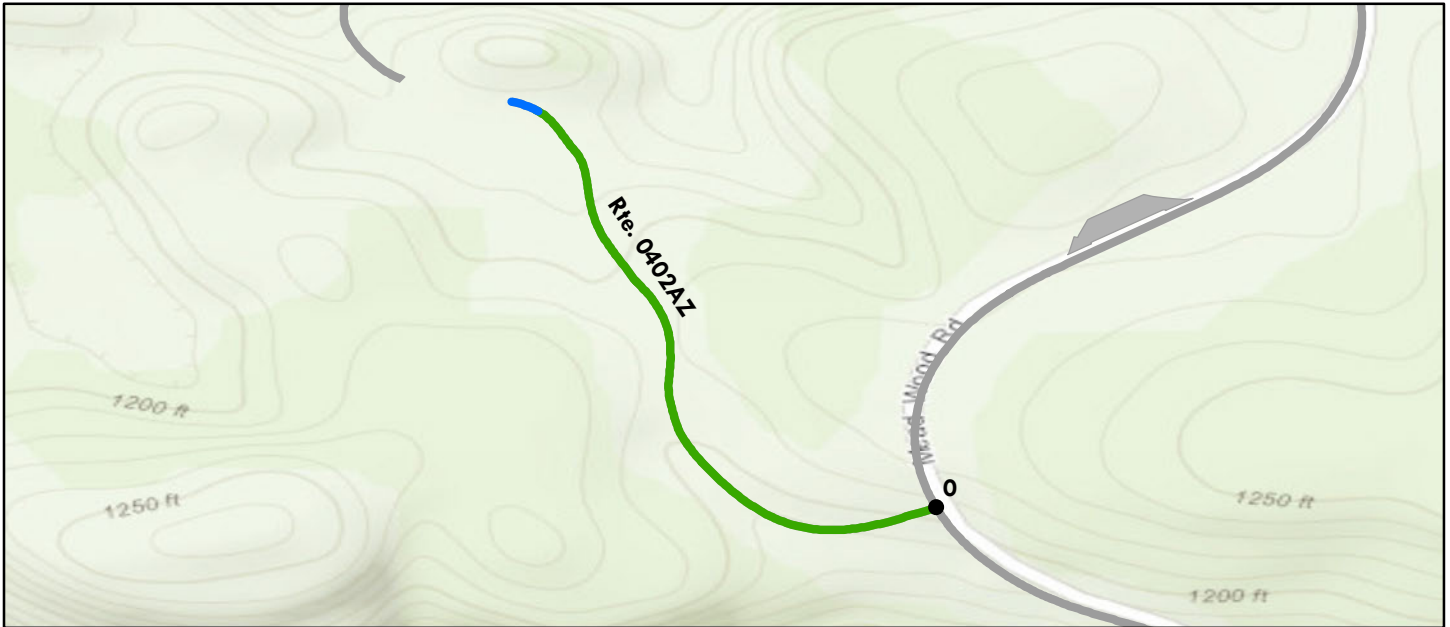
ROUTE 0402AZ: ASH RIVER MAINTENANCE AREA ACCESS ROAD A

Inspection Date: 6/22/2019	Beginning Section MP	0				
Paved Length (Miles): 0.31	Section Length (MI)	0.31				
Surface Type: ASPHALT	Route Summary					
Roadway Condition Information						
Pavement Condition Rating (PCR)	91	91				
Surface Condition Rating (SCR)	91	91				
Roughness Condition Index (RCI)	N/A	N/A				
Distress Index Values						
Structural Crack Index	99	99				
Alligator Crack Index	100	100				
Longitudinal Crack Index	99	99				
Transverse Cracking Index	91	91				
Patching Index	100	100				
Rutting Index	96	96				
International Roughness Index (IRI)	N/A	N/A				
Lane & Width Information						
Number of Lanes	2	2				
Paved Width (ft)	20.7	20.7				
Lane Width (ft)	9.8	9.8

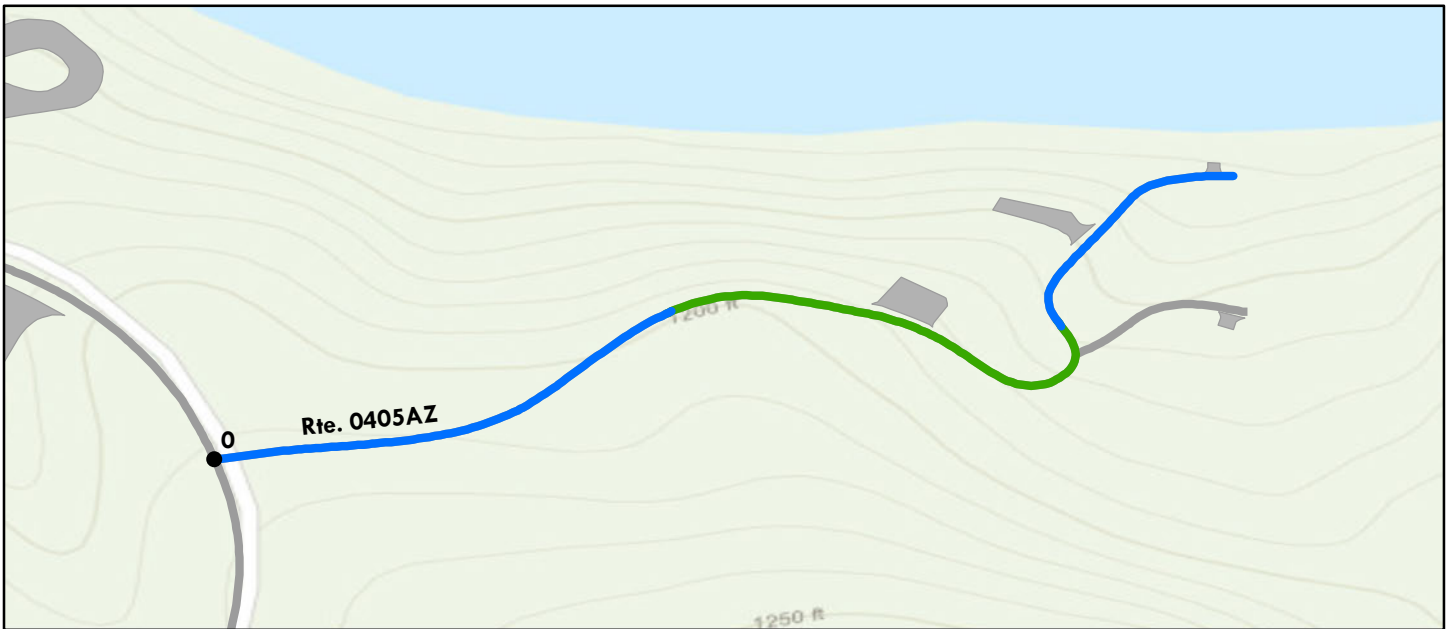
Inspection Date: 6/22/2019	Beginning Section MP	0				
Paved Length (Miles): 0.26	Section Length (MI)	0.26				
Surface Type: ASPHALT	Route Summary					
Roadway Condition Information						
Pavement Condition Rating (PCR)	96	96				
Surface Condition Rating (SCR)	96	96				
Roughness Condition Index (RCI)	N/A	N/A				
Distress Index Values						
Structural Crack Index	99	99				
Alligator Crack Index	100	100				
Longitudinal Crack Index	99	99				
Transverse Cracking Index	96	96				
Patching Index	100	100				
Rutting Index	98	98				
International Roughness Index (IRI)	N/A	N/A				
Lane & Width Information						
Number of Lanes	2	2				
Paved Width (ft)	18.6	18.6				
Lane Width (ft)	11.8	11.8

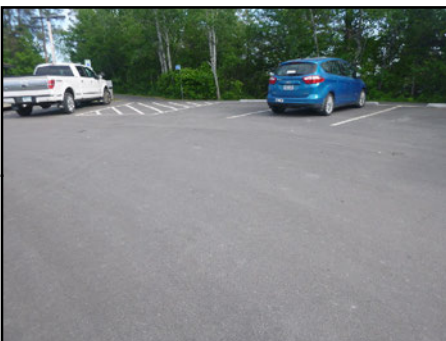
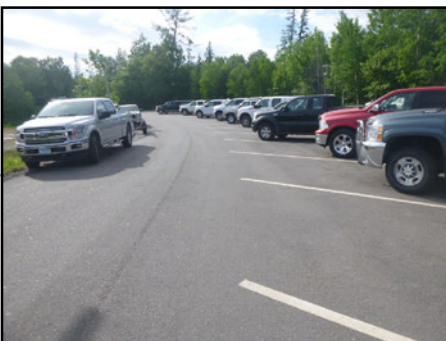
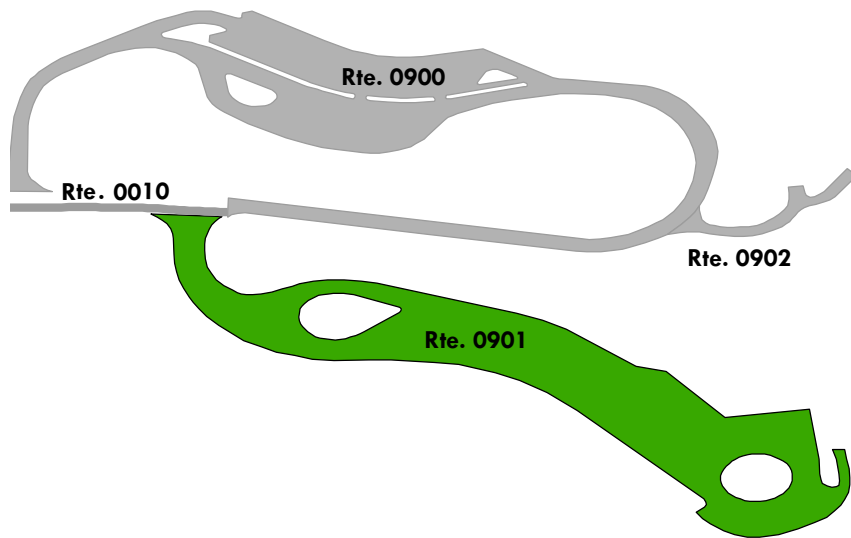
ROUTE 0901: RAINY LAKE BOAT LAUNCH PARKING

Inspection Date	FMSS Number	User Access	Surface Type
6/22/2019	51535	PUBLIC	ASPHALT
Area (Sq. Ft.)	Lane Miles (11' Widths)	Curb Reveal (Inches)	Curb Recommendation
65,720	1.132	2	DO NOTHING
Curb Type		Curb & Gutter Type	
WOOD		NO CURB AND GUTTER	
Pavement Recommendation		Condition Rating / PCR	
PREVENTIVE MAINTENANCE		GOOD / 90

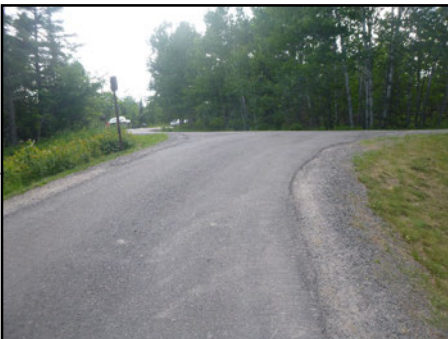
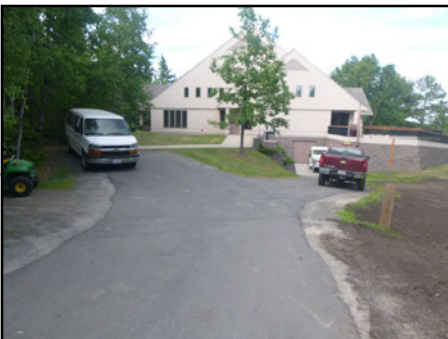
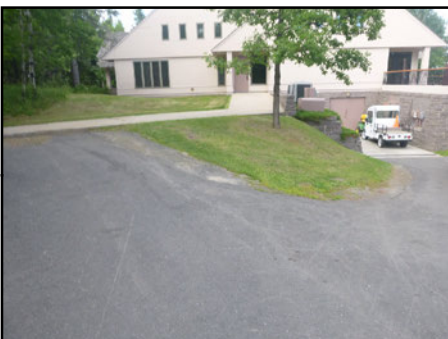
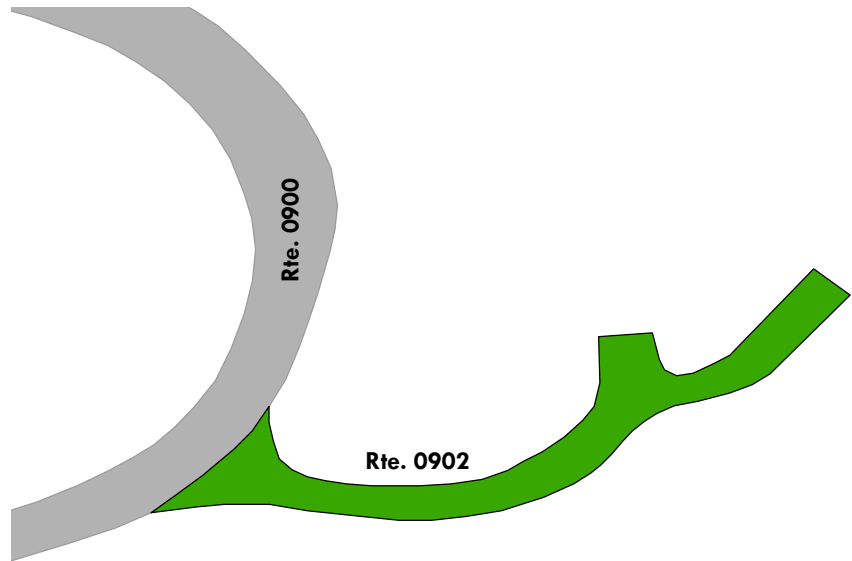
ROUTE 0902: RAINY LAKE VISITOR CENTER EMPLOYEE PARKING

Inspection Date	FMSS Number	User Access	Surface Type
6/22/2019	56342	NONPUBLIC	ASPHALT
Area (Sq. Ft.)	Lane Miles (11' Widths)	Curb Reveal (Inches)	Curb Recommendation
3,254	0.056	NOT APPLICABLE	NOT APPLICABLE
Curb Type		Curb & Gutter Type	
NO CURB		NO CURB AND GUTTER	
Pavement Recommendation		Condition Rating / PCR	
PREVENTIVE MAINTENANCE		GOOD / 90

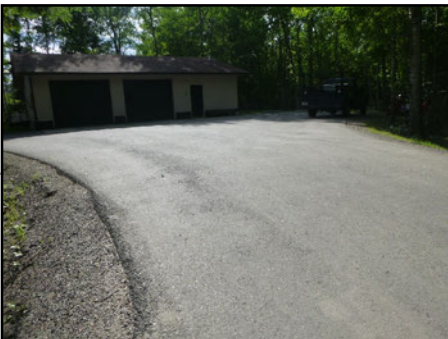
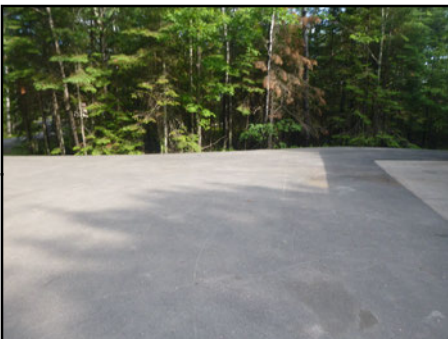
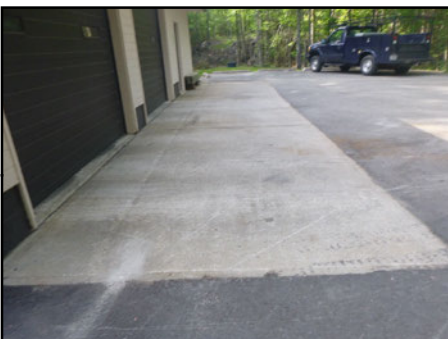
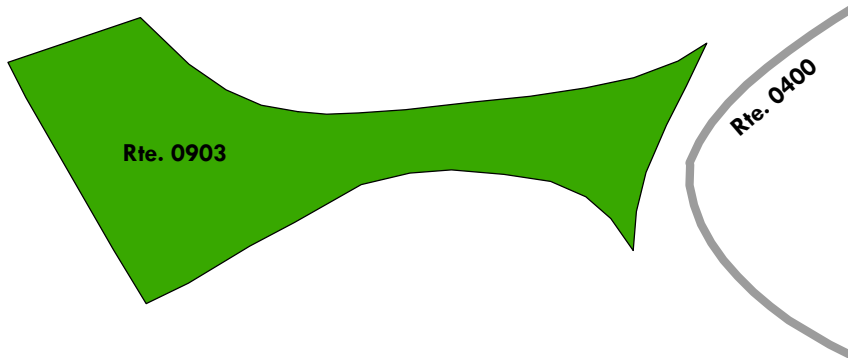
ROUTE 0903: RAINY LAKE MAINTENANCE PARKING

Inspection Date	FMSS Number	User Access	Surface Type
6/22/2019	37503	NONPUBLIC	ASPHALT
Area (Sq. Ft.)	Lane Miles (11' Widths)	Curb Reveal (Inches)	Curb Recommendation
3,434	0.059	NOT APPLICABLE	NOT APPLICABLE
Curb Type		Curb & Gutter Type	
NO CURB		NO CURB AND GUTTER	
Pavement Recommendation		Condition Rating / PCR	
PREVENTIVE MAINTENANCE		GOOD / 90

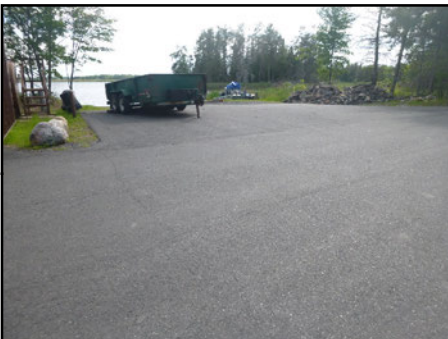
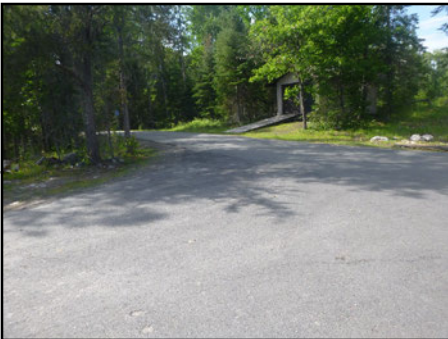
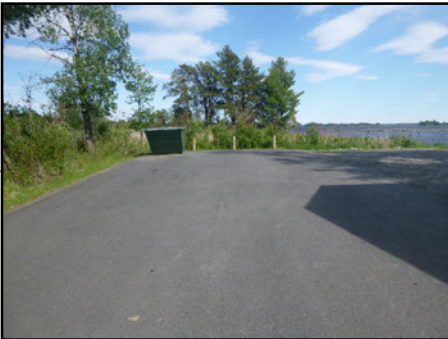
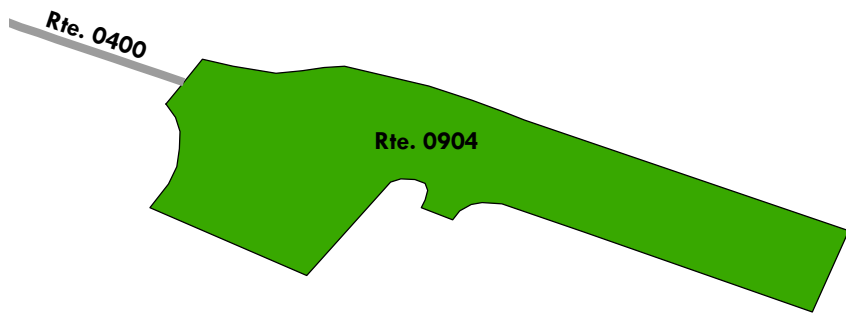
ROUTE 0904: RAINY LAKE BOAT FUELING AREA

Inspection Date	FMSS Number	User Access	Surface Type
6/22/2019	37504	NONPUBLIC	ASPHALT
Area (Sq. Ft.)	Lane Miles (11' Widths)	Curb Reveal (Inches)	Curb Recommendation
4,338	0.075	NOT APPLICABLE	NOT APPLICABLE
Curb Type		Curb & Gutter Type	
NO CURB		NO CURB AND GUTTER	
Pavement Recommendation		Condition Rating / PCR	
PREVENTIVE MAINTENANCE		GOOD / 90

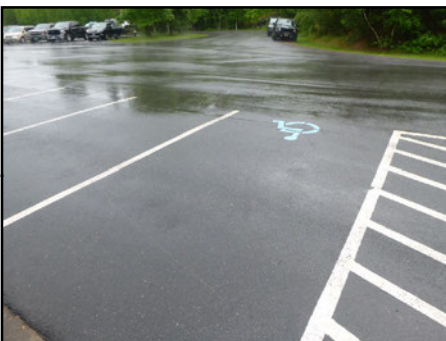
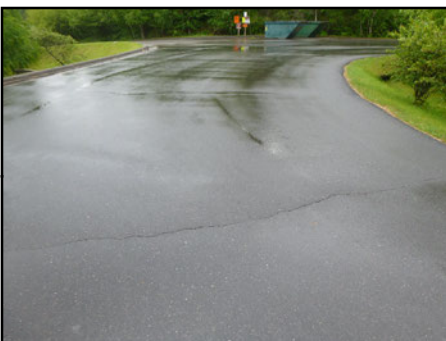
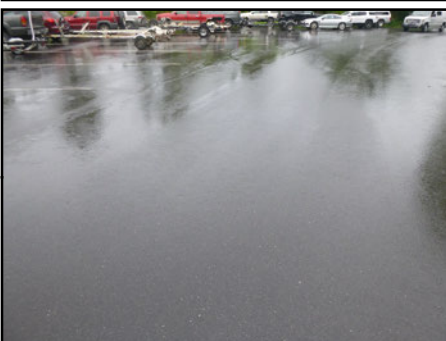
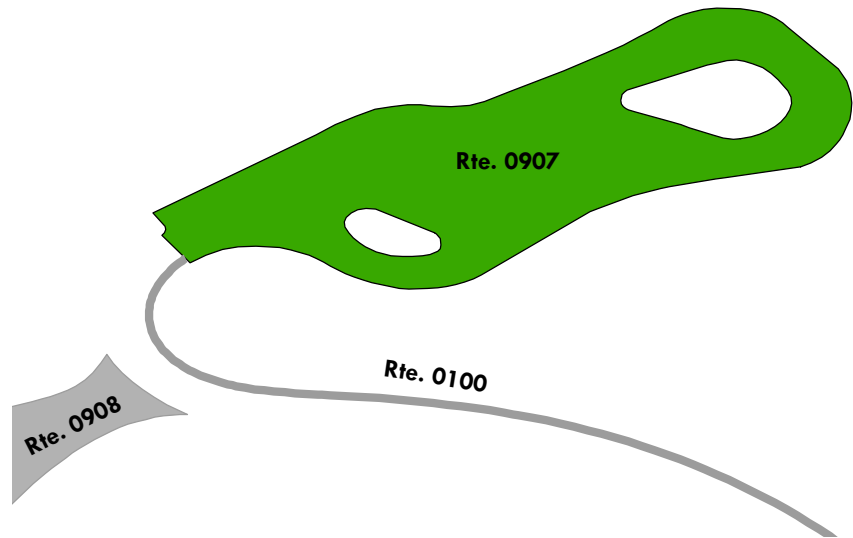
ROUTE 0907: ASH RIVER VISITOR CENTER PARKING

Inspection Date	FMSS Number	User Access	Surface Type
6/24/2019	37579	PUBLIC	ASPHALT
Area (Sq. Ft.)	Lane Miles (11' Widths)	Curb Reveal (Inches)	Curb Recommendation
39,489	0.68	NOT APPLICABLE	DO NOTHING
Curb Type		Curb & Gutter Type	
NO CURB		CONCRETE	
Pavement Recommendation		Condition Rating / PCR	
PREVENTIVE MAINTENANCE		GOOD / 90

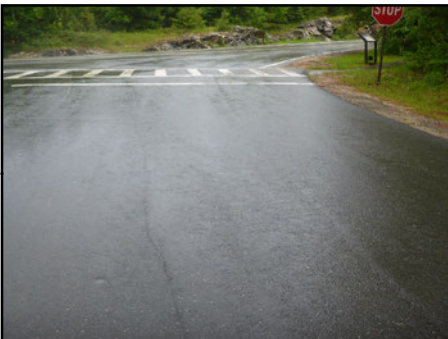
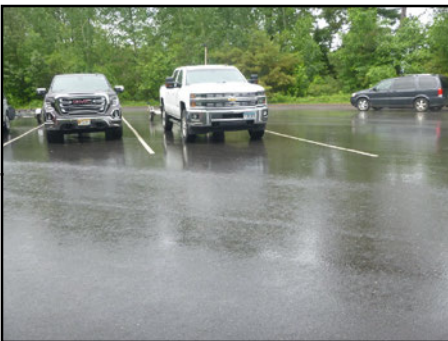
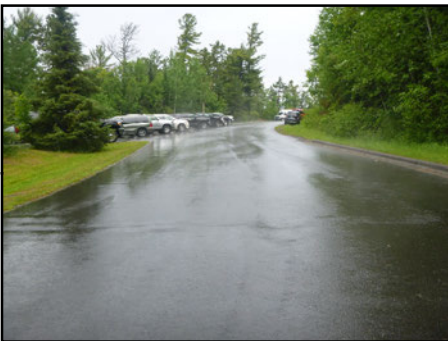
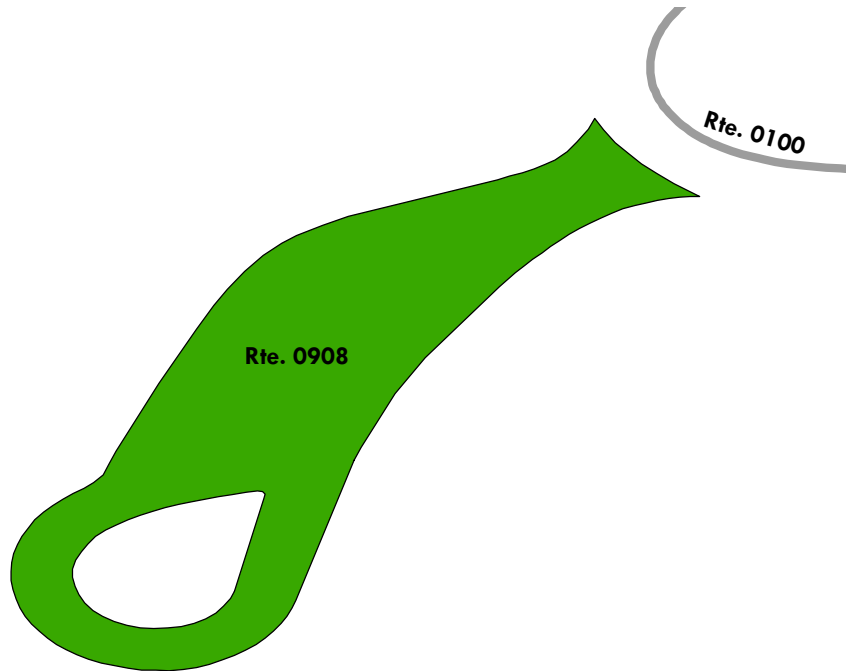
ROUTE 0908: ASH RIVER LOWER OVERFLOW PARKING

Inspection Date	FMSS Number	User Access	Surface Type
6/24/2019	56403	PUBLIC	ASPHALT
Area (Sq. Ft.)	Lane Miles (11' Widths)	Curb Reveal (Inches)	Curb Recommendation
30,833	0.531	NOT APPLICABLE	DO NOTHING
Curb Type		Curb & Gutter Type	
NO CURB		CONCRETE	
Pavement Recommendation		Condition Rating / PCR	
PREVENTIVE MAINTENANCE		GOOD / 90
