WHHO Cycle 6

Final Report

Road Inventory and Condition Assessment of Paved Routes White House - President's Park

White House - President's Park in District of Columbia

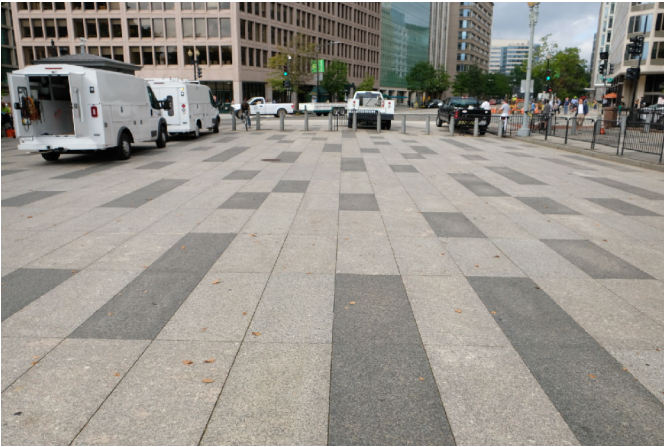
WHHO_0407_4849.JPG

Note: Middle section of exposed aggregate asphalt surface. Granite stone block sections on east and west end have some blocks with cracking (photo #3 on next page).
