Final Report

Road Inventory and Condition Assessment of Paved Routes Wind Cave National Park

Federal Lands Highway Road Inventory Program Prepared By: Federal Highway Administration Eastern Federal Lands Highway Division Road Inventory Program (RIP)

Report Date: May 2018

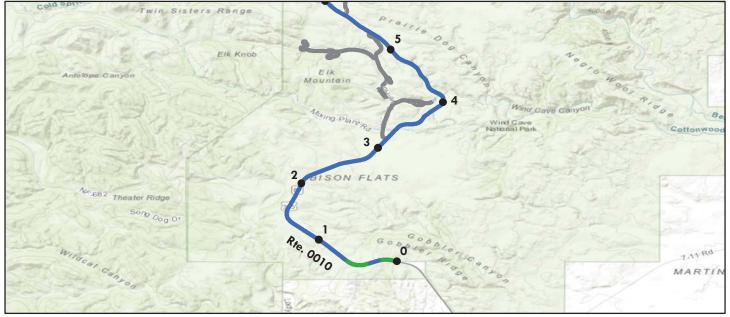
Wind Cave National Park ROUTE 0010: WIND CAVE HIGHWAY (U.S. 385)

Route Condition Legend – Pavement Condition Rating (PCR)							
Poor (0 - 60) Fair (6	Good (Good ((85 - 94)	Excellent (95 - 100)	Not Ra	ted	
	See Appendix for definitions and formulas						
Inspection Date: 7/19/2017	Beginning Section MP	0	1	2	3	4	
Paved Length (Miles): 6.52	Section Length (MI)	1	1	1	1	1	
Surface Type: ASPHALT	Route Summary						
Roadway Condition Information							
Pavement Condition Rating (PCR)	99	95	99	100	99	99	
Surface Condition Rating (SCR)	99	N/A	98	100	99	99	
Roughness Condition Index (RCI)	100	95	100	100	100	100	
Distress Index Values							
Structural Crack Index	100	N/A	100	100	100	100	
Alligator Crack Index	100	N/A	100	100	100	100	
Longitudinal Crack Index	100	N/A	100	100	100	100	
Transverse Cracking Index	99	N/A	100	100	99	99	
Patching Index	100	N/A	100	100	100	100	
Rutting Index	99	N/A	98	100	99	99	
International Roughness Index (IRI)	70	88	70	63	70	65	
Lane & Width Information

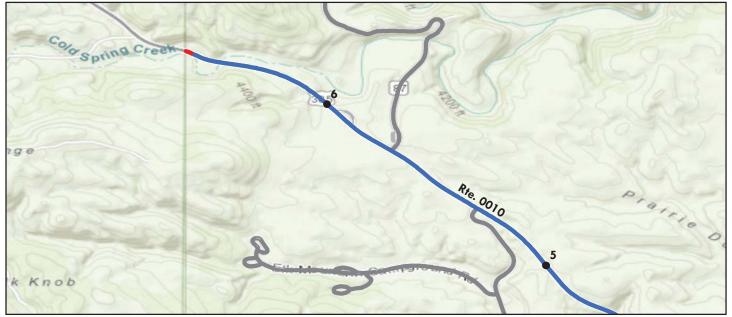
Wind Cave National Park ROUTE 0010: WIND CAVE HIGHWAY (U.S. 385)

Route Condition Legend – Pavement Condition Rating (PCR)						
Poor (0 - 60) Fair (6	1- 84) Good ((85 - 94)	Excellent (95 - 100)	Not Rated		
See Appendix for definitions and formulas						
Inspection Date: 7/19/2017	Beginning Section MP	5	6			
Paved Length (Miles): 6.52	Section Length (MI)	1	0.52			
Surface Type: ASPHALT	Route Summary					
Roadway Condition Information						
Pavement Condition Rating (PCR)	99	99	99			
Surface Condition Rating (SCR)	99	98	99			
Roughness Condition Index (RCI)	100	100	100			
Distress Index Values						
Structural Crack Index	100	100	100			
Alligator Crack Index	100	100	100			
Longitudinal Crack Index	100	100	100			
Transverse Cracking Index	99	100	99			
Patching Index	100	100	100			
Rutting Index	99	98	99			
International Roughness Index (IRI)	70	57	80			
Lane & Width Information						
Number of Lanes	2	2	2			
Paved Width (ft)	33.8	34.5	31.3			
Lane Width (ft)	11.5	11.3	11.4

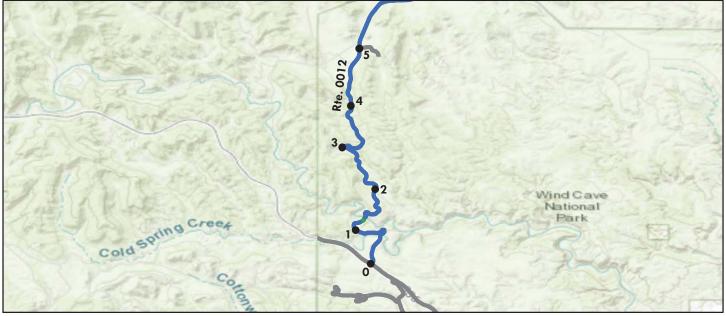
Wind Cave National Park ROUTE 0012: NORTH ENTRANCE ROAD (STATE HIGHWAY 87)

Route Condition Legend – Pavement Condition Rating (PCR)						
Poor (0 - 60) Fair (6	1- 84) Good ((85 - 94) Excellent (95 - 100)		95 - 100)	Not Rated	
See Appendix for definitions and formulas						
Inspection Date: 7/19/2017	Beginning Section MP	0	1	2	3	4
Paved Length (Miles): 7.15	Section Length (MI)	1	1	1	1	1
Surface Type: ASPHALT	Route Summary					
Roadway Condition Information						
Pavement Condition Rating (PCR)	99	99	100	99	99	99
Surface Condition Rating (SCR)	99	99	100	99	99	99
Roughness Condition Index (RCI)	100	100	100	100	100	100
Distress Index Values						
Structural Crack Index	100	100	100	100	100	100
Alligator Crack Index	100	100	100	100	100	100
Longitudinal Crack Index	100	100	100	100	100	100
Transverse Cracking Index	100	100	100	99	100	99
Patching Index	100	100	100	100	100	100
Rutting Index	99	99	100	100	99	99
International Roughness Index (IRI)	81	104	104	93	76	61
Lane & Width Information

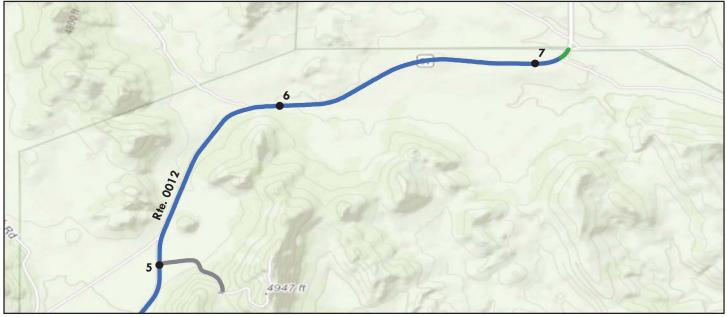
Wind Cave National Park ROUTE 0012: NORTH ENTRANCE ROAD (STATE HIGHWAY 87)

Route Condition Legend – Pavement Condition Rating (PCR)							
Poor (0 - 60) Fair (61- 84) Good	(85 - 94)	Excellent (95 - 100)	Not Rated		
See Appendix for definitions and formulas							
Inspection Date: 7/19/2017	Beginning Section MP	5	6	7			
Paved Length (Miles): 7.15	Section Length (MI)	1	1	0.15			
Surface Type: ASPHALT	Route Summary						
Roadway Condition Information							
Pavement Condition Rating (PCR)	99	99	99	98			
Surface Condition Rating (SCR)	99	98	99	98			
Roughness Condition Index (RCI)	100	100	100	98			
Distress Index Values							
Structural Crack Index	100	100	100	100			
Alligator Crack Index	100	100	100	100			
Longitudinal Crack Index	100	100	100	100			
Transverse Cracking Index	100	100	99	99			
Patching Index	100	100	100	100			
Rutting Index	99	98	100	98			
International Roughness Index (IRI)	81	66	65	119			
Lane & Width Information							
Number of Lanes	2	2	2	2			
Paved Width (ft)	22.8	22.1	22.2	22.1

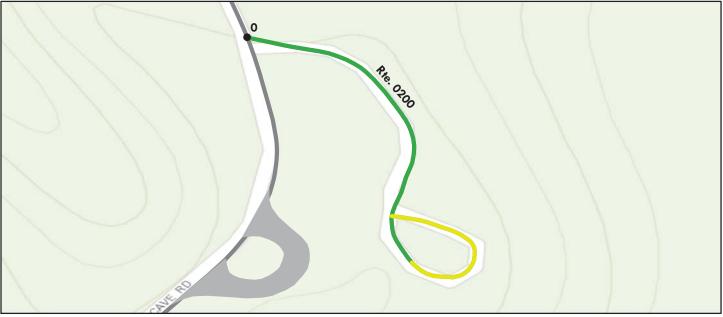
Wind Cave National Park ROUTE 0200: PICNIC AREA ACCESS ROAD

Route Condition Legend – Pavement Condition Rating (PCR)						
Poor (0 - 60) Fair (6)	1- 84) Good ((85 - 94)	Excellent (95 - 100)	Not Rated		
See Appendix for definitions and formulas						
Inspection Date: 7/19/2017	Beginning Section MP	0				
Paved Length (Miles): 0.14	Section Length (MI)	0.14				
Surface Type: ASPHALT	Route Summary			• •		
Roadway Condition Information						
Pavement Condition Rating (PCR)	90	90				
Surface Condition Rating (SCR)	90	90				
Roughness Condition Index (RCI)	N/A	N/A				
Distress Index Values						
Structural Crack Index	99	99				
Alligator Crack Index	100	100				
Longitudinal Crack Index	99	99				
Transverse Cracking Index	99	99				
Patching Index	99	99				
Rutting Index	90	90				
International Roughness Index (IRI)	N/A	N/A				
Lane & Width Information						
Number of Lanes	1	1				
Paved Width (ft)	12.2	12.2				
Lane Width (ft)	12.2	12.2

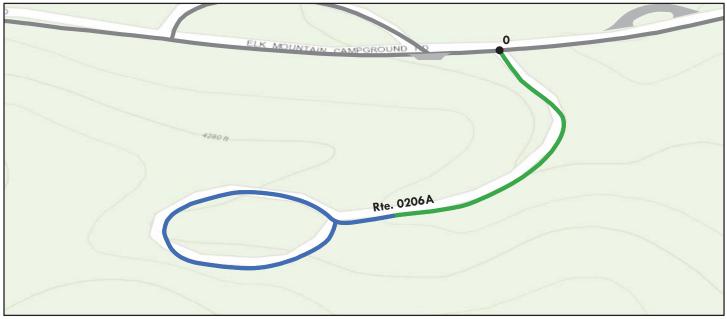
Wind Cave National Park ROUTE 0206A: ELK MOUNTAIN CAMPGROUND LOOPA

Route Condition Legend – Pavement Condition Rating (PCR)						
Poor (0 - 60) Fair (6	Good (Good ((85 - 94)	Excellent (95 - 100)	Not Rated		
See Appendix for definitions and formulas						
Inspection Date: 7/19/2017	Beginning Section MP	0				
Paved Length (Miles): 0.24	Section Length (MI)	0.24				
Surface Type: ASPHALT	Route Summary		•			
Roadway Condition Information						
Pavement Condition Rating (PCR)	96	96				
Surface Condition Rating (SCR)	96	96				
Roughness Condition Index (RCI)	N/A	N/A				
Distress Index Values						
Structural Crack Index	100	100				
Alligator Crack Index	100	100				
Longitudinal Crack Index	100	100				
Transverse Cracking Index	100	100				
Patching Index	100	100				
Rutting Index	96	96				
International Roughness Index (IRI)	N/A	N/A				
Lane & Width Information						
Number of Lanes	2	2				
Paved Width (ft)	16.3	16.3				
Lane Width (ft)	11.7	11.7

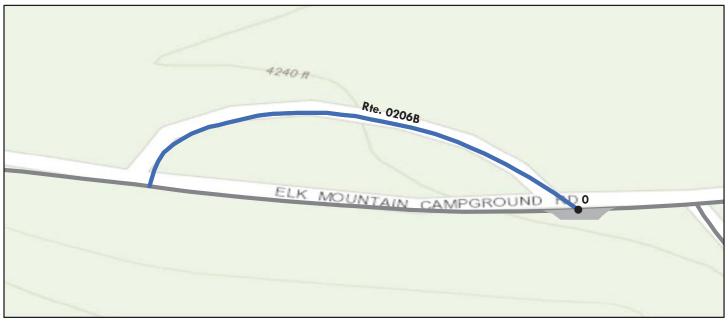
Wind Cave National Park ROUTE 0206B: ELK MOUNTAIN CAMPGROUND LOOP B

Route Condition Legend – Pavement Condition Rating (PCR)				
Poor (0 - 60) Fair (0	61-84) Good	(85 - 94)	Excellent (95 - 100)	Not Rated
	See Appendix for def	finitions and f	formulas	
Inspection Date: 7/19/2017	Beginning Section MP	0		
Paved Length (Miles): 0.09	Section Length (MI)	0.09		
Surface Type: ASPHALT	Route Summary			
Roadway Condition Information				
Pavement Condition Rating (PCR)	97	97		
Surface Condition Rating (SCR)	97	97		
Roughness Condition Index (RCI)	N/A	N/A		
Distress Index Values				
Structural Crack Index	100	100		
Alligator Crack Index	100	100		
Longitudinal Crack Index	100	100		
Transverse Cracking Index	100	100		
Patching Index	99	99		
Rutting Index	97	97		
International Roughness Index (IRI)	N/A	N/A		
Lane & Width Information				
Number of Lanes	1	1		
Paved Width (ft)	12.5	12.5		
Lane Width (ft)	12.5	12.5

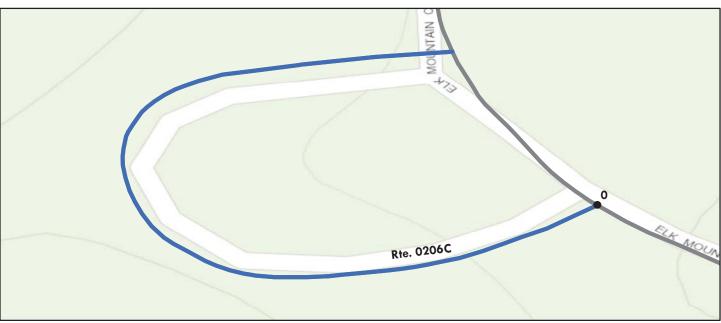
Wind Cave National Park ROUTE 0206C: ELK MOUNTAIN CAMPGROUND LOOP C

Route Condition Legend – Pavement Condition Rating (PCR)					
Poor (0 - 60) Fair (6)	1- 84) Good ((85 - 94)	Excellent (95 - 100)	Not Rated	
	See Appendix for def	initions and f	ormulas		
Inspection Date: 7/19/2017	Beginning Section MP	0			
Paved Length (Miles): 0.11	Section Length (MI)	0.11			
Surface Type: ASPHALT	Route Summary		•	•	
Roadway Condition Information					
Pavement Condition Rating (PCR)	97	97			
Surface Condition Rating (SCR)	97	97			
Roughness Condition Index (RCI)	N/A	N/A			
Distress Index Values					
Structural Crack Index	100	100			
Alligator Crack Index	100	100			
Longitudinal Crack Index	100	100			
Transverse Cracking Index	100	100			
Patching Index	100	100			
Rutting Index	97	97			
International Roughness Index (IRI)	N/A	N/A			
Lane & Width Information					
Number of Lanes	1	1			
Paved Width (ft)	10.3	10.3			
Lane Width (ft)	10.3	10.3

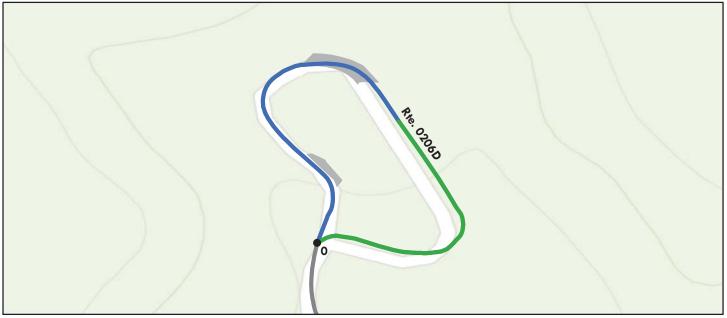
Wind Cave National Park ROUTE 0206D: ELK MOUNTAIN CAMPGROUND LOOP D

Route Condition Legend – Pavement Condition Rating (PCR)					
Poor (0 - 60) Fair (6	1- 84) Good ((85 - 94)	Excellent (95 - 100)	Not Rated	
	See Appendix for def	initions and f	ormulas		
Inspection Date: 7/19/2017	Beginning Section MP	0			
Paved Length (Miles): 0.17	Section Length (MI)	0.17			
Surface Type: ASPHALT	Route Summary				
Roadway Condition Information					
Pavement Condition Rating (PCR)	95	95			
Surface Condition Rating (SCR)	95	95			
Roughness Condition Index (RCI)	N/A	N/A			
Distress Index Values					
Structural Crack Index	100	100			
Alligator Crack Index	100	100			
Longitudinal Crack Index	100	100			
Transverse Cracking Index	100	100			
Patching Index	100	100			
Rutting Index	95	95			
International Roughness Index (IRI)	N/A	N/A			
Lane & Width Information					
Number of Lanes	1	1			
Paved Width (ft)	11.4	11.4			
Lane Width (ft)	11.4	11.4
