BAWA WIP Report

NPS Retaining Wall Inventory Program Baltimore - Washington Parkway National Capital

Federal Highway Administration
Eastern Federal Lands Highway Division
Road Inventory Program (RIP)

Data Collection Date: August 2007
Report Date: October 2015

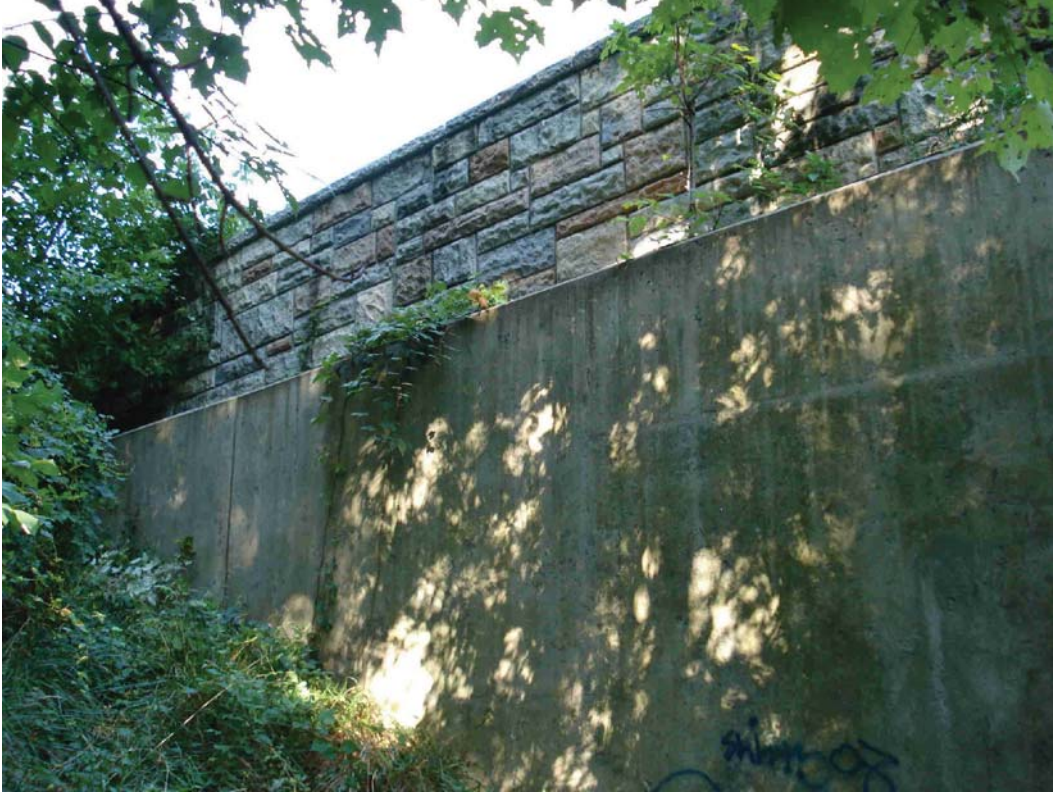
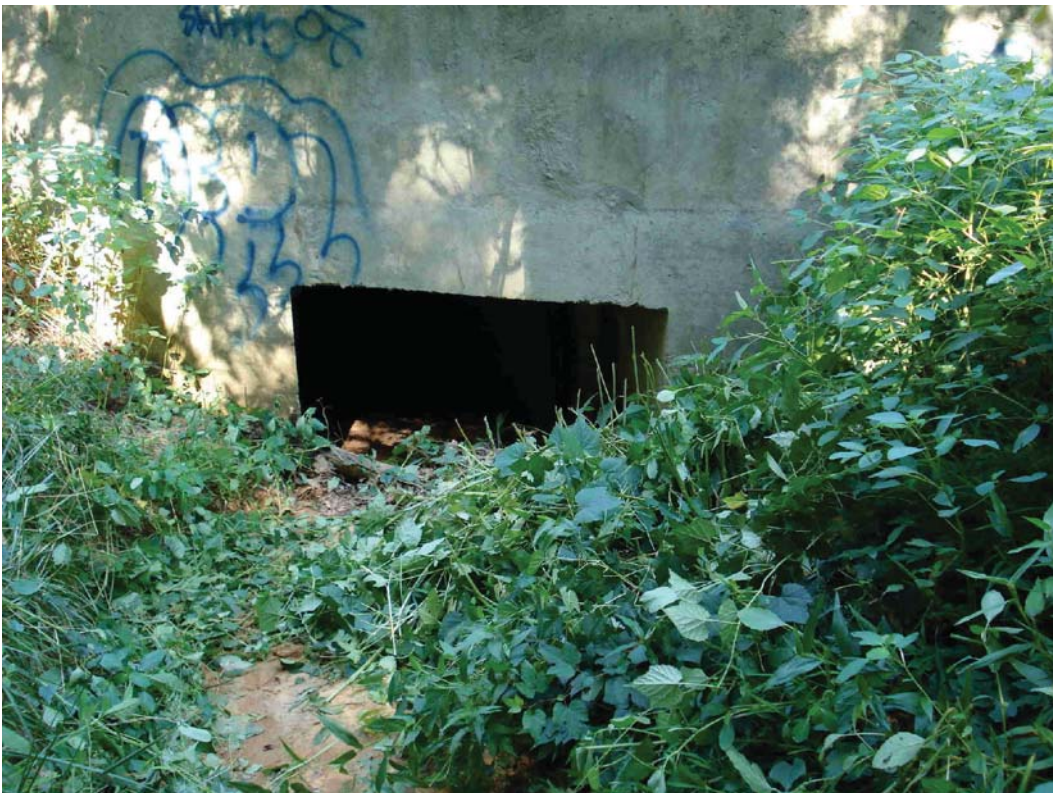
Wall ID:	BAWA-0001-1.876-R		
Route Name:	BALTIMORE-WASHINGTON PARKWAY (NB)		
Inspection Date:	August 14, 2007	Approximate Year Built:	1965
*Wall Rating:	86	Maintenance Action:	Maintenance
Wall Description			
Wall Function:	Head Wall	Primary Wall Type:	Gravity - Mass Concrete
Surface Treatment:		Secondary Wall Type:	
Secondary Surface Treatment:		Architectural Facing:	
General Description:	Concrete headwall underneath a guard wall constructed along right shoulder and directly supports a high ADT roadway high consequence of failure due to size and proximity to roadway		
Wall Measurements			
Wall Length (ft.):	90	Face Area (sq.):	769
Average Wall Height (ft.):	8	Face Angle (deg.):	90
Maximum Wall Height (ft.):	14	Vertical Offset (ft.):	-3
Assessed Elements			
Element (Weighting Factor)	Narrative		Condition Rating (0 - 10)
PERFORMANCE 8.00	Good condition; relatively new construction with no observed distress; vegetation growing in channel may promote water accumulation along base of wall		8

WALL FOUNDATION MATERIAL 8.00	Appears to be founded on a soil subgrade; no evidence of wall movement		9
CONCRETE 8.00	Good condition; relatively new construction with no evidence of distress		9
CULVERT 0.50	No observed distress to 5 ft x 3 ft concrete box culvert		8
DOWNSLOPE 0.50	No observed distress to well-forested slope; vegetation growing in channel may impede the flow of water		8
LATERAL SLOPE 0.50	No observed distress		8
VEGETATION 0.50	Area adjacent to wall is well-forested; no observed distress from vegetation growing near wall		8
CURB/BERM/DITCH 0.50	No distress to concrete curb and gutter		9
ROAD/SIDEWALK/SHOULDER 0.50	No distress to pavement or paved shoulder		9
Repair Recommendations			
Failure Consequence:	HIGH		
Recommendation Narrative:	Clear vegetation - 4 labor hrs (\$55/hr) = \$220		
Repair Cost:	\$220		
2007 cost estimate (ASTM Class D), preliminary for comparison to other repair costs only.

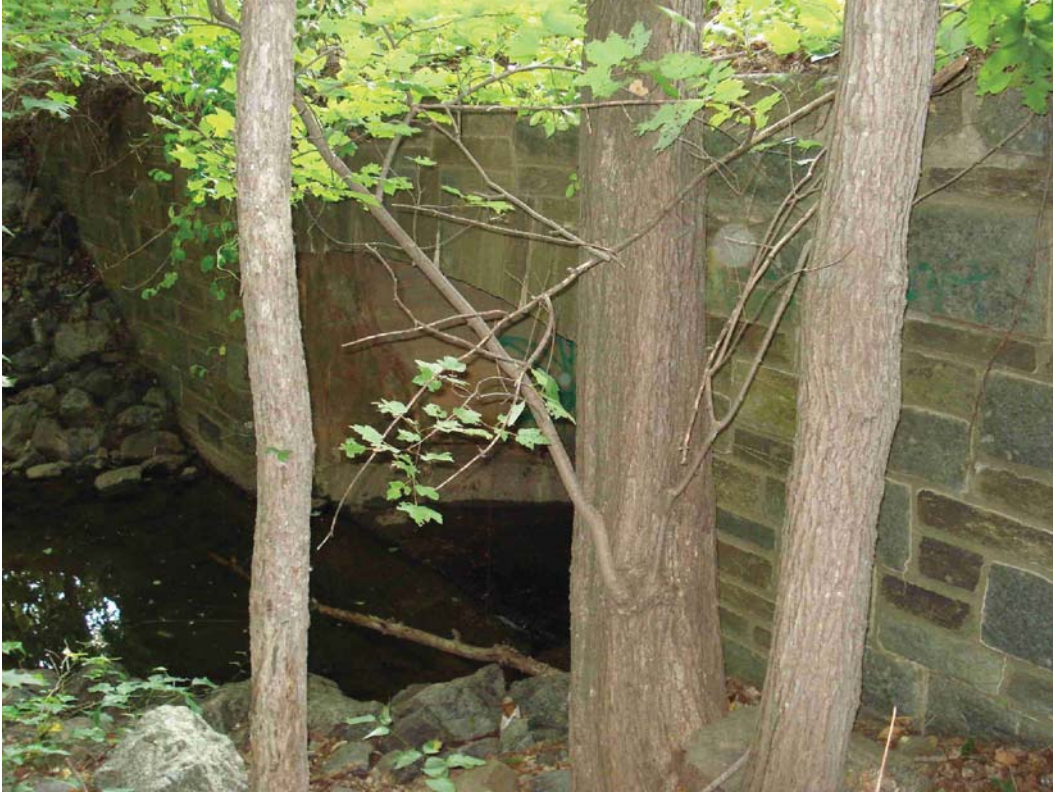
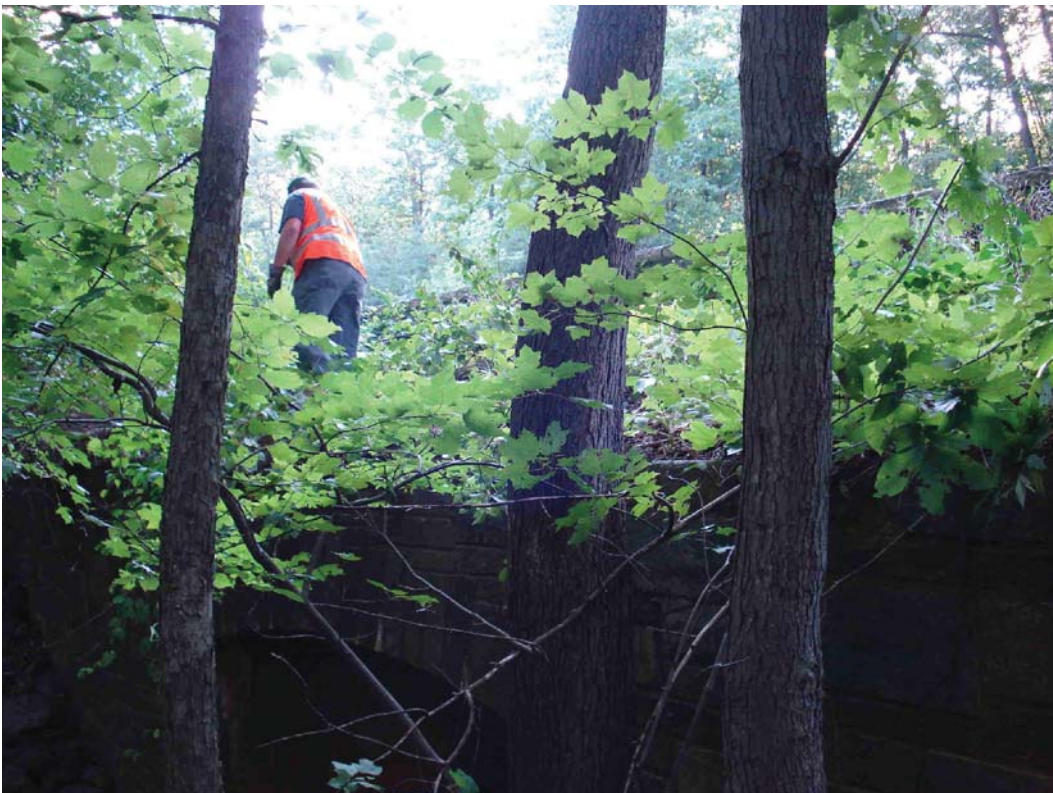
Wall ID:	BAWA-0001-7.567-L		
Route Name:	BALTIMORE-WASHINGTON PARKWAY (NB)		
Inspection Date:	August 15, 2007	Approximate Year Built:	1965
*Wall Rating:	81	Maintenance Action:	Maintenance
Wall Description			
Wall Function:	Head Wall	Primary Wall Type:	Gravity - Mortared Stone
Surface Treatment:		Secondary Wall Type:	
Secondary Surface Treatment:		Architectural Facing:	
General Description:	Stone masonry outlet headwall for a 6.5 ft x 12 ft concrete box culvert constructed along the left shoulder and partially supports a high ADT roadway high consequence of failure		
Wall Measurements			
Wall Length (ft.):	46	Face Area (sq.):	254
Average Wall Height (ft.):	5	Face Angle (deg.):	90
Maximum Wall Height (ft.):	10	Vertical Offset (ft.):	-2
Assessed Elements			
Element (Weighting Factor)	Narrative	Condition Rating (0 - 10)	
PERFORMANCE 8.00	Good condition of wall; several trees growing adjacent to wall threaten it's long-term stability	8

WALL FOUNDATION MATERIAL 8.00	Appears to be founded on a soil subgrade; no evidence of wall movement	9	
MORTAR 8.00	Good condition; general age-related weathering; minor efflorescence across wall	8	
STONE MASONRY 8.00	Good condition; no observed distress to blocks	9	
CULVERT 0.50	No distress to 6.5 ft x 12 ft concrete box culvert	8	
DOWNSLOPE 0.50	Good drainage away from wall; no observed distress to relatively-flat, forested slope	8	
LATERAL SLOPE 0.50	Good condition; no observed distress to well-vegetated slope	8	
UPSLOPE 0.50	No observed distress to gently-sloping, well-vegetated slope	8	
CURB/BERM/DITCH 0.50	No distress to concrete curb and gutter	10	
Repair Recommendations			
Failure Consequence:	HIGH		
Recommendation Narrative:	Cut trees - 2 large diameter trees (\$955/tree) = \$1,910, 3 medium diameter trees (\$200/tree) = \$600		
Repair Cost:	\$2,510		
2007 cost estimate (ASTM Class D), preliminary for comparison to other repair costs only.

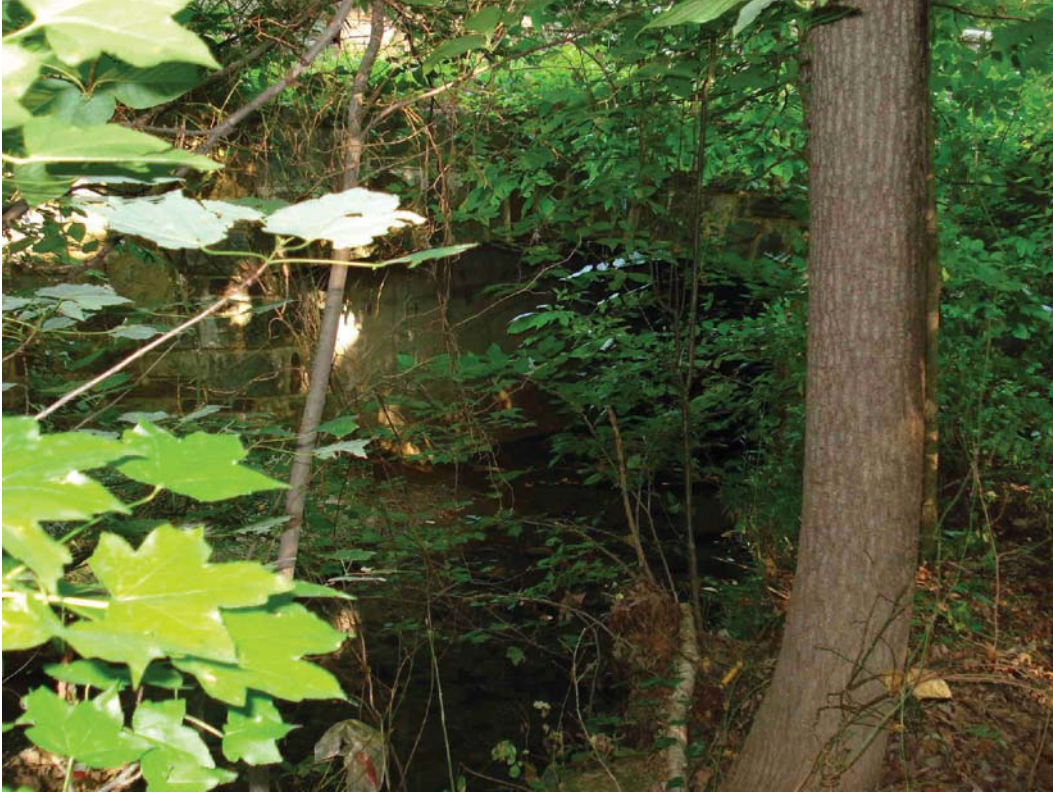
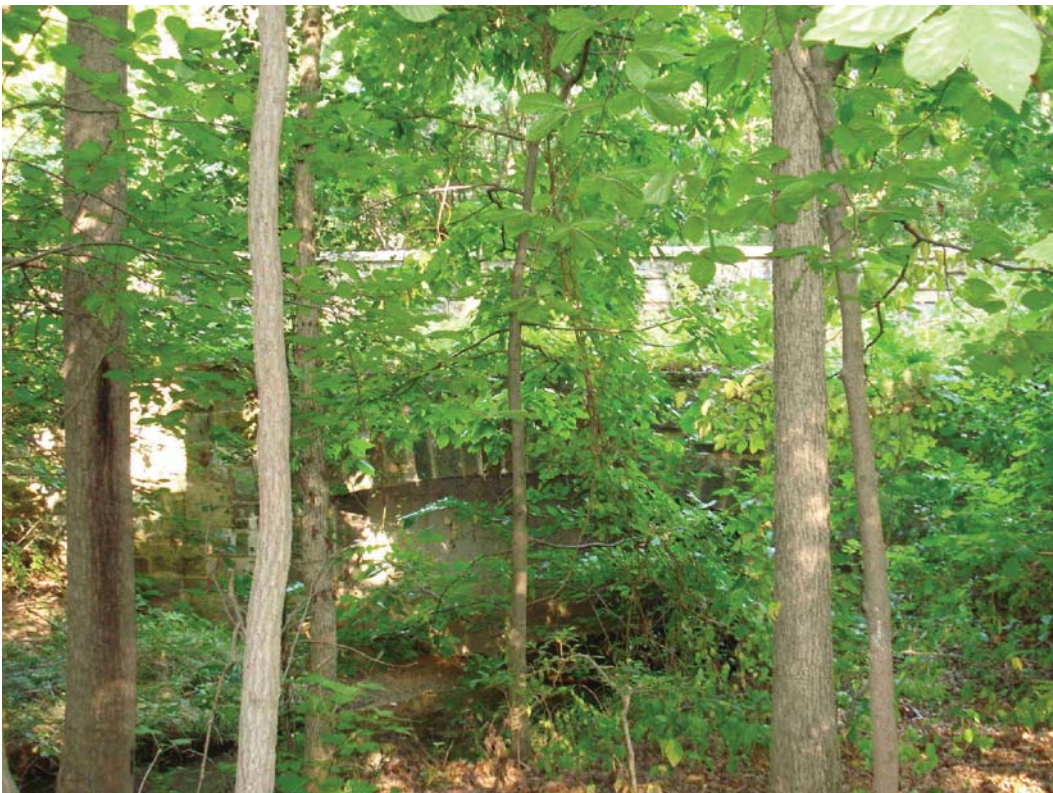
Wall ID:	BAWA-0001-7.567-R		
Route Name:	BALTIMORE-WASHINGTON PARKWAY (NB)		
Inspection Date:	August 15, 2007	Approximate Year Built:	1965
*Wall Rating:	83	Maintenance Action:	Maintenance
Wall Description			
Wall Function:	Head Wall	Primary Wall Type:	Gravity - Mortared Stone
Surface Treatment:		Secondary Wall Type:	
Secondary Surface Treatment:		Architectural Facing:	
General Description:	Stone masonry headwall for a 6 ft x 12 ft concrete arch culvert constructed along right shoulder and partially supports a high ADT roadway high consequence of failure		
Wall Measurements			
Wall Length (ft.):	60	Face Area (sq.):	348
Average Wall Height (ft.):	5	Face Angle (deg.):	90
Maximum Wall Height (ft.):	9	Vertical Offset (ft.):	-3
Assessed Elements			
Element (Weighting Factor)	Narrative		Condition Rating (0 - 10)
PERFORMANCE 8.00	Good condition; no distress to wall; ongoing minor erosion of south bank due migration of the channel resulting from the accumulation of gravel along the north bank.		8

WALL FOUNDATION MATERIAL 8.00	Appears to be founded on a soil subgrade; no observed distress		8
MORTAR 8.00	Good condition; general age-related weathering		8
STONE MASONRY 8.00	Good condition; no distress to blocks		9
CULVERT 0.50	No observed distress to 6 ft x 12 ft concrete box culvert		8
LATERAL SLOPE 0.50	Good condition; no observed distress to well-vegetated slope		8
ROAD/SIDEWALK/SHOULDER 0.50	Good condition; minor fatigue cracking of pavement and paved shoulder		8
VEGETATION 0.50	Good condition; no impact from vegetation growing near wall		9
WALL DRAINS 0.50	No observed drainage-related distress		9
Repair Recommendations			
Failure Consequence:	HIGH		
Recommendation Narrative:	Clear debris from channel - 16 labor hrs (\$55/hr) = \$880		
Repair Cost:	\$880		
2007 cost estimate (ASTM Class D), preliminary for comparison to other repair costs only.

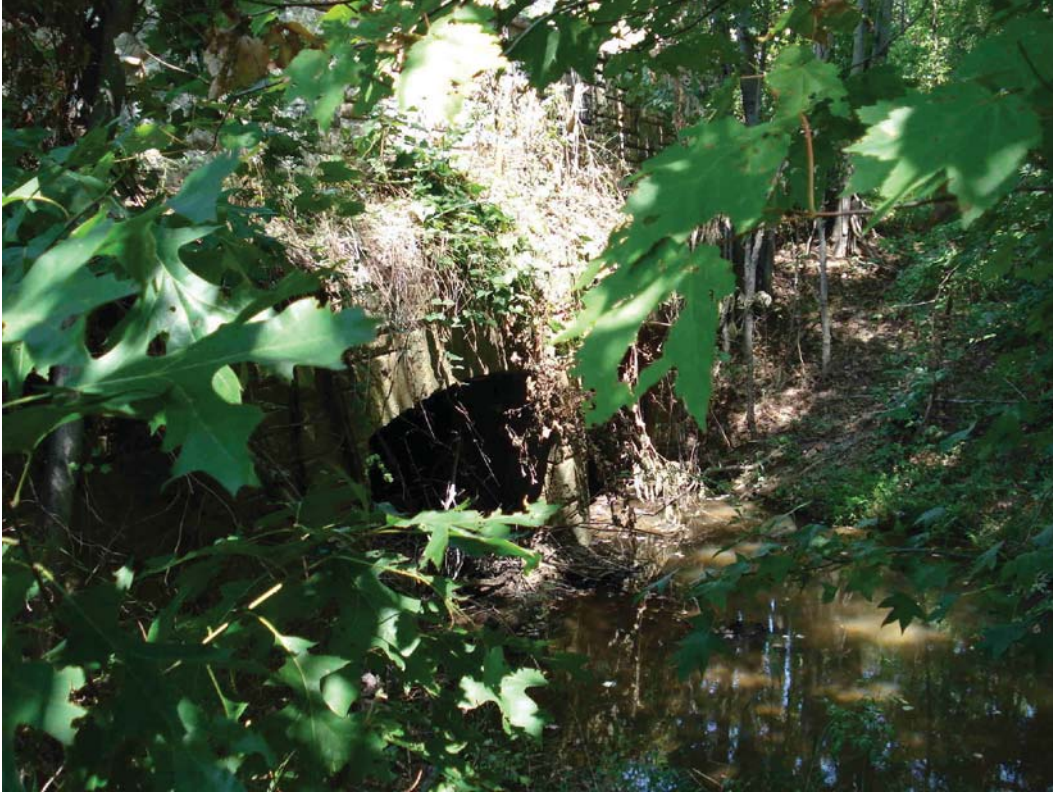
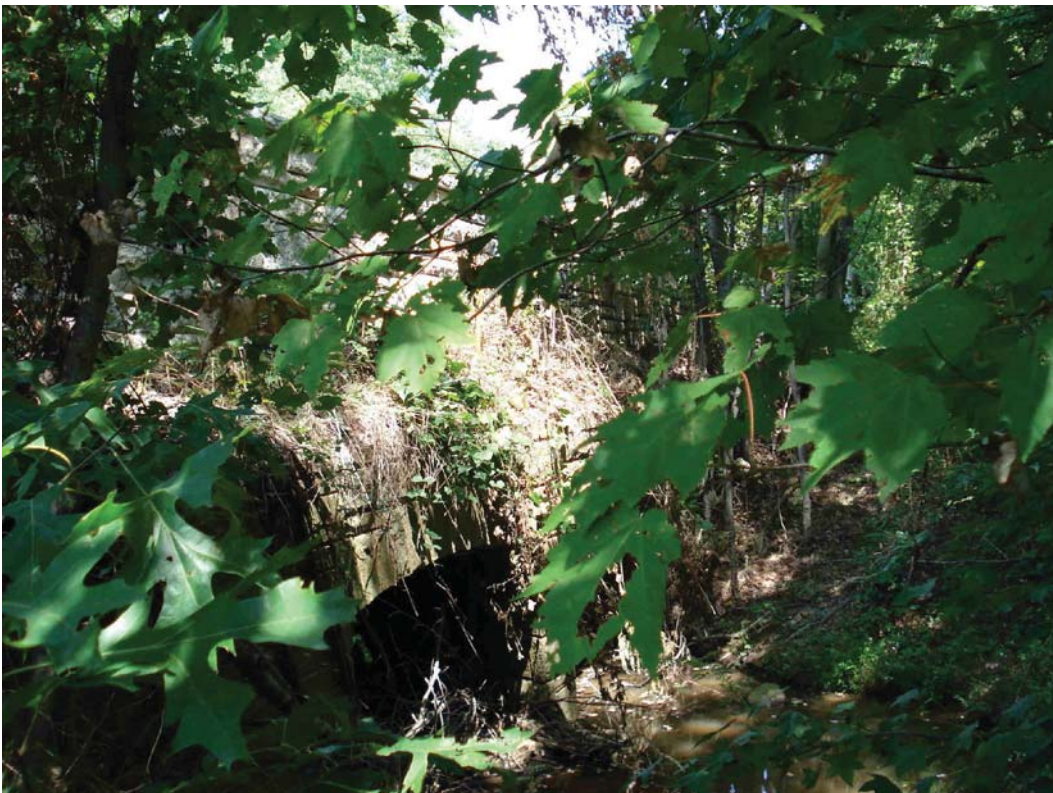
Wall ID:	BAWA-0001-7.750-R		
Route Name:	BALTIMORE-WASHINGTON PARKWAY (NB)		
Inspection Date:	August 14, 2007	Approximate Year Built:	1965
*Wall Rating:	76	Maintenance Action:	Maintenance
Wall Description			
Wall Function:	Head Wall	Primary Wall Type:	Gravity - Mortared Stone
Surface Treatment:		Secondary Wall Type:	
Secondary Surface Treatment:		Architectural Facing:	
General Description:	Stone masonry inlet headwall for twin 5.52 ft x 6 ft concrete box culverts constructed along right shoulder and partially supports a high ADT roadway high consequence of failure due to size and proximity to roadway		
Wall Measurements			
Wall Length (ft.):	60	Face Area (sq.):	374
Average Wall Height (ft.):	6	Face Angle (deg.):	90
Maximum Wall Height (ft.):	10	Vertical Offset (ft.):	-3
Assessed Elements			
Element (Weighting Factor)	Narrative		Condition Rating (0 - 10)
PERFORMANCE 8.00	Good condition; scour hole is undermining the foundation and threatens the wall's stability; several small diameter trees growing adjacent to wall threatens its long-term stability		7

WALL FOUNDATION MATERIAL 8.00	Fair to good; ongoing minor scour of foundation soils due to forming scour hole; scour hole threatens to undermine the foundation; no evidence of settlement or rotation		7
MORTAR 8.00	Good condition; general age-related weathering		8
STONE MASONRY 8.00	Good condition; no distress to cut blocks		8
CULVERT 0.50	No observed distress to twin 5.5 ft x 6 ft concrete box culverts		8
LATERAL SLOPE 0.50	No distress to lightly-vegetated slope		8
UPSLOPE 0.50	No distress to relatively-flat, narrow and lightly-vegetated slope		8
VEGETATION 0.50	Several small diameter trees are adjacent to wall; trees threaten the wall's long-term stability		8
TRAFFIC BARRIER/FENCE 0.50	No observe distress to concrete guard wall with mortared stone veneer		9
Repair Recommendations			
Failure Consequence:	HIGH		
Recommendation Narrative:	Backfill scour hole - earthwork geotextile, 69.4 sqft (\$5/sqft) = \$388.89. Place riprap, Class 3 - 23.15 cuyd (\$200/cuyd) = \$4,629.63. Cut trees - 1 medium diameter tree (\$200/tree) = \$200, 3 small diameter trees (\$100/tree) = \$300

Repair Cost:	\$5,519		
2007 cost estimate (ASTM Class D), preliminary for comparison to other repair costs only.

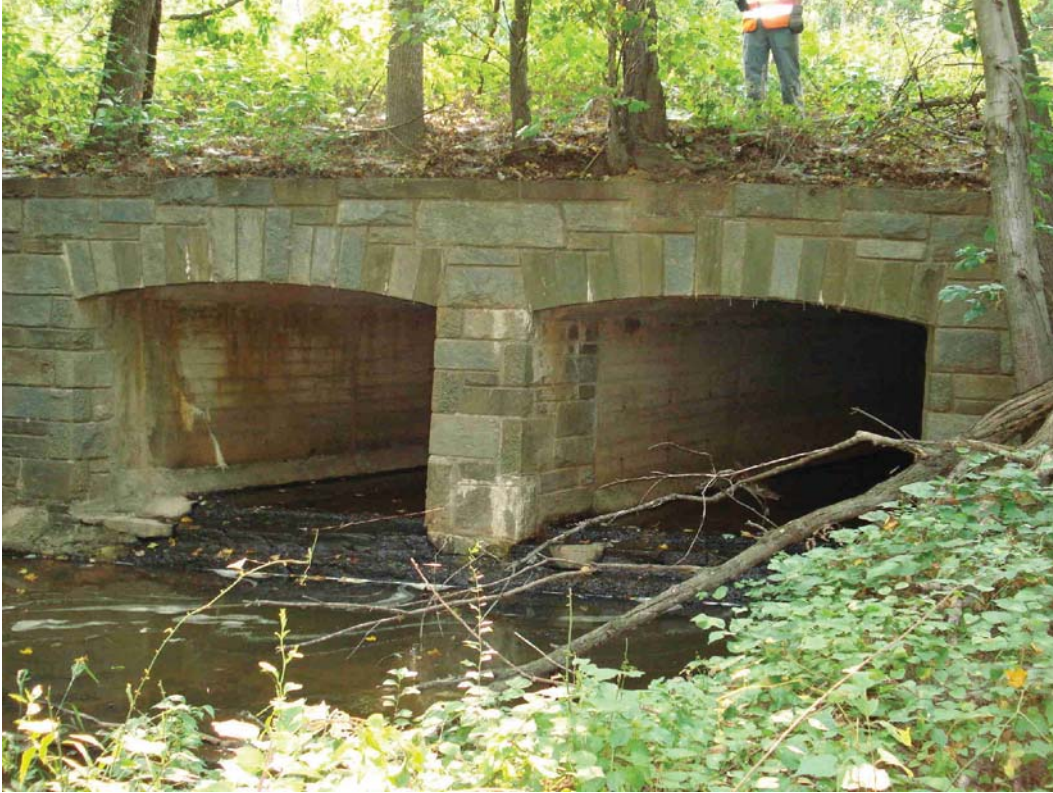
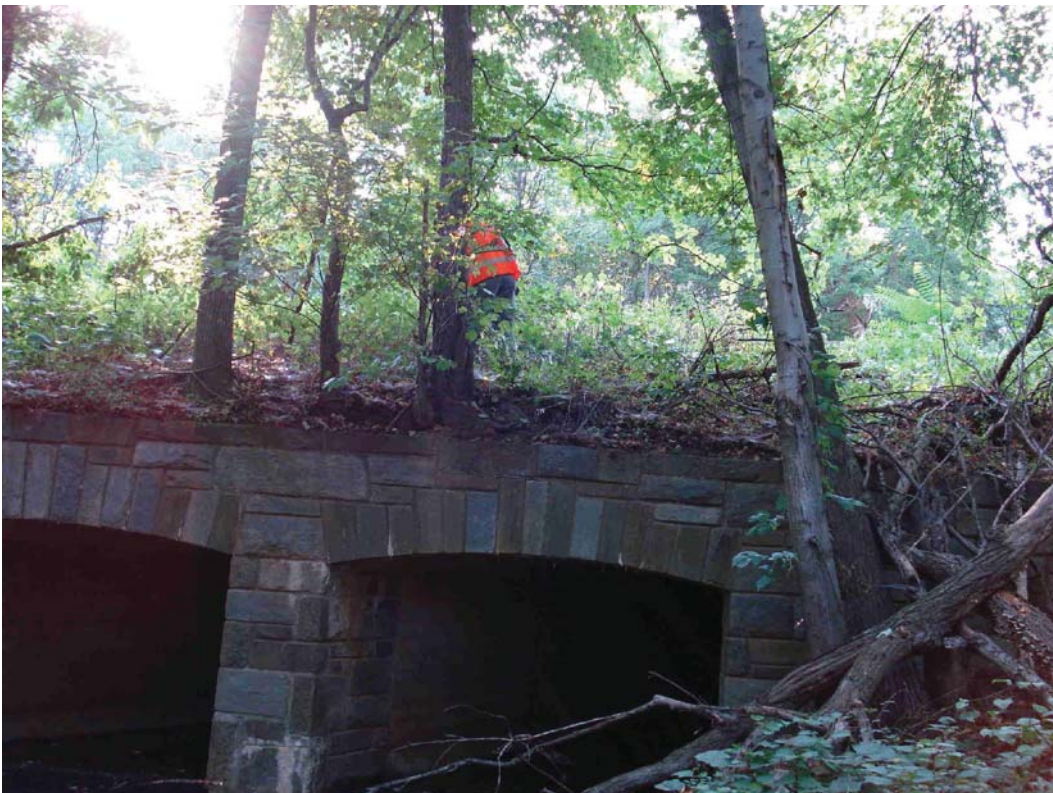
Wall ID:	BAWA-0001-7.758-L		
Route Name:	BALTIMORE-WASHINGTON PARKWAY (NB)		
Inspection Date:	August 15, 2007	Approximate Year Built:	1965
*Wall Rating:	74	Maintenance Action:	Maintenance
Wall Description			
Wall Function:	Head Wall	Primary Wall Type:	Gravity - Mortared Stone
Surface Treatment:		Secondary Wall Type:	
Secondary Surface Treatment:		Architectural Facing:	
General Description:	Stone masonry outlet headwall for twin 9 ft x 9 ft concrete box culverts constructed along right shoulder and along base of relatively flat slope low consequence of failure		
Wall Measurements			
Wall Length (ft.):	58	Face Area (sq.):	356
Average Wall Height (ft.):	6	Face Angle (deg.):	90
Maximum Wall Height (ft.):	11	Vertical Offset (ft.):	-5
Assessed Elements			
Element (Weighting Factor)	Narrative	Condition Rating (0 - 10)	
PERFORMANCE 8.00	Good condition; large scour hole is undermining the foundation and eroding banks; several medium diameter trees are growing atop and adjacent to wall; trees threaten the walls long-term stability	7

WALL FOUNDATION MATERIAL 8.00	Appears to be founded on a soil subgrade; minor erosion of foundation soil due to scour hole	7	
MORTAR 8.00	Good condition; minor debonding along top of wall; minor efflorescence	8	
STONE MASONRY 8.00	Good condition; no observed distress to cut blocks	8	
CULVERT 0.50	No observed distress to twin 8.5 ft x 9 ft concrete box culverts	8	
LATERAL SLOPE 0.50	No observed distress	8	
UPSLOPE 0.50	No observed distress to relatively flat, moderately-forested slope	8	
WALL DRAINS 0.50	No evidence of drainage-related distress	9	
CURB/BERM/DITCH 0.50	No distress to concrete curb and gutter	10	
Repair Recommendations			
Failure Consequence:	LOW		
Recommendation Narrative:	Backfill scour hole - earthwork geotextile = 400 sqyd (\$5/sqyd) = 2,000, placed riprap, Class 3 = 133.33 cuyd (\$200/cuyd) = \$26,666.70, select borrow backfill = 133.33 cuyd (\$60/cuyd) = \$13,466.70. Cut trees - 10 medium diameter trees (\$200/

Repair Cost:	\$44,133		
2007 cost estimate (ASTM Class D), preliminary for comparison to other repair costs only.

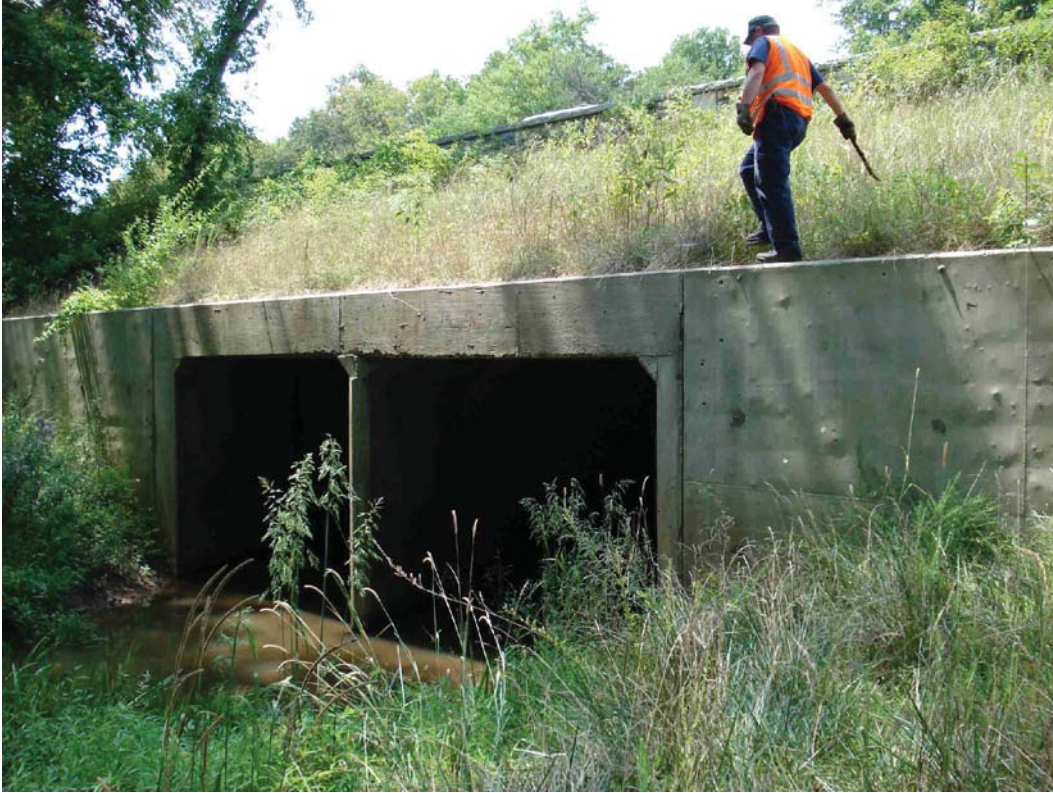
BAWA_0001_8.891_R_1.jpg

Wall ID:	BAWA-0001-8.891-R		
Route Name:	BALTIMORE-WASHINGTON PARKWAY (NB)		
Inspection Date:	August 14, 2007	Approximate Year Built:	1965
*Wall Rating:	85	Maintenance Action:	Maintenance
Wall Description			
Wall Function:	Head Wall	Primary Wall Type:	Gravity - Mass Concrete
Surface Treatment:		Secondary Wall Type:	
Secondary Surface Treatment:		Architectural Facing:	
General Description:	Concrete outlet headwall for two 9 ft x 9 ft concrete box culverts constructed along right shoulder and along base of moderate slope supporting a high ADT roadway moderate consequence of failure		
Wall Measurements			
Wall Length (ft.):	85	Face Area (sq.):	773
Average Wall Height (ft.):	9	Face Angle (deg.):	90
Maximum Wall Height (ft.):	11	Vertical Offset (ft.):	-8
Assessed Elements			
Element (Weighting Factor)	Narrative		Condition Rating (0 - 10)
PERFORMANCE 8.00	Good condition; poor drainage away from wall promotes the accumulation of water at outlet		8

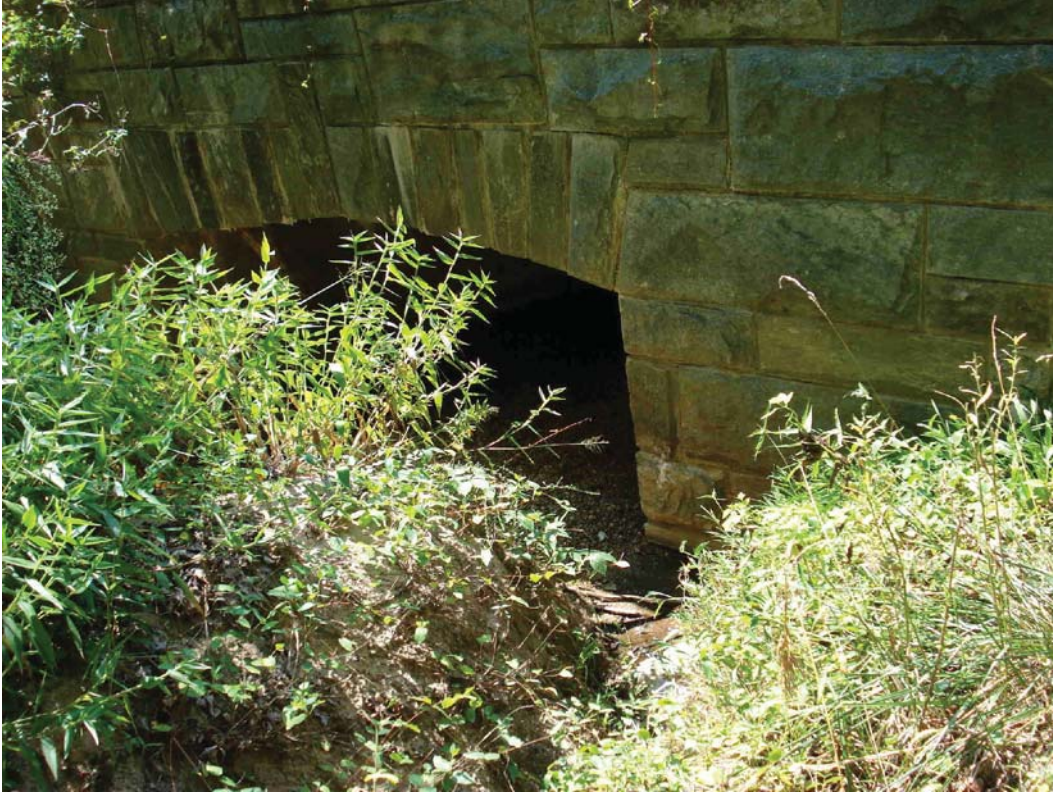
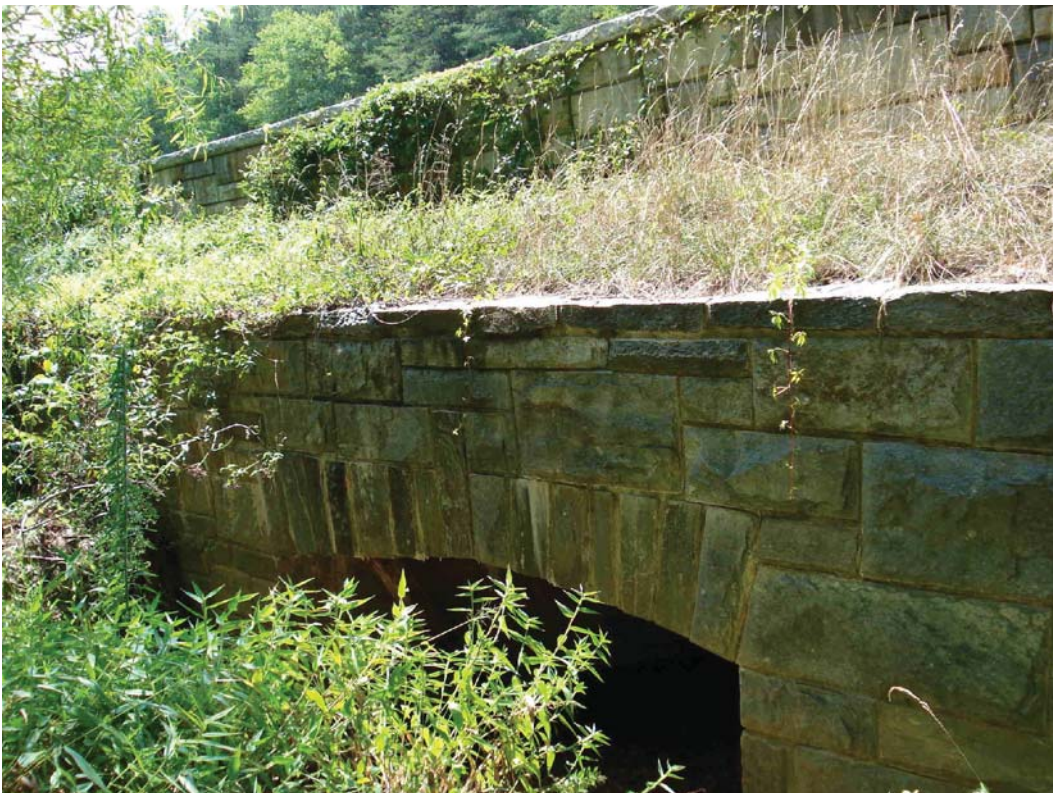
Wall ID:	BAWA-0001-10.265-R		
Route Name:	BALTIMORE-WASHINGTON PARKWAY (NB)		
Inspection Date:	August 14, 2007	Approximate Year Built:	1965
*Wall Rating:	81	Maintenance Action:	Maintenance
Wall Description			
Wall Function:	Head Wall	Primary Wall Type:	Gravity - Mortared Stone
Surface Treatment:		Secondary Wall Type:	
Secondary Surface Treatment:		Architectural Facing:	
General Description:	Stone masonry inlet headwall for a 4 ft x 9 ft concrete box culvert constructed along right shoulder and along base of a relatively flat embankment supporting a high ADT roadway moderate consequence of failure		
Wall Measurements			
Wall Length (ft.):	40	Face Area (sq.):	204
Average Wall Height (ft.):	5	Face Angle (deg.):	90
Maximum Wall Height (ft.):	7	Vertical Offset (ft.):	-2
Assessed Elements			
Element (Weighting Factor)	Narrative		Condition Rating (0 - 10)
PERFORMANCE 8.00	Good condition; approximately 6-in. of gravel along invert of culvert and in channel		8

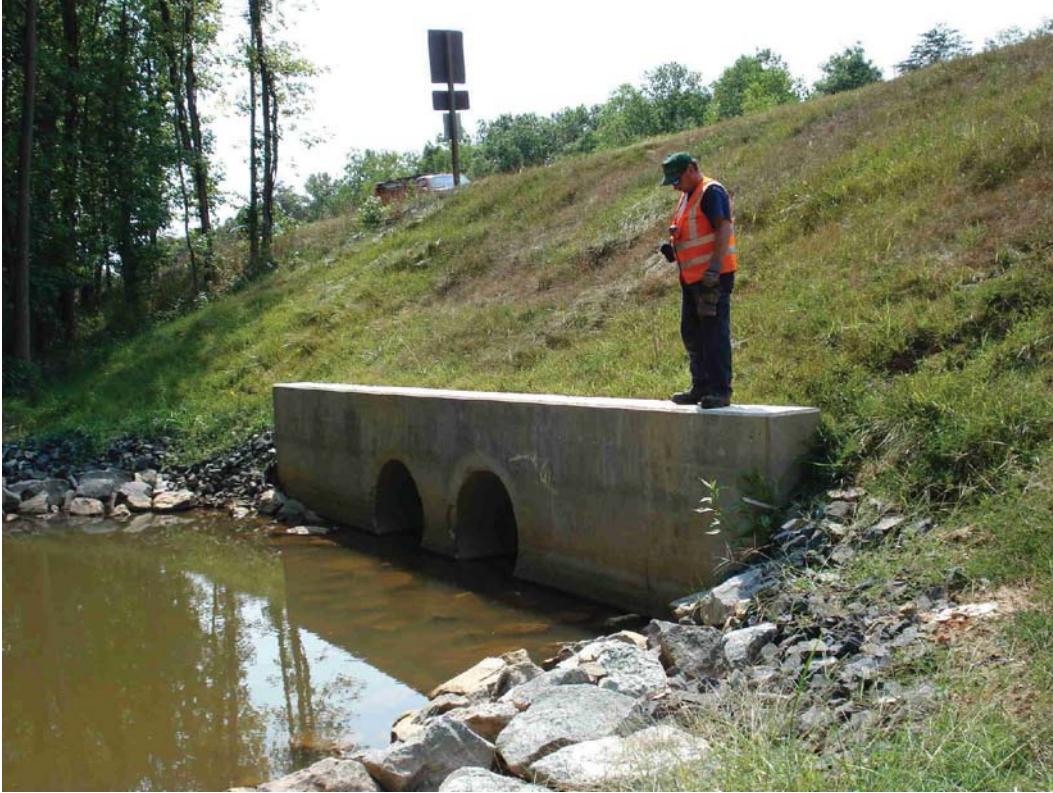
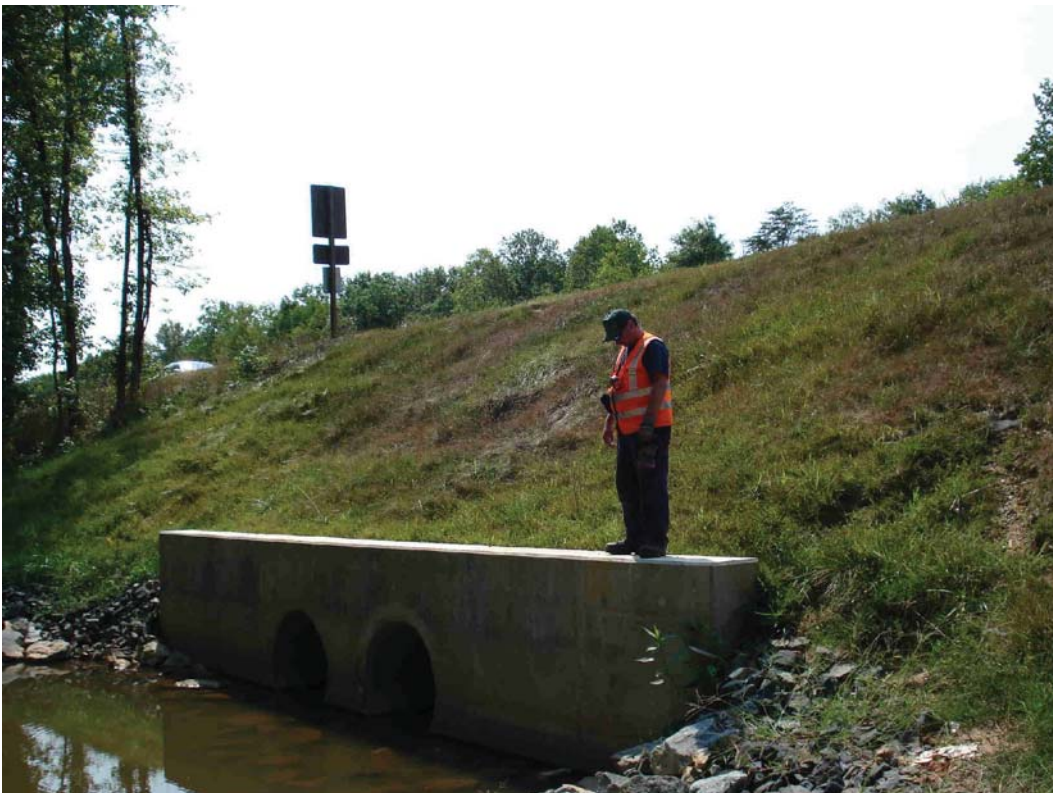
Wall ID:	BAWA-0001-12.185-R		
Route Name:	BALTIMORE-WASHINGTON PARKWAY (NB)		
Inspection Date:	August 11, 2007	Approximate Year Built:	2006
*Wall Rating:	87	Maintenance Action:	Maintenance
Wall Description			
Wall Function:	Head Wall	Primary Wall Type:	Gravity - Mass Concrete
Surface Treatment:		Secondary Wall Type:	
Secondary Surface Treatment:		Architectural Facing:	
General Description:	Relatively new concrete headwall for two 42 in diameter concrete pipe culverts constructed along right shoulder and along base of steep embankment supporting a high ADT roadway low consequence of failure		
Wall Measurements			
Wall Length (ft.):	30	Face Area (sq.):	161
Average Wall Height (ft.):	5	Face Angle (deg.):	90
Maximum Wall Height (ft.):	6	Vertical Offset (ft.):	15
Assessed Elements			
Element (Weighting Factor)	Narrative		Condition Rating (0 - 10)
PERFORMANCE 8.00	Good condition; poor drainage away from wall promotes the accumulation of water along the face of wall; standing water at outlet threatens the long term stability of the wall		8

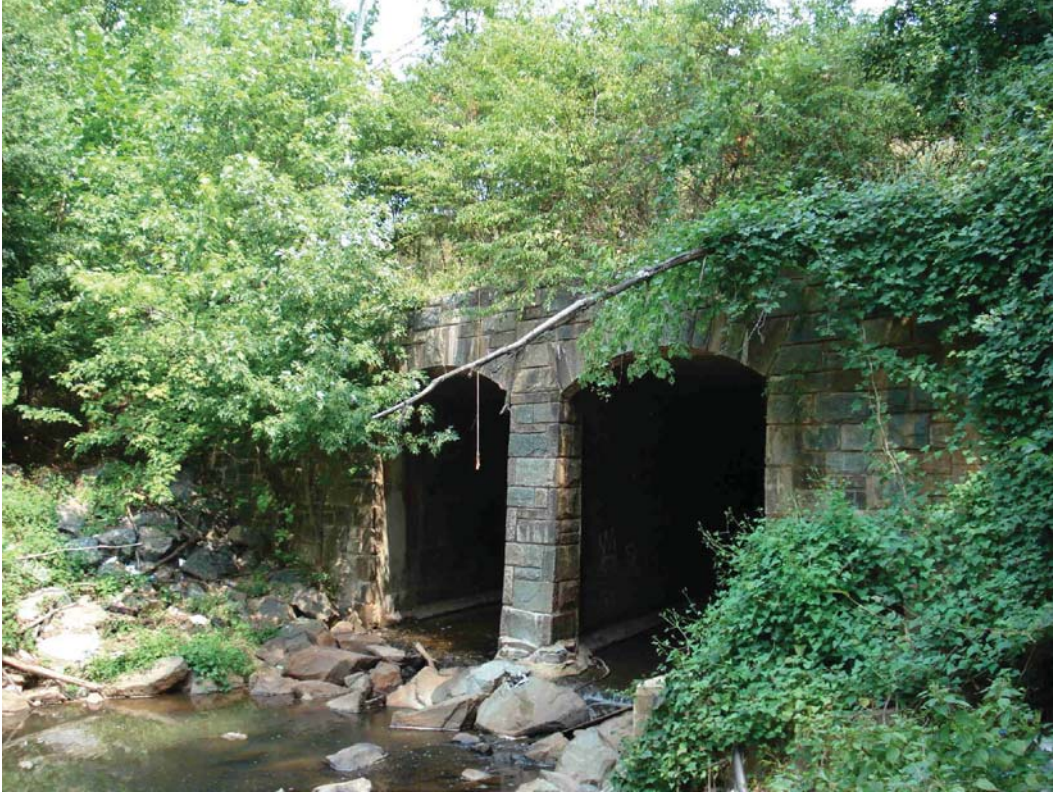
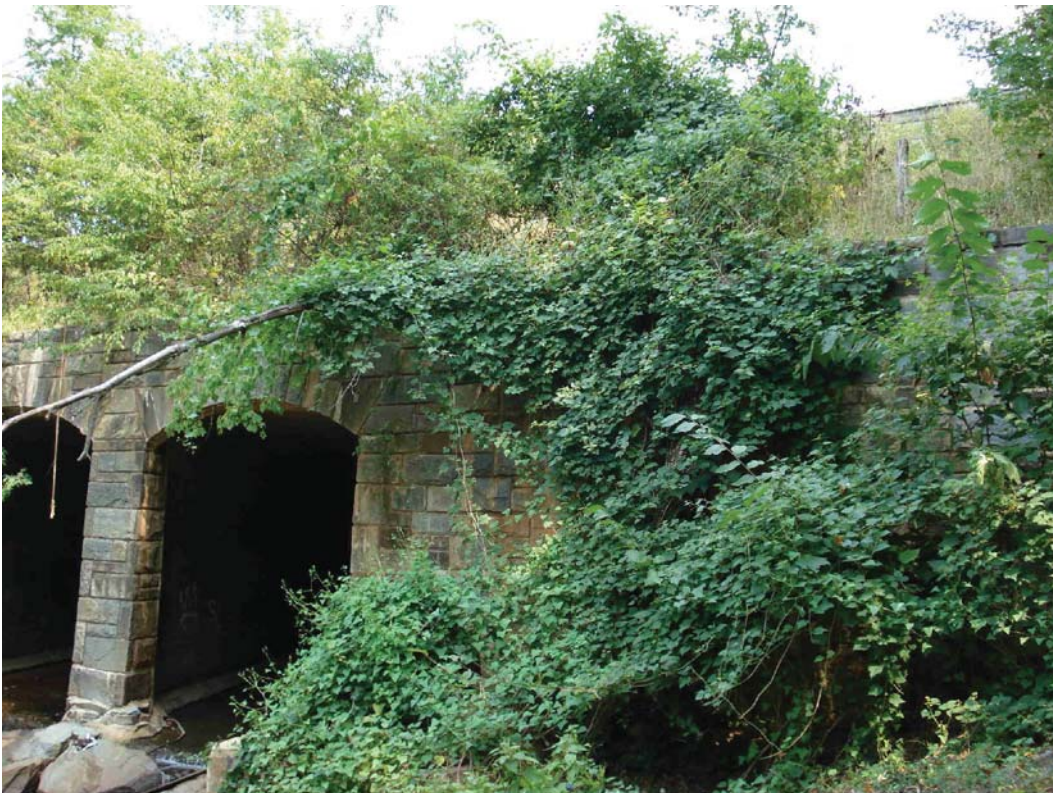
Wall ID:	BAWA-0001-14.489-R		
Route Name:	BALTIMORE-WASHINGTON PARKWAY (NB)		
Inspection Date:	August 15, 2007	Approximate Year Built:	1965
*Wall Rating:	74	Maintenance Action:	Maintenance
Wall Description			
Wall Function:	Head Wall	Primary Wall Type:	Gravity - Mortared Stone
Surface Treatment:		Secondary Wall Type:	
Secondary Surface Treatment:		Architectural Facing:	
General Description:	Stone masonry outlet headwall for two 11 ft x 12.5 ft concrete box culverts constructed along right shoulder and along base of steep embankment supporting a high ADT roadway moderate consequence of failure		
Wall Measurements			
Wall Length (ft.):	100	Face Area (sq.):	850
Average Wall Height (ft.):	8	Face Angle (deg.):	90
Maximum Wall Height (ft.):	15	Vertical Offset (ft.):	-10
Assessed Elements			
Element (Weighting Factor)	Narrative		Condition Rating (0 - 10)
PERFORMANCE 8.00	Good conditions; poor drainage away from wall promotes the accumulation of water along face of wall and threatens to undermine the foundation and erode the lateral slope		7

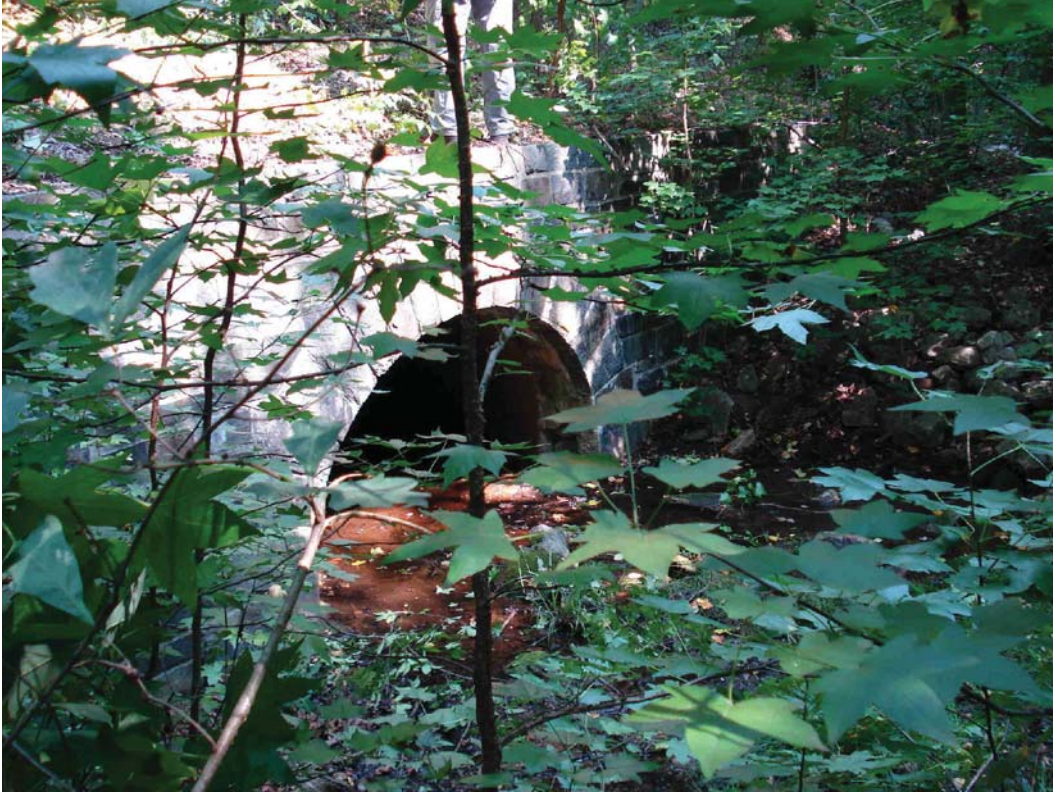
BAWA_0001_17.763_L_1.jpg

Wall ID:	BAWA-0001-17.763-L		
Route Name:	BALTIMORE-WASHINGTON PARKWAY (NB)		
Inspection Date:	August 15, 2007	Approximate Year Built:	1965
*Wall Rating:	85	Maintenance Action:	Repair Elements
Wall Description			
Wall Function:	Head Wall	Primary Wall Type:	Gravity - Mortared Stone
Surface Treatment:		Secondary Wall Type:	
Secondary Surface Treatment:		Architectural Facing:	
General Description:	Stone masonry outlet headwall for a 6 ft diameter concrete arch culvert constructed along left shoulder and along base of a gently sloping embankment supporting a high ADT roadway low consequence of failure		
Wall Measurements			
Wall Length (ft.):	25	Face Area (sq.):	87
Average Wall Height (ft.):	3	Face Angle (deg.):	90
Maximum Wall Height (ft.):	5	Vertical Offset (ft.):	-7
Assessed Elements			
Element (Weighting Factor)	Narrative	Condition Rating (0 - 10)	
PERFORMANCE 8.00	Good condition; minor localized spalling of mortar; small trees growing adjacent to wall	8

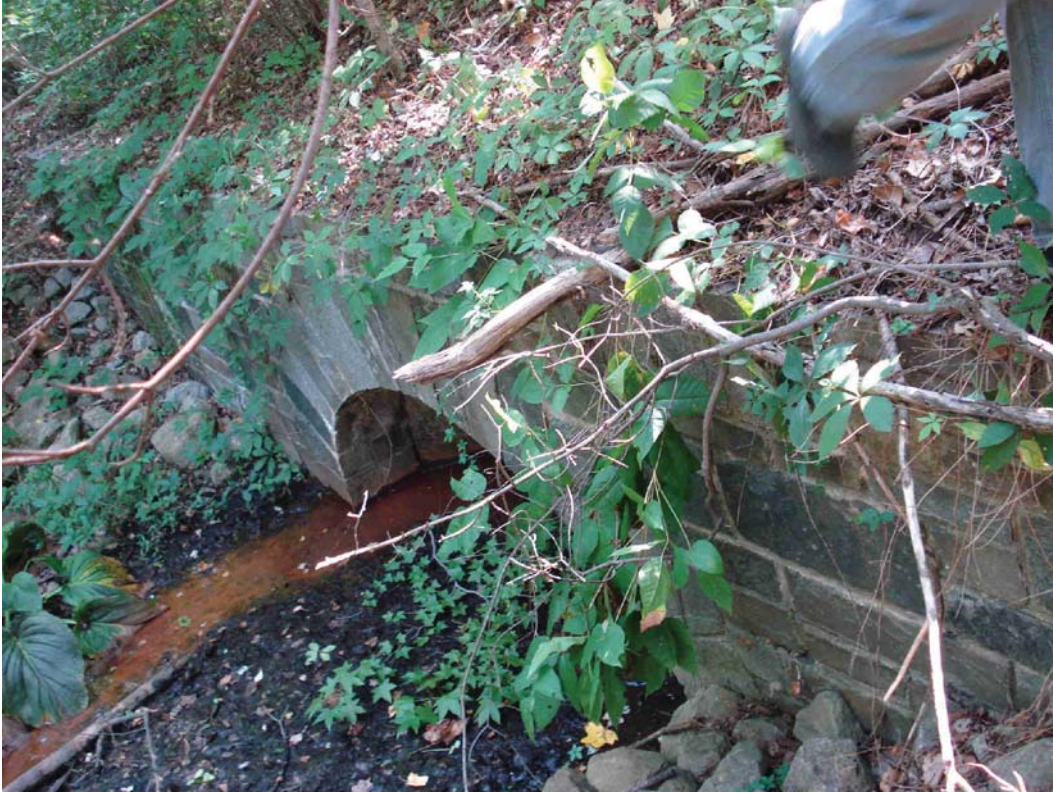
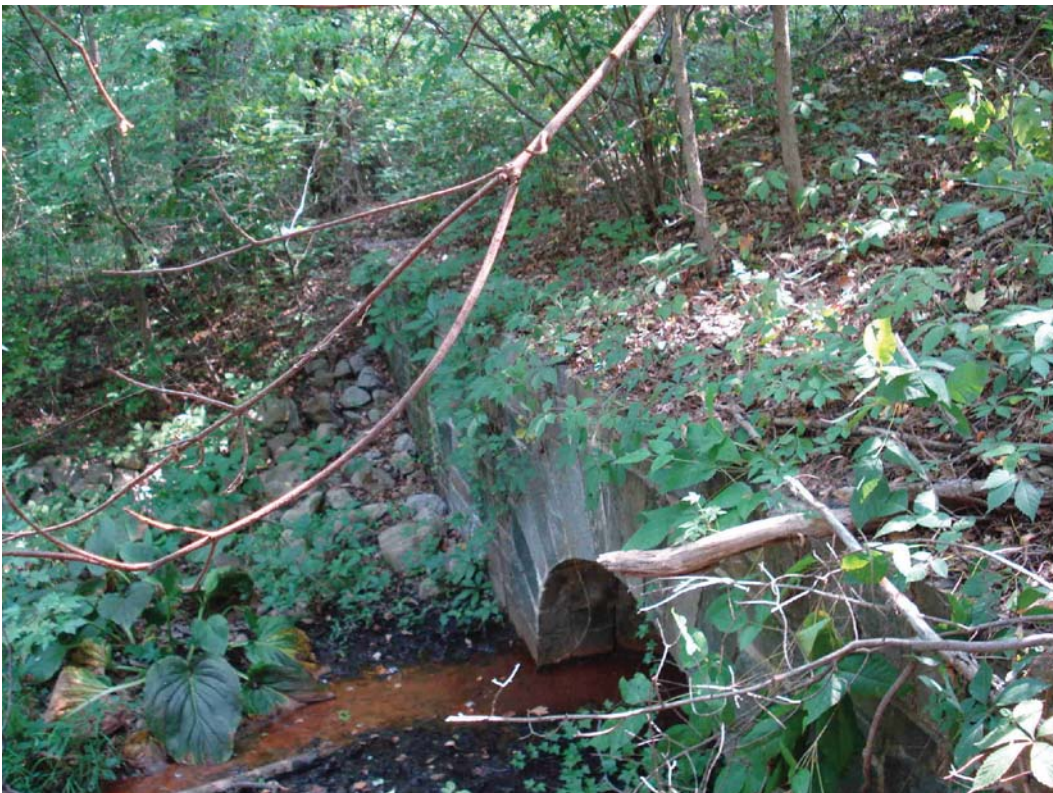
Wall ID:	BAWA-0001-17.765-R		
Route Name:	BALTIMORE-WASHINGTON PARKWAY (NB)		
Inspection Date:	August 15, 2007	Approximate Year Built:	1965
*Wall Rating:	83	Maintenance Action:	Maintenance
Wall Description			
Wall Function:	Head Wall	Primary Wall Type:	Gravity - Mortared Stone
Surface Treatment:		Secondary Wall Type:	
Secondary Surface Treatment:		Architectural Facing:	
General Description:	Stone masonry outlet headwall for a 4 ft x 9 ft diameter arch culvert constructed along right shoulder and along base of moderate slope supporting a high ADT roadway low consequence of failure		
Wall Measurements			
Wall Length (ft.):	33	Face Area (sq.):	133
Average Wall Height (ft.):	4	Face Angle (deg.):	90
Maximum Wall Height (ft.):	6	Vertical Offset (ft.):	-12
Assessed Elements			
Element (Weighting Factor)	Narrative		Condition Rating (0 - 10)
PERFORMANCE 8.00	Good condition; accumulating debris at outlet has forced channel left where it is eroding the bank		8
