BAWA WIP Report

NPS Retaining Wall Inventory Program Baltimore - Washington Parkway National Capital

Federal Highway Administration
Eastern Federal Lands Highway Division
Road Inventory Program (RIP)

Data Collection Date: August 2007
Report Date: October 2015

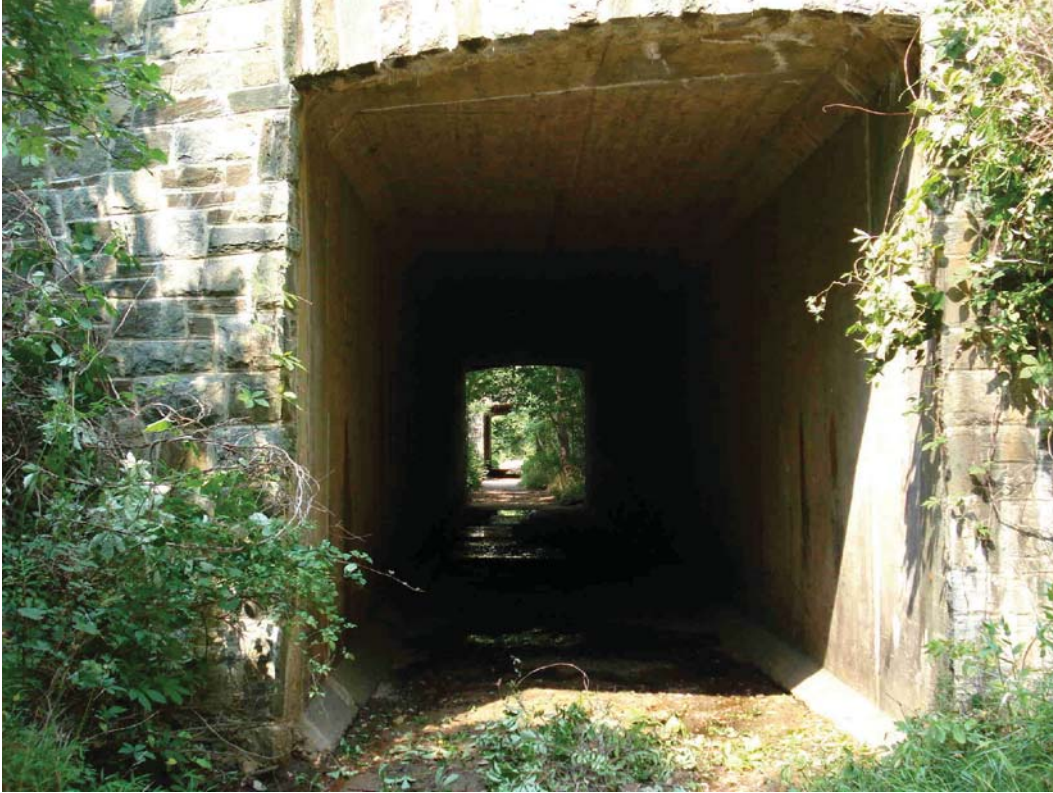
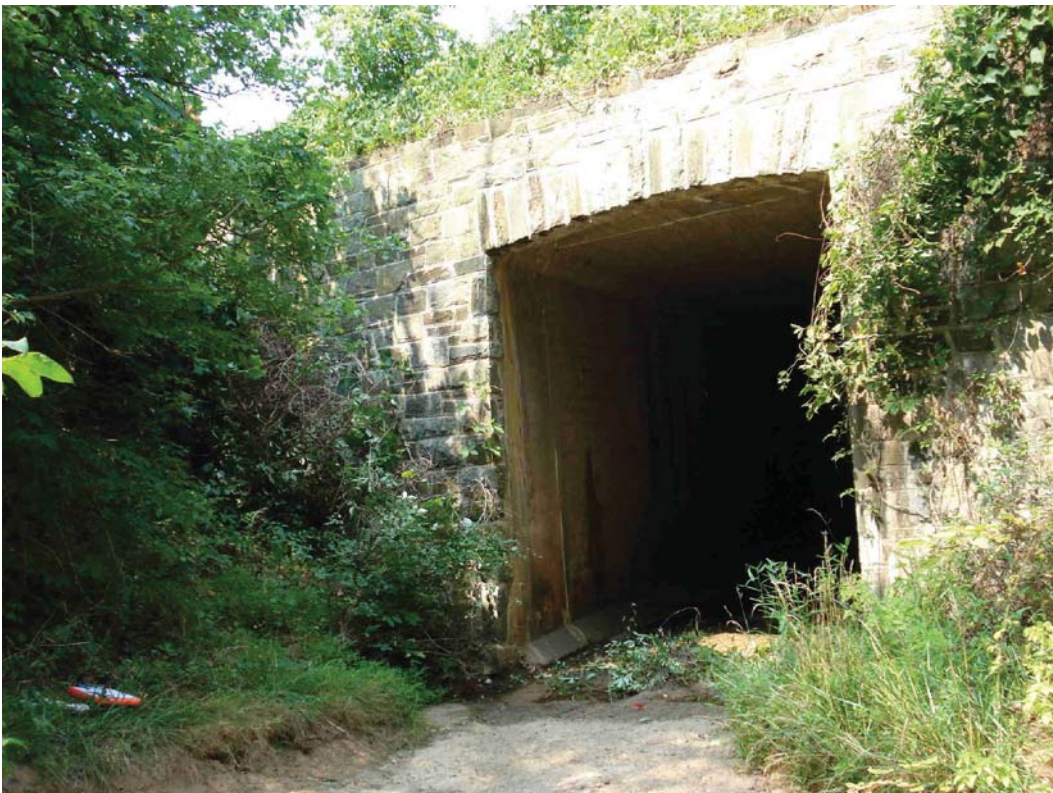
Wall ID:	BAWA-0001-18.185-L		
Route Name:	BALTIMORE-WASHINGTON PARKWAY (NB)		
Inspection Date:	August 15, 2007	Approximate Year Built:	1965
*Wall Rating:	86	Maintenance Action:	No Action
Wall Description			
Wall Function:	Head Wall	Primary Wall Type:	Gravity - Mortared Stone
Surface Treatment:		Secondary Wall Type:	
Secondary Surface Treatment:		Architectural Facing:	
General Description:	Stone masonry outlet headwall for a 12 ft square concrete box culvert constructed along left shoulder and along base of moderately sloping embankment supporting a high ADT roadway moderate consequence of failure		
Wall Measurements			
Wall Length (ft.):	75	Face Area (sq.):	531
Average Wall Height (ft.):	7	Face Angle (deg.):	90
Maximum Wall Height (ft.):	15	Vertical Offset (ft.):	-4
Assessed Elements			
Element (Weighting Factor)	Narrative		Condition Rating (0 - 10)
PERFORMANCE 8.00	Good condition; minor cracking inside of culvert; minor efflorescence along face of wall and inside culvert; minor cracking and debonding of mortar		8

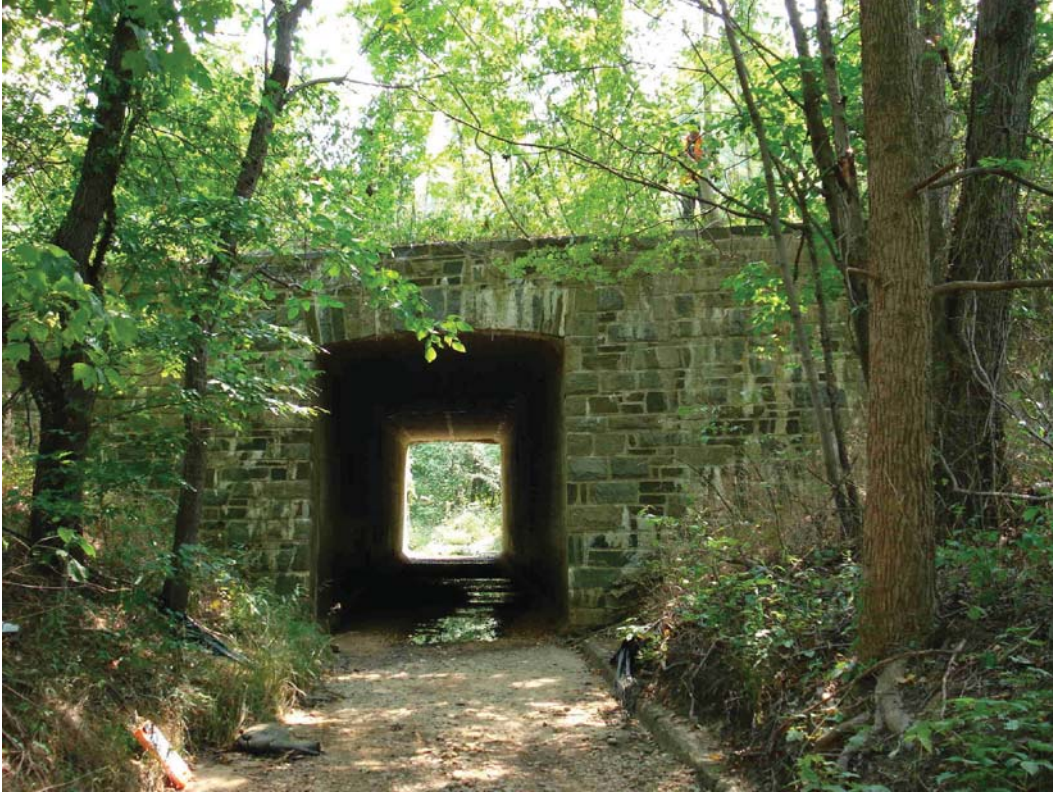
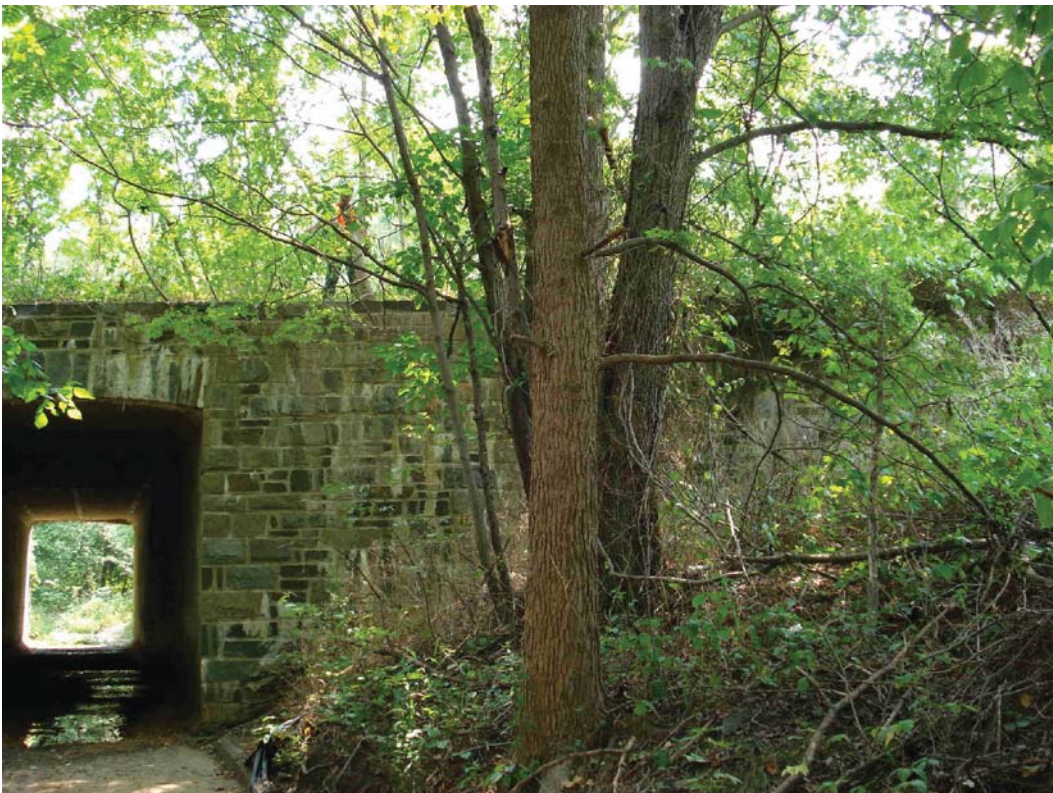
Wall ID:	BAWA-0001-18.185-R		
Route Name:	BALTIMORE-WASHINGTON PARKWAY (NB)		
Inspection Date:	August 15, 2007	Approximate Year Built:	1965
*Wall Rating:	88	Maintenance Action:	No Action
Wall Description			
Wall Function:	Head Wall	Primary Wall Type:	Gravity - Mortared Stone
Surface Treatment:		Secondary Wall Type:	
Secondary Surface Treatment:		Architectural Facing:	
General Description:	Stone masonry headwall for a 12 ft square concrete box culvert constructed along right shoulder and along base of relatively flat embankment supporting a high ADT roadway high consequence of failure		
Wall Measurements			
Wall Length (ft.):	65	Face Area (sq.):	456
Average Wall Height (ft.):	7	Face Angle (deg.):	90
Maximum Wall Height (ft.):	15	Vertical Offset (ft.):	-4
Assessed Elements			
Element (Weighting Factor)	Narrative		Condition Rating (0 - 10)
PERFORMANCE 8.00	Good to excellent condition		9
WALL FOUNDATION MATERIAL 8.00	Appears to be founded on a soil subgrade; no evidence of wall movement		9

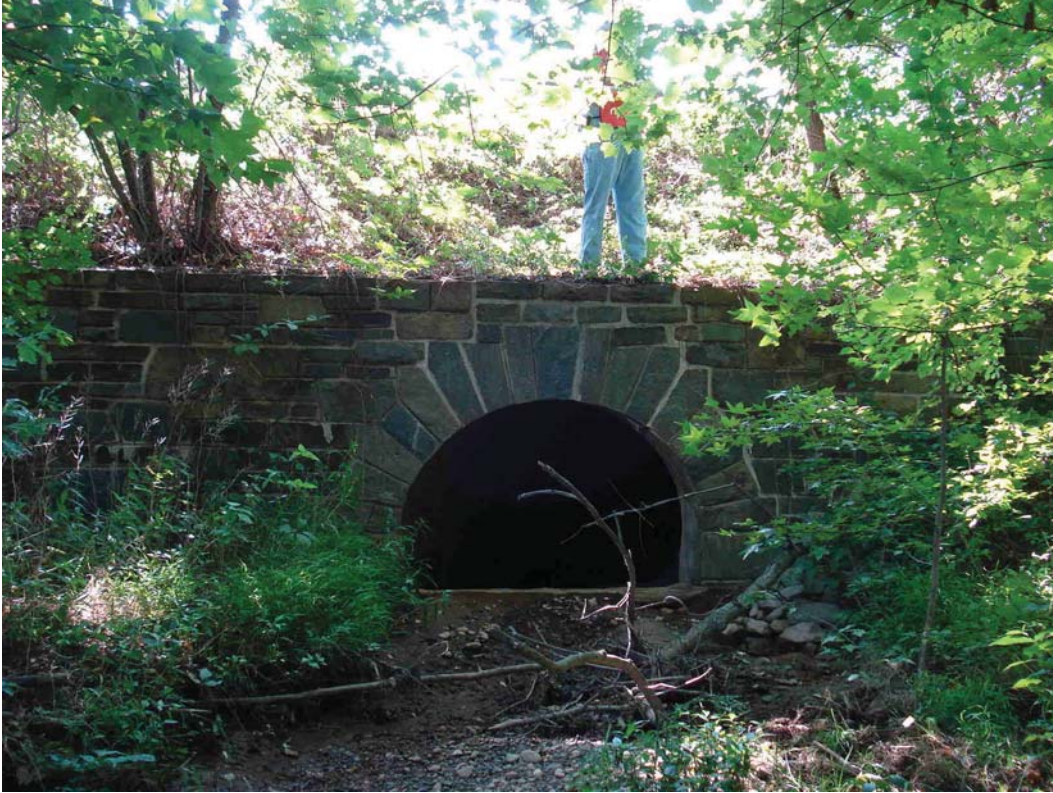
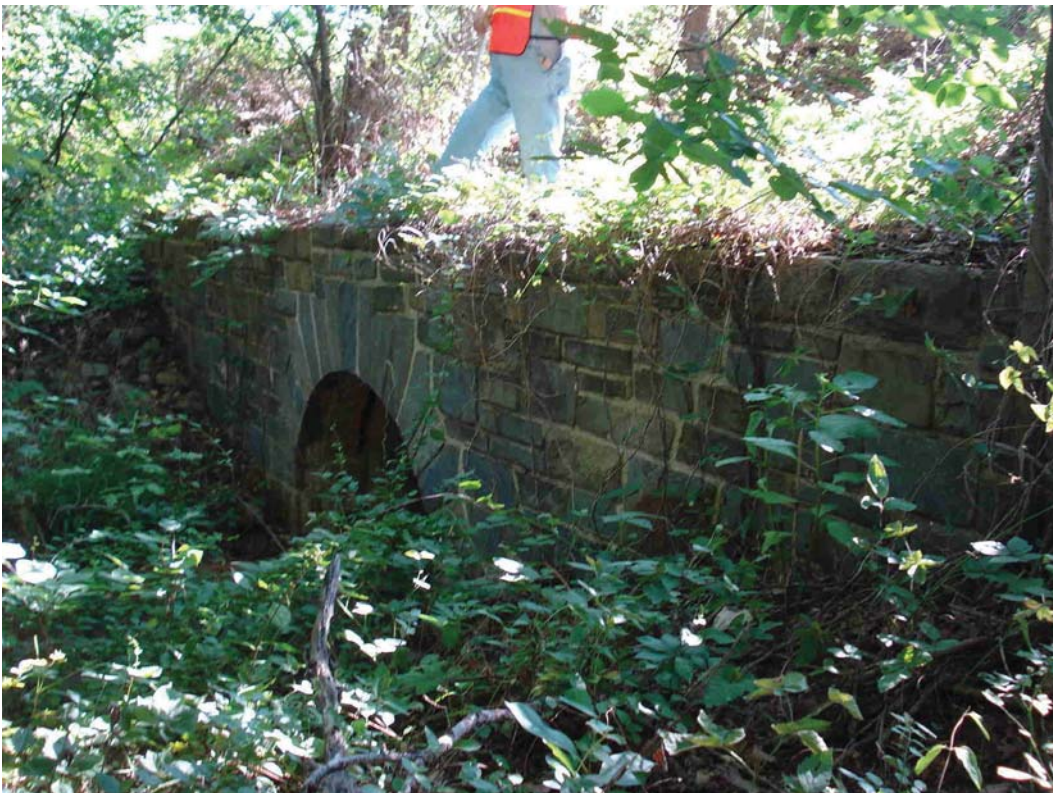
Wall ID:	BAWA-0002-0.192-R		
Route Name:	BALTIMORE-WASHINGTON PARKWAY (SB)		
Inspection Date:	August 14, 2007	Approximate Year Built:	1954
*Wall Rating:	85	Maintenance Action:	Maintenance
Wall Description			
Wall Function:	Head Wall	Primary Wall Type:	Gravity - Mortared Stone
Surface Treatment:		Secondary Wall Type:	
Secondary Surface Treatment:		Architectural Facing:	
General Description:	Stone masonry inlet headwall for a 5 ft x 6.5 ft concrete arch culvert constructed along right shoulder and along base of embankment supporting a high ADT roadway moderate consequence of failure		
Wall Measurements			
Wall Length (ft.):	38	Face Area (sq.):	165
Average Wall Height (ft.):	4	Face Angle (deg.):	90
Maximum Wall Height (ft.):	8	Vertical Offset (ft.):	-12
Assessed Elements			
Element (Weighting Factor)	Narrative	Condition Rating (0 - 10)	
PERFORMANCE 8.00	Good condition; minor cracking and debonding of mortar; small tree growing atop wall; debris at inlet	7

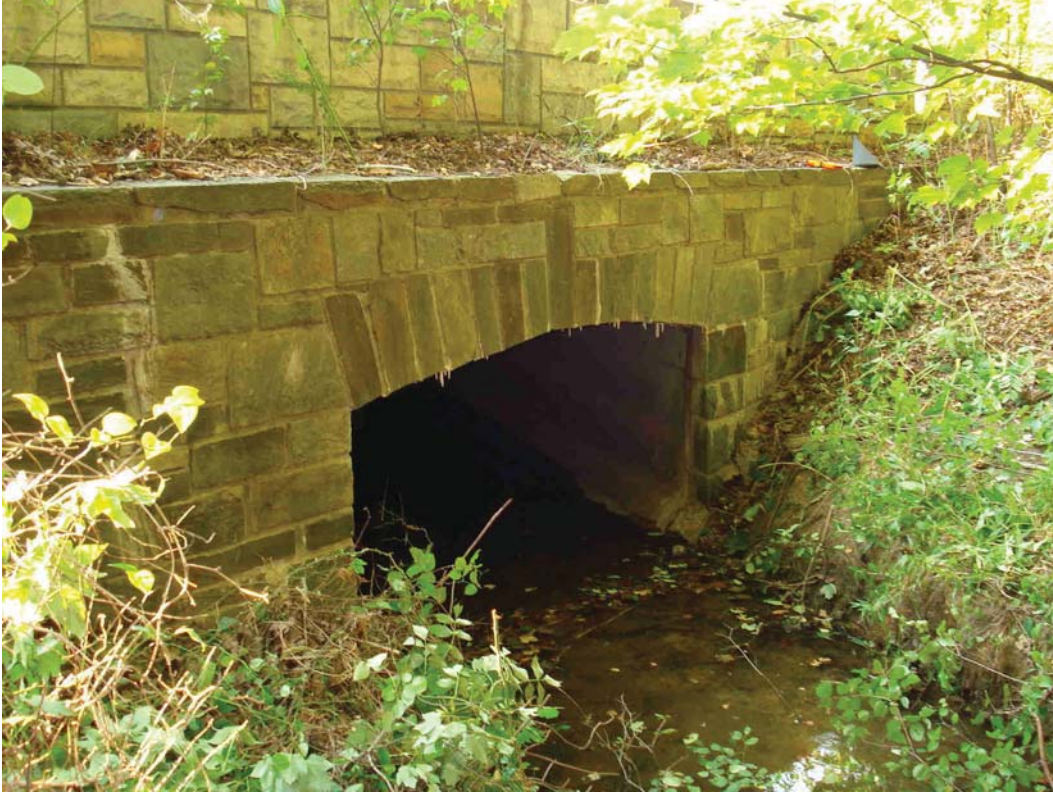
BAWA_0002_0.382_R_1.jpg

Wall ID:	BAWA-0002-0.382-R		
Route Name:	BALTIMORE-WASHINGTON PARKWAY (SB)		
Inspection Date:	August 15, 2007	Approximate Year Built:	1965
*Wall Rating:	88	Maintenance Action:	Maintenance
Wall Description			
Wall Function:	Head Wall	Primary Wall Type:	Gravity - Mortared Stone
Surface Treatment:		Secondary Wall Type:	
Secondary Surface Treatment:		Architectural Facing:	
General Description:	Stone masonry outlet headwall for a 4.75 ft x 9.5 ft concrete box culvert constructed along right shoulder and directly supports a high ADT roadway high consequence of failure due to size and proximity to roadway		
Wall Measurements			
Wall Length (ft.):	38	Face Area (sq.):	86
Average Wall Height (ft.):	2	Face Angle (deg.):	90
Maximum Wall Height (ft.):	8	Vertical Offset (ft.):	0
Assessed Elements			
Element (Weighting Factor)	Narrative		Condition Rating (0 - 10)
PERFORMANCE 8.00	Good condition; ongoing erosion of channel at threatens the long-term stability of the wall		8

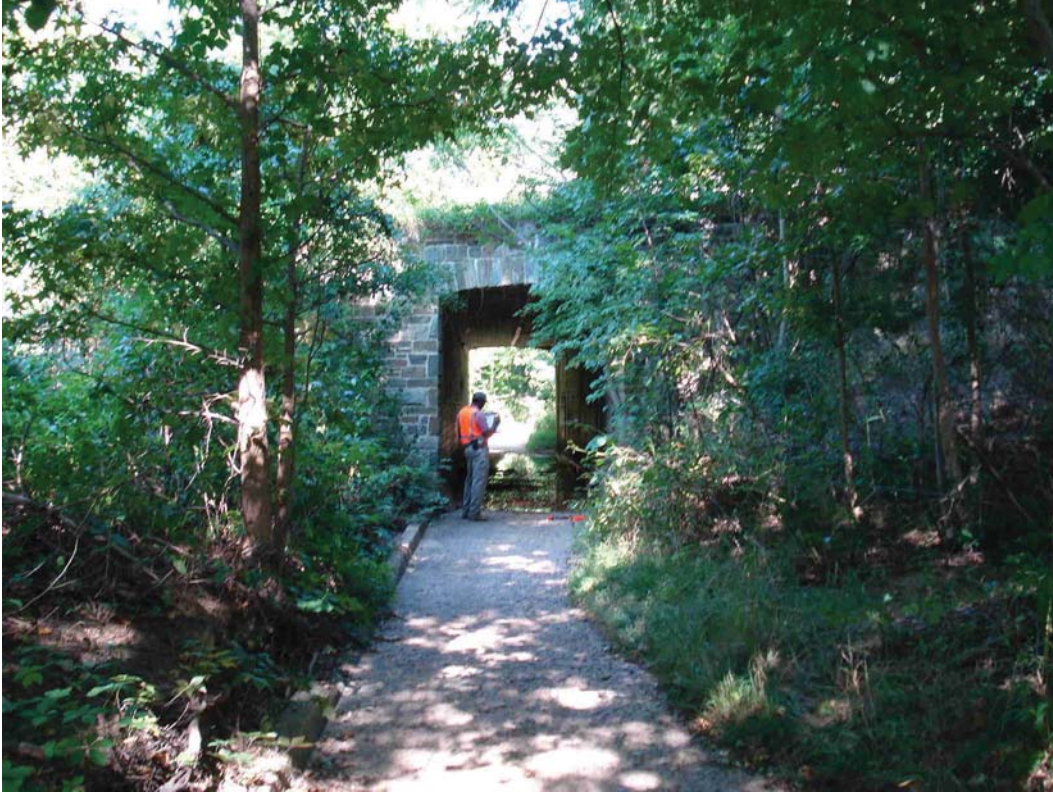
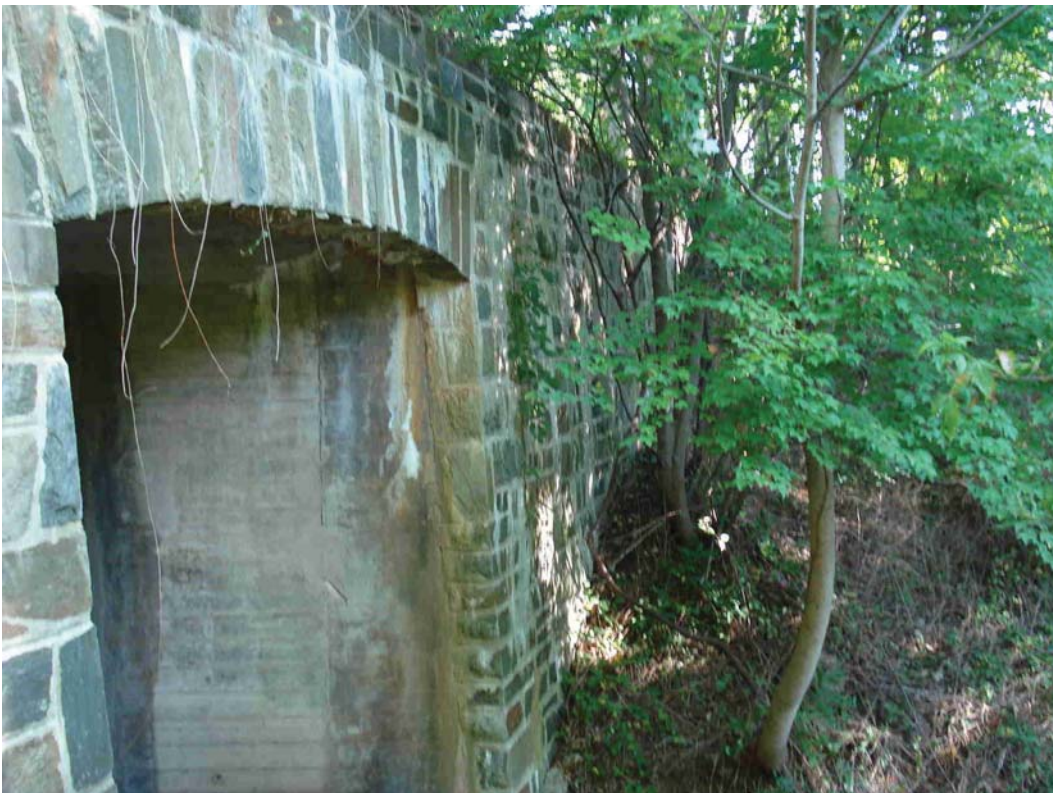
Wall ID:	BAWA-0002-0.487-L		
Route Name:	BALTIMORE-WASHINGTON PARKWAY (SB)		
Inspection Date:	August 14, 2007	Approximate Year Built:	1965
*Wall Rating:	88	Maintenance Action:	Maintenance
Wall Description			
Wall Function:	Head Wall	Primary Wall Type:	Gravity - Mortared Stone
Surface Treatment:		Secondary Wall Type:	
Secondary Surface Treatment:		Architectural Facing:	
General Description:	Stone masonry outlet headwall for a 10 ft x 12 ft concrete box culvert constructed along left shoulder and partially supports a high ADT roadway high consequence of failure due to size and proximity to roadway		
Wall Measurements			
Wall Length (ft.):	74	Face Area (sq.):	422
Average Wall Height (ft.):	5	Face Angle (deg.):	90
Maximum Wall Height (ft.):	15	Vertical Offset (ft.):	-2
Assessed Elements			
Element (Weighting Factor)	Narrative		Condition Rating (0 - 10)
PERFORMANCE 8.00	Good condition; efflorescence across face of wall; several small diameter trees growing within 3 ft of wall		8

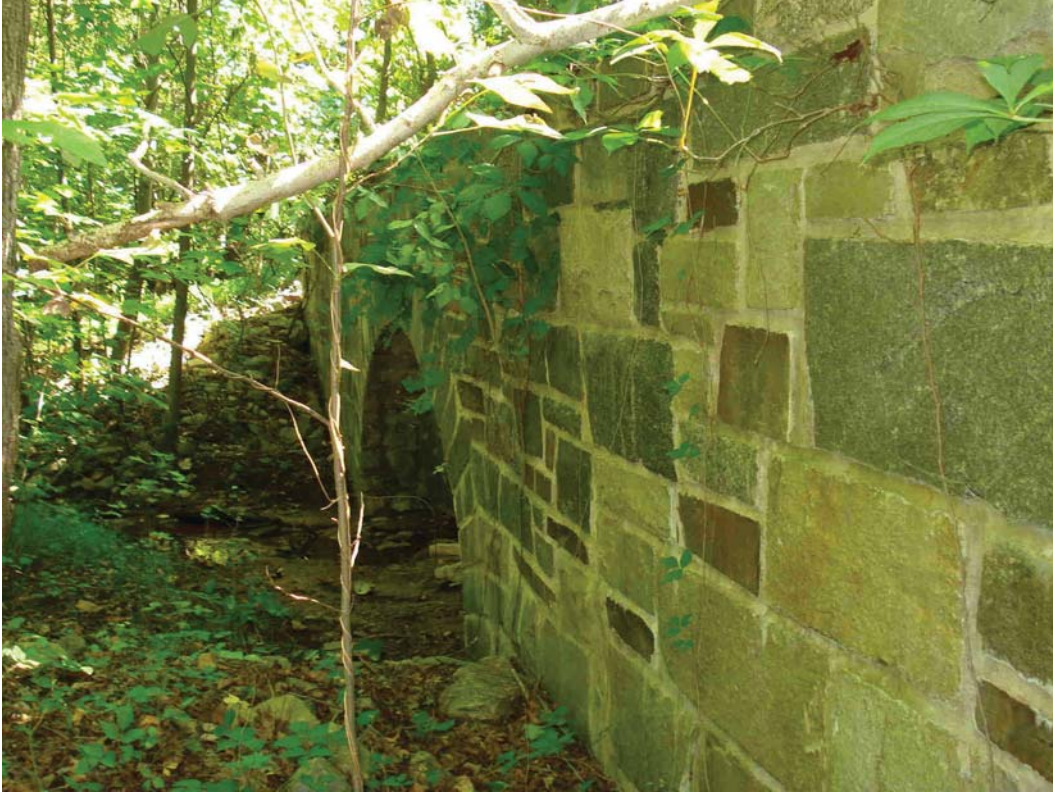
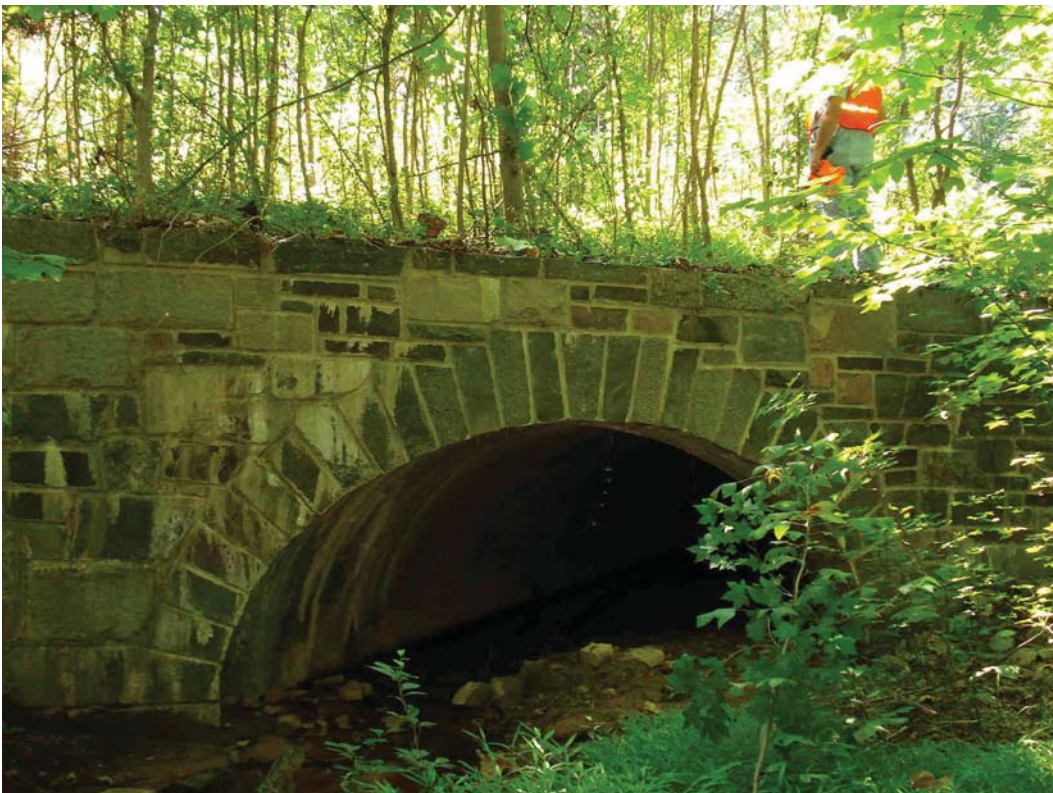
Wall ID:	BAWA-0002-0.769-R		
Route Name:	BALTIMORE-WASHINGTON PARKWAY (SB)		
Inspection Date:	August 14, 2007	Approximate Year Built:	1965
*Wall Rating:	83	Maintenance Action:	Maintenance
Wall Description			
Wall Function:	Head Wall	Primary Wall Type:	Gravity - Mortared Stone
Surface Treatment:		Secondary Wall Type:	
Secondary Surface Treatment:		Architectural Facing:	
General Description:	Stone masonry outlet headwall for a 6 ft x 12 ft concrete arch culvert constructed along right shoulder and along base of moderately sloping embankment supporting a high ADT roadway low consequence of failure		
Wall Measurements			
Wall Length (ft.):	45	Face Area (sq.):	259
Average Wall Height (ft.):	5	Face Angle (deg.):	90
Maximum Wall Height (ft.):	8	Vertical Offset (ft.):	-6
Assessed Elements			
Element (Weighting Factor)	Narrative	Condition Rating (0 - 10)	
PERFORMANCE 8.00	Good condition; minor cracking and spalling or mortar; 12-in. of sedimentation within the channel and inside of culvert	7

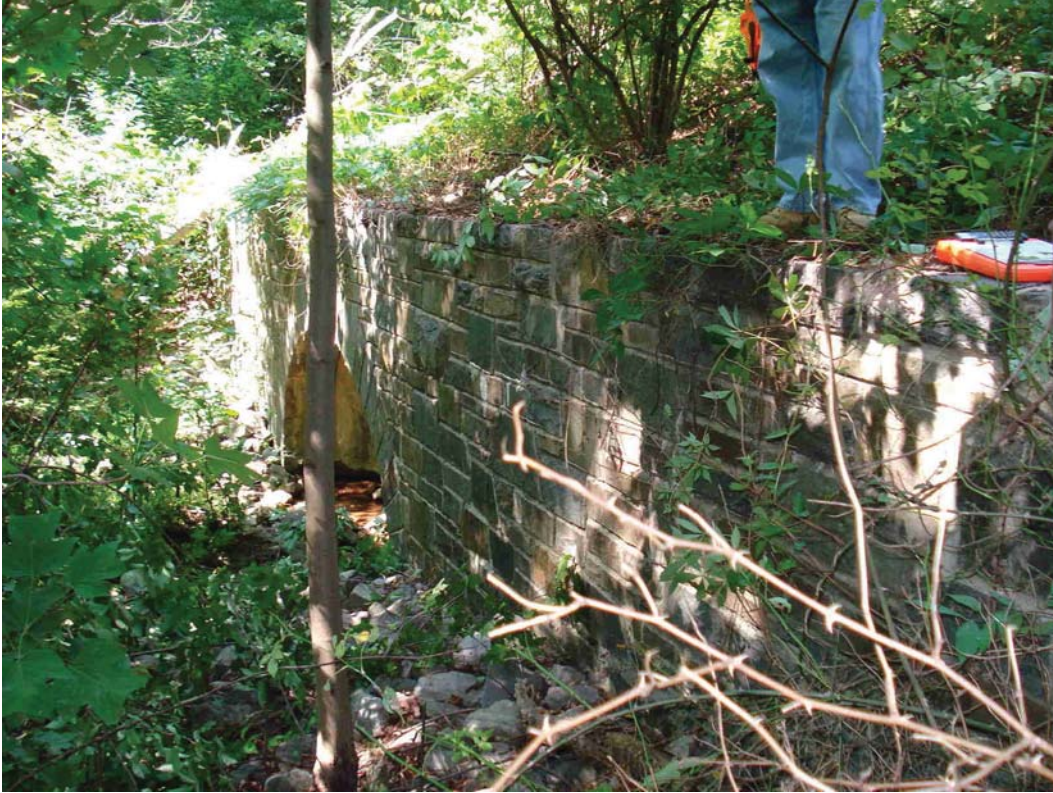
BAWA_0002_0.779_L_1.JPG

Wall ID:	BAWA-0002-0.779-L		
Route Name:	BALTIMORE-WASHINGTON PARKWAY (SB)		
Inspection Date:	August 14, 2007	Approximate Year Built:	1965
*Wall Rating:	84	Maintenance Action:	Maintenance
Wall Description			
Wall Function:	Head Wall	Primary Wall Type:	Gravity - Mortared Stone
Surface Treatment:		Secondary Wall Type:	
Secondary Surface Treatment:		Architectural Facing:	
General Description:	Stone masonry inlet headwall for a 4 ft x 8 ft concrete arch culvert constructed along left shoulder and along base of gently sloping embankment supporting a high ADT roadway low consequence failure		
Wall Measurements			
Wall Length (ft.):	26	Face Area (sq.):	159
Average Wall Height (ft.):	6	Face Angle (deg.):	90
Maximum Wall Height (ft.):	9	Vertical Offset (ft.):	-5
Assessed Elements			
Element (Weighting Factor)	Narrative	Condition Rating (0 - 10)	
PERFORMANCE 8.00	Good condition; there is an approximate 2-in. annulus between the headwall and the culvert resulting from the cracking and spalling of mortar	7

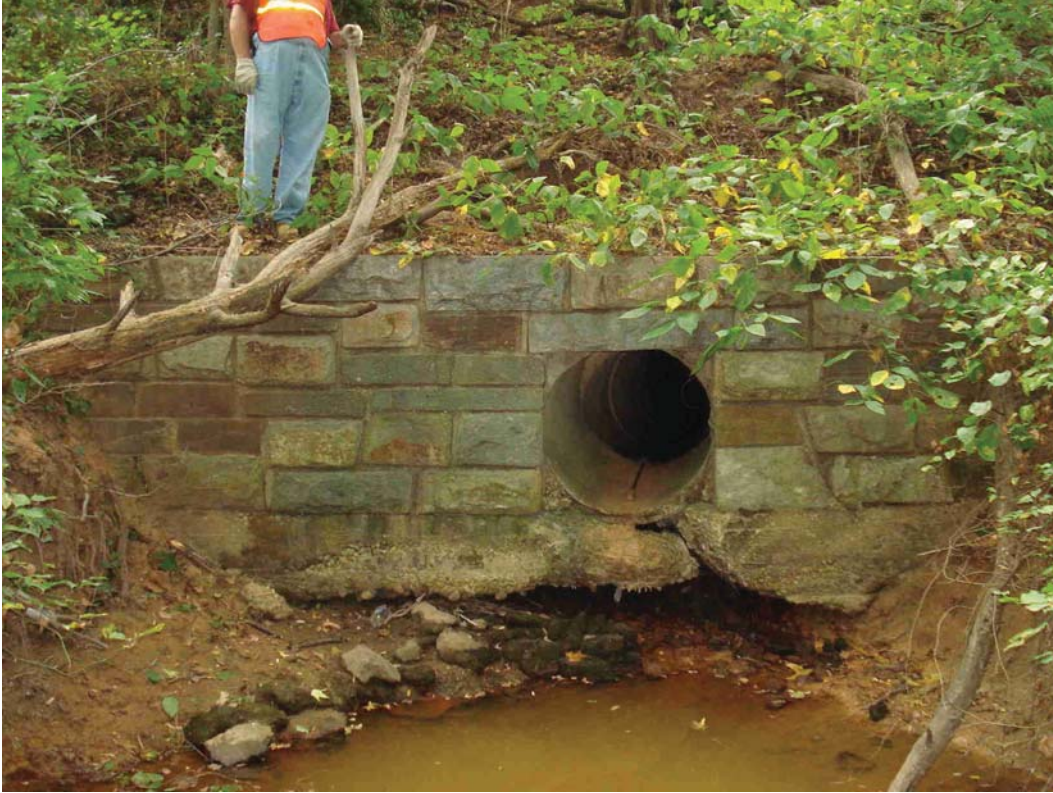
BAWA_0002_17.106_R_1.jpg

Wall Identification	Failure Consequence⁽¹⁾	Wall Rating⁽²⁾	Recommended Action⁽³⁾	2007 Repair Costs⁽⁴⁾
BAWA-0002-17.106-R	LOW	43	REPAIR ELEMENTS	\$125,585

Wall ID Inspection Date:	Wall Area (Sq. Ft.)	Wall Length (Ft.)	Wall Type	Wall Function	Overall Rating	Repair Cost
BAWA-0002-17.106-R 8/16/2007	103	20	Gravity - Mortared Stone	Head Wall	43	\$125,585.00
