# BISO WIP Report

## NPS Retaining Wall Inventory Program Big South Fork National River and Recreation Area

**Federal Highway Administration  
Eastern Federal Lands Highway Division  
Road Inventory Program (RIP)**

**Data Collection Date: September 2007  
Report Date: October 2015**

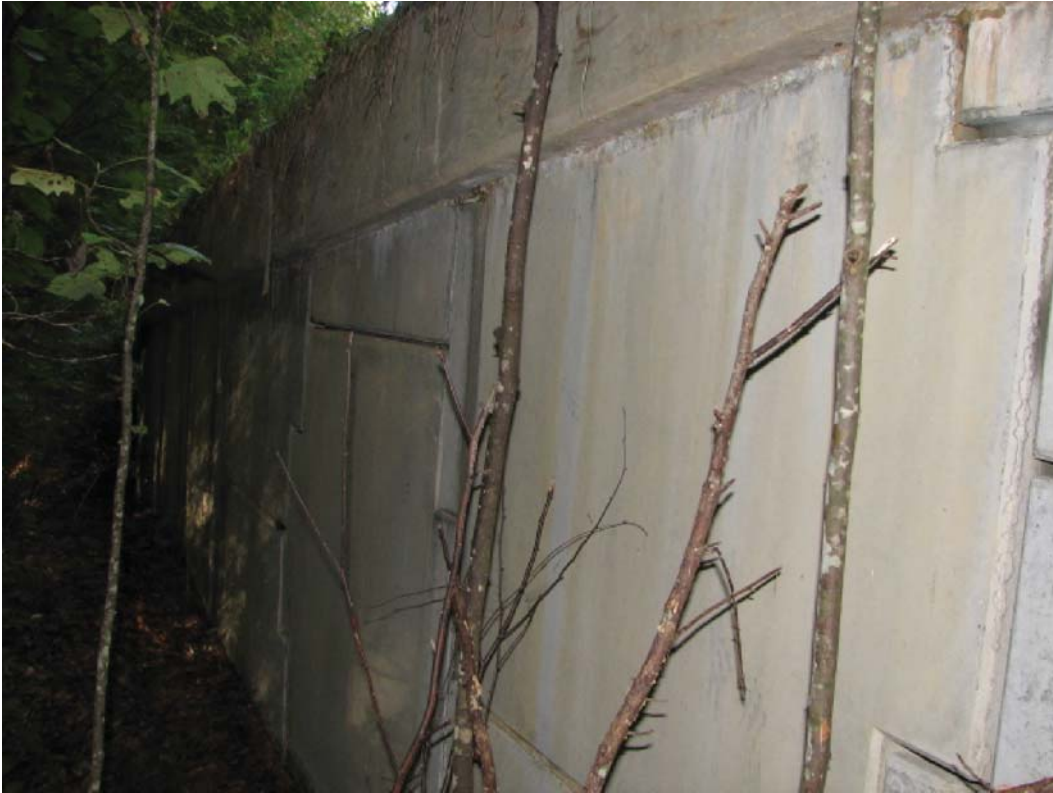
BISO\_0010\_1.460\_L\_1.jpg

| <b>Element<br/>(Weighting Factor)</b> | <b>Narrative</b> | <b>Condition Rating<br/>(0 - 10)</b> |
|---|---|---|
| WALL FOUNDATION MATERIAL<br>8.00 | Leaf litter covered firm soil. | 9 |
| WIRE/GEOSYNTHETIC FACING<br>8.00 | No distress observed. | 9 |

| <b>Recommendation Narrative:</b> | None |

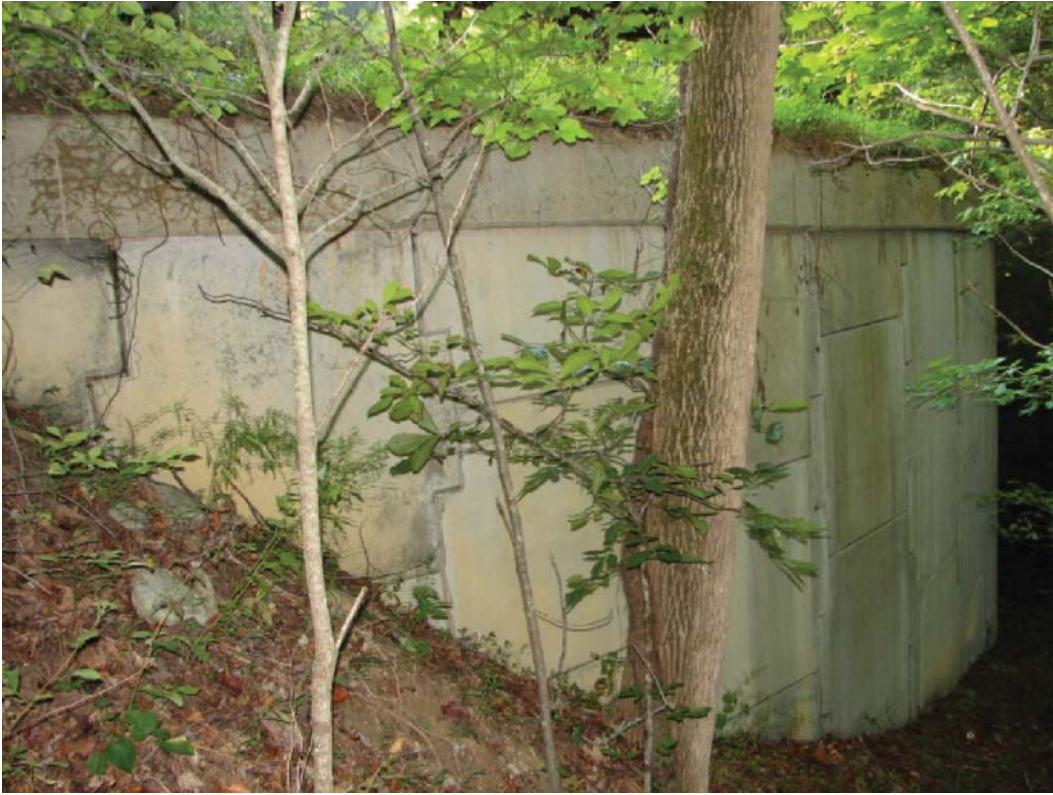
**BISO\_0010\_1.817\_R\_1.jpg**

| <b>Element<br/>(Weighting Factor)</b> | <b>Narrative</b> | <b>Condition Rating<br/>(0 - 10)</b> |
|---|---|---|
| WALL FOUNDATION MATERIAL<br>8.00 | Leaf covered firm soil. | 9 |

| <b>Recommendation Narrative:</b> | None |

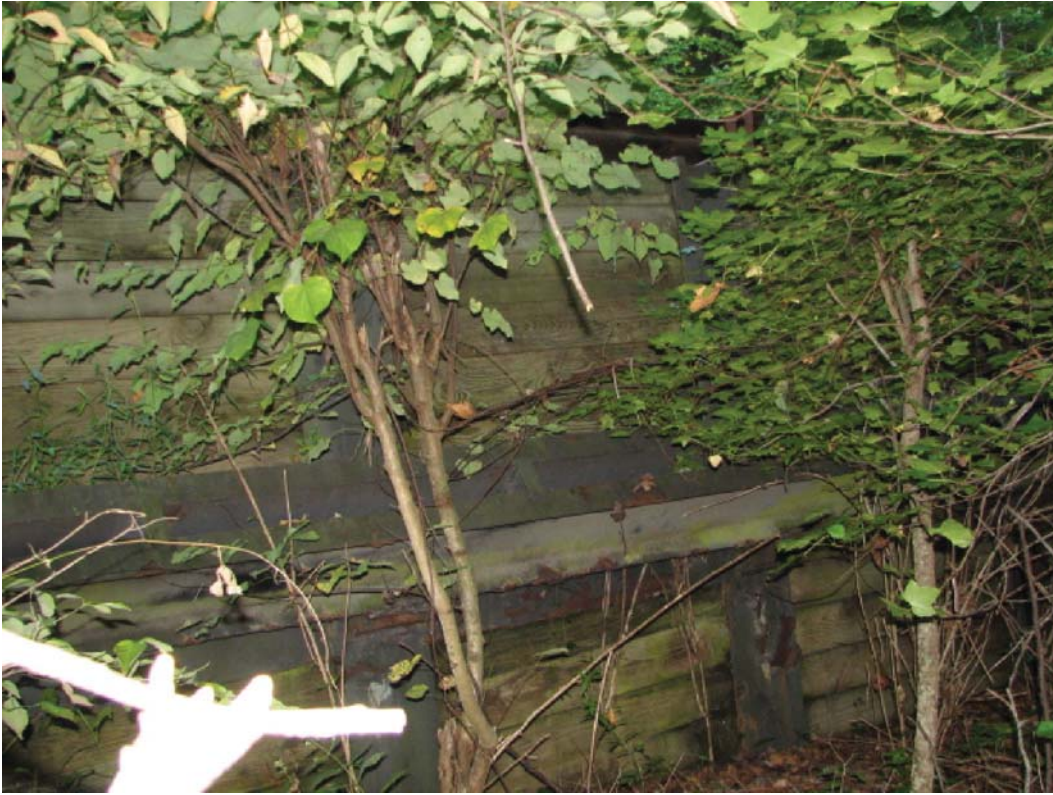
BISO\_0010\_1.949\_R\_1.jpg

| Element<br>(Weighting Factor) | Narrative | Condition Rating<br>(0 - 10) |
|---|---|---|
| PILES AND SHAFTS<br>8.00 | Painted steel H pile section. Paint is peeling, exposed steel has minor surface rust. | 7 |
| LAGGING<br>8.00 | Pressure treated wood lagging is in good condition. Minor surface weathering. | 8 |
| ROAD/SIDEWALK/SHOULDER<br>0.50 | Slight cracking in roadway - probably not related to wall movement. | 8 |

| <b>Recommendation Narrative:</b> | Remove vegetation from in front of wall. 2 laborers x 8 hours x \$55/hour = \$880. Remove paint and prepare surface for repainting - 27 piles x 6 ft tall x 1.2 ft wide = ~200 ft <sup>2</sup> + 19 anchor heads x 2 ft <sup>2</sup> = 38 ft <sup>2</sup> + 140 feet of waler x [Front of waler |

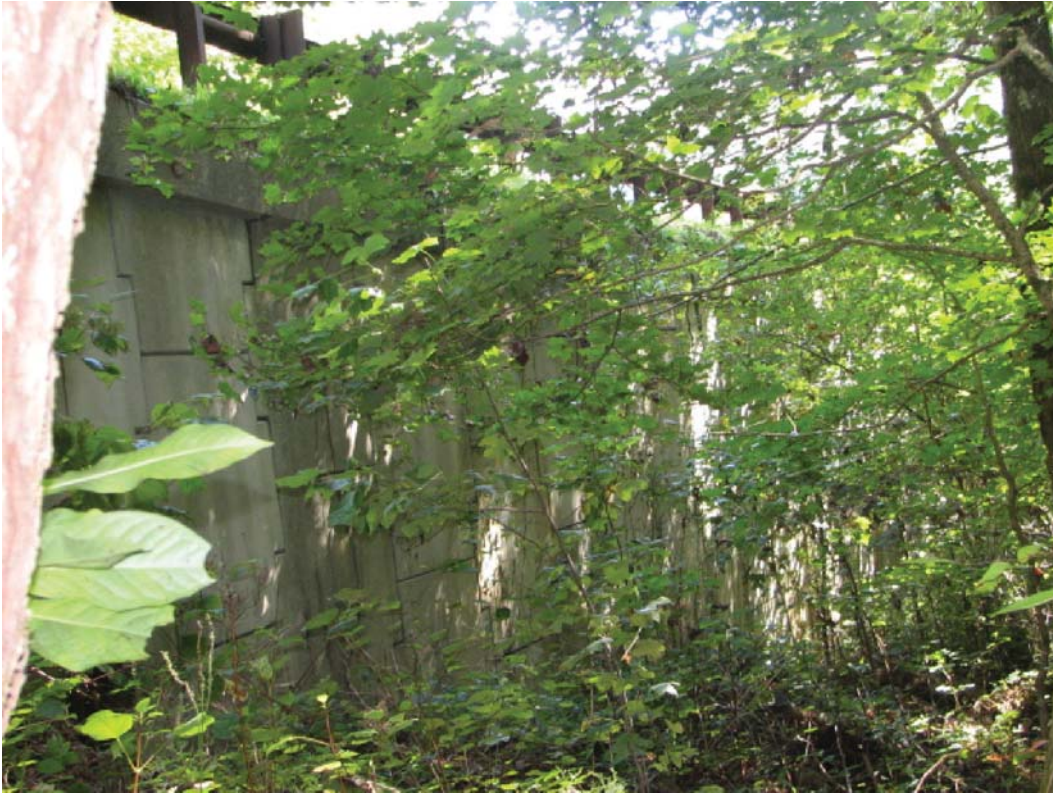
BISO\_0010\_2.385\_L\_1.jpg

| <b>Element<br/>(Weighting Factor)</b> | <b>Narrative</b> | <b>Condition Rating<br/>(0 - 10)</b> |
|---|--|---|
| WALL FOUNDATION MATERIAL<br>8.00 | Firm soil. | 9 |
| WIRE/GEOSYNTHETIC FACING<br>8.00 | No distress observed. | 9 |

| <b>Recommendation Narrative:</b> | None |

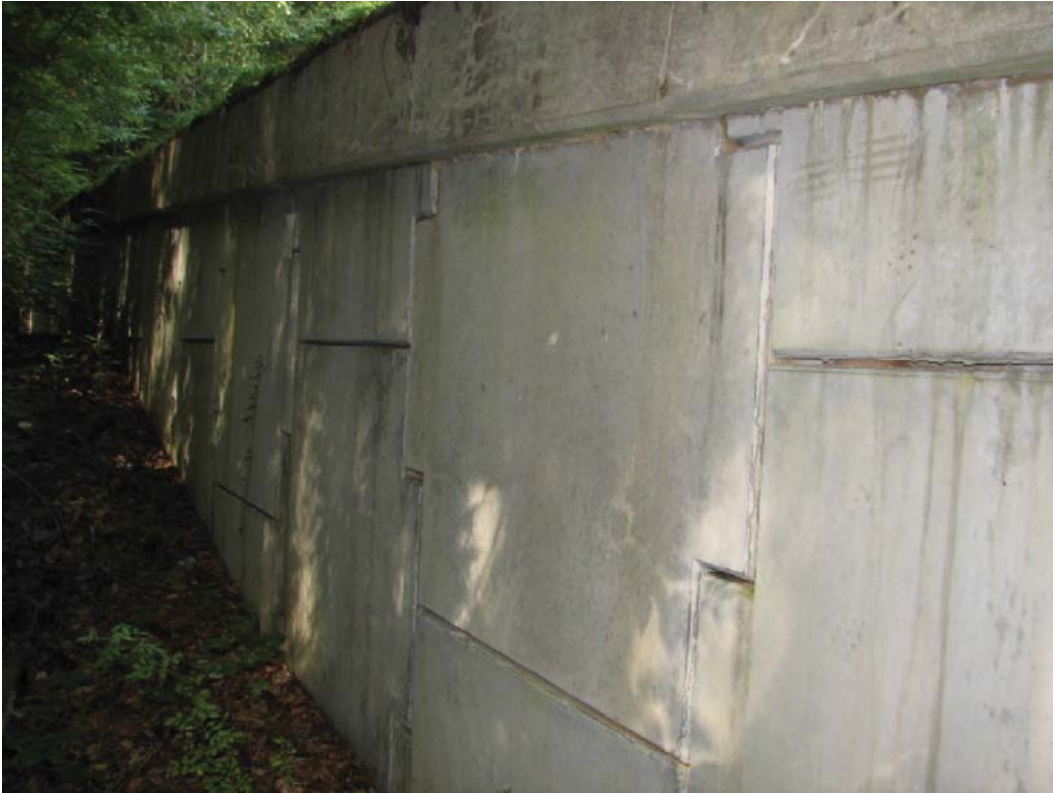
BISO\_0010\_2.514\_L\_1.jpg

| <b>Element<br/>(Weighting Factor)</b> | <b>Narrative</b> | <b>Condition Rating<br/>(0 - 10)</b> |
|---|---|---|
| WALL FOUNDATION MATERIAL<br>8.00 | Roadway embankment fill. | 9 |

| <b>Recommendation<br/>Narrative:</b> | None |

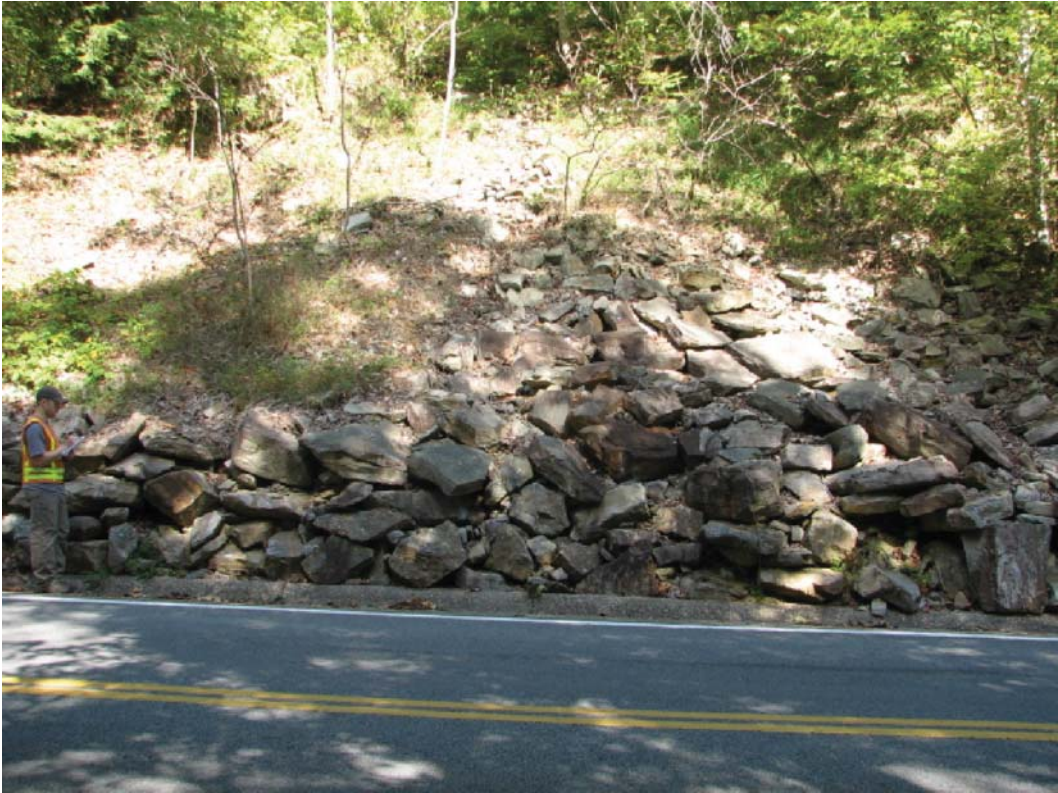
BISO\_0010\_2.514\_R\_1.jpg

| <b>Element<br/>(Weighting Factor)</b> | <b>Narrative</b> | <b>Condition Rating<br/>(0 - 10)</b> |
|---|--|---|
| WALL FOUNDATION MATERIAL<br>8.00 | Firm soil. | 9 |

| <b>Recommendation Narrative:</b> | None |

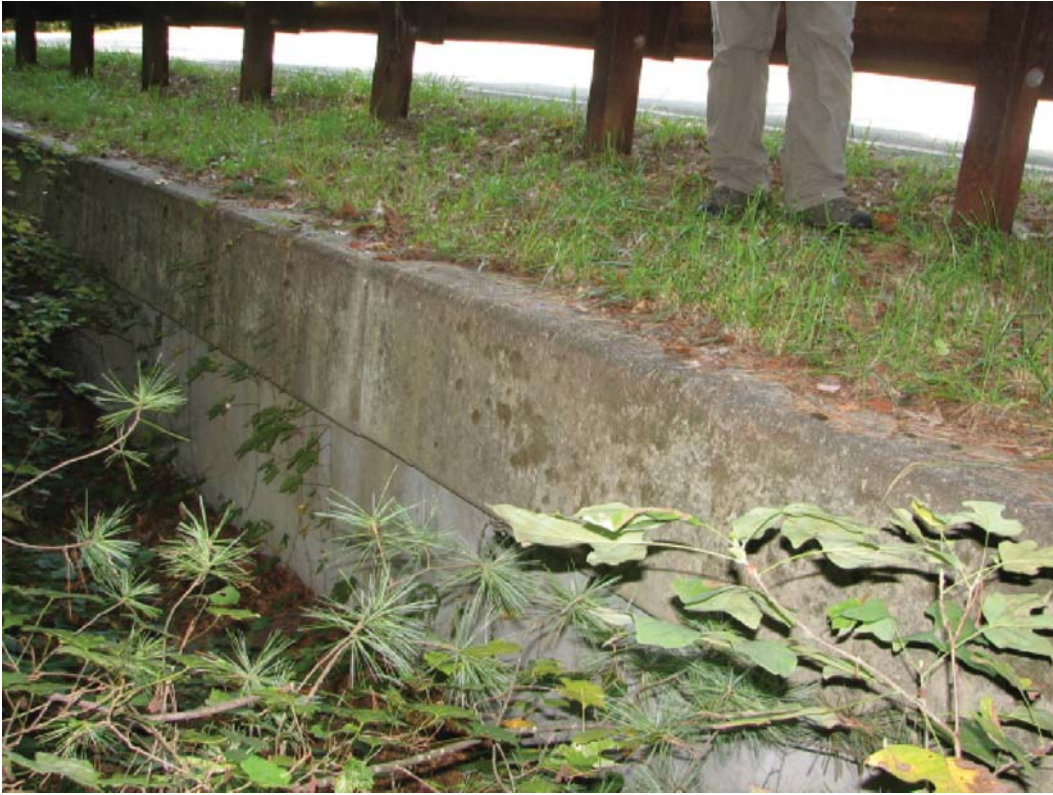
BISO\_0101\_0.420\_R\_1.jpg

| <b>Element<br/>(Weighting Factor)</b> | <b>Narrative</b> | <b>Condition Rating<br/>(0 - 10)</b> |
|---|---|---|
| WALL FOUNDATION MATERIAL<br>8.00 | Forest duff over firm soil. | 9 |

| <b>Recommendation Narrative:</b> | None |

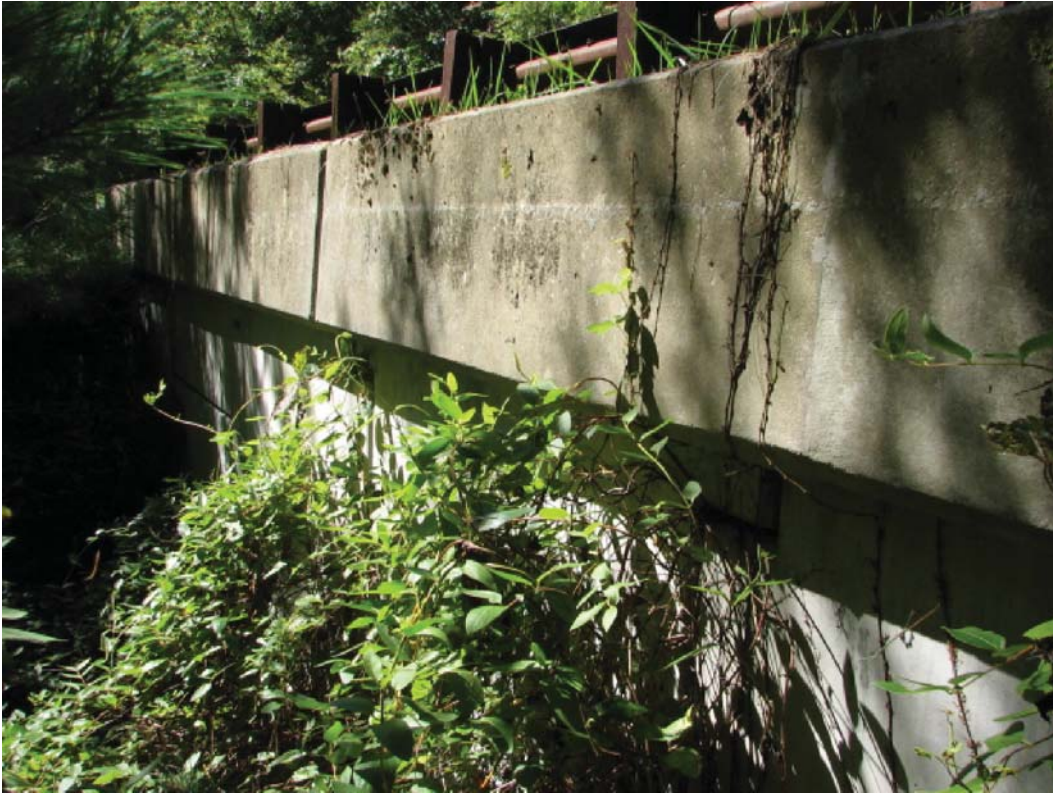
BISO\_0101\_0.457\_R\_1.jpg

| <b>Element<br/>(Weighting Factor)</b> | <b>Narrative</b> | <b>Condition Rating<br/>(0 - 10)</b> |
|---|---|---|
| WALL FOUNDATION MATERIAL<br>8.00 | Firm soil under forest duff. | 9 |

| <b>Recommendation Narrative:</b> | None |

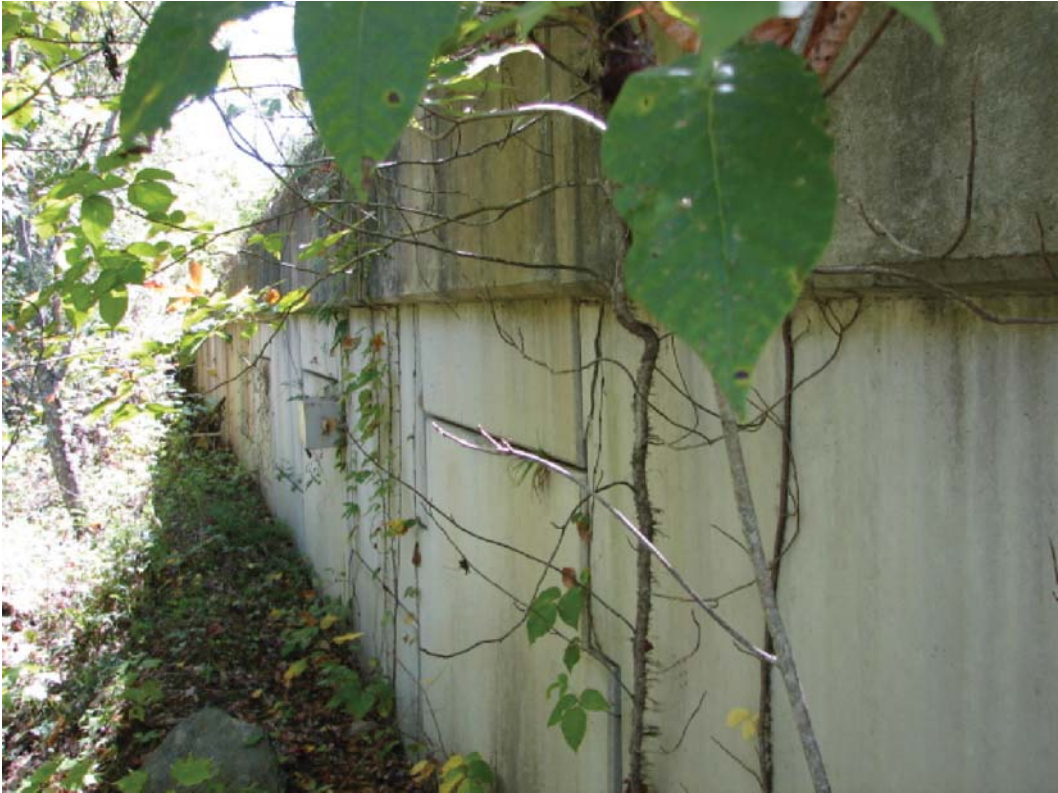
BISO\_0117\_1.430\_R\_1.jpg

| <b>Element<br/>(Weighting Factor)</b> | <b>Narrative</b> | <b>Condition Rating<br/>(0 - 10)</b> |
|---|---|---|
| WALL FOUNDATION MATERIAL<br>8.00 | Firm gravel | 9 |
| DOWNSLOPE<br>0.50 | Mix of forested slope and cliff outcrops, no creep observed | 8 |
| ROAD/SIDEWALK/SHOULDER<br>0.50 | Road is in good condition - As new, no cracks observed | 9 |

| <b>Recommendation Narrative:</b> | Use herbicide to remove vines and vegetation from between the panels on the wall face. Labor (4 hours) @ \$55 hr = \$220 |

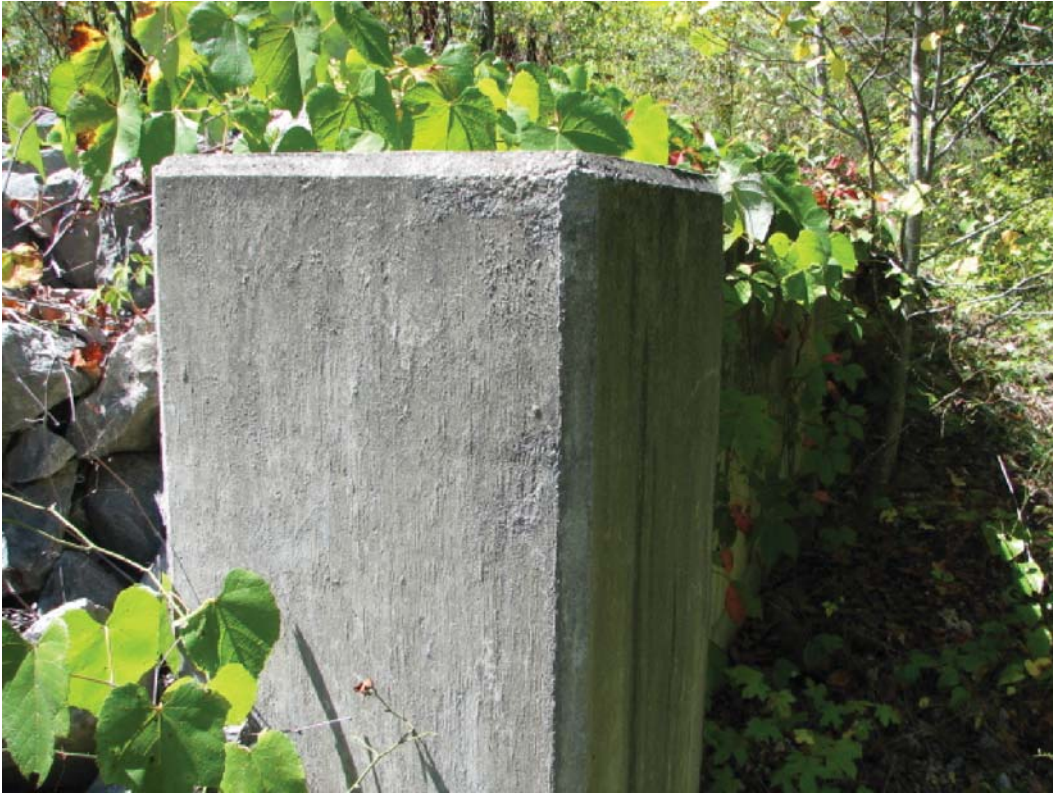
BISO\_0117\_1.578\_R\_1.jpg

| <b>Element<br/>(Weighting Factor)</b> | <b>Narrative</b> | <b>Condition Rating<br/>(0 - 10)</b> |
|---|---|---|
| WALL FOUNDATION MATERIAL<br>8.00 | Firm Gravel | 9 |

| <b>Recommendation Narrative:</b> | None |

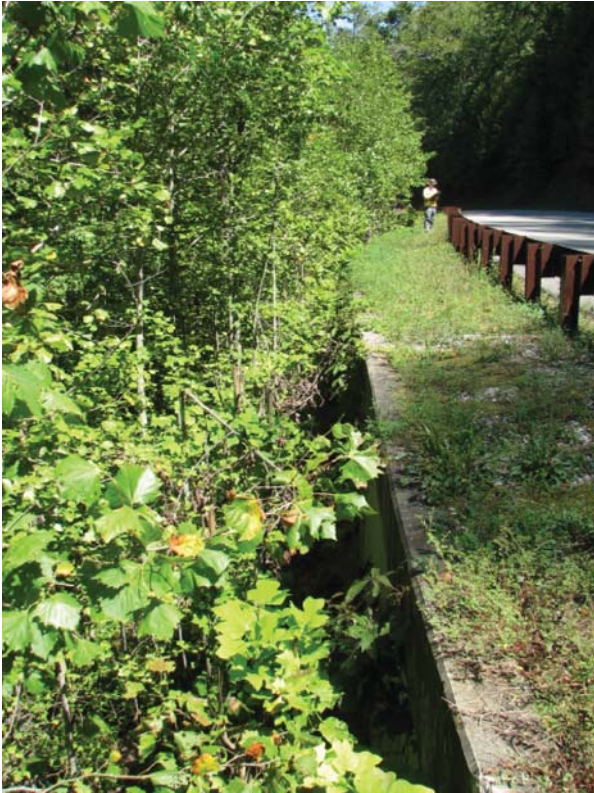
BISO\_0117\_1.668\_R\_1.jpg

| <b>Element<br/>(Weighting Factor)</b> | <b>Narrative</b> | <b>Condition Rating<br/>(0 - 10)</b> |
|---|---|---|
| WALL FOUNDATION MATERIAL<br>8.00 | Firm, gravel soil | 9 |

| <b>Recommendation Narrative:</b> | None |

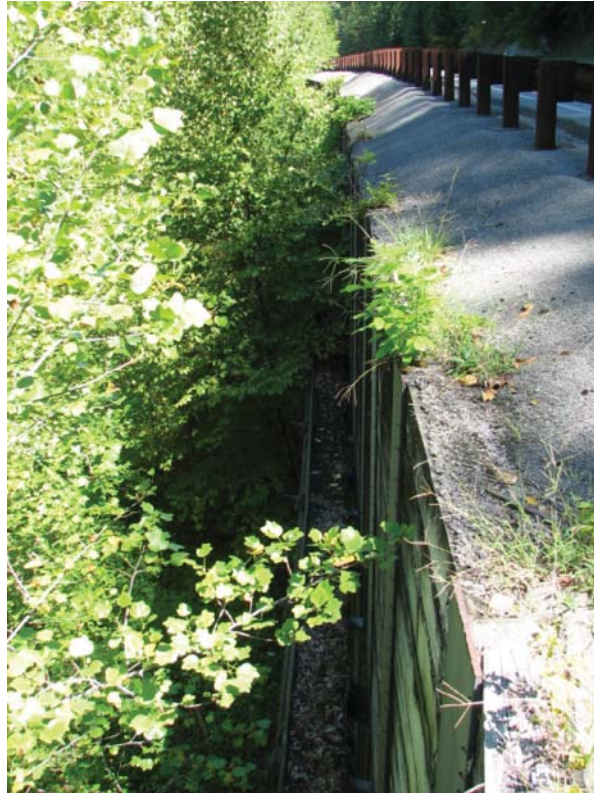
BISO\_0117\_1.772\_R\_1.jpg

| <b>Element<br/>(Weighting Factor)</b> | <b>Narrative</b> | <b>Condition Rating<br/>(0 - 10)</b> |
|---|--|---|
| WALL FOUNDATION MATERIAL<br>8.00 | Firm soil | 9 |
| ANCHOR HEADS<br>8.00 | Surface rust, good condition | 8 |
| LAGGING<br>8.00 | Weathered surface, good condition | 8 |
| PILES AND SHAFTS<br>8.00 | Surface pitting, good condition | 8 |

| <b>Recommendation Narrative:</b> | None |

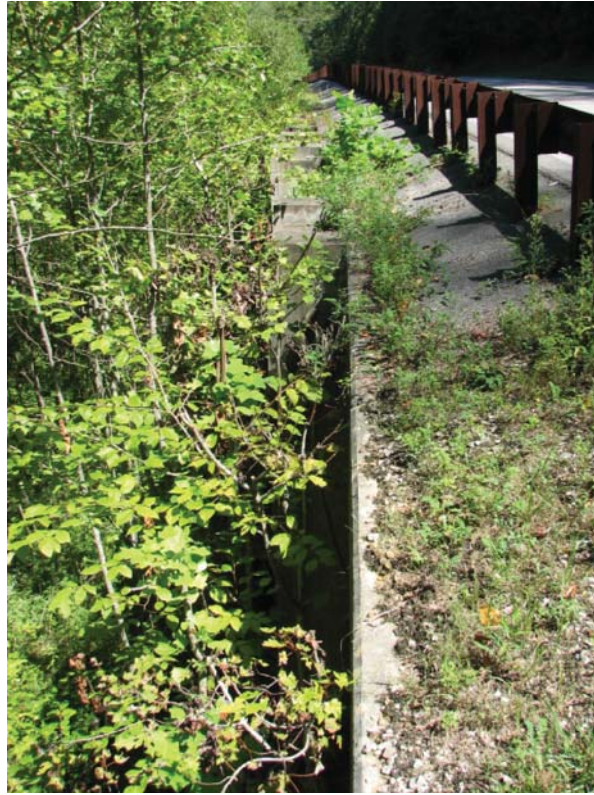
BISO\_0117\_1.818\_R\_1.jpg

| <b>Element<br/>(Weighting Factor)</b> | <b>Narrative</b> | <b>Condition Rating<br/>(0 - 10)</b> |
|---|---|---|
| WALL FOUNDATION MATERIAL<br>8.00 | Firm soil | 9 |
| ANCHOR HEADS<br>8.00 | Slight surface rust | 9 |

| <b>Recommendation Narrative:</b> | None |

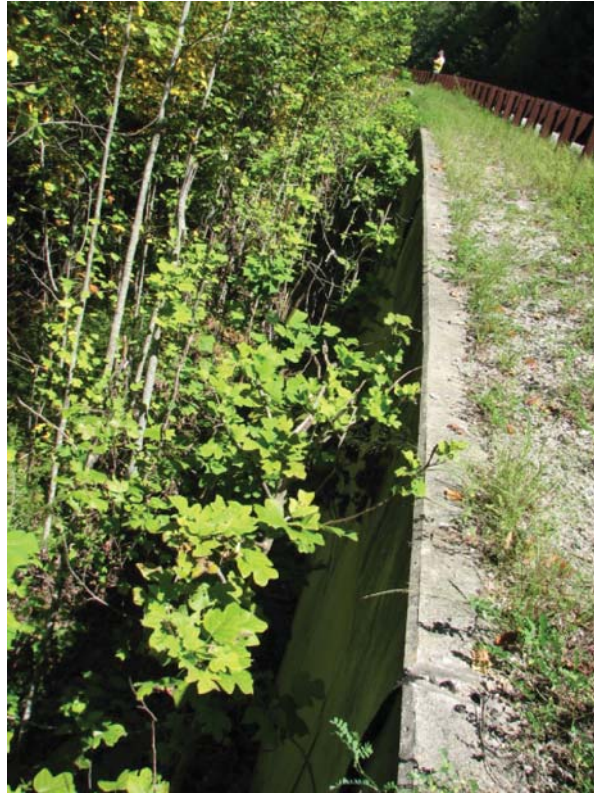
BISO\_0117\_1.830\_R\_1.jpg

| <b>Element<br/>(Weighting Factor)</b> | <b>Narrative</b> | <b>Condition Rating<br/>(0 - 10)</b> |
|---|--|---|
| WALL FOUNDATION MATERIAL<br>8.00 | Firm soil | 9 |

| <b>Recommendation Narrative:</b> | None |

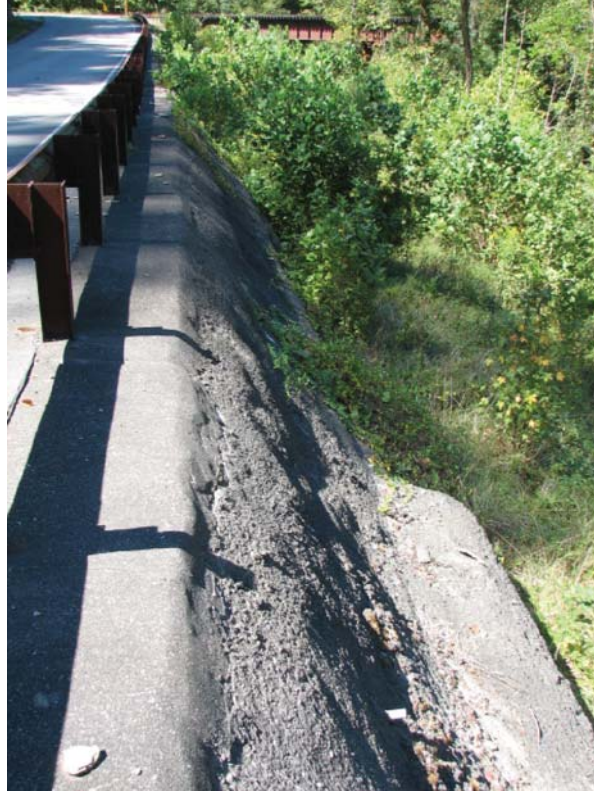
BISO\_0117\_2.245\_R\_1.jpg

| <b>Element<br/>(Weighting Factor)</b> | <b>Narrative</b> | <b>Condition Rating<br/>(0 - 10)</b> |
|---|--|---|
| ARCHITECTURAL FACING<br>1.00 | Shotcrete - minor cracking. | 7 |

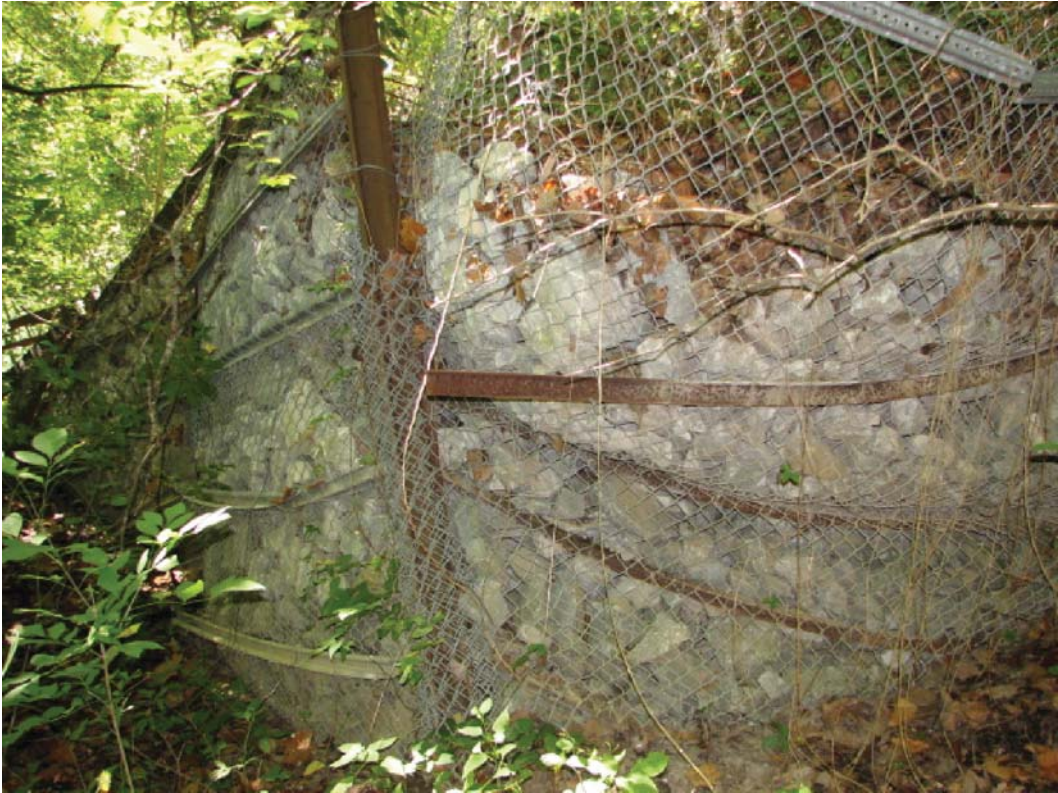
BISO\_0122\_0.028\_R\_1.jpg

| <b>Wall Identification</b> | <b>Failure Consequence<sup>(1)</sup></b> | <b>Wall Rating<sup>(2)</sup></b> | <b>Recommended Action<sup>(3)</sup></b> | <b>2007 Repair Costs<sup>(4)</sup></b> |
|---|--|---|---|--|
| BISO-0122-0.028-R | HIGH | 49 | REPLACE WALL | \$112,500 |
