BRCA WIP Report

NPS Retaining Wall Inventory Program Bryce Canyon National Park

Data Collection Date: April 2007
Report Date: October 2015

Bryce Canyon National Park in Utah

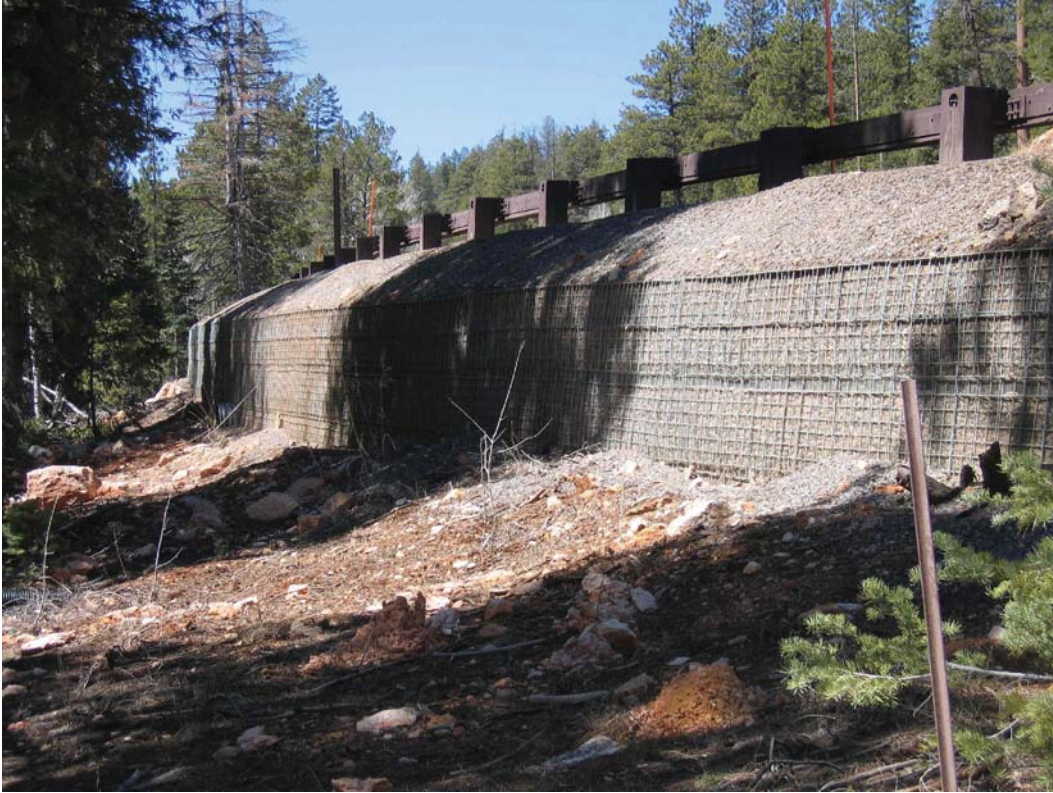
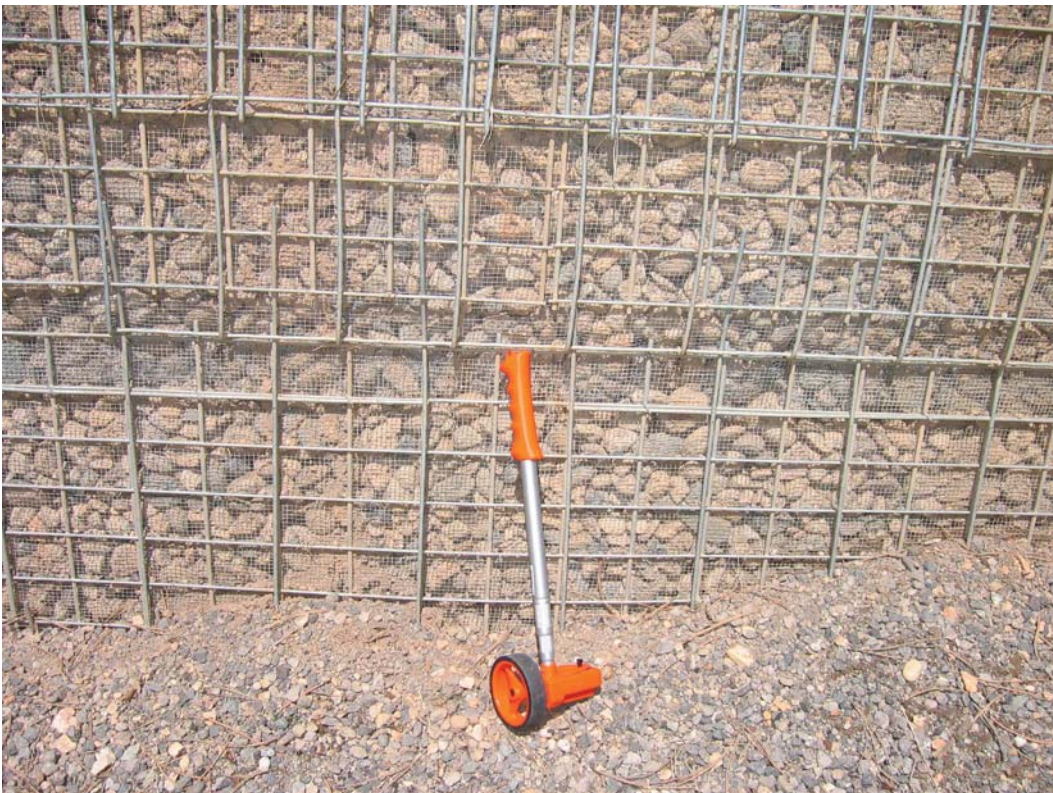
Element (Weighting Factor)	Narrative	Condition Rating (0 - 10)
PERFORMANCE 8.00	Performing as a new construction - no signs of any distress.	9
WALL FOUNDATION MATERIAL 8.00	No signs of distress. Good foundation soils.	9
WIRE/GEOSYNTHETIC FACING 8.00	No signs of corrosion. Facing wires are bulging in some locations due to basket settlement and wires loading each other. Wall face functioning well despite this construction flaw.	9
TRAFFIC BARRIER/FENCE 0.50	No signs of wall-related distress.	9
WALL DRAINS 0.50	Drains are present throughout the wall, and are all functioning as intended.	9
CURB/BERM/DITCH 0.50	Concrete curb shows no signs of cracking or displacement - looks like new.	10
DOWNSLOPE 0.50	Gentle downslope showing no signs of distress. No slope supporting vegetation (recent construction).	10
LATERAL SLOPE 0.50	No signs of any distress.	10
ROAD/SIDEWALK/SHOULDER 0.50	New condition, showing no cracking or other signs of distress.	10

Failure Consequence:	HIGH
Recommendation Narrative:	None
Repair Cost:	\$0

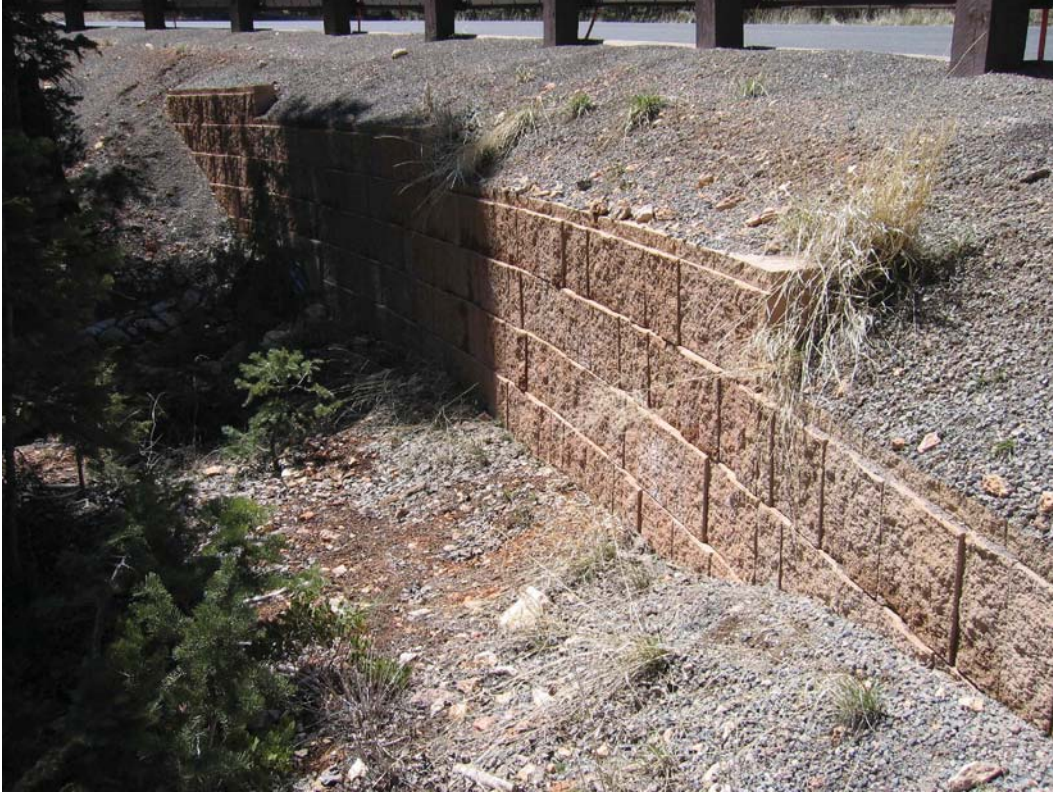
BRCA_0010_7.260_L_1.jpg

Element (Weighting Factor)	Narrative	Condition Rating (0 - 10)
PERFORMANCE 8.00	Wall is like new - functioning as intended.	10
WALL FOUNDATION MATERIAL 8.00	No signs of bulging, erosion, seepage - excellent condition.	9
MANUFACTURED BLOCK/BRICK 8.00	Blocks look like new, with no signs of distress.	10
CULVERT 0.50	Pipe and concrete headwall like new, showing no signs of distress.	10
DOWNSLOPE 0.50	Gentle, well-vegetated slope, showing no signs of distress.	10
LATERAL SLOPE 0.50	No signs of distress.	10
ROAD/SIDEWALK/SHOULDER 0.50	New condition, showing no cracking or other signs of distress.	10
TRAFFIC BARRIER/FENCE 0.50	Wood guardrail shows no signs of wall-related distress (like new).	10
WALL DRAINS 0.50	Regular drainage noted - functioning like new.	10

Failure Consequence:	HIGH
Recommendation Narrative:	None
Repair Cost:	\$0

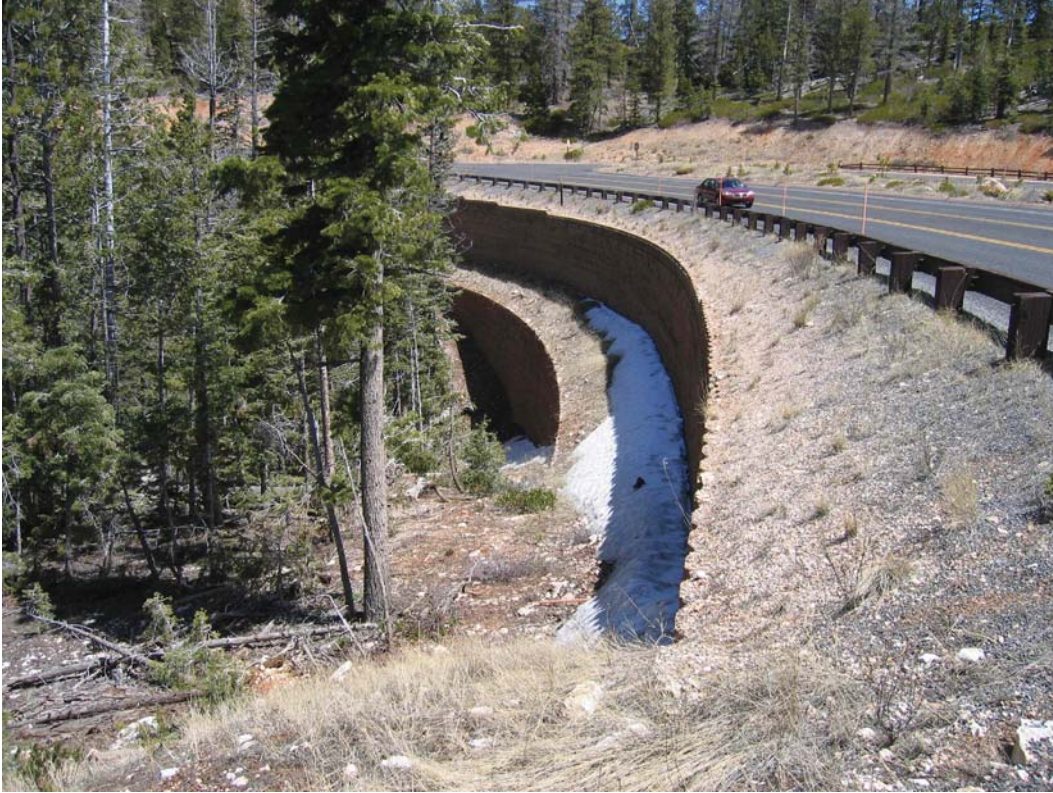
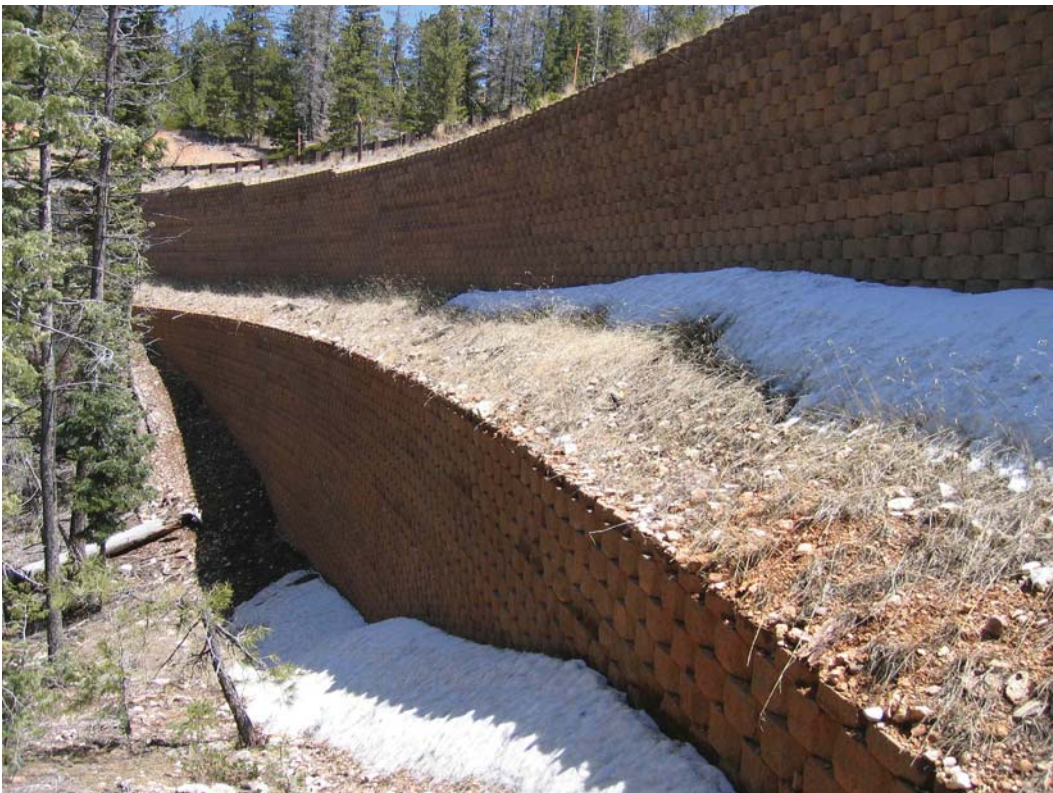
Element (Weighting Factor)	Narrative	Condition Rating (0 - 10)
PERFORMANCE 8.00	Wall looks new, with no signs of element or global distress.	10
WALL FOUNDATION MATERIAL 8.00	No signs of distress on either tier of the wall.	9
MANUFACTURED BLOCK/BRICK 8.00	In excellent, like-new condition, showing no signs of weathering, cracking, or displacement.	10
TRAFFIC BARRIER/FENCE 0.50	No wall-related distress.	8
DOWNSLOPE 0.50	Well-vegetated downslope showing no signs of erosion or slumping.	9
ROAD/SIDEWALK/SHOULDER 0.50	No signs of distress in the roadway.	9
CULVERT 0.50	Performing as intended, with no signs of seepage around the pipe, erosion below the outlet, or displacement of the pipe due to wall settlement.	10
CURB/BERM/DITCH 0.50	Colored concrete curb looks new - showing no signs of cracking or displacement.	10
LATERAL SLOPE 0.50	No signs of distress. Fully intact slope, well-vegetated.	10

Failure Consequence:	HIGH
Recommendation Narrative:	None
Repair Cost:	\$0

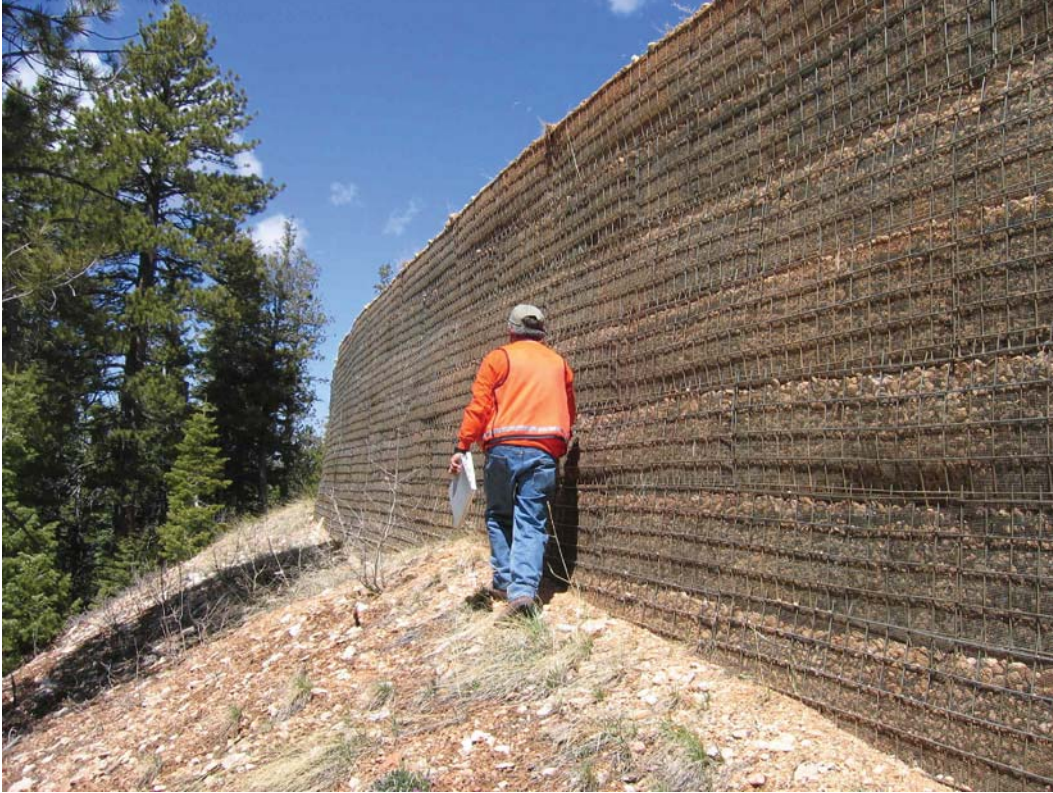
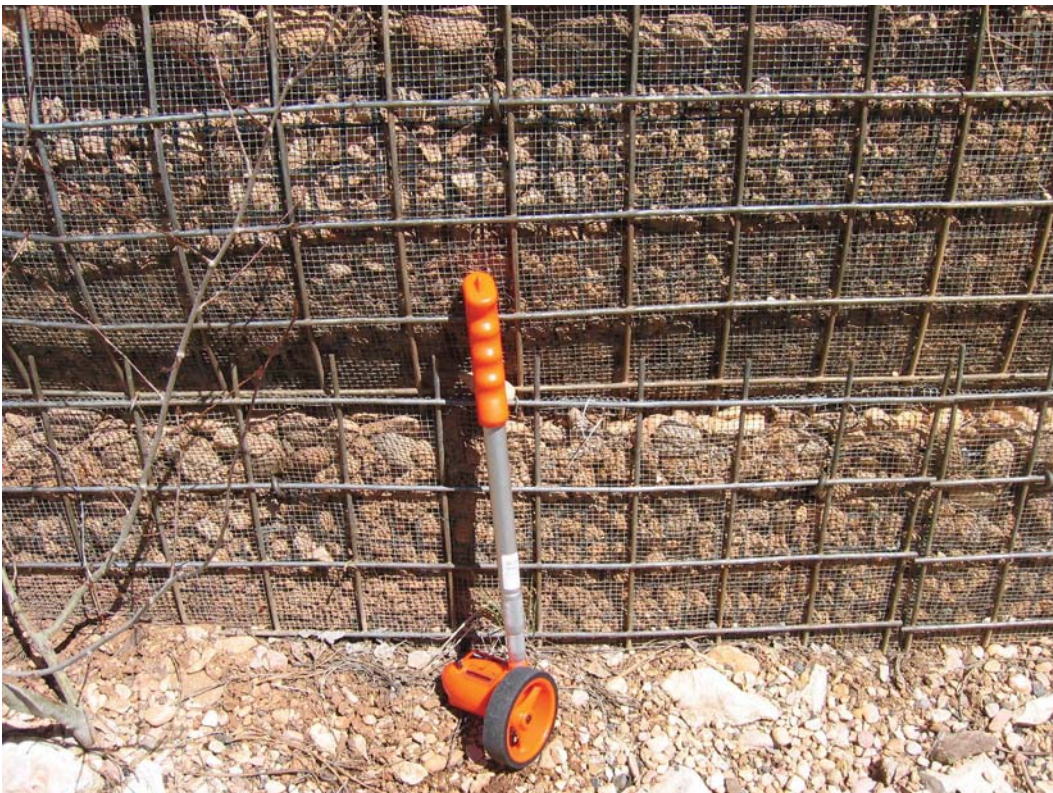
Element (Weighting Factor)	Narrative	Condition Rating (0 - 10)
PERFORMANCE 8.00	Wall is performing as intended, showing no signs of global distress.	9
WALL FOUNDATION MATERIAL 8.00	No signs of distress. Foundation soils are intact.	9
WIRE/GEOSYNTHETIC FACING 8.00	No signs of wire corrosion or weathering of facing rock. Minor bulging of some baskets, but connectors and struts are all intact.	9
DOWNSLOPE 0.50	Gentle slope, moderately vegetated, showing no signs of distress.	8
LATERAL SLOPE 0.50	No signs of distress. Slopes are fully intact.	9
ROAD/SIDEWALK/SHOULDER 0.50	Recent chip seal, with no signs of cracking or distress.	9
TRAFFIC BARRIER/FENCE 0.50	No wall-related signs of distress in the timber guardrail.	9
WALL DRAINS 0.50	Performing as intended - no signs of distress.	9

Failure Consequence:	HIGH
Recommendation Narrative:	None
Repair Cost:	\$0

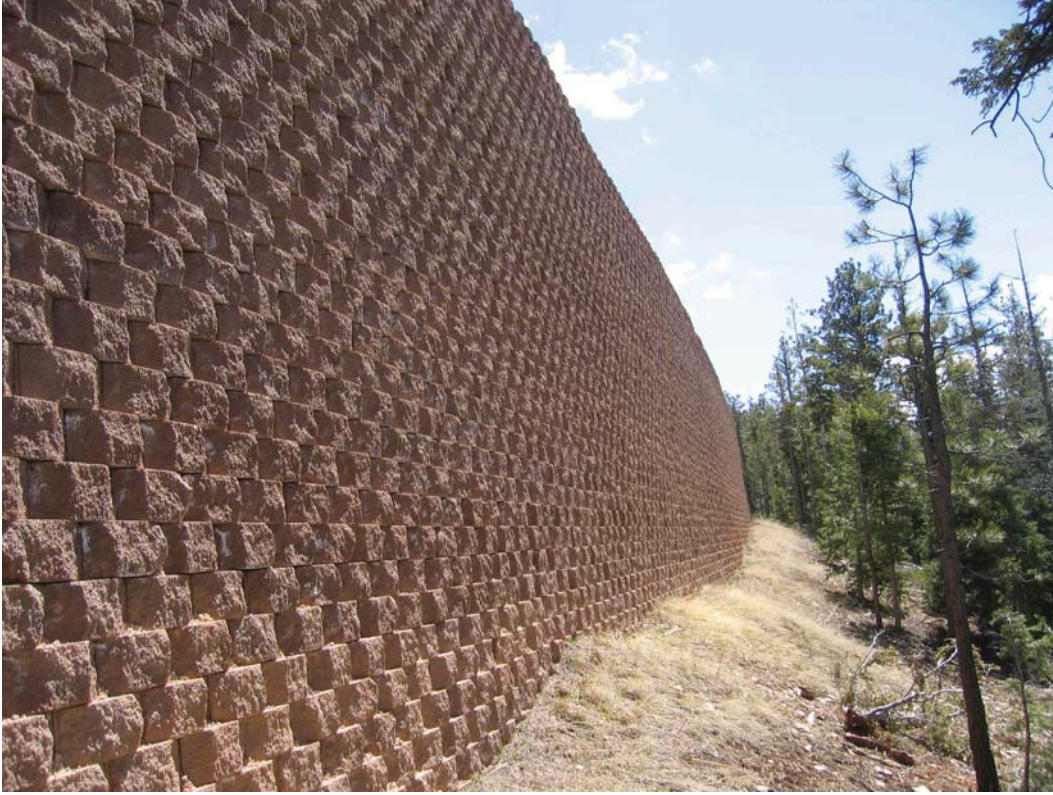
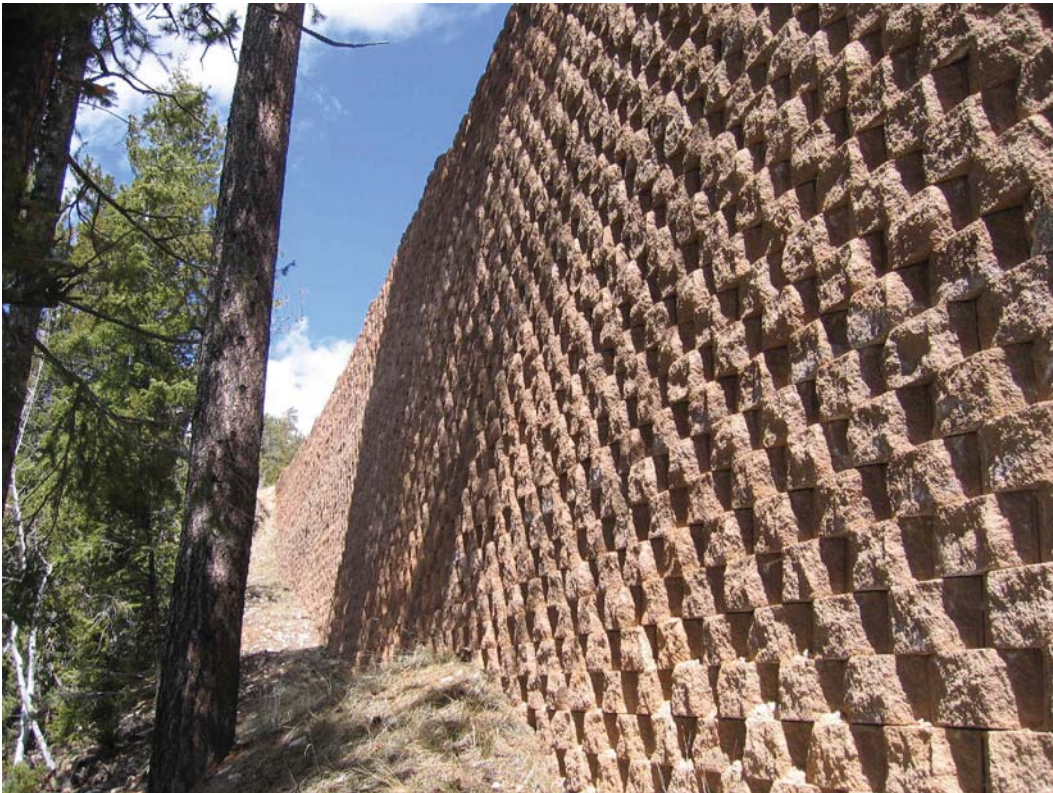
Element (Weighting Factor)	Narrative	Condition Rating (0 - 10)
PERFORMANCE 8.00	Wall is functioning as intended with no signs of element or global distress.	9
WALL FOUNDATION MATERIAL 8.00	No signs of distress. Modestly vegetated and fully intact.	9
MANUFACTURED BLOCK/BRICK 8.00	No significant signs of weathering or cracking. Minor bleaching of some cap pieces.	9
ROAD/SIDEWALK/SHOULDER 0.50	Recent chip seal. No signs of cracking or distress.	8
CURB/BERM/DITCH 0.50	Colored concrete curb shows no signs of cracking or displacement.	9
DOWNSLOPE 0.50	Gentle downslope with well-established vegetation.	9
LATERAL SLOPE 0.50	No signs of distress. No erosion.	9
TRAFFIC BARRIER/FENCE 0.50	No wall-related distress to the timber/stone barrier.	9
WALL DRAINS 0.50	Functioning as intended, with no signs of distress.	9

Failure Consequence:	HIGH
Recommendation Narrative:	None
Repair Cost:	\$0

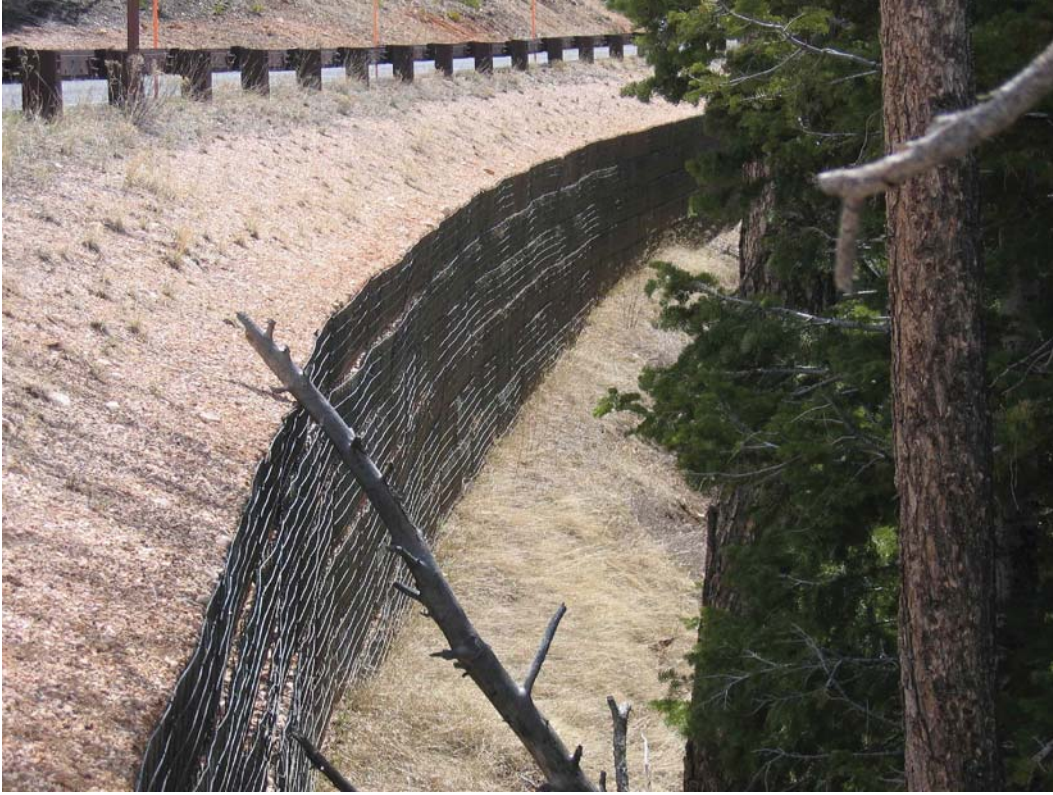
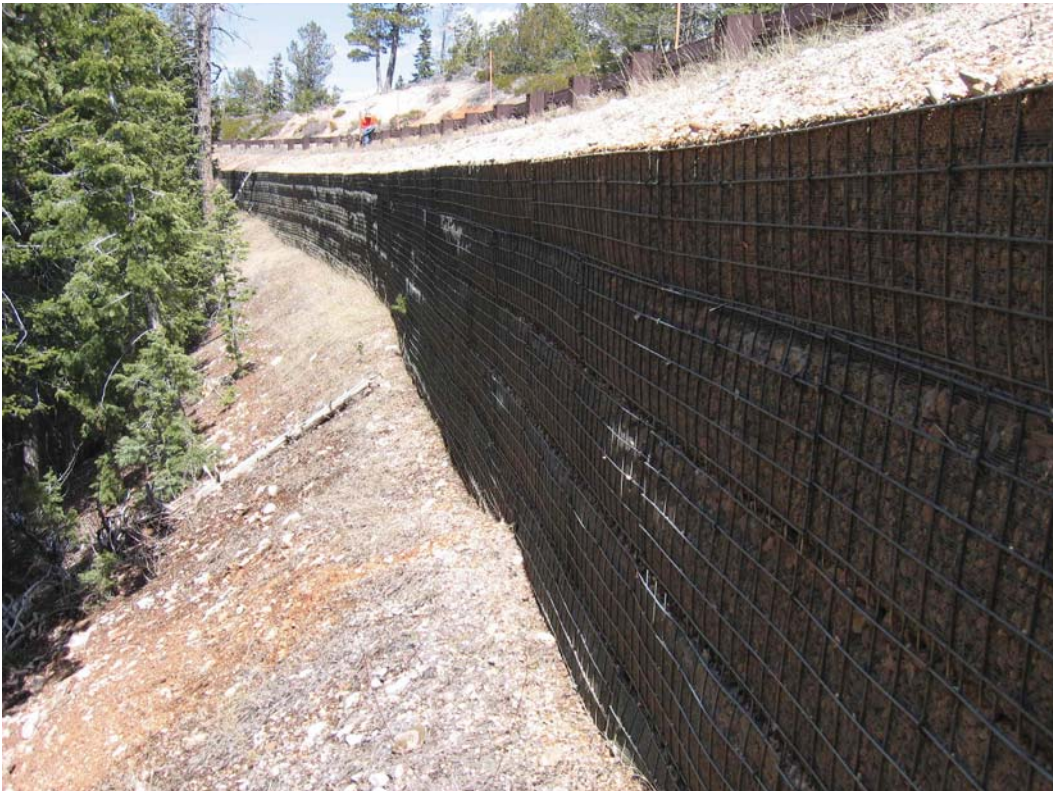
Element (Weighting Factor)	Narrative	Condition Rating (0 - 10)
PERFORMANCE 8.00	Wall performing as intended, with no signs of global distress.	9
WALL FOUNDATION MATERIAL 8.00	No signs of distress. Only minor isolated erosion occurring at wall face.	8
WIRE/GEOSYNTHETIC FACING 8.00	No signs of wire corrosion or face element bulging. Facing rock is fresh and intact, with no signs of material loss.	9
DOWNSLOPE 0.50	Moderate, stable slope, well-vegetated. Some minor signs of erosion.	8
ROAD/SIDEWALK/SHOULDER 0.50	Recent chip seal. No cracking or signs of distress.	8
CURB/BERM/DITCH 0.50	Colored concrete curb shows no signs of cracking or displacement.	9
LATERAL SLOPE 0.50	No signs of distress.	9
TRAFFIC BARRIER/FENCE 0.50	Guardrail shows no signs of wall-related distress.	9
WALL DRAINS 0.50	Appear to be functioning as intended, with no signs of distress.	9

Failure Consequence:	HIGH
Recommendation Narrative:	None
Repair Cost:	\$0

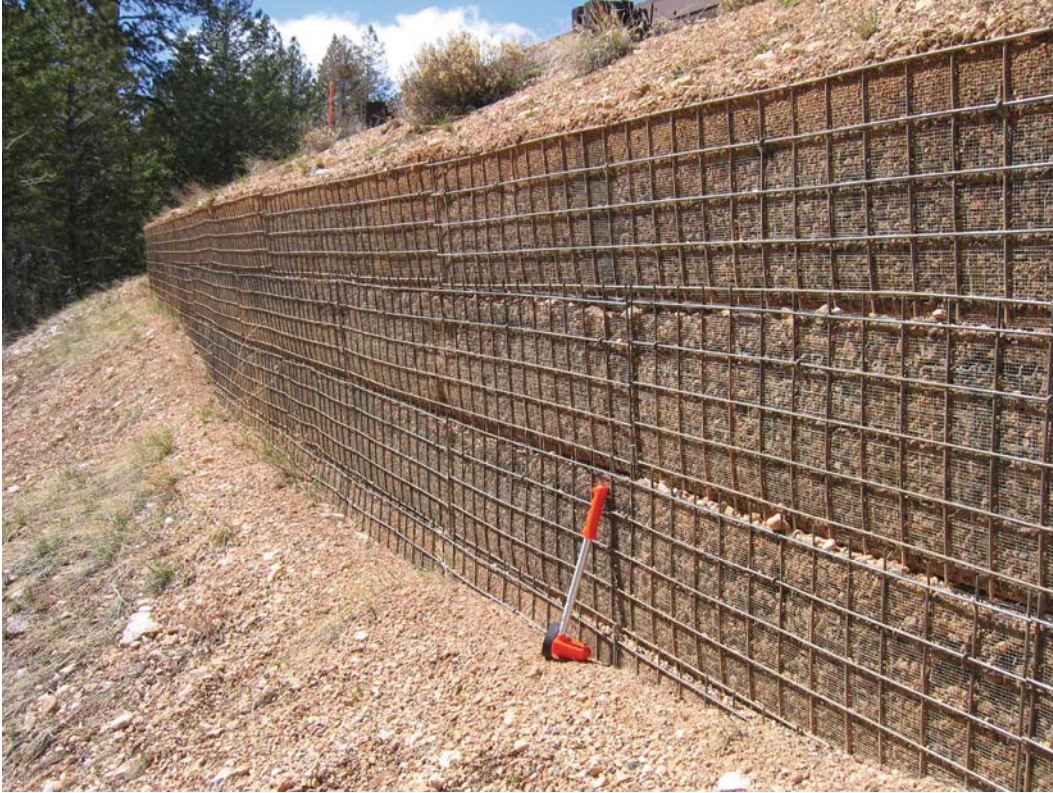
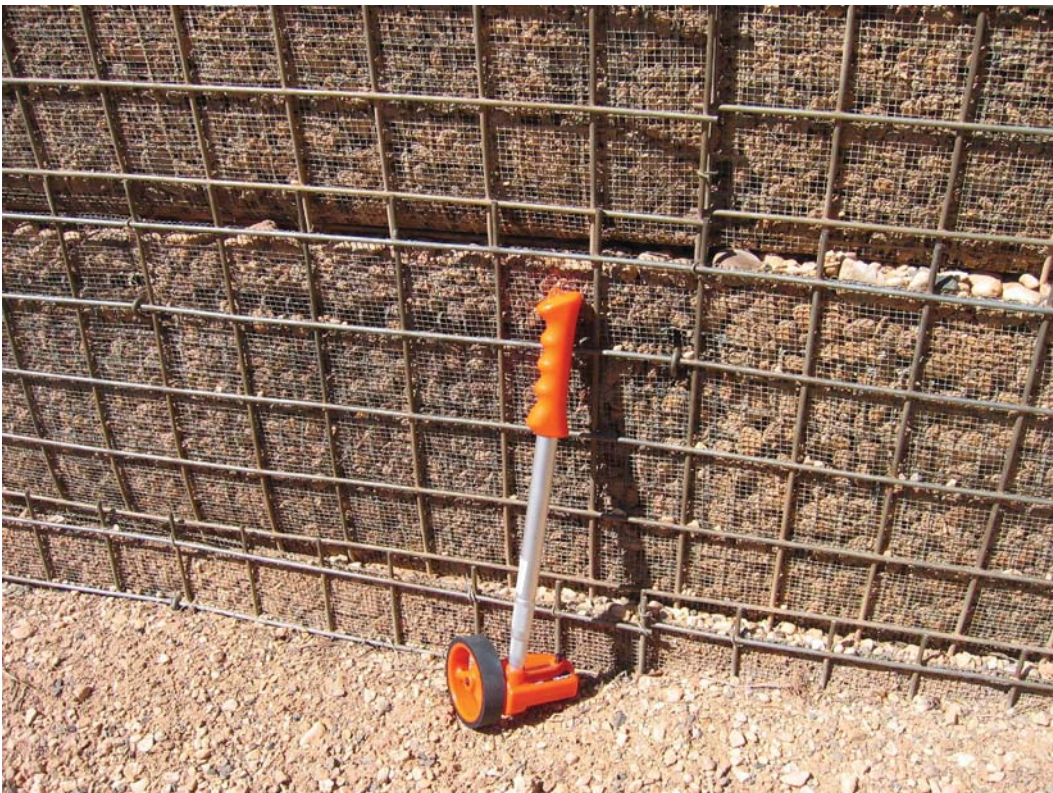
Element (Weighting Factor)	Narrative	Condition Rating (0 - 10)
PERFORMANCE 8.00	Wall is performing as intended with no signs of global distress.	9
WALL FOUNDATION MATERIAL 8.00	No signs of distress. Minor signs of erosion, though moderately vegetated.	8
WIRE/GEOSYNTHETIC FACING 8.00	No signs of corrosion, bulging, or loss of facing material.	9
LATERAL SLOPE 0.50	No signs of distress.	9
TRAFFIC BARRIER/FENCE 0.50	No signs of wall-related distress (some minor paint peeling on timbers).	9
WALL DRAINS 0.50	Appear to be functioning as intended.	9
DOWNSLOPE 1.00	Moderate to steep (difficult to walk), with no signs of significant distress. Minor erosion, soft soils, yet to vegetate well.	7

Failure Consequence:	HIGH
Recommendation Narrative:	None
Repair Cost:	\$0

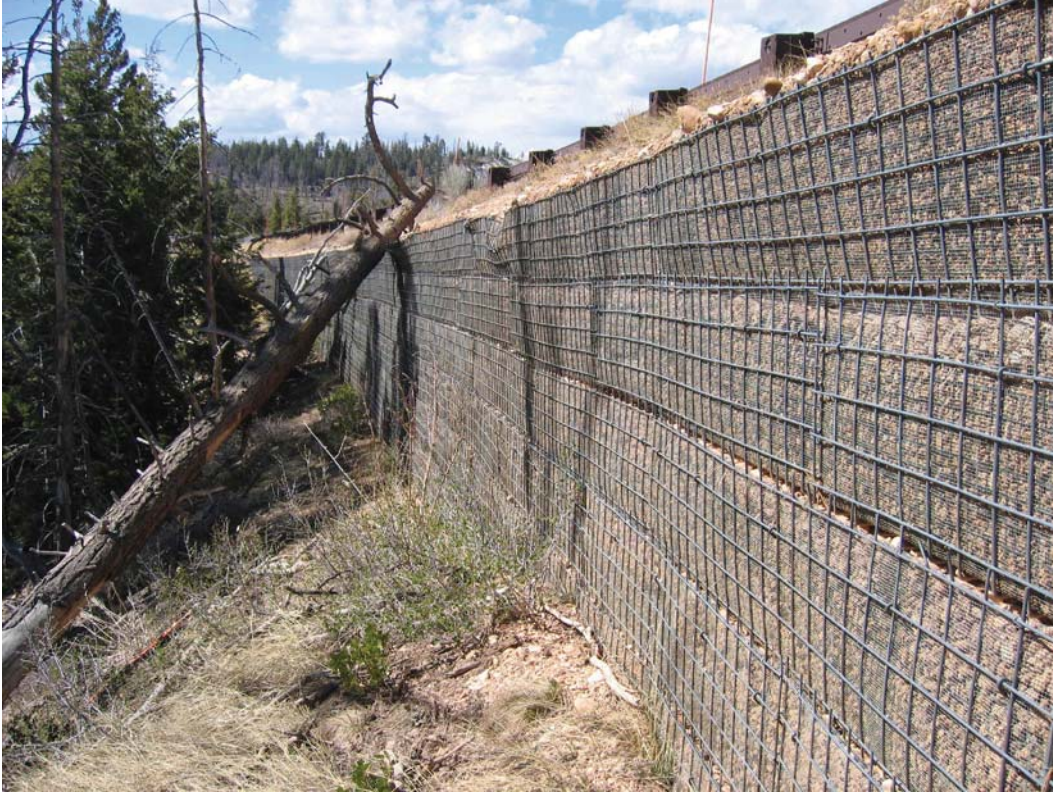
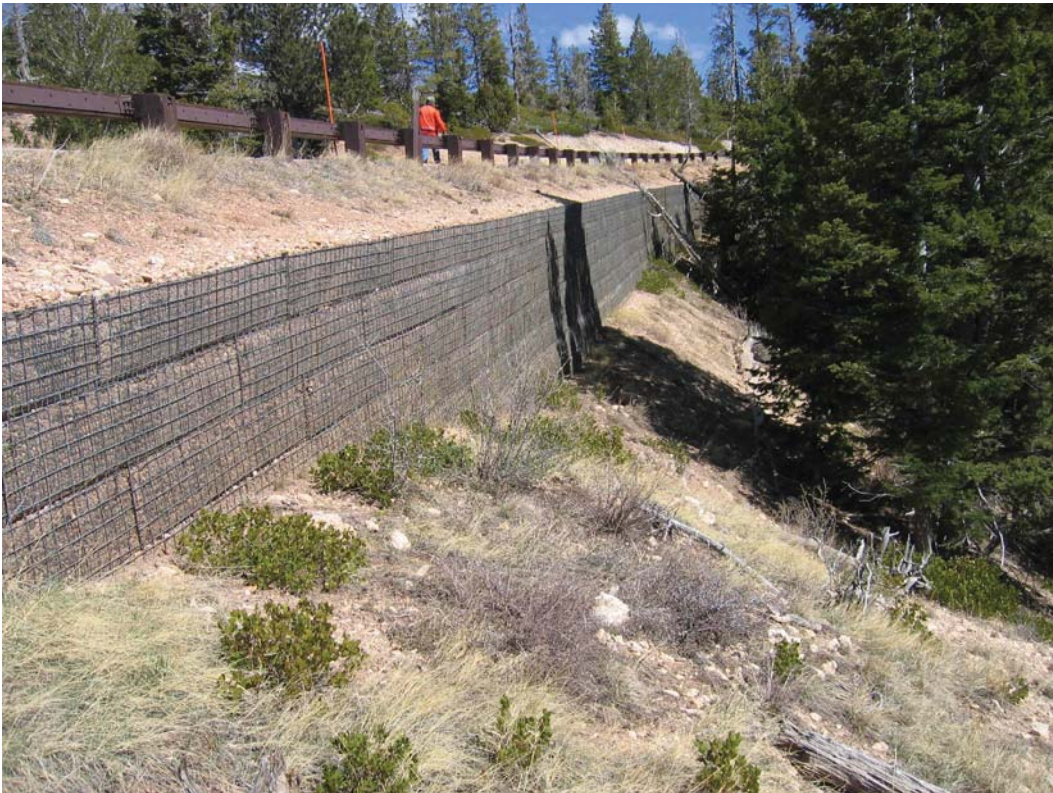
Element (Weighting Factor)	Narrative	Condition Rating (0 - 10)
PERFORMANCE 8.00	Wall is performing as intended with no signs of significant distress.	9
WALL FOUNDATION MATERIAL 8.00	No signs of distress.	9
WIRE/GEOSYNTHETIC FACING 8.00	No signs of corrosion or significant bulging. Minor deflection of baskets at top of wall at four limited locations.	8
CURB/BERM/DITCH 0.50	Colored concrete curb with no signs of cracking or displacement.	9
DOWNSLOPE 0.50	Moderately well vegetated, with no signs of distress.	9
LATERAL SLOPE 0.50	No signs of erosion or bulging. Moderately well vegetated.	9
ROAD/SIDEWALK/SHOULDER 0.50	Recent chip seal. No signs of distress.	9
WALL DRAINS 0.50	No signs of distress - functioning as intended.	9

Failure Consequence:	HIGH
Recommendation Narrative:	None
Repair Cost:	\$0

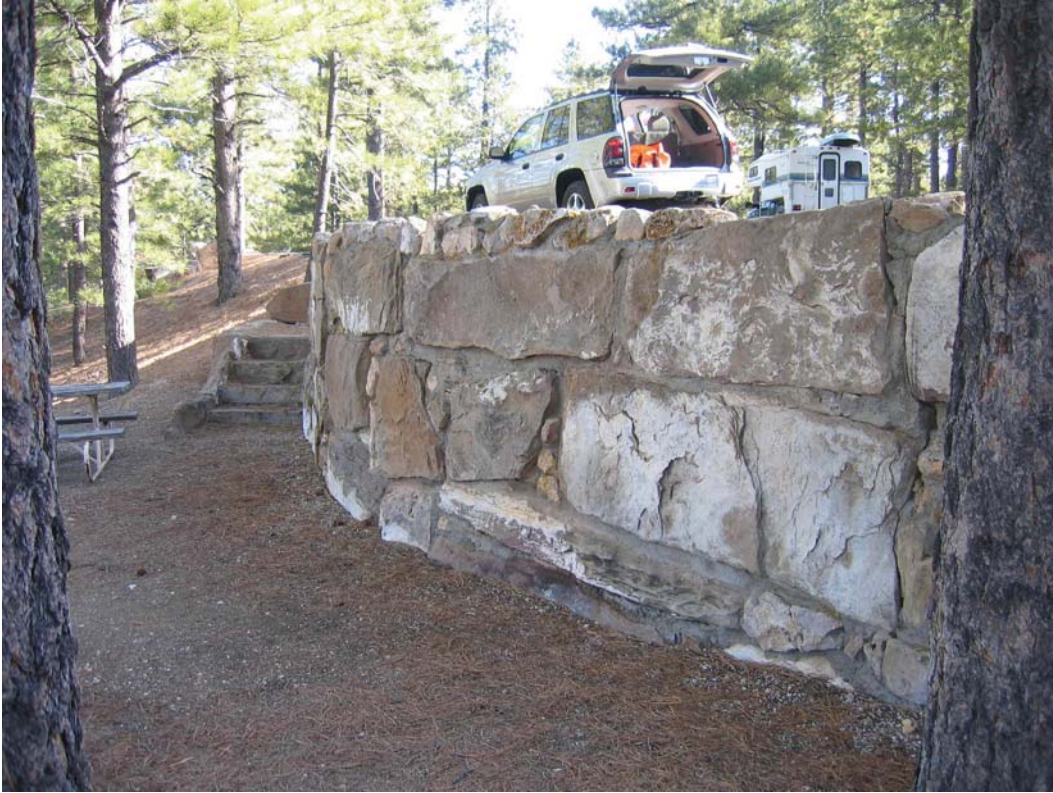
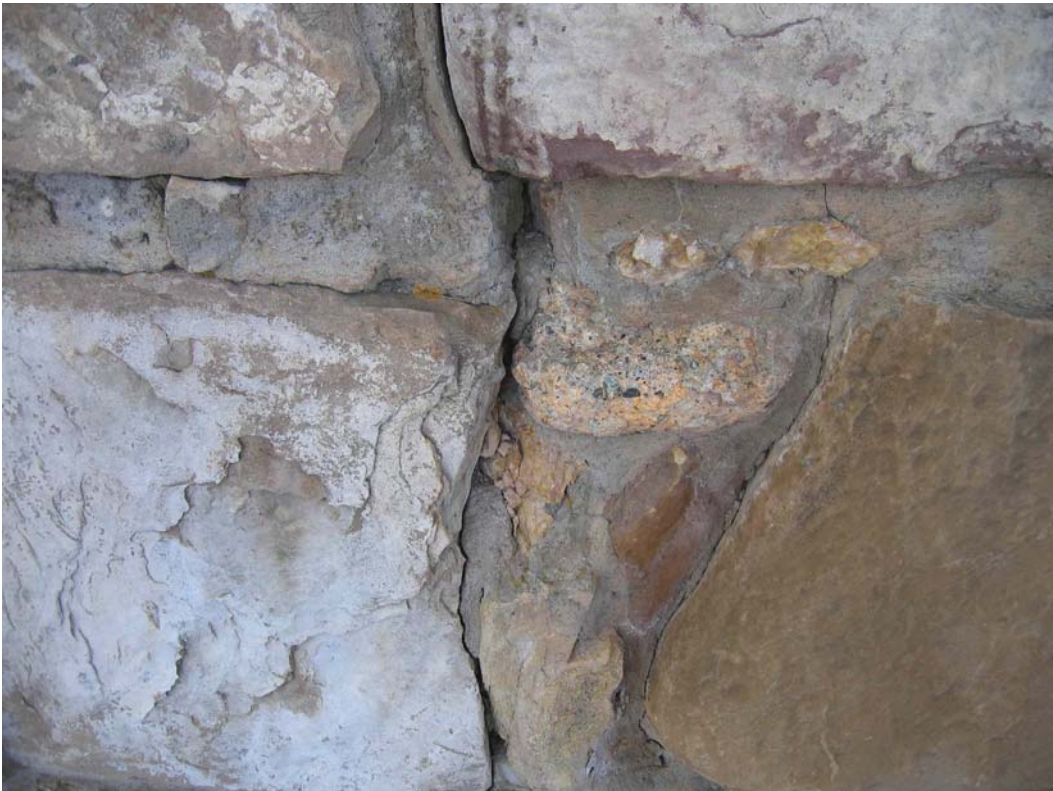
Wall ID:	BRCA-0201BA-.092-L		
Route Name:	NORTH CAMPGROUND LOOP ROAD B, OUTERLOOP		
Inspection Date:	April 17, 2007	Approximate Year Built:	Unknown
*Wall Rating:	69	Maintenance Action:	Maintenance

Wall Function:	Fill Wall	Primary Wall Type:	Gravity - Mortared Stone
Surface Treatment:		Secondary Wall Type:	
Secondary Surface Treatment:		Architectural Facing:	
General Description:	Mortared sandstone masonry rock wall located at campground site No.39 (failure would impact adjacent roadway).

Element (Weighting Factor)	Narrative	Condition Rating (0 - 10)
PERFORMANCE 8.00	Missing mortar and opening gaps between stone blocks at south end of wall suggests wall is rotating out slightly.	7
WALL FOUNDATION MATERIAL 8.00	No distress. Fully intact, moderate slope. Minor evidence of erosion.	8
MORTAR 8.00	0.25-in gaps in mortar throughout the wall. 1-in gaps along the steps through the wall. Some mortar is missing near the steps.	6
STONE MASONRY 8.00	Sandstone blocks are only moderately weathered, with one capblock missing.	6
DOWNSLOPE 0.50	No signs of distress. Modestly vegetated.	9
LATERAL SLOPE 0.50	No signs of distress.	9
WALL DRAINS 0.50	No signs of drainage issues.	9

Failure Consequence:	LOW
Recommendation Narrative:	Remove and replace damaged/missing mortar throughout the wall, particularly at the south end of the wall along the steps. 3 hrs general labor at \$55/hr = \$165. 2 bags of mortar at \$10/bag = \$20. Total = \$185
Repair Cost:	\$185

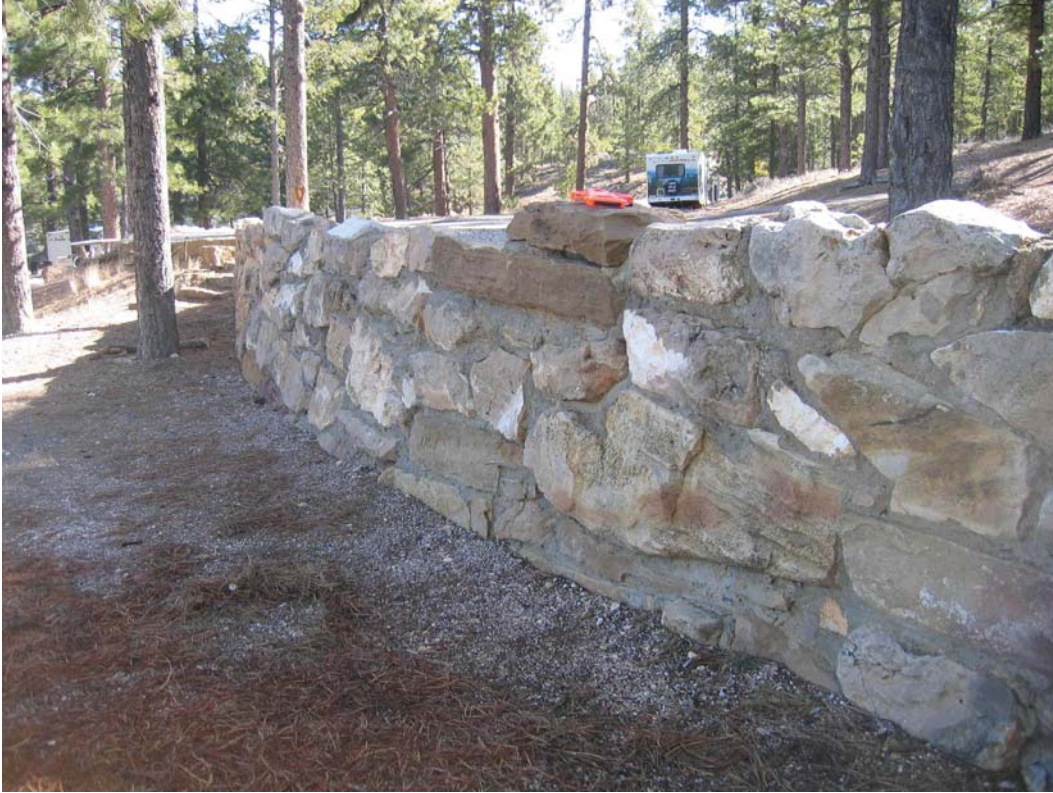
BRCA_0201BA_0.110_L_1.jpg

Element (Weighting Factor)	Narrative	Condition Rating (0 - 10)
PERFORMANCE 8.00	Wall shows no signs of significant global distress - functioning as intended.	8
WALL FOUNDATION MATERIAL 8.00	No signs of distress.	9
STONE MASONRY 8.00	Moderate weathering of the sandstone blocks. Missing one capstone.	6
MORTAR 8.00	Minor gaps in the mortar. Mortar is still hard, durable, and sound.	7
DOWNSLOPE 0.50	Gentle downslope showing no signs of bulging, slumping, or water problems.	9
LATERAL SLOPE 0.50	No signs of distress - functioning as built.	9
WALL DRAINS 0.50	No wall drains present, but no signs of wall drainage problems.	9

Failure Consequence:	LOW
Recommendation Narrative:	None
Repair Cost:	\$0

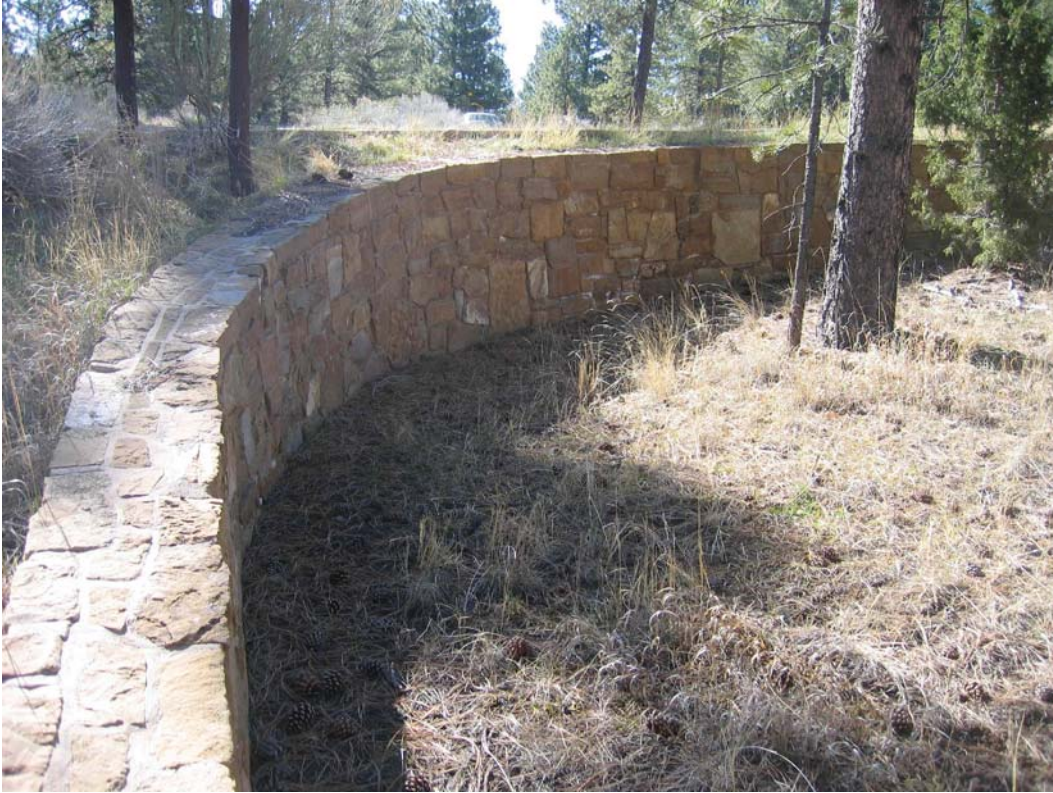
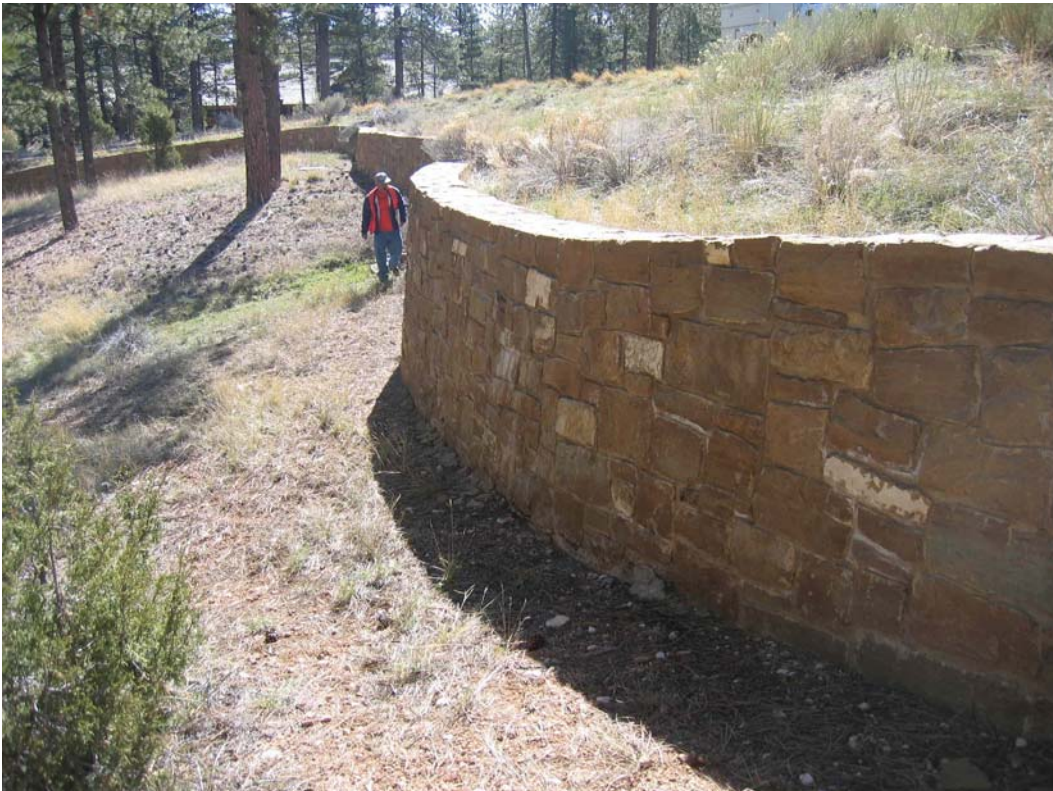
Element (Weighting Factor)	Narrative	Condition Rating (0 - 10)
PERFORMANCE 8.00	Wall is performing as intended, with no signs of distress.	9
WALL FOUNDATION MATERIAL 8.00	Concrete footer is visible at base of wall, and shows no signs of cracking or displacement. Slope is gentle, and shows no signs of distress.	9
MORTAR 8.00	Solid, intact, durable mortar showing no significant signs of weathering.	9
STONE MASONRY 8.00	Fresh cut sandstone, showing no signs of weathering or cracking.	9
DOWNSLOPE 0.50	Gentle downslope showing no signs of distress.	9
LATERAL SLOPE 0.50	No signs of distress.	9
UPSLOPE 0.50	Well-vegetated, gentle upslope showing no signs of settlement or other distress.	9
WALL DRAINS 0.50	Regular weep holes and drain pipe, all in very good condition - functioning as intended.	9

Failure Consequence:	LOW
Recommendation Narrative:	None
Repair Cost:	\$0

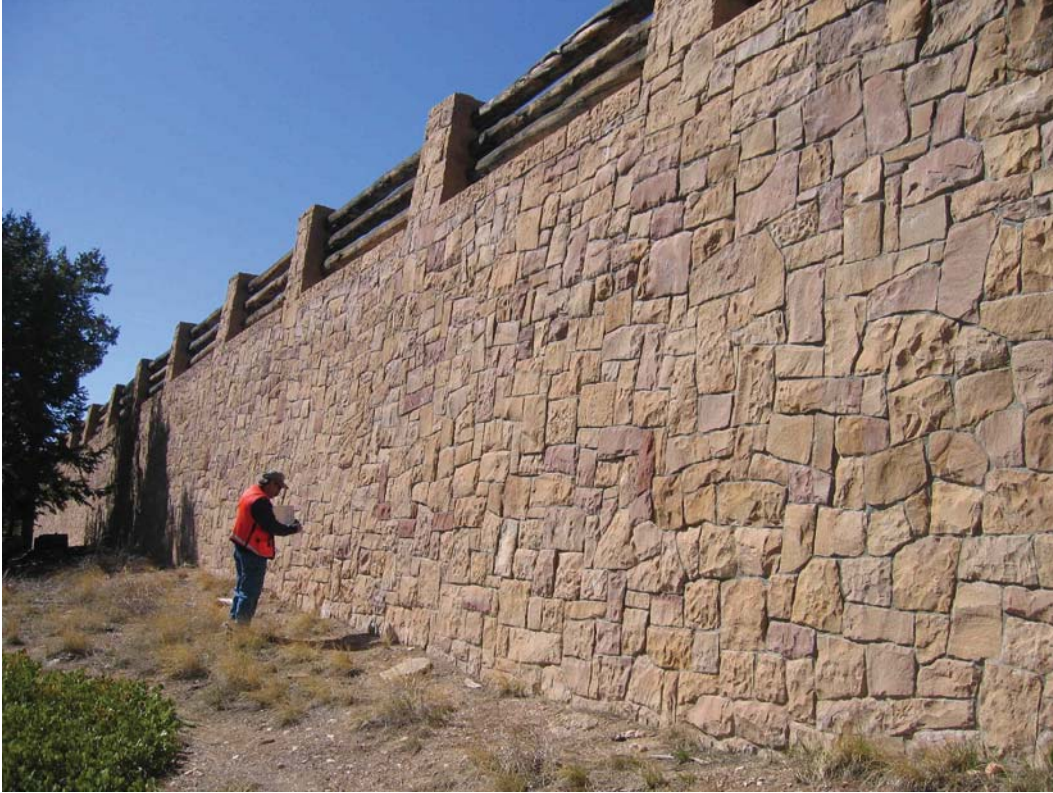
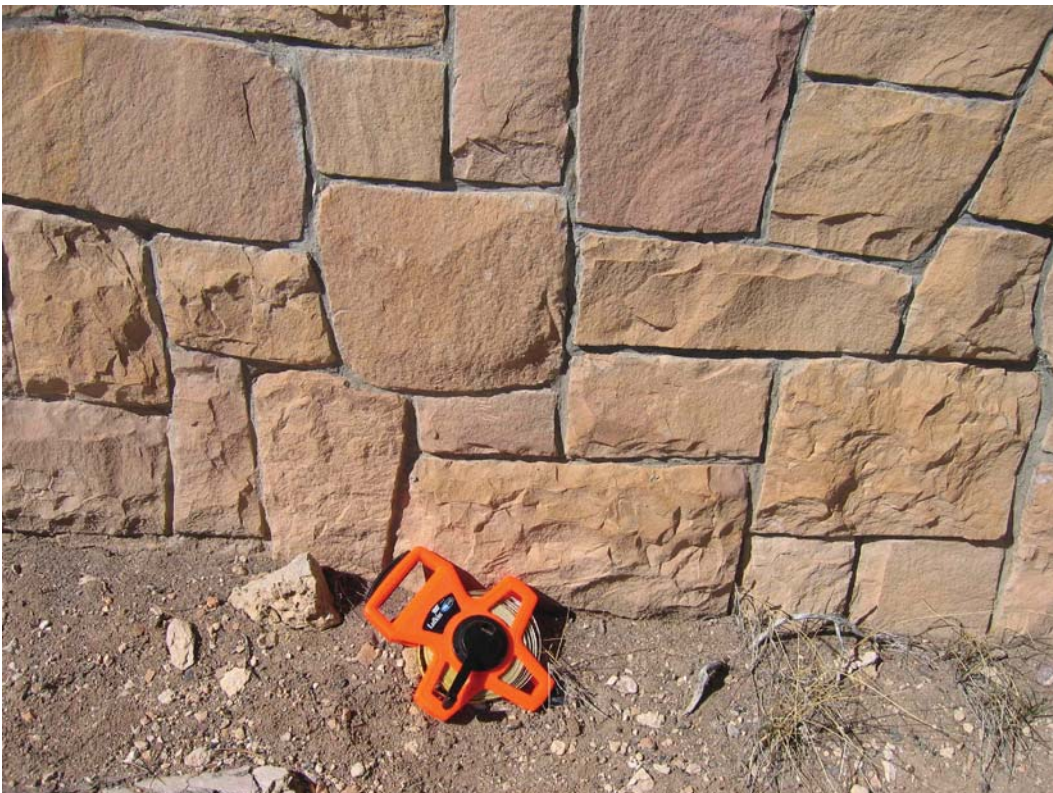
Element (Weighting Factor)	Narrative	Condition Rating (0 - 10)
PERFORMANCE 8.00	Wall is functioning as intended showing no signs of global distress. Only minor mortar cracking evident at some locations in the face.	9
WALL FOUNDATION MATERIAL 8.00	Footing is visible in one location due to minor erosion of the toe slope soils. No signs of settlement, bulging or cracking in the wall due to foundation soils.	9
MORTAR 8.00	0.125-in gap in some places, but overall the mortar is intact, fresh, and durable.	8
STONE MASONRY 8.00	Fresh sandstone blocks showing no signs of weathering or cracking.	10
WALL DRAINS 0.50	No signs of seepage through the wall blocks. No signs of drainage distress.	8
DOWNSLOPE 0.50	Gentle slope showing no signs of distress.	9
LATERAL SLOPE 0.50	No signs of distress.	9

Failure Consequence:	MODERATE
Recommendation Narrative:	None
Repair Cost:	\$0

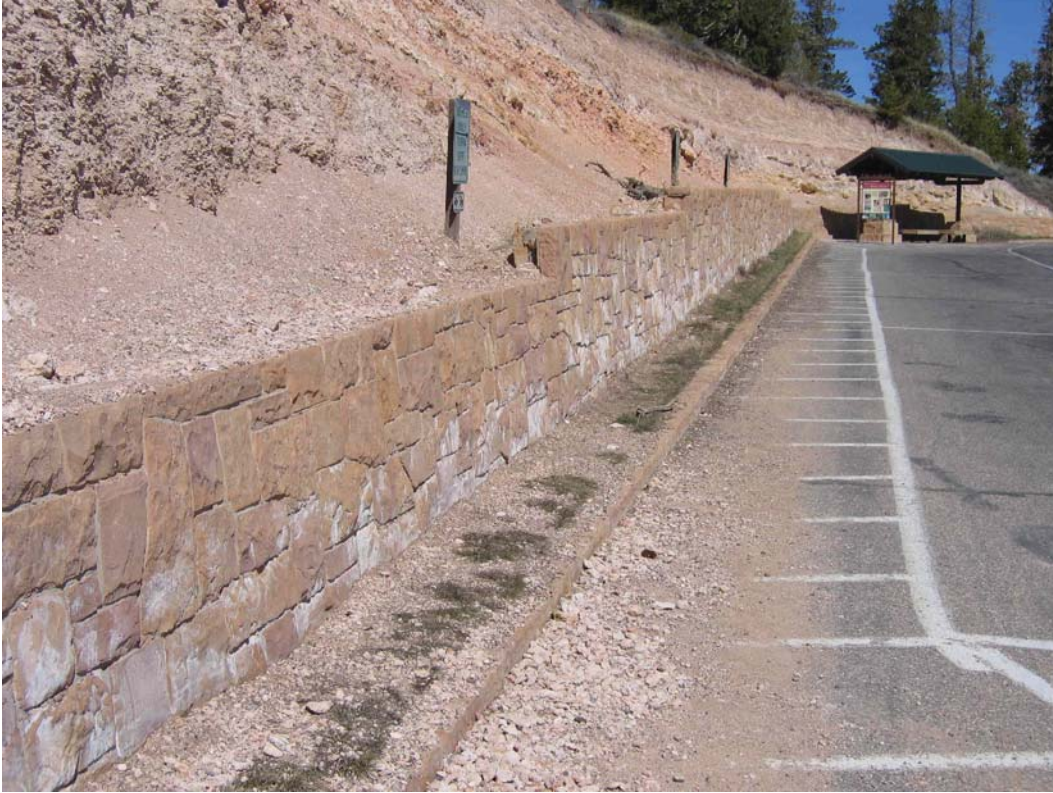
BRCA_0919_0.000_P2_1.jpg

Wall ID:	BRCA-0919-0-P2		
Route Name:	BRYCE POINT PARKING		
Inspection Date:	April 17, 2007	Approximate Year Built:	1994
*Wall Rating:	90	Maintenance Action:	Maintenance

Element (Weighting Factor)	Narrative	Condition Rating (0 - 10)
PERFORMANCE 8.00	Performing as intended, with no signs of global distress.	9
WALL FOUNDATION MATERIAL 8.00	Footing visible on north end of wall. No signs of distress or erosion.	9
STONE MASONRY 8.00	Fresh sandstone cut blocks with no signs of distress. One missing capblock, and one loose capblock.	8
MORTAR 8.00	Fresh mortar with no cracking or signs of significant distress.	10
UPSLOPE 0.50	Raveling cutslope above the wall. Loose soil and weathering rock, with no vegetation. Eroding slope is not affecting the wall.	8
LATERAL SLOPE 0.50	No signs of distress.	9
WALL DRAINS 0.50	No signs of drainage problems. Functioning PVC weep holes present at north end of wall.	9
