NPS Retaining Wall Inventory Program Capulin Volcano National Monument

**Federal Lands Highway
Road Inventory Program**

**Federal Highway Administration
Eastern Federal Lands Highway Division
Road Inventory Program (RIP)**

**Data Collection Date: November 2006
Report Date: October 2015**

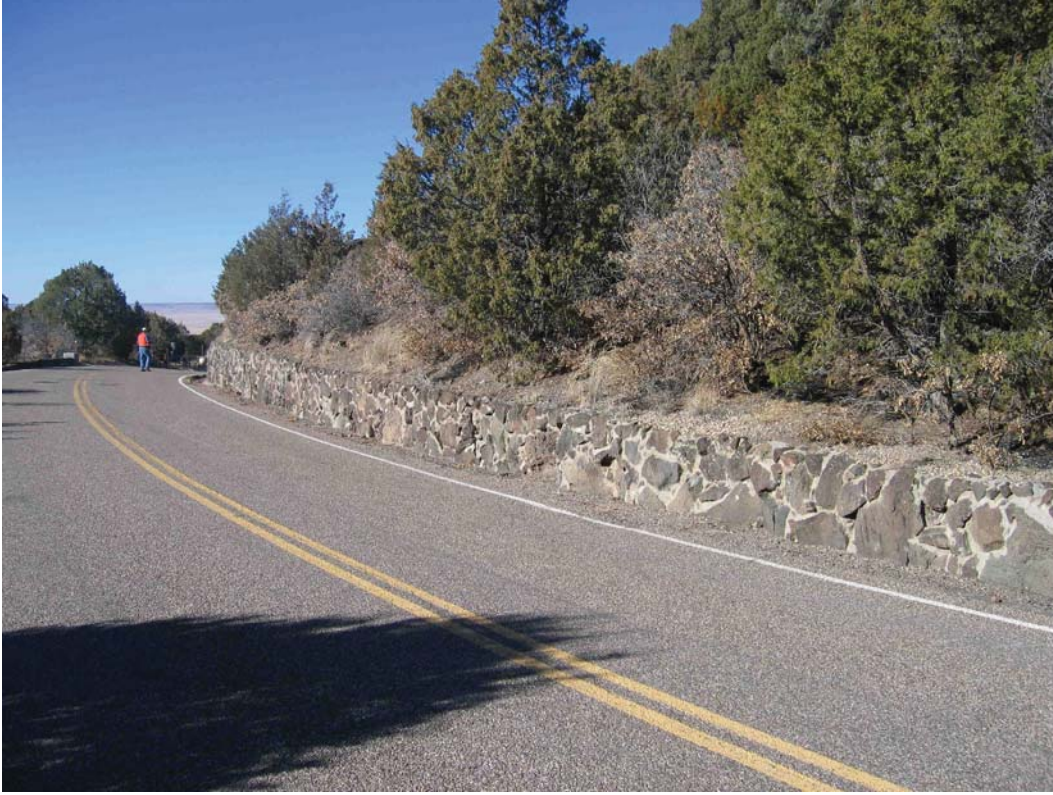
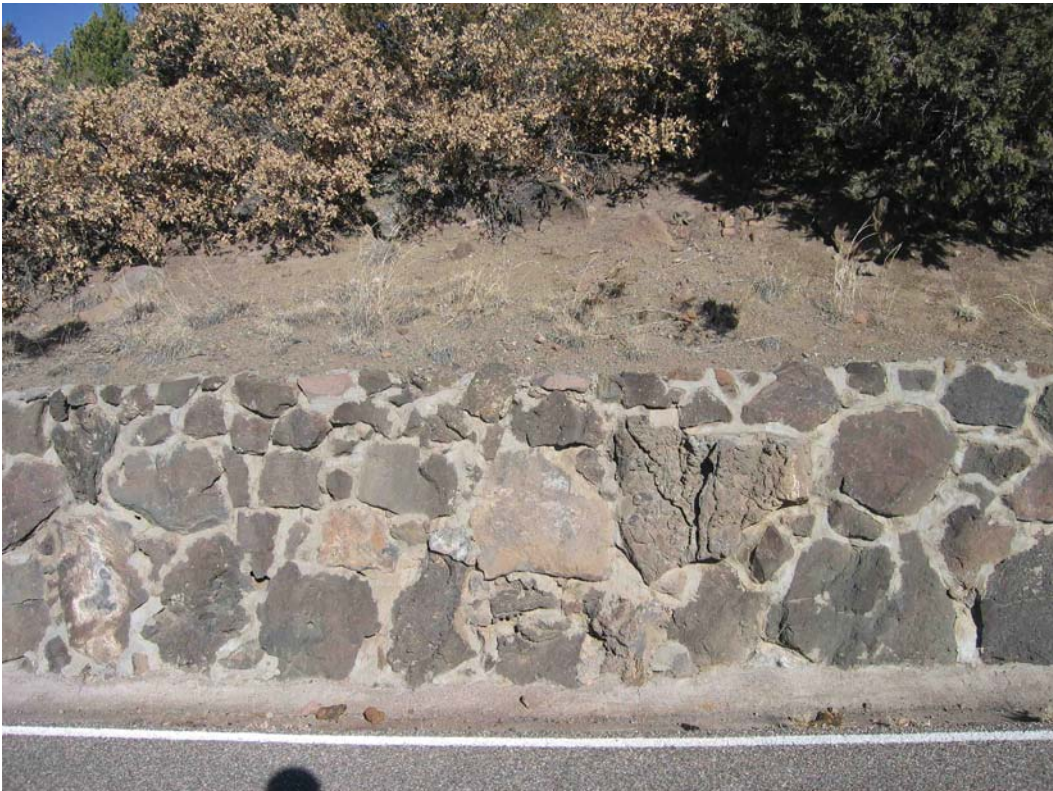
| Element (Weighting Factor) | Narrative | Condition Rating (0 - 10) |
|---|--|---|
| WALL FOUNDATION MATERIAL 8.00 | Appears dense, drained, strong, and shows no signs of settlement or deformation. | 10 |
| STONE MASONRY 8.00 | Strong, unweathered rock showing no signs of cracking or degradation. Mortar is sound, durable, and shows little or no signs of cracking or deterioration. | 10 |
| CURB/BERM/DITCH 0.50 | Concrete lined ditch is in excellent condition, showing little signs of cracking or distress. | 9 |

| Recommendation Narrative: | None |

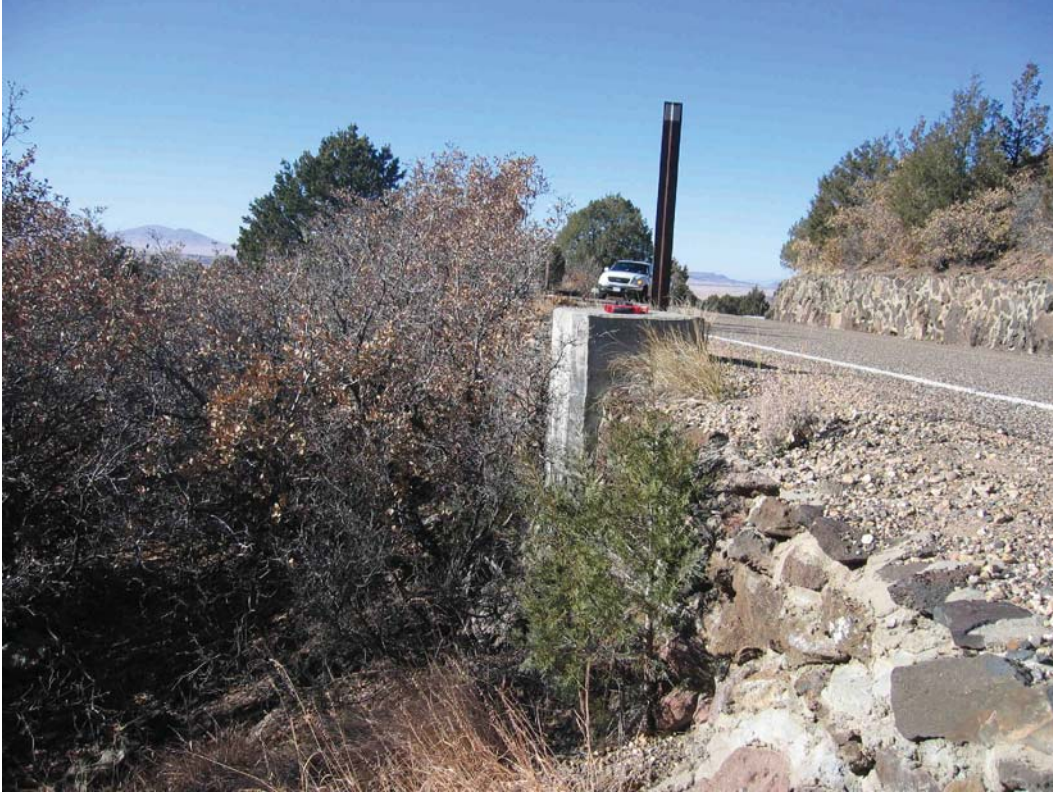
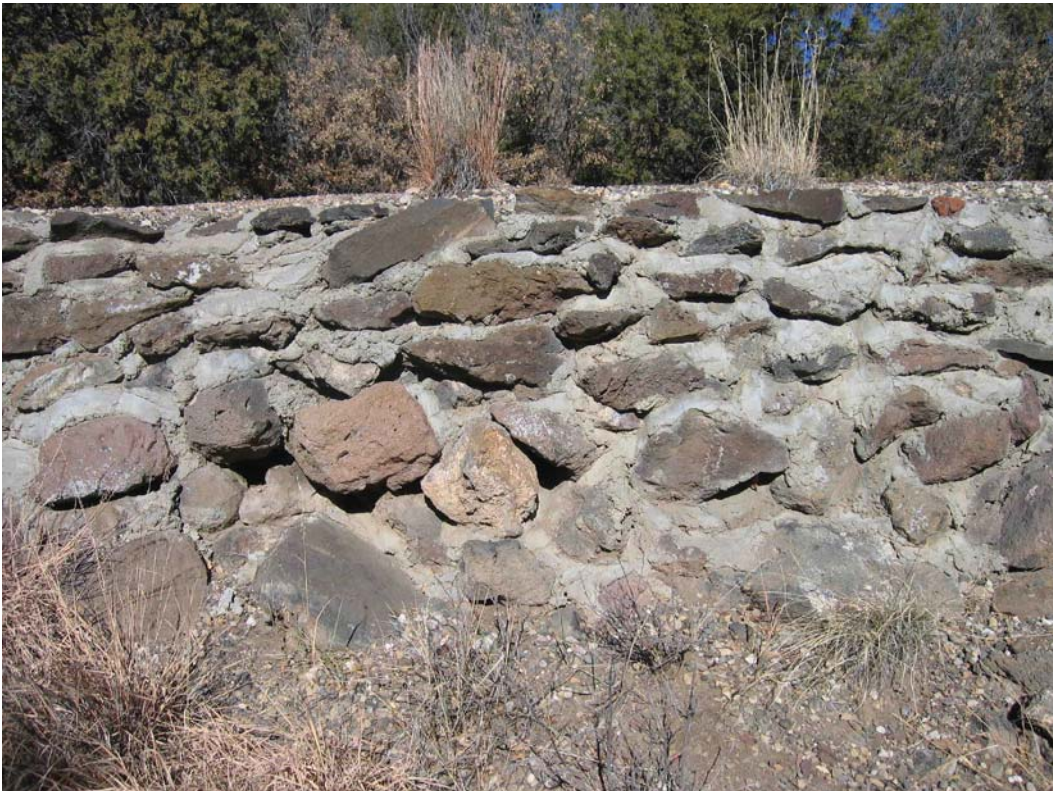
| Wall ID: | CAVO-0010-0.534-R | | |

| Element (Weighting Factor) | Narrative | Condition Rating (0 - 10) |
|---|--|---|
| WALL FOUNDATION MATERIAL 8.00 | Very gentle toe slope that appears dense, drained and very stable. No signs of settlement or wall deformation due to foundation failure. | 10 |
| CONCRETE 8.00 | Concrete buttresses in excellent condition showing no signs of weathering, deterioration, cracking or distress. Not sure of the structural function of these structures. | 10 |
| STONE MASONRY 8.00 | Strong, unweathered rock showing no signs of cracking or degradation. Mortar is sound, durable, and shows little or no signs of cracking or deterioration. | 10 |
| DOWNSLOPE 0.50 | Well-vegetated, gentle downslope showing no signs of slope failure, poor drainage, or significant erosion. | 10 |

| Recommendation Narrative: | None |

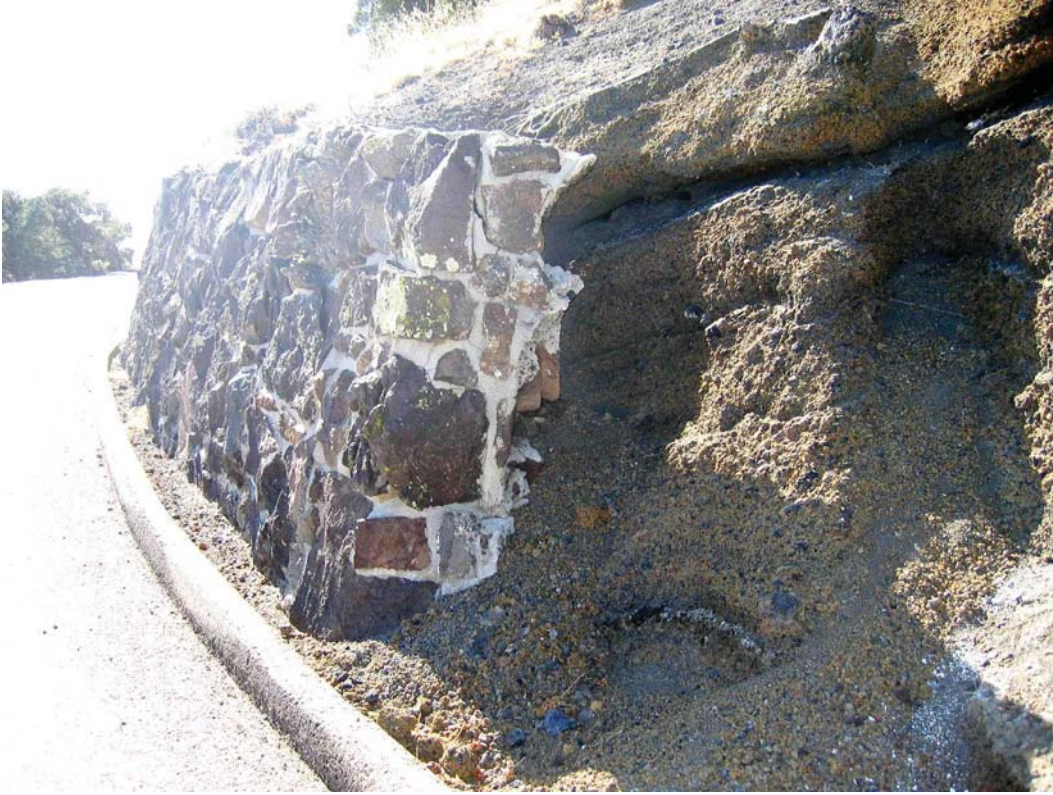
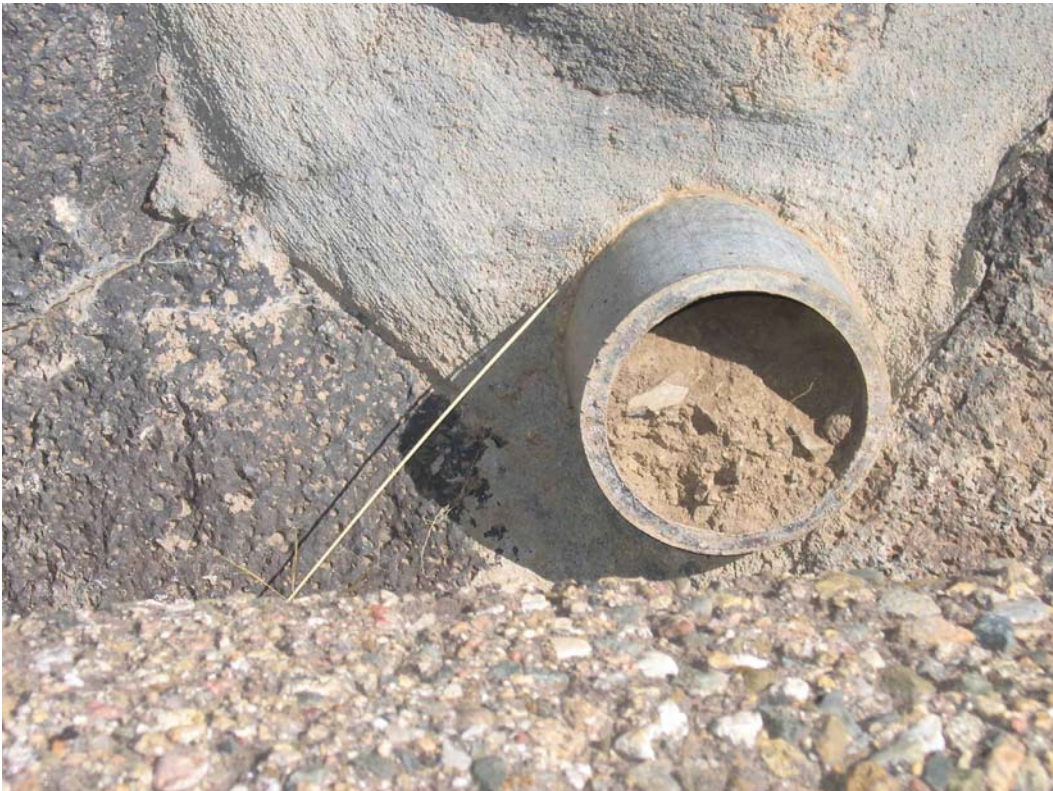
| Wall ID: | CAVO-0010-0.838-L | | |

| General Description: | Rock masonry wall. Photos: far, up station end of the wall (minor damage area) 2 plugged drain 3 wall length 4 varying wall rock area. | | |

| Element (Weighting Factor) | Narrative | Condition Rating (0 - 10) |
|---|--|---|
| PERFORMANCE 8.00 | Excellent overall wall performance and stability. Only the very upstation end of the all needs any repair work done. | 9 |
| LATERAL SLOPE 1.00 | Upstation end of the wall subject to erosion behind the wall end, requiring repair. Wall elements are still sound. | 7 |
| UPSLOPE 1.00 | Upslope is generally stable, showing only very isolated signs of shallow slope failure. Extensive surface erosion of volcanic cinder is evident along a majority of the wall. Does not impact performance. | 7 |

| Recommendation Narrative: | Clean drains: 2 hrs @ \$55/hr = \$110. Construct 2 cuyd rock masonry wall @ \$1155/cuyd = \$2310. Total = \$2420. |
| Repair Cost: | \$2,420 |

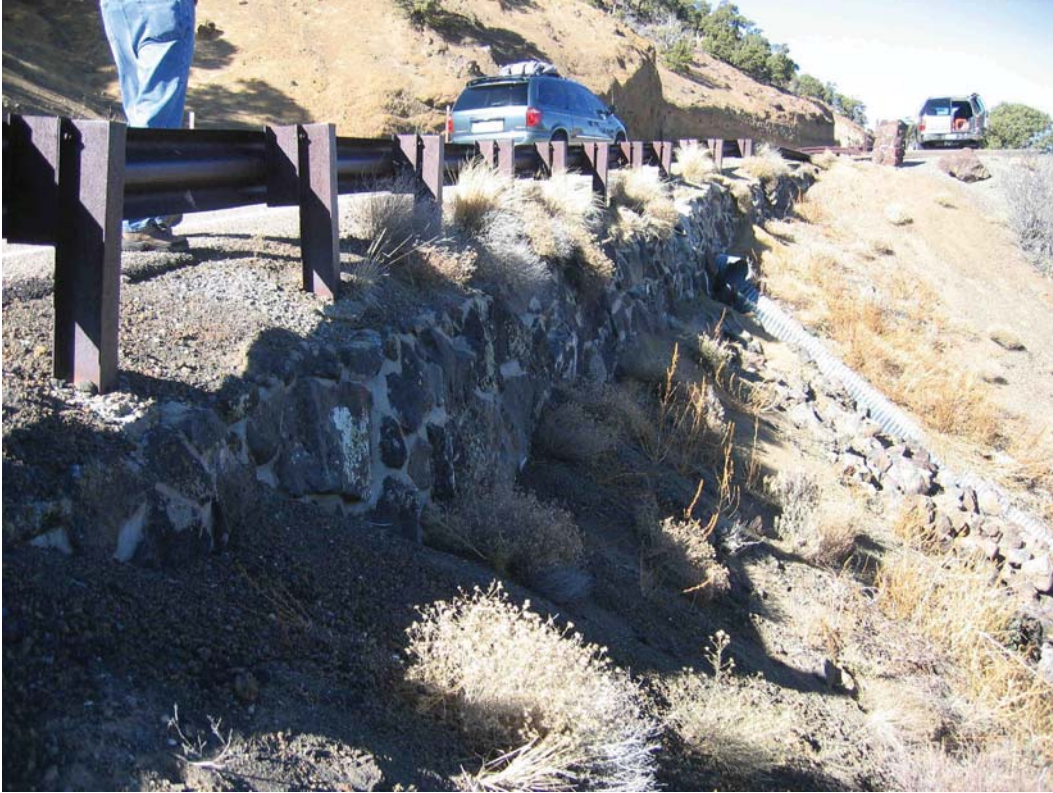
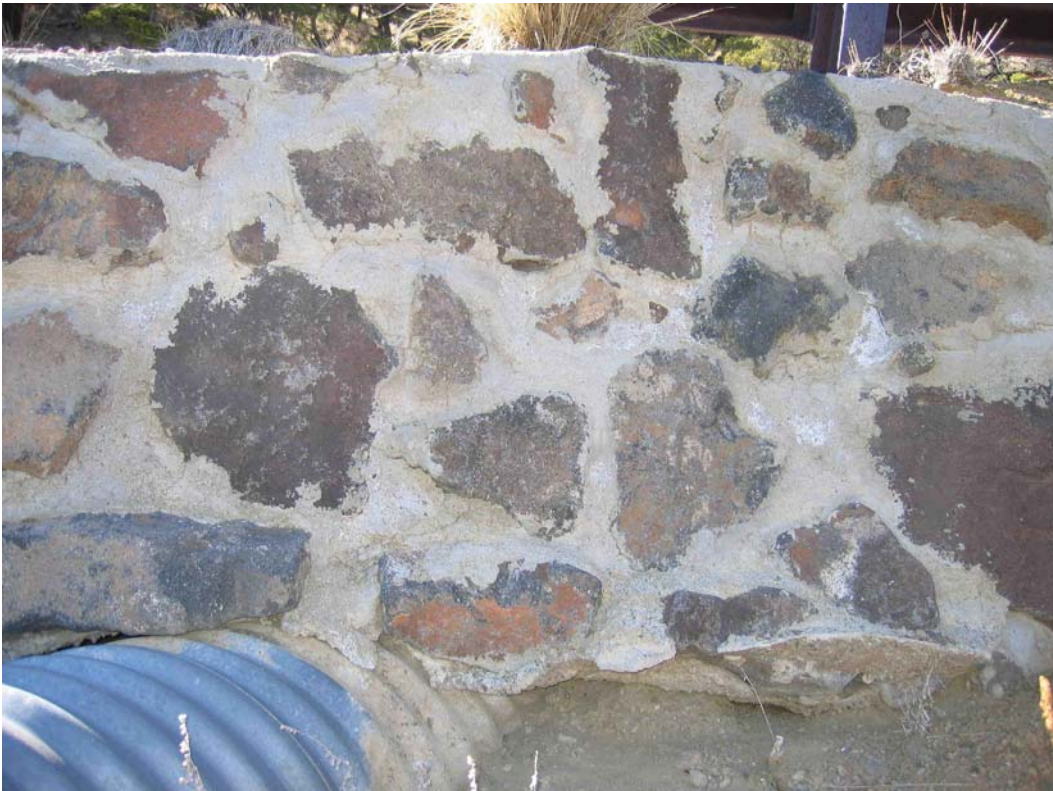
| Wall ID: | CAVO-0010-1.902-R | | |

| General Description: | Rock masonry wall with guardrail. Photos: 1 along wall length 2 wall face (typical) 3 wall foundation. | | |

| Element (Weighting Factor) | Narrative | Condition Rating (0 - 10) |
|---|--|---|
| WALL FOUNDATION MATERIAL 8.00 | Appears dense, drained, and strong, and generally shows no signs of settlement or deformation. Some erosion has occurred around the culvert pipe, but does not impact wall stability or long-term performance. | 8 |

| Recommendation Narrative: | None |

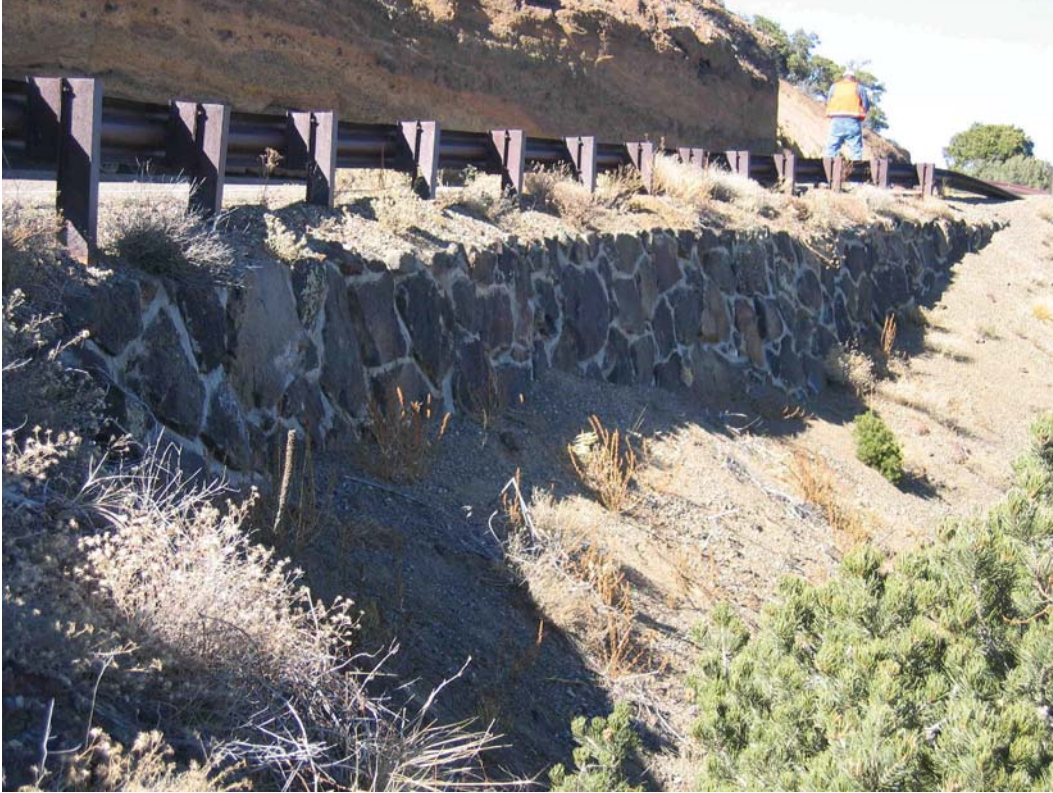
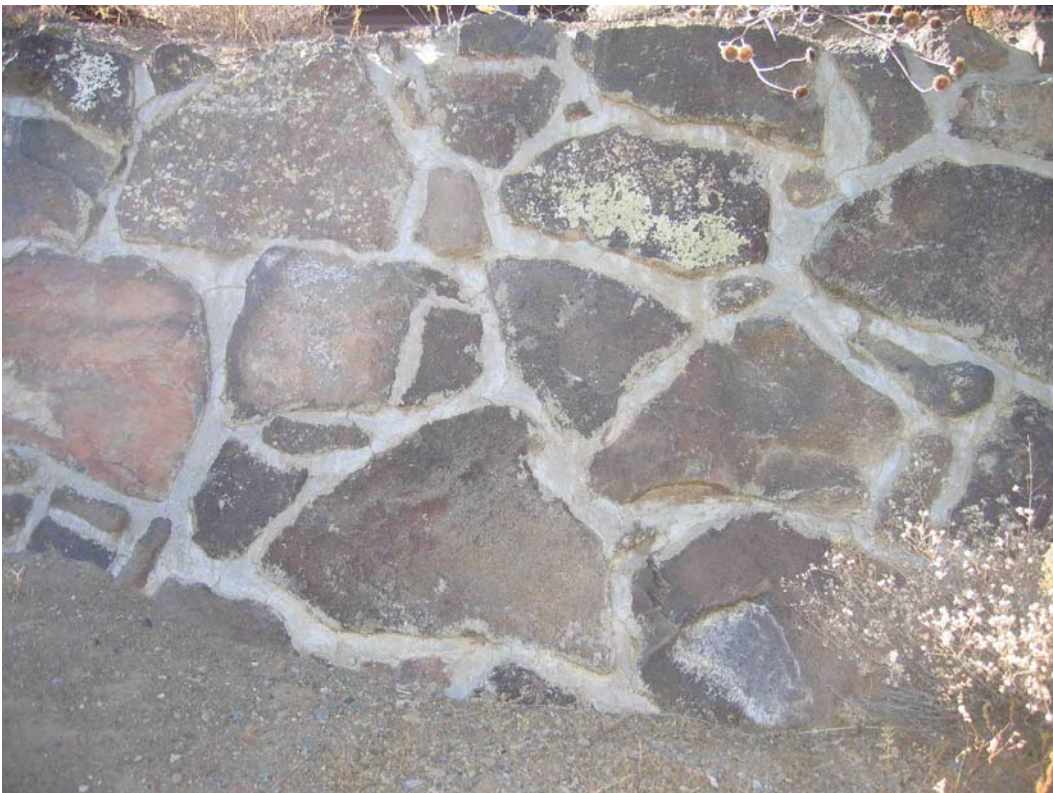
| Wall ID: | CAVO-0010-1.935-R | | |

| Element (Weighting Factor) | Narrative | Condition Rating (0 - 10) |
|---|--|---|
| WALL FOUNDATION MATERIAL 8.00 | Appears dense, drained, strong and stable, and shows no signs of settlement or deformation. | 10 |
| STONE MASONRY 8.00 | Strong, unweathered rock showing no signs of cracking or degradation. Mortar is sound, durable, and shows little or no signs of cracking or deterioration. | 10 |
| DOWNSLOPE 0.50 | Minor erosion across a poorly vegetated downslope. No impacts to wall, and no signs of past or pending slope failure. | 8 |

| Recommendation Narrative: | None |

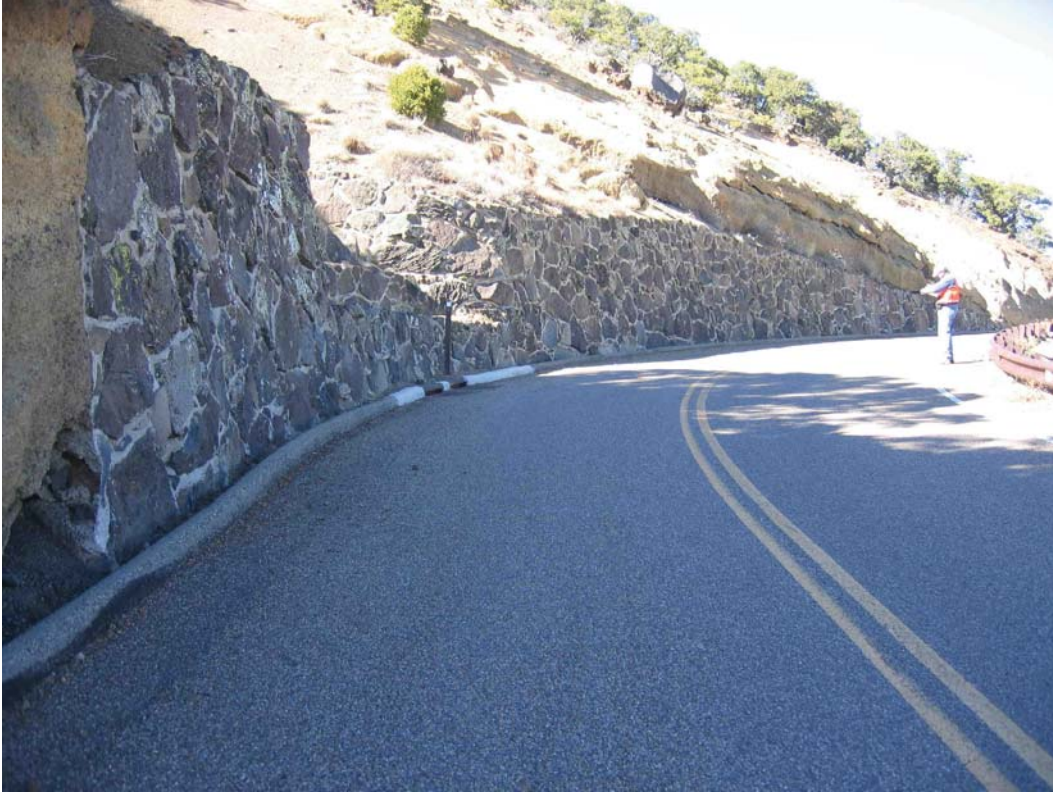
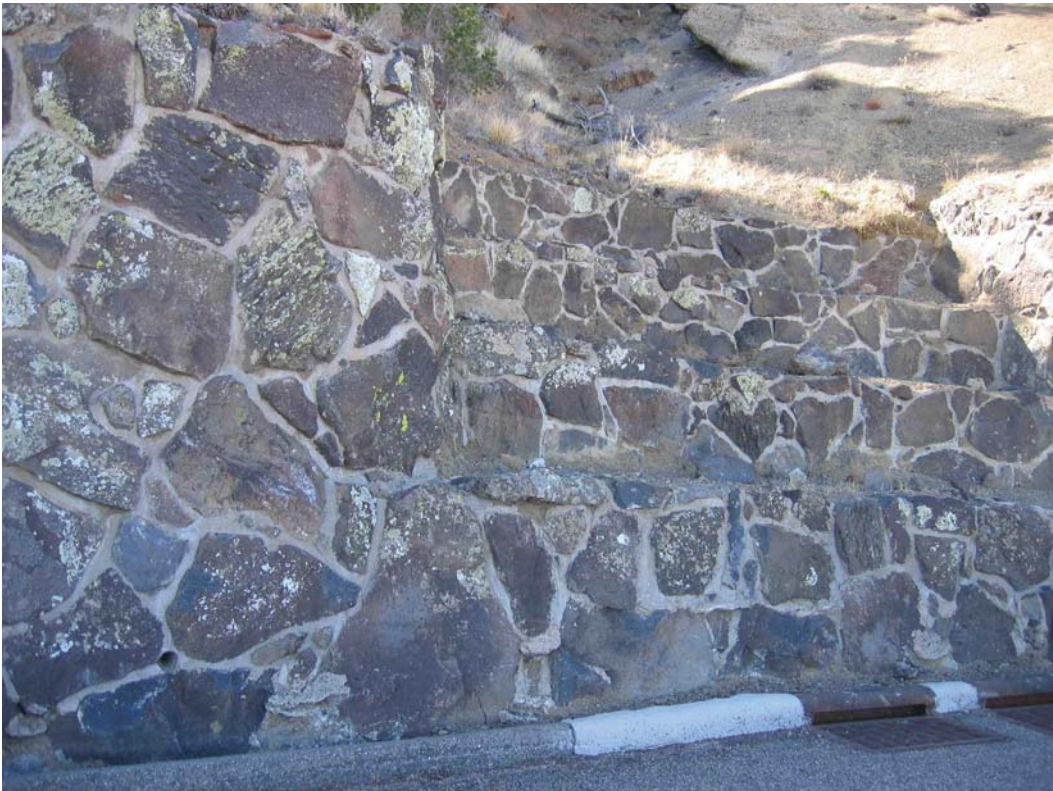
| Wall ID: | CAVO-0010-1.979-L | | |

| Element (Weighting Factor) | Narrative | Condition Rating (0 - 10) |
|---|---|---|
| WALL FOUNDATION MATERIAL 8.00 | Roadway at toe of wall shows no sign of distress due to wall settlement or rotation. | 10 |
| STONE MASONRY 8.00 | Strong, unweathered rock showing no signs of cracking or degradation. Mortar is sound, durable, and shows little or no sign of cracking or deterioration. | 10 |
| CURB/BERM/DITCH 0.50 | Curbing is generally in very good condition, showing only minor cracking. Functioning as intended. | 8 |
| CULVERT 0.50 | Culvert inlet at tiered wall section is in excellent condition, showing no signs of distress. | 10 |
| LATERAL SLOPE 1.00 | Downstation end of wall is eroded behind lower corner. Does not impact wall function or stability, and does not warrant repair. | 7 |

| Recommendation Narrative: | None |

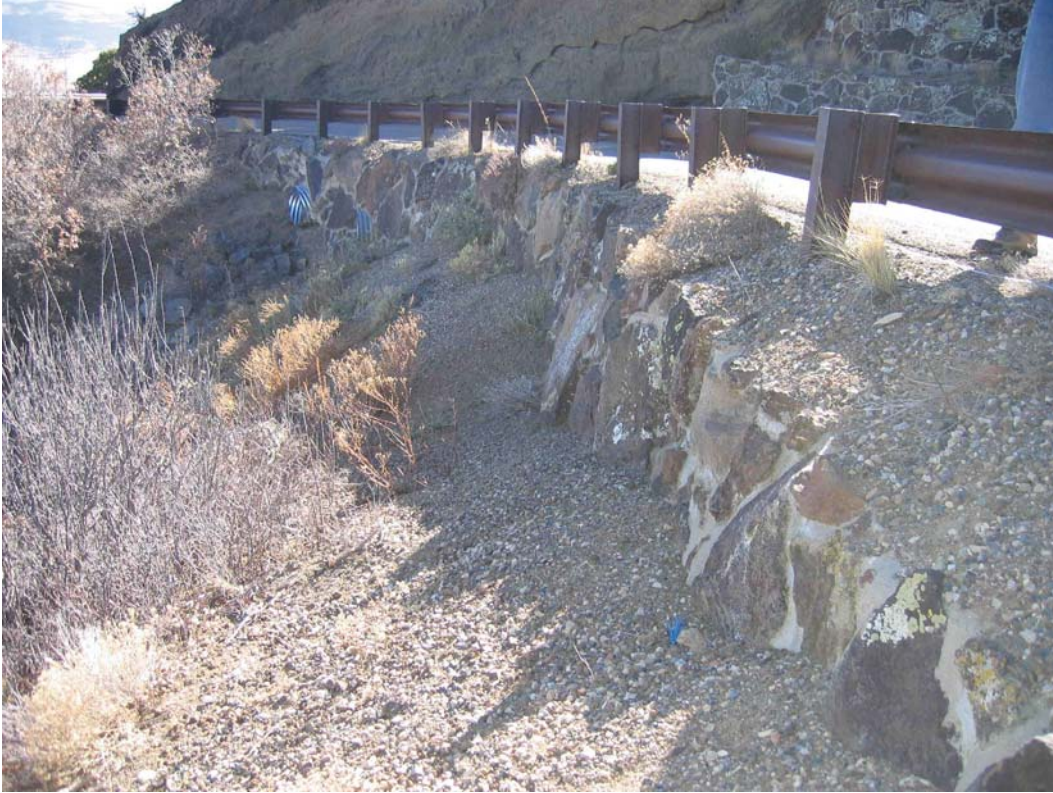
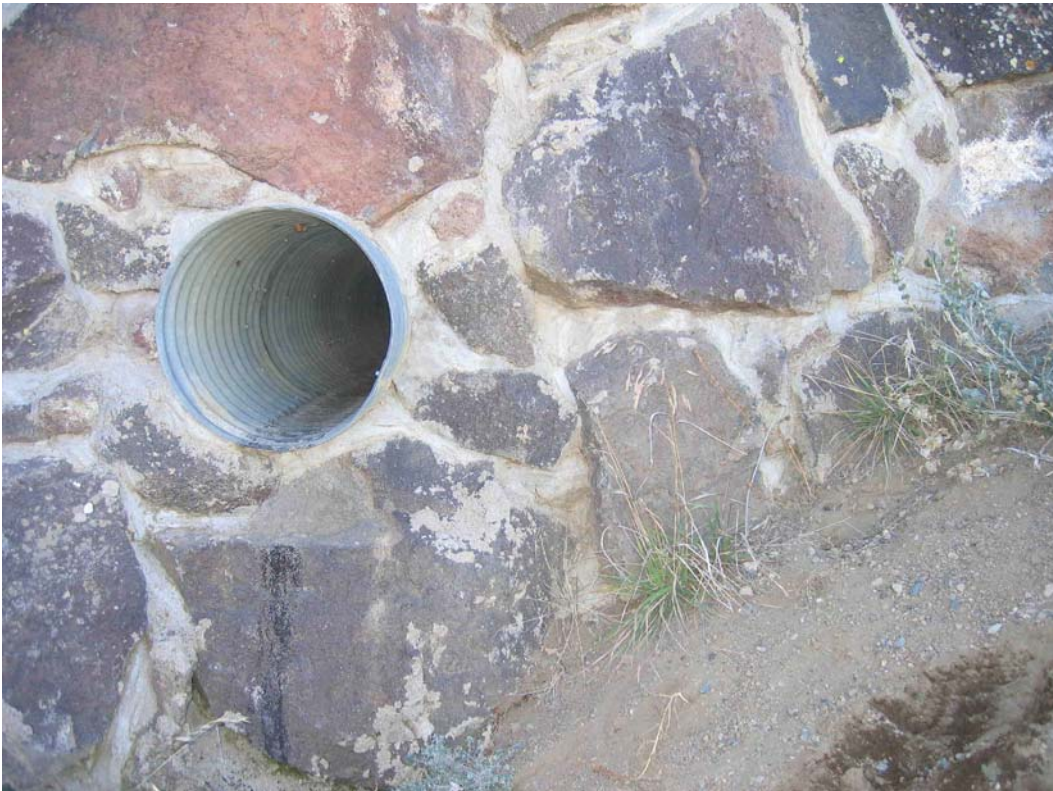
| Wall ID: | CAVO-0010-2.032-R | | |

| Element (Weighting Factor) | Narrative | Condition Rating (0 - 10) |
|---|---|---|
| WALL FOUNDATION MATERIAL 8.00 | Appears dense, drained, strong, and stable, showing no signs of settlement or deformation. | 10 |
| STONE MASONRY 8.00 | Strong, unweathered rock showing no signs of cracking or degradation. Mortar is sound, durable, and shows little or no sign of cracking or deterioration. | 10 |
| DOWNSLOPE 0.50 | Gentle, poorly vegetated downslope showing minor surface erosion. No indications of slope failure or impacts to wall performance. | 10 |

| Recommendation Narrative: | None |

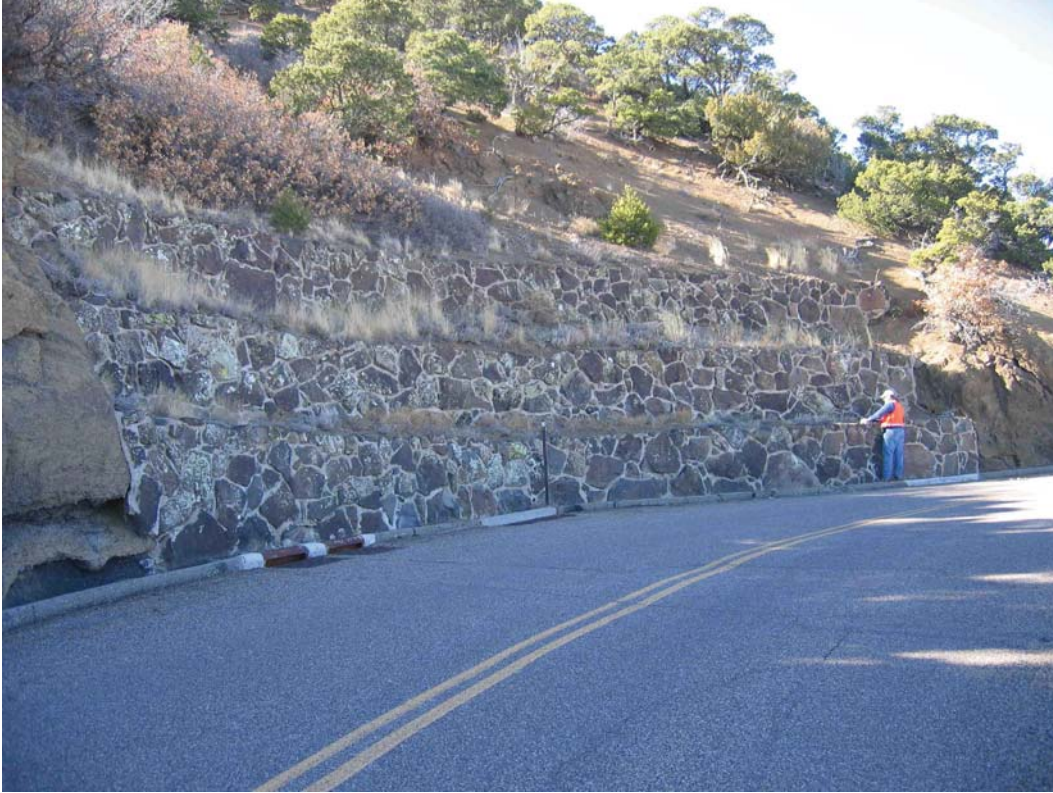
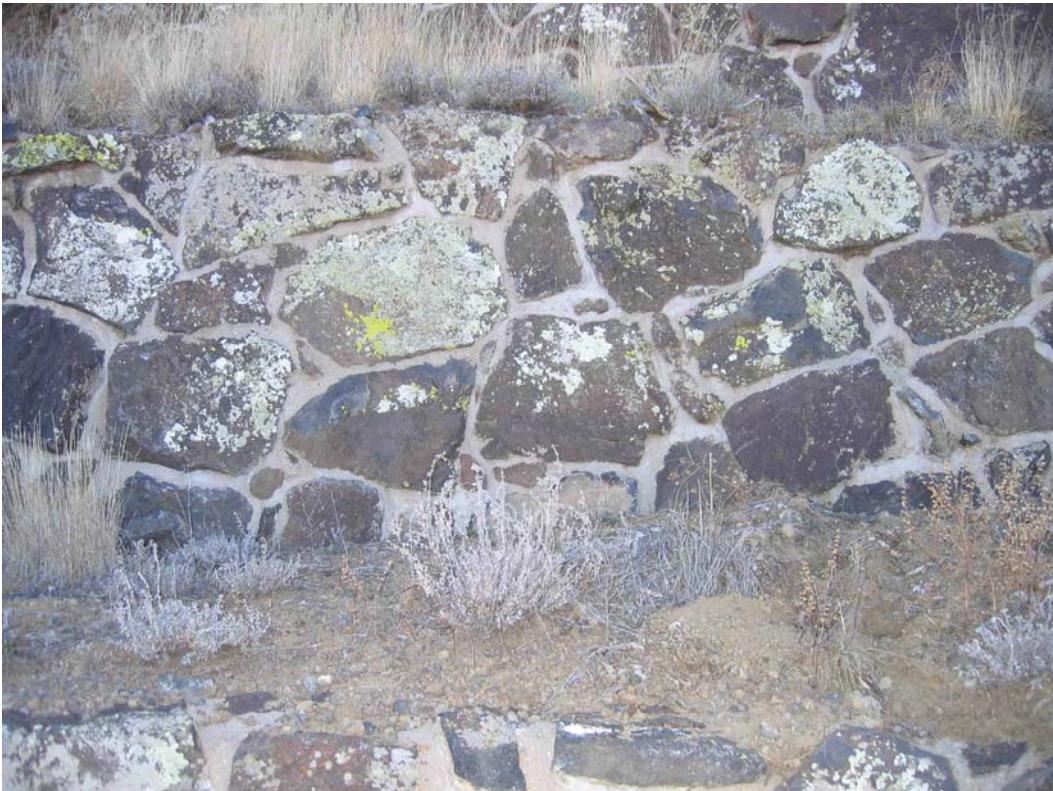
| Wall ID: | CAVO-0010-2.038-L | | |

| Element (Weighting Factor) | Narrative | Condition Rating (0 - 10) |
|---|--|---|
| WALL FOUNDATION MATERIAL 8.00 | Each tier's foundation appears dense, strong, stable, and well-drained, showing no signs of wall settlement or deformation due to foundation instability. | 10 |
| STONE MASONRY 8.00 | Strong, unweathered rock, showing no signs of cracking or degradation. Mortar is sound, durable, and shows little or no signs of cracking or deterioration. | 10 |
| LATERAL SLOPE 0.50 | Lateral slopes are keyed to volcanic beds showing no signs of erosion or degradation at wall ends. Some upslope erosion is evident that is minimally encroaching on either end of the wall system. | 8 |
| CURB/BERM/DITCH 1.00 | Curb has minor cracks, with some newly replaced sections evident. | 7 |

| Recommendation Narrative: | None |

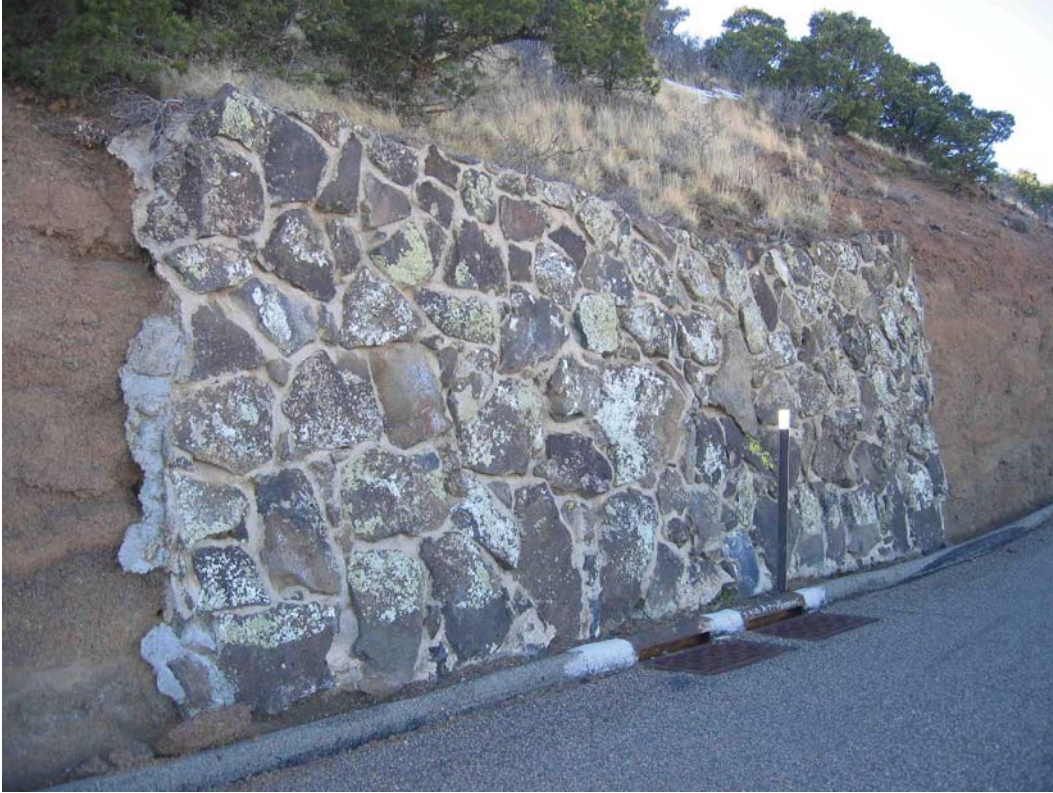
| Wall ID: | CAVO-0010-2.097-L | | |

| Element (Weighting Factor) | Narrative | Condition Rating (0 - 10) |
|---|--|---|
| WALL FOUNDATION MATERIAL 8.00 | Road below wall toe shows no signs of distress due to wall deformation, indicating foundation is strong, dense and well-drained. | 10 |
| STONE MASONRY 8.00 | Strong, unweathered rock showing no signs of cracking or degradation. Mortar is sound, durable, and shows little or no signs of cracking or deterioration. | 10 |
| CURB/BERM/DITCH 0.50 | Curb is in very good condition, showing only minor cracking. | 9 |
| CULVERT 0.50 | Drop inlet at toe of wall is in excellent working condition, showing no signs of settlement or distress. | 10 |

| Recommendation Narrative: | None |

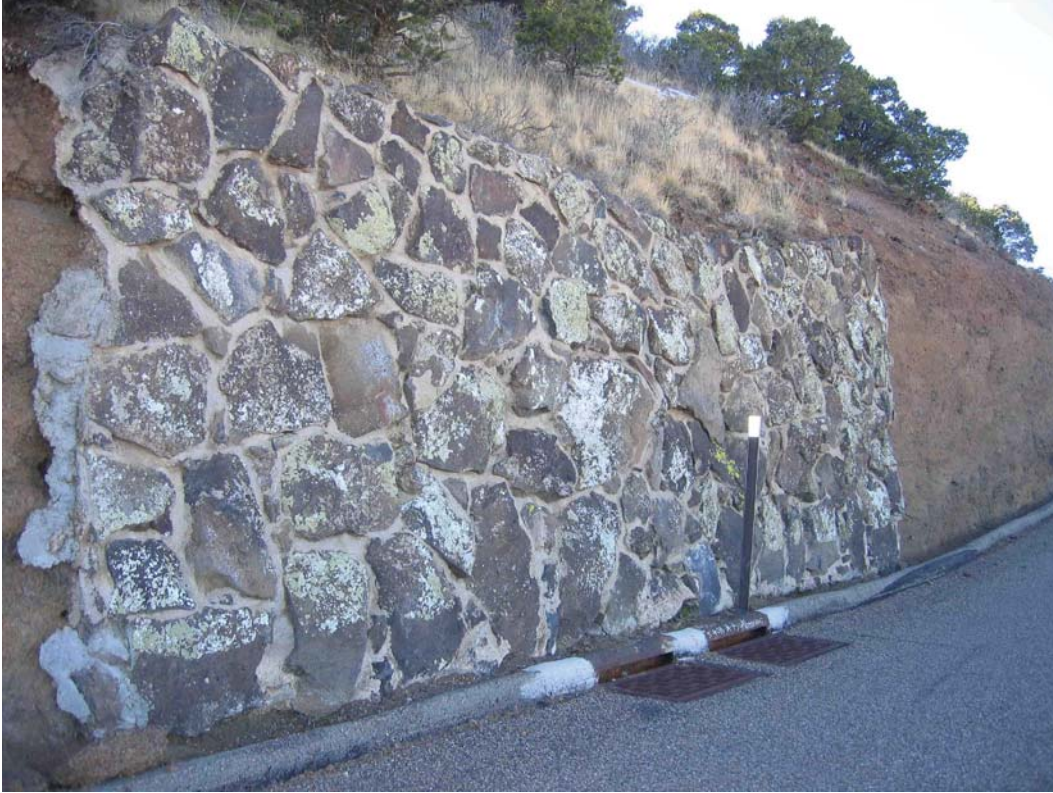
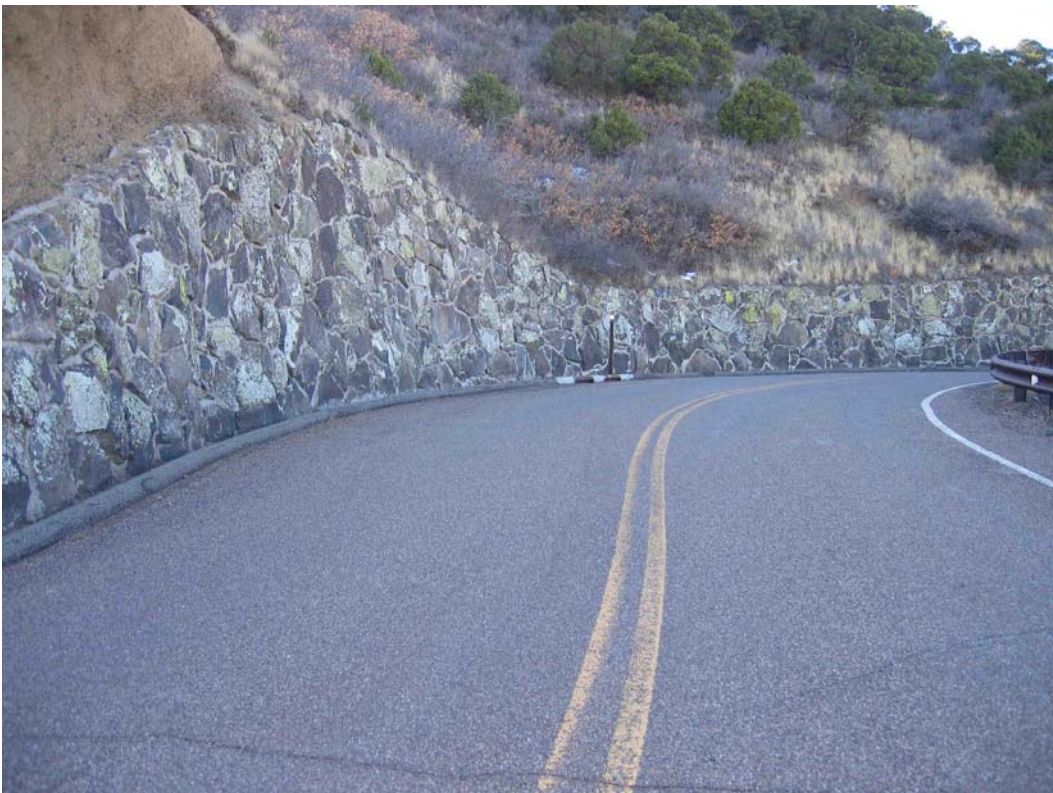
| Wall ID: | CAVO-0010-2.138-L | | |

| Element (Weighting Factor) | Narrative | Condition Rating (0 - 10) |
|---|--|---|
| WALL FOUNDATION MATERIAL 8.00 | Road at wall base shows no signs of distress due to wall settlement or deformation, indicating foundation is dense, strong, stable, and well-drained. | 10 |
| STONE MASONRY 8.00 | Strong, unweathered rock, showing no signs of cracking or degradation. Mortar is sound, durable, and shows little or no signs of cracking or deterioration. | 10 |
| CURB/BERM/DITCH 0.50 | Curbing performing as intended, showing only minor cracking. | 9 |

| Recommendation Narrative: | None |
