# COLM WIP Report

## NPS Retaining Wall Inventory Program Colorado National Monument

**Federal Lands Highway  
Road Inventory Program**

**Data Collection Date: May 2007  
Report Date: October 2015**

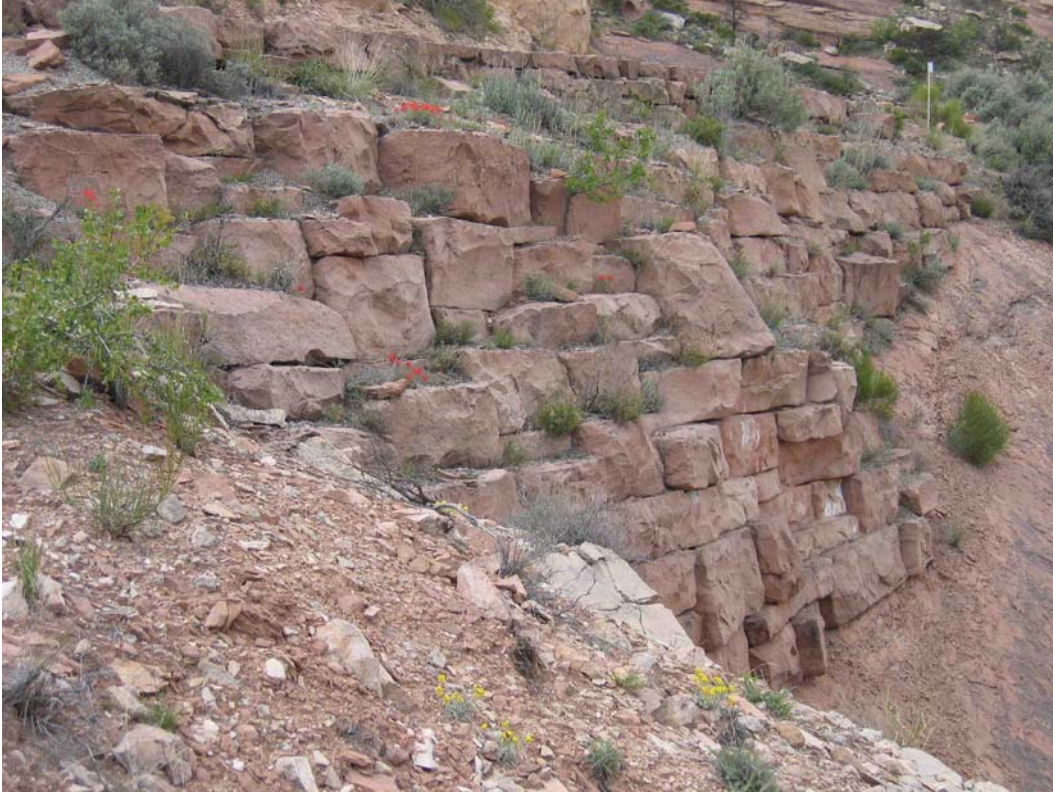
COLM\_0010\_0.840\_R\_1.jpg

<b>Element (Weighting Factor)</b>	<b>Narrative</b>	<b>Condition Rating (0 - 10)</b>
PERFORMANCE 8.00	No signs of global distresses. Functioning as intended.	8
WALL FOUNDATION MATERIAL 8.00	Foundation is hard, durable and stable sandstone, showing no signs of bearing distress.	9
PLACED STONE 8.00	See stone masonry.	8
STONE MASONRY 8.00	Dense, fresh cut sandstone blocks showing no signs of weathering, cracking, or similar distress. No blocks are missing or displaced.	8
ROAD/SIDEWALK/SHOULDER 0.50	No signs of distress, cracking, or settlement.	8
WALL DRAINS 0.50	No visible drains, but wall appears to be draining without problem - no signs of water staining, seepage, or soft ground.	8
LATERAL SLOPE 0.50	Lateral slopes are either exposed durable bedrock or well-vegetated, draining soil slopes showing no signs of erosion or slope distress.	9
TRAFFIC BARRIER/FENCE 1.00	Mortared stone guard wall with no significant signs of wall-related distress. Some minor mortar cracking, possibly due to wall settlement or weathering.	7

<b>Failure Consequence:</b>	HIGH
<b>Recommendation Narrative:</b>	None
<b>Repair Cost:</b>	\$0

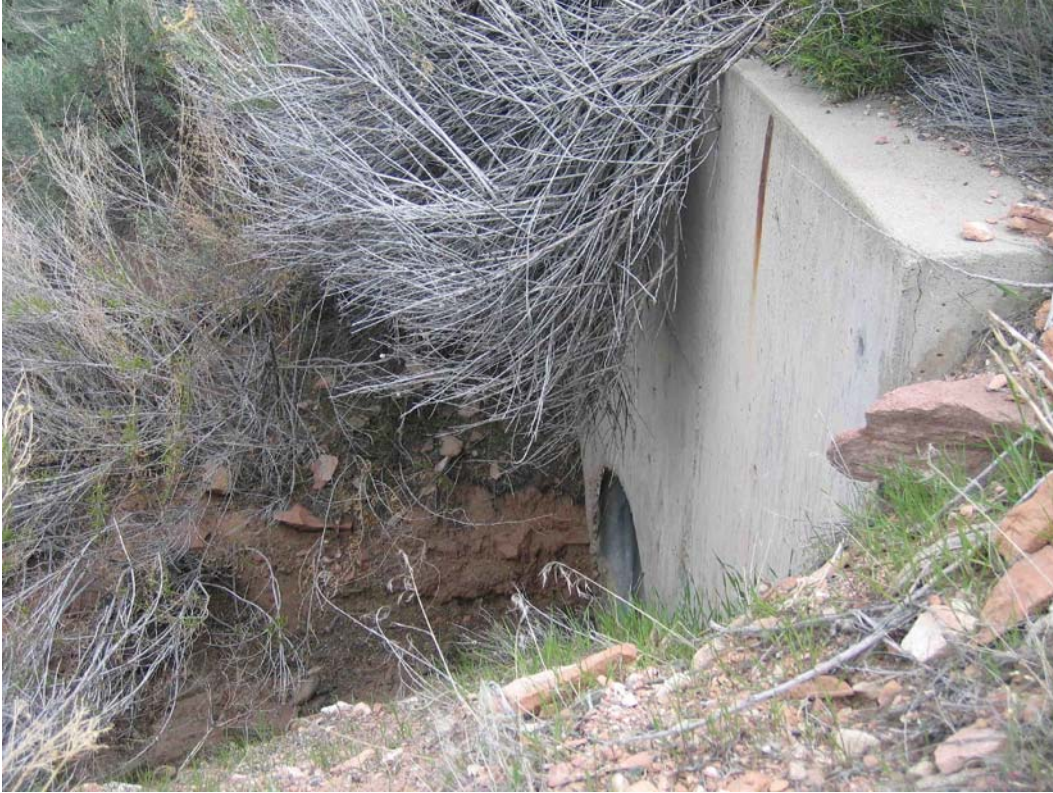
COLM\_0010\_1.040\_R\_1.jpg

<b>Element (Weighting Factor)</b>	<b>Narrative</b>	<b>Condition Rating (0 - 10)</b>
PERFORMANCE 8.00	No signs of global distresses. Performing as intended. No signs of rotation, significant settlement, or lost bearing due to scour.	9
WALL FOUNDATION MATERIAL 8.00	Firm, stable sandstone boulder and cobble soil mass. No signs of seepage, excessive erosion, etc.	8
CONCRETE 8.00	Excellent condition (like new), showing no signs of cracking, weathering or chemical attack.	9
DOWNSLOPE 0.50	Steep, 40 deg. Slope comprised of broken sandstone rock. Appears stable with minor soil erosion.	8
LATERAL SLOPE 0.50	Steep slope comprised of broken sandstone blocks. Appears stable with minor soil erosion.	8
ROAD/SIDEWALK/SHOULDER 0.50	No signs of headwall-related distress.	8
CULVERT 0.50	Culvert pipe is functioning as intended, with no signs of distress to the headwall.	9
WALL DRAINS 0.50	No drains, but wall is clearly unaffected by water seepage.	9
