# CRLA WIP Report

## NPS Retaining Wall Inventory Program Crater Lake National Park

Data Collection Date: July 2007  
Report Date: October 2015

# Crater Lake National Park in Oregon

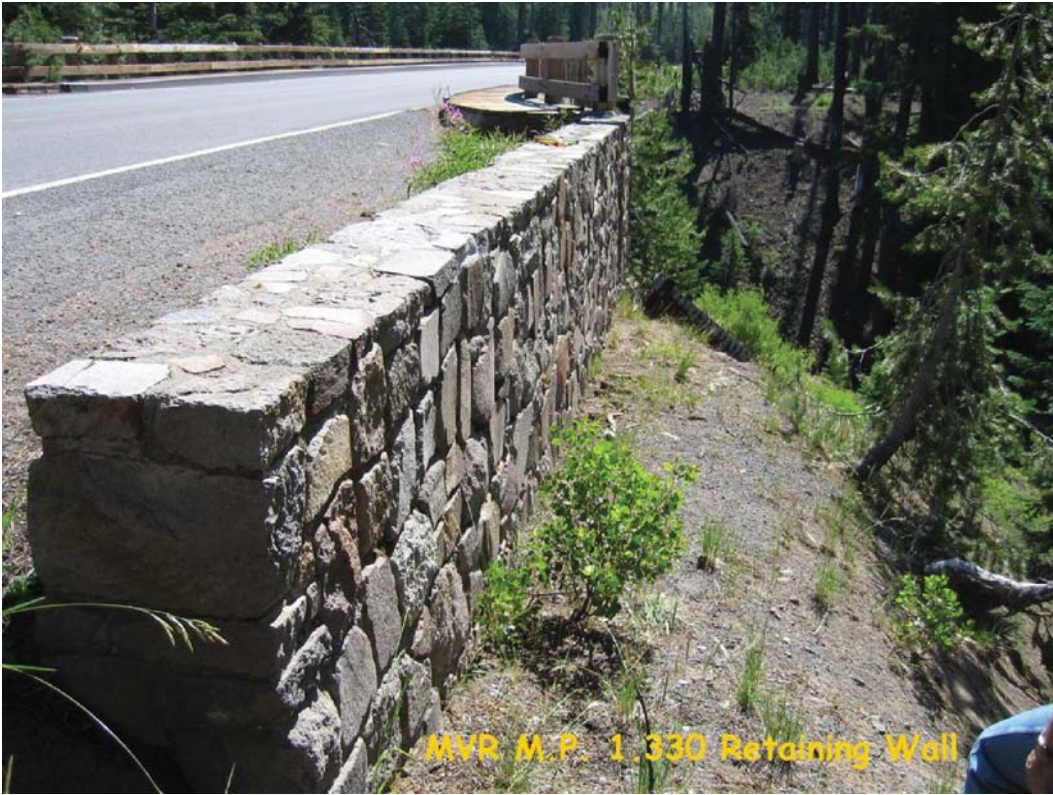
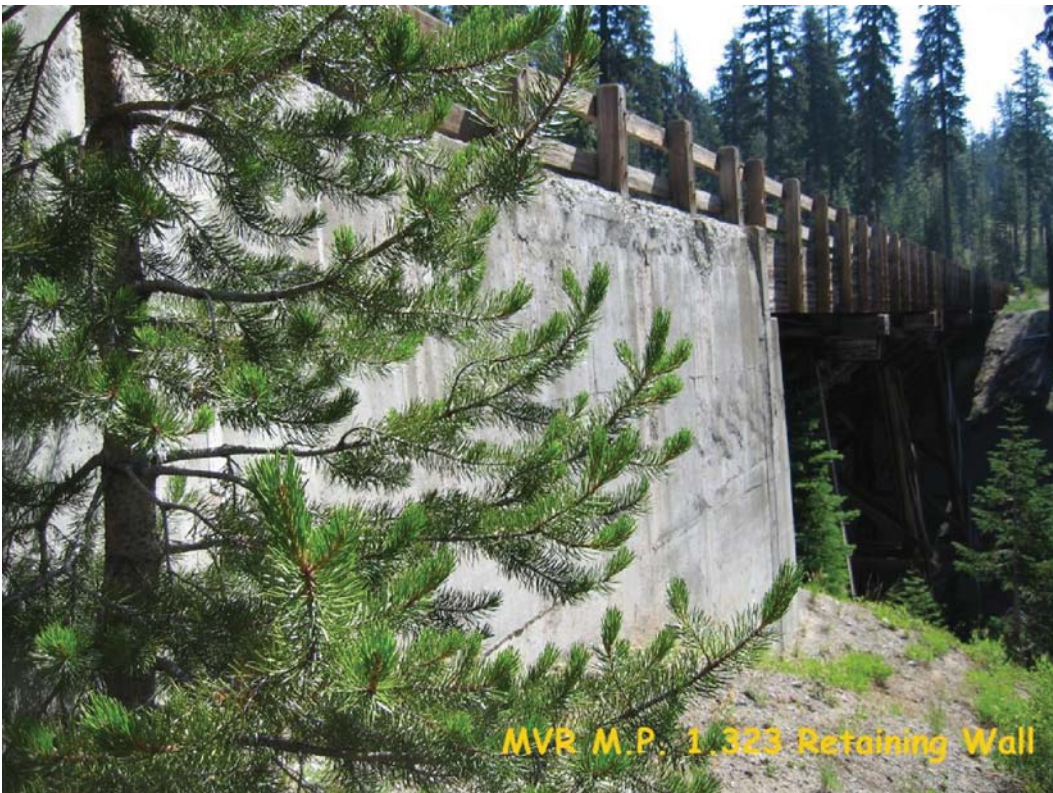
<b>Element (Weighting Factor)</b>	<b>Narrative</b>	<b>Condition Rating (0 - 10)</b>
PERFORMANCE 8.00	Wall is performing as constructed however to stop slope erosion under down drain, repair is recommended.	8
WALL FOUNDATION MATERIAL 8.00	4 foot flat soil bench/ road fill	9
MORTAR 8.00	Evidence of debonding and spalling over 10% of the wall area. Average depth is 2 inches and width of 0.5 to 1 inch. There is one vertical crack mostly in the mortar, at 18.5 feet from start, 1/8 inch wide with one stone cracked. Not effecting the pe	8
STONE MASONRY 8.00	Strong stones that do not show any distress	9
DOWNSLOPE 0.50	35 degree soil slope with a few trees. Evidence of surface depth erosion	8
LATERAL SLOPE 0.50	Soil; some vegetation on the start end. At end of wall is a concrete bridge abutment	9
ROAD/SIDEWALK/SHOULDER 0.50	No wall related distress.	9
WALL DRAINS 0.50	No obvious drains, no distress	9
CURB/BERM/DITCH 1.00	Surface drainage at 32 feet from start of wall. 1/2 round CMP down drain below surface drain outlet that has shifted towards the end of the wall 1.5 feet O.C. It is missing one anchor on top	6

<b>Failure Consequence:</b>	HIGH
<b>Recommendation Narrative:</b>	Re-establish correct position for down drain and remove and replace 4 anchors at top. 16 man hrs. * \$55m = 880. 4 anchors * \$75 = 300. 300+880=1180
<b>Repair Cost:</b>	\$1,180

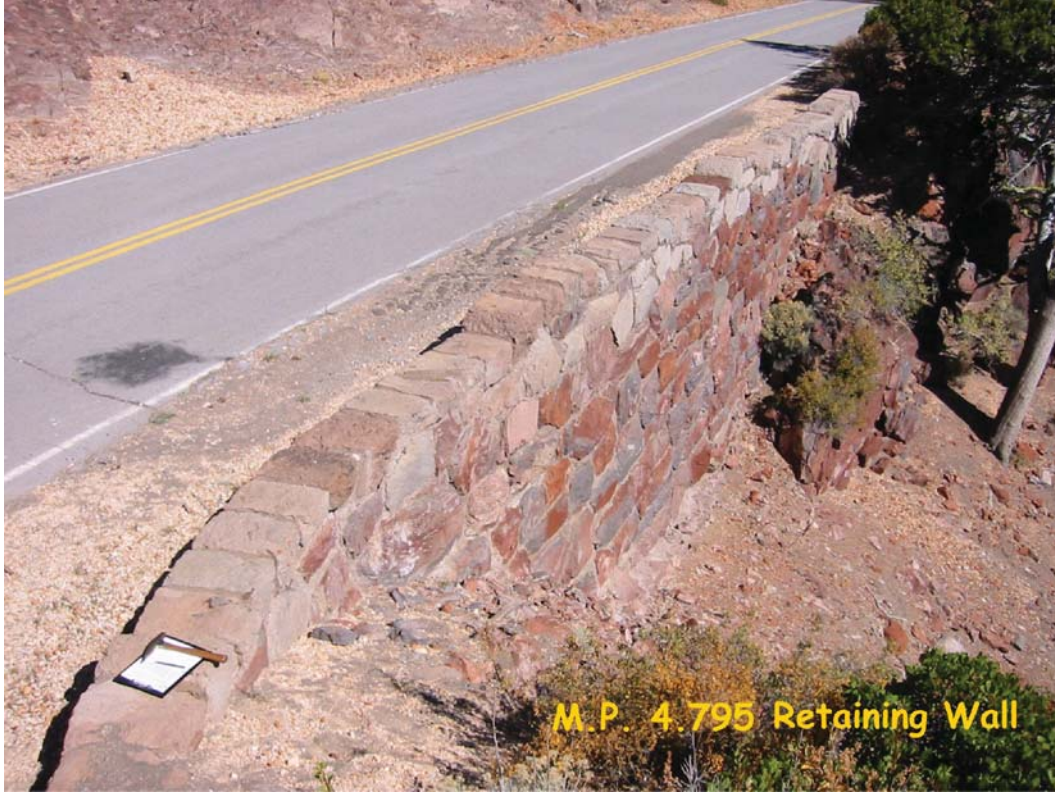
CRLA\_0013\_4.800\_L\_1.jpg

<b>Element (Weighting Factor)</b>	<b>Narrative</b>	<b>Condition Rating (0 - 10)</b>
PERFORMANCE 8.00	Foundation repaired	8
WALL FOUNDATION MATERIAL 8.00	Floater stones placed, rock & colluvium	8
MORTAR 8.00	Minor mortar cracking/debonding with an average depth of 2 inches and 1 inch wide over 10% of the wall surface.	8
STONE MASONRY 8.00	No distress	9
DOWNSLOPE 0.50	Steep colluvium, stable	8
CURB/BERM/DITCH 0.50	No wall related distress.	9
LATERAL SLOPE 0.50	Steep colluvium, stable	9
ROAD/SIDEWALK/SHOULDER 0.50	No wall related distress.	10
UPSLOPE 0.50	Red cliffs, stable	10

<b>Failure Consequence:</b>	MODERATE
<b>Recommendation Narrative:</b>	None
<b>Repair Cost:</b>	\$0

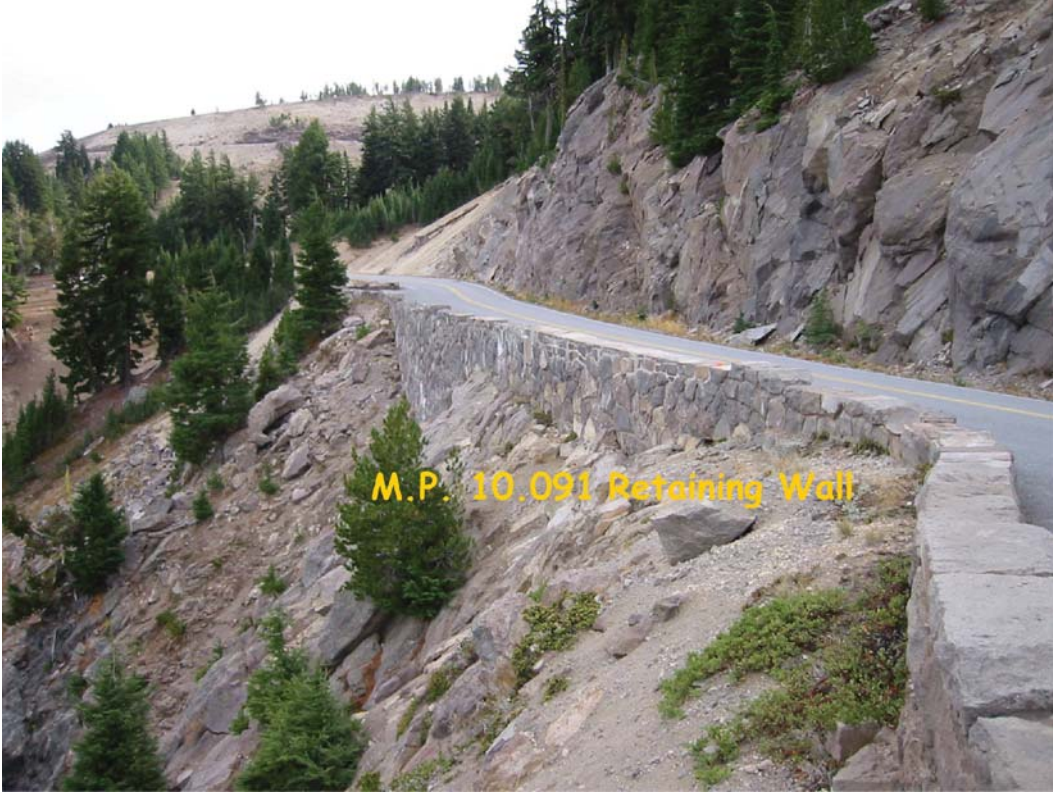
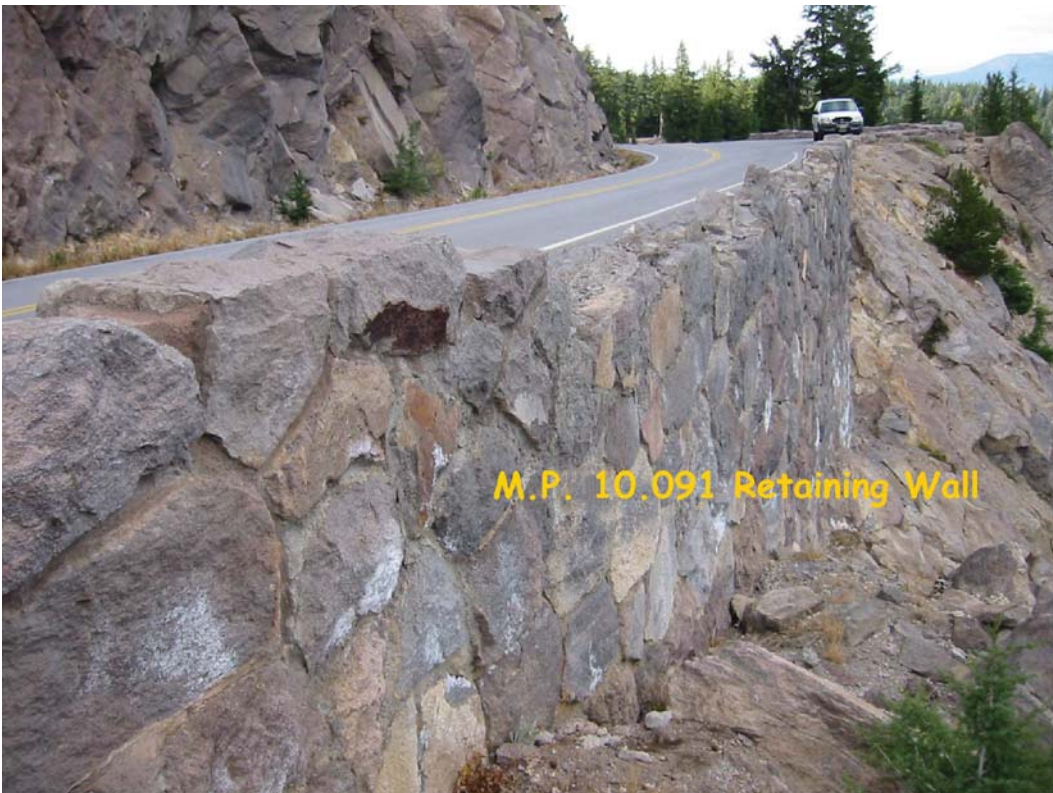
<b>Element (Weighting Factor)</b>	<b>Narrative</b>	<b>Condition Rating (0 - 10)</b>
PERFORMANCE 8.00	Performing as intended	10
WALL FOUNDATION MATERIAL 8.00	On rock	10
MORTAR 8.00	Repointed on upper wall and guardwall, in 2006-2007 season. Lower wall - cracking 1/8" to 1/4" ~ 15%. 1 to 2 inch voids infrequent. Lower wall end was repointed earlier	8
STONE MASONRY 8.00	No distress	9
CURB/BERM/DITCH 0.50	No wall related distress.	10
DOWNSLOPE 0.50	Rock slope	10
LATERAL SLOPE 0.50	Steep and rocky	10
ROAD/SIDEWALK/SHOULDER 0.50	No wall related distress.	10
UPSLOPE 0.50	Rock slope	10

<b>Failure Consequence:</b>	MODERATE
<b>Recommendation Narrative:</b>	None
<b>Repair Cost:</b>	\$0

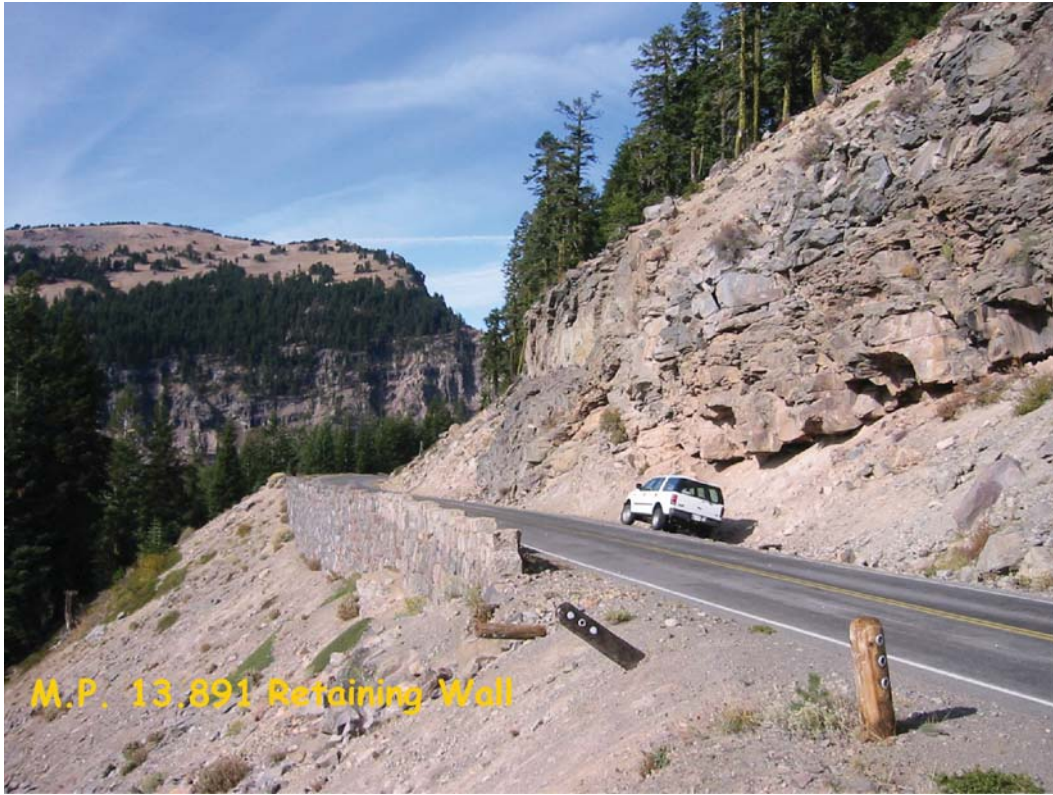
CRLA\_0013\_13.930\_L\_1.jpg

<b>Element (Weighting Factor)</b>	<b>Narrative</b>	<b>Condition Rating (0 - 10)</b>
PERFORMANCE 8.00	Mortar distress problem long term.	7
WALL FOUNDATION MATERIAL 8.00	No bedrock, no undermining; probable repair at base, but could be original construction	9
MORTAR 8.00	First 45 feet of wall shows considerable spalling over 60% - voids to 4" deep and 2" wide. From 45-160 ft debonding over 15%, remaining wall debonding over about 35%.	6
STONE MASONRY 8.00	No distress.	9
DOWNSLOPE 0.50	Steep colluvium that can ravel. Appears to be stable.	8
LATERAL SLOPE 0.50	Steep colluvium	9
WALL DRAINS 0.50	At least two weep holes present	9
CURB/BERM/DITCH 0.50	No wall related distress.	10
ROAD/SIDEWALK/SHOULDER 0.50	No wall related distress.	10

<b>Failure Consequence:</b>	HIGH
<b>Recommendation Narrative:</b>	Repointing of 50% of wall face: Wall area = 2040.3 x 0.5 = 963.275 Repointing 1020.15sf * \$75/sf = \$76511
<b>Repair Cost:</b>	\$76,511

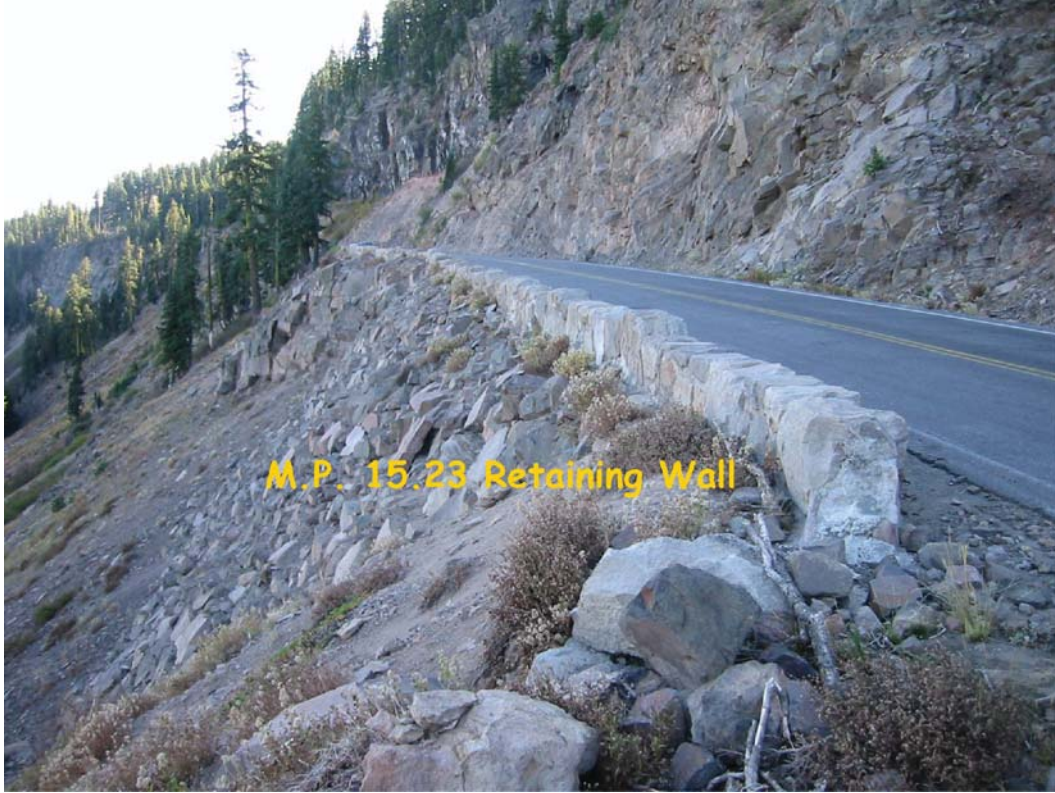
CRLA\_0013\_15.271\_L\_1.jpg

<b>Element (Weighting Factor)</b>	<b>Narrative</b>	<b>Condition Rating (0 - 10)</b>
PERFORMANCE 8.00	Performing as intended	9
WALL FOUNDATION MATERIAL 8.00	Steep colluvium, no bench, stable	8
PLACED STONE 8.00	Minimal voids, slight surface irregularities, stones tight (good interlock).	9
ROAD/SIDEWALK/SHOULDER 0.50	Pavement cracking at base of parapet, parapet related	8
DOWNSLOPE 0.50	Colluvial, ravelly but stable	9
LATERAL SLOPE 0.50	Rock outcrop at end, stable colluvium at start	9
WALL DRAINS 0.50	Self draining face, no distress	9

<b>Failure Consequence:</b>	MODERATE
<b>Recommendation Narrative:</b>	None
<b>Repair Cost:</b>	\$0

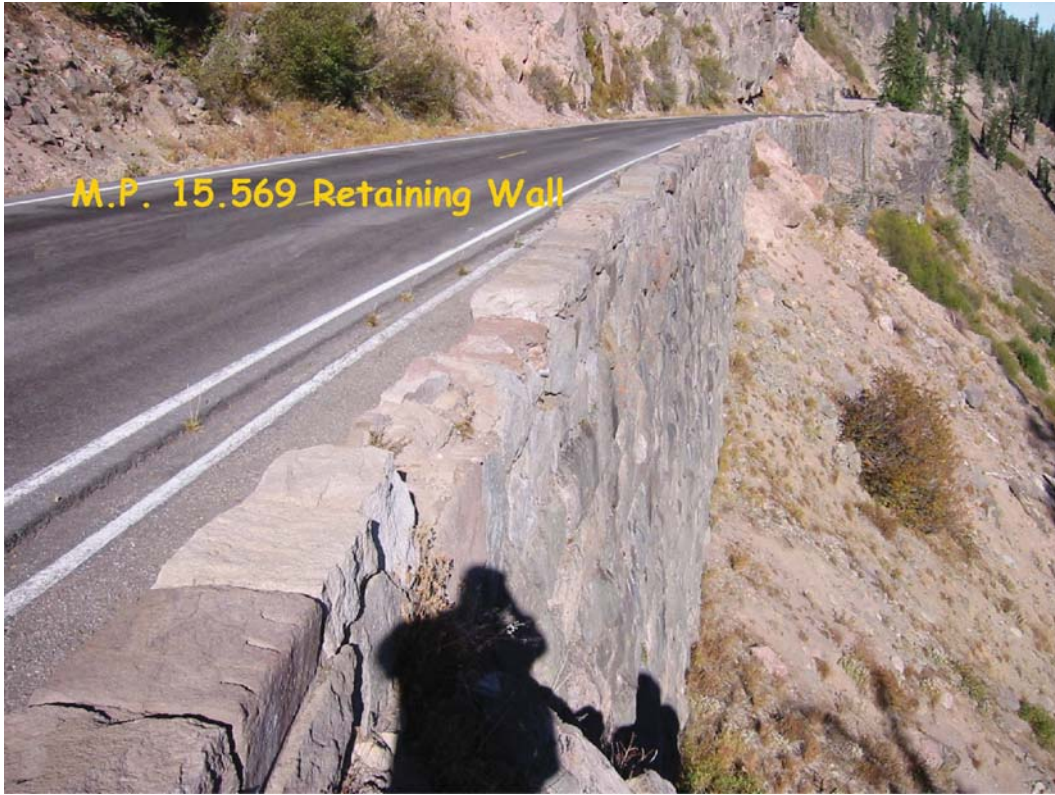
CRLA\_0013\_15.623\_L\_1.jpg

<b>Wall ID:</b>	CRLA-0013-15.623-L		
<b>Route Name:</b>	EAST RIM DRIVE		
<b>Inspection Date:</b>	July 18, 2007	<b>Approximate Year Built:</b>	1937
<b>*Wall Rating:</b>	78	<b>Maintenance Action:</b>	Repair Elements

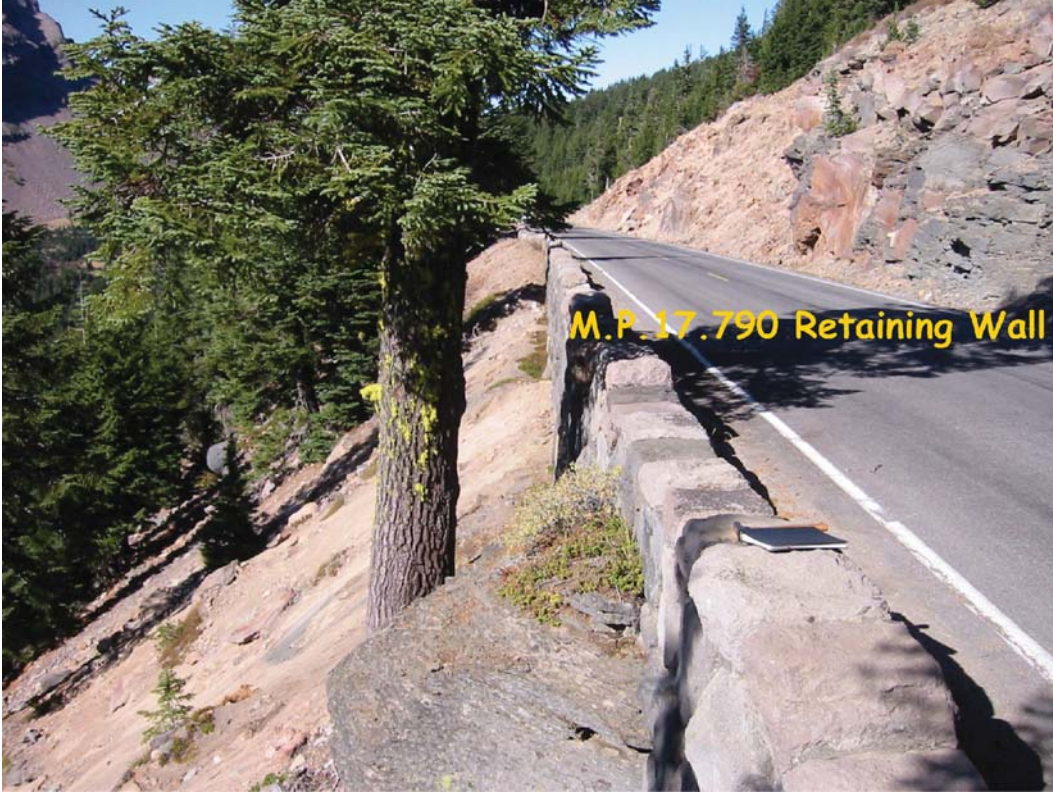
CRLA\_0013\_17.832\_L\_1.jpg

<b>Wall ID:</b>	CRLA-0013-17.832-L		
<b>Route Name:</b>	EAST RIM DRIVE		
<b>Inspection Date:</b>	July 18, 2007	<b>Approximate Year Built:</b>	Unknown
<b>*Wall Rating:</b>	88	<b>Maintenance Action:</b>	No Action

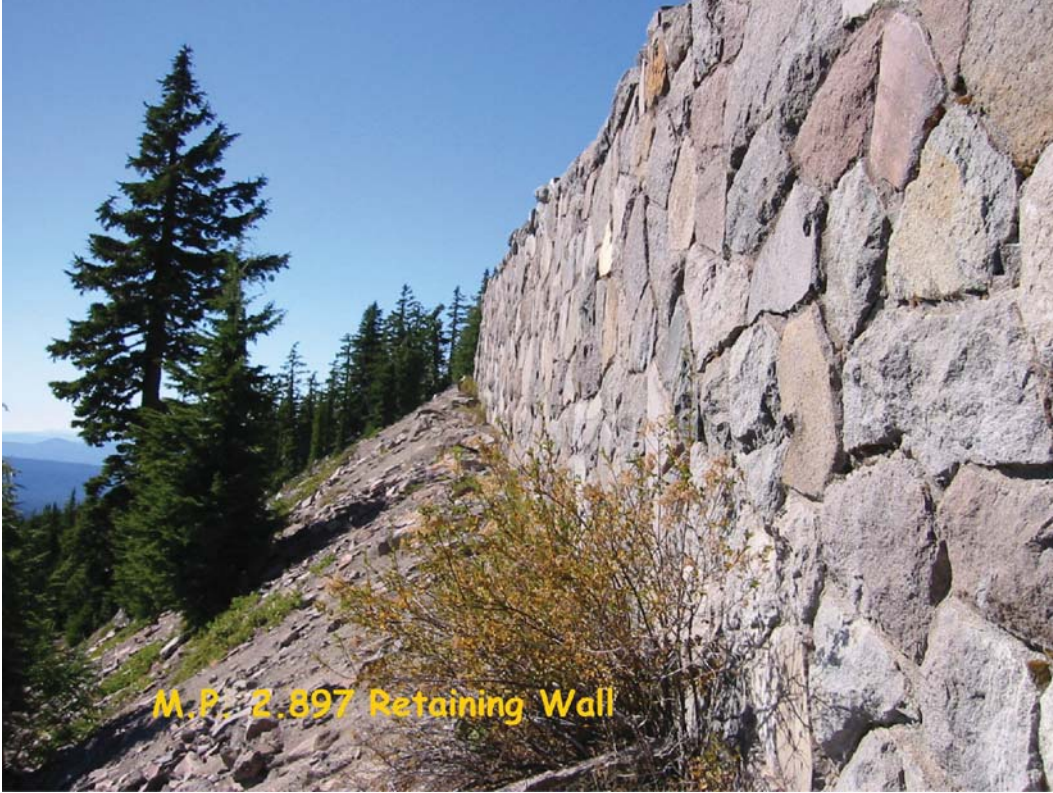
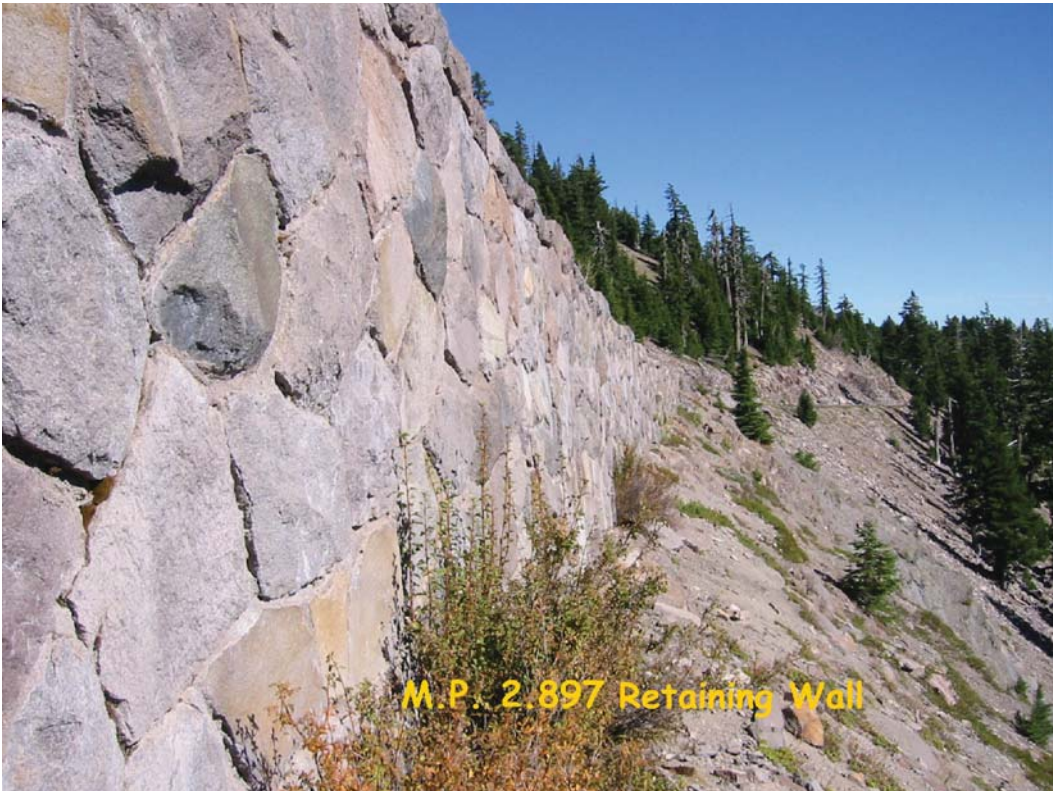
<b>Wall ID:</b>	CRLA-0014-2.900-L		
<b>Route Name:</b>	WEST RIM DRIVE		
<b>Inspection Date:</b>	July 17, 2007	<b>Approximate Year Built:</b>	1931
<b>*Wall Rating:</b>	63	<b>Maintenance Action:</b>	Replace Elements
<b>Wall Description</b>			
<b>Wall Function:</b>	Fill Wall	<b>Primary Wall Type:</b>	Gravity - Mortared Stone
<b>Surface Treatment:</b>		<b>Secondary Wall Type:</b>	
<b>Secondary Surface Treatment:</b>		<b>Architectural Facing:</b>	
<b>General Description:</b>	Rock cut upslope, guardwall full length		
<b>Wall Measurements</b>			
<b>Wall Length (ft.):</b>	328	<b>Face Area (sq.):</b>	2642
<b>Average Wall Height (ft.):</b>	8	<b>Face Angle (deg.):</b>	87
<b>Maximum Wall Height (ft.):</b>	10	<b>Vertical Offset (ft.):</b>	0
<b>Assessed Elements</b>			
<b>Element (Weighting Factor)</b>	<b>Narrative</b>		<b>Condition Rating (0 - 10)</b>
PERFORMANCE 8.00	Surface drainage and mortar distress threatening short term wall performance		6

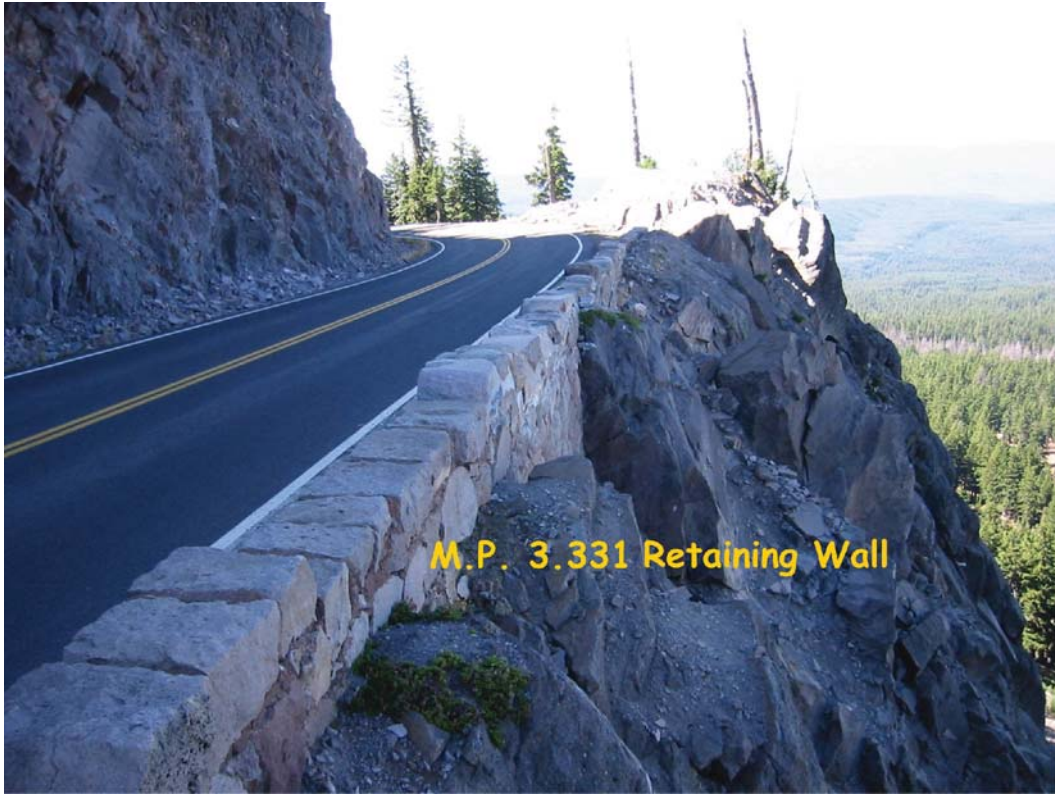
CRLA\_0014\_3.333\_L\_1.jpg

<b>Wall ID:</b>	CRLA-0014-3.333-L		
<b>Route Name:</b>	WEST RIM DRIVE		
<b>Inspection Date:</b>	July 17, 2007	<b>Approximate Year Built:</b>	1931
<b>*Wall Rating:</b>	88	<b>Maintenance Action:</b>	No Action

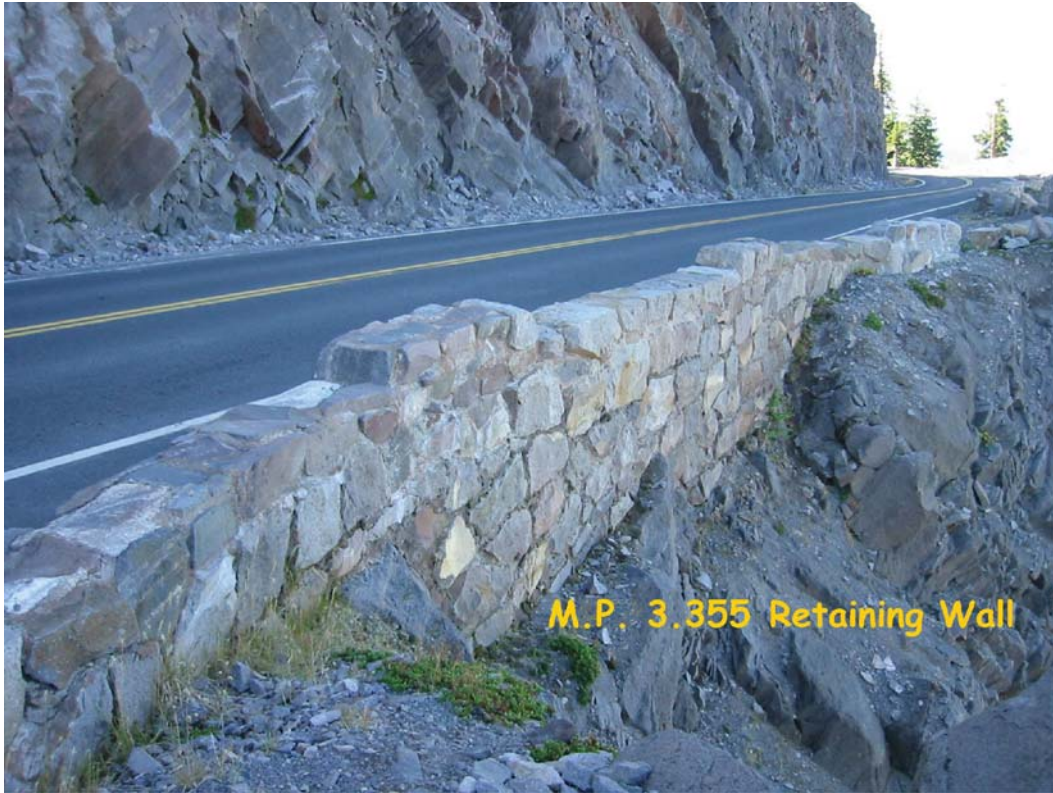
CRLA\_0014\_3.359\_L\_1.jpg

<b>Wall ID:</b>	CRLA-0014-3.359-L		
<b>Route Name:</b>	WEST RIM DRIVE		
<b>Inspection Date:</b>	July 17, 2007	<b>Approximate Year Built:</b>	1931
<b>*Wall Rating:</b>	86	<b>Maintenance Action:</b>	No Action

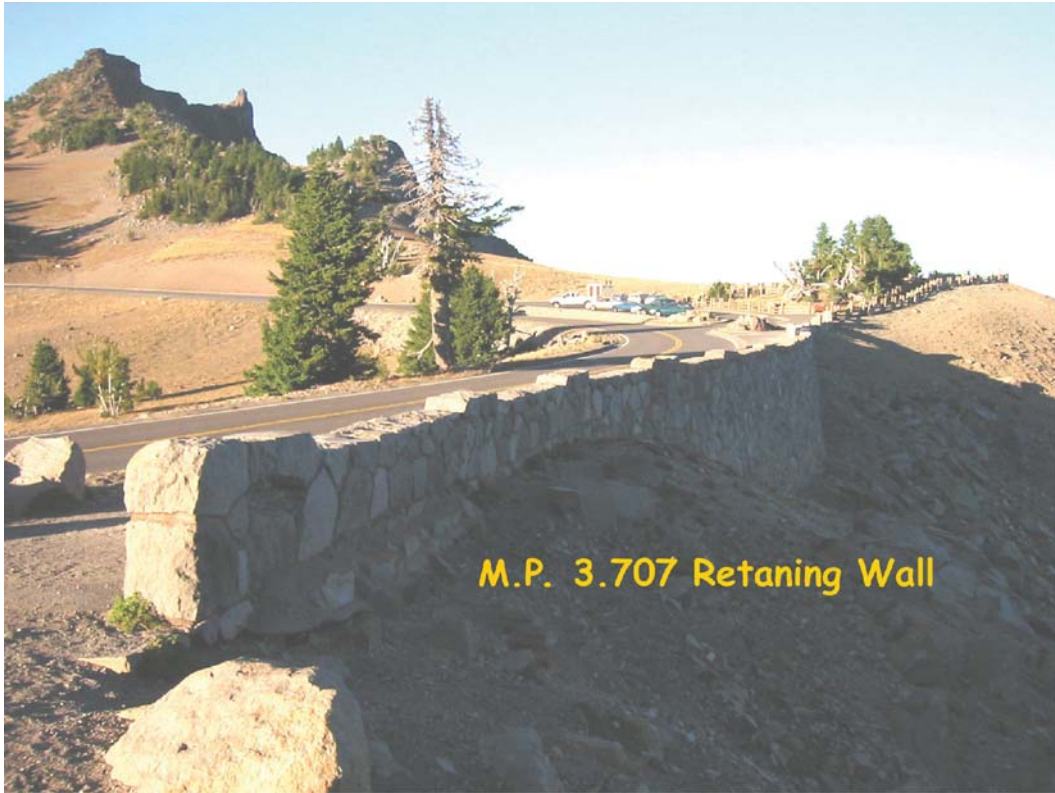
CRLA\_0014\_3.710\_R\_1.jpg

<b>Wall ID:</b>	CRLA-0014-3.710-R		
<b>Route Name:</b>	WEST RIM DRIVE		
<b>Inspection Date:</b>	July 17, 2007	<b>Approximate Year Built:</b>	1931
<b>*Wall Rating:</b>	78	<b>Maintenance Action:</b>	No Action

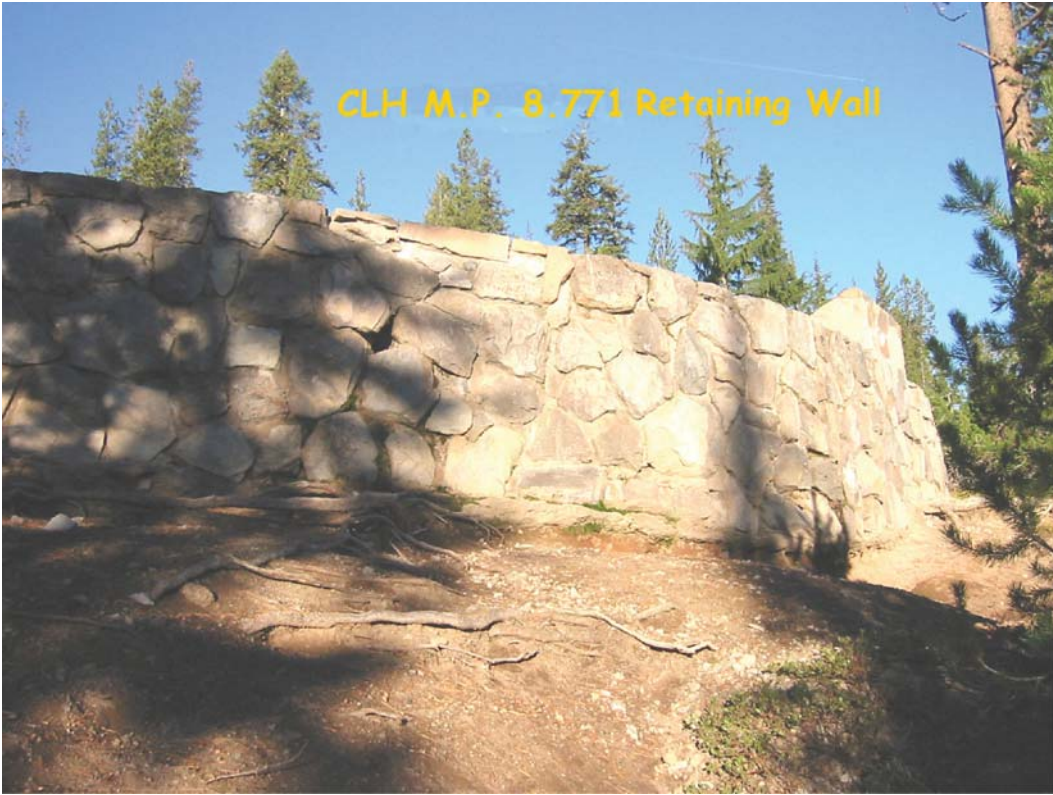
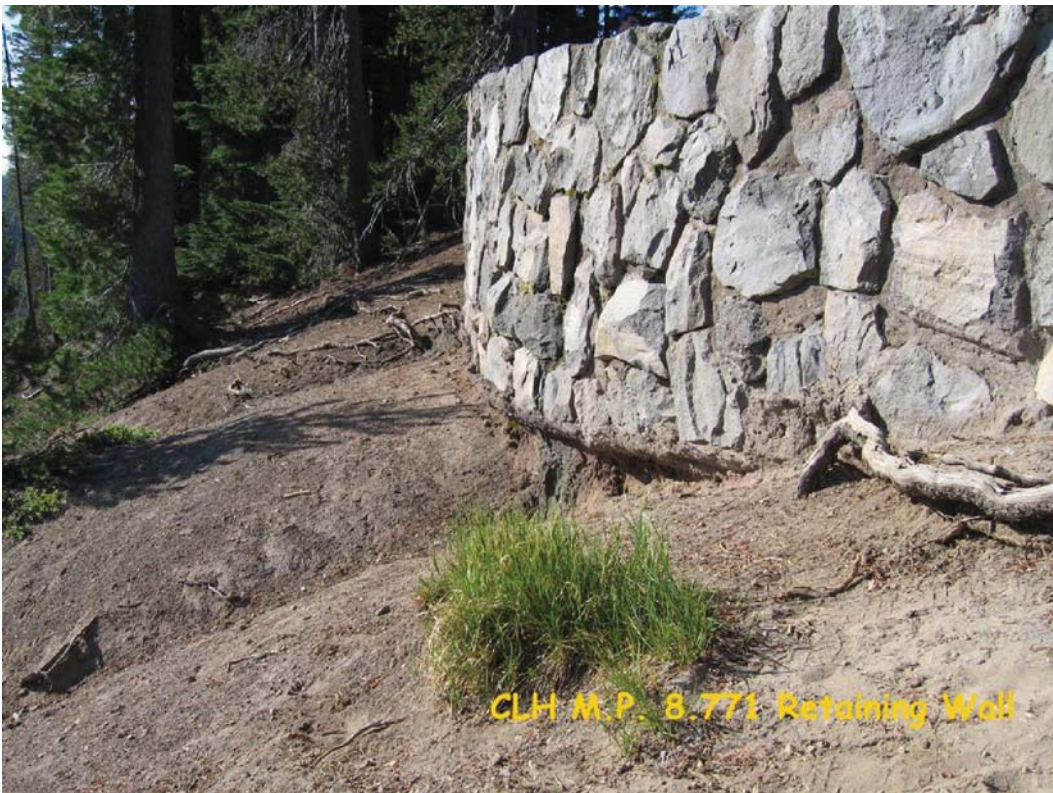
<b>Wall ID:</b>	CRLA-0914-0.000-P1		
<b>Route Name:</b>	FOSSIL FUMARoles - GODFREY GLEN OVERLOOK		
<b>Inspection Date:</b>	July 17, 2007	<b>Approximate Year Built:</b>	1958
<b>*Wall Rating:</b>	68	<b>Maintenance Action:</b>	Repair Elements

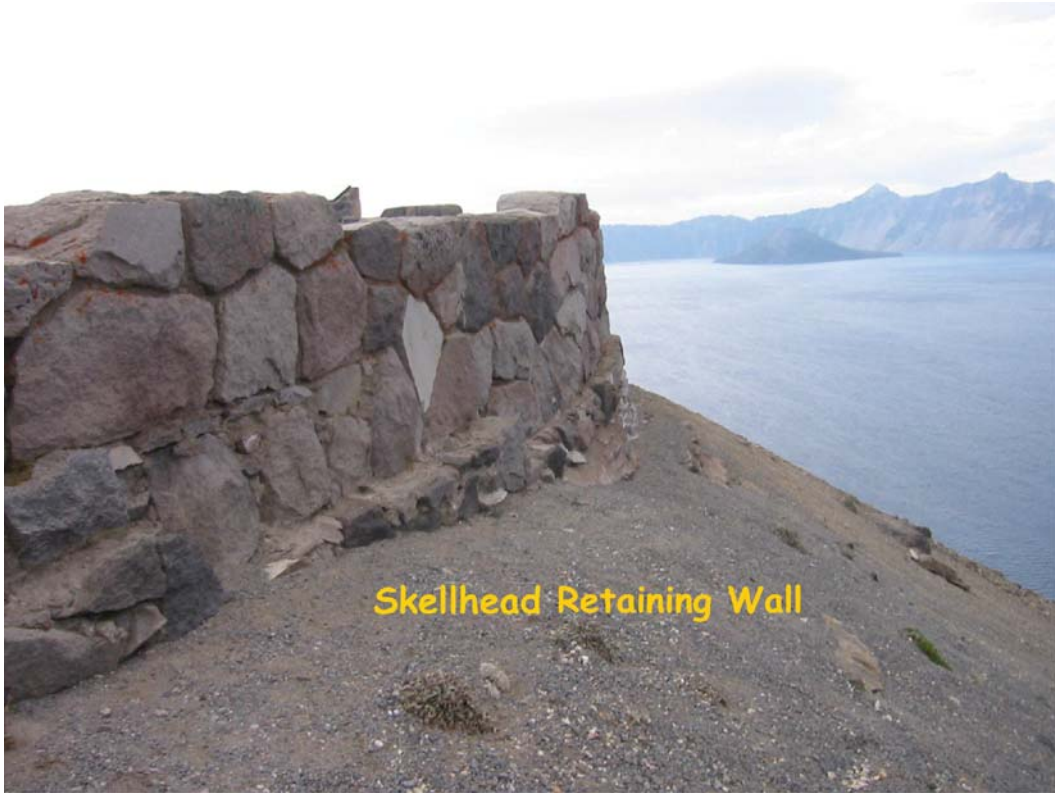
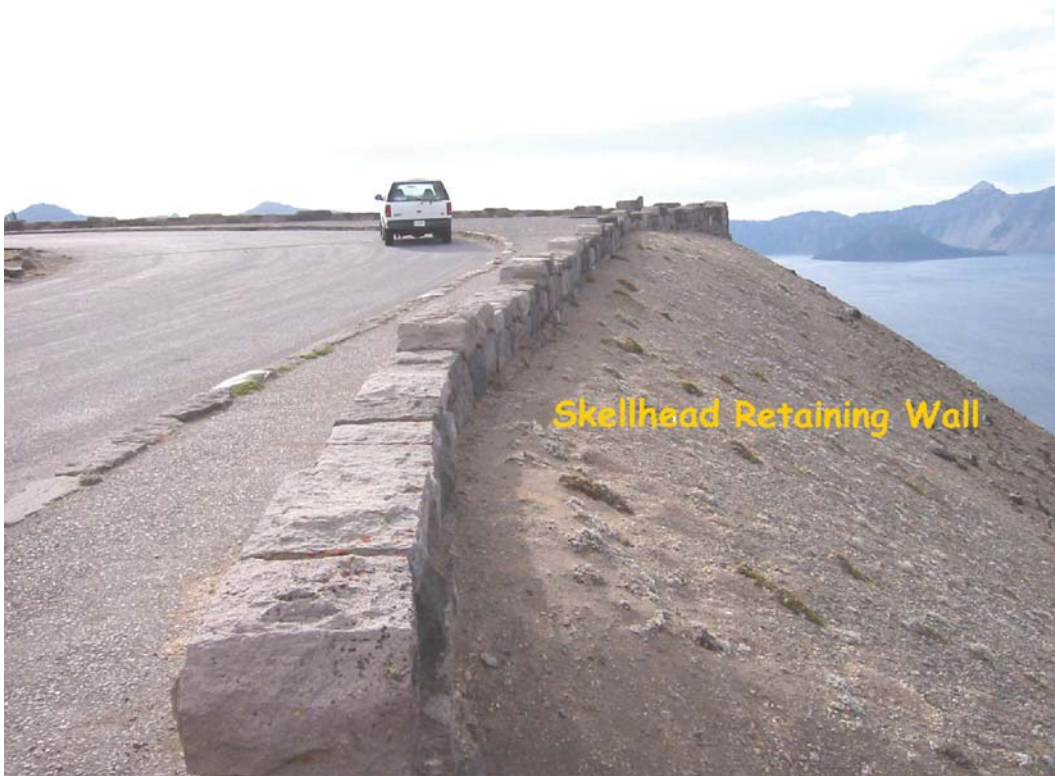
<b>Wall ID:</b>	CRLA-0932-0.000-P1		
<b>Route Name:</b>	SKELL HEAD OVERLOOK		
<b>Inspection Date:</b>	July 17, 2007	<b>Approximate Year Built:</b>	1934
<b>*Wall Rating:</b>	61	<b>Maintenance Action:</b>	Repair Elements

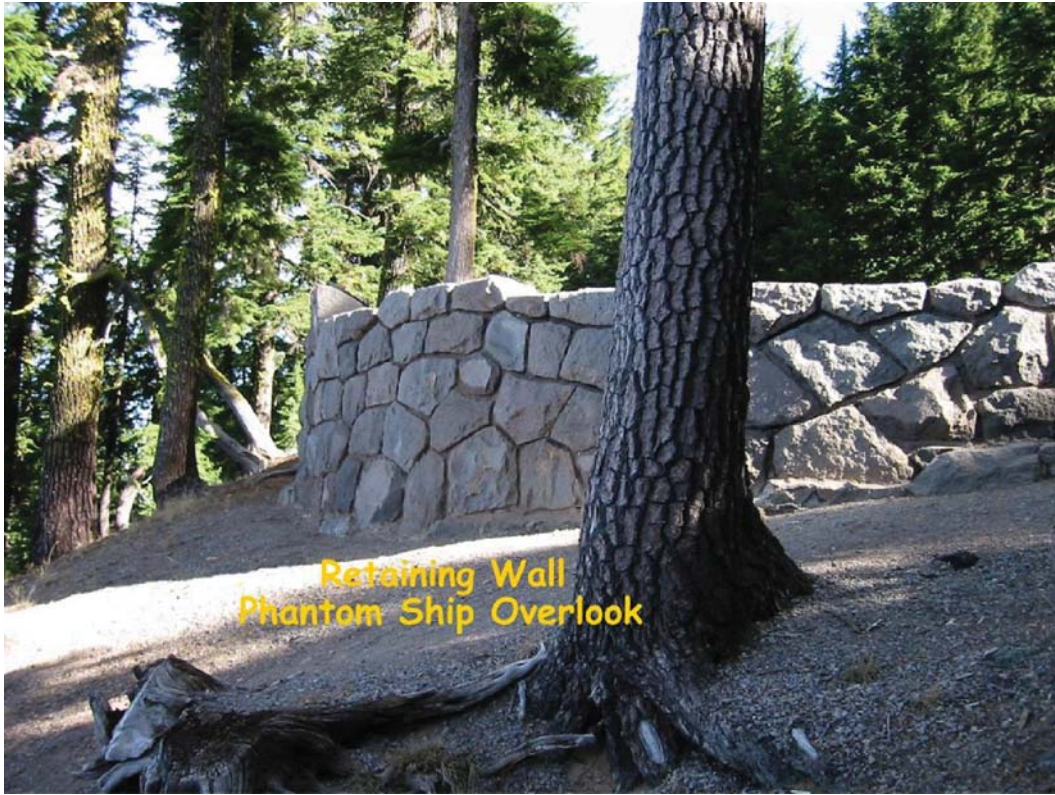
**CRLA\_0939\_0.000\_P1\_1.jpg**

<b>Wall ID:</b>	CRLA-0939-0.000-P1		
<b>Route Name:</b>	PHANTOM SHIP OVERLOOK		
<b>Inspection Date:</b>	July 17, 2007	<b>Approximate Year Built:</b>	1936
<b>*Wall Rating:</b>	85	<b>Maintenance Action:</b>	No Action
