# DEWA WIP Report

## NPS Retaining Wall Inventory Program Delaware Water Gap National Recreation Area

**Federal Lands Highway  
Road Inventory Program**

Data Collection Date: December 2007  
Report Date: October 2015

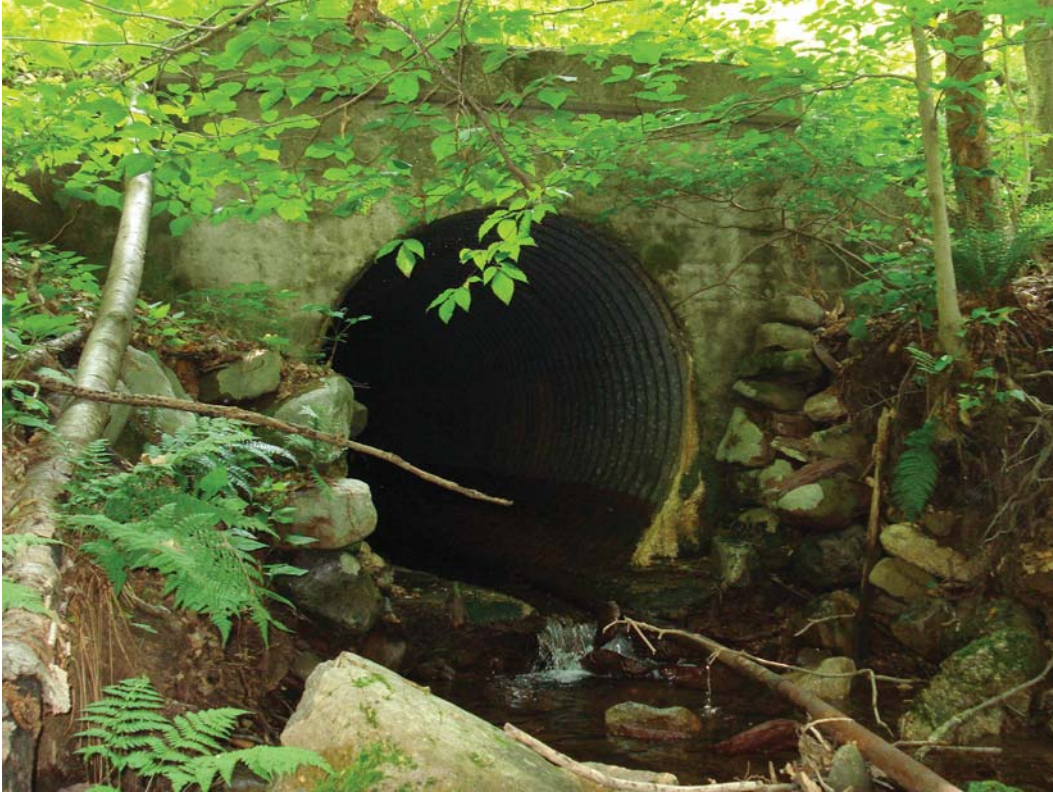
DEWA\_0010\_0.484\_L\_1.jpg

<b>Wall ID:</b>	DEWA-0010-0.484-L		
<b>Route Name:</b>	OLD MINE ROAD (SOUTH SECTION)		
<b>Inspection Date:</b>	August 02, 2007	<b>Approximate Year Built:</b>	Unknown
<b>*Wall Rating:</b>	72	<b>Maintenance Action:</b>	Repair Elements
<b>Wall Description</b>			
<b>Wall Function:</b>	Head Wall	<b>Primary Wall Type:</b>	Gravity - Mass Concrete
<b>Surface Treatment:</b>		<b>Secondary Wall Type:</b>	
<b>Secondary Surface Treatment:</b>		<b>Architectural Facing:</b>	
<b>General Description:</b>	Concrete outlet headwall for a 60 in diameter CMP culvert constructed along left shoulder and along base of steep slope supporting a very low ADT roadway moderate consequence of failure		
<b>Wall Measurements</b>			
<b>Wall Length (ft.):</b>	20	<b>Face Area (sq.):</b>	94
<b>Average Wall Height (ft.):</b>	4	<b>Face Angle (deg.):</b>	90
<b>Maximum Wall Height (ft.):</b>	9	<b>Vertical Offset (ft.):</b>	-25
<b>Assessed Elements</b>

<b>Element (Weighting Factor)</b>	<b>Narrative</b>		<b>Condition Rating (0 - 10)</b>
PERFORMANCE 8.00	Good condition; 1/8-in. crack along top of wall; scour hole causing ongoing bank erosion and undermining of concrete apron; several medium to large diameter trees growing within 3 ft of wall		5
WALL FOUNDATION MATERIAL 8.00	No evidence of rotation, seepage or undermining; crack along top of wall suggests minor settlement along southern half of wall		8
CONCRETE 8.00	1/8-inch crack emanating from crown of culvert and extending up to top of wall; minor efflorescence around opening		8
WALL DRAINS 0.50	No evidence of drainage-related distress		9
LATERAL SLOPE 0.50	No distress; no evidence of movement; no erosion		10
ROAD/SIDEWALK/SHOULDER 0.50	No distress to pavement		10
TRAFFIC BARRIER/FENCE 0.50	No distress to relatively new steel-backed timber guard rail		10
UPSLOPE 0.50	No distress to moderate-to-steep heavily-vegetated slope		10

DOWNSLOPE 1.00	7-ft diameter x 0.5-ft deep scour hole adjacent to wall; scour hole is causing ongoing bank erosion		6
<b>Repair Recommendations</b>			
<b>Failure Consequence:</b>	MODERATE		
<b>Recommendation Narrative:</b>	Repair crack - 4.75 lft (\$5/lft) = \$23.75. Backfill scour hole - earthwork geotextile - (49sqft/9)(\$5/sqyd) = \$27.22. Placed riprap, class 3 - (24.5 cuft/27)(\$200/cuyd) = \$181.48 - 8 labor hrs (\$55/hr) = \$440. Reline 60-in. dia. cu		
<b>Repair Cost:</b>	\$39,902		
2007 cost estimate (ASTM Class D), preliminary for comparison to other repair costs only.

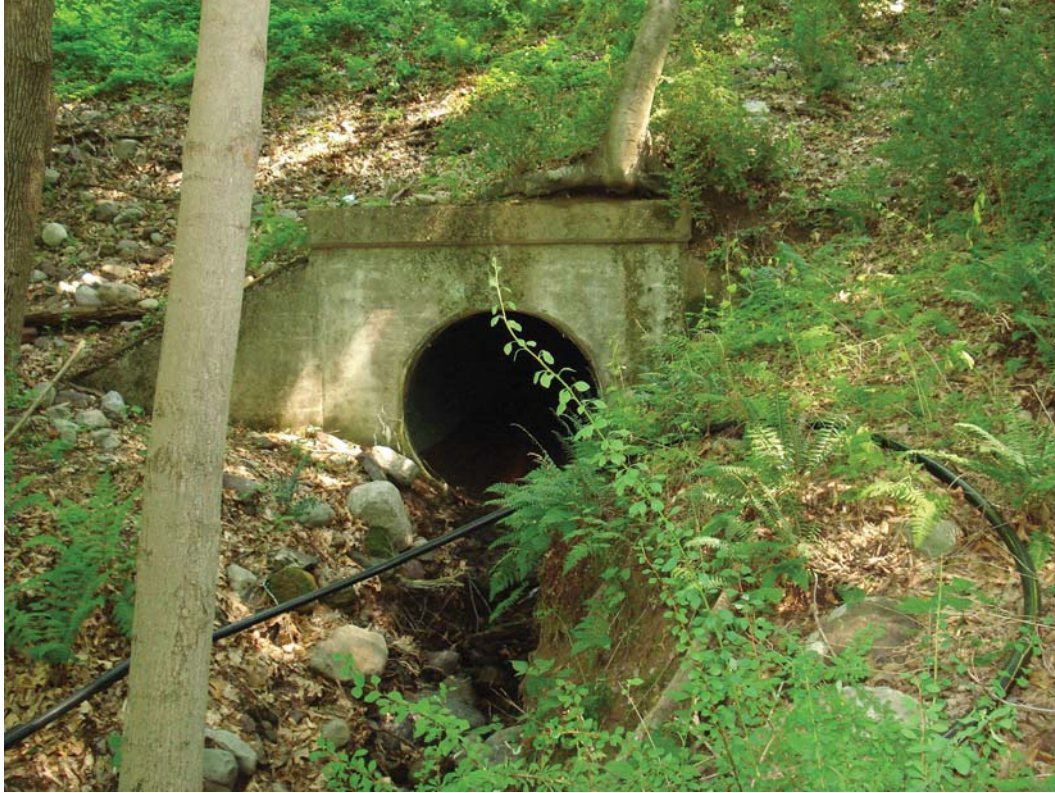
**DEWA\_0010\_0.803\_L\_1.jpg**

<b>Wall ID:</b>	DEWA-0010-0.803-L		
<b>Route Name:</b>	OLD MINE ROAD (SOUTH SECTION)		
<b>Inspection Date:</b>	August 02, 2007	<b>Approximate Year Built:</b>	Unknown
<b>*Wall Rating:</b>	72	<b>Maintenance Action:</b>	Repair Elements
<b>Wall Description</b>			
<b>Wall Function:</b>	Head Wall	<b>Primary Wall Type:</b>	Gravity - Mass Concrete
<b>Surface Treatment:</b>		<b>Secondary Wall Type:</b>	
<b>Secondary Surface Treatment:</b>		<b>Architectural Facing:</b>	
<b>General Description:</b>	Concrete inlet headwall for a 60 in diameter CMP constructed along left shoulder and along base of steep slope supporting a very low ADT roadway low consequence of failure		
<b>Wall Measurements</b>			
<b>Wall Length (ft.):</b>	20	<b>Face Area (sq.):</b>	74
<b>Average Wall Height (ft.):</b>	3	<b>Face Angle (deg.):</b>	90
<b>Maximum Wall Height (ft.):</b>	8	<b>Vertical Offset (ft.):</b>	-30
<b>Assessed Elements</b>			
<b>Element (Weighting Factor)</b>	<b>Narrative</b>		<b>Condition Rating (0 - 10)</b>

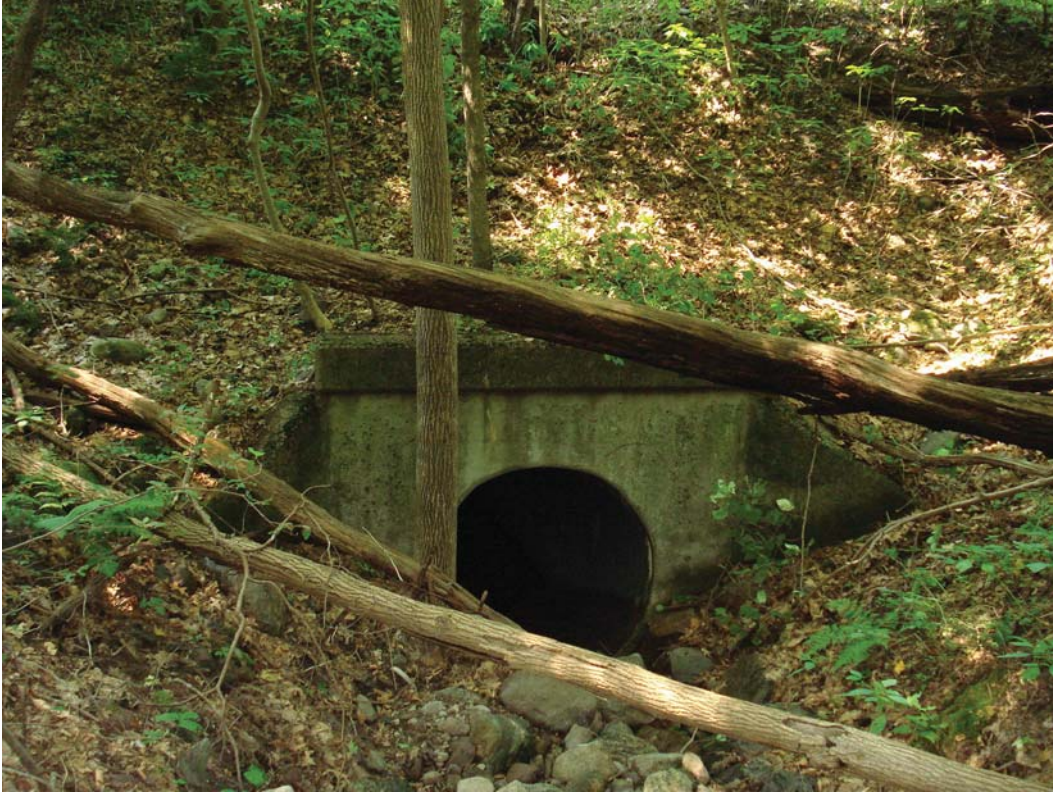
**DEWA\_0010\_0.803\_R\_1.jpg**

<b>Wall ID:</b>	DEWA-0010-0.803-R		
<b>Route Name:</b>	OLD MINE ROAD (SOUTH SECTION)		
<b>Inspection Date:</b>	August 02, 2007	<b>Approximate Year Built:</b>	Unknown
<b>*Wall Rating:</b>	87	<b>Maintenance Action:</b>	Maintenance
<b>Wall Description</b>			
<b>Wall Function:</b>	Head Wall	<b>Primary Wall Type:</b>	Gravity - Mass Concrete
<b>Surface Treatment:</b>		<b>Secondary Wall Type:</b>	
<b>Secondary Surface Treatment:</b>		<b>Architectural Facing:</b>	
<b>General Description:</b>	Concrete inlet headwall for a 60 in diameter CMP culvert constructed along right shoulder and along base of steep to moderate slope supporting a very low ADT roadway moderate consequence of failure		
<b>Wall Measurements</b>			
<b>Wall Length (ft.):</b>	18	<b>Face Area (sq.):</b>	72
<b>Average Wall Height (ft.):</b>	4	<b>Face Angle (deg.):</b>	90
<b>Maximum Wall Height (ft.):</b>	8	<b>Vertical Offset (ft.):</b>	-15
<b>Assessed Elements</b>

<b>Recommendation Narrative:</b>	Cut medium dia. Tree - 1 tree (\$200/tree) = \$200. Line 60-in. dia. Culvert (1/2 length) - 51.5 lnft (\$750/lnft) = \$38,625		
<b>Repair Cost:</b>	\$40,625		
2007 cost estimate (ASTM Class D), preliminary for comparison to other repair costs only.

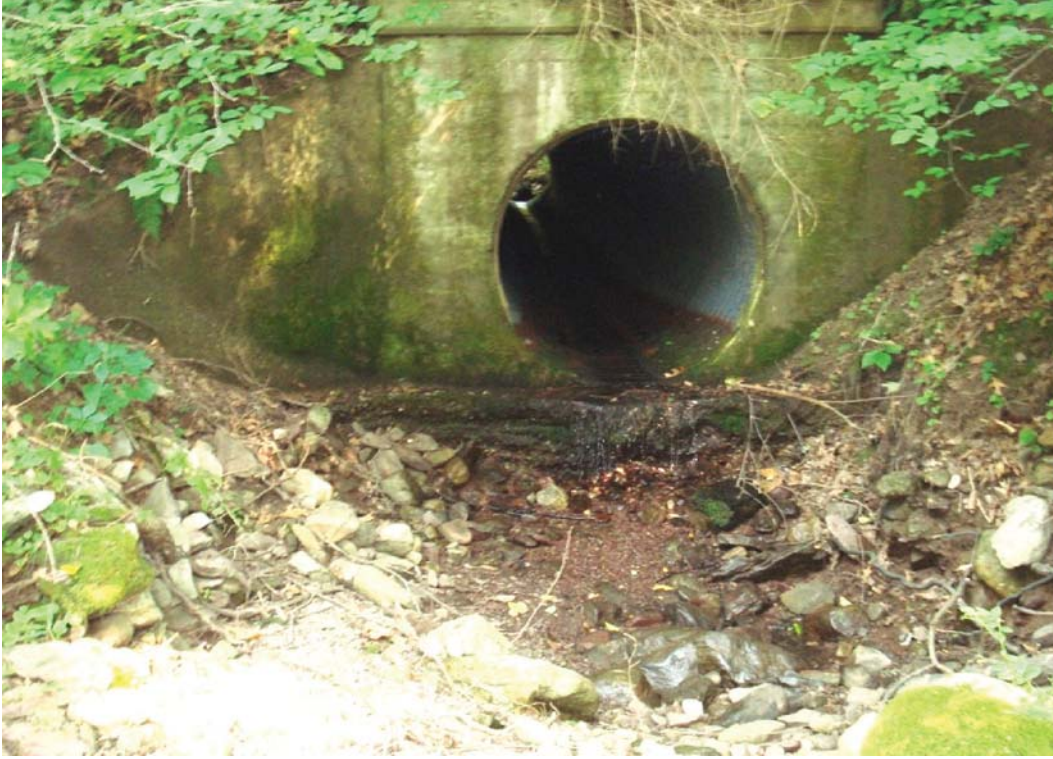
**DEWA\_0010\_1.137\_L\_1.jpg**

<b>Wall ID:</b>	DEWA-0010-1.137-L		
<b>Route Name:</b>	OLD MINE ROAD (SOUTH SECTION)		
<b>Inspection Date:</b>	August 02, 2007	<b>Approximate Year Built:</b>	Unknown
<b>*Wall Rating:</b>	83	<b>Maintenance Action:</b>	Maintenance
<b>Wall Description</b>			
<b>Wall Function:</b>	Head Wall	<b>Primary Wall Type:</b>	Gravity - Mass Concrete
<b>Surface Treatment:</b>		<b>Secondary Wall Type:</b>	
<b>Secondary Surface Treatment:</b>		<b>Architectural Facing:</b>	
<b>General Description:</b>	Concrete outlet headwall for a 60 in diameter CMP culvert constructed along left shoulder and along base of steep slope supporting a very low ADT roadway moderate consequence of failure		
<b>Wall Measurements</b>			
<b>Wall Length (ft.):</b>	22	<b>Face Area (sq.):</b>	90
<b>Average Wall Height (ft.):</b>	4	<b>Face Angle (deg.):</b>	90
<b>Maximum Wall Height (ft.):</b>	8	<b>Vertical Offset (ft.):</b>	-17
<b>Assessed Elements</b>

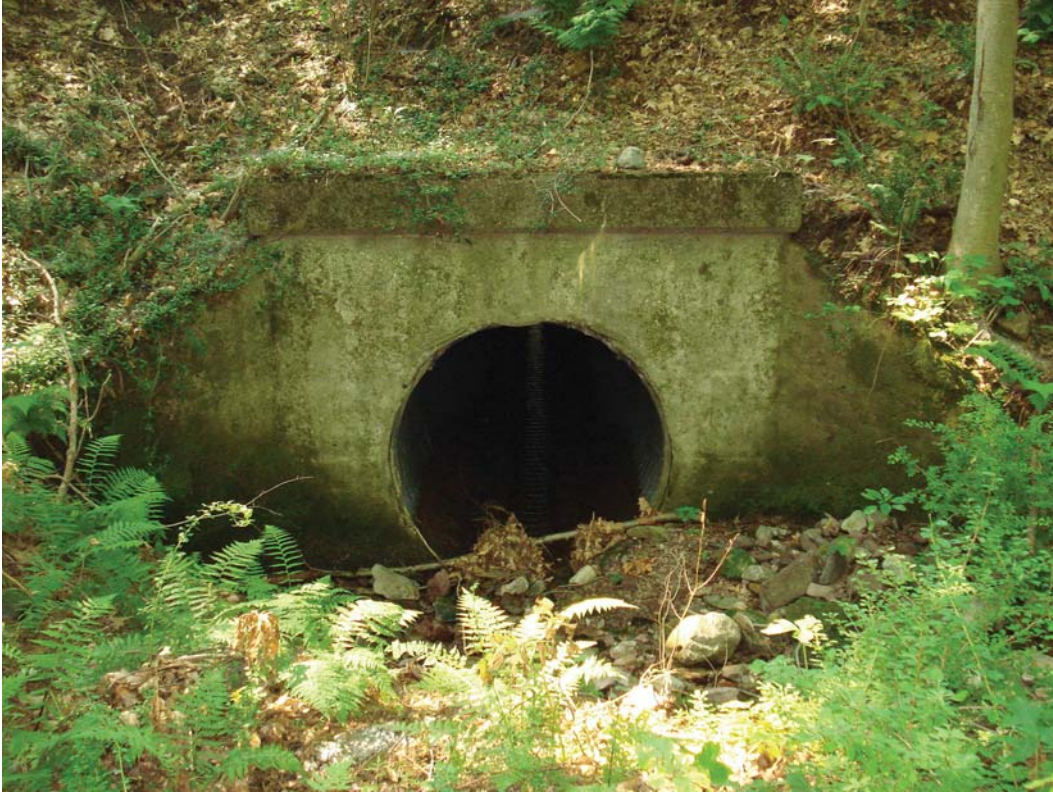
**DEWA\_0010\_1.137\_R\_1.jpg**

<b>Wall ID:</b>	DEWA-0010-1.137-R		
<b>Route Name:</b>	OLD MINE ROAD (SOUTH SECTION)		
<b>Inspection Date:</b>	August 02, 2007	<b>Approximate Year Built:</b>	Unknown
<b>*Wall Rating:</b>	84	<b>Maintenance Action:</b>	Maintenance
<b>Wall Description</b>			
<b>Wall Function:</b>	Head Wall	<b>Primary Wall Type:</b>	Gravity - Mass Concrete
<b>Surface Treatment:</b>		<b>Secondary Wall Type:</b>	
<b>Secondary Surface Treatment:</b>		<b>Architectural Facing:</b>	
<b>General Description:</b>	Concrete inlet headwall for 60 in diameter CMP constructed along right shoulder and along base of steep slope supporting very low ADT roadway moderate consequence of failure		
<b>Wall Measurements</b>			
<b>Wall Length (ft.):</b>	23	<b>Face Area (sq.):</b>	107
<b>Average Wall Height (ft.):</b>	4	<b>Face Angle (deg.):</b>	90
<b>Maximum Wall Height (ft.):</b>	8	<b>Vertical Offset (ft.):</b>	-12
<b>Assessed Elements</b>			
<b>Element (Weighting Factor)</b>	<b>Narrative</b>		<b>Condition Rating (0 - 10)</b>

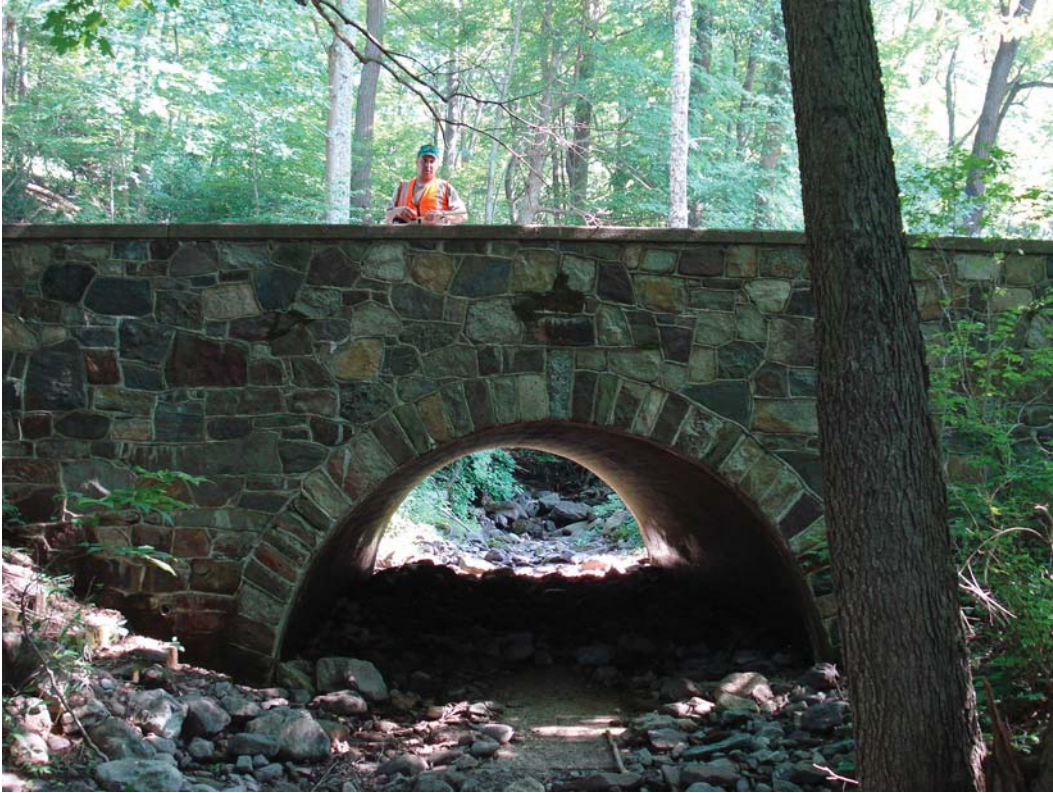
**DEWA\_0010\_1.650\_L\_1.jpg**

<b>Wall ID:</b>	DEWA-0010-1.650-L		
<b>Route Name:</b>	OLD MINE ROAD (SOUTH SECTION)		
<b>Inspection Date:</b>	August 02, 2007	<b>Approximate Year Built:</b>	1936
<b>*Wall Rating:</b>	81	<b>Maintenance Action:</b>	Maintenance
<b>Wall Description</b>			
<b>Wall Function:</b>	Head Wall	<b>Primary Wall Type:</b>	Gravity - Mortared Stone
<b>Surface Treatment:</b>		<b>Secondary Wall Type:</b>	
<b>Secondary Surface Treatment:</b>		<b>Architectural Facing:</b>	
<b>General Description:</b>	Stone masonry outlet headwall for 13 ft diameter concrete arch culvert 2.75 ft integrated stone masonry guard wall integrated into wall constructed along left side and directly supports a low ADT roadway		
<b>Wall Measurements</b>			
<b>Wall Length (ft.):</b>	44	<b>Face Area (sq.):</b>	191
<b>Average Wall Height (ft.):</b>	4	<b>Face Angle (deg.):</b>	90
<b>Maximum Wall Height (ft.):</b>	8	<b>Vertical Offset (ft.):</b>	0
<b>Assessed Elements</b>

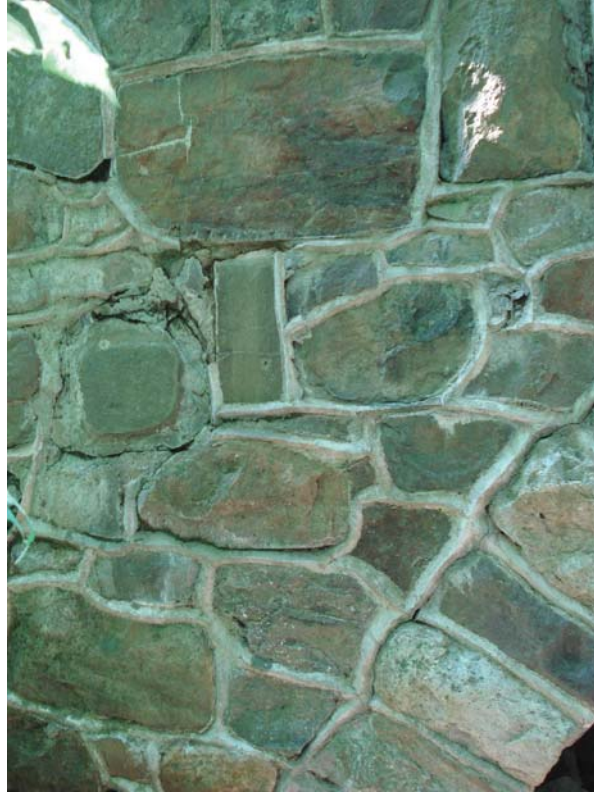
DEWA\_0010\_1.650\_R\_1.jpg

<b>Wall ID:</b>	DEWA-0010-1.650-R		
<b>Route Name:</b>	OLD MINE ROAD (SOUTH SECTION)		
<b>Inspection Date:</b>	August 02, 2007	<b>Approximate Year Built:</b>	1936
<b>*Wall Rating:</b>	76	<b>Maintenance Action:</b>	Repair Elements
<b>Wall Description</b>			
<b>Wall Function:</b>	Head Wall	<b>Primary Wall Type:</b>	Gravity - Mortared Stone
<b>Surface Treatment:</b>		<b>Secondary Wall Type:</b>	
<b>Secondary Surface Treatment:</b>		<b>Architectural Facing:</b>	
<b>General Description:</b>	Stone masonry inlet headwall for a 13 ft x 6 ft concrete arch culvert 2.75 ft integrated stone masonry guard wall integrated into wall constructed along right side and directly supports a low ADT roadway		
<b>Wall Measurements</b>			
<b>Wall Length (ft.):</b>	34	<b>Face Area (sq.):</b>	131
<b>Average Wall Height (ft.):</b>	3	<b>Face Angle (deg.):</b>	90
<b>Maximum Wall Height (ft.):</b>	8	<b>Vertical Offset (ft.):</b>	0

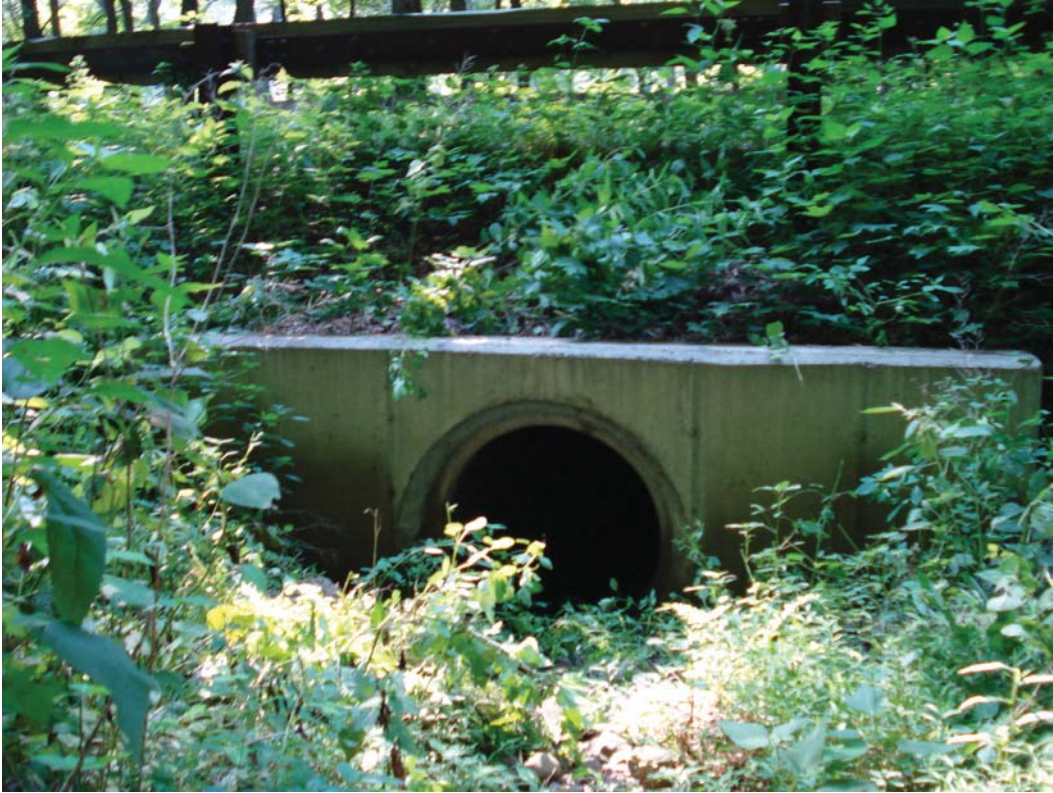
**DEWA\_0010\_2.425\_L\_1.jpg**

<b>Wall ID:</b>	DEWA-0010-2.425-L		
<b>Route Name:</b>	OLD MINE ROAD (SOUTH SECTION)		
<b>Inspection Date:</b>	August 02, 2007	<b>Approximate Year Built:</b>	Unknown
<b>*Wall Rating:</b>	100	<b>Maintenance Action:</b>	No Action
<b>Wall Description</b>			
<b>Wall Function:</b>	Head Wall	<b>Primary Wall Type:</b>	Gravity - Mass Concrete
<b>Surface Treatment:</b>		<b>Secondary Wall Type:</b>	
<b>Secondary Surface Treatment:</b>		<b>Architectural Facing:</b>	
<b>General Description:</b>	Relatively new concrete inlet headwall for a 36 in diameter concrete pipe culvert constructed along right shoulder of very low ADT roadway low consequence of failure		
<b>Wall Measurements</b>			
<b>Wall Length (ft.):</b>	12	<b>Face Area (sq.):</b>	41
<b>Average Wall Height (ft.):</b>	3	<b>Face Angle (deg.):</b>	90
<b>Maximum Wall Height (ft.):</b>	4	<b>Vertical Offset (ft.):</b>	-3
<b>Assessed Elements</b>			
<b>Element (Weighting Factor)</b>	<b>Narrative</b>		<b>Condition Rating (0 - 10)</b>

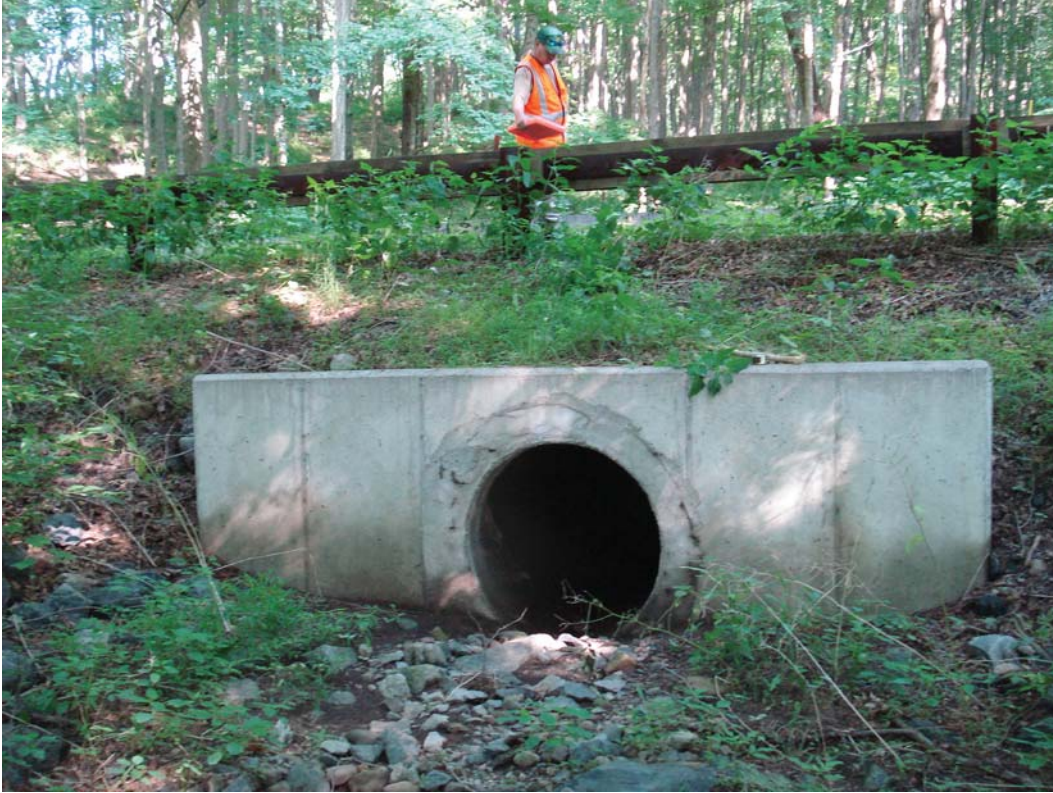
**DEWA\_0010\_2.425\_R\_1.jpg**

<b>Wall ID:</b>	DEWA-0010-2.425-R		
<b>Route Name:</b>	OLD MINE ROAD (SOUTH SECTION)		
<b>Inspection Date:</b>	August 02, 2007	<b>Approximate Year Built:</b>	Unknown
<b>*Wall Rating:</b>	97	<b>Maintenance Action:</b>	No Action
<b>Wall Description</b>			
<b>Wall Function:</b>	Head Wall	<b>Primary Wall Type:</b>	Gravity - Mass Concrete
<b>Surface Treatment:</b>		<b>Secondary Wall Type:</b>	
<b>Secondary Surface Treatment:</b>		<b>Architectural Facing:</b>	
<b>General Description:</b>	Relatively new concrete outlet headwall for a 36 in diameter concrete pipe culvert constructed along left shoulder of very low ADT roadway low consequence of failure		
<b>Wall Measurements</b>			
<b>Wall Length (ft.):</b>	12	<b>Face Area (sq.):</b>	47
<b>Average Wall Height (ft.):</b>	3	<b>Face Angle (deg.):</b>	90
<b>Maximum Wall Height (ft.):</b>	4	<b>Vertical Offset (ft.):</b>	-2
<b>Assessed Elements</b>			
<b>Element (Weighting Factor)</b>	<b>Narrative</b>		<b>Condition Rating (0 - 10)</b>

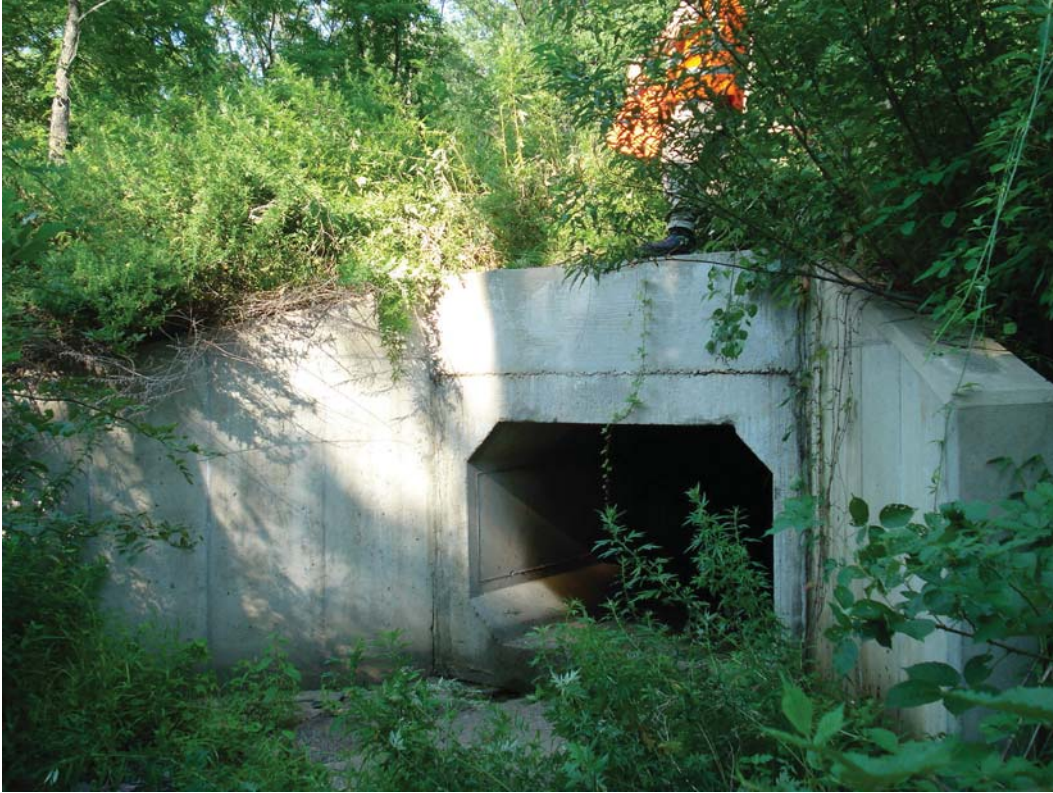
**DEWA\_0010\_2.820\_L\_1.jpg**

<b>Wall ID:</b>	DEWA-0010-2.820-L		
<b>Route Name:</b>	OLD MINE ROAD (SOUTH SECTION)		
<b>Inspection Date:</b>	August 02, 2007	<b>Approximate Year Built:</b>	Unknown
<b>*Wall Rating:</b>	91	<b>Maintenance Action:</b>	No Action
<b>Wall Description</b>			
<b>Wall Function:</b>	Head Wall	<b>Primary Wall Type:</b>	Gravity - Mass Concrete
<b>Surface Treatment:</b>		<b>Secondary Wall Type:</b>	
<b>Secondary Surface Treatment:</b>		<b>Architectural Facing:</b>	
<b>General Description:</b>	Relatively new concrete outlet headwall for a 4 ft x 6 ft concrete box culvert constructed along left shoulder of very low ADT roadway high consequence of failure as structure directly supports roadway		
<b>Wall Measurements</b>			
<b>Wall Length (ft.):</b>	24	<b>Face Area (sq.):</b>	156
<b>Average Wall Height (ft.):</b>	6	<b>Face Angle (deg.):</b>	90
<b>Maximum Wall Height (ft.):</b>	8	<b>Vertical Offset (ft.):</b>	-1
<b>Assessed Elements</b>

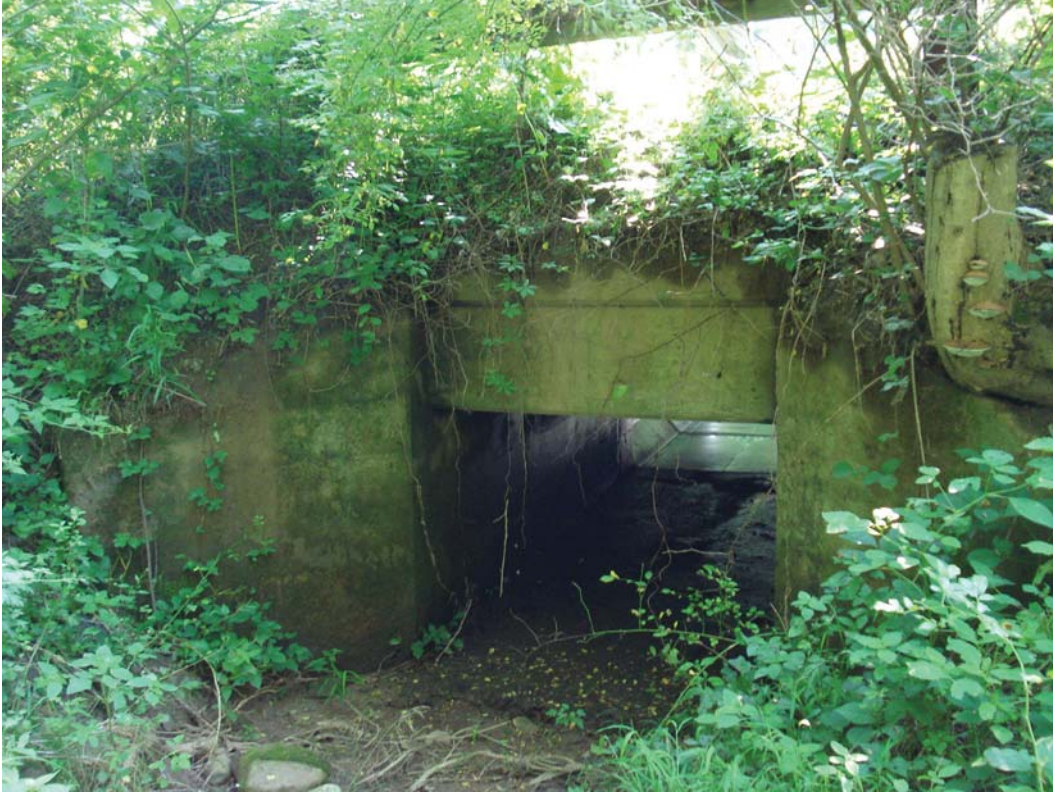
**DEWA\_0010\_2.820\_R\_1.jpg**

<b>Wall ID:</b>	DEWA-0010-2.820-R		
<b>Route Name:</b>	OLD MINE ROAD (SOUTH SECTION)		
<b>Inspection Date:</b>	August 02, 2007	<b>Approximate Year Built:</b>	Unknown
<b>*Wall Rating:</b>	90	<b>Maintenance Action:</b>	No Action
<b>Wall Description</b>			
<b>Wall Function:</b>	Head Wall	<b>Primary Wall Type:</b>	Gravity - Mass Concrete
<b>Surface Treatment:</b>		<b>Secondary Wall Type:</b>	
<b>Secondary Surface Treatment:</b>		<b>Architectural Facing:</b>	
<b>General Description:</b>	Concrete inlet headwall for 3.75 ft x 5.5 ft concrete box culvert constructed along right shoulder of a very low ADT roadway high consequence of failure		
<b>Wall Measurements</b>			
<b>Wall Length (ft.):</b>	16	<b>Face Area (sq.):</b>	51
<b>Average Wall Height (ft.):</b>	3	<b>Face Angle (deg.):</b>	90
<b>Maximum Wall Height (ft.):</b>	6	<b>Vertical Offset (ft.):</b>	-2
<b>Assessed Elements</b>			
<b>Element (Weighting Factor)</b>	<b>Narrative</b>		<b>Condition Rating (0 - 10)</b>
