GATE WIP Report

NPS Retaining Wall Inventory Program Gateway National Recreation Area

Federal Highway Administration
Eastern Federal Lands Highway Division
Road Inventory Program (RIP)

Data Collection Date: October 2008
Report Date: November 2015

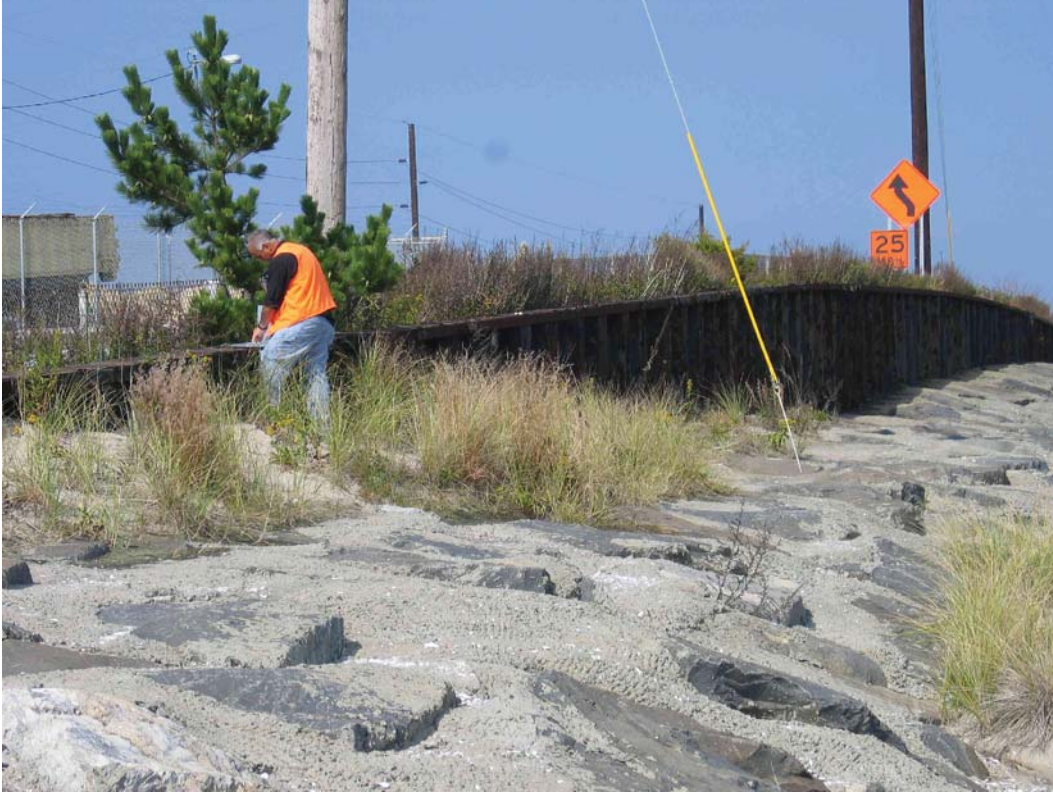
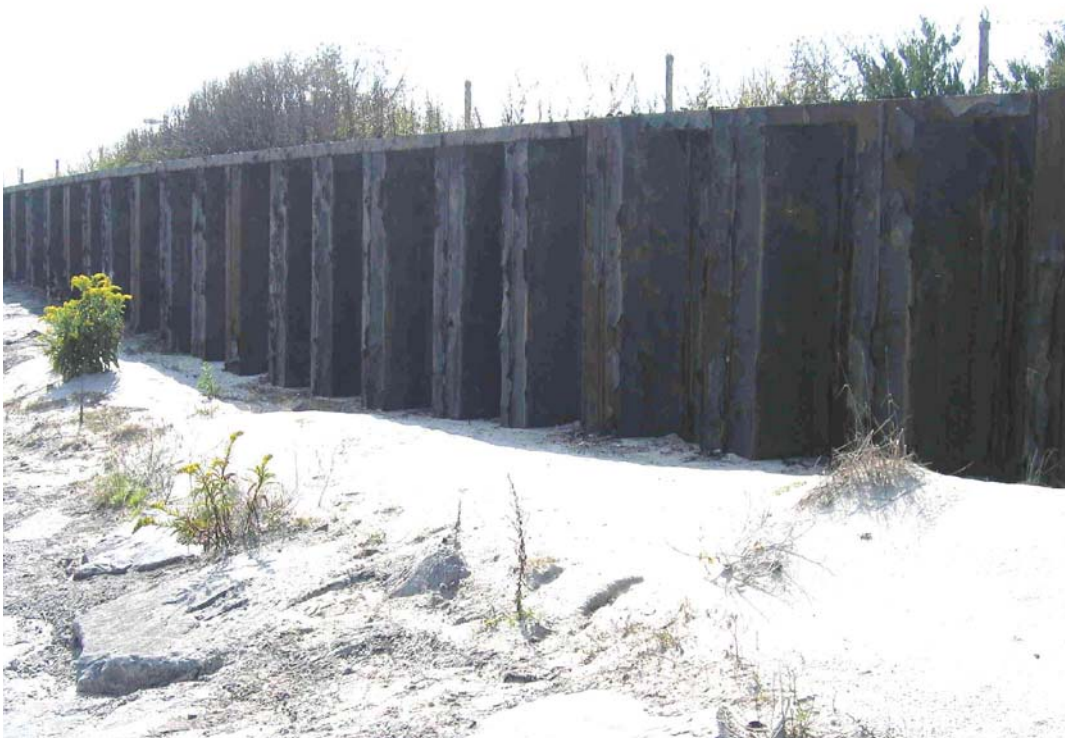
Wall Function:	Fill Wall	Primary Wall Type:	Other -Metal Sheet Pile
Surface Treatment:	Painted	Secondary Wall Type:	
Secondary Surface Treatment:		Architectural Facing:	
General Description:	Metal sheet pile fill wall for roadway grade support, with a grouted riprap toe slope (erosion protection). Corrosion protection coating is severely weathered and needs to be reapplied.

Element (Weighting Factor)	Narrative	Condition Rating (0 - 10)
PERFORMANCE 8.00	Excellent global condition. No signs of global instability or settlement in front or behind the wall. Corrosion protection is peeling off and needs to be reapplied to extend structural life.	6
WALL FOUNDATION MATERIAL 8.00	Grouted riprap has been placed at the toe of the wall to protect against erosion. No signs of cracking or settlement within the riprap. Sound foundation.	9
PILES AND SHAFTS 8.00	Metal sheet piles are in good condition. Corrosion protection paint is highly weathered and peeling off, though the piles show only minor corrosion. All joints are tight, and there are no significant signs of wall distress. Corrosion coating needs to be	6
ROAD/SIDEWALK/SHOULDER 0.50	No cracking or settlement in roadway due to wall distress.	8
TRAFFIC BARRIER/FENCE 0.50	K-rail traffic barrier is in good condition, showing no signs of wall-related distress. Chain link fencing is also in good condition.	8

WALL DRAINS 0.50	No wall drains are visible, though none are likely required. No signs of seepage or water staining.	8
DOWNSLOPE 0.50	Grouted riprap. Very stable with no signs of distress.	9
LATERAL SLOPE 0.50	Grouted riprap and gentle grassy slopes. No significant erosion or other signs of distress.	9

Failure Consequence:	HIGH
Recommendation Narrative:	Remove peeled corrosion protection coating and prep piling surface. Apply new corrosion protection coating. Site prep (minor sand removal along wall face, labor/equip, sample testing, etc.): Lump sum = \$2,500. Weathered coating removal
Repair Cost:	\$67,500

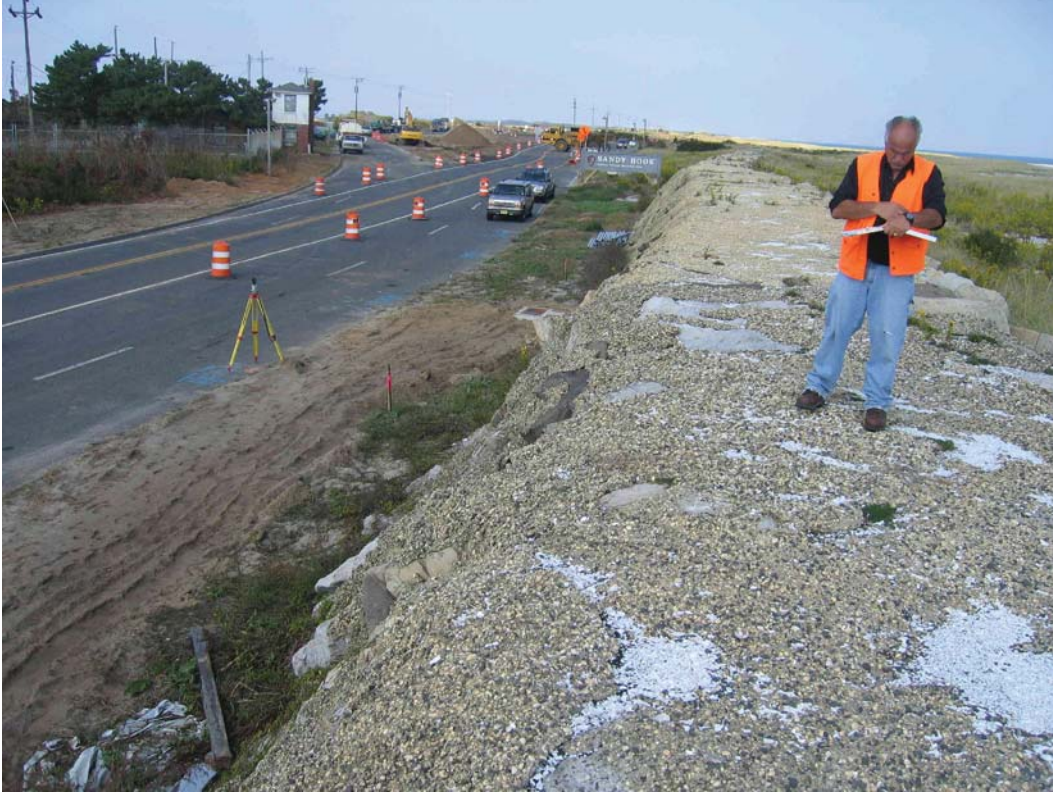
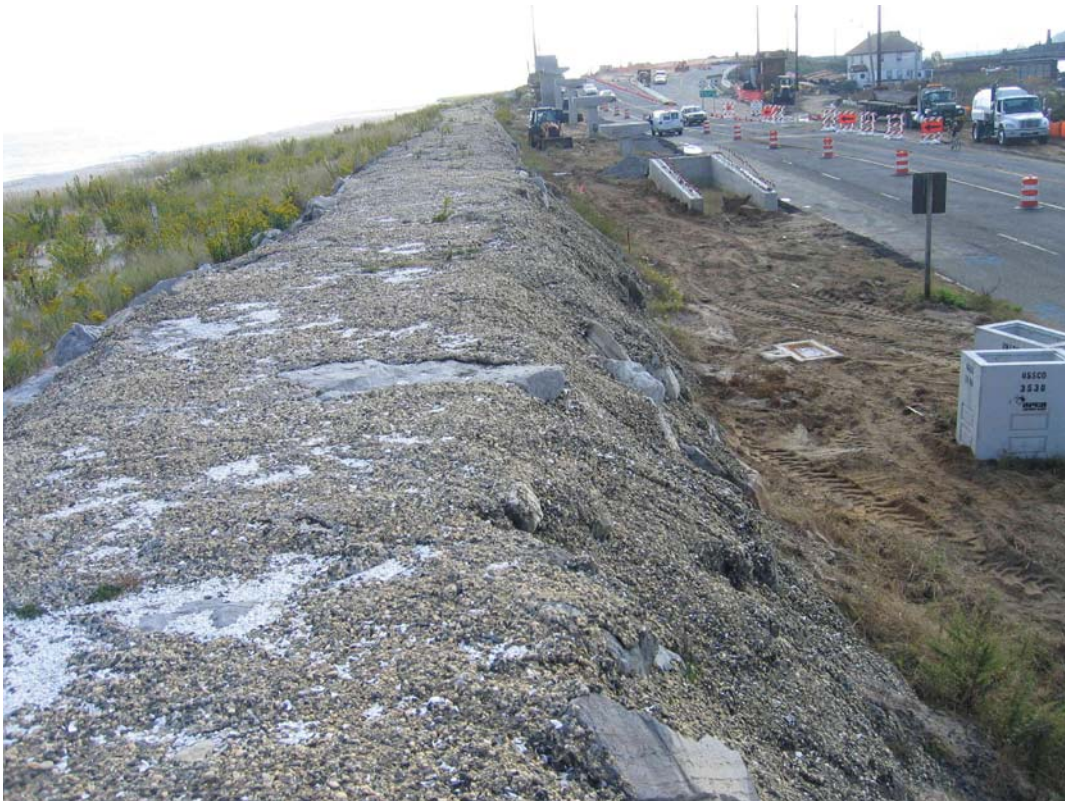
Wall ID:	GATE-0060-0.170-R		
Route Name:	HARTSHORNE DRIVE (NORTHBOUND)		
Inspection Date:	October 09, 2008	Approximate Year Built:	Unknown
*Wall Rating:	79	Maintenance Action:	No Action

Element (Weighting Factor)	Narrative	Condition Rating (0 - 10)
PERFORMANCE 8.00	No signs of global instability, settlement or missing elements. No scour or significant structural distress.	8
WALL FOUNDATION MATERIAL 8.00	Assumed dense beach sands. No signs of scour or settlement due to poor foundation materials.	8
MORTAR 8.00	Weathered mortar with coarse, exposed aggregate. Minor cracking. Overall, mortar is generally intact and functioning very well.	8
PLACED STONE 8.00	Variety of placed stone materials, ranging from basalt, granite, schist, possibly slate. As a result, variably weathered. Some cracking, though largely intact and in good to very good condition. No missing elements.	8
LATERAL SLOPE 0.50	Grouted riprap at both ends (non-qualifying or Park-related structures). Very stable.	8
ROAD/SIDEWALK/SHOULDER 0.50	Adjacent roadway shows no signs of wall-related distress.	8
UPSLOPE 0.50	Upslope is actually oceanside. Comprised of gently sloping beach sands with minor vegetation. No signs of settlement distress behind the wall.	8

Failure Consequence:	LOW
Recommendation Narrative:	None
Repair Cost:	\$0

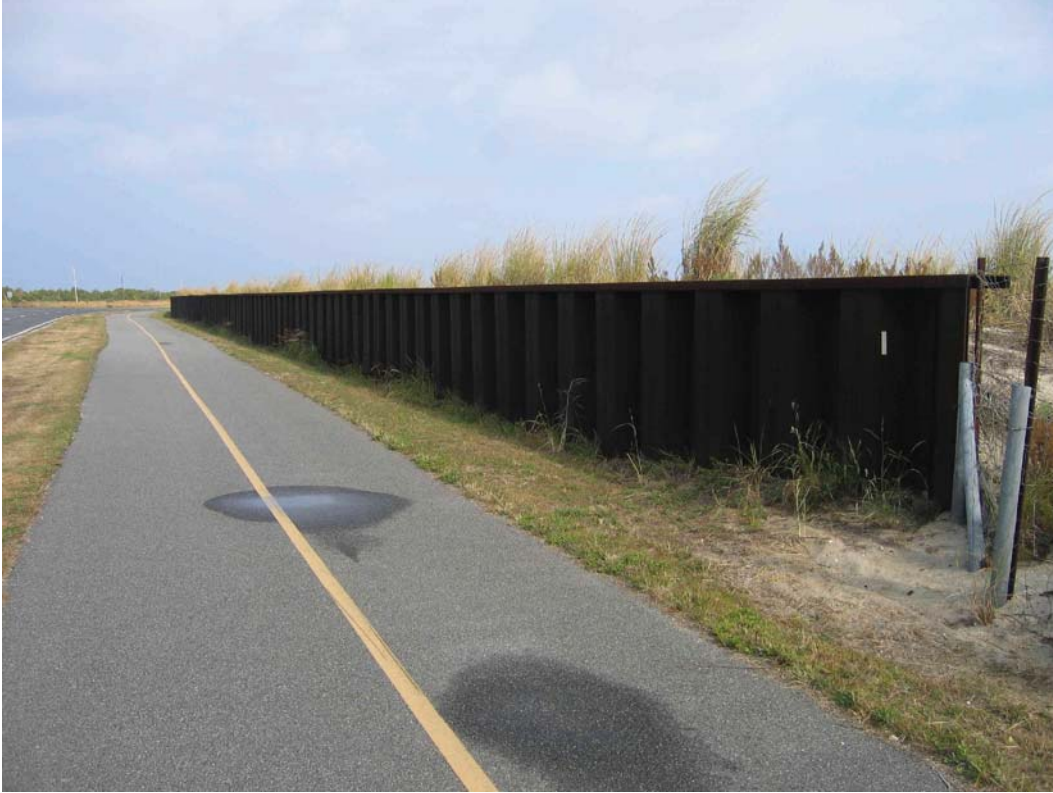
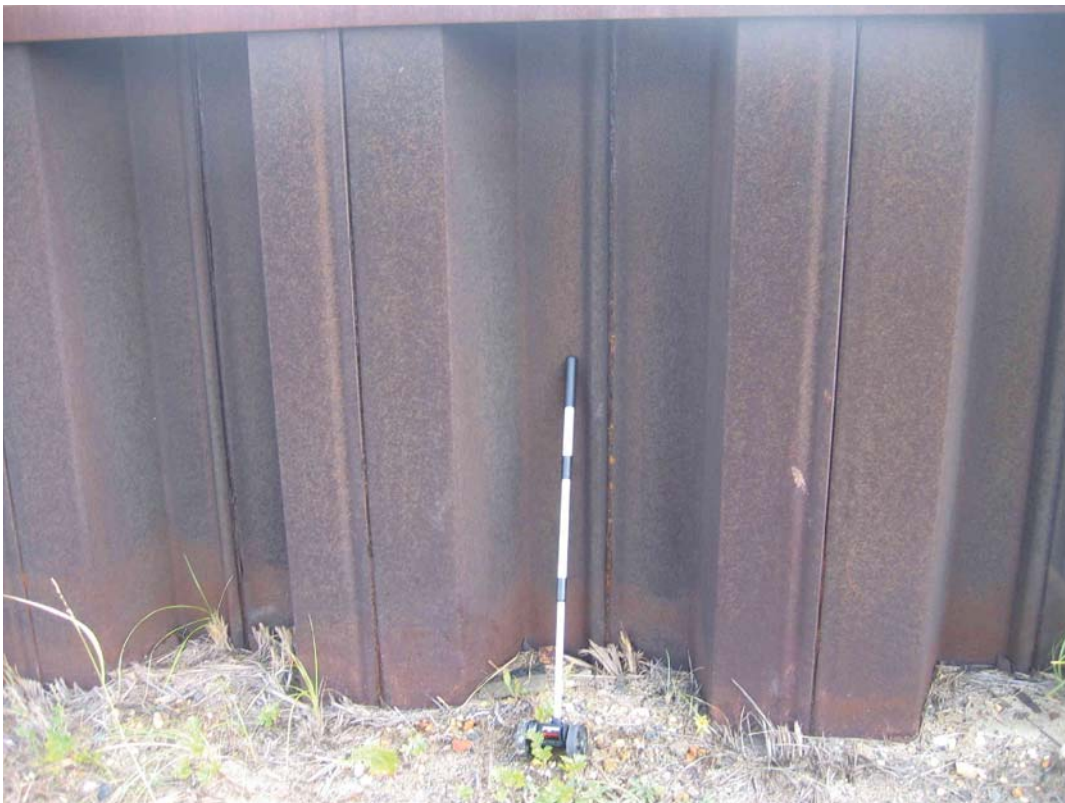
Wall ID:	GATE-0060-1.640-R		
Route Name:	HARTSHORNE DRIVE (NORTHBOUND)		
Inspection Date:	October 09, 2008	Approximate Year Built:	Unknown
*Wall Rating:	81	Maintenance Action:	No Action

Element (Weighting Factor)	Narrative	Condition Rating (0 - 10)
PERFORMANCE 8.00	Minor weathering of metal elements, but no signs of global distress or wall settlement.	8
WALL FOUNDATION MATERIAL 8.00	Appears to be dense sand. No scour or signs of wall settlement.	8
PILES AND SHAFTS 8.00	Metal sheet piles are in very good condition, showing little to no signs of corrosion, and no signs of distortion, bending, cracking or significant weathering.	8
DOWNSLOPE 0.50	Flat downslope comprised of dense sand. Paved walkway at toe of wall shows no signs of wall-related distress.	9
LATERAL SLOPE 0.50	Gentle lateral slopes comprised of dense to loose sand with minor vegetation.	9
UPSLOPE 0.50	Generally flat top slope comprised of dense to loose sand with minor vegetation. No signs of settlement or sinkholes behind wall face.	9
VEGETATION 0.50	No vegetation impacts to wall elements.	9
WALL DRAINS 0.50	No wall drains are evident - and it appears that none are needed.	9

Failure Consequence:	LOW
Recommendation Narrative:	None
Repair Cost:	\$0

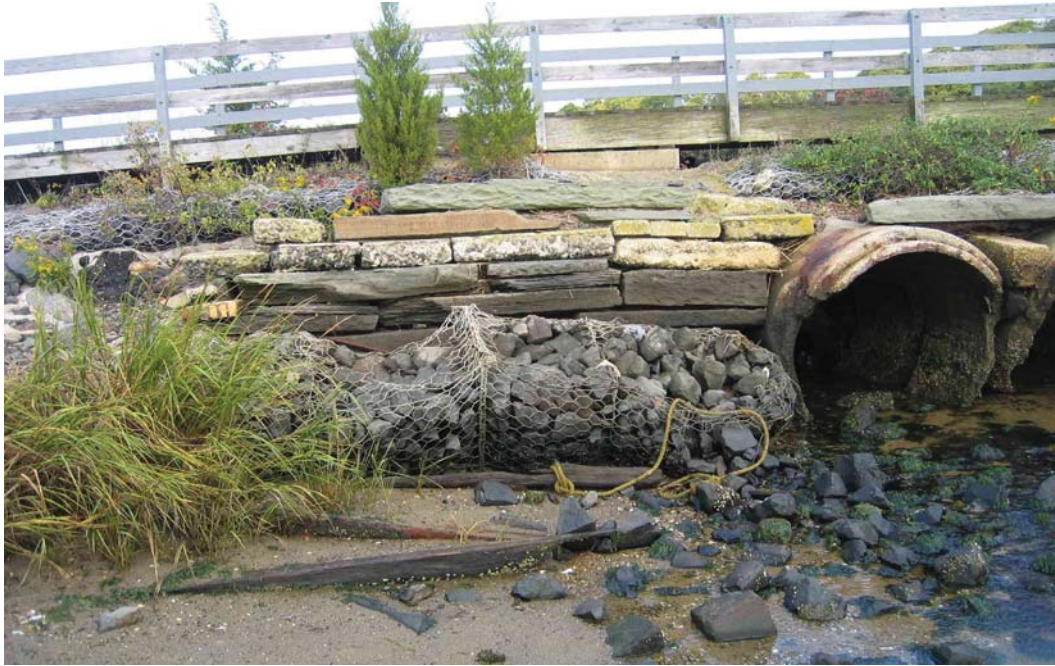
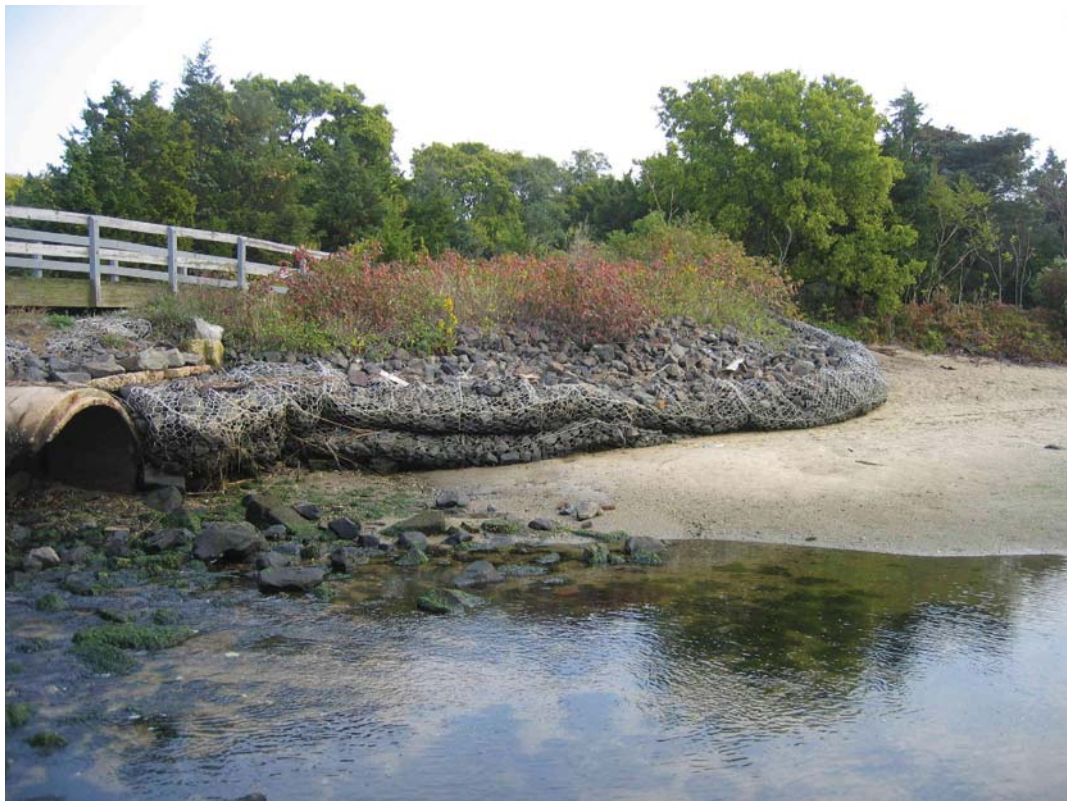
Wall ID:	GATE-0060-4.002-L		
Route Name:	HARTSHORNE DRIVE (NORTHBOUND)		
Inspection Date:	October 09, 2008	Approximate Year Built:	Unknown
*Wall Rating:	52	Maintenance Action:	Replace Elements

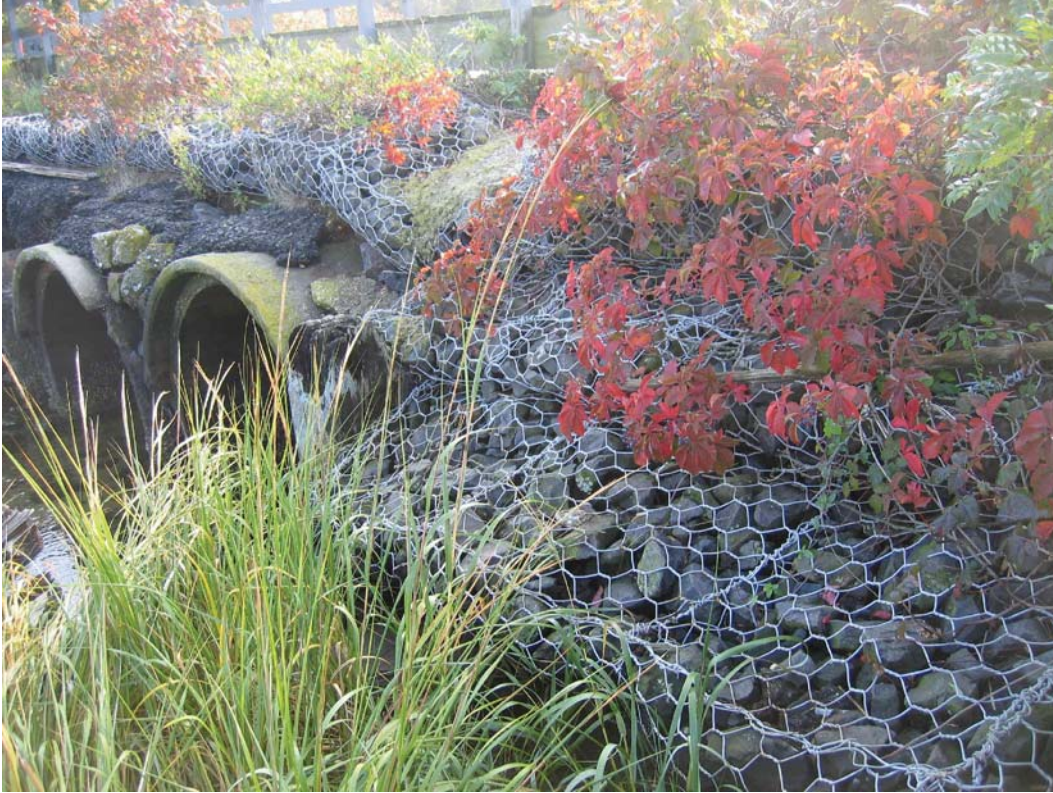
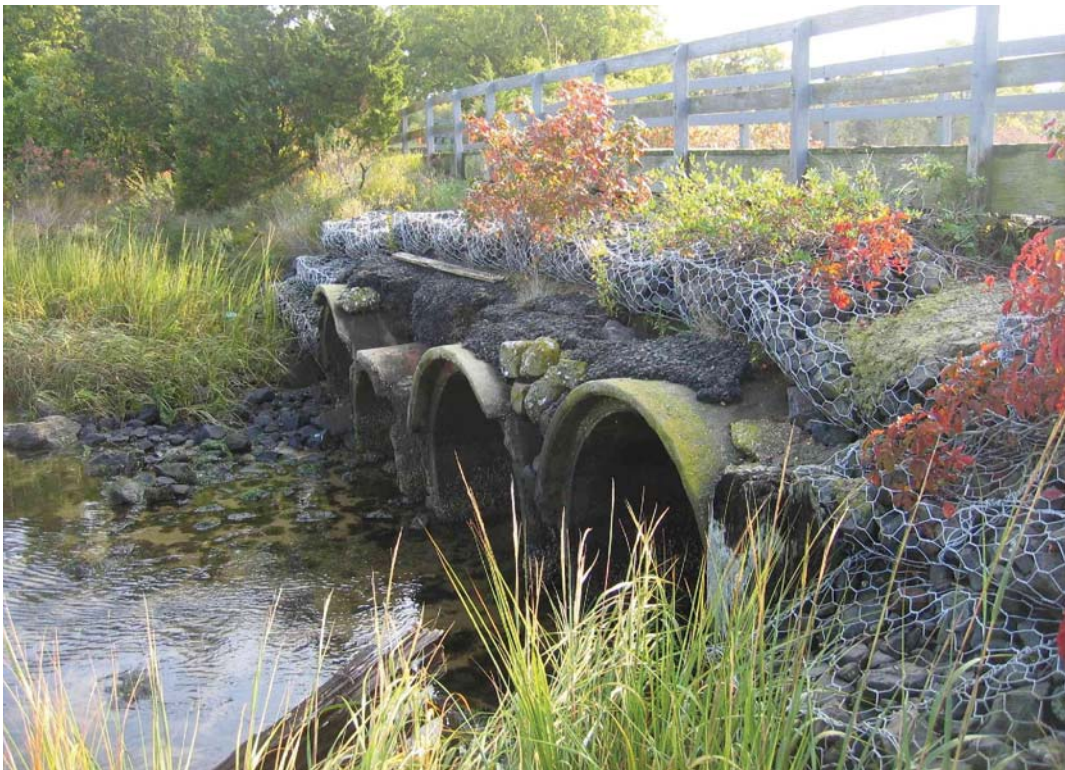
Wall ID:	GATE-0060-4.005-L		
Route Name:	HARTSHORNE DRIVE (NORTHBOUND)		
Inspection Date:	October 09, 2008	Approximate Year Built:	Unknown
*Wall Rating:	59	Maintenance Action:	Repair Elements

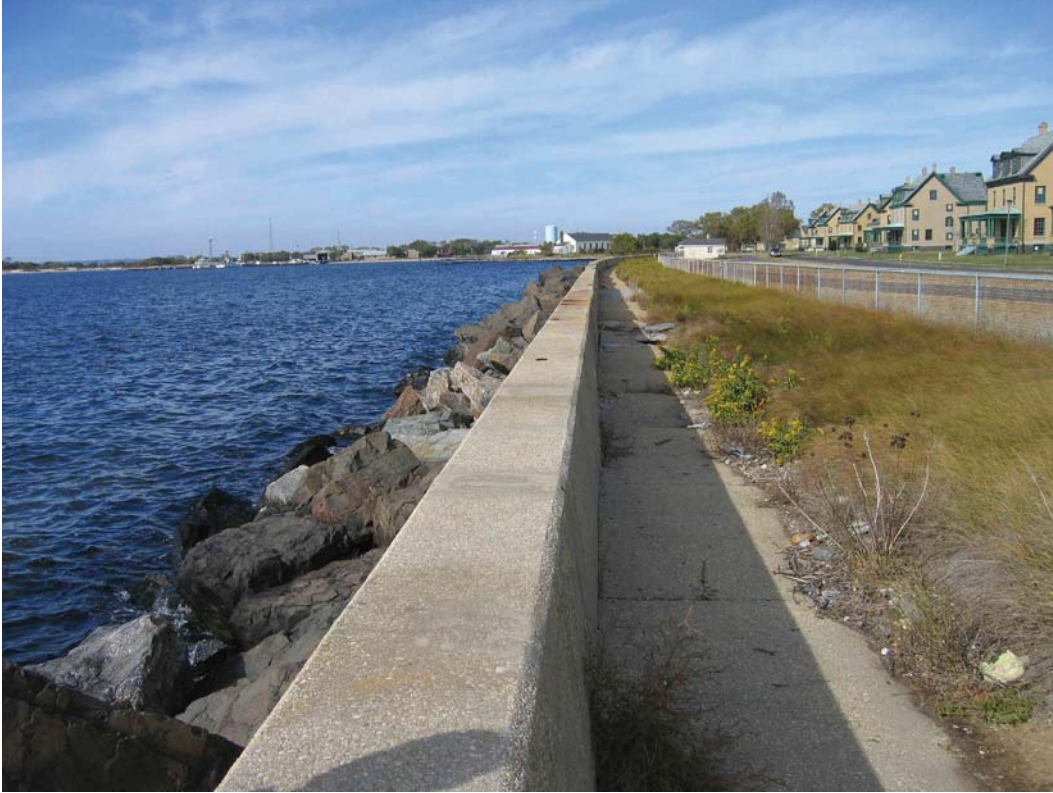
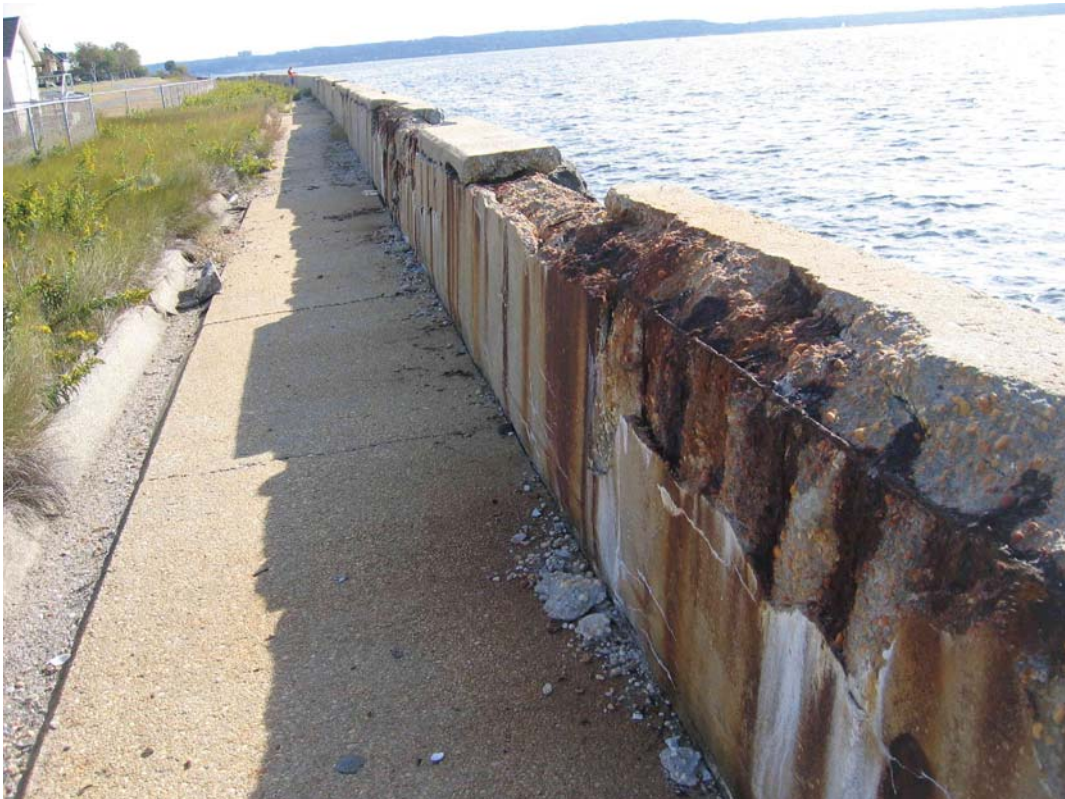
Wall ID:	GATE-0060-4.918-L		
Route Name:	HARTSHORNE DRIVE (NORTHBOUND)		
Inspection Date:	October 08, 2008	Approximate Year Built:	Unknown
*Wall Rating:	46	Maintenance Action:	Replace Elements
Wall Description			
Wall Function:	Flood Wall	Primary Wall Type:	Gravity - Mass Concrete
Surface Treatment:		Secondary Wall Type:	Other - Placed jetty rock in front
Secondary Surface Treatment:		Architectural Facing:	
General Description:	Gravity mass concrete seawall with 3.5 ft parapet. Jetty rock is placed at base of wall to protect scour. Jetty in front of this wall, protecting officer housing (est. at 2500 lineal ft) is designated FMSS# 21616.		
Wall Measurements			
Wall Length (ft.):	1212	Face Area (sq.):	4848
Average Wall Height (ft.):	4	Face Angle (deg.):	90
Maximum Wall Height (ft.):	4	Vertical Offset (ft.):	-1
Assessed Elements			
Element (Weighting Factor)	Narrative		Condition Rating (0 - 10)
PERFORMANCE 8.00	Primary wall is highly weathered with substantial sections fully undermined or pending erosional failure. Sections still intact do not show rotation or deformation, but are exhibiting severe structural damage at the waterline/foundation. Structure is i		5

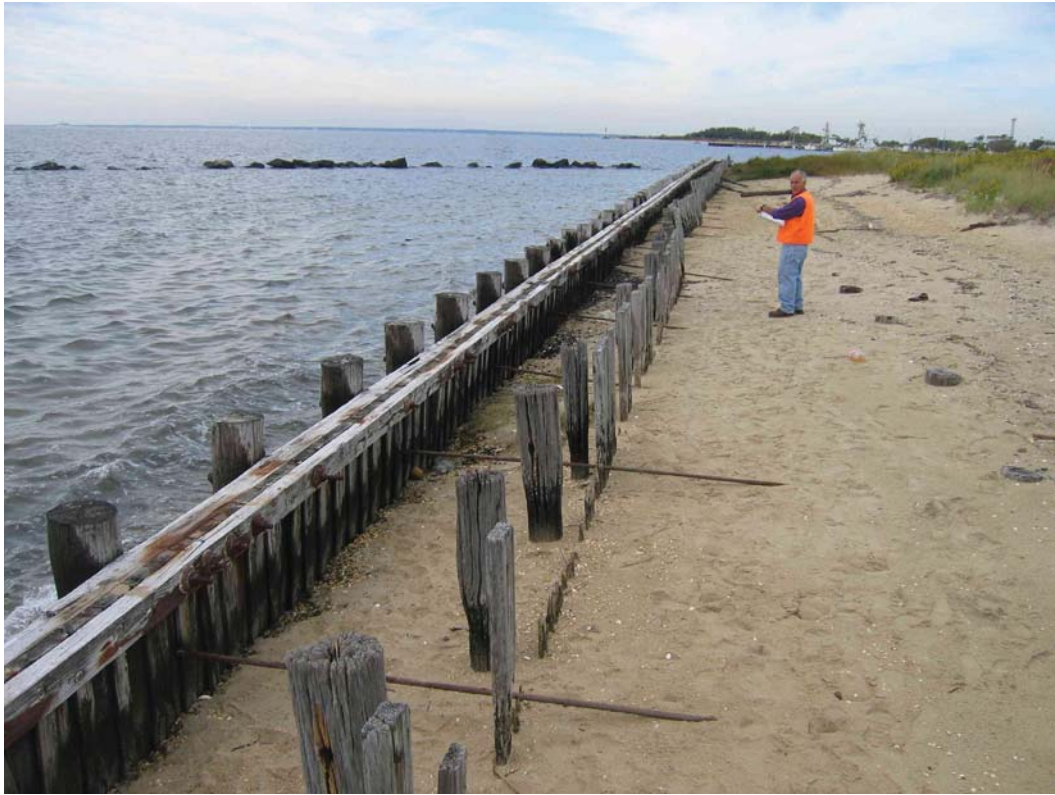
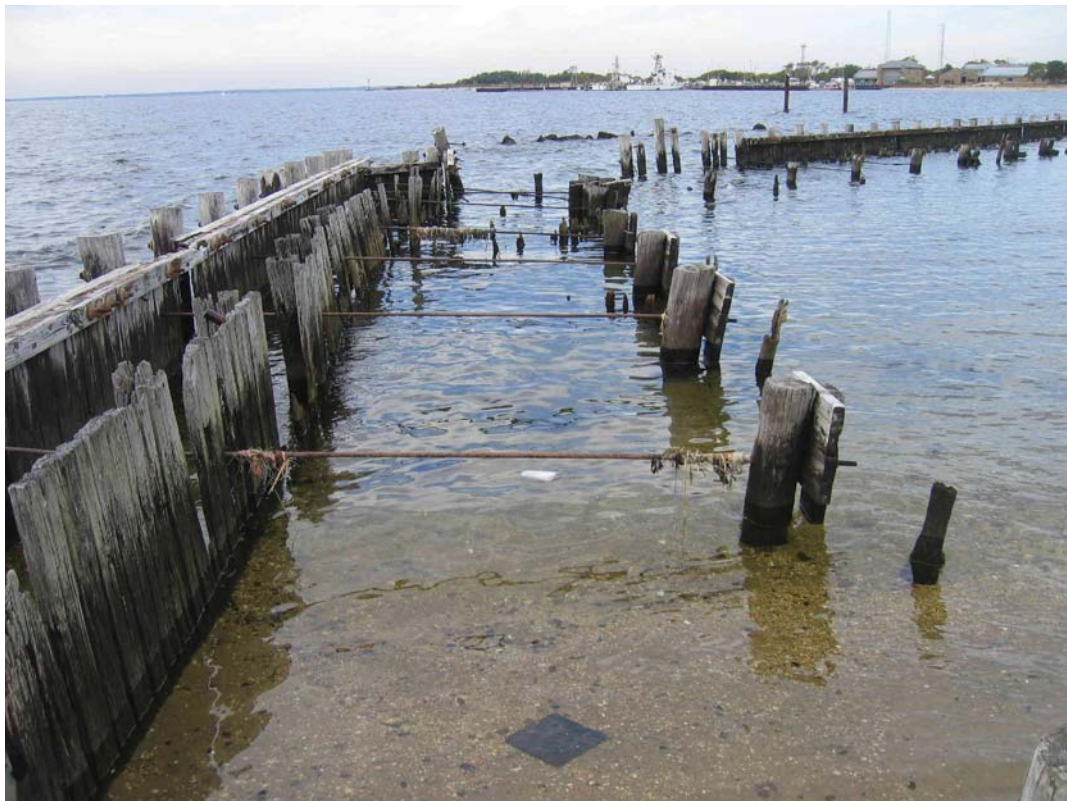
Wall ID:	GATE-0060-5.139-L		
Route Name:	HARTSHORNE DRIVE (NORTHBOUND)		
Inspection Date:	October 08, 2008	Approximate Year Built:	Unknown
*Wall Rating:	37	Maintenance Action:	Repair Elements
Wall Description			
Wall Function:	Flood Wall	Primary Wall Type:	Other - Anchor Tieback Timber
Surface Treatment:		Secondary Wall Type:	
Secondary Surface Treatment:		Architectural Facing:	
General Description:	Timber-lagged, timber pile wall anchored to timber post deadmen with steel tiebacks. Portions are fully non-functioning, with severely weathered and/or missing wall elements. Oceanside rock jetty placed to serve as coastal erosion protection.		
Wall Measurements			
Wall Length (ft.):	1330	Face Area (sq.):	6650
Average Wall Height (ft.):	5	Face Angle (deg.):	90
Maximum Wall Height (ft.):	5	Vertical Offset (ft.):	-5
Assessed Elements			
Element (Weighting Factor)	Narrative		Condition Rating (0 - 10)
PERFORMANCE 8.00	Severely weathered structured with missing and non-functioning elements. Anchor system is non-functioning over substantial section of wall. Although some sections are still retaining earth, primary purpose is to forestall erosion. Rock jetty is serving		4

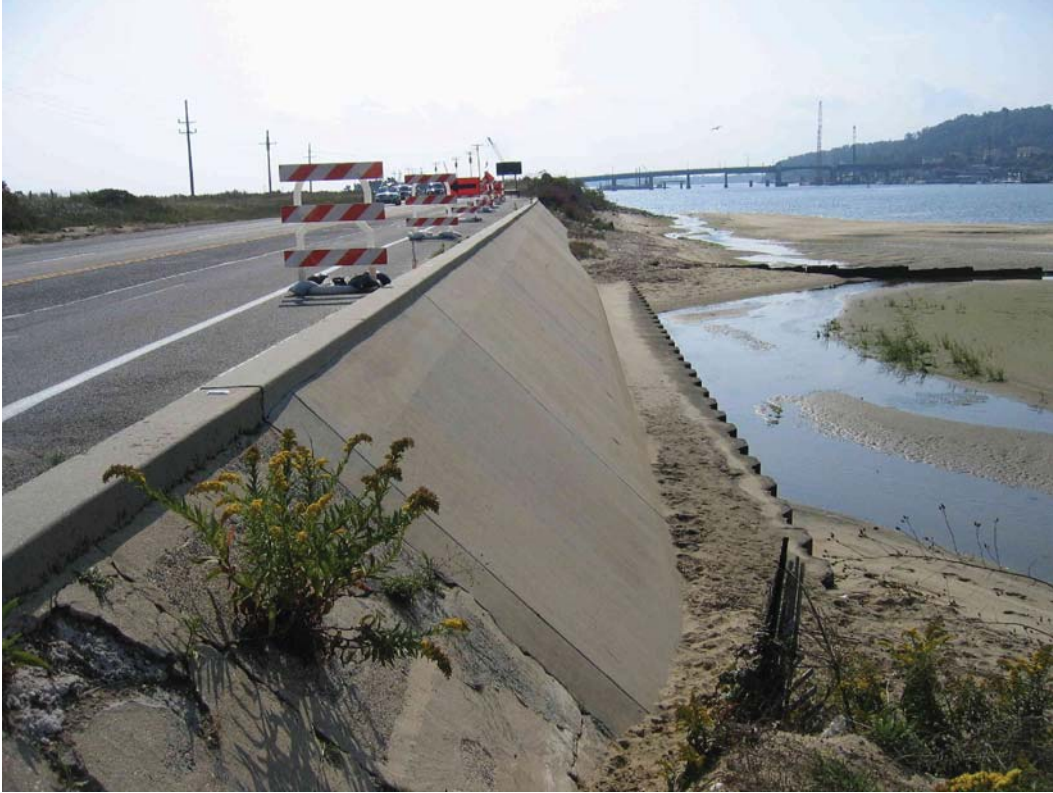
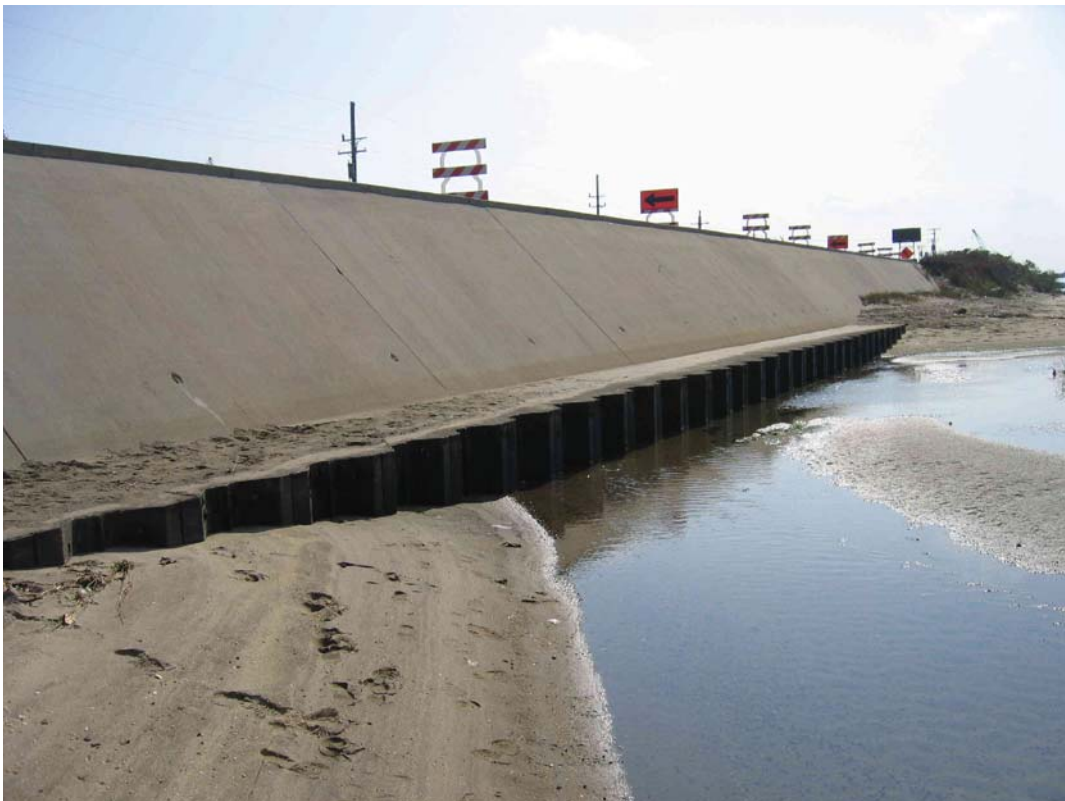
Wall ID:	GATE-0061-3.155-R		
Route Name:	HARTSHORNE DRIVE (SOUTHBOUND)		
Inspection Date:	October 09, 2008	Approximate Year Built:	Unknown
*Wall Rating:	77	Maintenance Action:	No Action
