NPS Retaining Wall Inventory Program Glacier National Park

**Federal Lands Highway
Road Inventory Program**

**Federal Highway Administration
Eastern Federal Lands Highway Division
Road Inventory Program (RIP)**

**Data Collection Date: September 2007
Report Date: October 2015**

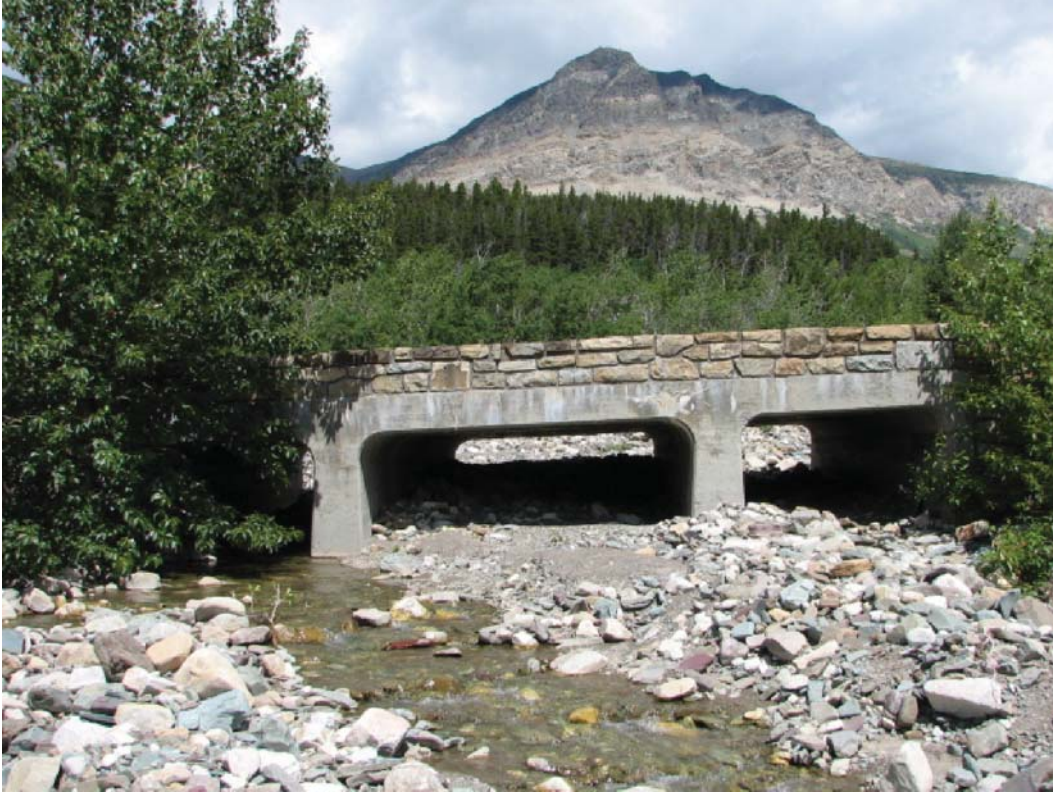
GLAC_0014_10.973_L_1.jpg

Wall Identification	Failure Consequence⁽¹⁾	Wall Rating⁽²⁾	Recommended Action⁽³⁾	2007 Repair Costs⁽⁴⁾
GLAC-0014-10.972-L	MODERATE	48	REPLACE ELEMENTS	\$26,920
GLAC-0014-10.973-L	MODERATE	48	REPLACE ELEMENTS	\$26,920
