GOGA WIP Report

NPS Retaining Wall Inventory Program Golden Gate National Recreation Area

**Federal Highway Administration
Eastern Federal Lands Highway Division
Road Inventory Program (RIP)**

**Data Collection Date: November 2007
Report Date: November 2015**

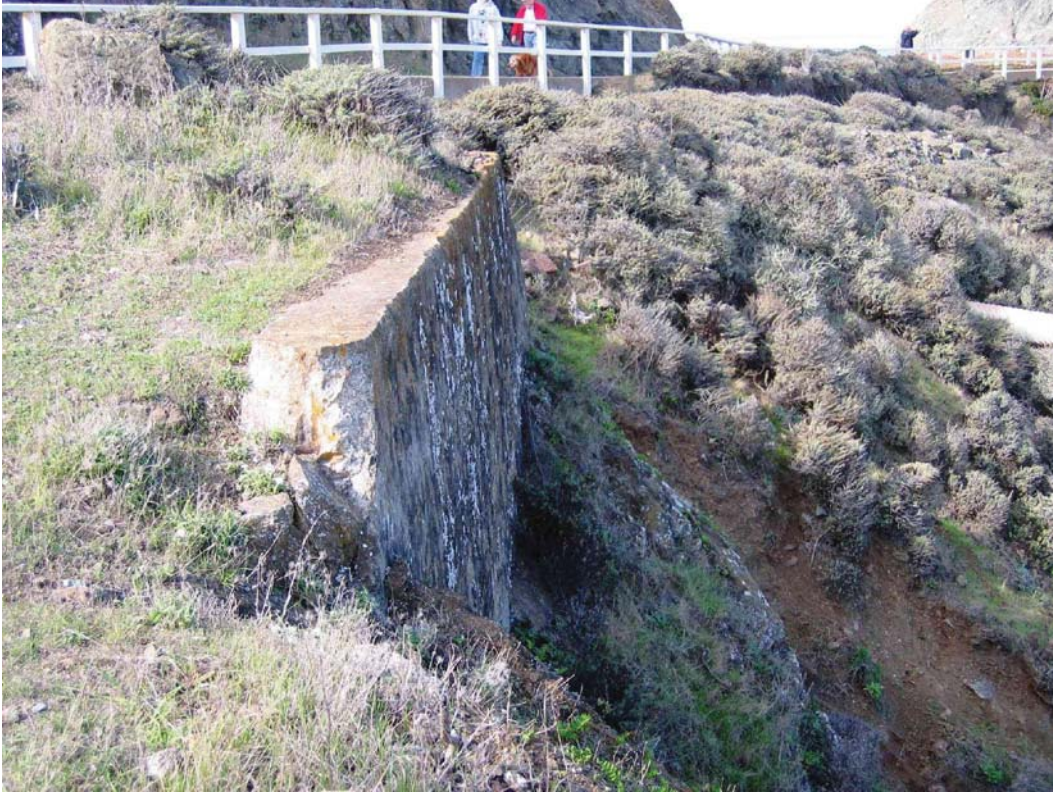
GOGA_0109ZZ_0.455_L_1.jpg

Wall ID:	GOGA-0109ZZ-0.455-L		
Route Name:	CONZELMAN ROAD		
Inspection Date:	November 09, 2007	Approximate Year Built:	Unknown
*Wall Rating:	77	Maintenance Action:	No Action

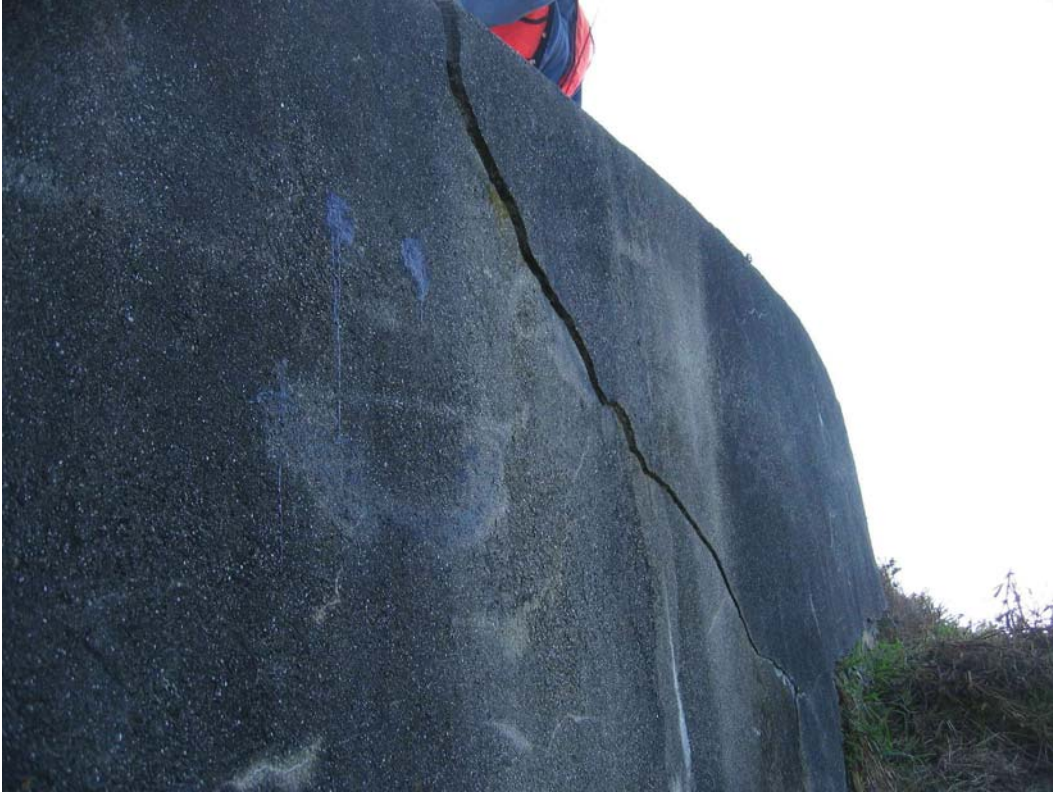
GOGA_0405_0.080_R_1.jpg

Wall ID:	GOGA-0405-0.080-R		
Route Name:	MCDOWELL AVENUE		
Inspection Date:	November 06, 2007	Approximate Year Built:	Unknown
*Wall Rating:	62	Maintenance Action:	Repair Elements

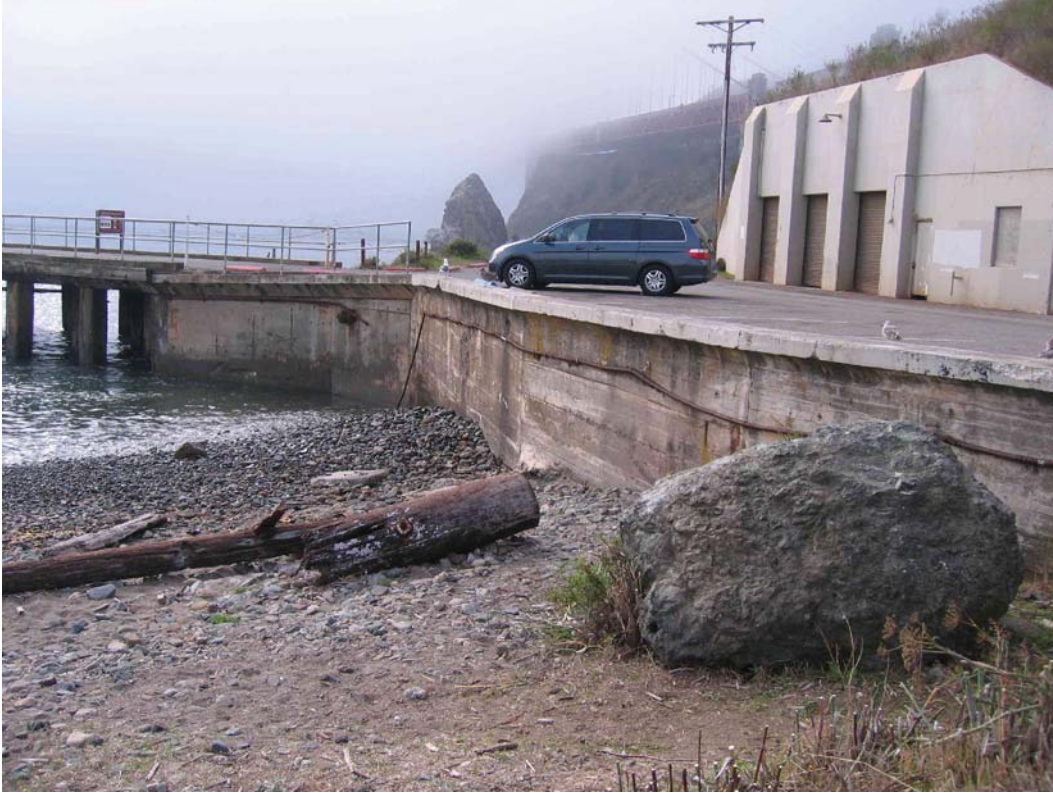
GOGA_0419_0.134_L_1.jpg

Wall ID:	GOGA-0419-0.134-L		
Route Name:	MOORE ROAD		
Inspection Date:	November 07, 2007	Approximate Year Built:	Unknown
*Wall Rating:	65	Maintenance Action:	Repair Elements

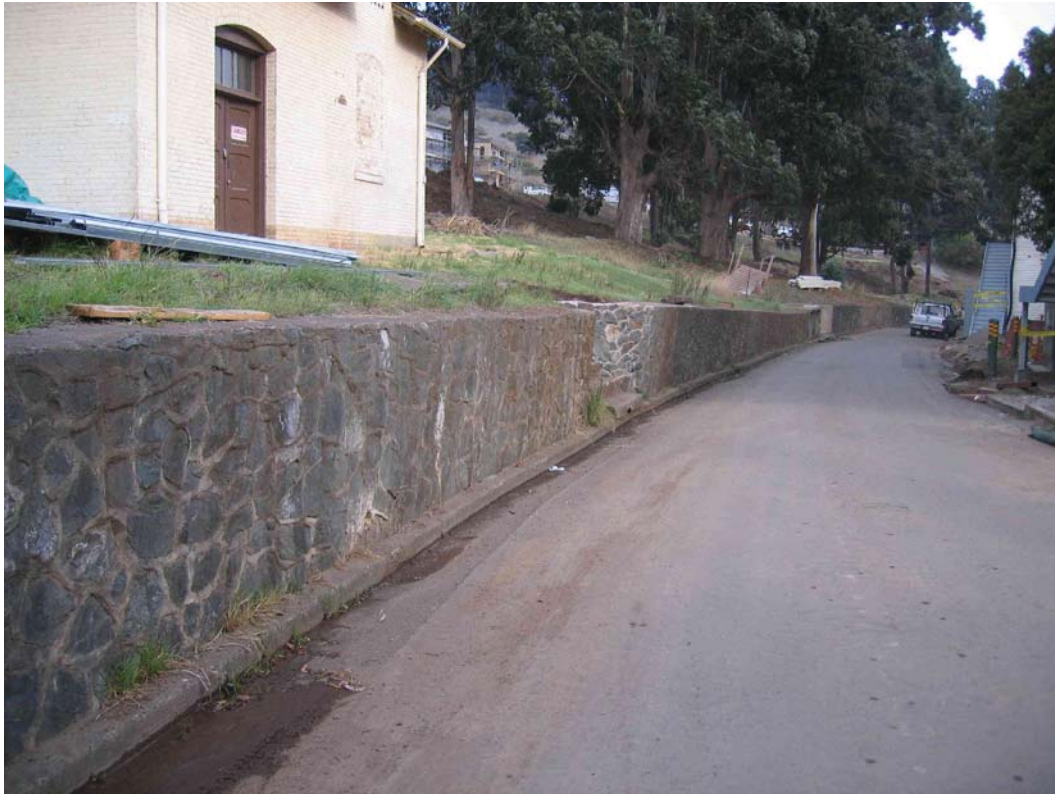
GOGA_0420ZZ_0.007_R_1.jpg

Wall ID Inspection Date:	Wall Area (Sq. Ft.)	Wall Length (Ft.)	Wall Type	Wall Function	Overall Rating	Repair Cost
GOGA-0420ZZ-0.007-R 11/7/2007	4,756	1,189	Gravity - Mortared Stone	Cut Wall	54	\$2,400.00

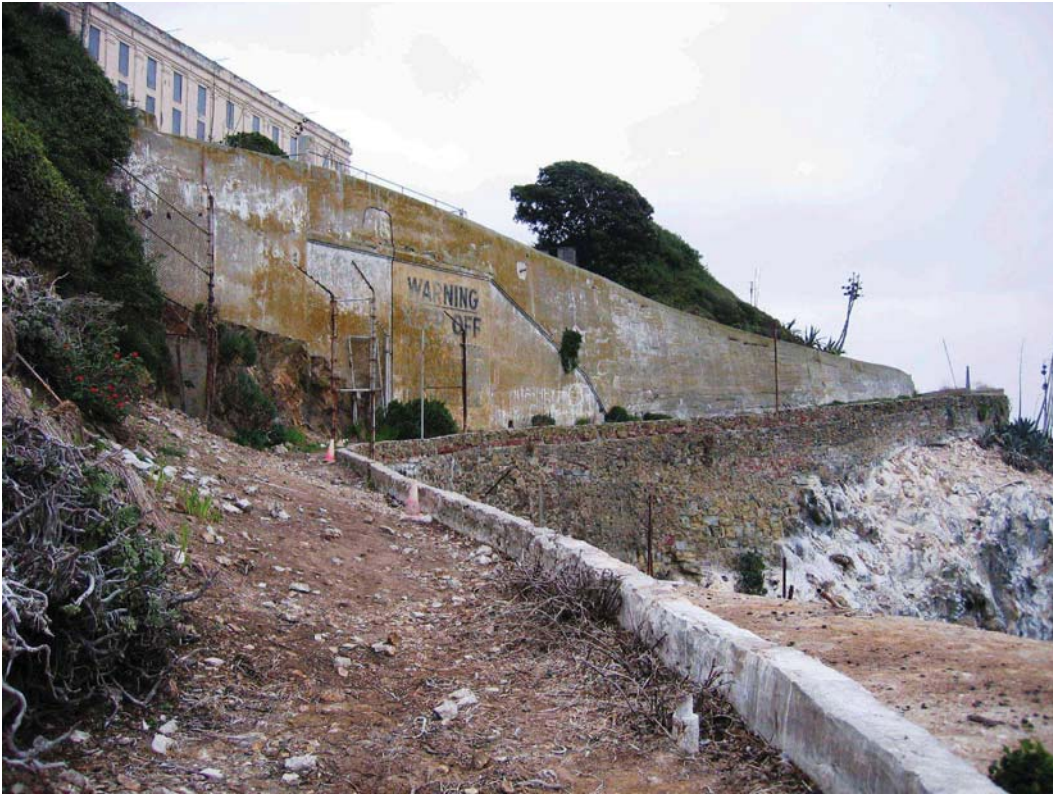
GOGA_0502B_0.120_L_1.jpg

Wall Identification	Failure Consequence⁽¹⁾	Wall Rating⁽²⁾	Recommended Action⁽³⁾	2007 Repair Costs⁽⁴⁾
GOGA-0109ZZ-0.835-L	HIGH	10	REPLACE WALL	\$51,500
GOGA-0425-0.004-R	HIGH	36	REPLACE WALL	\$200,000
GOGA-0502B-0.120-L	LOW	43	NO ACTION	\$0
