NPS Retaining Wall Inventory Program George Washington Memorial Parkway

**Federal Lands Highway
Road Inventory Program**

**Data Collection Date: December 2007
Report Date: October 2015**

George Washington Memorial Parkway in District of Columbia, Maryland, and Virginia

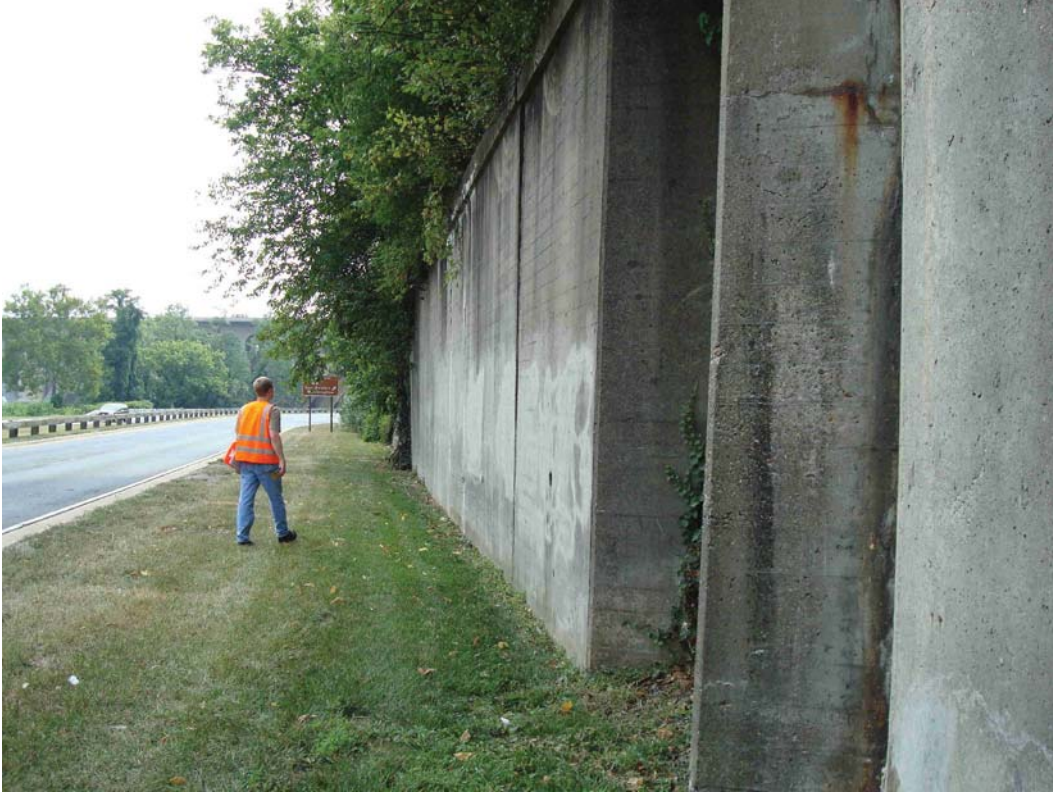
GWMP_0001_17.241_R_1.jpg

Wall ID:	GWMP-0001-17.241-R		
Route Name:	GWMP - SOUTHBOUND		
Inspection Date:	August 09, 2007	Approximate Year Built:	Unknown
*Wall Rating:	64	Maintenance Action:	Repair Elements

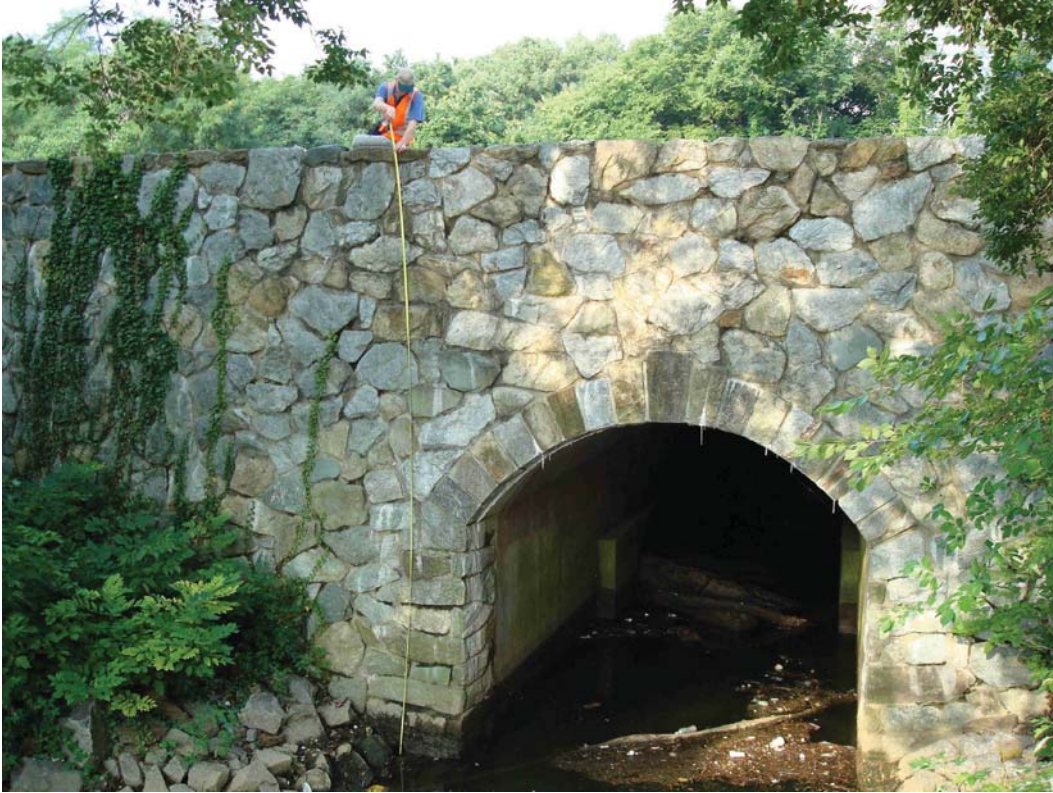
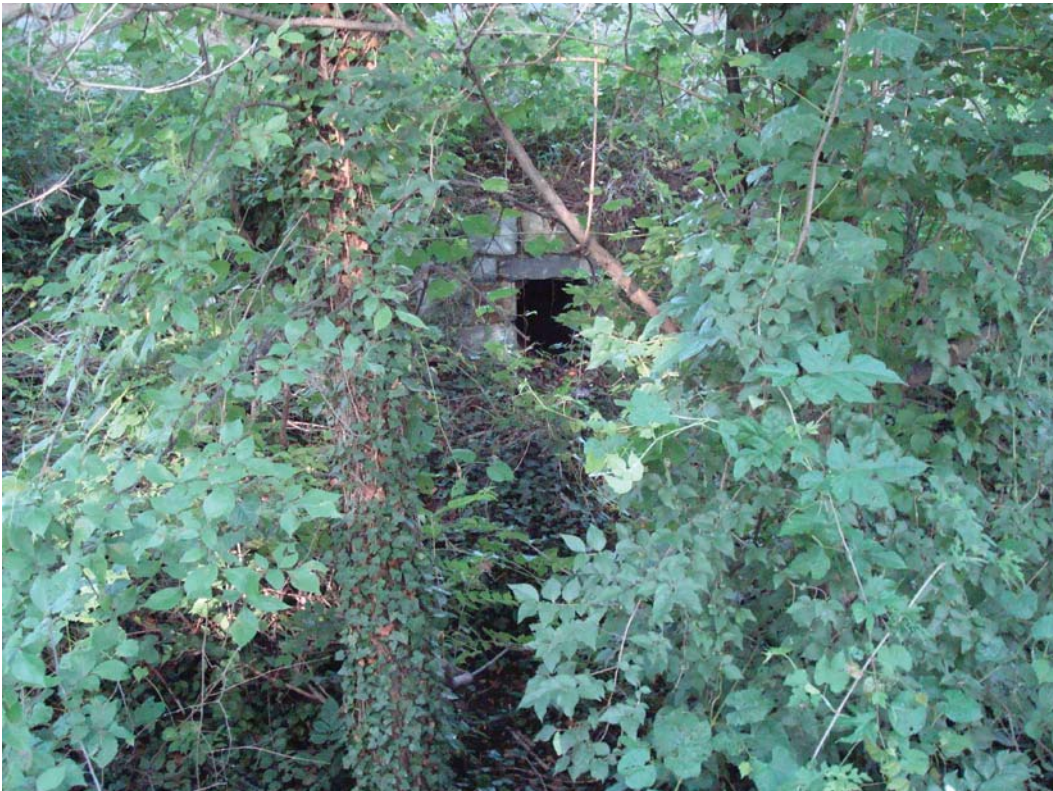
GWMP_0002_16.538_R_1.jpg

Wall ID:	GWMP-0002-16.538-R		
Route Name:	GWMP - NORTHBOUND		
Inspection Date:	July 11, 2007	Approximate Year Built:	Unknown
*Wall Rating:	68	Maintenance Action:	No Action

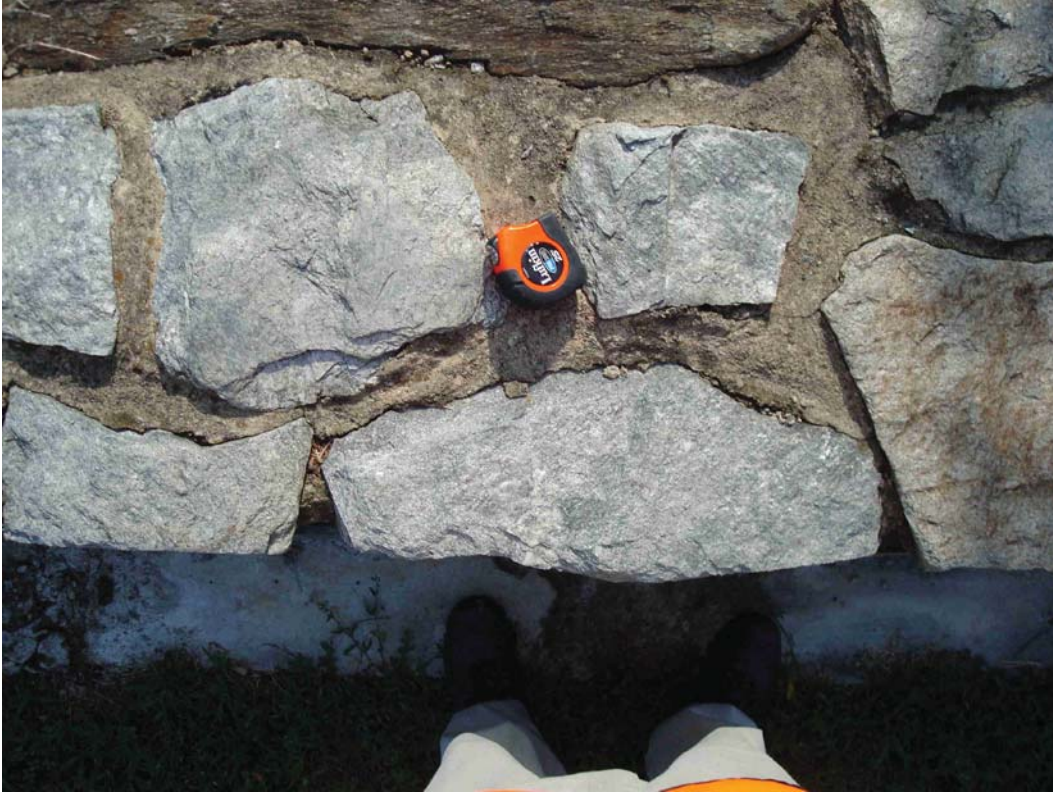
GWMP_0002_16.859_R_1.jpg

Wall ID:	GWMP-0002-16.859-R		
Route Name:	GWMP - NORTHBOUND		
Inspection Date:	July 11, 2007	Approximate Year Built:	Unknown
*Wall Rating:	73	Maintenance Action:	Repair Elements

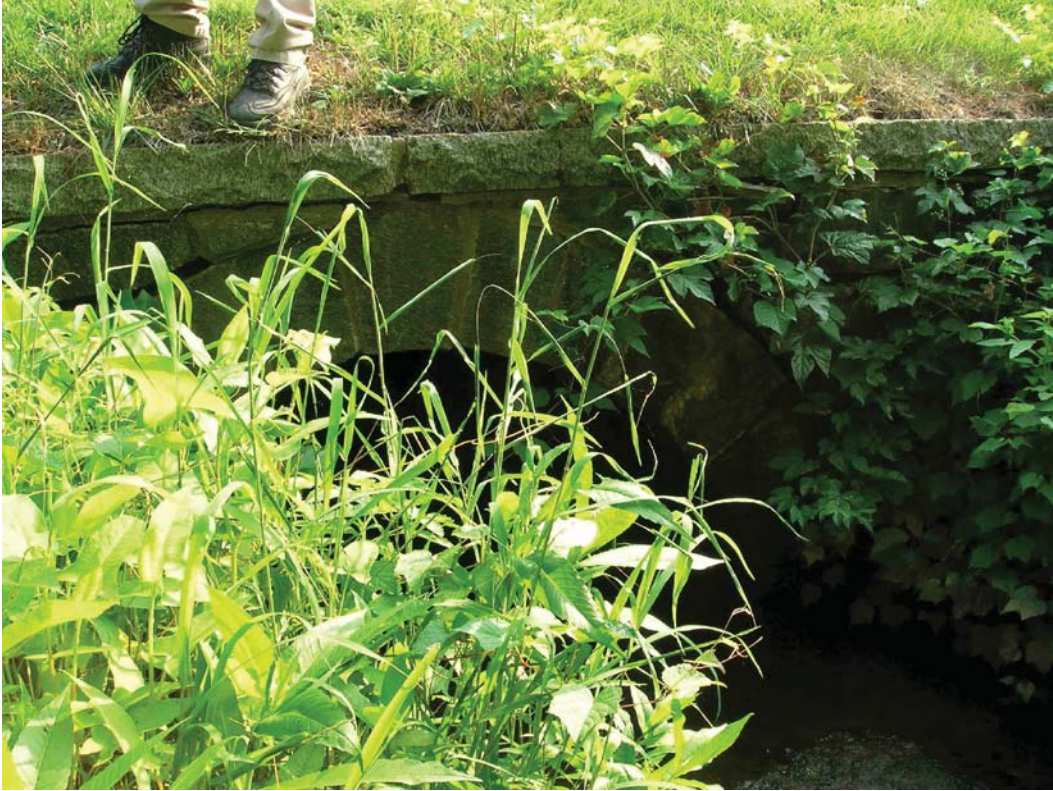
GWMP_0003ZZ_0.954_R_1.jpg

Wall ID:	GWMP-0003ZZ-0.954-R		
Route Name:	MOUNT VERNON PARKWAY		
Inspection Date:	July 10, 2007	Approximate Year Built:	Unknown
*Wall Rating:	68	Maintenance Action:	Repair Elements

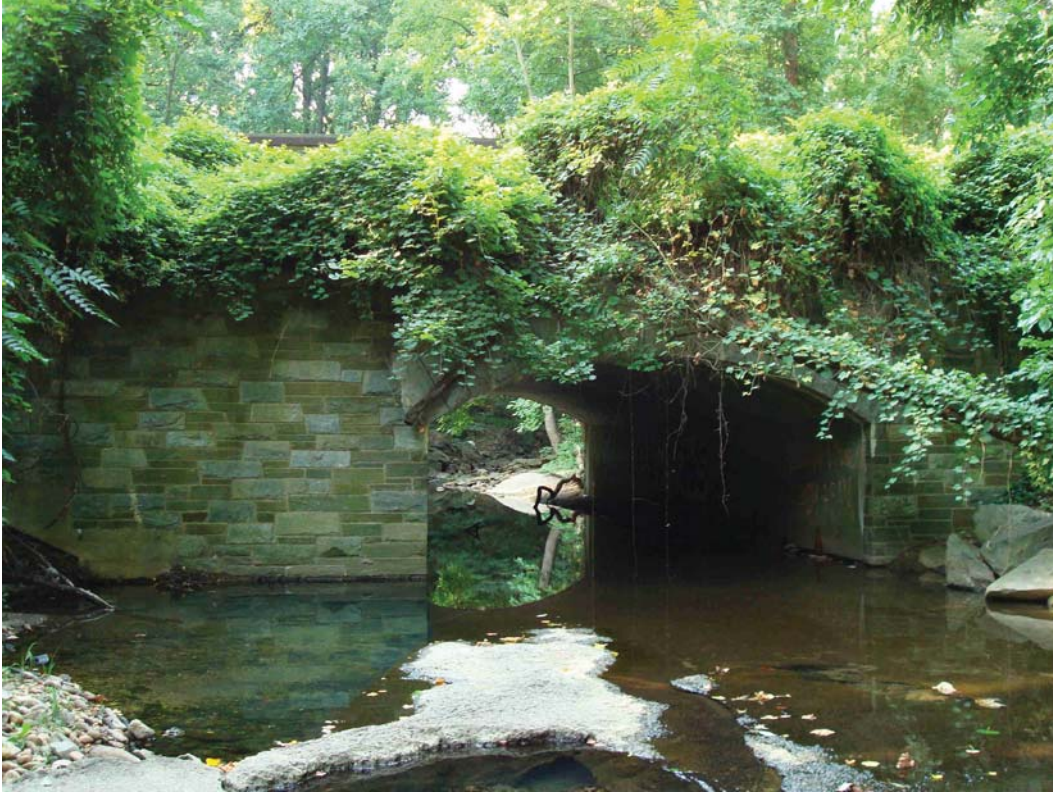
GWMP_0004_0.323_L_1.jpg

Wall ID:	GWMP-0004-0.323-L		
Route Name:	SPOUT RUN PARKWAY EASTBOUND		
Inspection Date:	July 16, 2007	Approximate Year Built:	Unknown
*Wall Rating:	68	Maintenance Action:	No Action

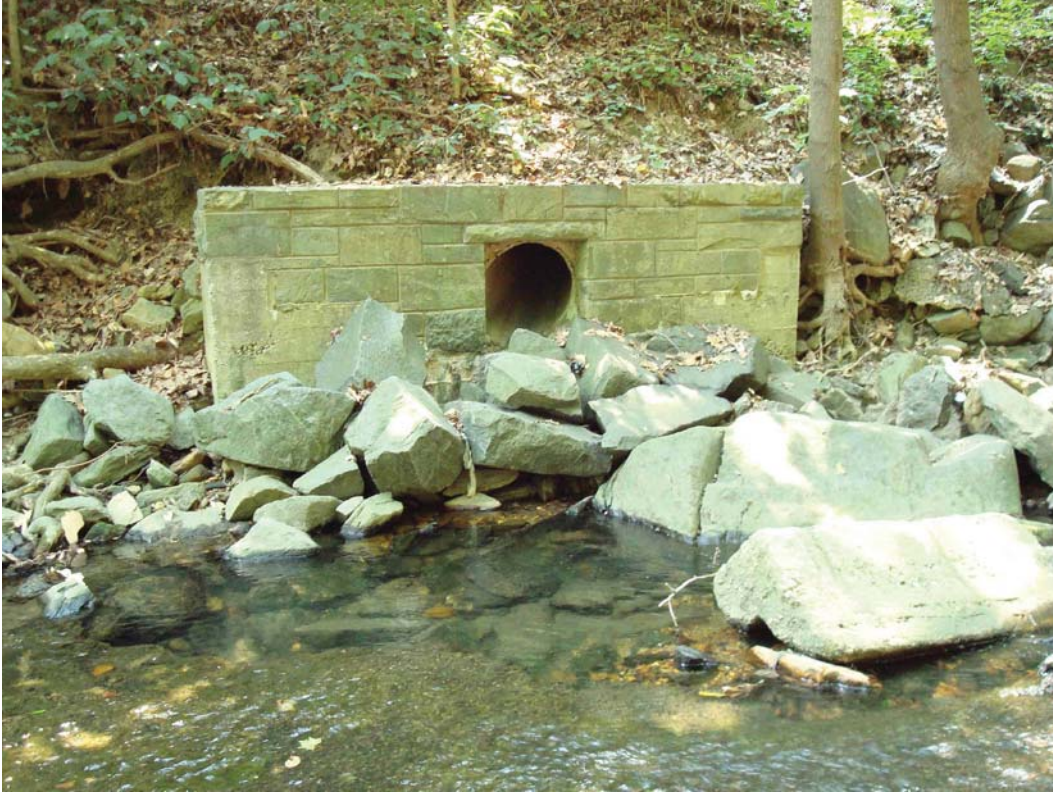
GWMP_0004_0.561_L_1.jpg

Wall ID:	GWMP-0004-0.561-L		
Route Name:	SPOUT RUN PARKWAY EASTBOUND		
Inspection Date:	July 16, 2007	Approximate Year Built:	Unknown
*Wall Rating:	59	Maintenance Action:	Repair Elements

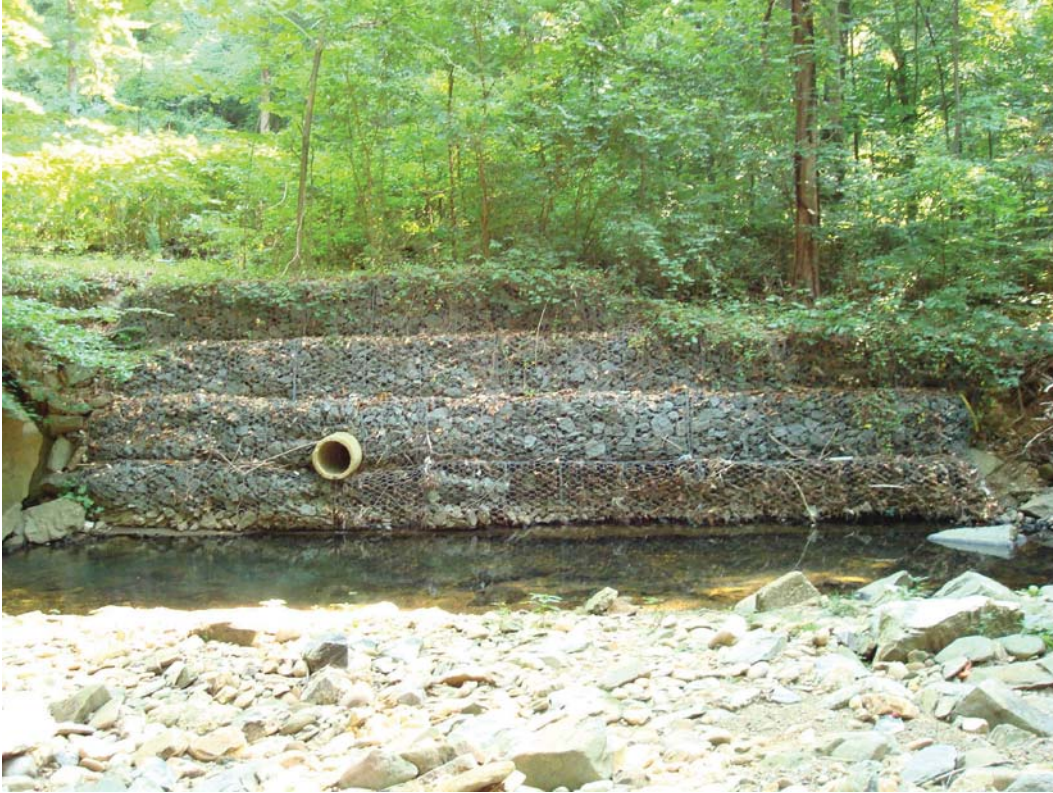
GWMP_0005ZZ_0.446_L_1.jpg

Wall Identification	Failure Consequence⁽¹⁾	Wall Rating⁽²⁾	Recommended Action⁽³⁾	2007 Repair Costs⁽⁴⁾
GWMP-0005ZZ-0.446-L	MODERATE	44	REPLACE WALL	\$117,500
GWMP-0936ZZ-0.000-P1	LOW	48	REPLACE WALL	\$151,200
