HALE WIP Report

NPS Retaining Wall Inventory Program Haleakala National Park

Federal Highway Administration
Eastern Federal Lands Highway Division
Road Inventory Program (RIP)

Data Collection Date: July 2007
Report Date: October 2015

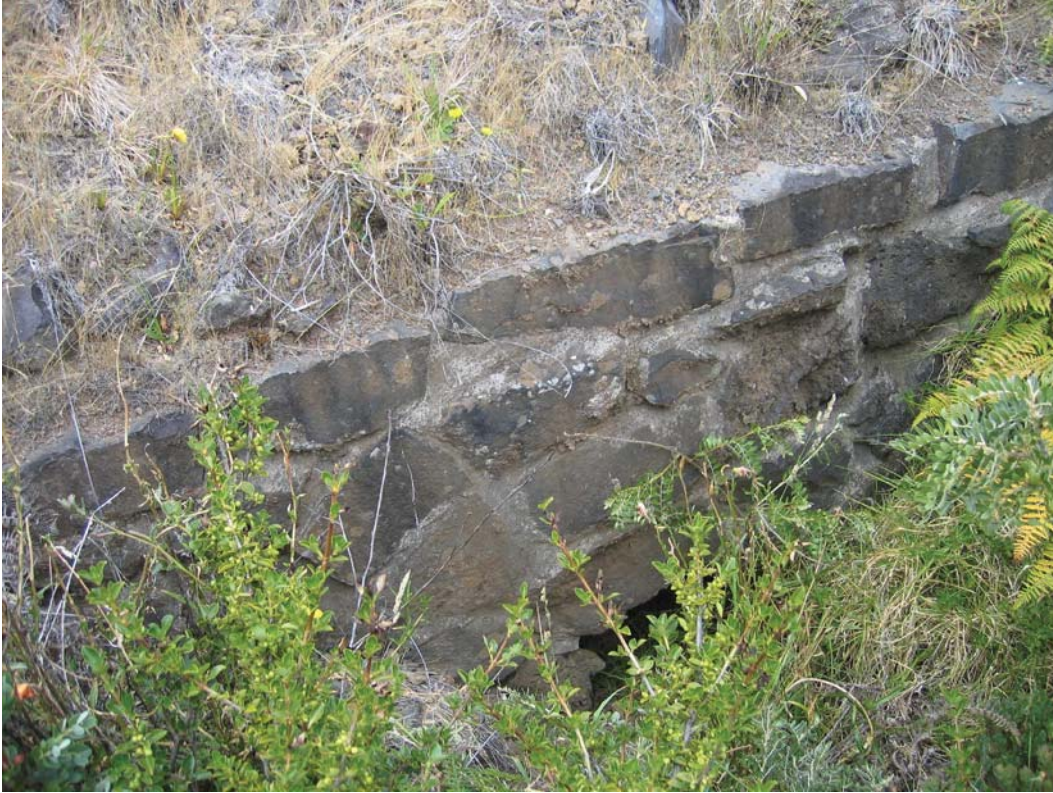
HALE_0010_1.231_L_1.jpg

Wall ID:	HALE-0010-1.231-L		
Route Name:	HALEAKALA PARK ROAD		
Inspection Date:	July 09, 2007	Approximate Year Built:	1934
*Wall Rating:	78	Maintenance Action:	No Action

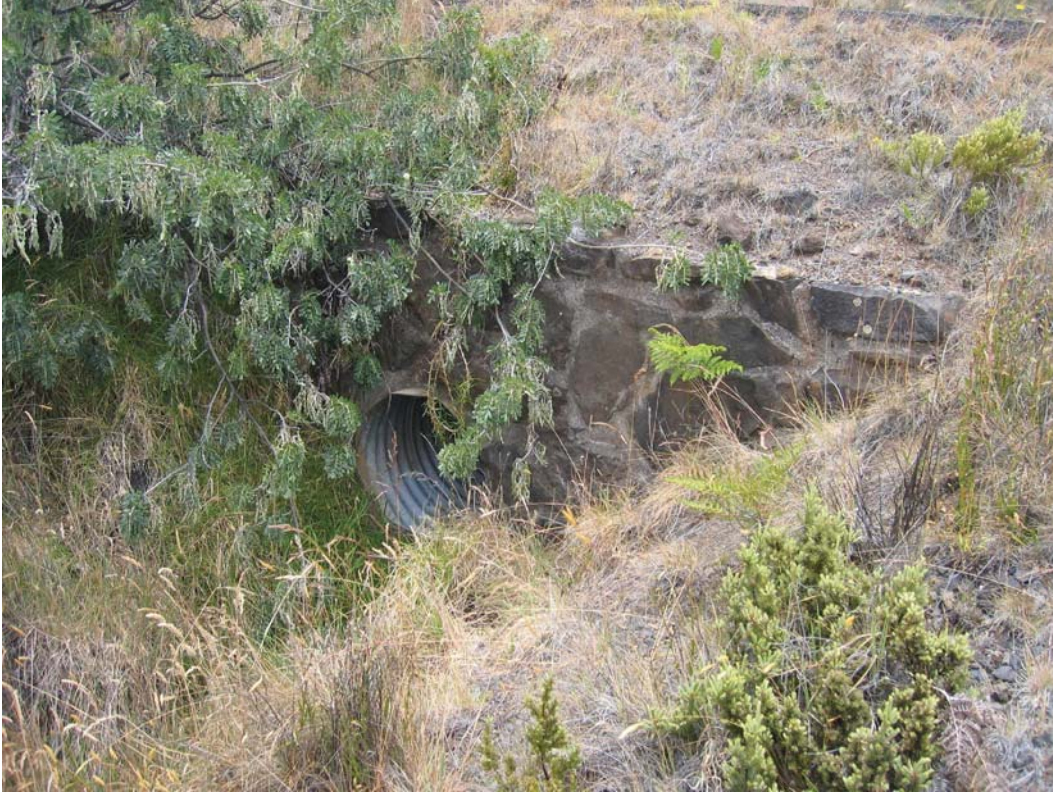
HALE_0010_1.397_L_1.jpg

Wall ID:	HALE-0010-1.397-L		
Route Name:	HALEAKALA PARK ROAD		
Inspection Date:	July 09, 2007	Approximate Year Built:	1934
*Wall Rating:	78	Maintenance Action:	No Action

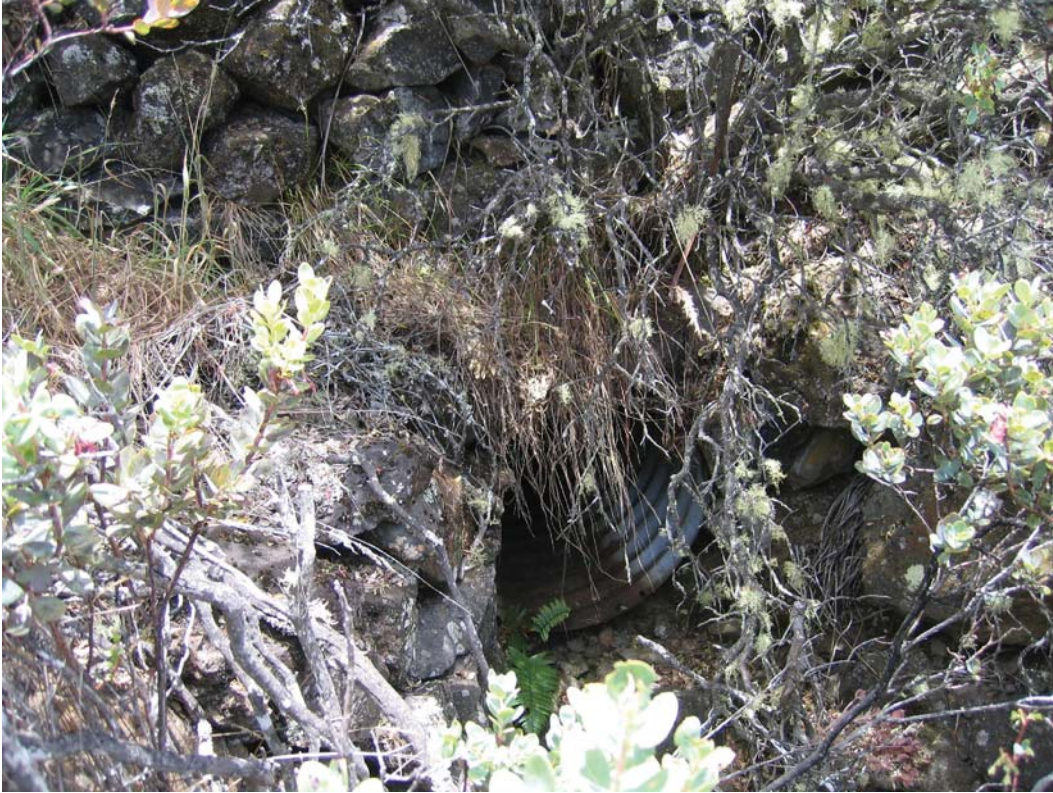
HALE_0010_1.644_L_1.jpg

Wall ID:	HALE-0010-1.644-L		
Route Name:	HALEAKALA PARK ROAD		
Inspection Date:	July 09, 2007	Approximate Year Built:	1934
*Wall Rating:	52	Maintenance Action:	Maintenance

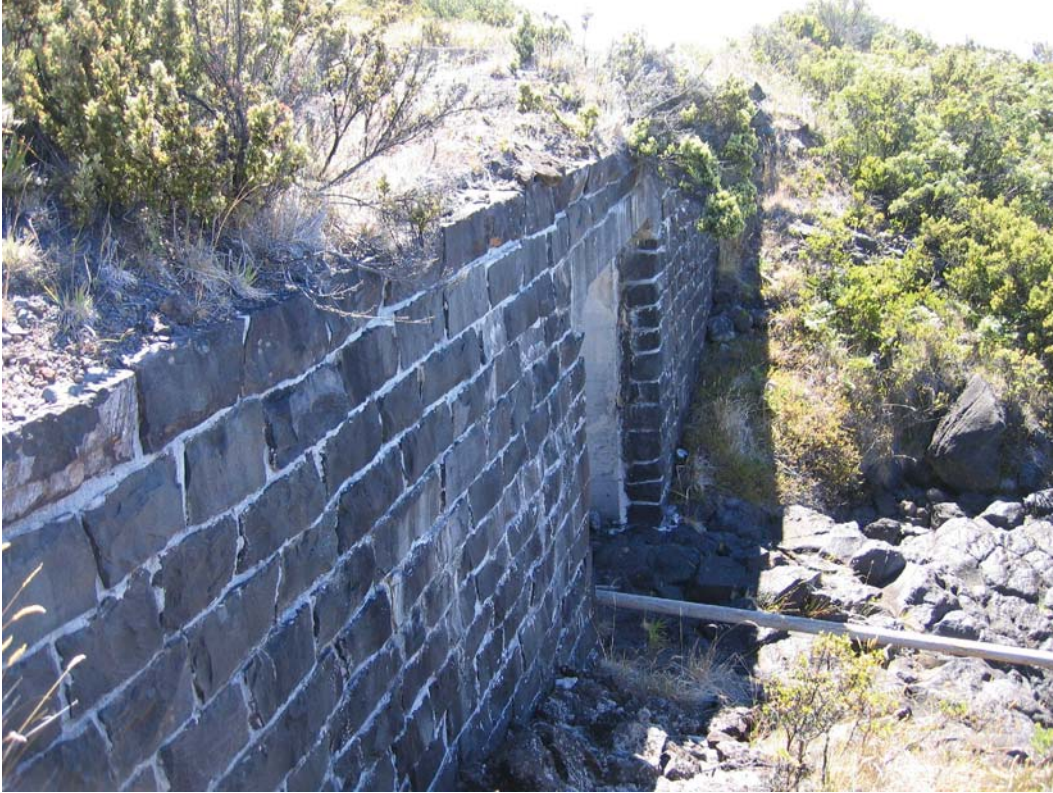
HALE_0010_1.982_L_1.jpg

Wall ID:	HALE-0010-1.982-L		
Route Name:	HALEAKALA PARK ROAD		
Inspection Date:	July 09, 2007	Approximate Year Built:	1934
*Wall Rating:	79	Maintenance Action:	No Action

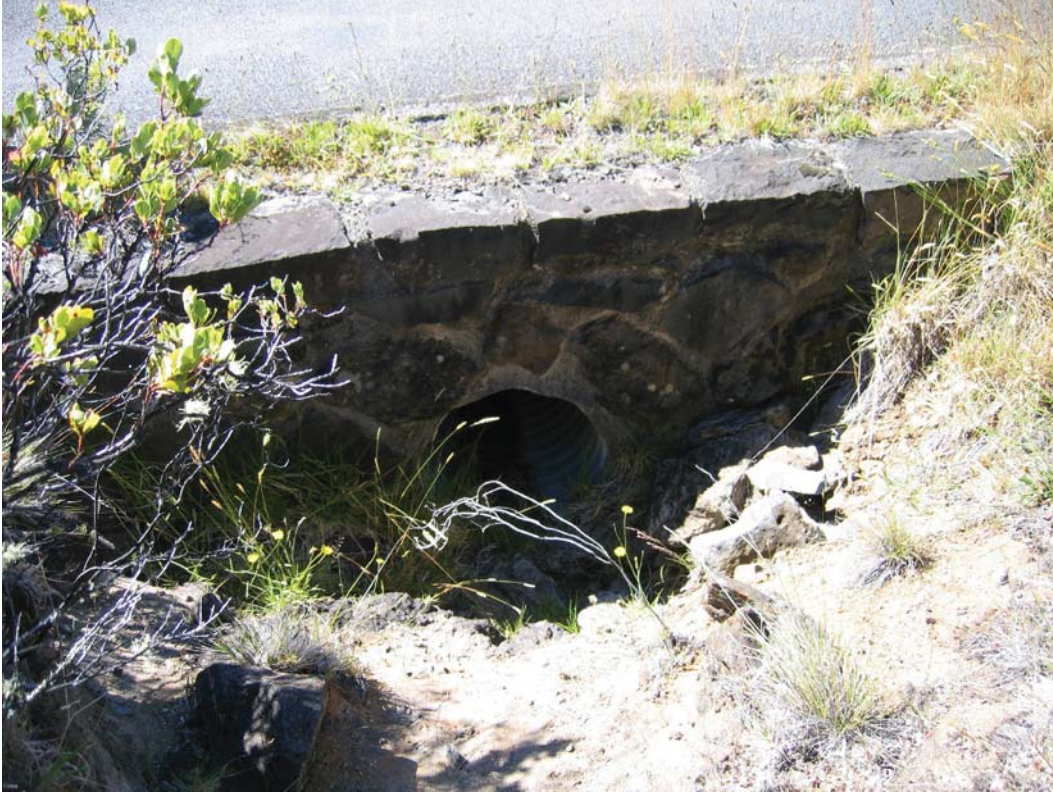
HALE_0010_2.050_R_1.jpg

Wall ID:	HALE-0010-2.050-R		
Route Name:	HALEAKALA PARK ROAD		
Inspection Date:	July 09, 2007	Approximate Year Built:	1934
*Wall Rating:	78	Maintenance Action:	No Action

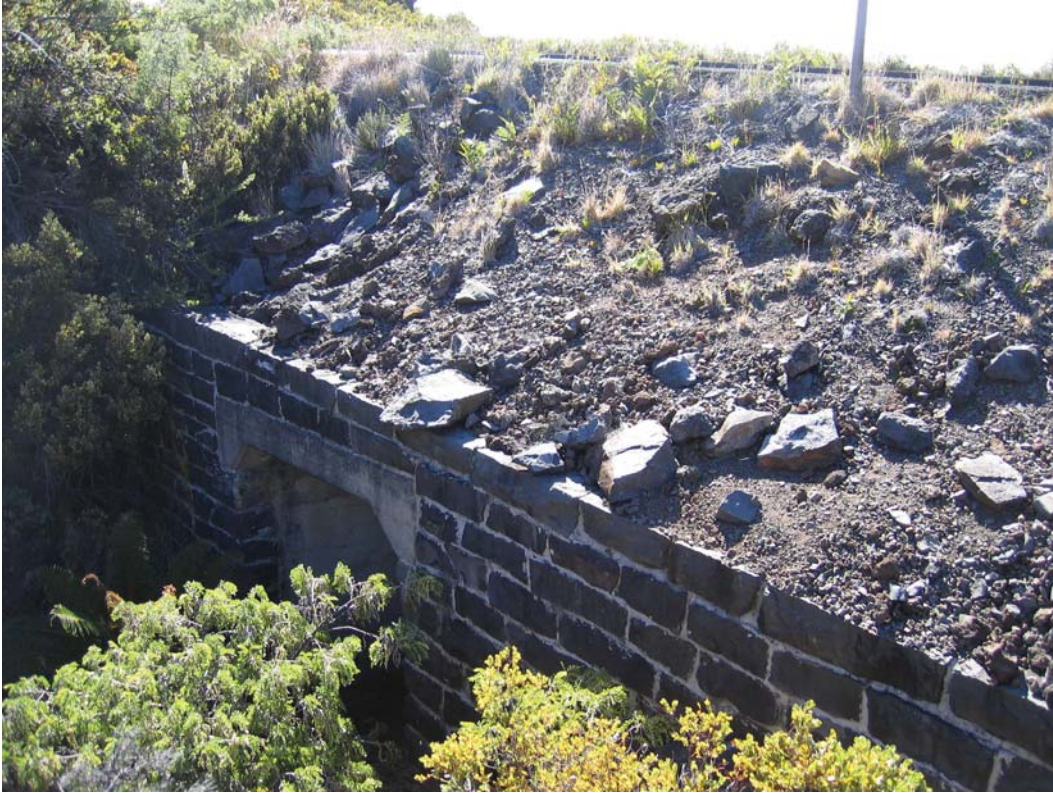
HALE_0010_2.584_L_1.jpg

Wall ID:	HALE-0010-2.584-L		
Route Name:	HALEAKALA PARK ROAD		
Inspection Date:	July 09, 2007	Approximate Year Built:	1934
*Wall Rating:	79	Maintenance Action:	No Action

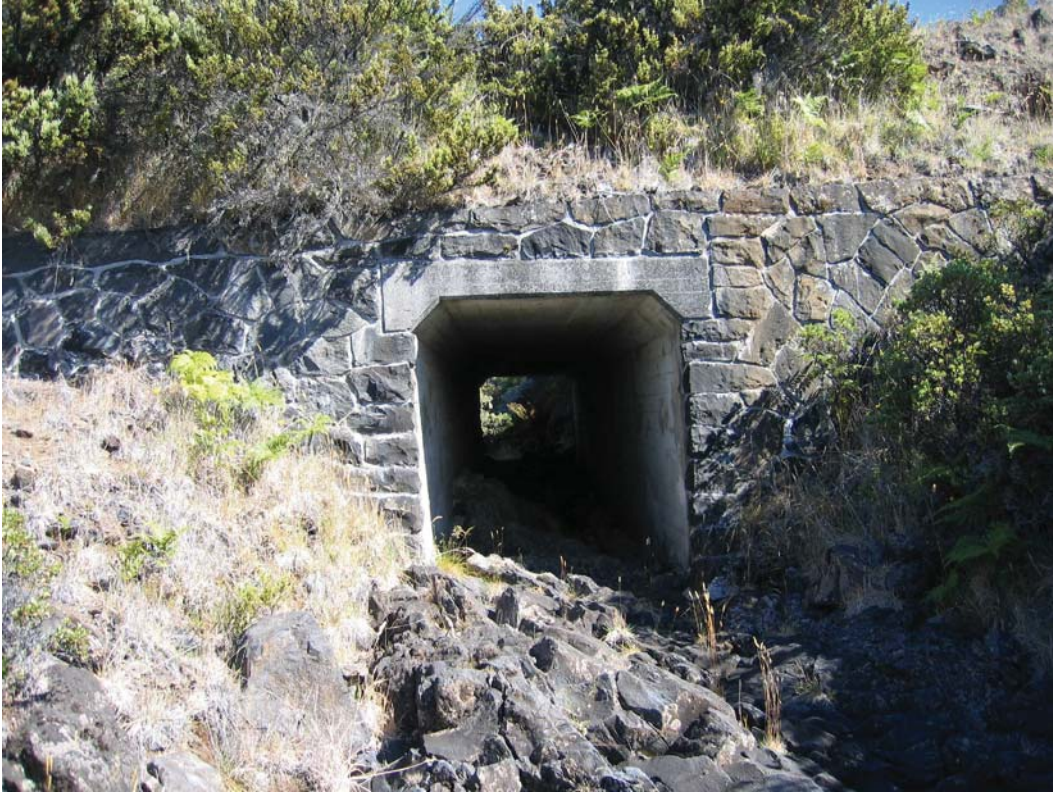
HALE_0010_2.584_R_1.jpg

Wall ID:	HALE-0010-2.584-R		
Route Name:	HALEAKALA PARK ROAD		
Inspection Date:	July 09, 2007	Approximate Year Built:	1934
*Wall Rating:	79	Maintenance Action:	No Action

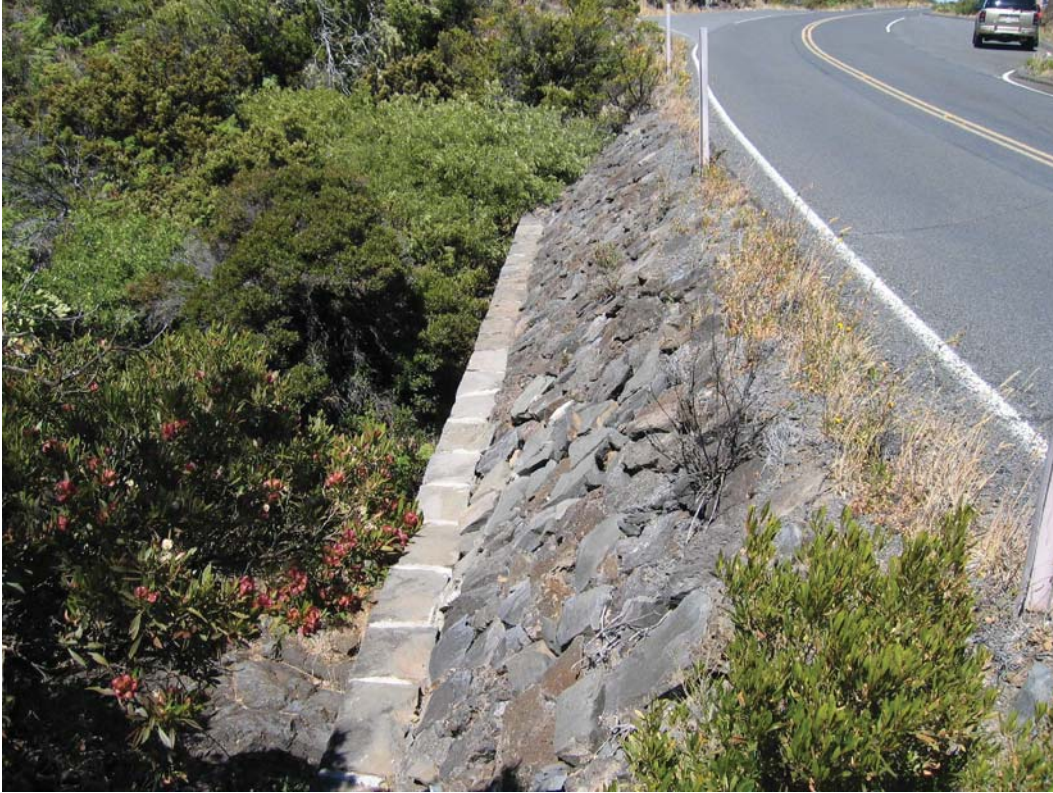
HALE_0010_2.947_L_1.jpg

Wall ID:	HALE-0010-2.947-L		
Route Name:	HALEAKALA PARK ROAD		
Inspection Date:	July 10, 2007	Approximate Year Built:	1934
*Wall Rating:	79	Maintenance Action:	No Action

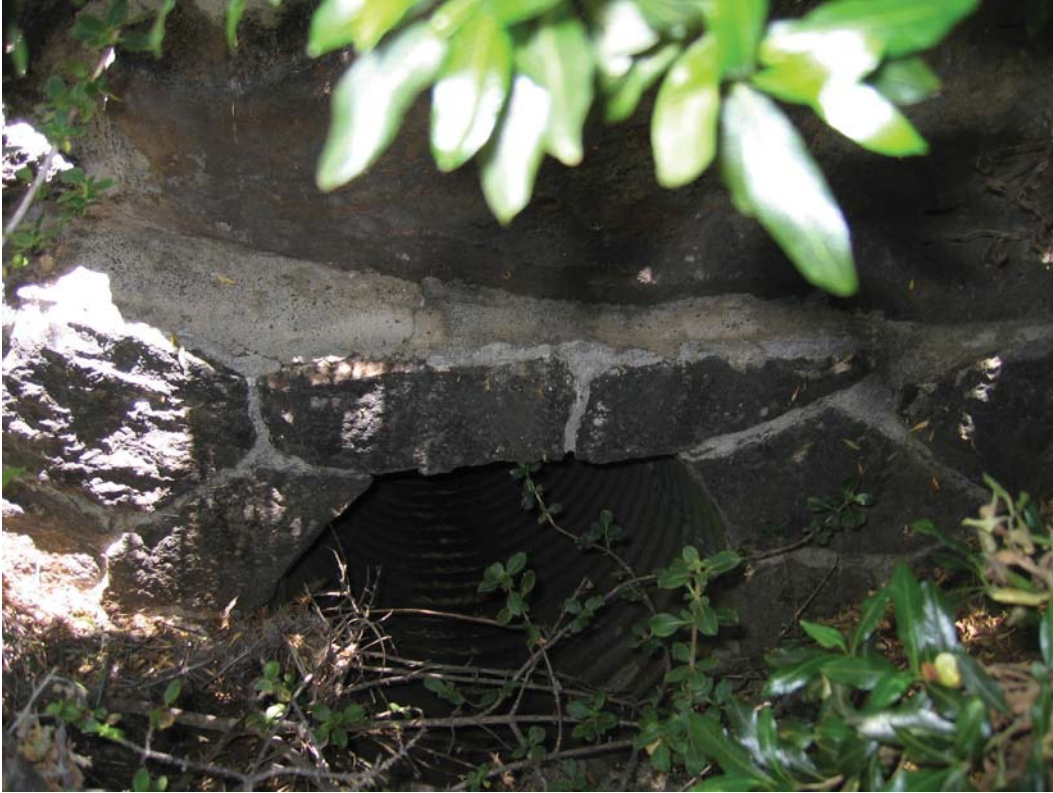
HALE_0010_3.515_R_1.jpg

Wall ID:	HALE-0010-3.515-R		
Route Name:	HALEAKALA PARK ROAD		
Inspection Date:	July 10, 2007	Approximate Year Built:	1934
*Wall Rating:	70	Maintenance Action:	No Action

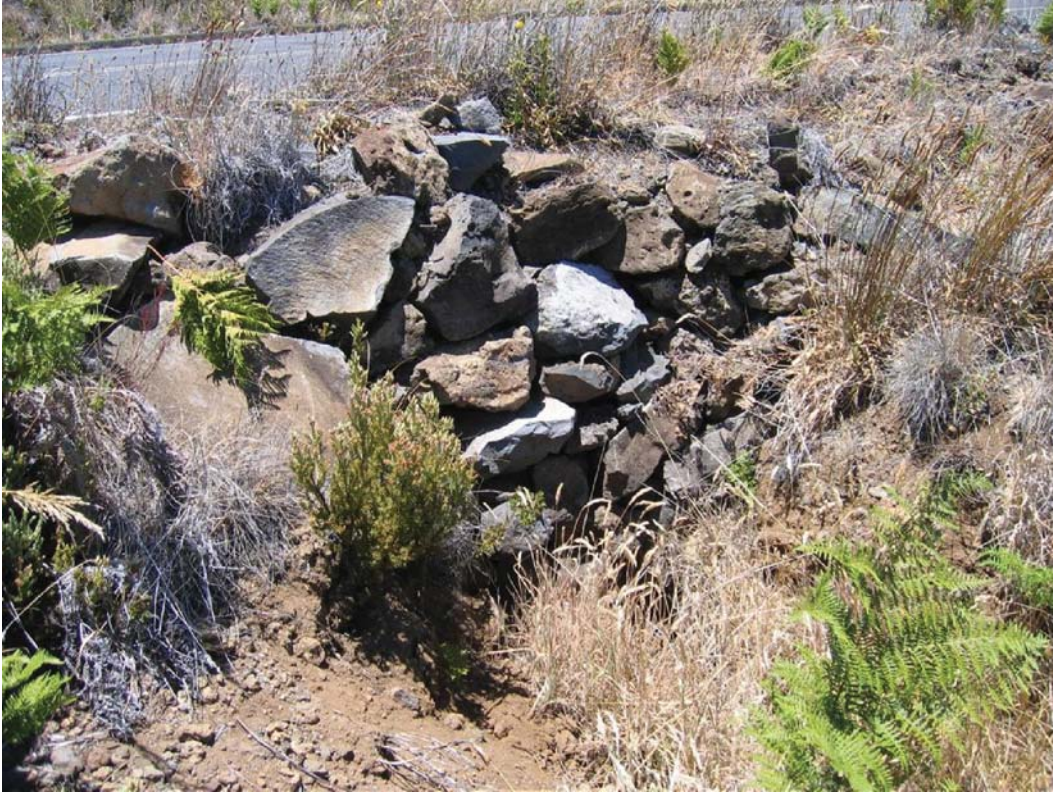
HALE_0010_3.692_L_1.jpg

Wall ID:	HALE-0010-3.692-L		
Route Name:	HALEAKALA PARK ROAD		
Inspection Date:	July 10, 2007	Approximate Year Built:	1934
*Wall Rating:	73	Maintenance Action:	No Action

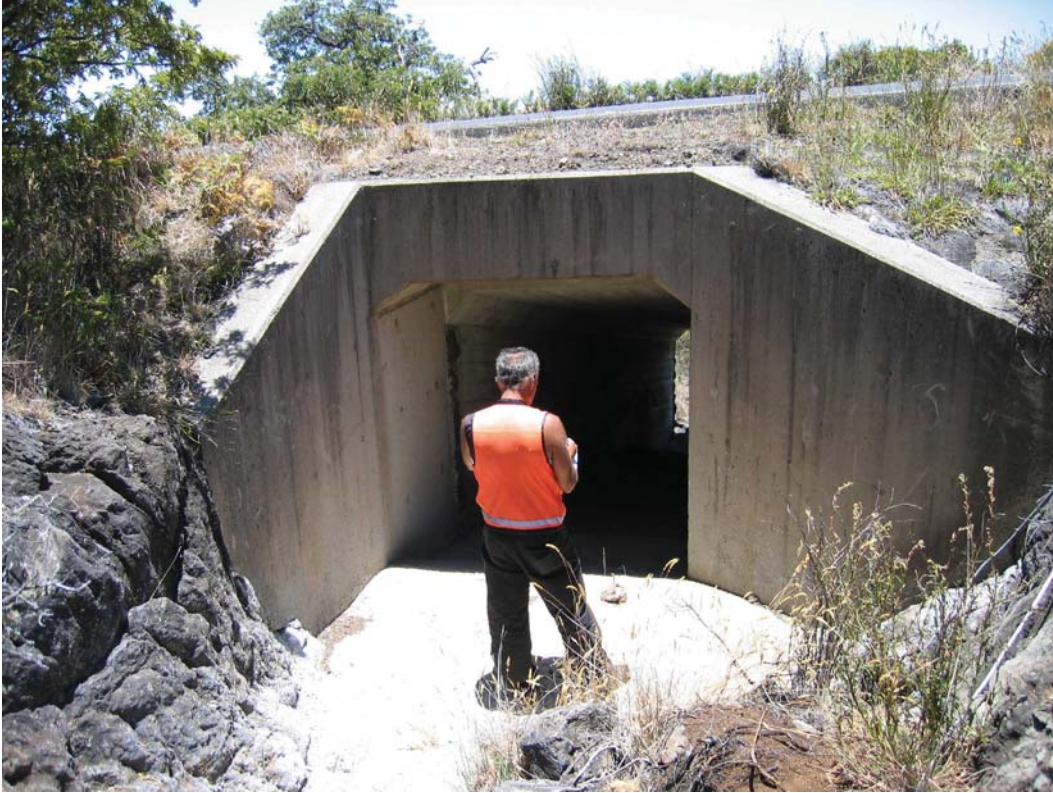
HALE_0010_3.859_R_1.jpg

Wall ID:	HALE-0010-3.859-R		
Route Name:	HALEAKALA PARK ROAD		
Inspection Date:	July 10, 2007	Approximate Year Built:	1934
*Wall Rating:	78	Maintenance Action:	No Action

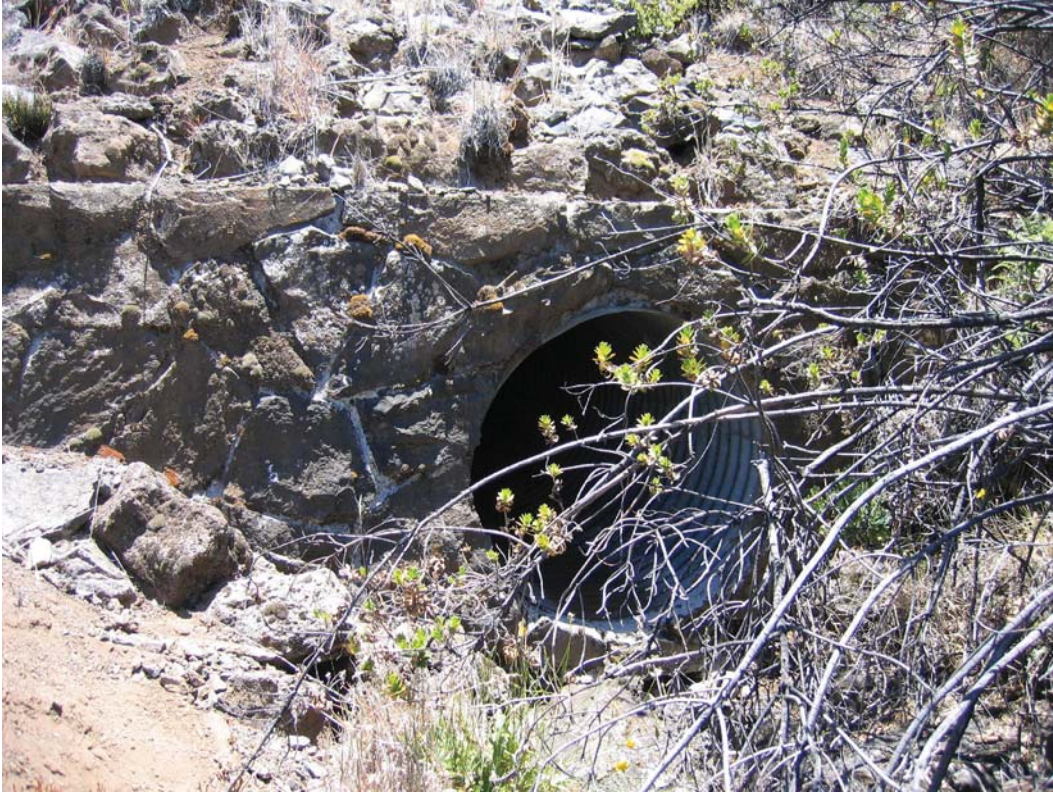
HALE_0010_4.098_L_1.jpg

Wall ID:	HALE-0010-4.098-L		
Route Name:	HALEAKALA PARK ROAD		
Inspection Date:	July 10, 2007	Approximate Year Built:	1934
*Wall Rating:	70	Maintenance Action:	No Action

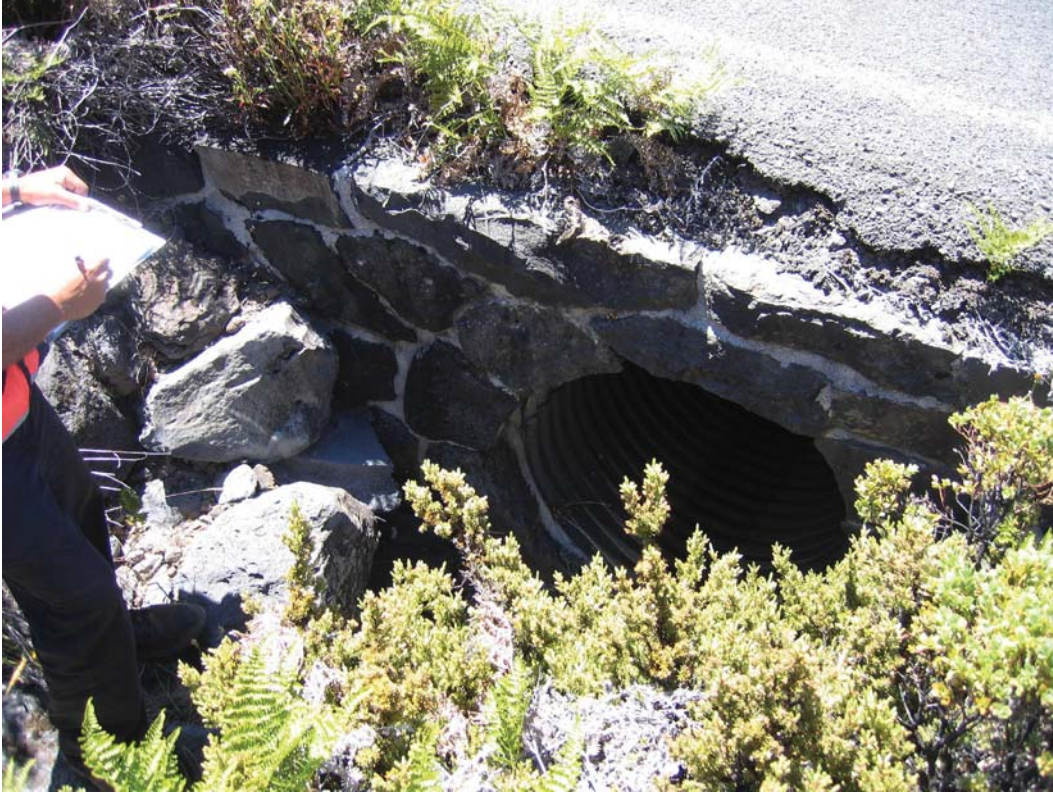
HALE_0010_4.877_L_1.jpg

Wall ID:	HALE-0010-4.877-L		
Route Name:	HALEAKALA PARK ROAD		
Inspection Date:	July 10, 2007	Approximate Year Built:	1934
*Wall Rating:	70	Maintenance Action:	No Action

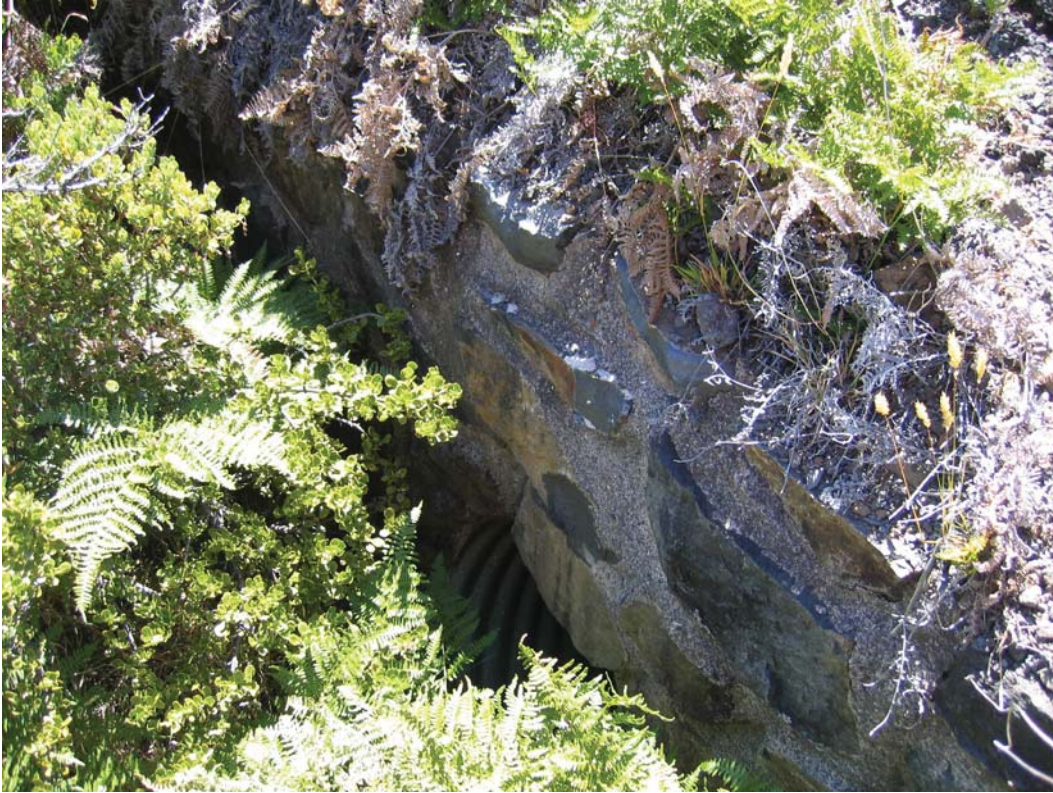
HALE_0010_4.988_L_1.jpg

Wall ID:	HALE-0010-4.988-L		
Route Name:	HALEAKALA PARK ROAD		
Inspection Date:	July 10, 2007	Approximate Year Built:	1934
*Wall Rating:	70	Maintenance Action:	No Action
