# HOSP WIP Report

## NPS Retaining Wall Inventory Program Hot Springs National Park

Data Collection Date: April 2007  
Report Date: October 2015

# Hot Springs National Park in Arkansas

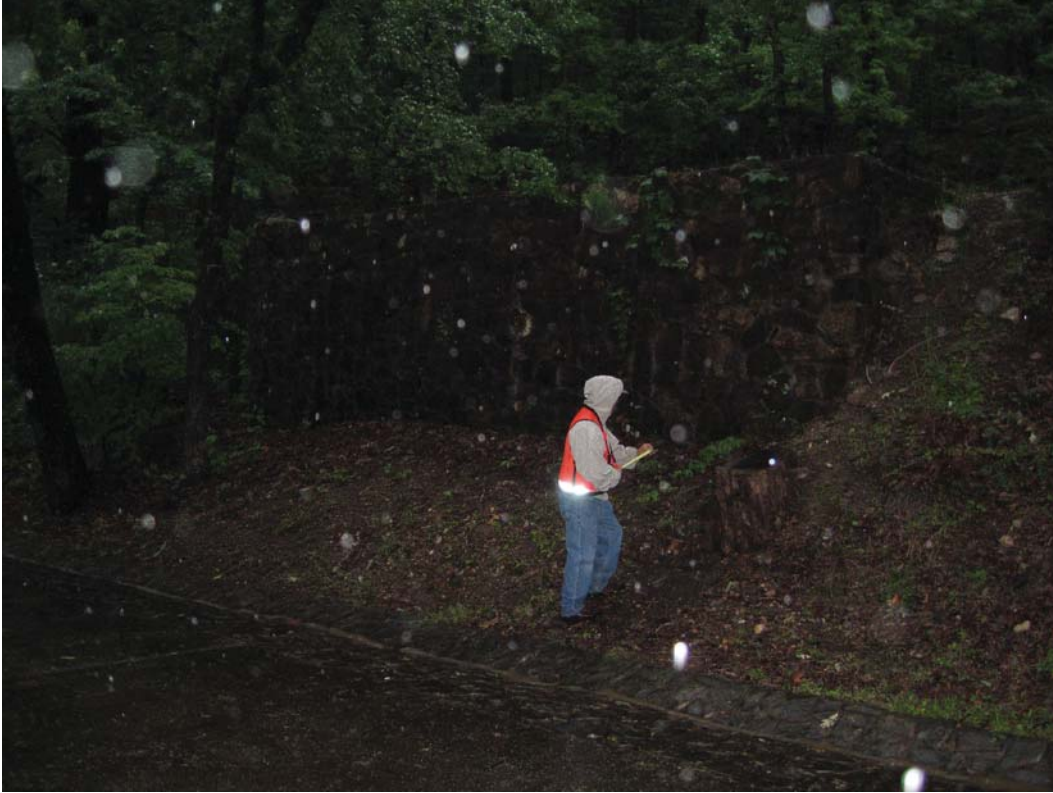
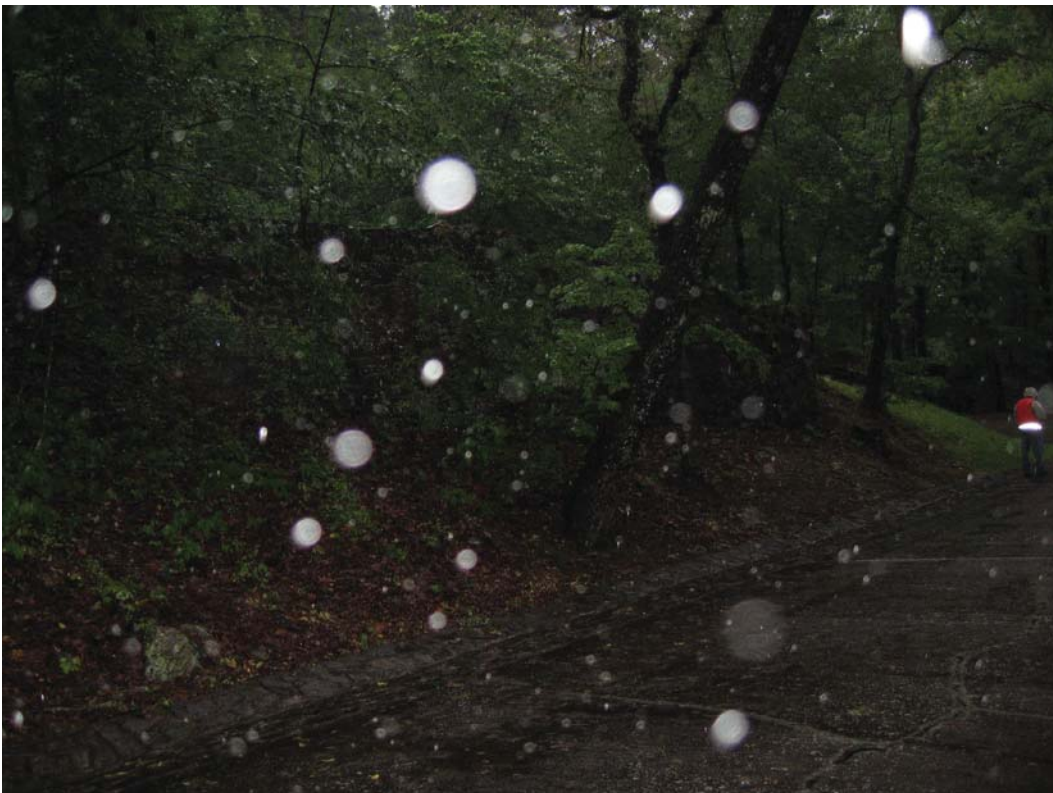
<b>Wall Function:</b>	Switchback Wall	<b>Primary Wall Type:</b>	Gravity - Mortared Stone
<b>Surface Treatment:</b>		<b>Secondary Wall Type:</b>	Gravity - Dry Stone
<b>Secondary Surface Treatment:</b>		<b>Architectural Facing:</b>	
<b>General Description:</b>	Stone mortared wall on switchback measured on outside (left side), dry stacked repair at wall start

<b>Element (Weighting Factor)</b>	<b>Narrative</b>	<b>Condition Rating (0 - 10)</b>
PERFORMANCE 8.00	Good condition, performing as intended, no guardwall, some repairs made	7
WALL FOUNDATION MATERIAL 8.00	No signs of distress or settlement	8
MORTAR 8.00	Minor cracking, 1/8-1/4-inch gaps, minor spalling	7
PLACED STONE 8.00	Non-weathered rock, none missing, one displaced	7
LATERAL SLOPE 0.50	Minor repair at wall start with dry stacked section, gentle at wall end	8
ROAD/SIDEWALK/SHOULDER 0.50	Road- older concrete pavement, some cracks but not related to wall	8
CURB/BERM/DITCH 0.50	Ditch, no signs of displacement or cracks on ditch	9
DOWNSLOPE 0.50	2H:1V short segment, some trees, no erosional features	9
WALL DRAINS 0.50	Drains observed, no signs of water-related problems	9

<b>Failure Consequence:</b>	HIGH
<b>Recommendation Narrative:</b>	None
<b>Repair Cost:</b>	\$0

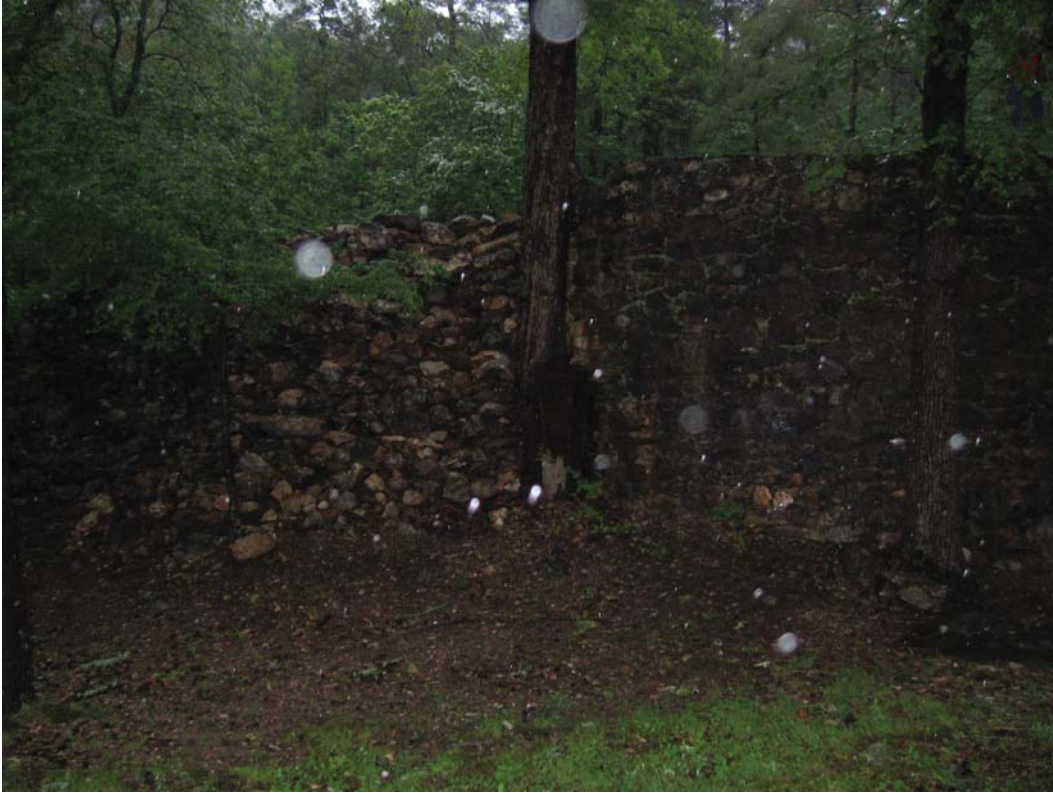
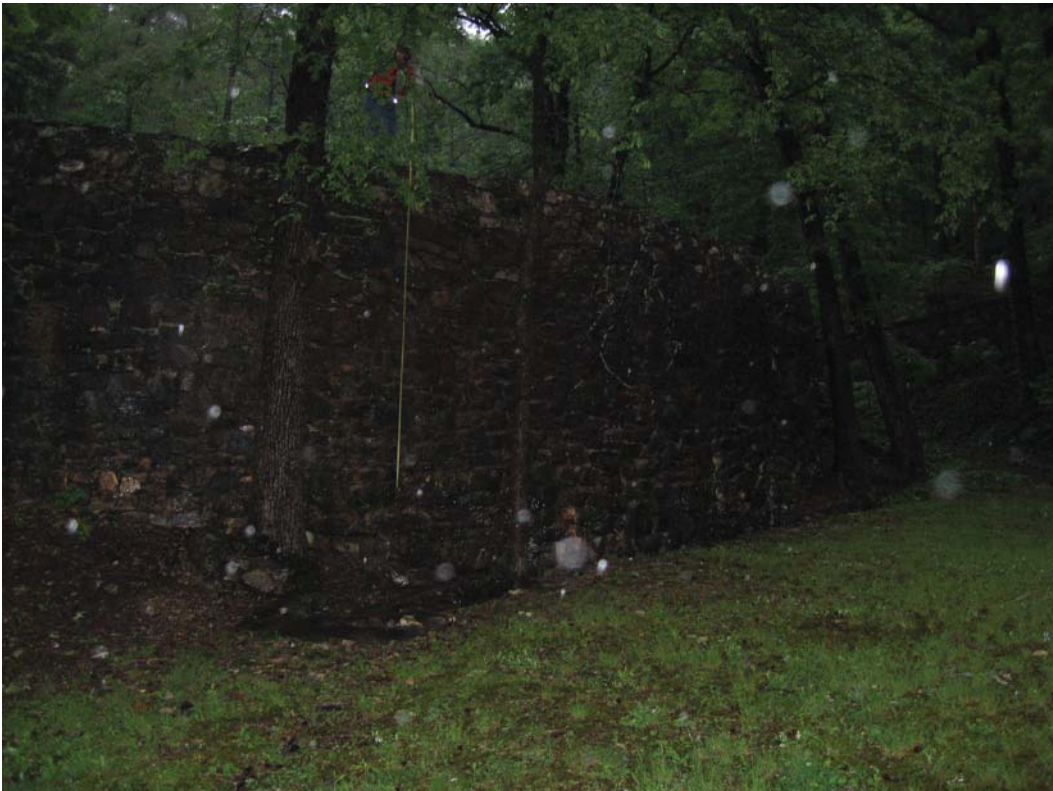
<b>Wall ID:</b>	HOSP-0010-0.040-R		
<b>Route Name:</b>	HOT SPRINGS MOUNTAIN DRIVE		
<b>Inspection Date:</b>	April 25, 2007	<b>Approximate Year Built:</b>	1911
<b>*Wall Rating:</b>	61	<b>Maintenance Action:</b>	No Action

<b>Element (Weighting Factor)</b>	<b>Narrative</b>	<b>Condition Rating (0 - 10)</b>
PERFORMANCE 8.00	Fair, some repair in the form of dry stacked rock made at each end of the older stone masonry wall and near the highest section of wall vertical cracking, outward movement is evident at the highest wall section near the vertical crack, needs to be monitor	6
WALL FOUNDATION MATERIAL 8.00	No signs of displacement or movement	8
MORTAR 8.00	Large up to 3-inch opening entire height of wall near center, poor condition, old tree removed from this location (which could have been supporting a portion of the wall), appears as if minor spot repairs have been made, outward movement at the highest wa	4
PLACED STONE 8.00	Sound durable rock, non-weathered	8
DOWNSLOPE 0.50	Relatively flat with landscaped grass below (park), channelized drain at the base across half of the wall length	8
LATERAL SLOPE 0.50	Good condition, channelized drain on one side, no signs of distress	8

WALL DRAINS 0.50	None observed, no signs of water-related problems with the wall	8
ROAD/SIDEWALK/SHOULDER 1.00	Road- older rigid pavement with low to moderate block cracks	5
VEGETATION 5.00	Some adverse vegetation causing cracking in the mortar	3

<b>Failure Consequence:</b>	HIGH
<b>Recommendation Narrative:</b>	None
<b>Repair Cost:</b>	\$0

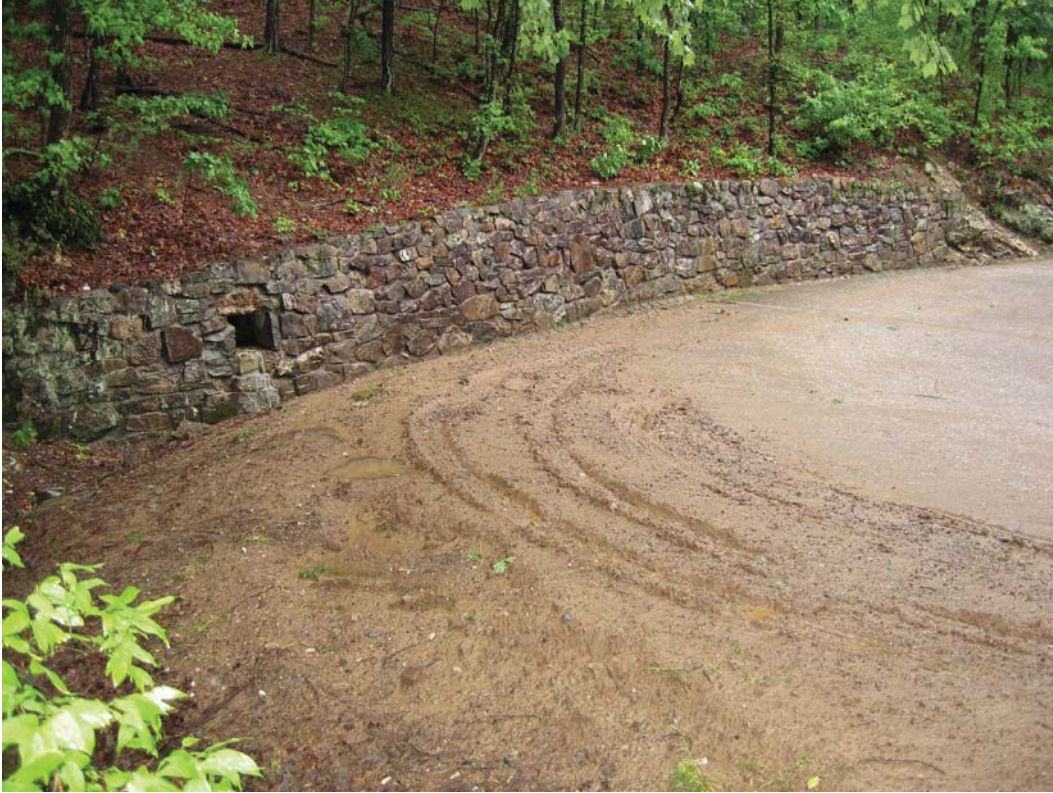
<b>Wall ID:</b>	HOSP-0010-0.095-L		
<b>Route Name:</b>	HOT SPRINGS MOUNTAIN DRIVE		
<b>Inspection Date:</b>	April 25, 2007	<b>Approximate Year Built:</b>	1911
<b>*Wall Rating:</b>	81	<b>Maintenance Action:</b>	No Action

<b>Element (Weighting Factor)</b>	<b>Narrative</b>	<b>Condition Rating (0 - 10)</b>
PERFORMANCE 8.00	Good condition, wall performing as intended	8
WALL FOUNDATION MATERIAL 8.00	Founded on rock ditch, no signs of settlement or displacement	9
MORTAR 8.00	Old, but only a few 1/8 to 1/4-inch wide minor cracks, no spalling, occasional gaps	7
PLACED STONE 8.00	No loose or missing elements, occasional partially loose caprock, durable stone	8
ROAD/SIDEWALK/SHOULDER 0.50	Road older rigid pavement with occasional block cracking not associated with wall movement	8
CULVERT 0.50	18-inch PVC, draining well, no observed distress associated with wall	9
CURB/BERM/DITCH 0.50	Rock-lined ditch, no missing rock, minor sedimentation, no associated distress related to wall	9
LATERAL SLOPE 0.50	Ties into bedrock outcrop on both ends	9
UPSLOPE 0.50	2H:1V slope, good vegetation, no erosion observed	9

<b>Failure Consequence:</b>	MODERATE
<b>Recommendation Narrative:</b>	None
<b>Repair Cost:</b>	\$0

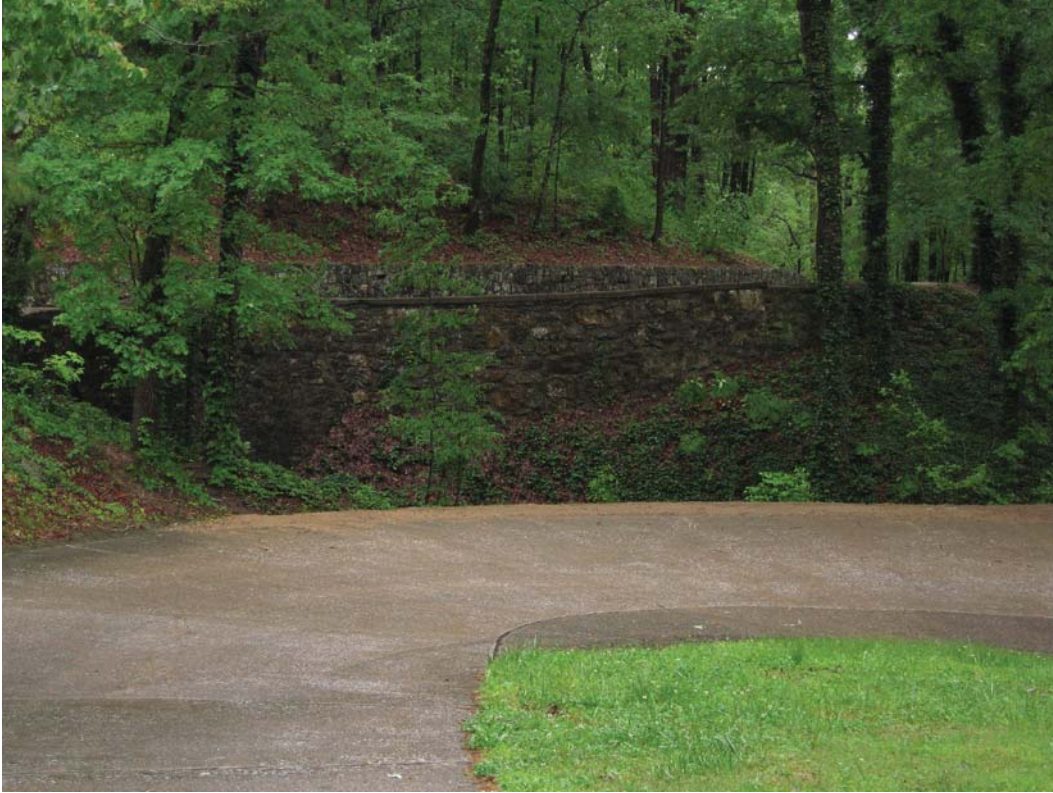
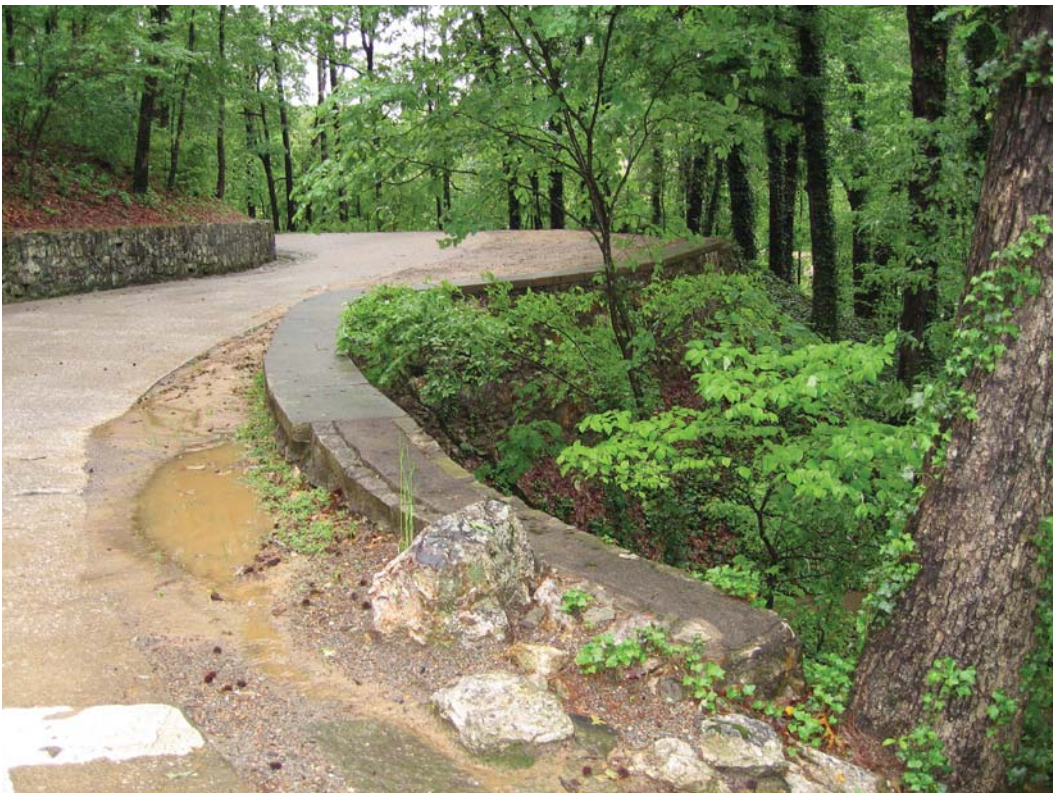
<b>Wall ID:</b>	HOSP-0010-0.117-R		
<b>Route Name:</b>	HOT SPRINGS MOUNTAIN DRIVE		
<b>Inspection Date:</b>	April 25, 2007	<b>Approximate Year Built:</b>	1911
<b>*Wall Rating:</b>	80	<b>Maintenance Action:</b>	No Action

WALL DRAINS 0.50	None observed, no indication of water-related issues with the wall	9
DOWNSLOPE 1.00	Varies from 1H:1V to flat, minor cracking, fair to moderate condition	7
