WIP Report

**NPS Retaining Wall Inventory Program
Kings Canyon National Park**

**Federal Lands Highway
Road Inventory Program**

**Data Collection Date: August 2007
Report Date: November 2015**

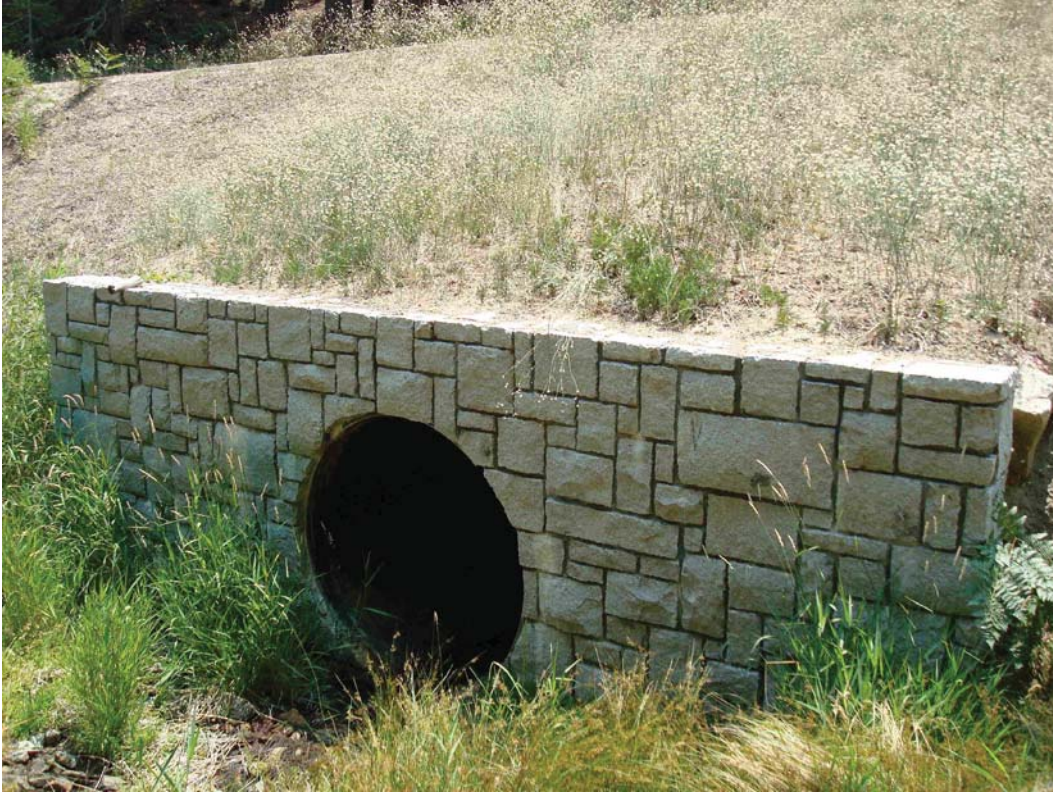
KICA_0015_2.767_R_1.jpg

Wall ID:	KICA-0015-2.767-R		
Route Name:	GRANT GROVE ROAD		
Inspection Date:	August 14, 2007	Approximate Year Built:	Unknown
*Wall Rating:	88	Maintenance Action:	No Action

Wall Function:	Head Wall	Primary Wall Type:	Gravity - Mortared Stone
Surface Treatment:		Secondary Wall Type:	
Secondary Surface Treatment:		Architectural Facing:	
General Description:	Mortared stone masonry headwall with 72 in CMP

Element (Weighting Factor)	Narrative	Condition Rating (0 - 10)
PERFORMANCE 8.00	No significant wall distress - performing like new.	10
WALL FOUNDATION MATERIAL 8.00	Minor seepage evident along one side of wall, though no signs of settlement, wall staining, or eroded foundation materials.	7
MORTAR 8.00	Sound, durable, intact with no signs of cracking or significant weathering.	9
STONE MASONRY 8.00	Hard, fresh, durable, unweathered granite with no missing or cracked blocks.	10
DOWNSLOPE 0.50	Bottom of drainage. Shows no signs of instability or erosion.	8
LATERAL SLOPE 0.50	Very stable lateral slopes with no signs of settlement, slumping, or erosion.	8
UPSLOPE 0.50	Stable roadway fill with minor vegetation.	8
CULVERT 0.50	Nearly new culvert with no signs of significant corrosion or settlement-related deformation.	9
CURB/BERM/DITCH 0.50	No wall-related distress to concrete curb.	9

Failure Consequence:	MODERATE
Recommendation Narrative:	None
Repair Cost:	\$0

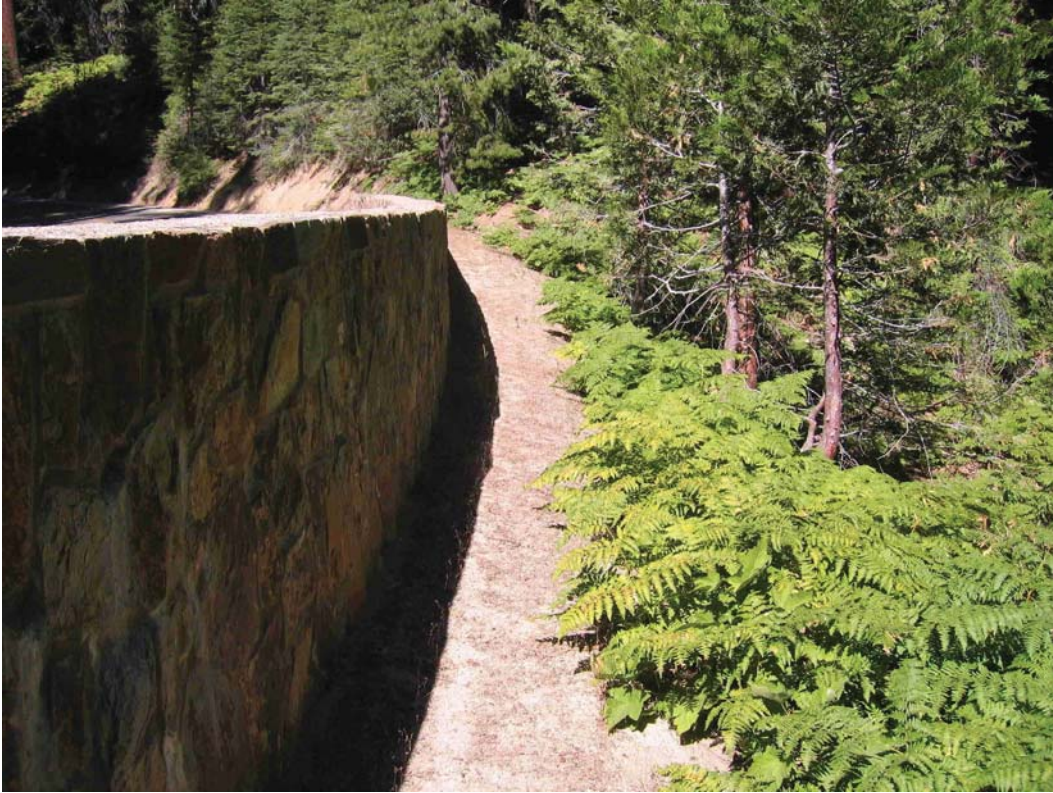
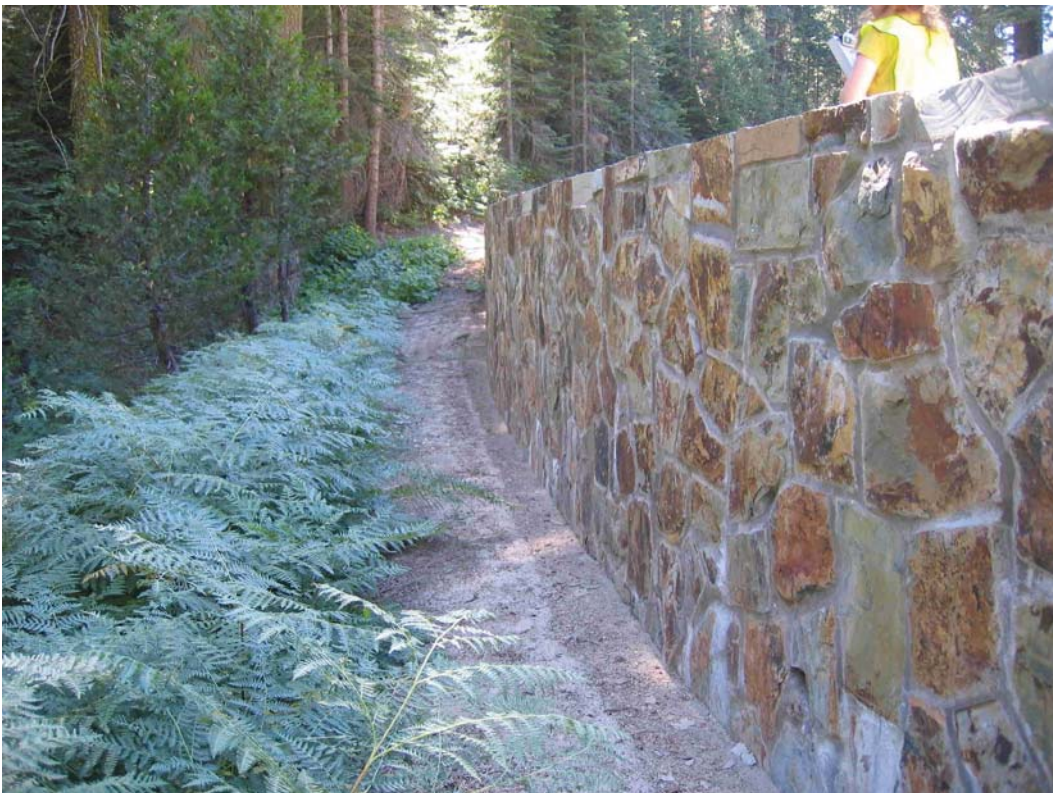
Wall ID:	KICA-0015-4.387-R		
Route Name:	GRANT GROVE ROAD		
Inspection Date:	August 22, 2007	Approximate Year Built:	2002
*Wall Rating:	86	Maintenance Action:	No Action

Wall Function:	Fill Wall	Primary Wall Type:	Cantilever - Concrete
Surface Treatment:		Secondary Wall Type:	
Secondary Surface Treatment:		Architectural Facing:	Stone Veneer
General Description:	Cast in place concrete wall with a schist parapet (stone veneer on all faces).

Element (Weighting Factor)	Narrative	Condition Rating (0 - 10)
PERFORMANCE 8.00	Excellent performance. No overturning, settlement, or global instability.	9
WALL FOUNDATION MATERIAL 8.00	Compacted fill (decomposed granite) with 5 ft bench and no signs of erosion. Sufficient to support wall. Toe of wall is exposed near wall begin and near a weep hole at mid point.	8
CONCRETE 8.00	Concrete is faced with schist veneer. No visible and no signs of severe cracking.	9
VEGETATION 0.50	No vegetation on wall face.	8
ARCHITECTURAL FACING 0.50	Schist stone veneer are slight weathering and no cracks or shrinkage in mortar.	9
DOWNSLOPE 0.50	Compacted fill with ferns and trees. 2H:1V slopes. No signs of erosion are observed.	9
ROAD/SIDEWALK/SHOULDER 0.50	No cracks or distress are observed.	9
TRAFFIC BARRIER/FENCE 0.50	Parapet with schist veneer all sides. Parapet slightly weathered. Excellent condition.	9
WALL DRAINS 0.50	Weep holes are clean and functioning.	9

Failure Consequence:	MODERATE
Recommendation Narrative:	None
Repair Cost:	\$0
