LAVO WIP Report

NPS Retaining Wall Inventory Program Lassen Volcanic National Park

Federal Highway Administration
Eastern Federal Lands Highway Division
Road Inventory Program (RIP)

Data Collection Date: August 2008
Report Date: October 2015

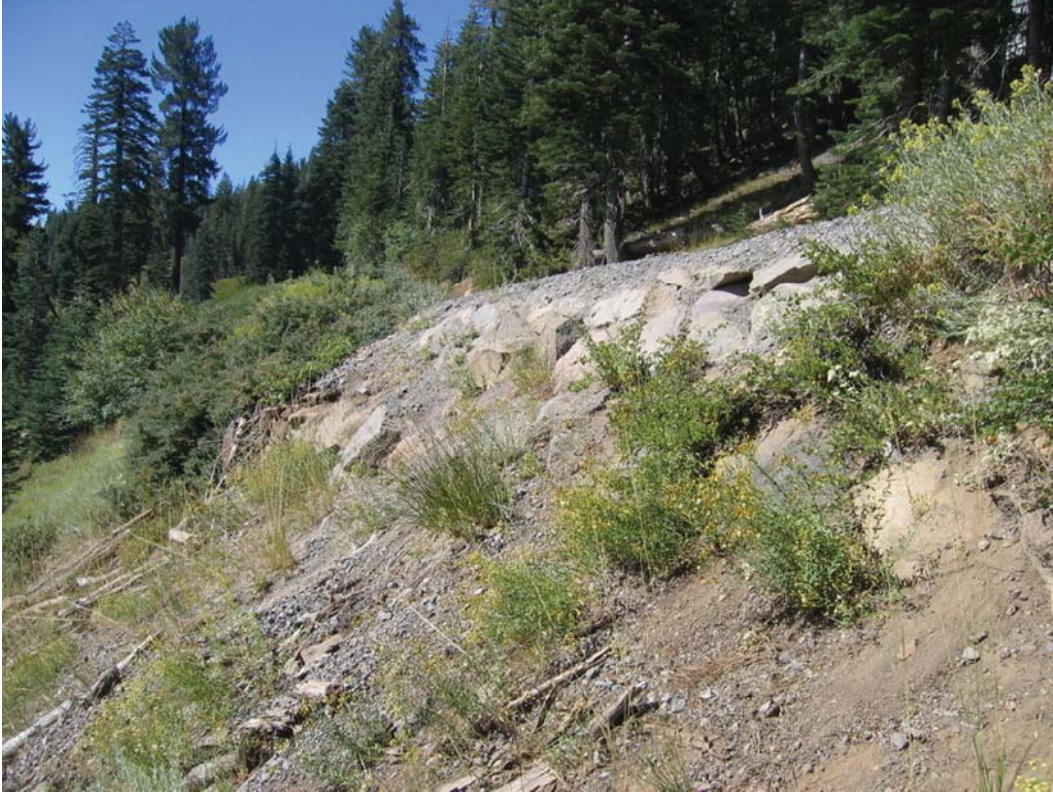
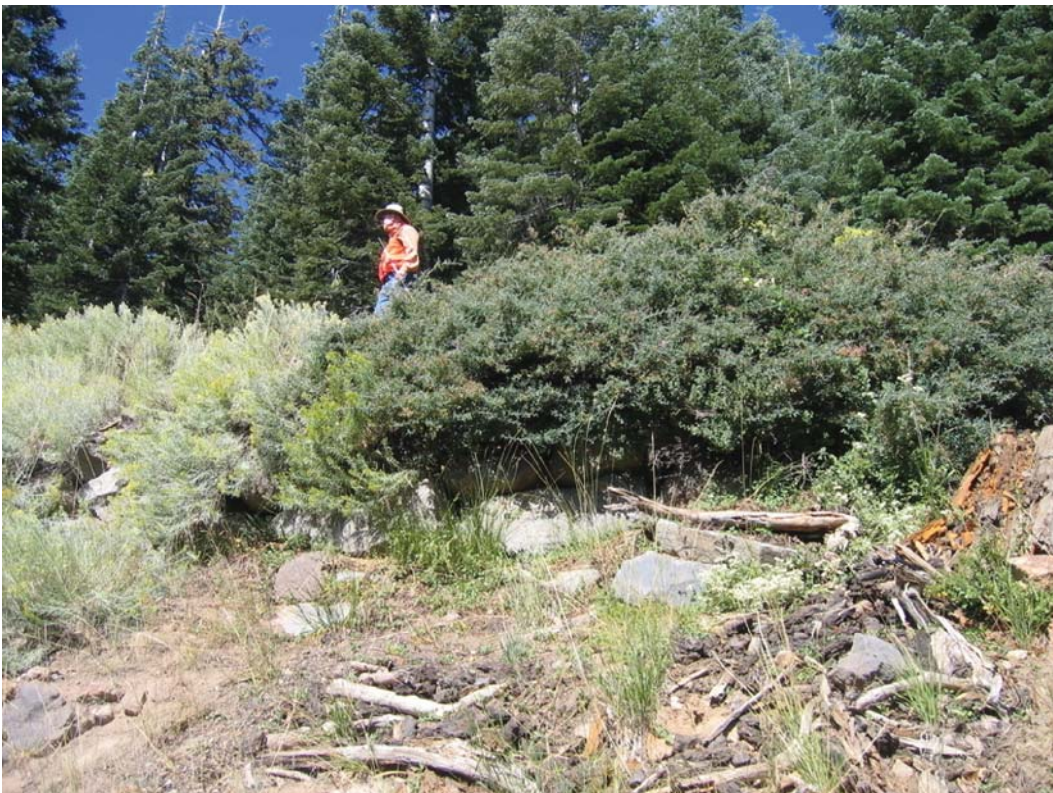
Element (Weighting Factor)	Narrative	Condition Rating (0 - 10)
PERFORMANCE 8.00	No signs of global instability, wall settlement, or structure deformation.	7
WALL FOUNDATION MATERIAL 8.00	Stable, but steep soil slope. No signs of slumping or erosion at toe of wall.	7
PLACED STONE 8.00	Large, hard, durable rock with minor weathering. Missing minor rocks - no impact to wall function or stability. Some silt filtering through and over wall face. No signs of sinkhole development at top of wall.	7
WALL DRAINS 0.50	Free draining wall. Minor silt migration through the face.	8
CURB/BERM/DITCH 0.50	Ditch line is stable, clear and functioning.	9
LATERAL SLOPE 0.50	Stable, vegetated side slopes. No signs of significant erosion.	9
ROAD/SIDEWALK/SHOULDER 0.50	No signs of wall-related distress.	9
UPSLOPE 0.50	Nearly flat top slope with no signs of settlement or erosion issues.	10
DOWNSLOPE 1.00	Steep, erosive, lightly vegetated slope. No signs of instability or significant erosion.	7

Failure Consequence:	MODERATE
Recommendation Narrative:	Clear brush, bushes and small trees from wall face (leave brush/trees at wall toe). Labor: 25 hours @ \$55/hr = \$1,375
Repair Cost:	\$1,375

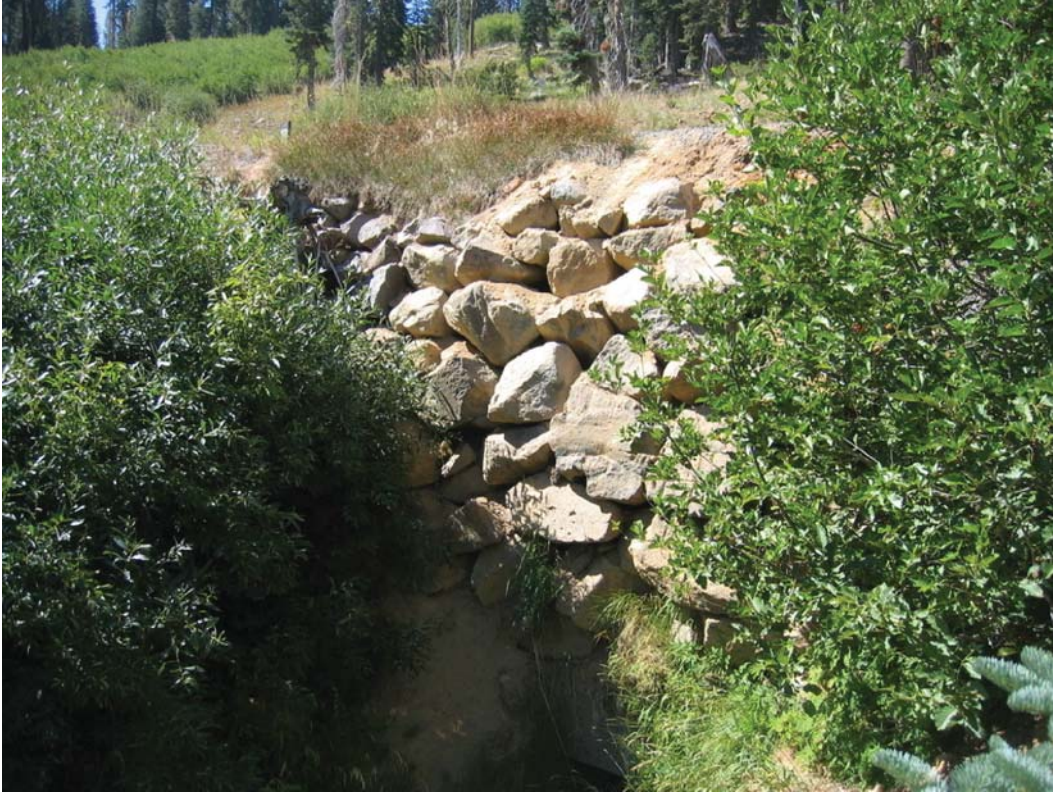
LAVO_0010_0.575_R_1.jpg

Wall ID:	LAVO-0010-0.575-R		
Route Name:	LASSEN PARK ROAD		
Inspection Date:	August 19, 2008	Approximate Year Built:	1972
*Wall Rating:	70	Maintenance Action:	No Action

Element (Weighting Factor)	Narrative	Condition Rating (0 - 10)
PERFORMANCE 8.00	No global distress. Minor rock displacement in face. No significant wall settlement observed.	7
WALL FOUNDATION MATERIAL 8.00	No signs of scour or settlement.	8
PLACED STONE 8.00	Large durable boulders, poorly placed, poorly chinked. Minor silt migration through wall. Missing/displaced stones in wall face.	6
DOWNSLOPE 0.50	Drainage channel is stable and vegetated, with some erosion along channel sidewalls.	8
VEGETATION 0.50	Minor vegetation in and above wall. Large brush growing at base of wall helps to stabilize lateral slopes.	8
WALL DRAINS 0.50	Free draining. Minor top slope erosion and some silt migration through wall face.	8
ROAD/SIDEWALK/SHOULDER 0.50	No wall-related distress.	9
UPSLOPE 1.00	Loose, erosive soils above wall to edge of roadway, though no significant erosion noted.	6
LATERAL SLOPE 1.00	Soft soils with minor erosion.	7

Failure Consequence:	HIGH
Recommendation Narrative:	None
Repair Cost:	\$0

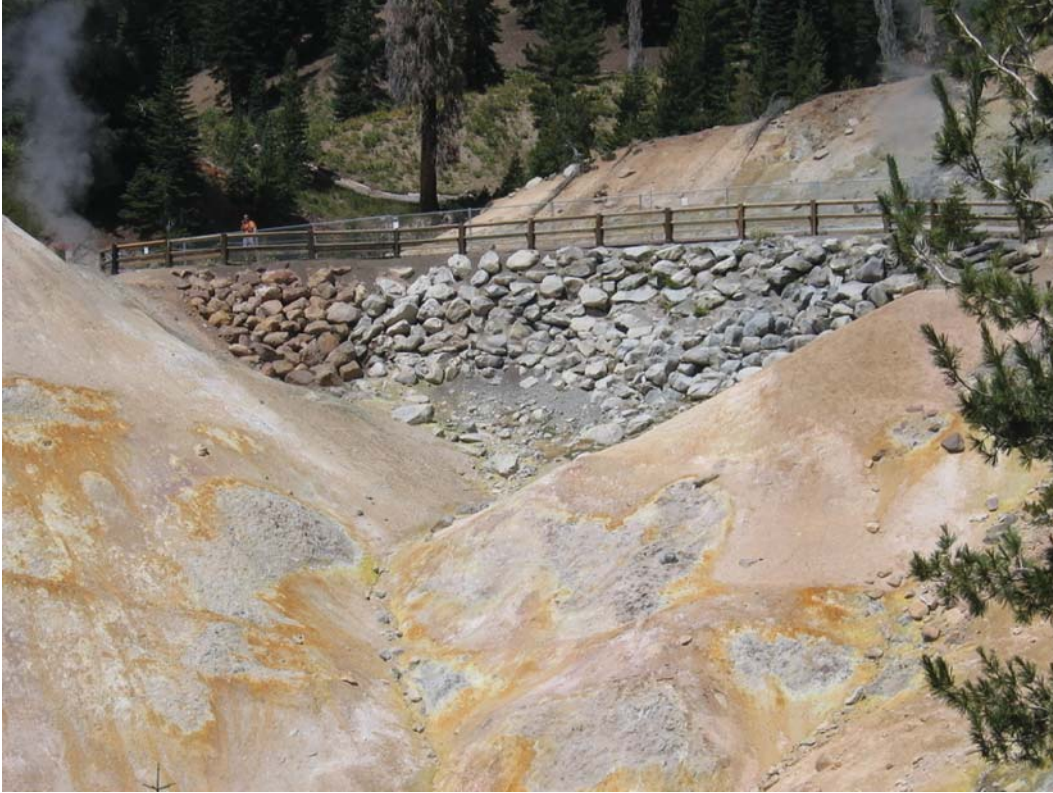
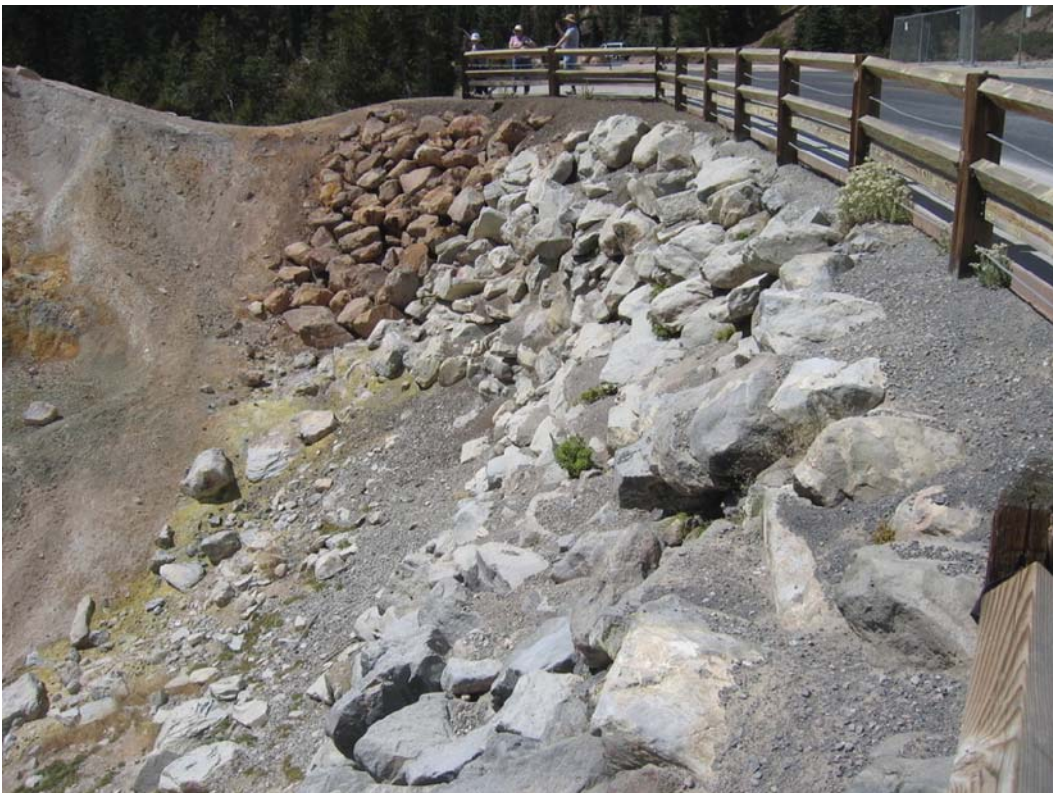
Wall ID:	LAVO-0010-1.992-R		
Route Name:	LASSEN PARK ROAD		
Inspection Date:	August 19, 2008	Approximate Year Built:	1965
*Wall Rating:	90	Maintenance Action:	No Action

Element (Weighting Factor)	Narrative	Condition Rating (0 - 10)
PERFORMANCE 8.00	No global distress indicated or distress related to wall settlement or element displacement.	9
WALL FOUNDATION MATERIAL 8.00	Firm granular soil showing no signs of erosion or settlement.	10
PLACED STONE 8.00	Large, durable, hard boulders with some chinking. Minor boulders dislodged. No impact to wall function or stability.	8
DOWNSLOPE 0.50	Gentle, bare-soil downslope showing minor erosion.	9
LATERAL SLOPE 0.50	Bare-soil lateral slopes showing only very minor erosion.	9
ROAD/SIDEWALK/SHOULDER 0.50	Very minor curb/gutter cracking. No wall-related roadway distress.	9
TRAFFIC BARRIER/FENCE 0.50	Wooden fencing shows no sign of wall-related distress or deformation along the topline of the wall.	10
WALL DRAINS 1.00	None visible. Some migration of fill fines through wall face.	7

Failure Consequence:	HIGH
Recommendation Narrative:	None
Repair Cost:	\$0

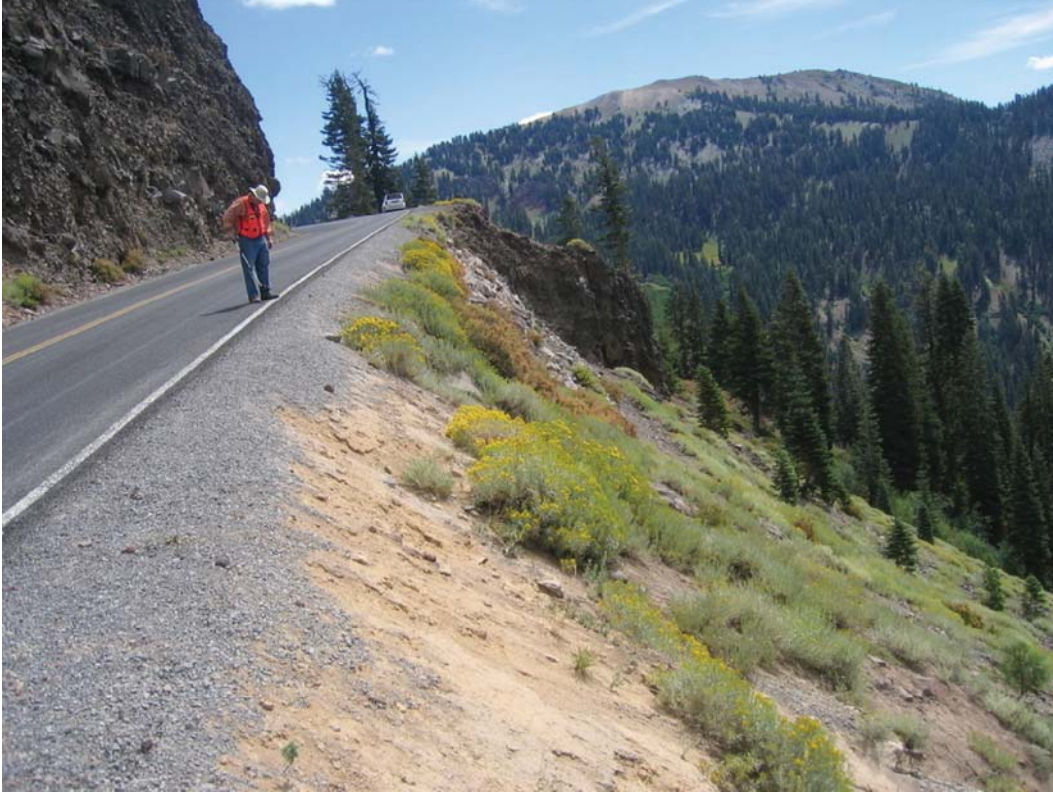
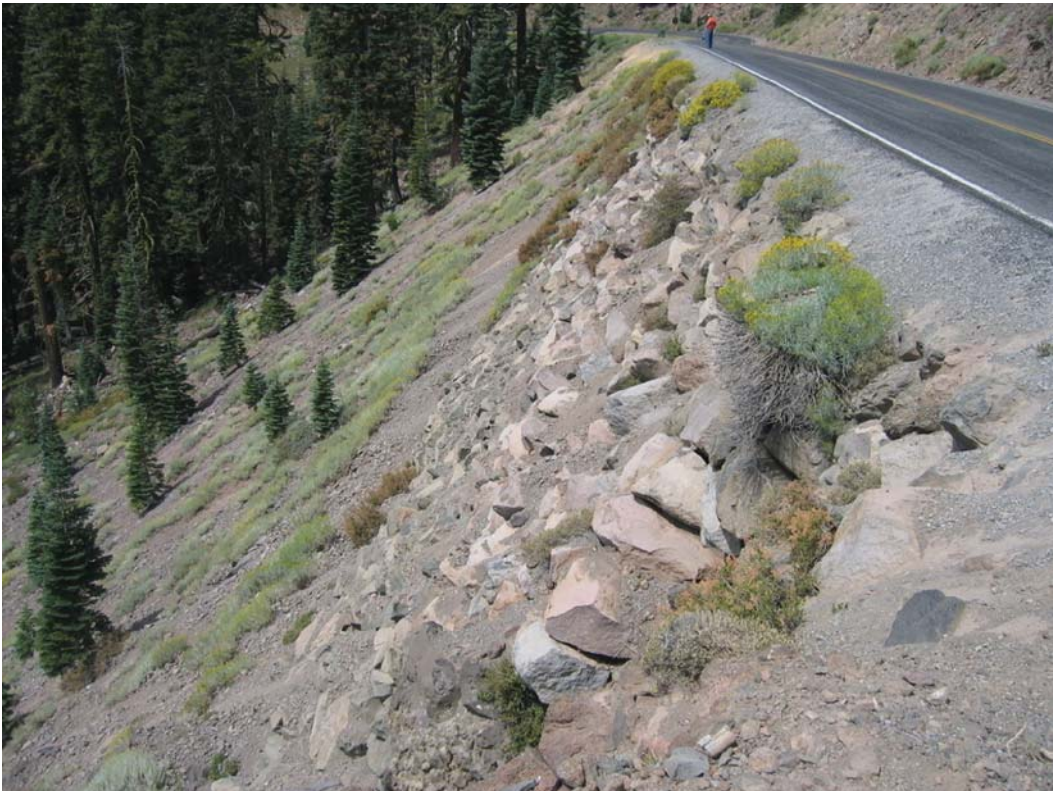
Wall ID:	LAVO-0010-3.192-R		
Route Name:	LASSEN PARK ROAD		
Inspection Date:	August 19, 2008	Approximate Year Built:	1972
*Wall Rating:	84	Maintenance Action:	No Action

Element (Weighting Factor)	Narrative	Condition Rating (0 - 10)
PERFORMANCE 8.00	Bulging likely due to construction. No signs of road/shoulder settlement or displacement.	8
WALL FOUNDATION MATERIAL 8.00	Outcropping volcanic rock. Good foundation.	9
PLACED STONE 8.00	Large, hard durable boulders. Adequate construction. No significant rock displacement or missing elements.	8
VEGETATION 0.50	Minor bushes along wall face; no impact.	8
WALL DRAINS 0.50	None visible. Some soil migration through wall face and over top of wall.	8
DOWNSLOPE 0.50	Steep talus slope. Minor vegetation. Minor erosion to bedrock in some areas.	9
LATERAL SLOPE 0.50	Bedrock outcrop on one end. Stable talus/soil slope at other end.	9
ROAD/SIDEWALK/SHOULDER 0.50	No wall-related distress along paved roadway.	9

Failure Consequence:	HIGH
Recommendation Narrative:	None
Repair Cost:	\$0

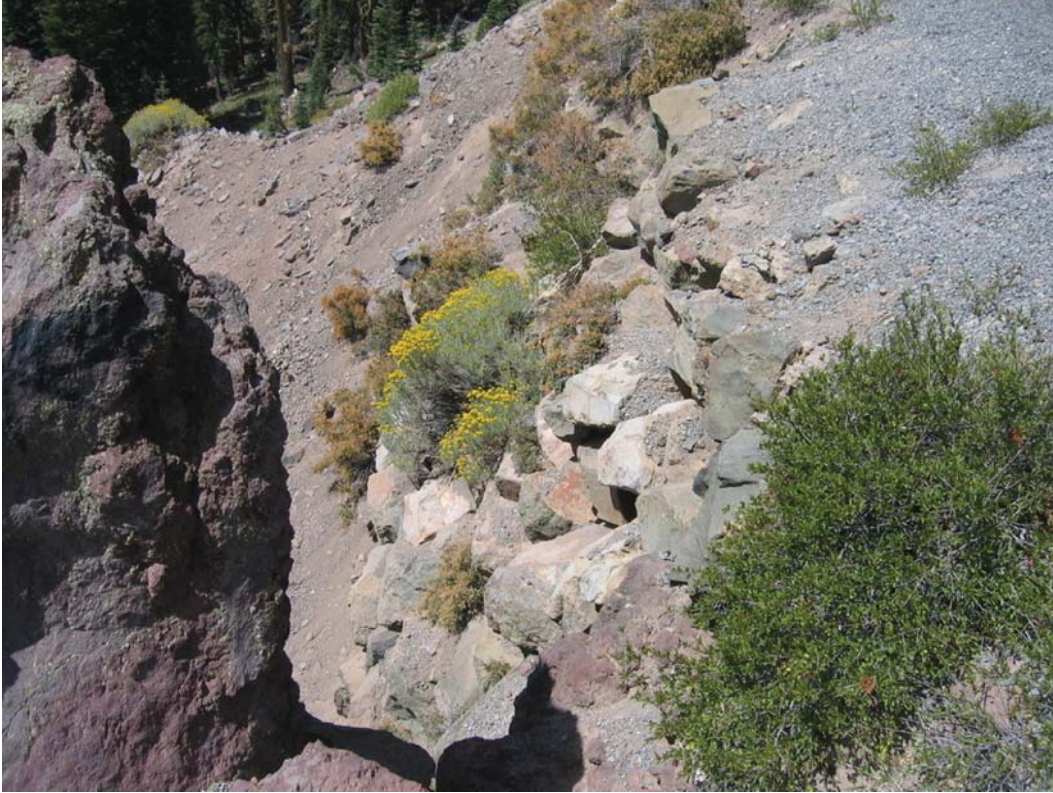
LAVO_0010_3.233_R_1.jpg

Wall ID:	LAVO-0010-3.233-R		
Route Name:	LASSEN PARK ROAD		
Inspection Date:	August 19, 2008	Approximate Year Built:	1972
*Wall Rating:	84	Maintenance Action:	No Action

Element (Weighting Factor)	Narrative	Condition Rating (0 - 10)
PERFORMANCE 8.00	Apparent displacements likely due to construction. No signs of road or shoulder settlement or deformation.	8
WALL FOUNDATION MATERIAL 8.00	Outcropping rock abutments. Solid foundation. No erosion.	9
PLACED STONE 8.00	Large, hard, durable boulders, adequately placed. No visible rock displacement or missing elements.	8
VEGETATION 0.50	Minor bushes along wall face. No impact to wall.	8
WALL DRAINS 0.50	None visible. Some soil migration through wall face and over top of wall.	8
DOWNSLOPE 0.50	Steep talus slope with signs of minor water erosion. Very stable over bedrock.	9
LATERAL SLOPE 0.50	Bedrock outcrops on lateral slopes. Very stable.	9
ROAD/SIDEWALK/SHOULDER 0.50	No wall-related distress along paved roadway.	9

Failure Consequence:	HIGH
Recommendation Narrative:	None
Repair Cost:	\$0

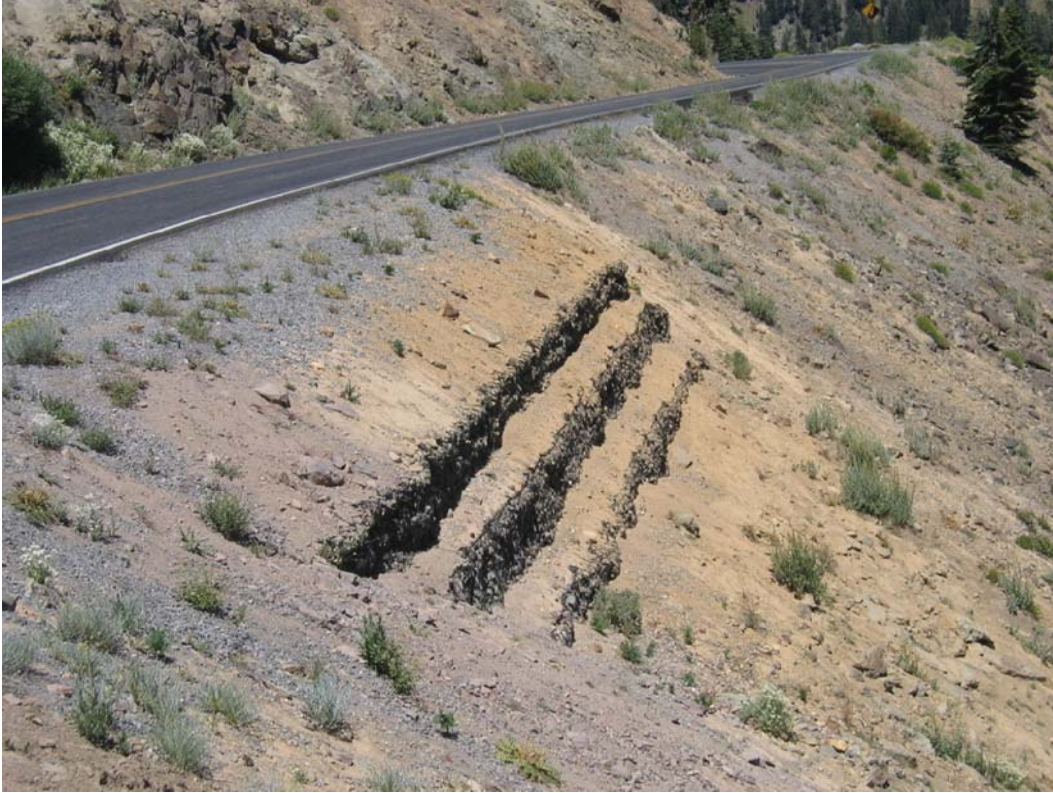
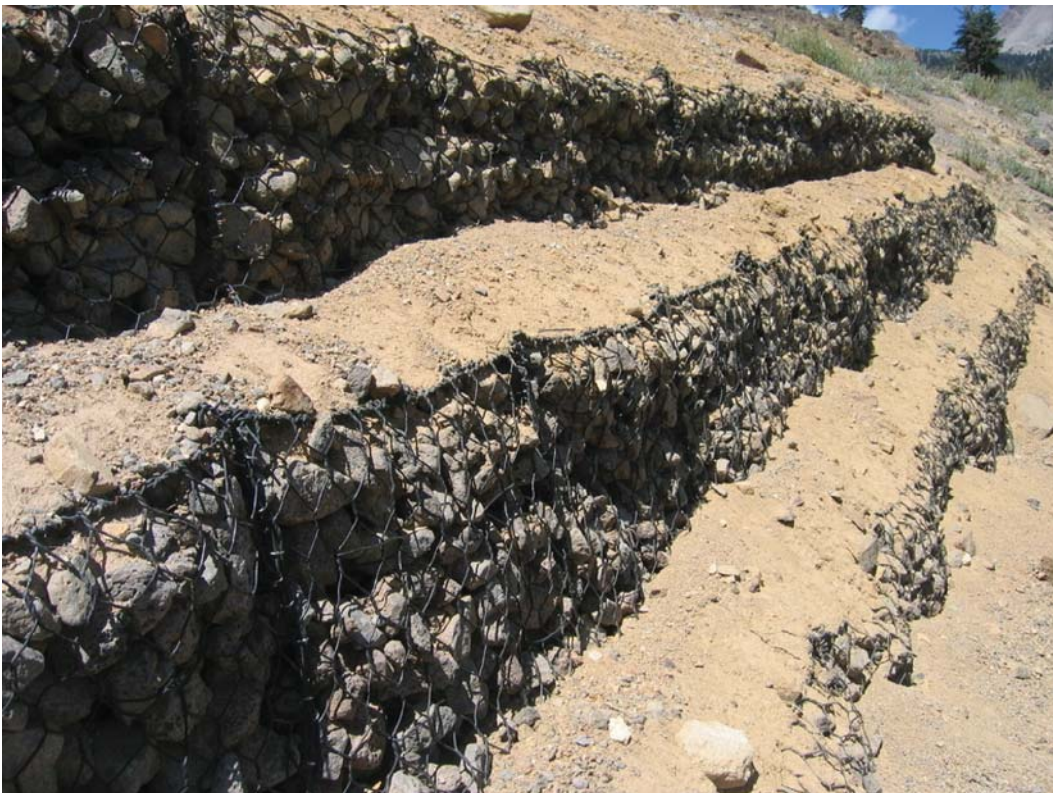
Wall ID:	LAVO-0010-3.610-R		
Route Name:	LASSEN PARK ROAD		
Inspection Date:	August 19, 2008	Approximate Year Built:	1982
*Wall Rating:	79	Maintenance Action:	No Action

Element (Weighting Factor)	Narrative	Condition Rating (0 - 10)
PERFORMANCE 8.00	Basket elements appear poorly constructed, but no global distress, foundation or roadway settlement evident.	9
WALL FOUNDATION MATERIAL 8.00	Rock fill; steep, but stable.	8
WIRE/GEOSYNTHETIC FACING 8.00	Bulging PVC-coated wire baskets (built that way). Minor corrosion on hog rings. Baskets are distorted, but stable.	7
ROAD/SIDEWALK/SHOULDER 0.50	No wall-related distress along roadway.	9
WALL DRAINS 0.50	None. Free draining. No signs of water distress.	9
LATERAL SLOPE 1.00	Steep fill. Bare slopes. Significant erosion at up-station end.	6
DOWNSLOPE 1.00	Steep rock fill with loose soil. Sparsely vegetated. Minor erosion downslope.	7

Failure Consequence:	MODERATE
Recommendation Narrative:	None
Repair Cost:	\$0

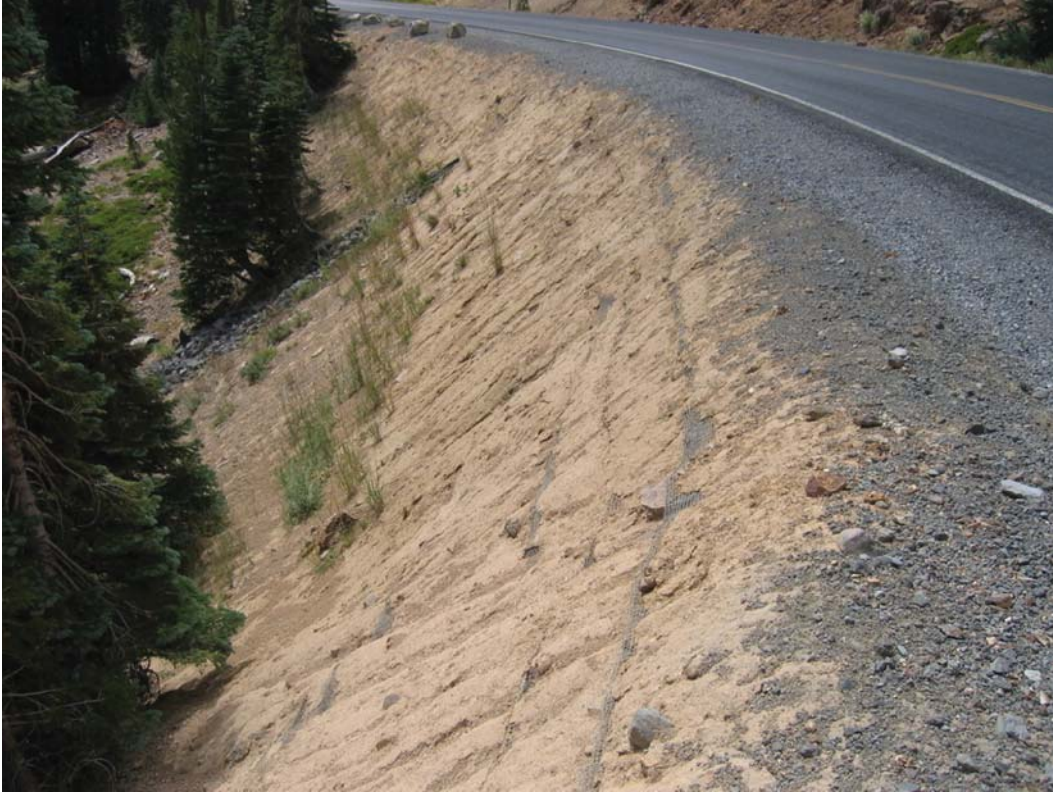
LAVO_0010_5.790_R_1.jpg

Wall ID:	LAVO-0010-5.790-R		
Route Name:	LASSEN PARK ROAD		
Inspection Date:	August 19, 2008	Approximate Year Built:	2002
*Wall Rating:	86	Maintenance Action:	No Action
Wall Description			
Wall Function:	Fill Wall	Primary Wall Type:	Other - Geogrid Reinforced Soil
Surface Treatment:		Secondary Wall Type:	
Secondary Surface Treatment:		Architectural Facing:	
General Description:	Geogrid reinforced soil slope - 1:1 slope ratio.		
Wall Measurements			
Wall Length (ft.):	162	Face Area (sq.):	1215
Average Wall Height (ft.):	7	Face Angle (deg.):	45
Maximum Wall Height (ft.):	9	Vertical Offset (ft.):	-1
Assessed Elements			
Element (Weighting Factor)	Narrative		Condition Rating (0 - 10)
PERFORMANCE 8.00	No global instability visible. Minor surficial erosion along slope face.		8
WALL FOUNDATION MATERIAL 8.00	Steep, bare-soil slope. No signs of slumping or settlement.		9
WIRE/GEOSYNTHETIC FACING 8.00	Geogrid extending from slope face is intact and appears to have been installed correctly. No torn/missing segments. Spacings are even and appropriate for slope. Functioning very well despite poor surface vegetation cover.		9

DOWNSLOPE 0.50	Steep, sparsely vegetated slope- though several large trees present. Very stable.		8
CURB/BERM/DITCH 0.50	Culvert pipe and riprap apron show no signs of erosion.		9
ROAD/SIDEWALK/SHOULDER 0.50	No signs of settlement or cracking along roadway or shoulder.		9
WALL DRAINS 1.00	None visible. Erosion rills down slope face from surface water roadway runoff (mostly sheet flow across superelevation at curve).		6
LATERAL SLOPE 1.00	Sparsely vegetated lateral slopes with minor surficial erosion.		7
Repair Recommendations			
Failure Consequence:	HIGH		
Recommendation Narrative:	None		
Repair Cost:	\$0		
2007 cost estimate (ASTM Class D), preliminary for comparison to other repair costs only.

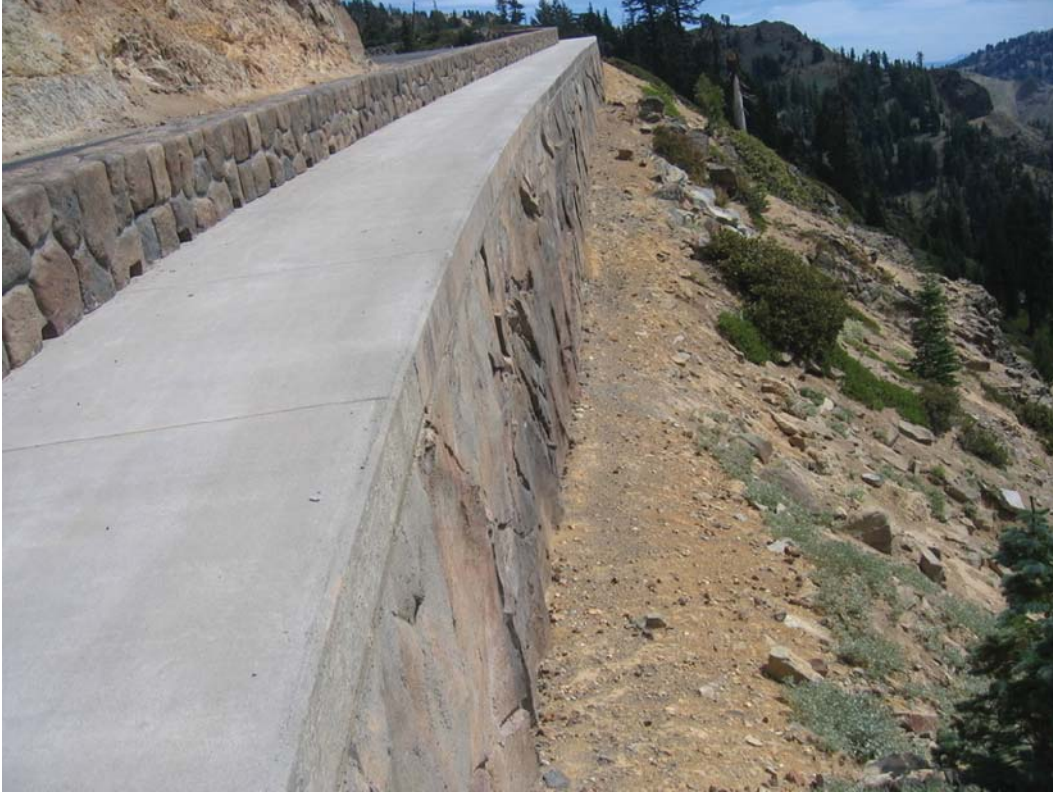
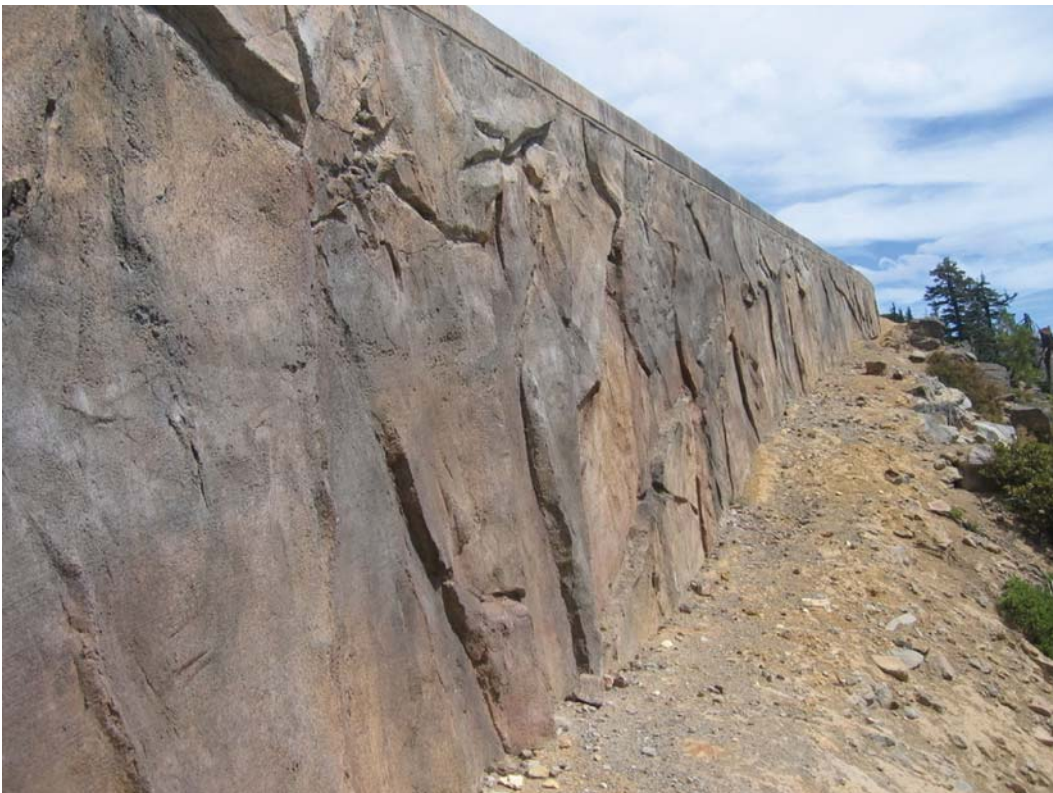
Wall ID:	LAVO-0010-6.126-R		
Route Name:	LASSEN PARK ROAD		
Inspection Date:	August 19, 2008	Approximate Year Built:	2002
*Wall Rating:	93	Maintenance Action:	No Action

Element (Weighting Factor)	Narrative	Condition Rating (0 - 10)
PERFORMANCE 8.00	No signs of global or settlement distress.	10
WALL FOUNDATION MATERIAL 8.00	Rock outcrops and stable placed rock fill. Very stable foundation.	9
CONCRETE 8.00	Concrete in this CL wall cannot be observed, but assumed no distress issues as no cracks are reflected in shotcrete facing or differential settlement along top of wall.	10
SHOTCRETE 8.00	Sculpted shotcrete is in excellent condition. Very minor cracking with minor efflorescence. No spalling.	10
LATERAL SLOPE 0.50	Placed rockfill and rock outcrops showing minor erosion.	8
DOWNSLOPE 0.50	Steep, rocky downslope. Very stable.	9
ROAD/SIDEWALK/SHOULDER 0.50	No wall-related distress. Very good condition.	9
TRAFFIC BARRIER/FENCE 0.50	No wall-related distress to movable guardwall on top of wall. No differential settlement observed.	9
ARCHITECTURAL FACING 0.50	Sculpted shotcrete looks near new. Stain is weathered. No spalling. Very minor cracking.	10

Failure Consequence:	HIGH
Recommendation Narrative:	None
Repair Cost:	\$0

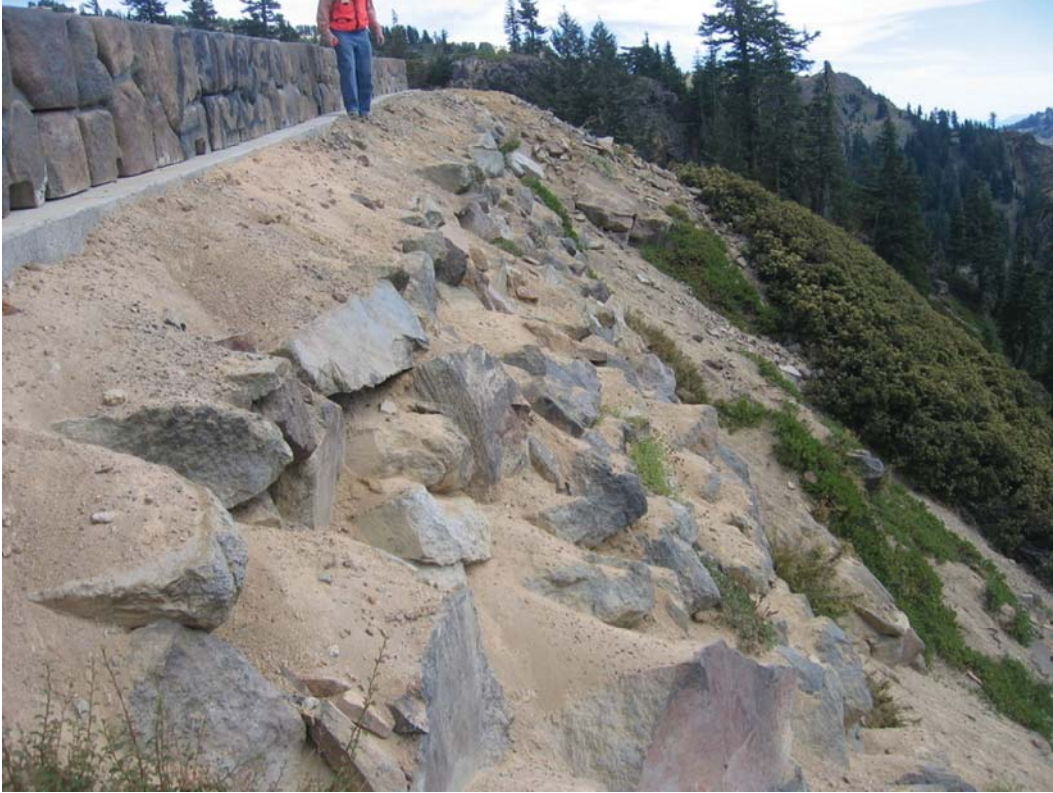
LAVO_0010_6.166_R_1.jpg

Wall ID:	LAVO-0010-6.166-R		
Route Name:	LASSEN PARK ROAD		
Inspection Date:	August 19, 2008	Approximate Year Built:	1960
*Wall Rating:	89	Maintenance Action:	No Action

Element (Weighting Factor)	Narrative	Condition Rating (0 - 10)
PERFORMANCE 8.00	Minor erosion along face. No global distress or signs of wall settlement or displacement.	9
WALL FOUNDATION MATERIAL 8.00	Rock outcrop, stable soils. Very stable foundation.	9
PLACED STONE 8.00	Large, intact, hard, durable boulders. Well placed. No missing elements.	9
WALL DRAINS 0.50	Free draining. Signs of silt migration through and over the top of the wall, though no sinkholing at top of wall evident.	8
LATERAL SLOPE 0.50	Retaining wall on one abutment. Rock outcrop on other abutment. Very stable.	9
ROAD/SIDEWALK/SHOULDER 0.50	No signs of wall-related distress.	9
TRAFFIC BARRIER/FENCE 0.50	No signs of wall-related distress.	9
VEGETATION 0.50	Very minor vegetation on wall face. No impact to wall.	9
DOWNSLOPE 1.00	Very steep, sparsely vegetated downslope with signs of minor surface erosion.	7

Failure Consequence:	HIGH
Recommendation Narrative:	None
Repair Cost:	\$0

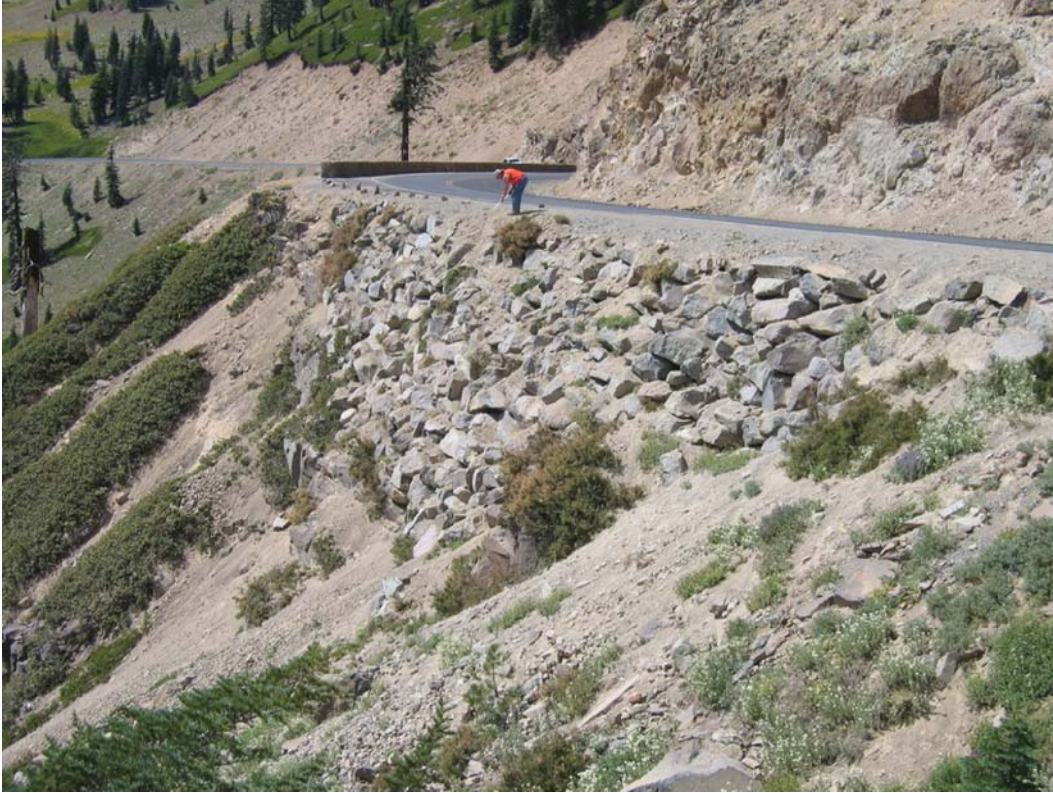
LAVO_0010_6.191_R_1.jpg

Wall ID:	LAVO-0010-6.191-R		
Route Name:	LASSEN PARK ROAD		
Inspection Date:	August 19, 2008	Approximate Year Built:	1960
*Wall Rating:	84	Maintenance Action:	No Action

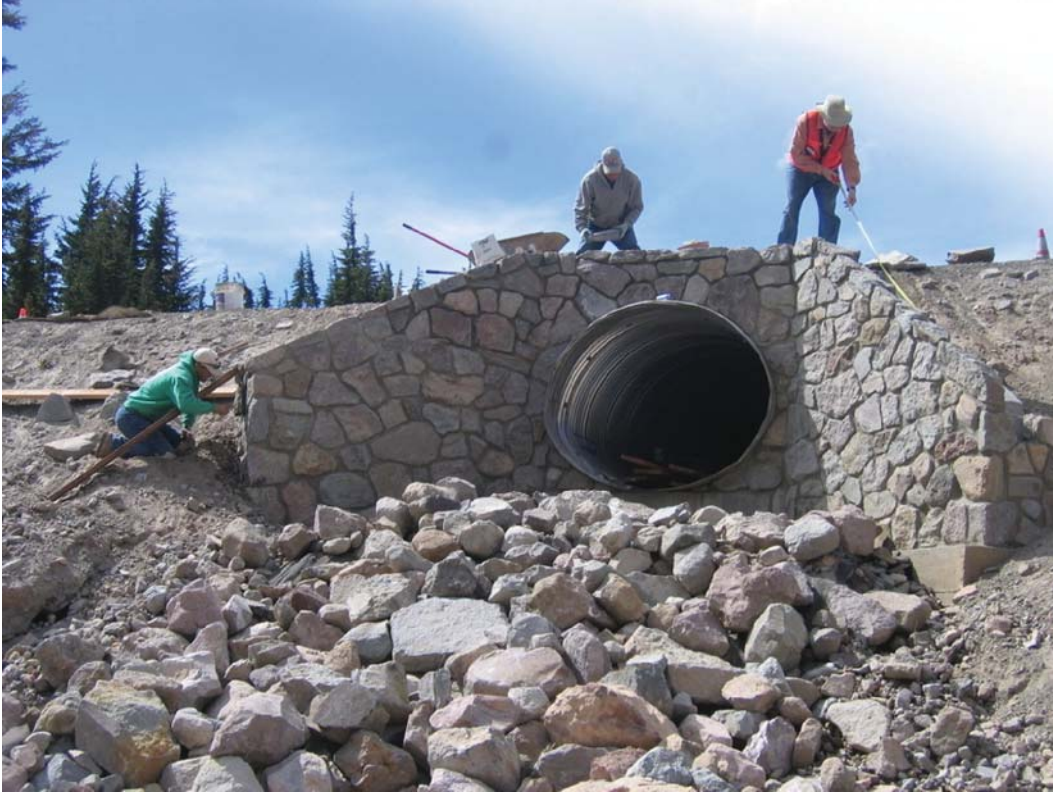
LAVO_0010_7.847_R_1.jpg

Wall ID:	LAVO-0010-7.847-R		
Route Name:	LASSEN PARK ROAD		
Inspection Date:	August 19, 2008	Approximate Year Built:	2008
*Wall Rating:	100	Maintenance Action:	No Action

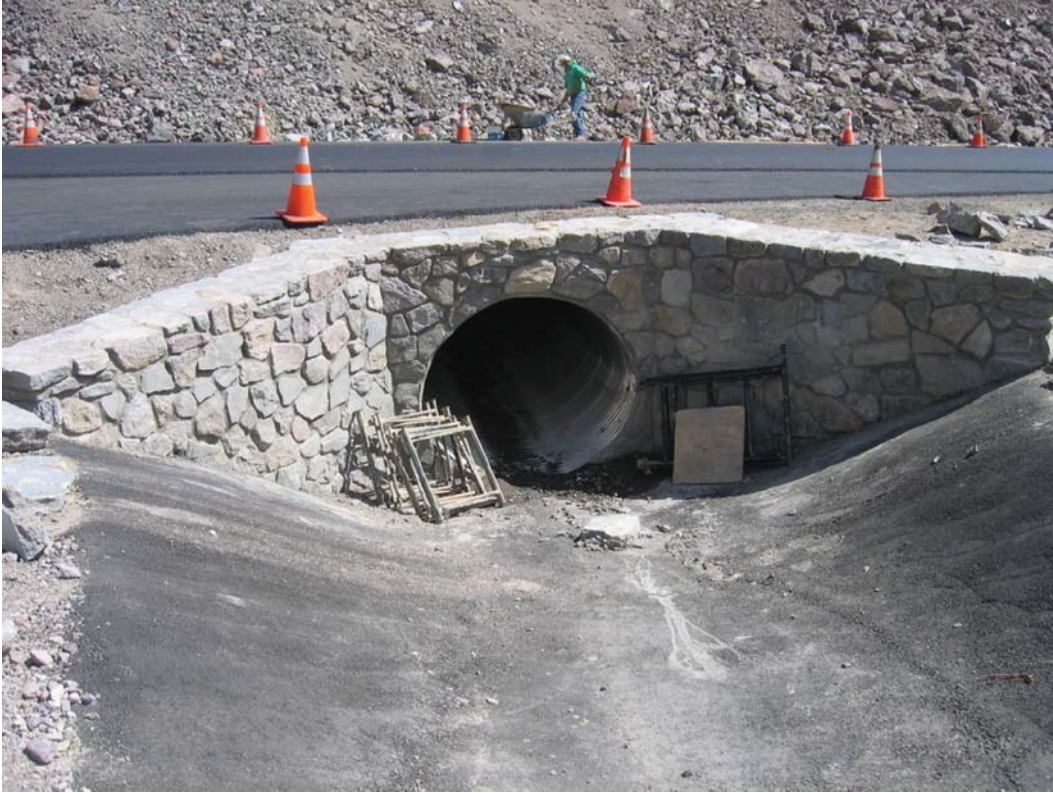
LAVO_0010_7.847_L_1.jpg

Wall ID:	LAVO-0010-7.847-L		
Route Name:	LASSEN PARK ROAD		
Inspection Date:	August 19, 2008	Approximate Year Built:	2008
*Wall Rating:	100	Maintenance Action:	No Action

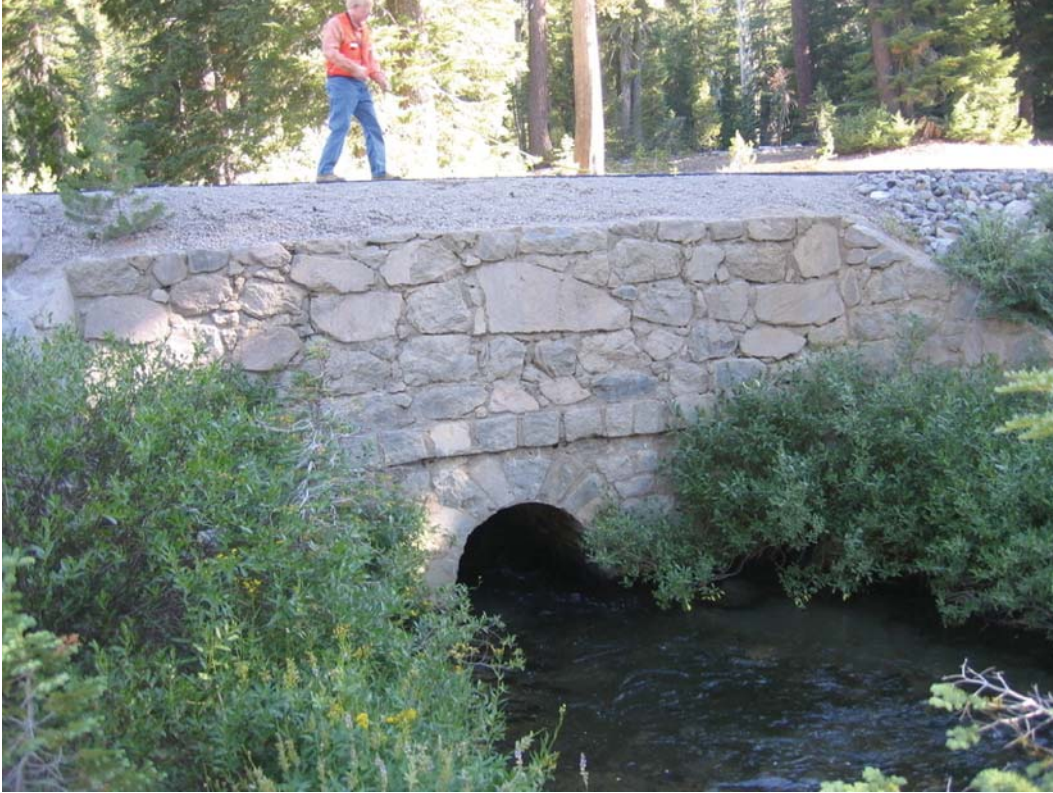
LAVO_0010_13.132_R_1.jpg

Wall ID:	LAVO-0010-13.132-R		
Route Name:	LASSEN PARK ROAD		
Inspection Date:	August 20, 2008	Approximate Year Built:	Unknown
*Wall Rating:	88	Maintenance Action:	No Action

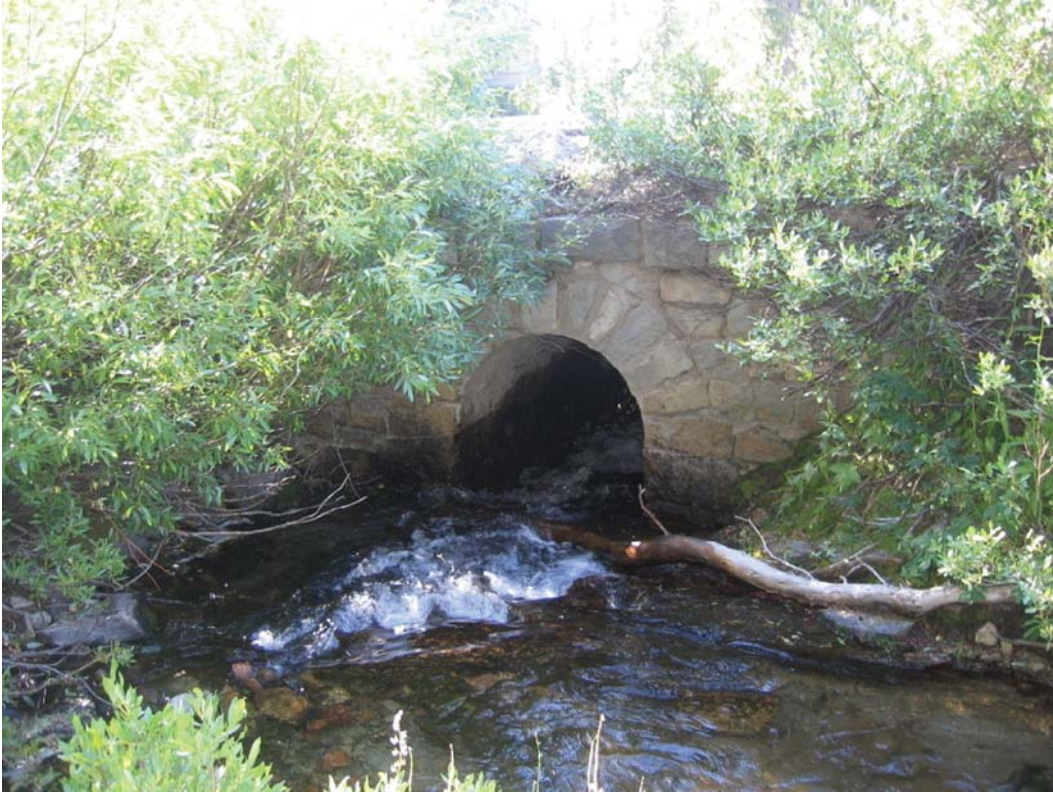
LAVO_0010_13.133_L_1.jpg

Wall ID:	LAVO-0010-13.133-L		
Route Name:	LASSEN PARK ROAD		
Inspection Date:	August 20, 2008	Approximate Year Built:	Unknown
*Wall Rating:	87	Maintenance Action:	Maintenance

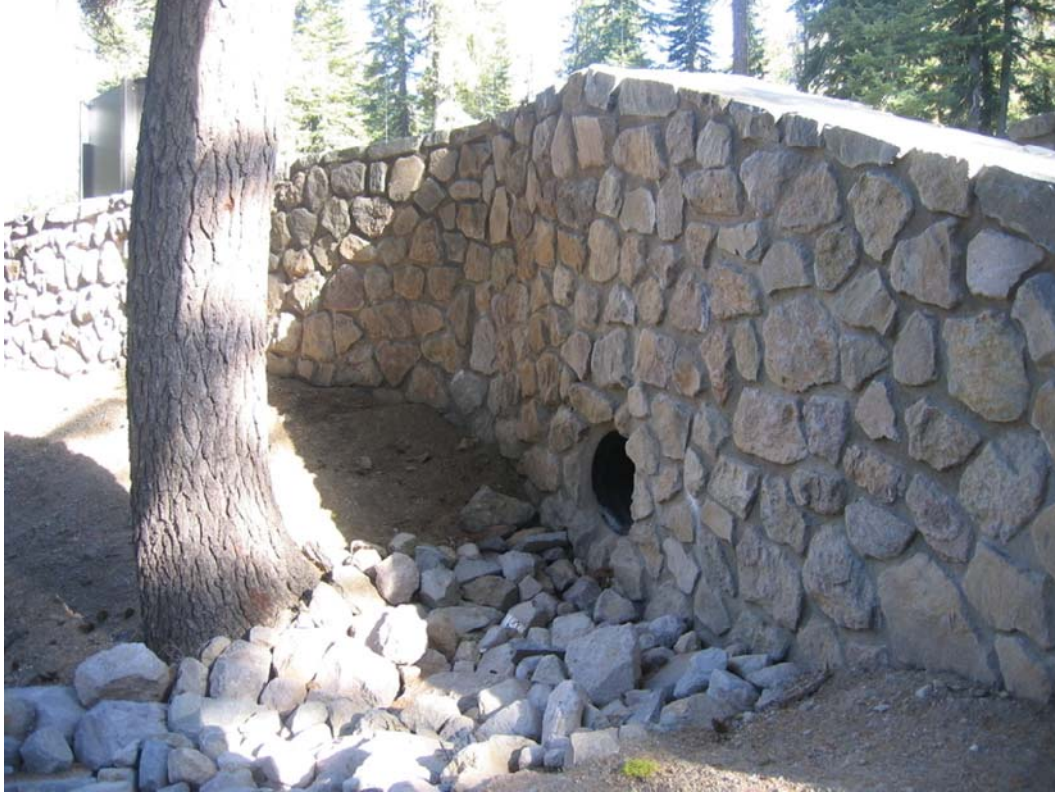
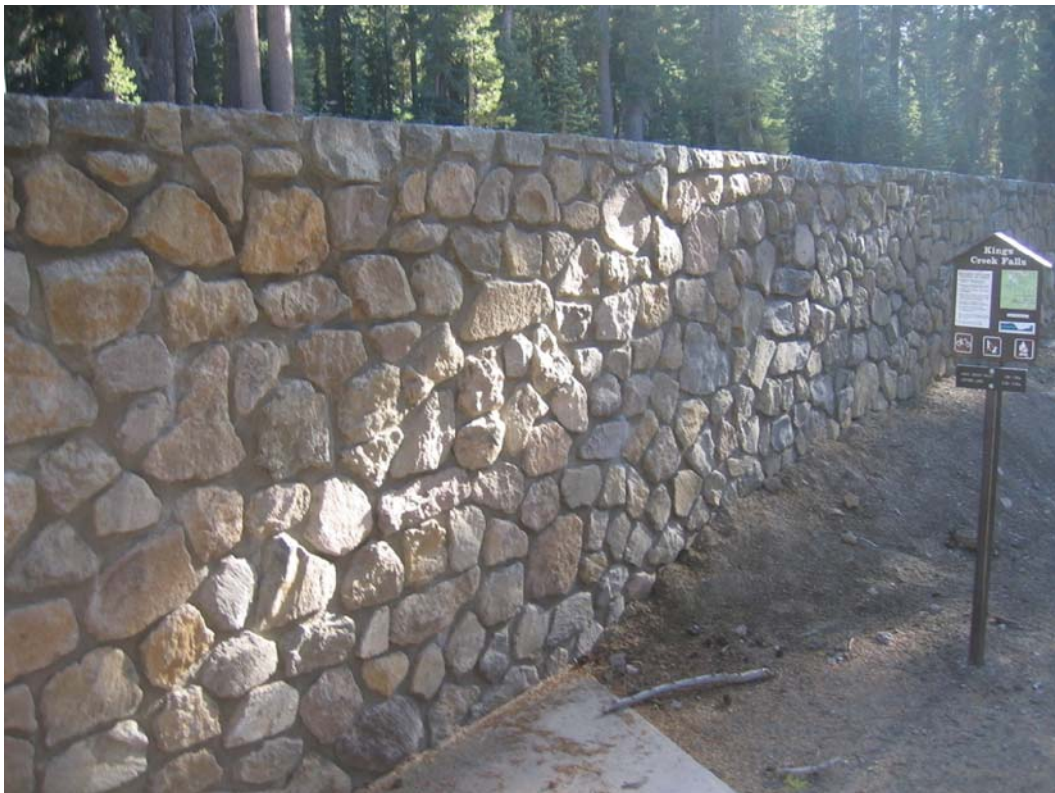
Wall ID:	LAVO-0010-13.142-R		
Route Name:	LASSEN PARK ROAD		
Inspection Date:	August 20, 2008	Approximate Year Built:	2008
*Wall Rating:	100	Maintenance Action:	No Action

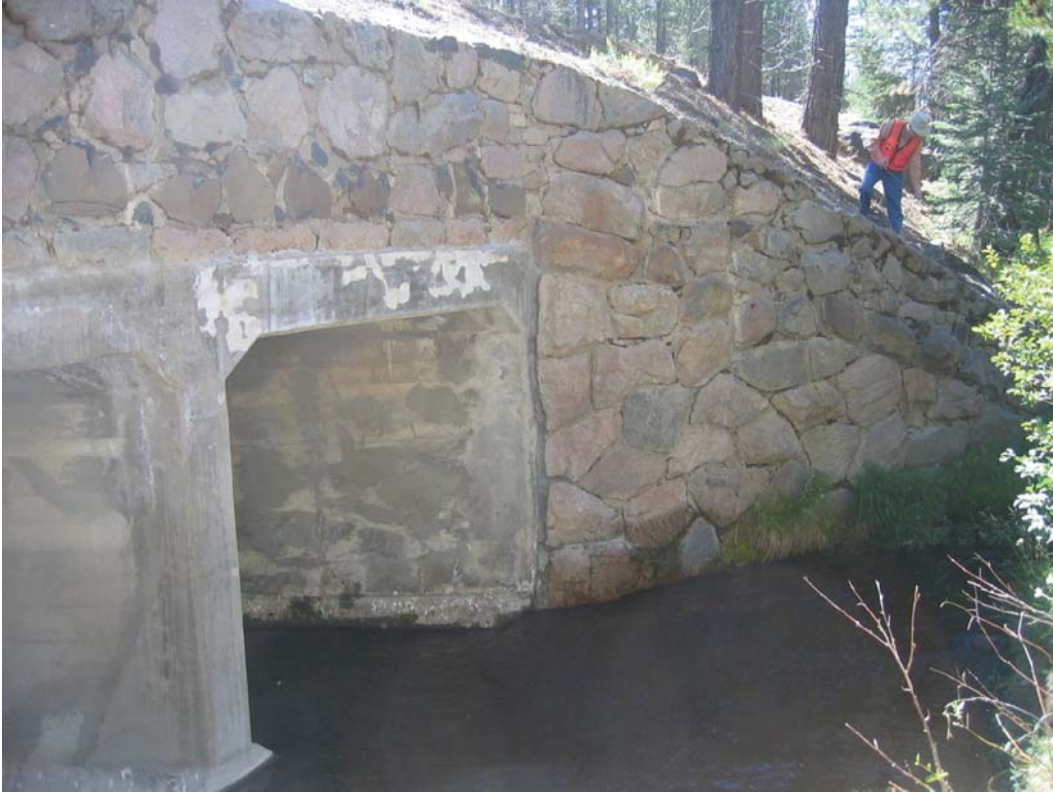
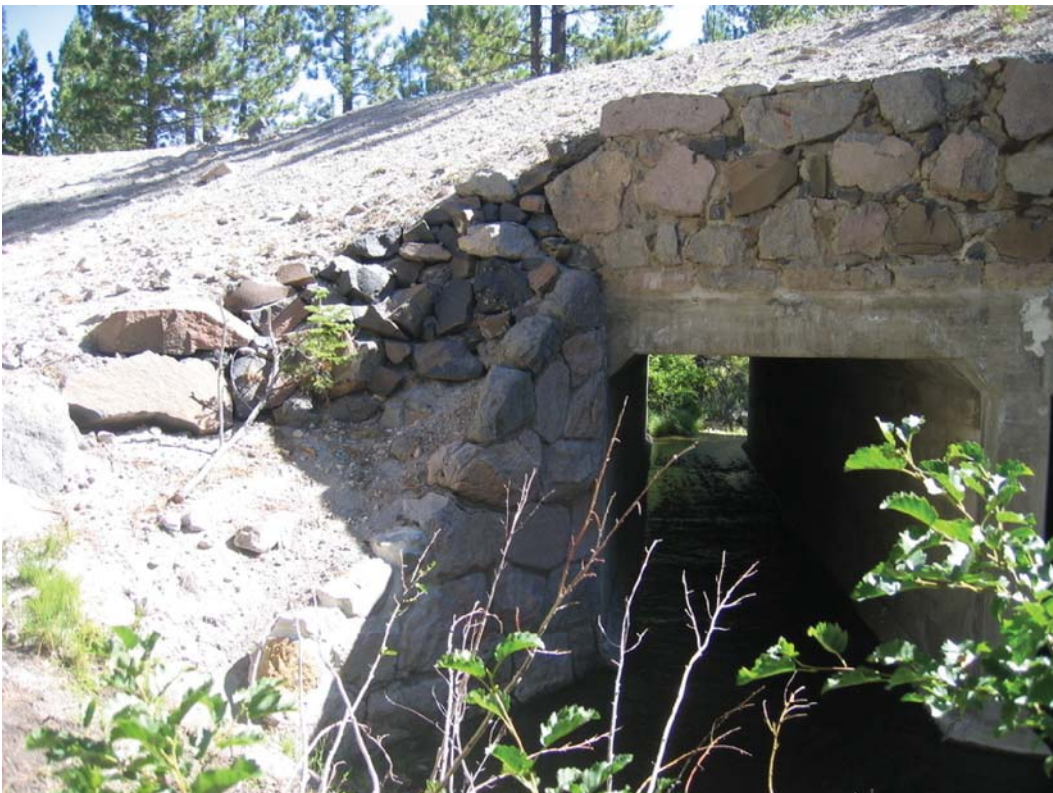
Wall ID:	LAVO-0010-22.114-L		
Route Name:	LASSEN PARK ROAD		
Inspection Date:	August 20, 2008	Approximate Year Built:	Unknown
*Wall Rating:	84	Maintenance Action:	No Action
