LAVO WIP Report

NPS Retaining Wall Inventory Program Lassen Volcanic National Park

Federal Highway Administration
Eastern Federal Lands Highway Division
Road Inventory Program (RIP)

Data Collection Date: August 2008
Report Date: October 2015

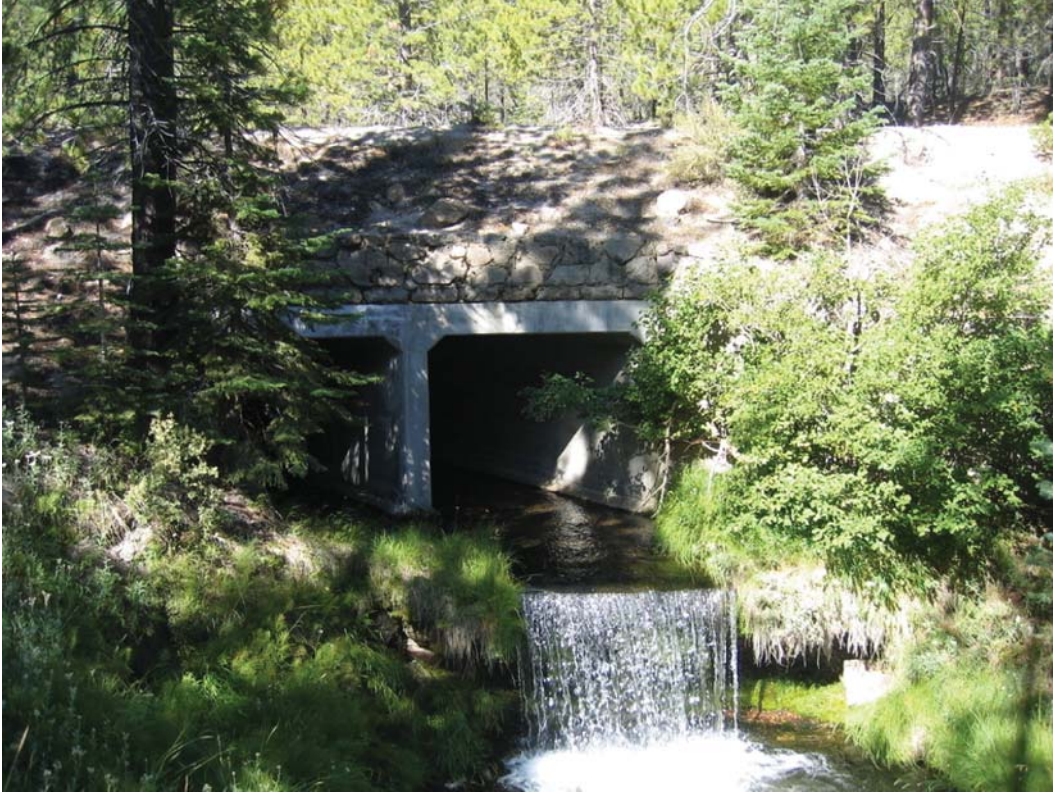
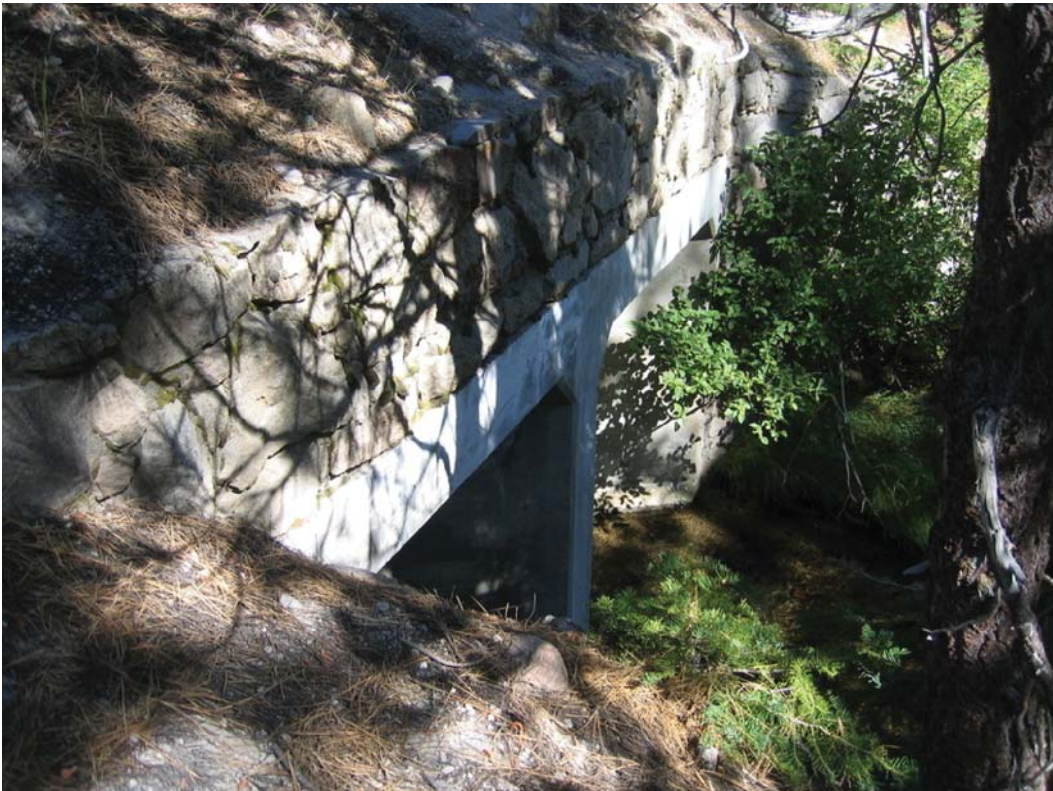
Wall ID:	LAVO-0010-22.123-R		
Route Name:	LASSEN PARK ROAD		
Inspection Date:	August 20, 2008	Approximate Year Built:	Unknown
*Wall Rating:	80	Maintenance Action:	No Action

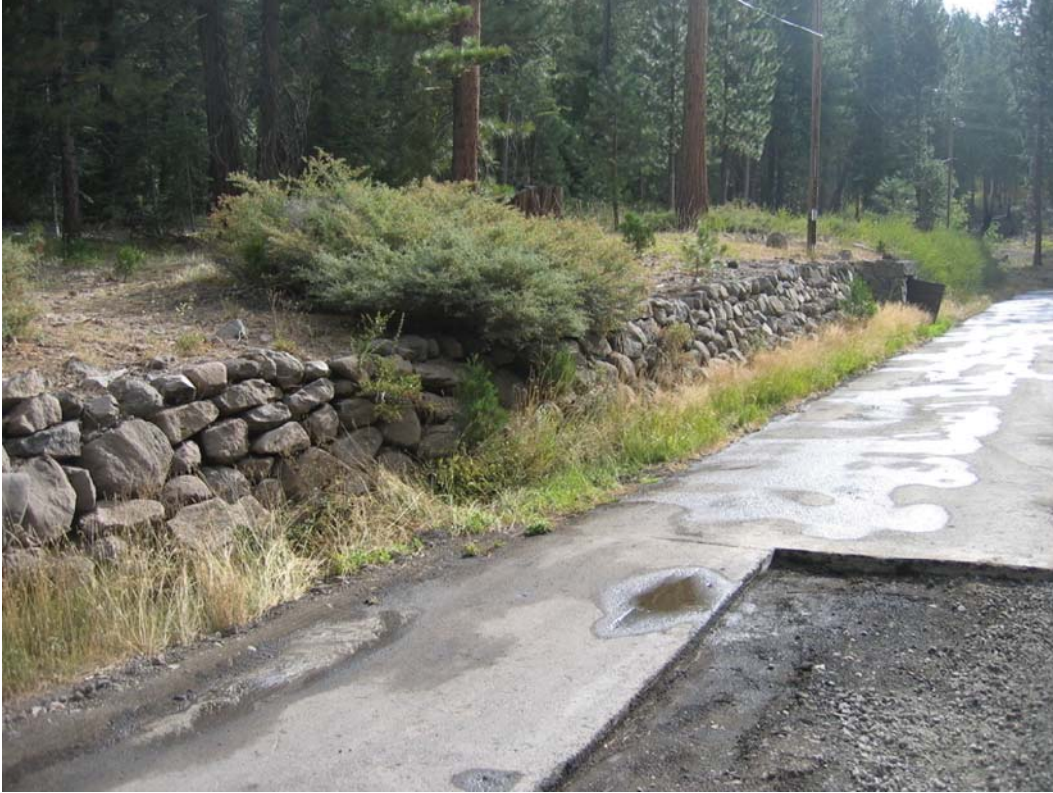
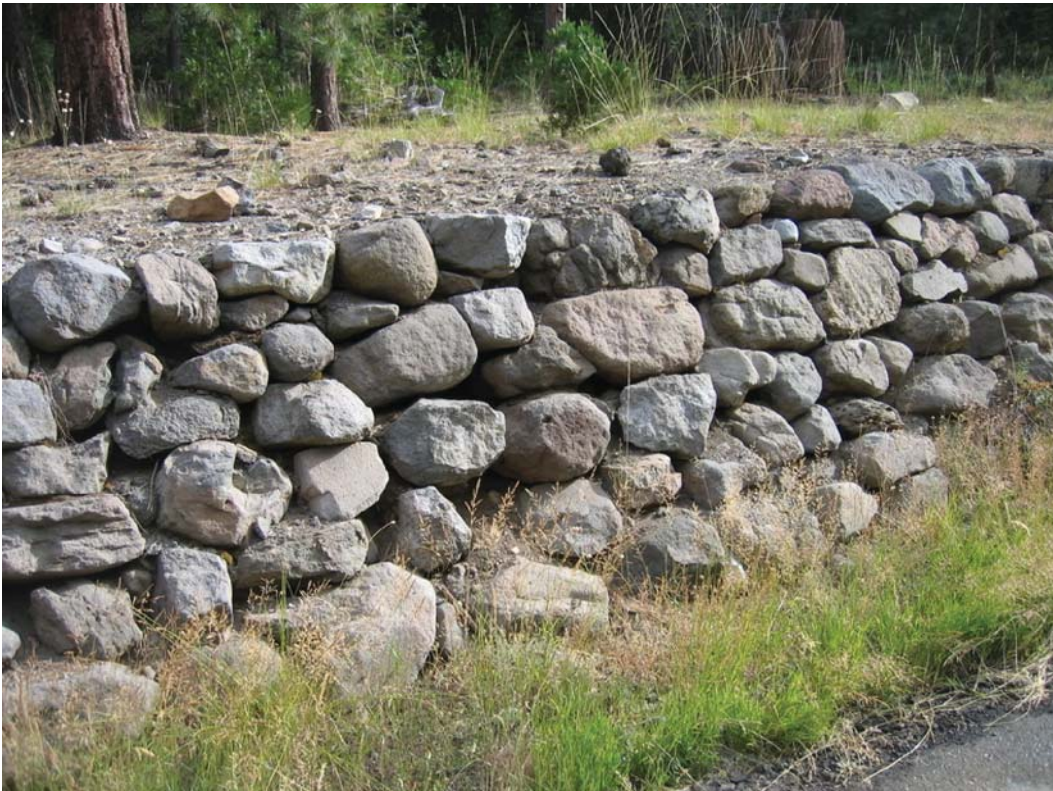
Wall ID:	LAVO-0902ZZ-0.000-P1		
Route Name:	PARK HEADQUARTERS RANGER / MAINTENANCE PARKING AREAS		
Inspection Date:	August 19, 2008	Approximate Year Built:	1940
*Wall Rating:	78	Maintenance Action:	Maintenance

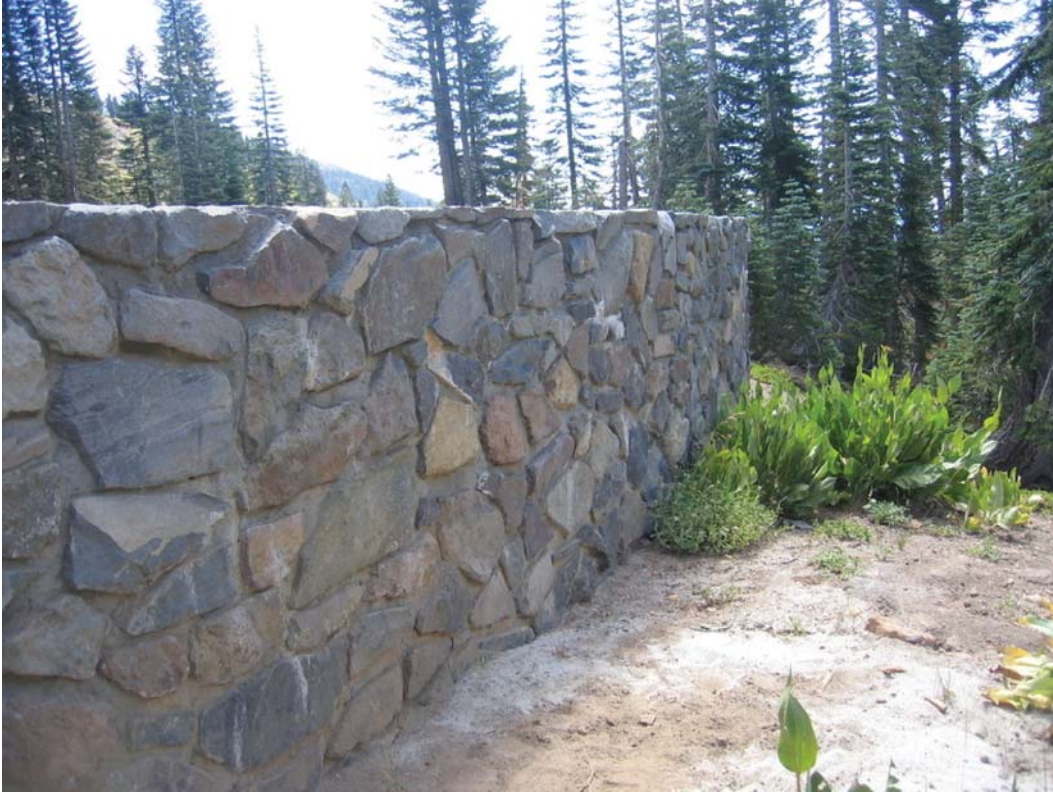
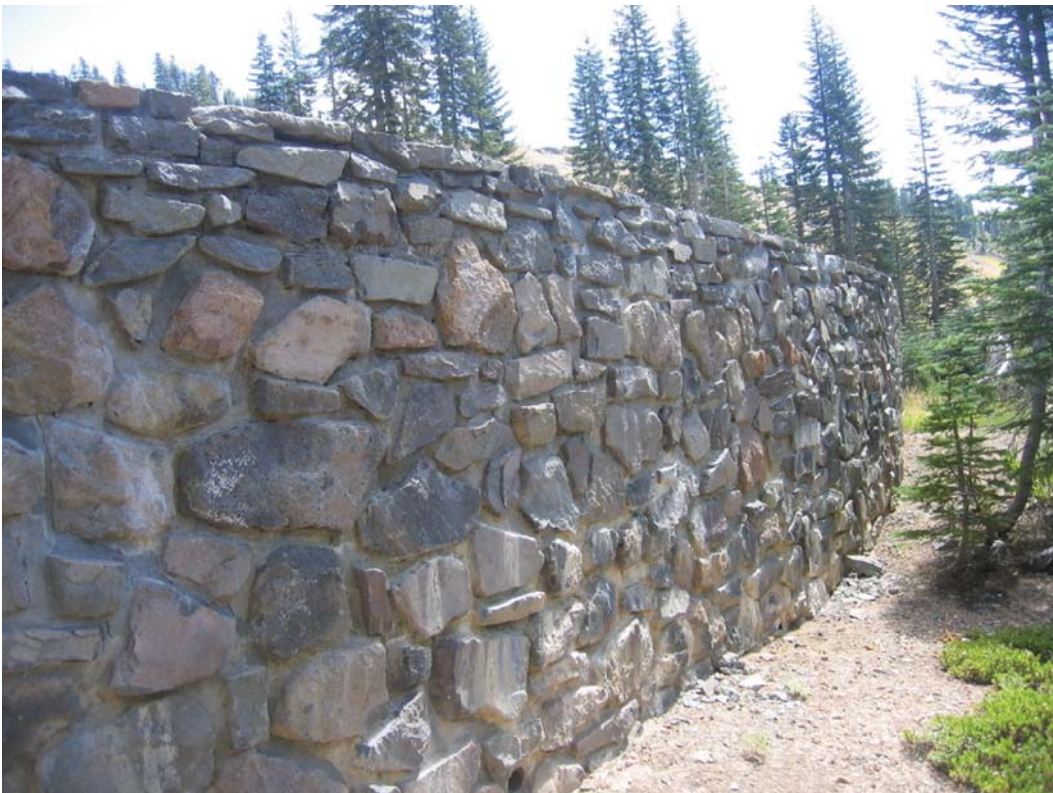
Wall ID:	LAVO-0908-0.000-P1		
Route Name:	SULPHUR WORKS PARKING		
Inspection Date:	August 19, 2008	Approximate Year Built:	1965
*Wall Rating:	93	Maintenance Action:	No Action
