MEVE WIP Report

NPS Retaining Wall Inventory Program Mesa Verde National Park

**Federal Highway Administration
Eastern Federal Lands Highway Division
Road Inventory Program (RIP)**

**Data Collection Date: December 2006
Report Date: October 2015**

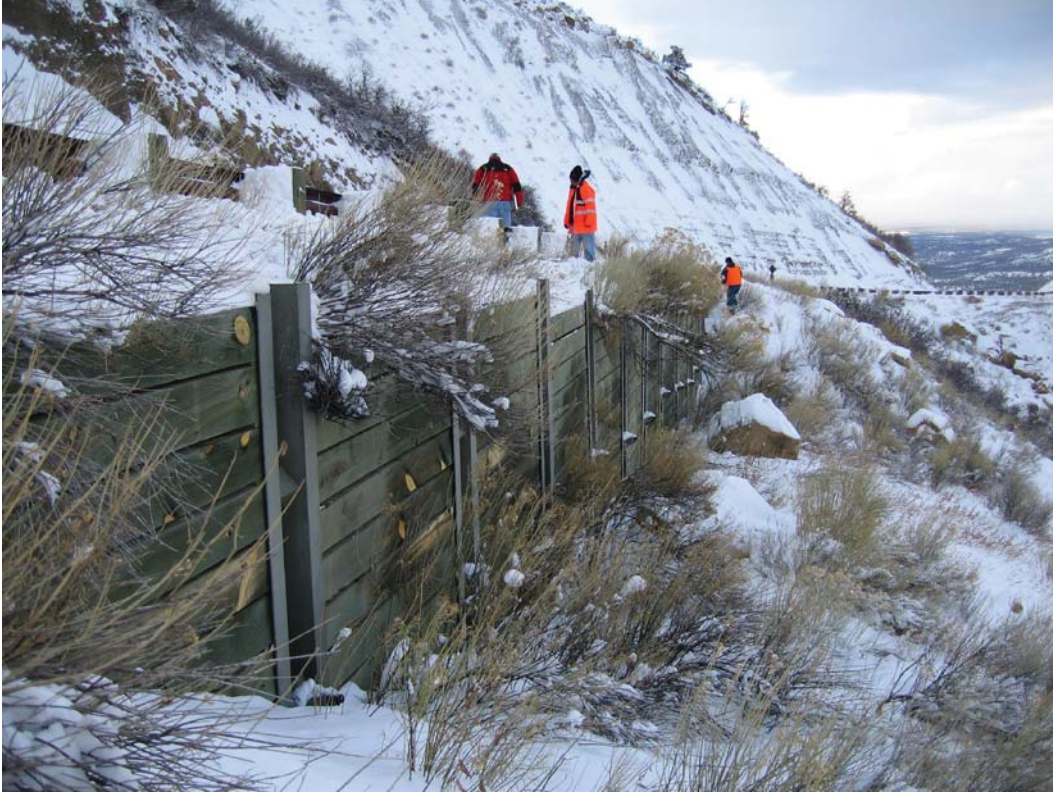
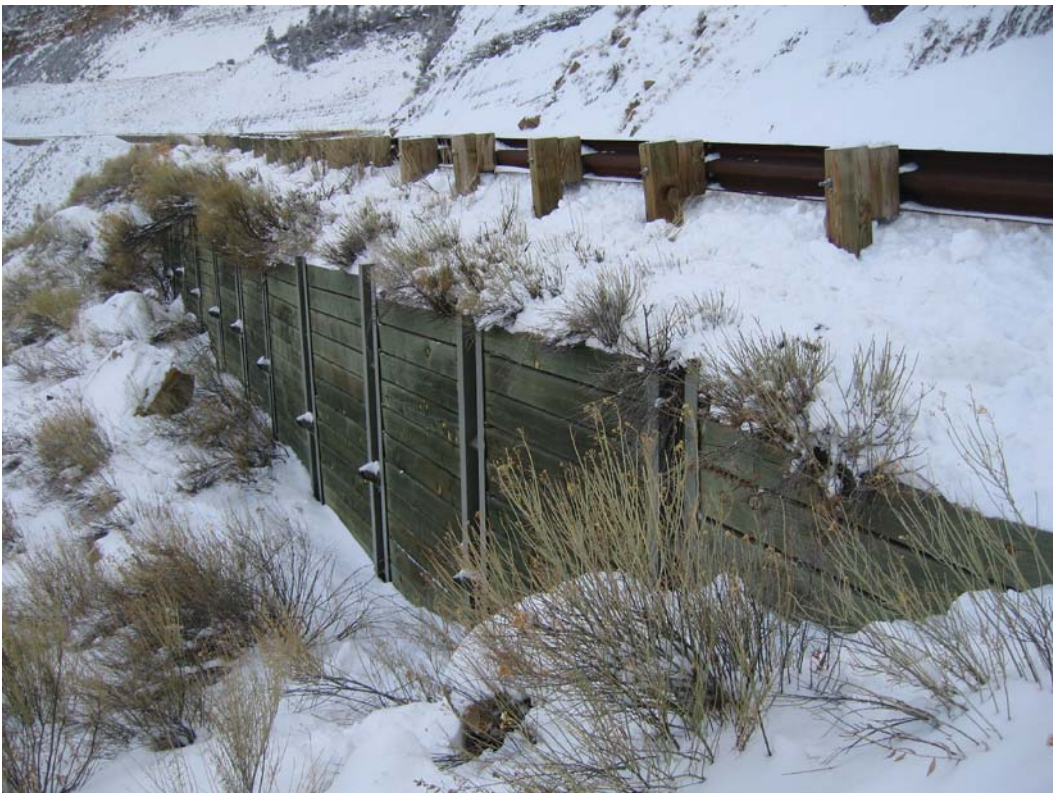
MEVE_0010_2.526_L_1.jpg

Element (Weighting Factor)	Narrative	Condition Rating (0 - 10)
PERFORMANCE 8.00	Wall is in excellent condition and functioning as intended	9
ANCHOR HEADS 8.00	Minor staining, wall elements fully bearing against retained units w/o distortion	9
LAGGING 8.00	Isolated evidence of element cracking, minimal cracking w/o loss of function	9
PILES AND SHAFTS 8.00	No evidence of corrosion, no evidence of element cracking, no signs of distortion or deflection, no wall elements are missing	9
ROAD/SIDEWALK/SHOULDER 0.50	Road, limited visibility due to snow cover, limited cracking in outward tire lane, which may be typical of entire roadway	8
DOWNSLOPE 0.50	Steep, but low visibility due to snow cover, no signs of erosion associated with retaining wall	9
LATERAL SLOPE 0.50	Steep, but low visibility due to snow cover, no signs of erosion associated with retaining wall	9
TRAFFIC BARRIER/FENCE 0.50	Guardrail shows no distress due to retaining wall displacement	10

Failure Consequence:	MODERATE
Recommendation Narrative:	None
Repair Cost:	\$0

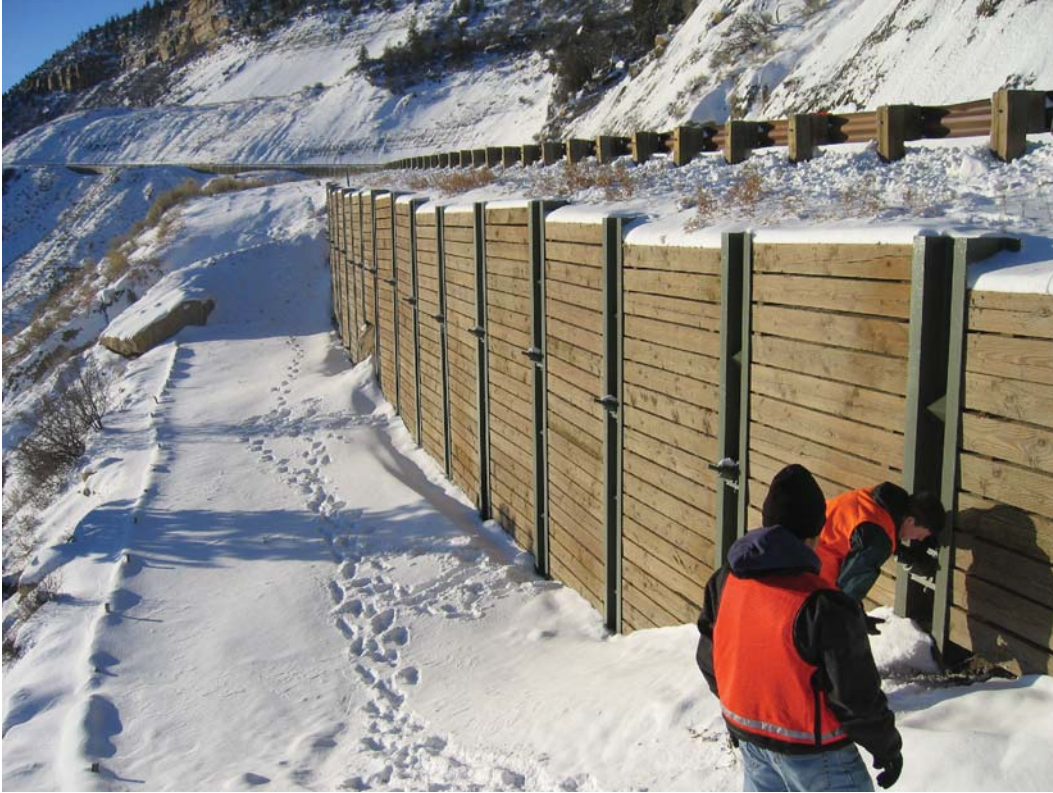
MEVE_0010_2.576_L_1.jpg

Wall ID:	MEVE-0010-2.576-L		
Route Name:	ENTRANCE ROAD		
Inspection Date:	December 12, 2006	Approximate Year Built:	2004
*Wall Rating:	97	Maintenance Action:	No Action

Element (Weighting Factor)	Narrative	Condition Rating (0 - 10)
PERFORMANCE 8.00	Wall is in excellent condition, relatively new and functioning as intended	10
LAGGING 8.00	Isolated evidence of minor cracking without loss of function	9
ANCHOR HEADS 8.00	Minor staining, wall elements fully bearing against retained units without distortion	10
PILES AND SHAFTS 8.00	Relatively new, few signs of distress	10
DOWNSLOPE 0.50	Approximately 15ft-wide bench in front of retaining wall, low visibility below due to snow cover, minor signs of erosion associated with retaining wall, no observed impact on retaining wall	9
LATERAL SLOPE 0.50	Steep slope, low visibility due to snow cover, no signs of erosion or impact to retaining wall	9
ROAD/SIDEWALK/SHOULDER 0.50	Road shows no signs of distress due to retaining wall	9
TRAFFIC BARRIER/FENCE 0.50	Guardrail shows no distress due to retaining wall displacement	10

Failure Consequence:	MODERATE
Recommendation Narrative:	None
Repair Cost:	\$0

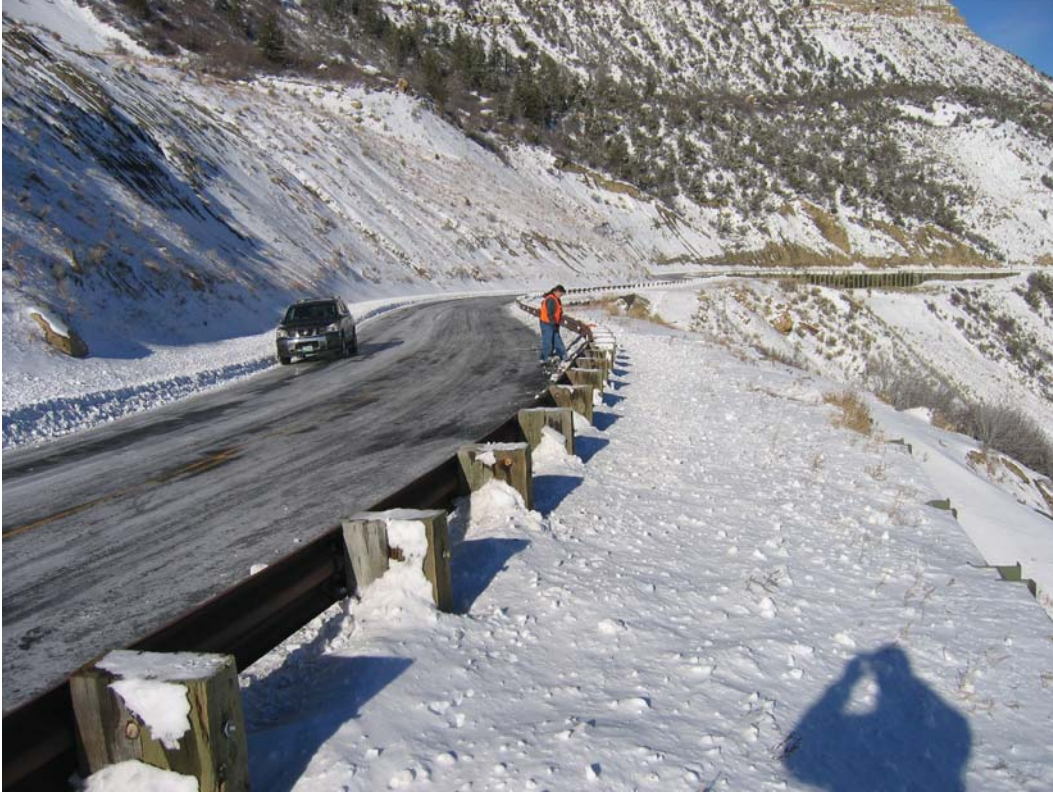
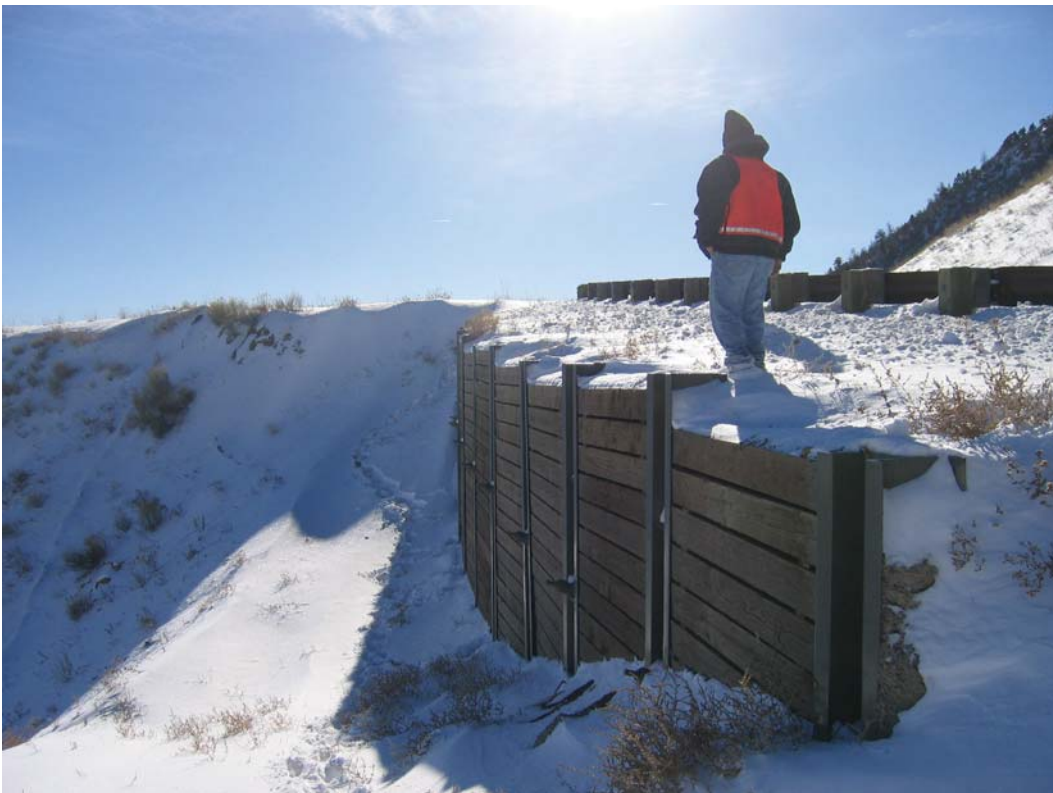
MEVE_0010_3.057_L_1.jpg

Wall ID:	MEVE-0010-3.057-L		
Route Name:	ENTRANCE ROAD		
Inspection Date:	December 12, 2006	Approximate Year Built:	2004
*Wall Rating:	98	Maintenance Action:	No Action

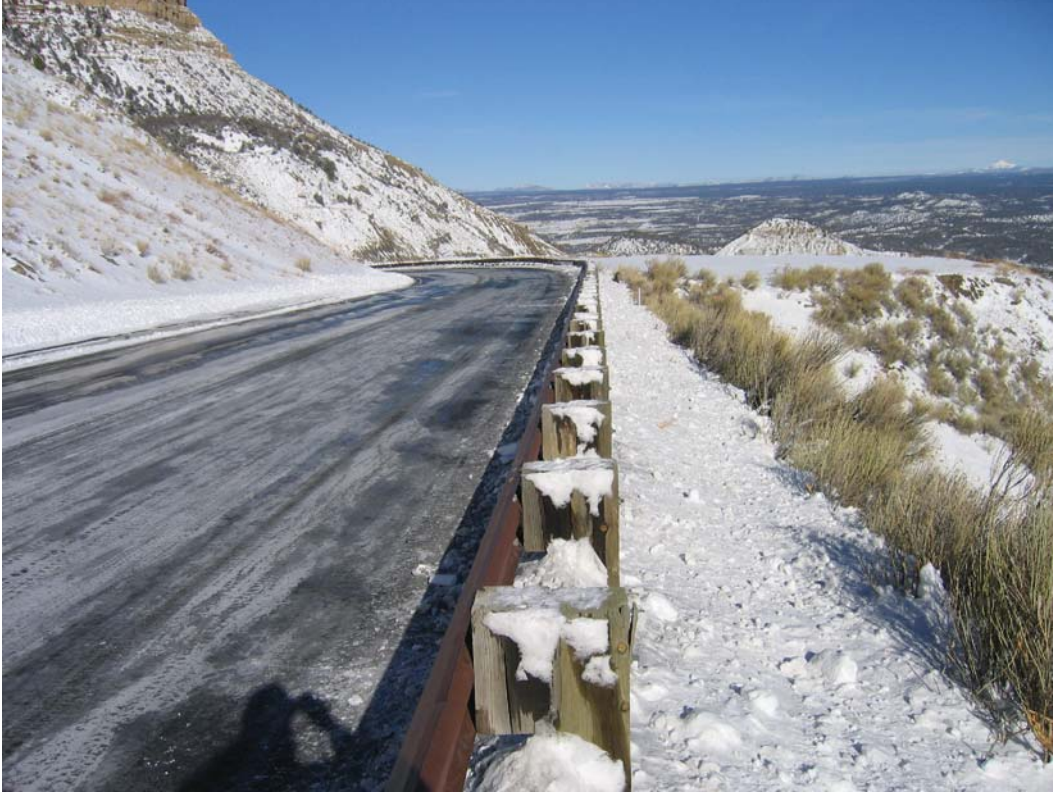
MEVE_0010_3.107_L_1.jpg

Wall ID:	MEVE-0010-3.107-L		
Route Name:	ENTRANCE ROAD		
Inspection Date:	December 12, 2006	Approximate Year Built:	1980
*Wall Rating:	84	Maintenance Action:	Maintenance

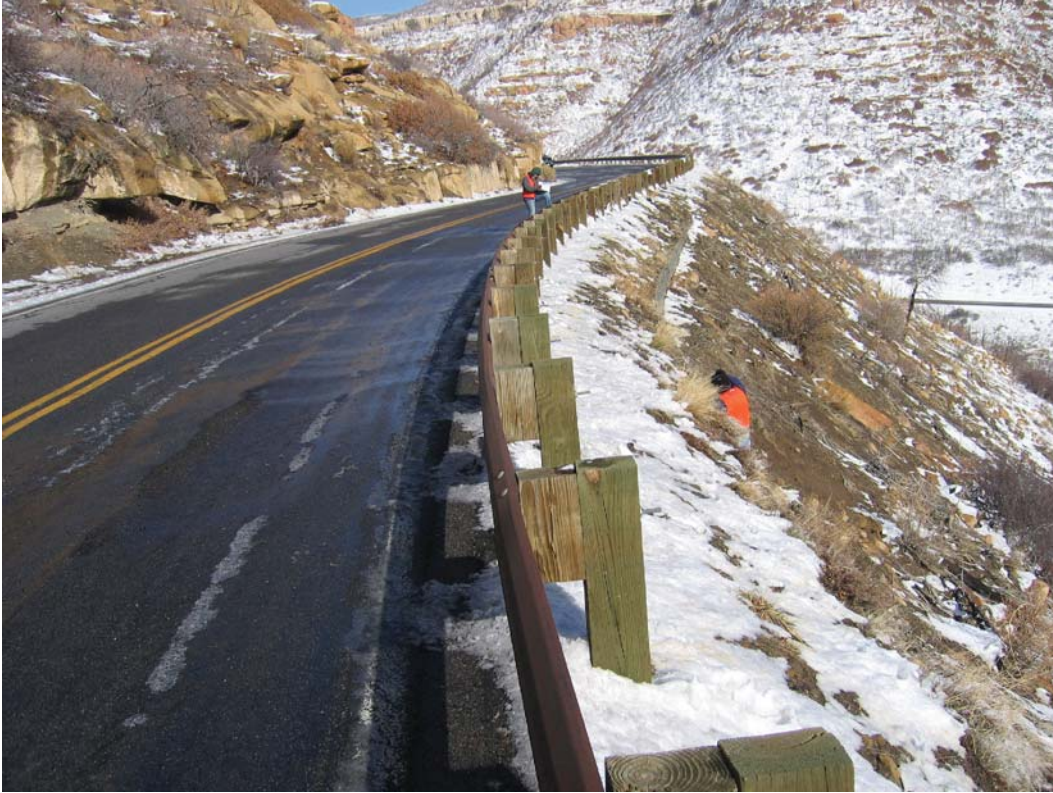
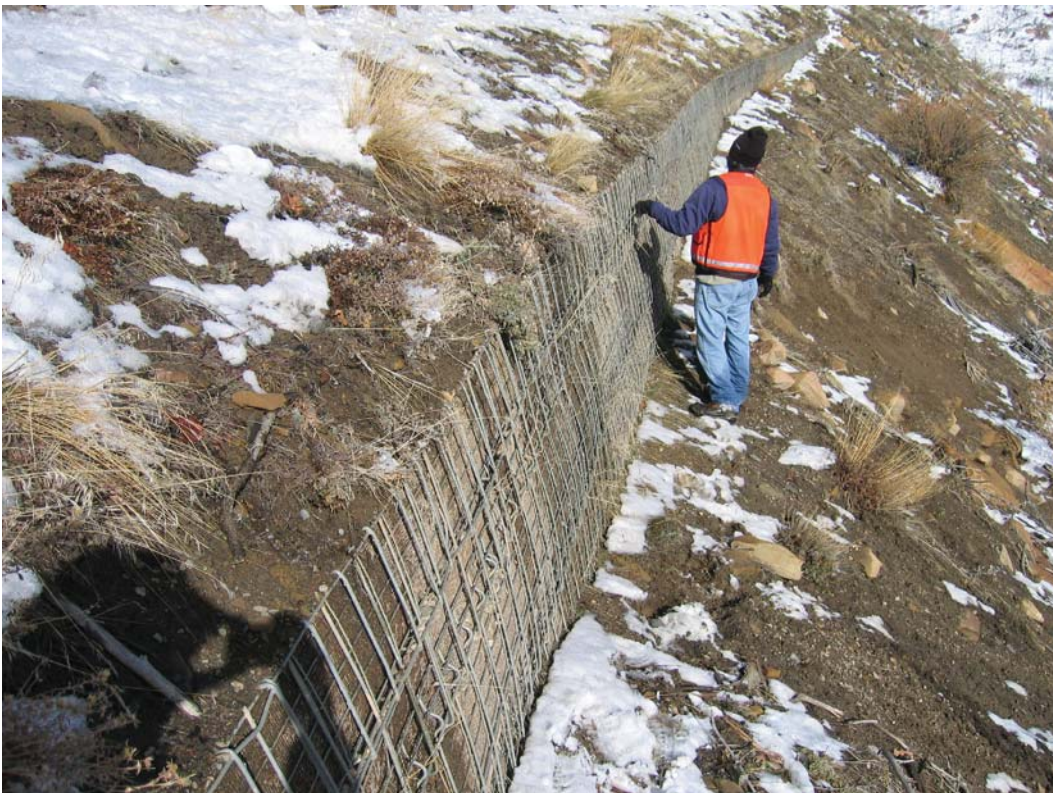
MEVE_0010_6.901_L_1.jpg

Wall ID:	MEVE-0010-6.901-L		
Route Name:	ENTRANCE ROAD		
Inspection Date:	December 12, 2006	Approximate Year Built:	1984
*Wall Rating:	83	Maintenance Action:	Maintenance

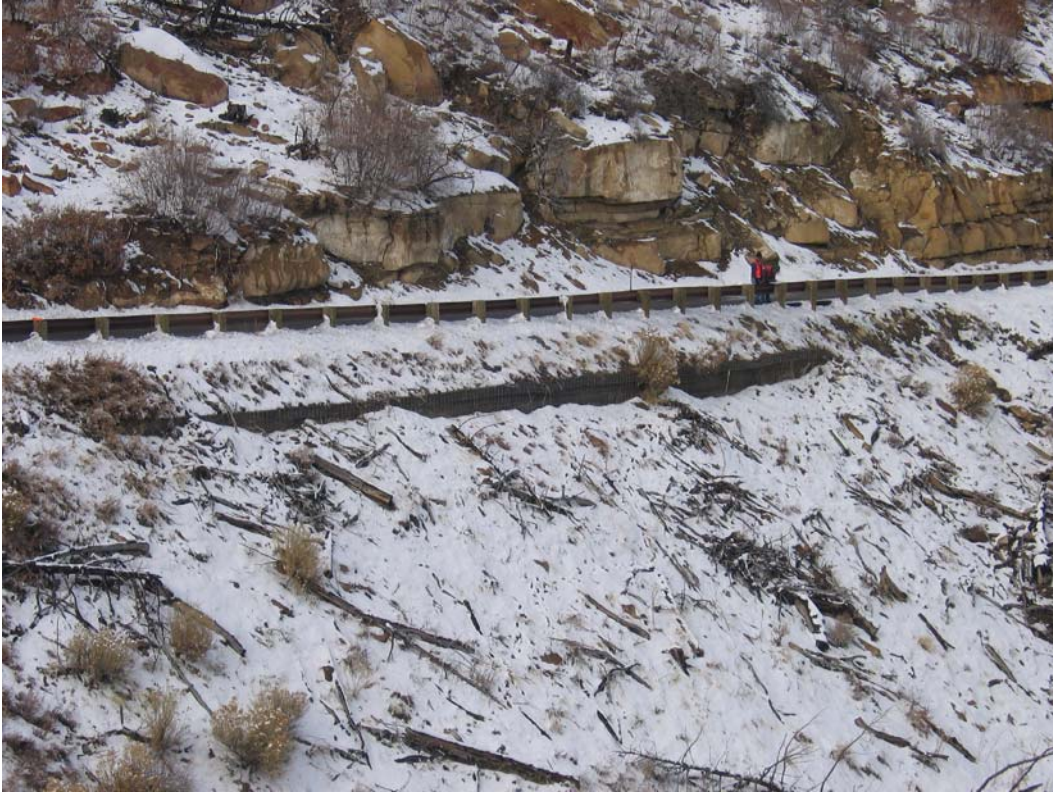
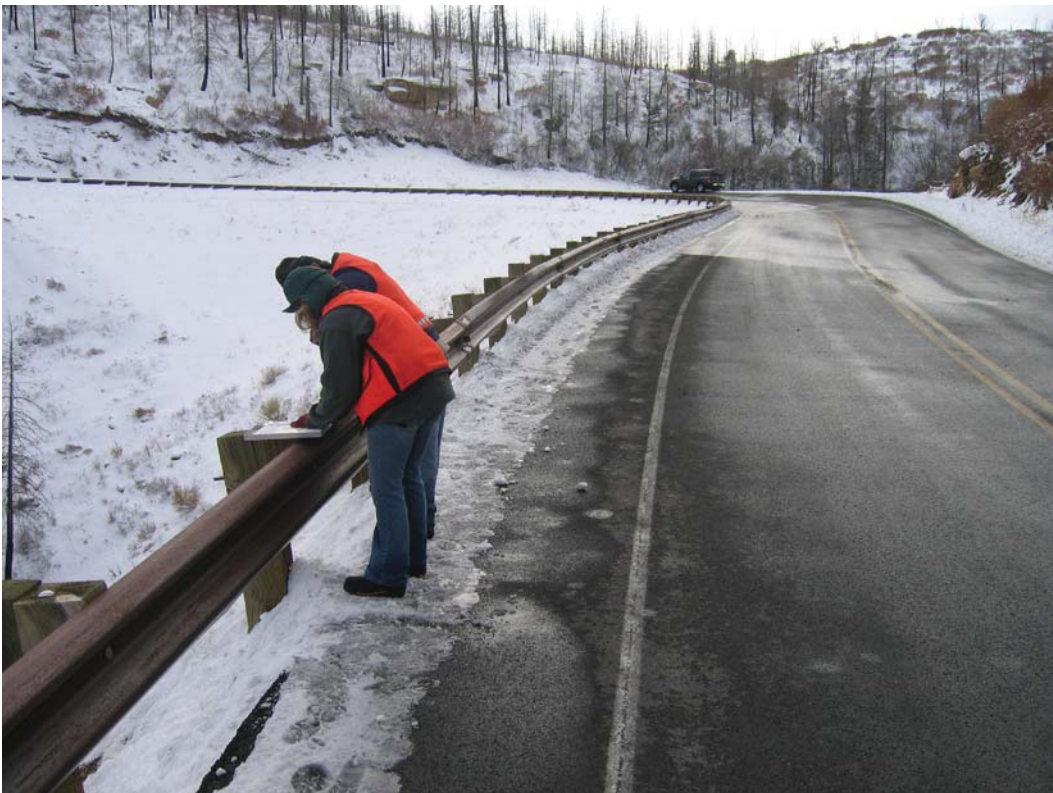
MEVE_0010_6.995_L_1.jpg

Wall ID:	MEVE-0010-6.995-L		
Route Name:	ENTRANCE ROAD		
Inspection Date:	December 12, 2006	Approximate Year Built:	1984
*Wall Rating:	84	Maintenance Action:	No Action

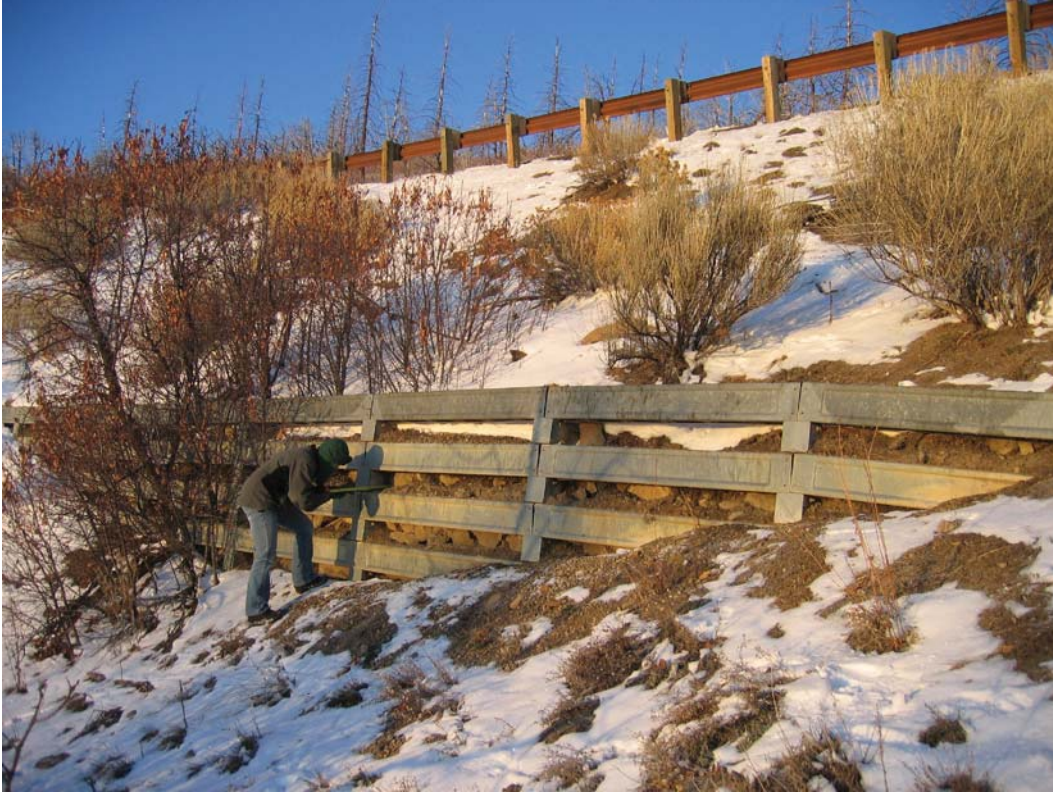
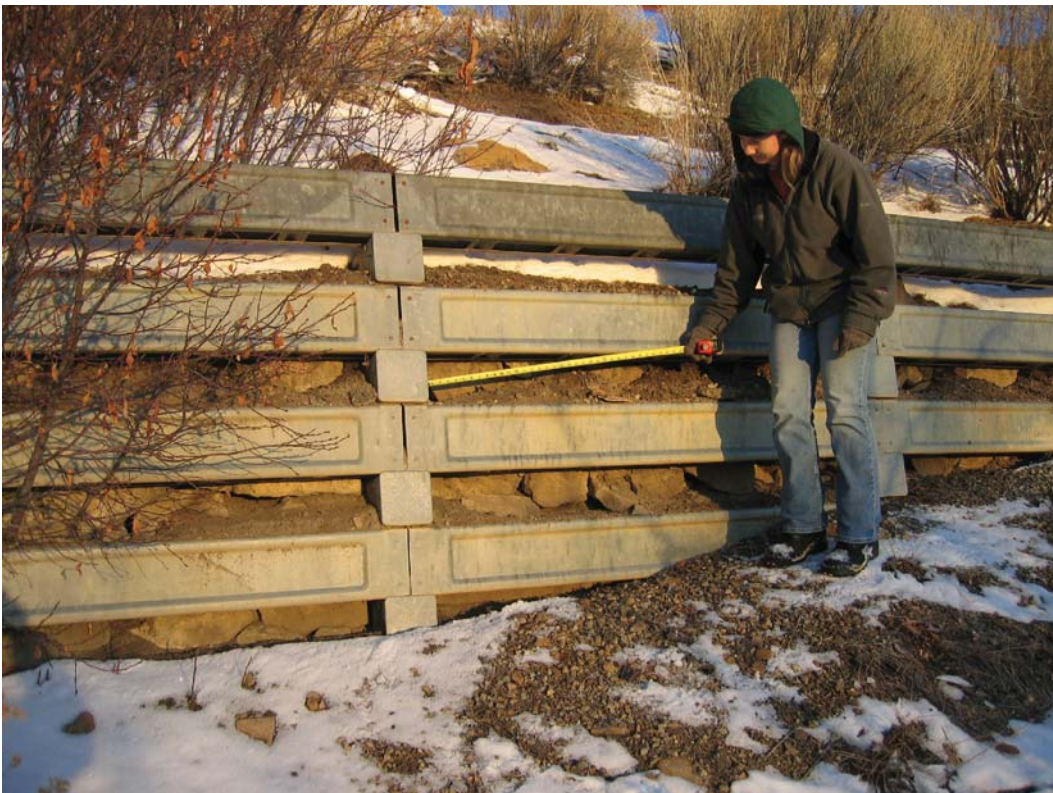
MEVE_0010_7.513_L_1.jpg

Wall ID:	MEVE-0010-7.513-L		
Route Name:	ENTRANCE ROAD		
Inspection Date:	December 13, 2006	Approximate Year Built:	1970
*Wall Rating:	80	Maintenance Action:	Maintenance

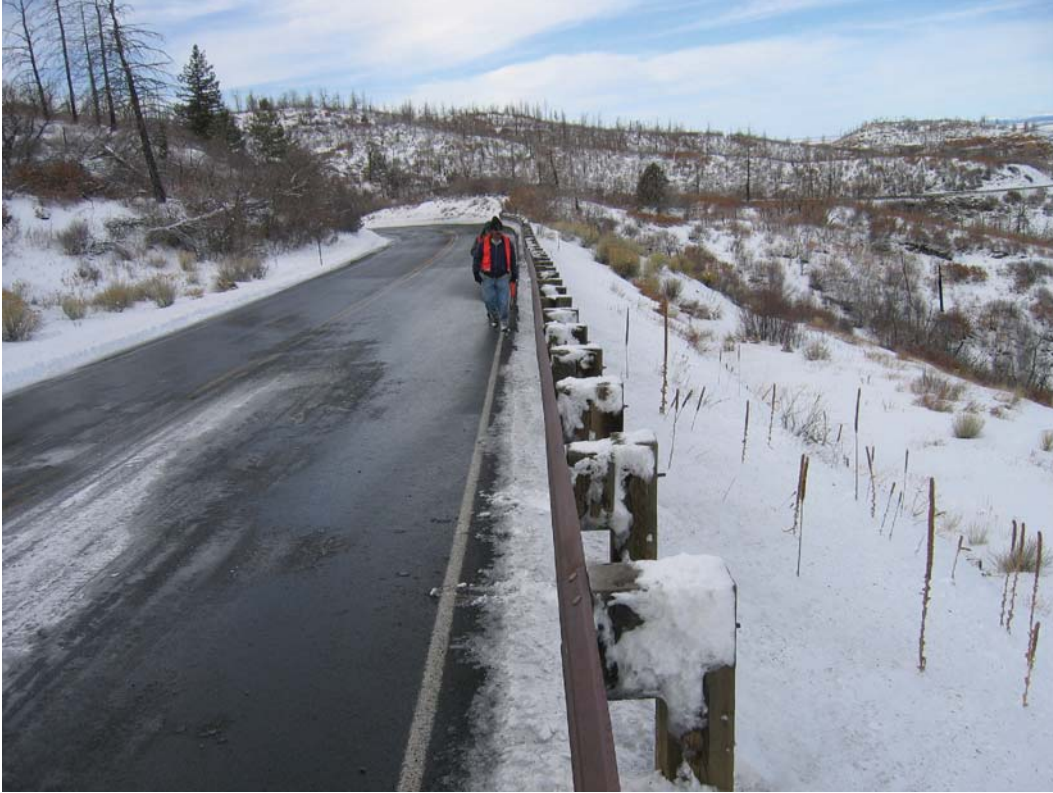
MEVE_0010_7.776_L_1.jpg

Wall ID:	MEVE-0010-7.776-L		
Route Name:	ENTRANCE ROAD		
Inspection Date:	December 12, 2006	Approximate Year Built:	1990
*Wall Rating:	86	Maintenance Action:	Maintenance
Wall Description			
Wall Function:	Fill Wall	Primary Wall Type:	Anchor - Tieback H-Pile
Surface Treatment:	Other - Wood Preservative (Cu)	Secondary Wall Type:	
Secondary Surface Treatment:		Architectural Facing:	
General Description:	Soldier Pile and Timber Lagging Tieback Wall, Single anchor per soldier pile		
Wall Measurements			
Wall Length (ft.):	180	Face Area (sq.):	2160
Average Wall Height (ft.):	12	Face Angle (deg.):	85
Maximum Wall Height (ft.):	13	Vertical Offset (ft.):	-5
Assessed Elements			
Element (Weighting Factor)	Narrative		Condition Rating (0 - 10)
PERFORMANCE 8.00	Good condition, minor corrosion of piles and anchor heads (needs paint), wall functioning as intended		8
WALL FOUNDATION MATERIAL 8.00	Covered, no settlement or signs of distress from base, base appears to be near bedrock		10

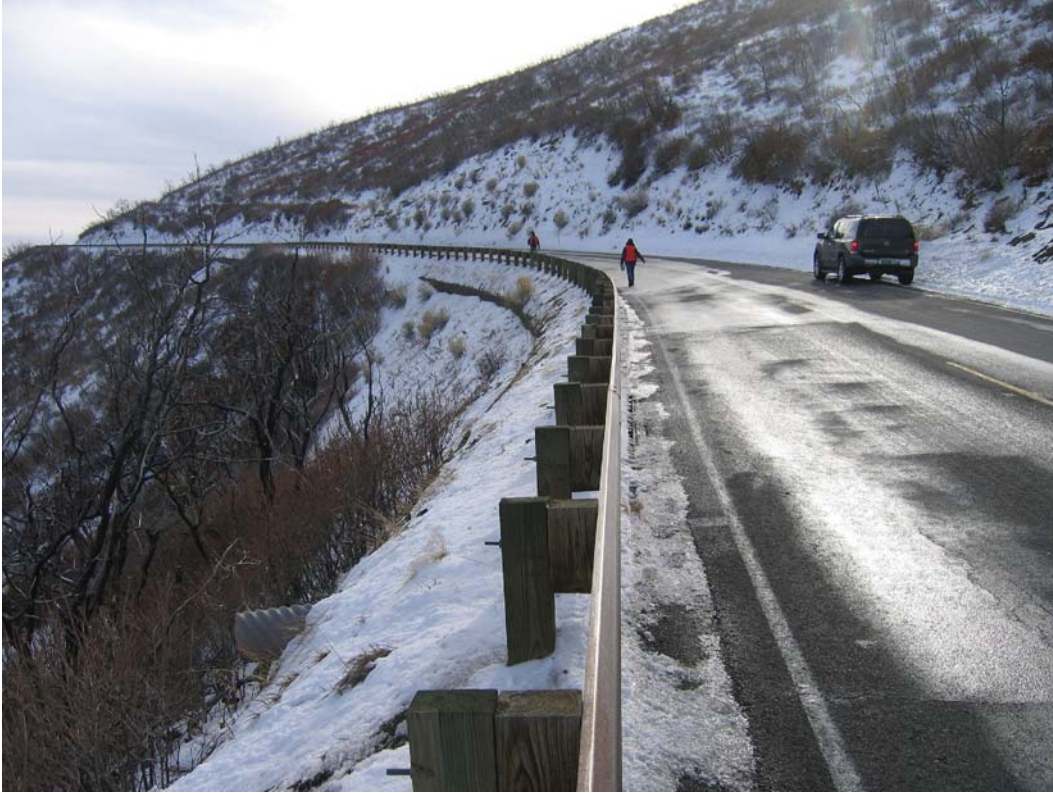
MEVE_0010_10.037_L_1.jpg

Wall ID:	MEVE-0010-10.037-L		
Route Name:	ENTRANCE ROAD		
Inspection Date:	December 12, 2006	Approximate Year Built:	1984
*Wall Rating:	83	Maintenance Action:	No Action

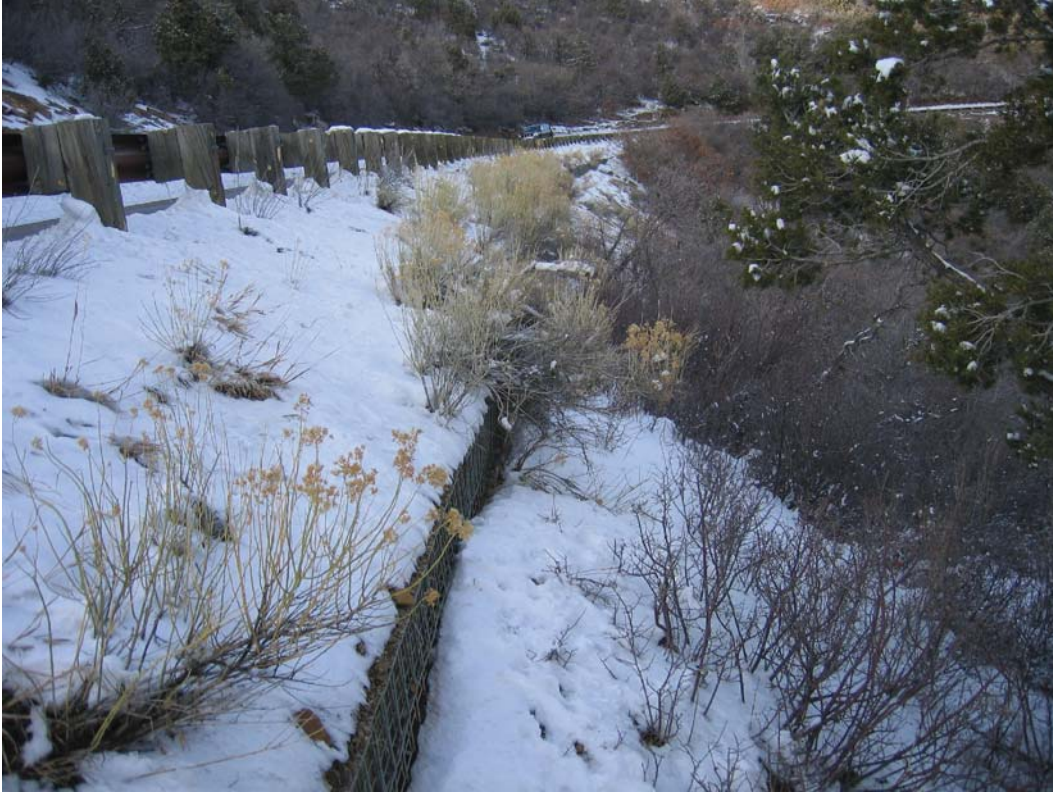
MEVE_0010_11.761_L_1.jpg

Wall ID:	MEVE-0010-11.761-L		
Route Name:	ENTRANCE ROAD		
Inspection Date:	December 12, 2006	Approximate Year Built:	1984
*Wall Rating:	83	Maintenance Action:	No Action

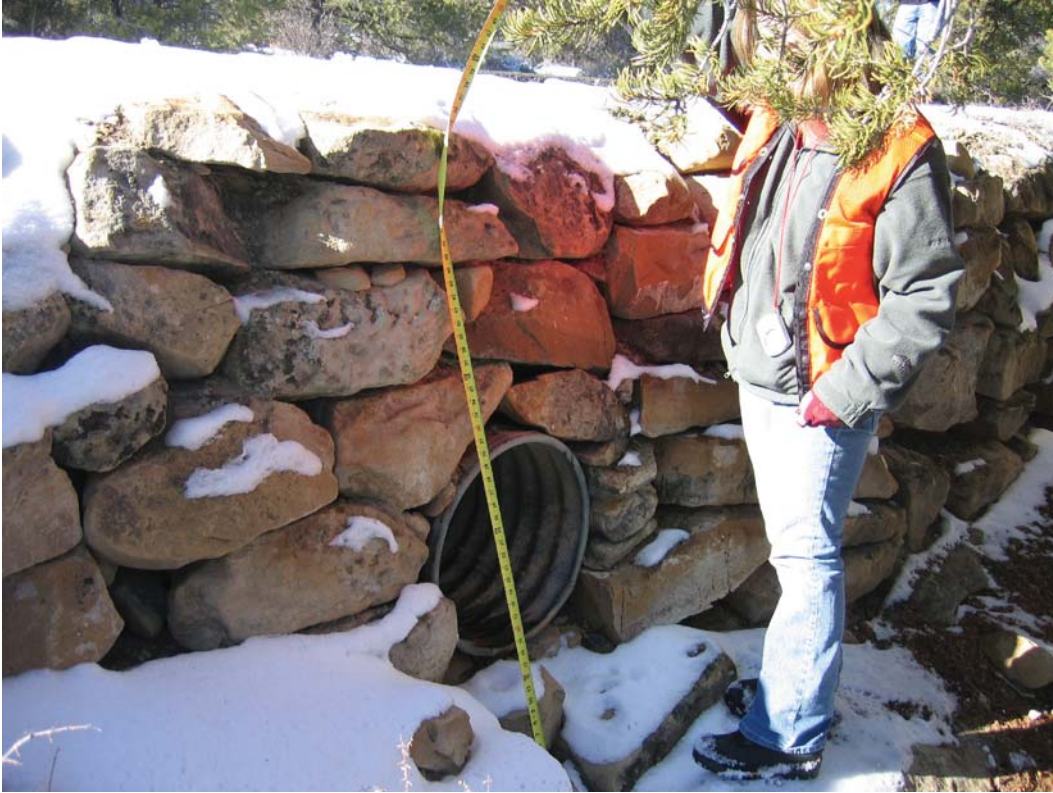
MEVE_0101_3.243_R_1.jpg

Wall ID:	MEVE-0101-3.243-R		
Route Name:	MESA TOP ROAD		
Inspection Date:	December 13, 2006	Approximate Year Built:	1923
*Wall Rating:	90	Maintenance Action:	No Action
