**NPS Retaining Wall Inventory Program  
Morristown National Historical Park**

**Federal Lands Highway  
Road Inventory Program**

**Federal Highway Administration  
Eastern Federal Lands Highway Division  
Road Inventory Program (RIP)**

**Data Collection Date: October 2008  
Report Date: November 2015**

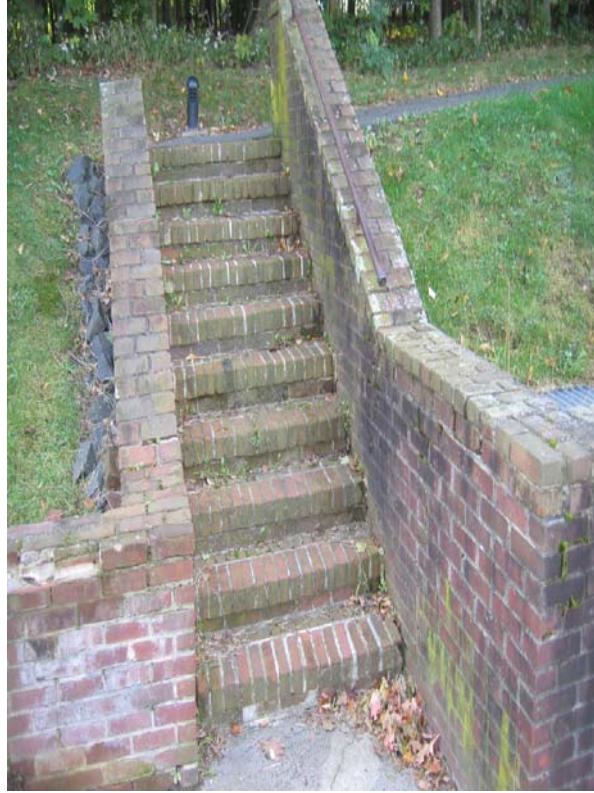
**MORR\_0900\_0.000\_P1\_1.jpg**

<b>Assessed Elements</b>			
<b>Element (Weighting Factor)</b>	<b>Narrative</b>		<b>Condition Rating (0 - 10)</b>
PERFORMANCE 8.00	Wall suffers from bearing failure, overturning, and lateral displacement along shears through the mortar. Because the wall is short, earth and hydrostatic pressures are relatively small and thus acting slowly on the wall structure. The structure does no		3
WALL FOUNDATION MATERIAL 8.00	Foundation materials appear to be water saturated at different times of the year and very soft. The wall does not appear to have a footer of sufficient width to provide adequate bearing capacity, resulting in rotation of the wall at various locations.		3
MORTAR 8.00	Mortar is weathered, cracked and missing in some areas. Majority of the mortar is hard and remains durable, though water is seeping through portions of the wall. One section of the wall has sheared along a mortar joint.		5

MANUFACTURED BLOCK/BRICK 8.00	Manufactured brick veneer is generally sound and in good condition. There are some missing bricks, and water seepage has stained and weathered sections of the wall. The interior concrete blocks, where exposed, appear to be intact.		7
ROAD/SIDEWALK/SHOULDER 1.00	The sidewalk in front of the wall shows signs of minor heave distress, likely due to water issues and soft soils.		6
ARCHITECTURAL FACING 1.00	The wall is comprised of a concrete block core faced with red brick. The facing brick is in good overall condition and salvageable should repairs/replacement be undertaken.		7
DOWNSLOPE 1.00	Sidewalk transitioning to paved parking area. Sidewalk indicates soft soil issues (heaving), but no problems in the parking area were observed.		7
LATERAL SLOPE 1.00	Gentle grassy slopes with no apparent stability or erosion issues.		7
UPSLOPE 1.00	Gentle, moderately vegetated upslope. Trees along the slope suggest some slope movement has occurred. The slope appears to be comprised of soft soils which are often wet.		7

<b>Failure Consequence:</b>	LOW
<b>Recommendation Narrative:</b>	Replace the existing retaining wall, step structures, and lightstand structure with a new gravity concrete block and brick veneer retaining wall. Construct an adequate well-drained footer (following soils investigation) to resist bearing and overturning
<b>Repair Cost:</b>	\$214,900
