NERI WIP Report

NPS Retaining Wall Inventory Program New River Gorge National River

Data Collection Date: October 2008
Report Date: November 2015

New River Gorge National River in West Virginia

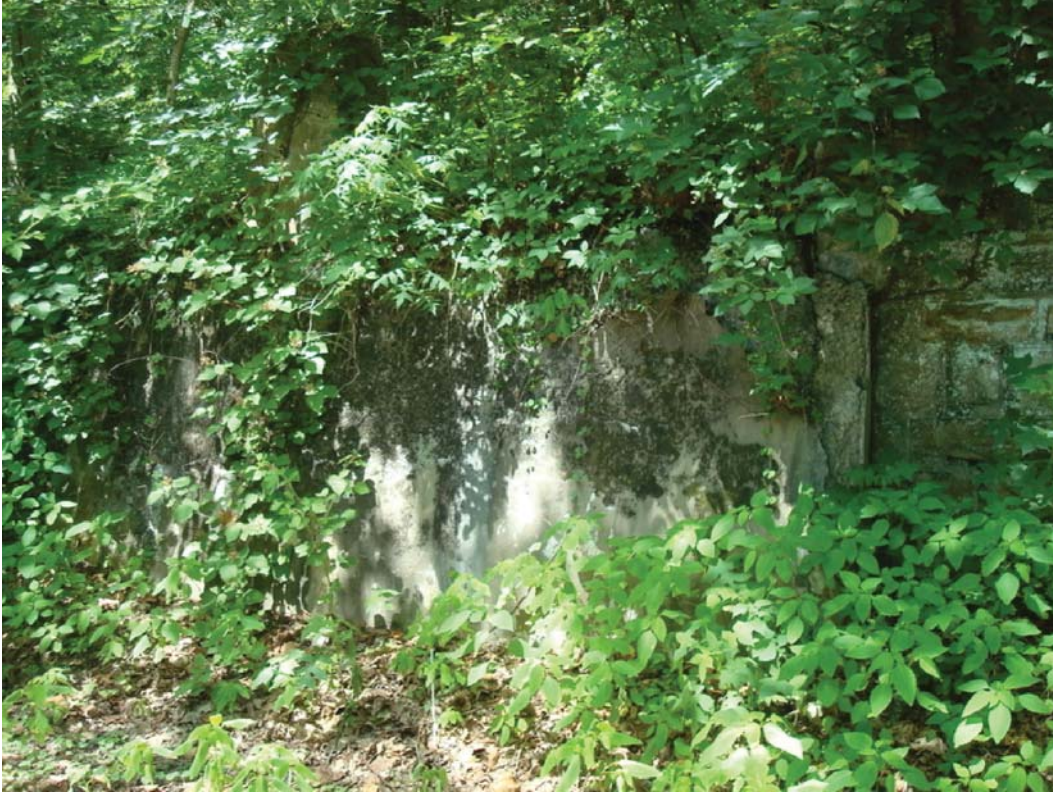
NERI_0108_0.225_R_1.JPG

Wall ID:	NERI-0108-.225-R		
Route Name:	COAL RUN (FISHERMAN'S ACCESS) ROAD		
Inspection Date:	June 25, 2008	Approximate Year Built:	Unknown
*Wall Rating:	72	Maintenance Action:	Maintenance
