OLYM WIP Report

NPS Retaining Wall Inventory Program Olympic National Park

**Federal Highway Administration
Eastern Federal Lands Highway Division
Road Inventory Program (RIP)**

**Data Collection Date: July 2007
Report Date: October 2015**

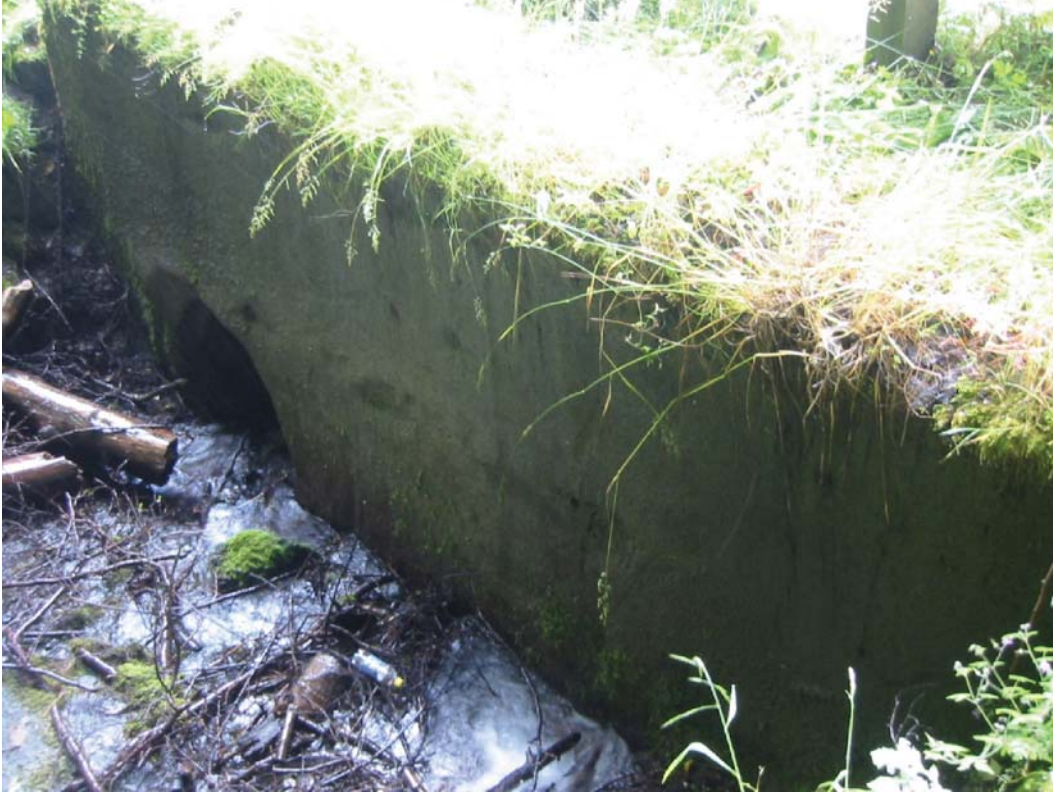
OLYM_0011_0.511_L_1.jpg

Wall ID:	OLYM-0011-0.511-L		
Route Name:	LAKE CRESCENT HIGHWAY (US 101)		
Inspection Date:	July 19, 2007	Approximate Year Built:	Unknown
*Wall Rating:	88	Maintenance Action:	No Action

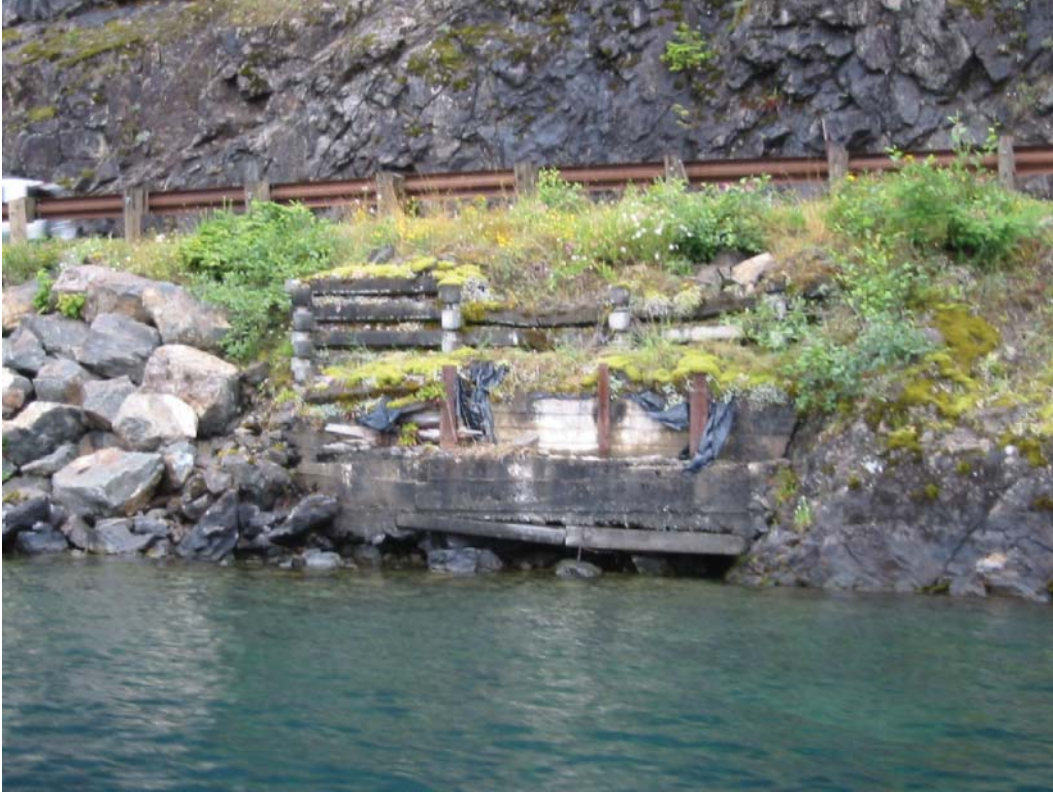
OLYM_0011_2.656_R_1.jpg

Wall ID:	OLYM-0011-2.656-R		
Route Name:	LAKE CRESCENT HIGHWAY (US 101)		
Inspection Date:	July 23, 2007	Approximate Year Built:	Unknown
*Wall Rating:	81	Maintenance Action:	No Action

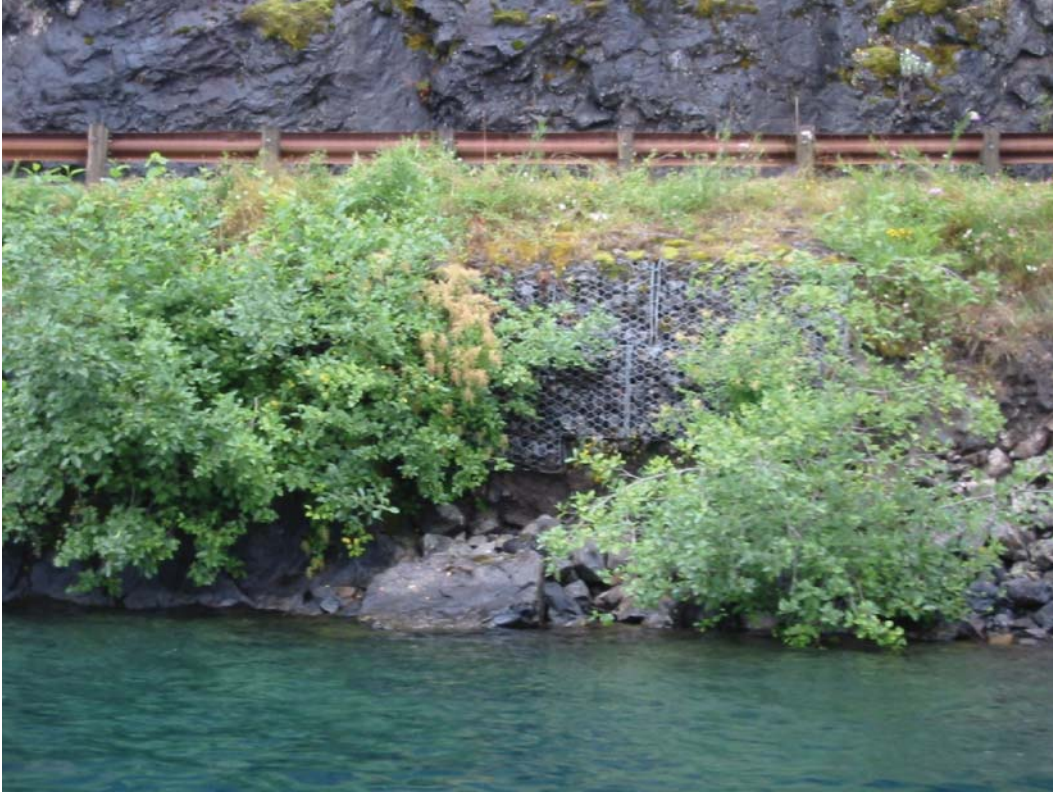
OLYM_0011_2.668_R_1.jpg

Wall ID:	OLYM-0011-2.668-R		
Route Name:	LAKE CRESCENT HIGHWAY (US 101)		
Inspection Date:	July 23, 2007	Approximate Year Built:	Unknown
*Wall Rating:	78	Maintenance Action:	Repair Elements

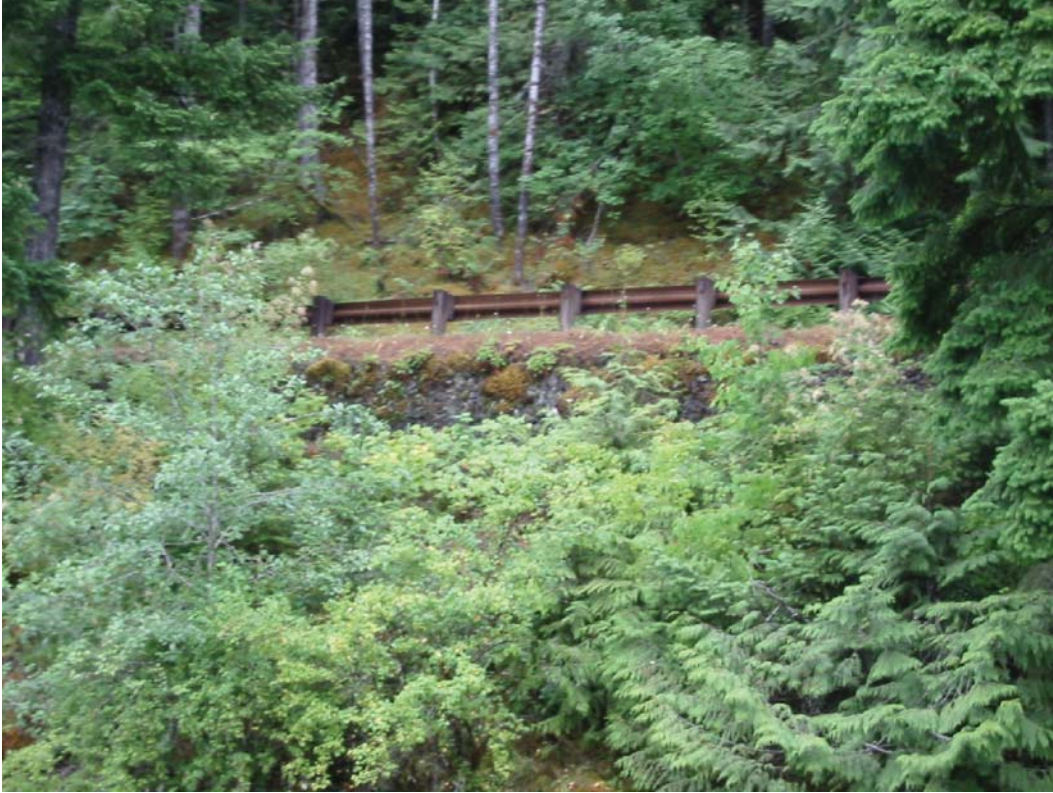
OLYM_0011_2.968_R_1.jpg

Wall ID:	OLYM-0011-2.968-R		
Route Name:	LAKE CRESCENT HIGHWAY (US 101)		
Inspection Date:	July 23, 2007	Approximate Year Built:	1984
*Wall Rating:	91	Maintenance Action:	No Action

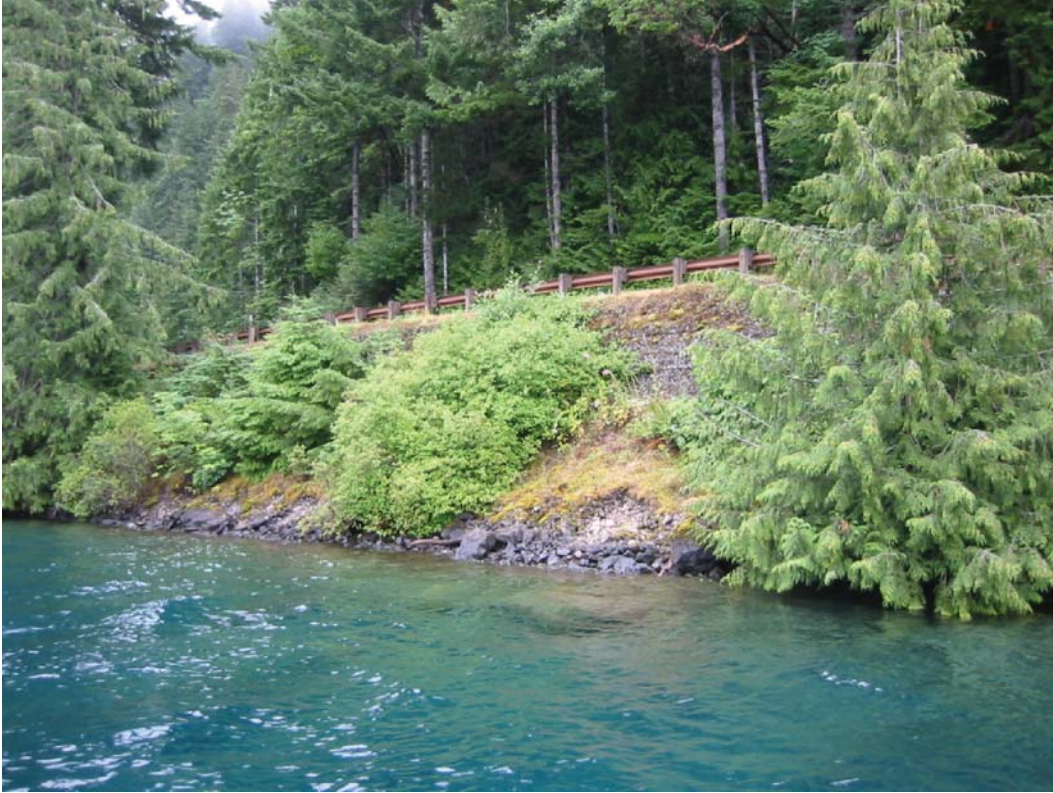
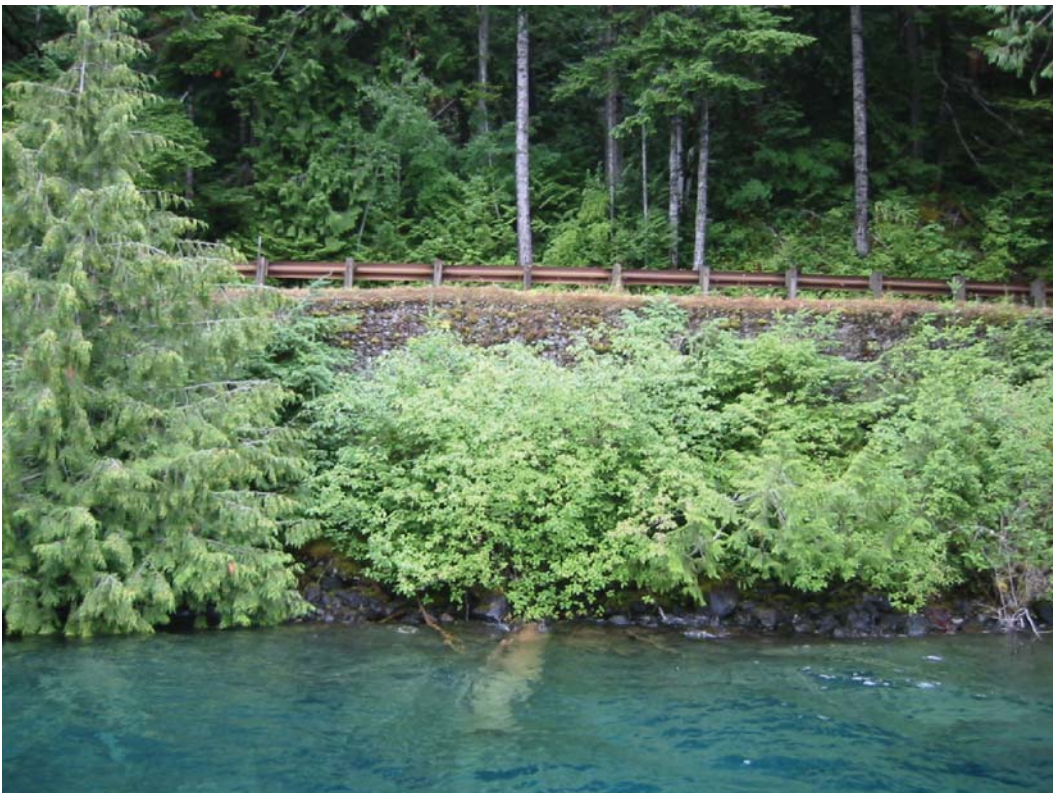
Wall ID:	OLYM-0011-3.002-R		
Route Name:	LAKE CRESCENT HIGHWAY (US 101)		
Inspection Date:	July 23, 2007	Approximate Year Built:	1984
*Wall Rating:	91	Maintenance Action:	No Action

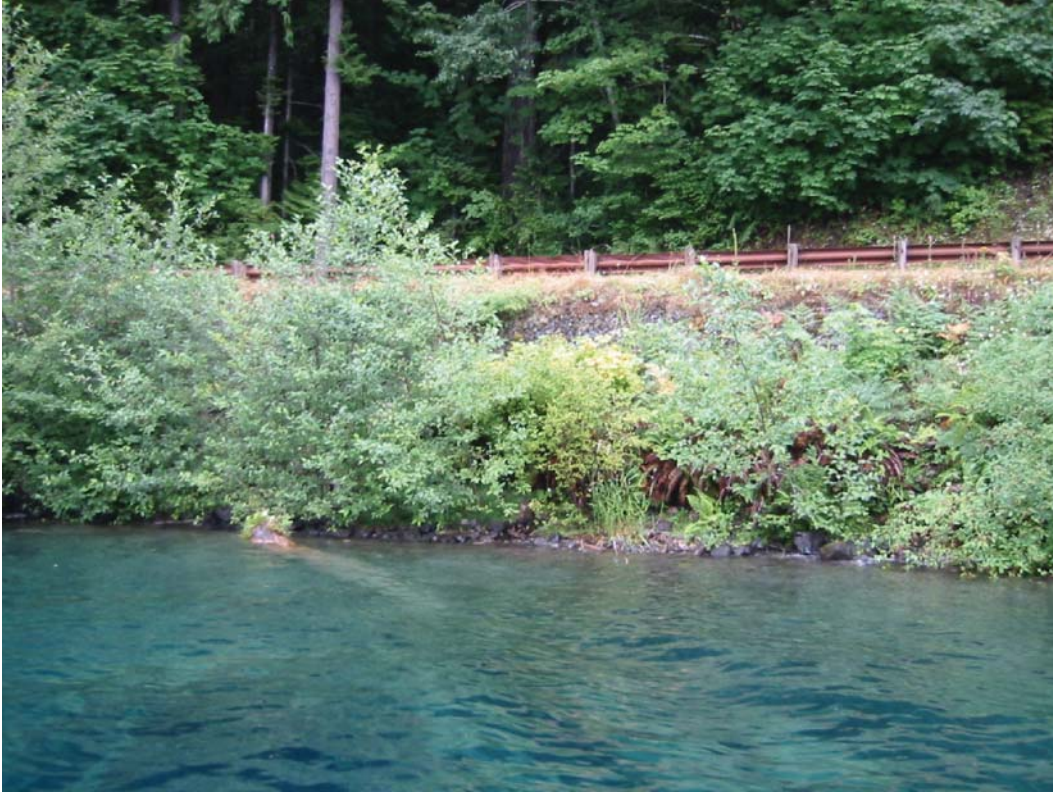
OLYM_0011_3.094_R_1.jpg

Wall ID:	OLYM-0011-3.094-R		
Route Name:	LAKE CRESCENT HIGHWAY (US 101)		
Inspection Date:	July 23, 2007	Approximate Year Built:	1984
*Wall Rating:	81	Maintenance Action:	Repair Elements

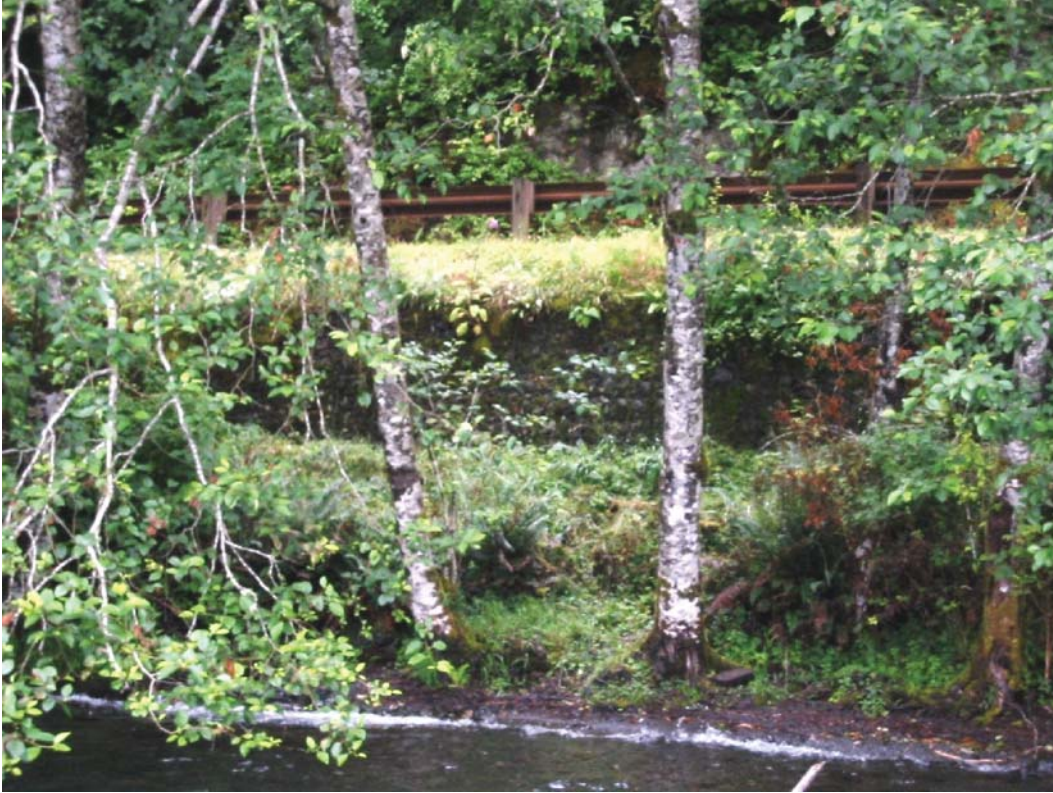
OLYM_0011_3.208_R_1.jpg

Wall ID:	OLYM-0011-3.208-R		
Route Name:	LAKE CRESCENT HIGHWAY (US 101)		
Inspection Date:	July 23, 2007	Approximate Year Built:	1984
*Wall Rating:	91	Maintenance Action:	No Action

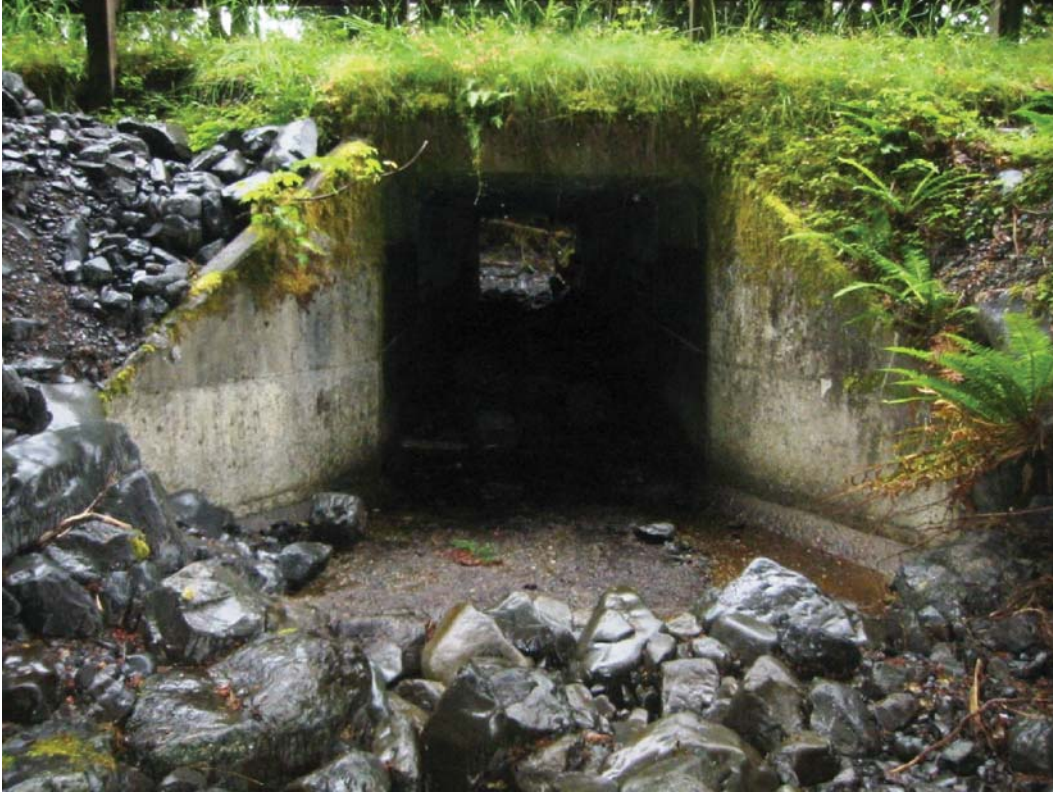
OLYM_0011_4.261_L_1.jpg

Wall ID:	OLYM-0011-4.261-L		
Route Name:	LAKE CRESCENT HIGHWAY (US 101)		
Inspection Date:	July 19, 2007	Approximate Year Built:	Unknown
*Wall Rating:	97	Maintenance Action:	No Action

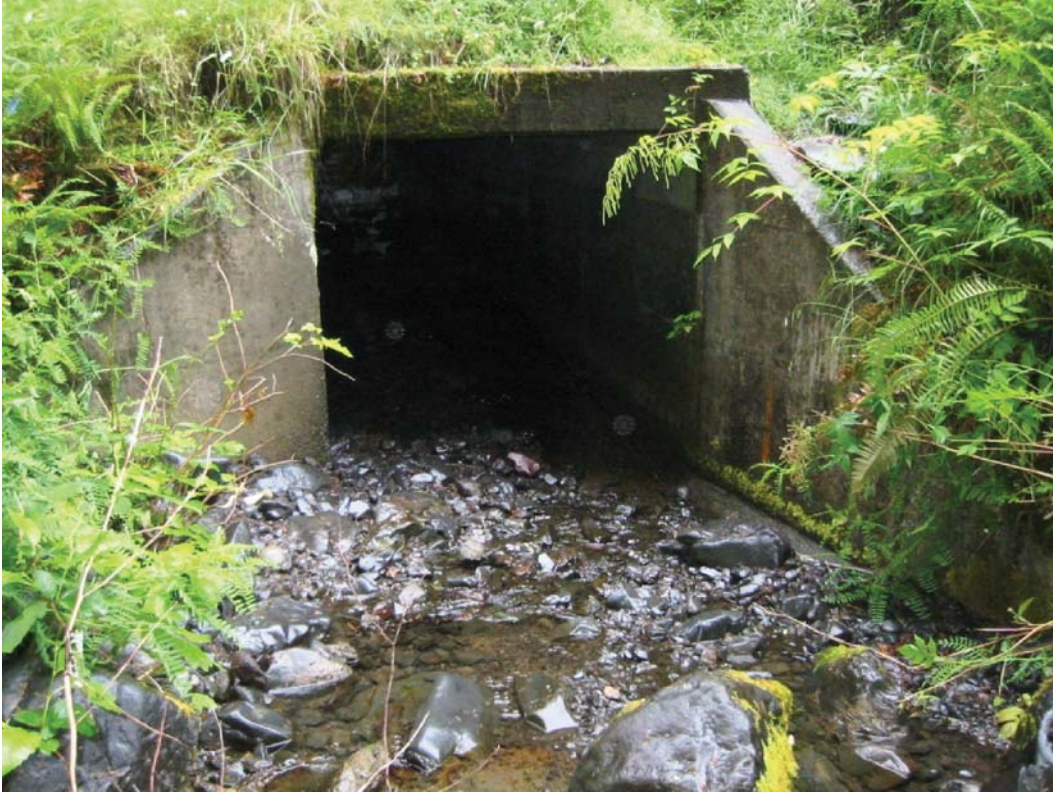
OLYM_0011_4.264_R_1.jpg

Wall ID:	OLYM-0011-4.264-R		
Route Name:	LAKE CRESCENT HIGHWAY (US 101)		
Inspection Date:	July 19, 2007	Approximate Year Built:	Unknown
*Wall Rating:	86	Maintenance Action:	No Action

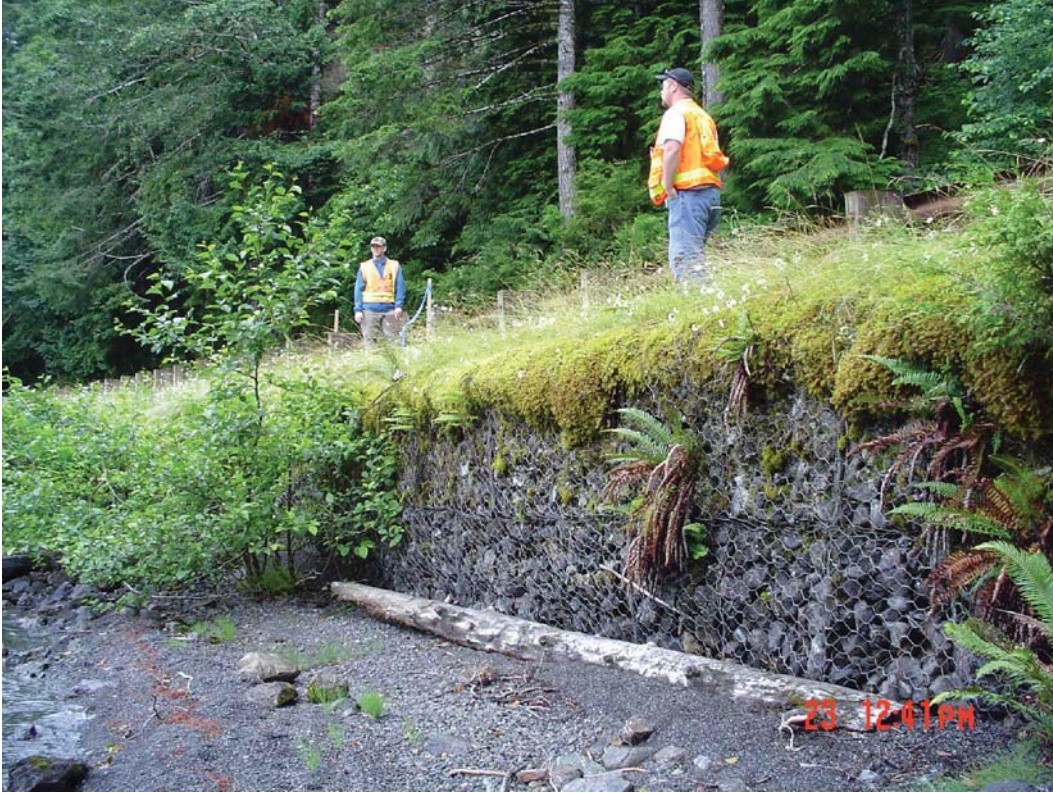
OLYM_0011_4.850_R_1.jpg

Wall ID:	OLYM-0011-4.850-R		
Route Name:	LAKE CRESCENT HIGHWAY (US 101)		
Inspection Date:	July 23, 2007	Approximate Year Built:	Unknown
*Wall Rating:	83	Maintenance Action:	No Action

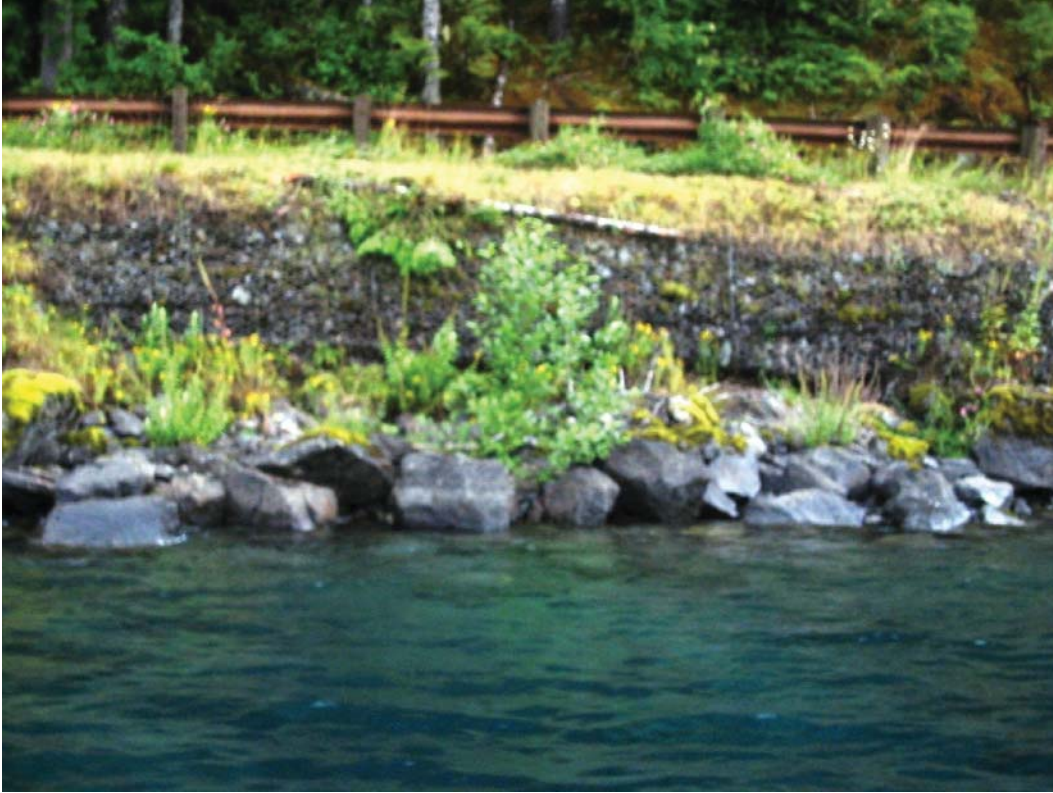
OLYM_0011_5.111_R_1.jpg

Wall ID:	OLYM-0011-5.111-R		
Route Name:	LAKE CRESCENT HIGHWAY (US 101)		
Inspection Date:	July 19, 2007	Approximate Year Built:	Unknown
*Wall Rating:	87	Maintenance Action:	No Action

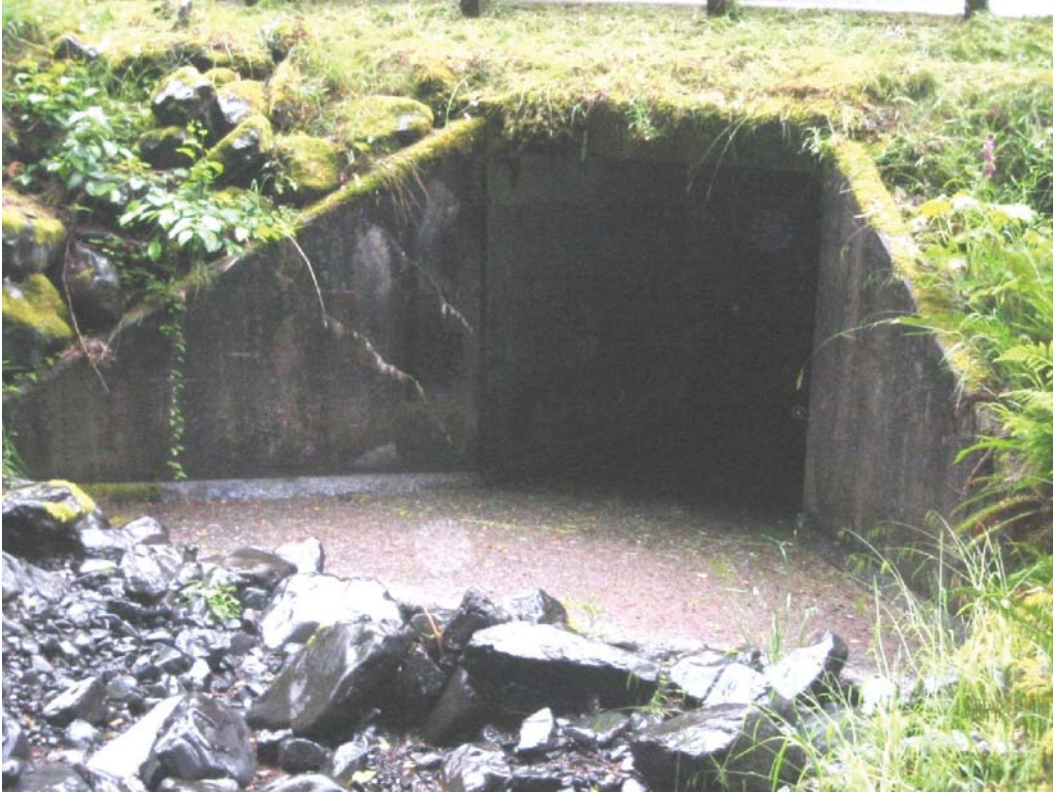
OLYM_0011_5.112_L_1.jpg

Wall ID:	OLYM-0011-5.112-L		
Route Name:	LAKE CRESCENT HIGHWAY (US 101)		
Inspection Date:	July 19, 2007	Approximate Year Built:	Unknown
*Wall Rating:	99	Maintenance Action:	No Action

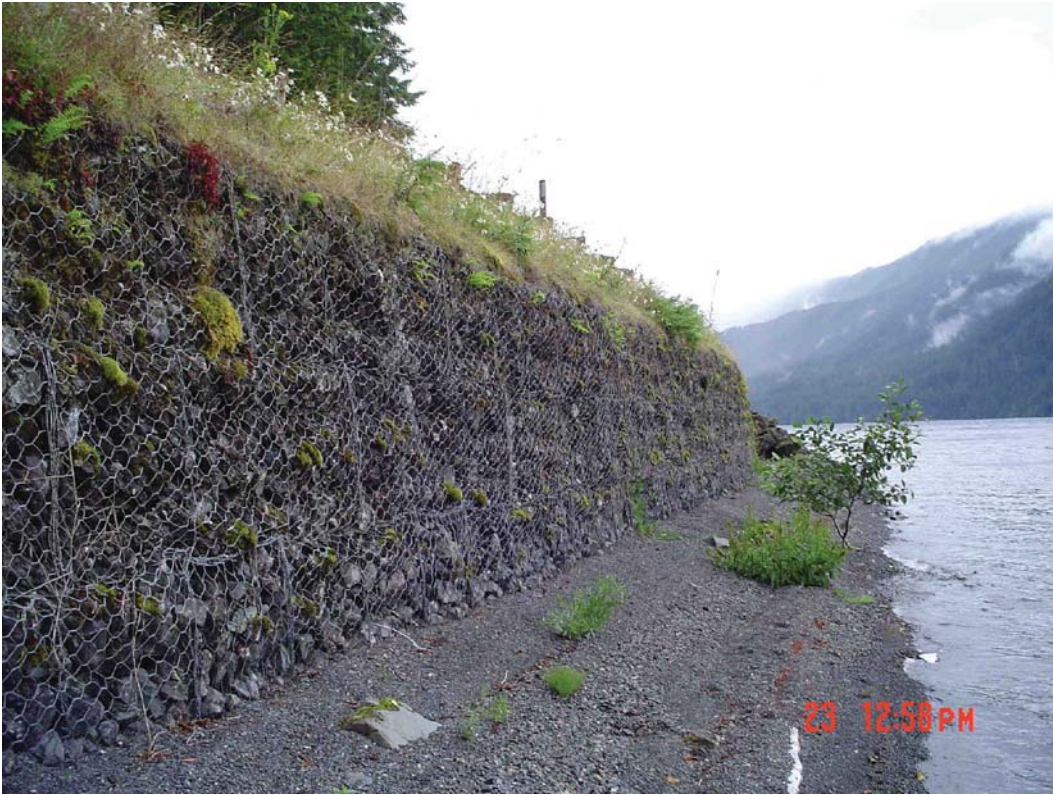
OLYM_0011_5.206_R_1.jpg

Wall ID:	OLYM-0011-5.206-R		
Route Name:	LAKE CRESCENT HIGHWAY (US 101)		
Inspection Date:	July 23, 2007	Approximate Year Built:	Unknown
*Wall Rating:	80	Maintenance Action:	No Action

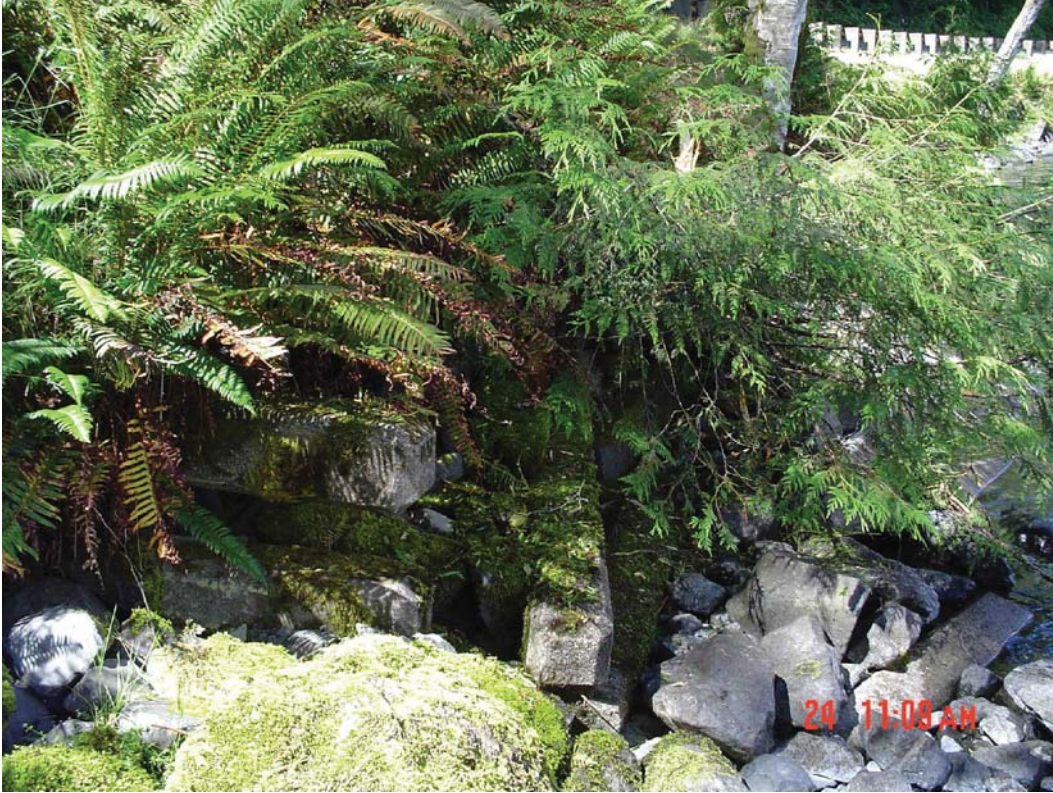
OLYM_0011_9.117_R_1.jpg

Wall Identification	Failure Consequence⁽¹⁾	Wall Rating⁽²⁾	Recommended Action⁽³⁾	2007 Repair Costs⁽⁴⁾
OLYM-0011-9.117-R	LOW	44	REPLACE WALL	\$23,072
