WIP Report

**NPS Retaining Wall Inventory Program
Presidio of San Francisco**

**Data Collection Date: November 2007
Report Date: November 2015**

Wall ID:	PRES-0969ZZ-0.000-P1		
Route Name:	GOLDEN GATE BRIDGE SOUTHWEST PARKING LOTS		
Inspection Date:	November 07, 2007	Approximate Year Built:	1937
*Wall Rating:	80	Maintenance Action:	No Action

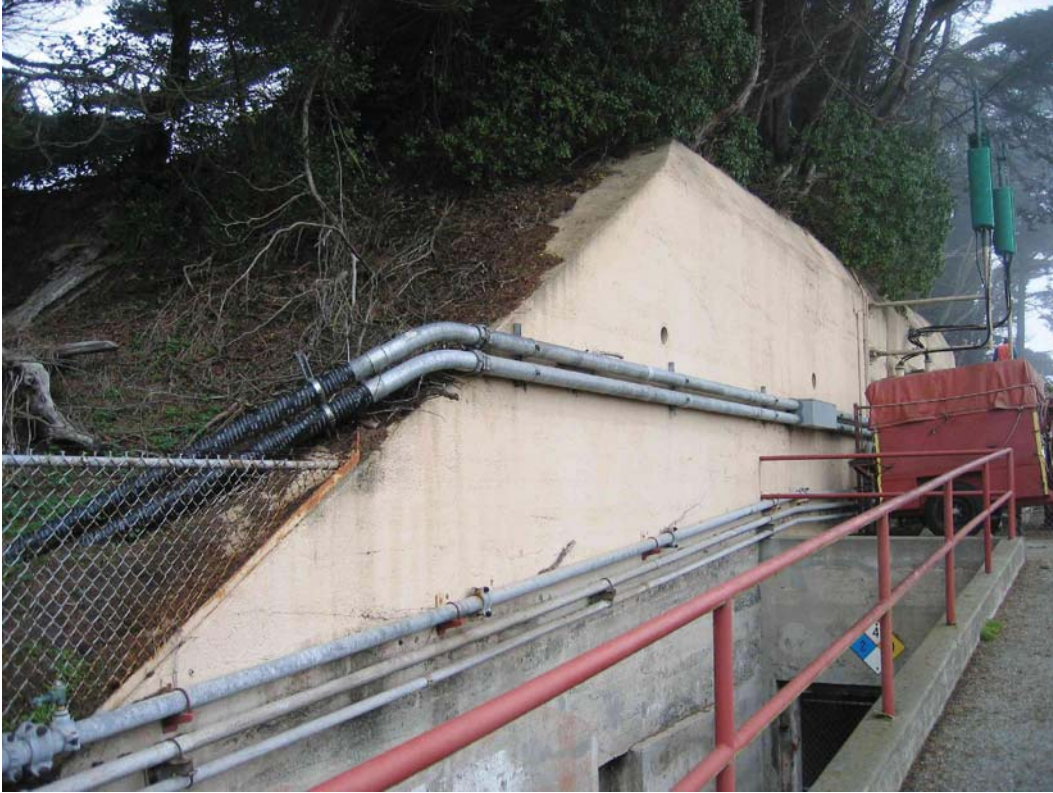
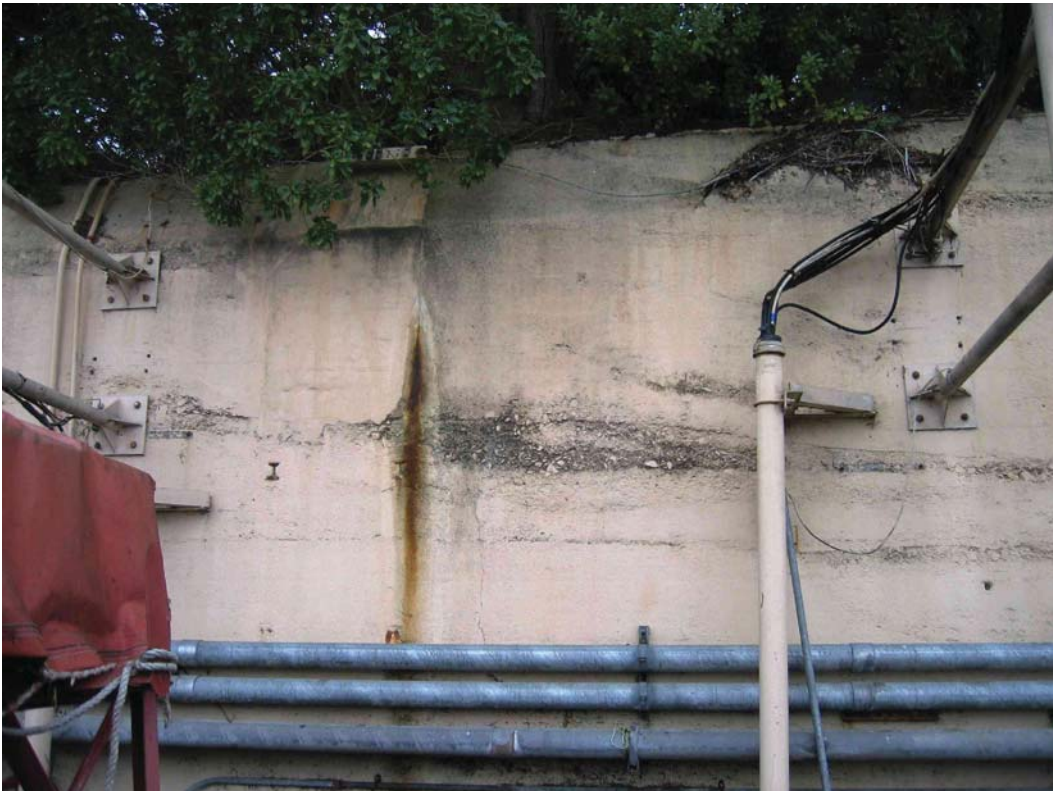
Element (Weighting Factor)	Narrative	Condition Rating (0 - 10)
PERFORMANCE 8.00	Good, no signs of global distress. Minor cracking.	8
WALL FOUNDATION MATERIAL 8.00	No signs of distress . Paved parking at wall toe. No settlement evident.	9
CONCRETE 8.00	Generally hard, though some aggregate exposed due to construction. Minor cracking. Minor water seeps. North end of wall has been drilled shut to make way for bridge access.	7
LATERAL SLOPE 0.50	Heavily vegetated, stable, no significant erosion.	9
ROAD/SIDEWALK/SHOULDER 0.50	Parking area at a toe wall shows no signs of wall-related distress.	9
UPSLOPE 0.50	Flat, heavily vegetated with large trees. No signs of top slope problems.	9
VEGETATION 0.50	Very large trees growing out of top of wall, but roots do not appear to be impacting the wall.	9
WALL DRAINS 1.00	Very few, very small drains. Seeps at a couple of cracks.	7

Failure Consequence:	LOW
Recommendation Narrative:	None
Repair Cost:	\$0
