NPS Retaining Wall Inventory Program Rocky Mountain National Park

**Federal Lands Highway
Road Inventory Program**

**Federal Highway Administration
Eastern Federal Lands Highway Division
Road Inventory Program (RIP)**

**Data Collection Date: September 2007
Report Date: October 2015**

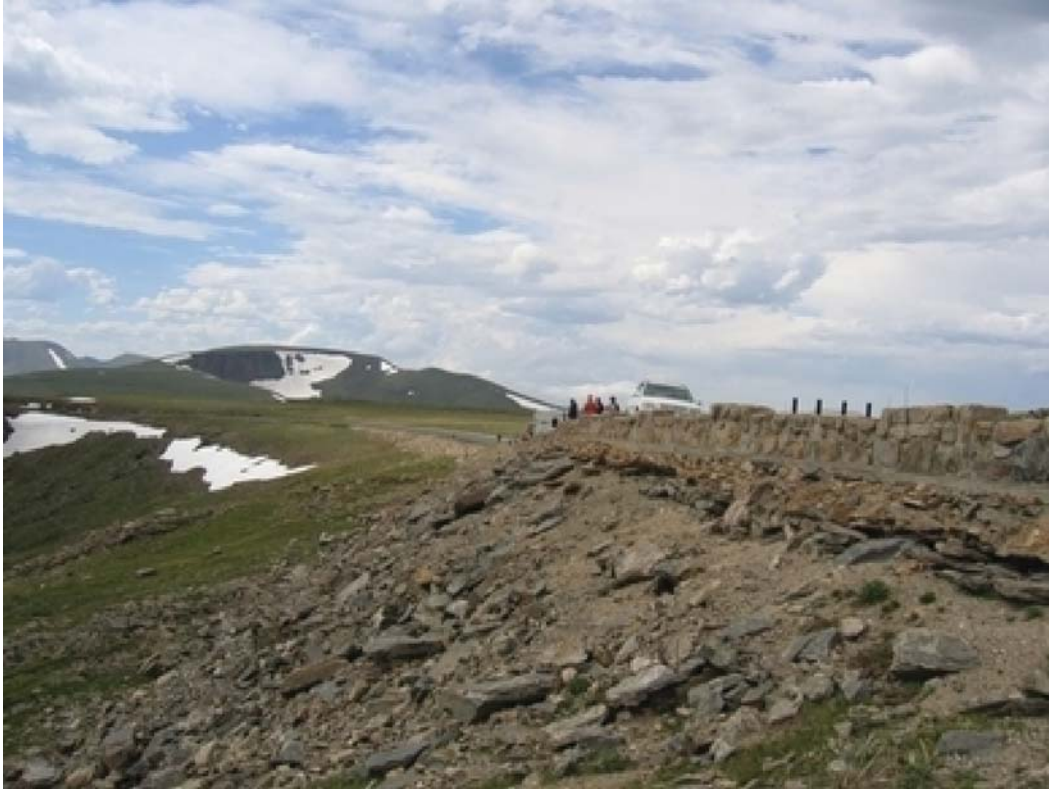
ROMO_0010_17.206_L_1.jpg

Wall Identification	Failure Consequence⁽¹⁾	Wall Rating⁽²⁾	Recommended Action⁽³⁾	2007 Repair Costs⁽⁴⁾
ROMO-0010-17.206-L	LOW	43	REPLACE ELEMENTS	\$20,000
