SHEN WIP Report

NPS Retaining Wall Inventory Program Shenandoah National Park

Federal Highway Administration
Eastern Federal Lands Highway Division
Road Inventory Program (RIP)

Data Collection Date: May 2007
Report Date: October 2015

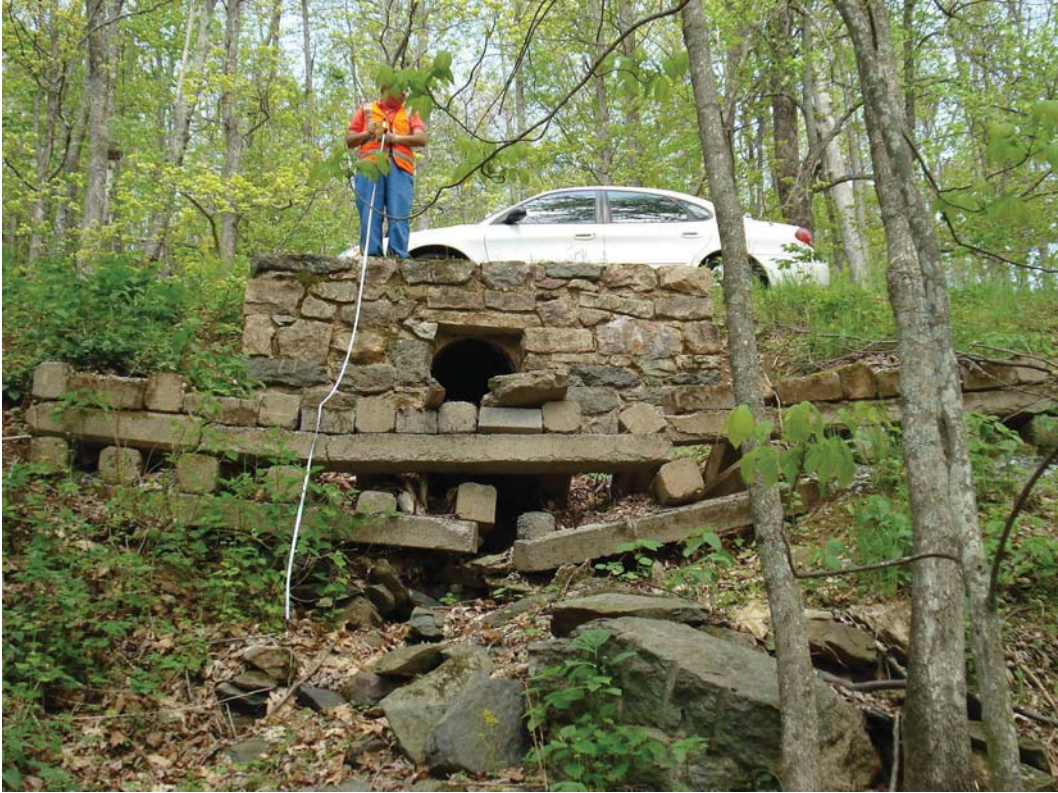
SHEN_0010B_62.820_L_1.jpg

Wall Identification	Failure Consequence⁽¹⁾	Wall Rating⁽²⁾	Recommended Action⁽³⁾	2007 Repair Costs⁽⁴⁾
SHEN-0010B-62.820-L	MODERATE	47	REPAIR ELEMENTS	\$47,000

Wall ID Inspection Date:	Wall Area (Sq. Ft.)	Wall Length (Ft.)	Wall Type	Wall Function	Overall Rating	Repair Cost
SHEN-0010B-62.609-R 5/18/2007	66	12	Gravity - Mortared Stone	Head Wall	80	\$0.00
SHEN-0010B-62.820-L 5/17/2007	60	10	Gravity - Mortared Stone	Head Wall	47	\$47,000.00
