STEAM WIP Report

NPS Retaining Wall Inventory Program Steamtown National Historic Site

**Federal Highway Administration
Eastern Federal Lands Highway Division
Road Inventory Program (RIP)**

**Data Collection Date: October 2008
Report Date: November 2015**

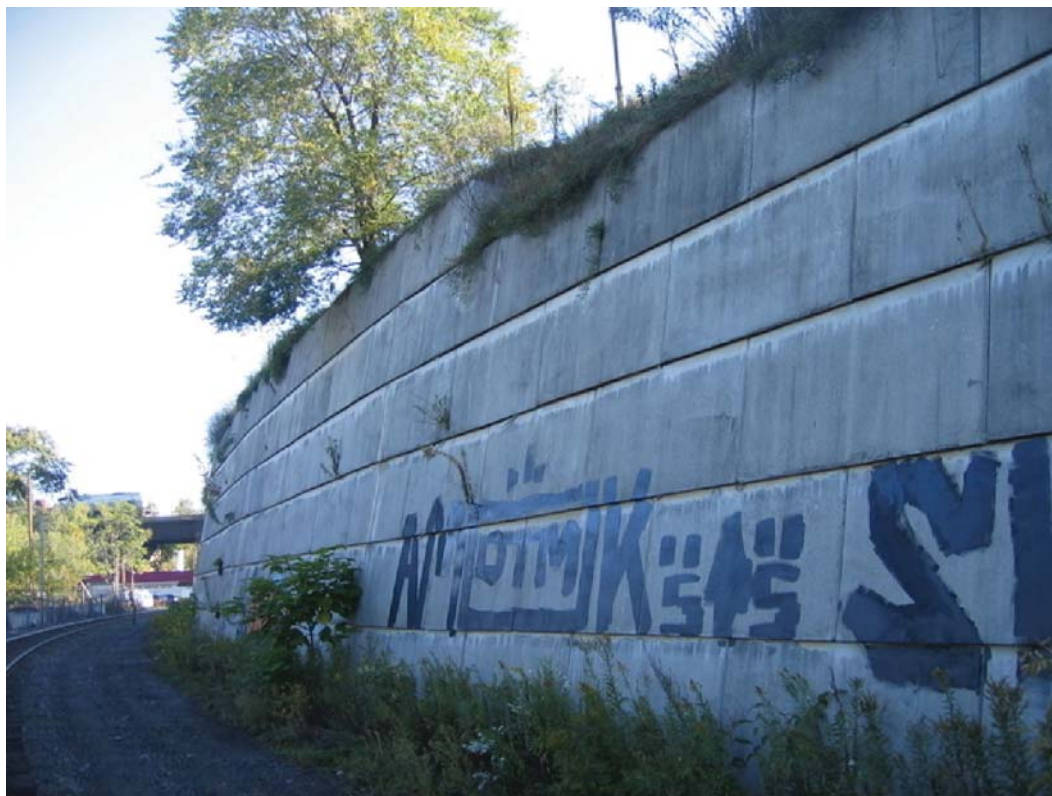
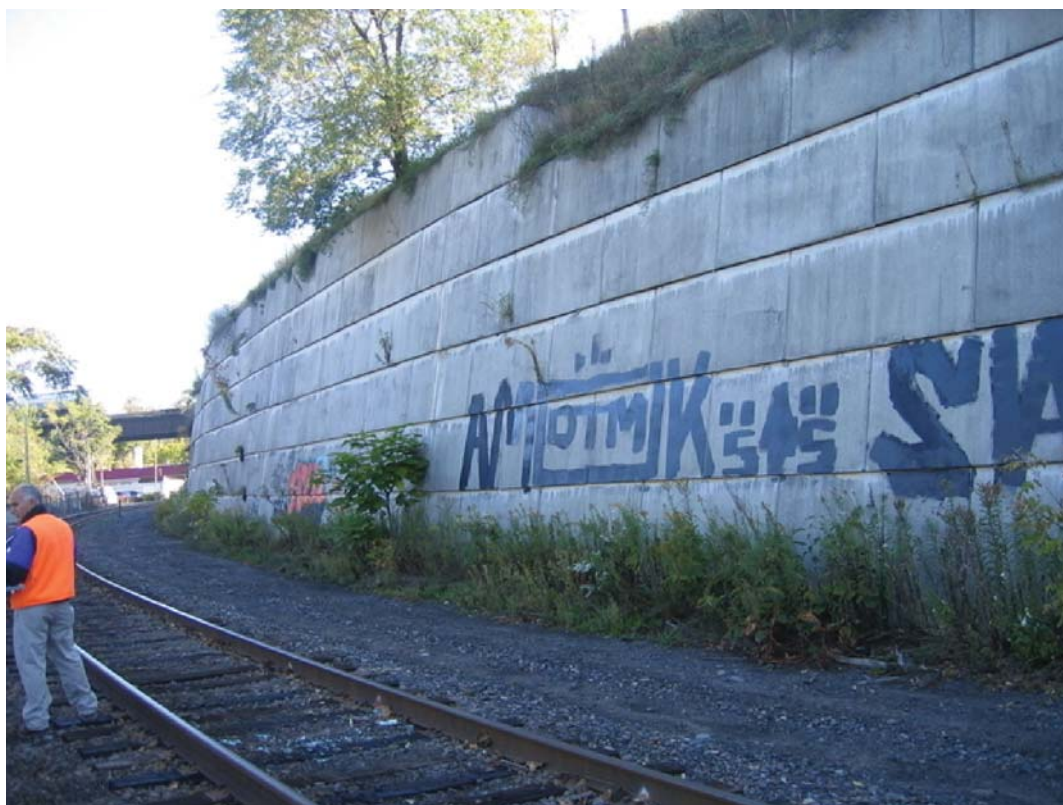
Wall ID:	STEA-0400ZZ-0.110-R		
Route Name:	MAIN ENTRANCE ROADS		
Inspection Date:	October 07, 2008	Approximate Year Built:	1994
*Wall Rating:	77	Maintenance Action:	Maintenance
Wall Description			
Wall Function:	Fill Wall	Primary Wall Type:	Bin - Concrete
Surface Treatment:		Secondary Wall Type:	
Secondary Surface Treatment:		Architectural Facing:	
General Description:	Aggregate-filled 8 x 4 x 4 large modular concrete block. Outboard fill wall below Cliff Ave at Mechanic St. Wall is along outboard side of west entrance, supporting the roadway above the rail line.		
Wall Measurements			
Wall Length (ft.):	280	Face Area (sq.):	3760
Average Wall Height (ft.):	13	Face Angle (deg.):	80
Maximum Wall Height (ft.):	24	Vertical Offset (ft.):	-1
Assessed Elements			
Element (Weighting Factor)	Narrative	Condition Rating (0 - 10)	
PERFORMANCE 8.00	No global instability or settlement deformation. Vegetation could be a future problem.	6

WALL FOUNDATION MATERIAL 8.00	Firm, stiff soils. No signs of erosion or localized settlement. No soft areas evident.	9	
BIN OR CRIB 8.00	Very good condition. No significant signs of cracking or weathering. No missing blocks. Joints are still tight, with no signs of significant block displacement.	8	
LATERAL SLOPE 0.50	Well-vegetated lateral slopes with no indication of slumping or erosion.	8	
ROAD/SIDEWALK/SHOULDER 0.50	Roadway shows no wall-related signs of distress.	8	
UPSLOPE 0.50	Well-vegetated gentle upslope. No signs of slumping or significant erosion.	8	
CURB/BERM/DITCH 0.50	Concrete curb shows no signs of wall settlement or deformation.	9	
DOWNSLOPE 0.50	Flat ground adjacent to rail line. No wall-related distress observed.	9	
TRAFFIC BARRIER/FENCE 0.50	K-rail at top of wall is in excellent condition, showing no signs of wall settlement or deformation.	9	
Repair Recommendations			
Failure Consequence:	HIGH

Recommendation Narrative:	Remove large brush and trees from toe and face of wall, and within 6-8 ft of the top of the wall face. 40 hours general labor @ \$55/hr = \$2,200		
Repair Cost:	\$2,200		
2007 cost estimate (ASTM Class D), preliminary for comparison to other repair costs only.
