# WICA WIP Report

## NPS Retaining Wall Inventory Program Wind Cave National Park

**Federal Highway Administration  
Eastern Federal Lands Highway Division  
Road Inventory Program (RIP)**

**Data Collection Date: November 2006  
Report Date: October 2015**

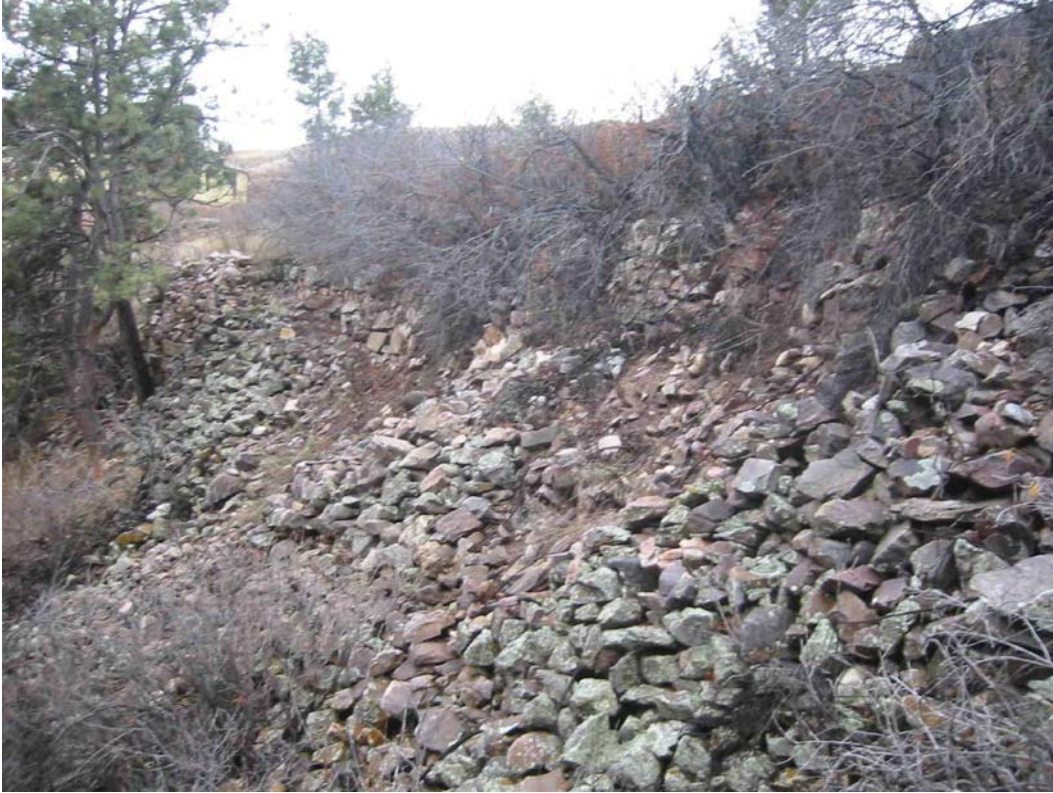
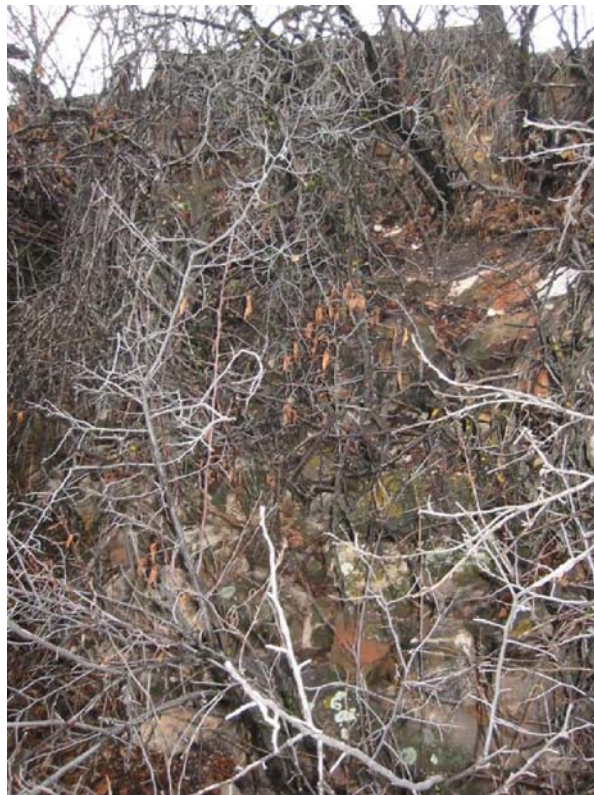
<b>Wall ID:</b>	WICA-0011ZZ-.025-R		
<b>Route Name:</b>	VISITOR CENTER/CAVE ACCESS ROADS		
<b>Inspection Date:</b>	November 14, 2006	<b>Approximate Year Built:</b>	1935
<b>*Wall Rating:</b>	52	<b>Maintenance Action:</b>	Repair Elements

<b>Element (Weighting Factor)</b>	<b>Narrative</b>	<b>Condition Rating (0 - 10)</b>
PERFORMANCE 8.00	Wall is failing but road supported by wall shows no distress. 15' section of wall failed and replaced in 1992.	5
WALL FOUNDATION MATERIAL 8.00	Lower wall section on steep, well vegetated foundation. Upper wall sections founded on lower wall which has raveled wall in several areas, causing undermining and loss of foundation support.	5
PLACED STONE 8.00	Loose overall. Failure in 3 areas, one of which was repaired. Existing areas 10'x20' and 8'x12'. Extensive raveling throughout.	4
DOWNSLOPE 0.50	in-place rock in some places. No distress.	10
LATERAL SLOPE 0.50	In-place rock	10
ROAD/SIDEWALK/SHOULDER 0.50	no distress	10
TRAFFIC BARRIER/FENCE 0.50	no distress	10
VEGETATION 0.50	Vegetation above upper wall (between wall and roadway) likely increasing stability by preventing erosion.	10

<b>Failure Consequence:</b>	LOW
<b>Recommendation Narrative:</b>	Replace 2 failed wall sections. Use methods and materials similar to south end repair in 1992. Areas: 15x25 + 15x15 = 600sf. 600sf*\$75/sf = \$45,000 - used FHWA unit cost for rockery replacement.
<b>Repair Cost:</b>	\$45,000

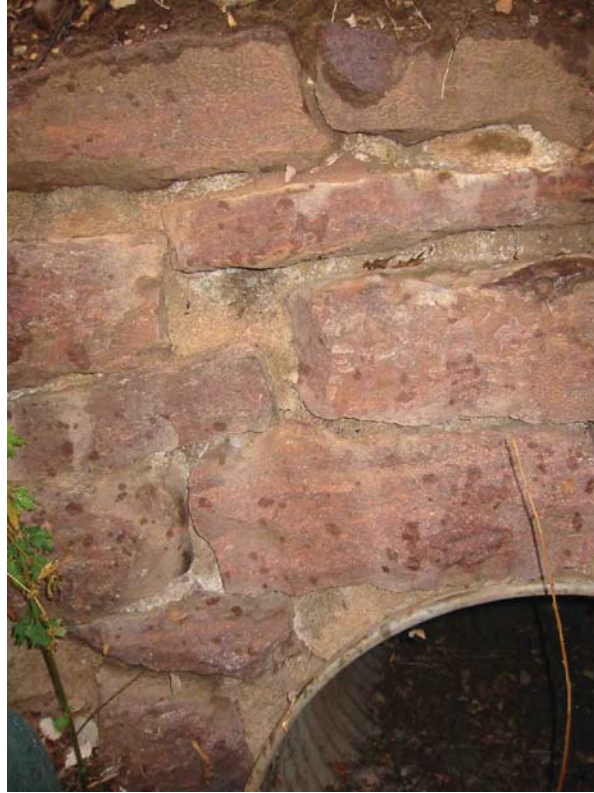
WICA\_0011ZZ\_0.142\_R\_1.jpg

<b>Wall ID:</b>	WICA-0011ZZ-.142-R		
<b>Route Name:</b>	VISITOR CENTER/CAVE ACCESS ROADS		
<b>Inspection Date:</b>	November 15, 2006	<b>Approximate Year Built:</b>	1935
<b>*Wall Rating:</b>	84	<b>Maintenance Action:</b>	Maintenance

<b>Element (Weighting Factor)</b>	<b>Narrative</b>	<b>Condition Rating (0 - 10)</b>
PERFORMANCE 8.00	Overall in good condition.	8
WALL FOUNDATION MATERIAL 8.00	No distress	10
STONE MASONRY 8.00	Minor cracks in grout, stones intact. Minor grout loss.	8
CULVERT 0.50	2 culverts, one in headwall, both in good condition. Lower outlet partly blocked. Outlet erosion at upper culvert about 6-8" deep.	8
VEGETATION 0.50	Vegetation on and around wall - not impacting wall stability	8
ROAD/SIDEWALK/SHOULDER 0.50	No distress	10
LATERAL SLOPE 1.00	Erosion at side of wall caused by upper culvert outlet.	6

<b>Failure Consequence:</b>	LOW
<b>Recommendation Narrative:</b>	Upper culvert outlet repair: Place 5cy armor stone at outlet for erosion control. 5cy*\$120/cy = \$620 - FHWA class 4 riprap unit cost. Repoint mortar: 32sf*\$6.5/sf = 240 - 2005 RSMMeans average unit cost. Veg Trim and clean culvert: 4 hrs misc labor
<b>Repair Cost:</b>	\$1,020

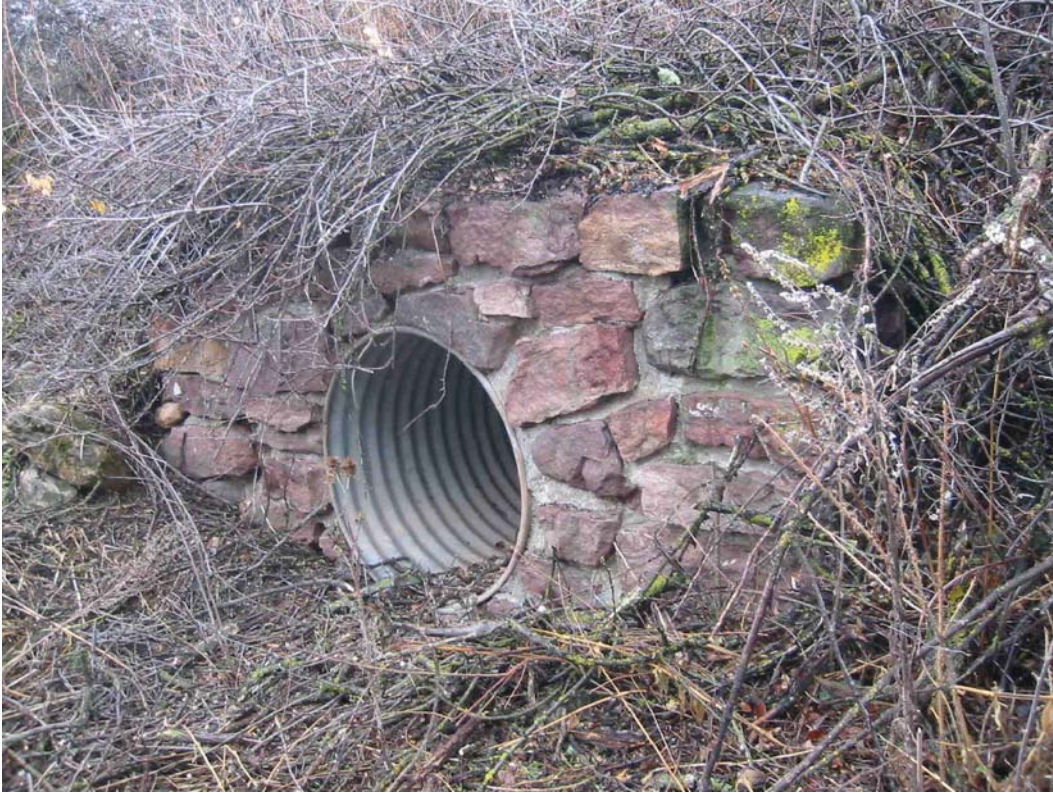
WICA\_0011ZZ\_0.480\_R\_1.jpg

<b>Wall ID:</b>	WICA-0011ZZ--48-R		
<b>Route Name:</b>	VISITOR CENTER/CAVE ACCESS ROADS		
<b>Inspection Date:</b>	November 14, 2006	<b>Approximate Year Built:</b>	1935
<b>*Wall Rating:</b>	100	<b>Maintenance Action:</b>	No Action

<b>Element (Weighting Factor)</b>	<b>Narrative</b>	<b>Condition Rating (0 - 10)</b>
PERFORMANCE 8.00	Excellent condition.	10
WALL FOUNDATION MATERIAL 8.00	Good Condition	10
STONE MASONRY 8.00	Strong, unweathered rock, showing no signs of cracking or degradation. Mortar is sound, durable, and shows little or no signs of cracking or deterioration. Lower, older wall is sound and shows no signs of distress.	10
CULVERT 0.50	Good Condition	10
ROAD/SIDEWALK/SHOULDER 0.50	Good Condition	10

<b>Failure Consequence:</b>	LOW
<b>Recommendation Narrative:</b>	None
<b>Repair Cost:</b>	\$0

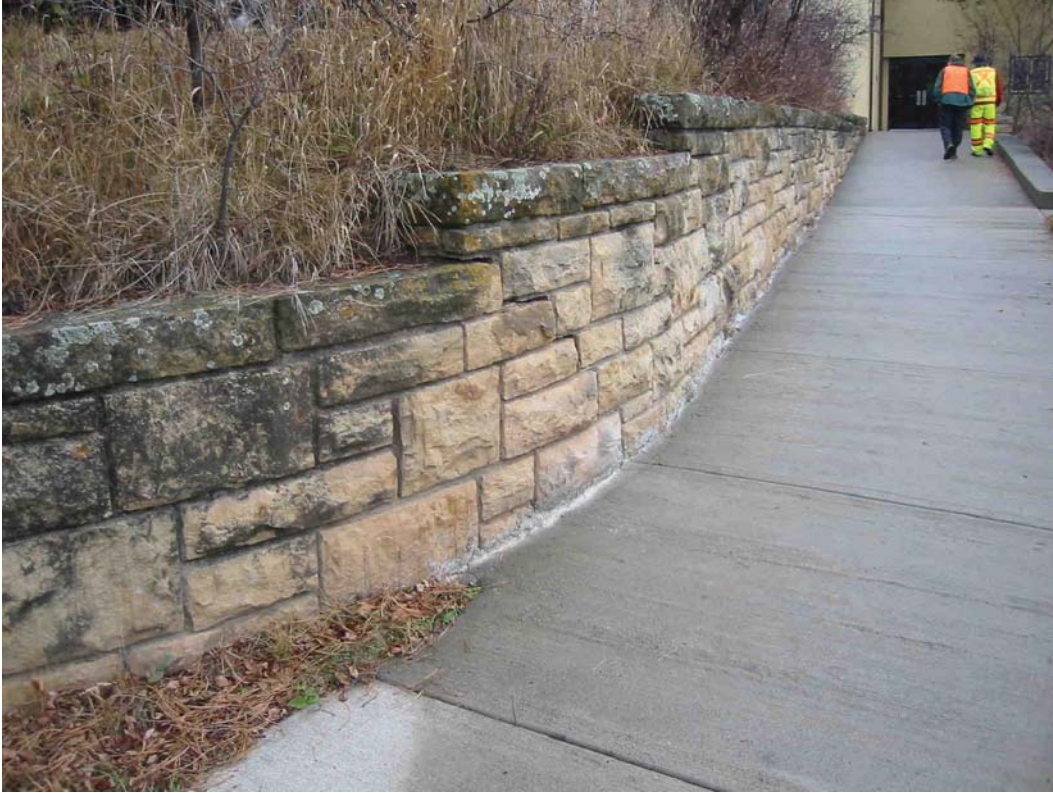
WICA\_0011ZZ\_0.676\_R\_1.jpg

<b>Wall ID:</b>	WICA-0011ZZ--676-R		
<b>Route Name:</b>	VISITOR CENTER/CAVE ACCESS ROADS		
<b>Inspection Date:</b>	November 13, 2006	<b>Approximate Year Built:</b>	1935
<b>*Wall Rating:</b>	97	<b>Maintenance Action:</b>	Maintenance

<b>Element (Weighting Factor)</b>	<b>Narrative</b>	<b>Condition Rating (0 - 10)</b>
PERFORMANCE 8.00	Good.	10
WALL FOUNDATION MATERIAL 8.00	No distress	10
CONCRETE 8.00	Face is bulged and irregular but probably built that way. Two full height cracks that appear to penetrate through facing into concrete. Wall obscured by facing.	9
ROAD/SIDEWALK/SHOULDER 0.50	No distress	10
TRAFFIC BARRIER/FENCE 0.50	No deflection in fence above wall	10

<b>Failure Consequence:</b>	LOW
<b>Recommendation Narrative:</b>	Seal 2 large full-height cracks with grout. Repoint smaller cracks as needed. 4 hrs*2crew*\$40/hr = \$320 - used CESS extra labor unit cost. NOTE: Default to minimum WO amount of \$500.
<b>Repair Cost:</b>	\$500

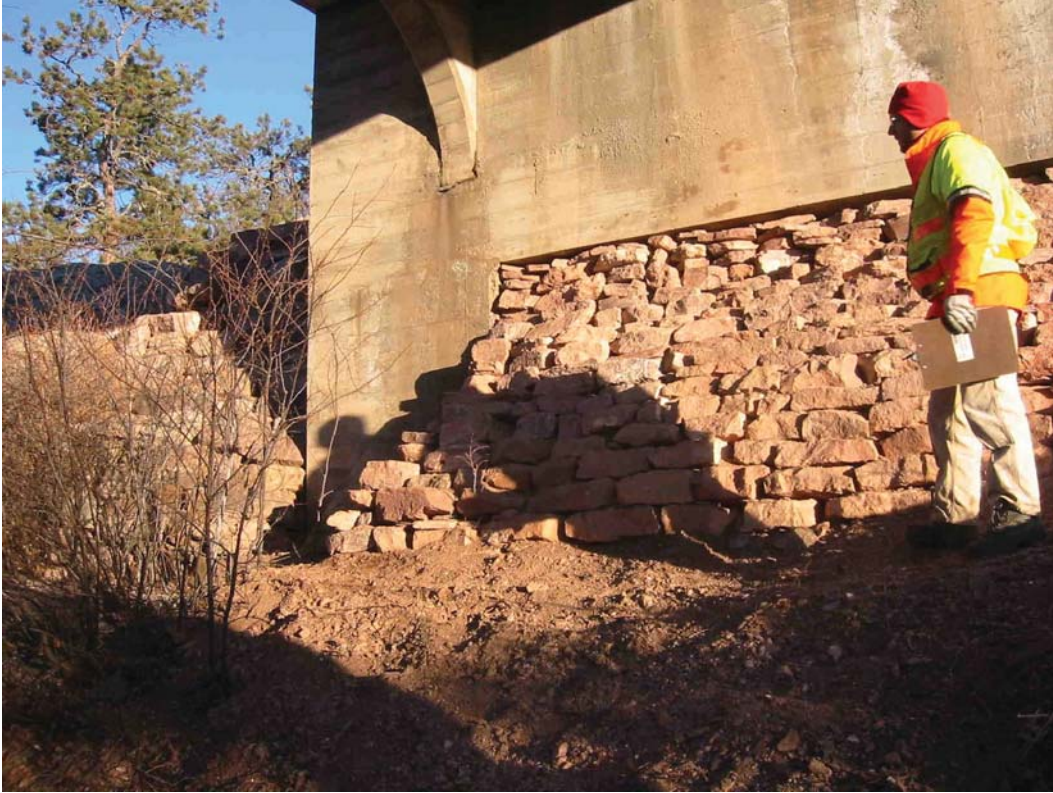
WICA\_0012\_1.276\_L\_1.jpg

<b>Wall ID:</b>	WICA-0012-1.276-L		
<b>Route Name:</b>	NORTH ENTRANCE ROAD (STATE HIGHWAY 87)		
<b>Inspection Date:</b>	November 15, 2006	<b>Approximate Year Built:</b>	1929
<b>*Wall Rating:</b>	91	<b>Maintenance Action:</b>	Repair Elements

<b>Element (Weighting Factor)</b>	<b>Narrative</b>	<b>Condition Rating (0 - 10)</b>
PERFORMANCE 8.00	Overall in very good condition.	10
WALL FOUNDATION MATERIAL 8.00	Erosion/void under high point of wall. Foundation slope steep, stable.	7
STONE MASONRY 8.00	Strong, unweathered rock, showing no signs of cracking or degradation. Mortar is sound, durable, and shows little or no signs of cracking or deterioration. Lower, older wall is sound and shows no signs of distress.	10
VEGETATION 0.50	Small shrub on wall	9
DOWNSLOPE 0.50	Stable fill	10
LATERAL SLOPE 0.50	Good Condition	10
ROAD/SIDEWALK/SHOULDER 0.50	No distress	10

<b>Failure Consequence:</b>	MODERATE
<b>Recommendation Narrative:</b>	Dig out under wall, add large (2-3 man) foundation stones (1-3 stones) below wall high point. Trim vegetation on wall face. Use stones consistent with existing cultural fabric. Labor: 2 person crew for 8 hrs. Material cost unknown: Add 25% to labor cost
<b>Repair Cost:</b>	\$800

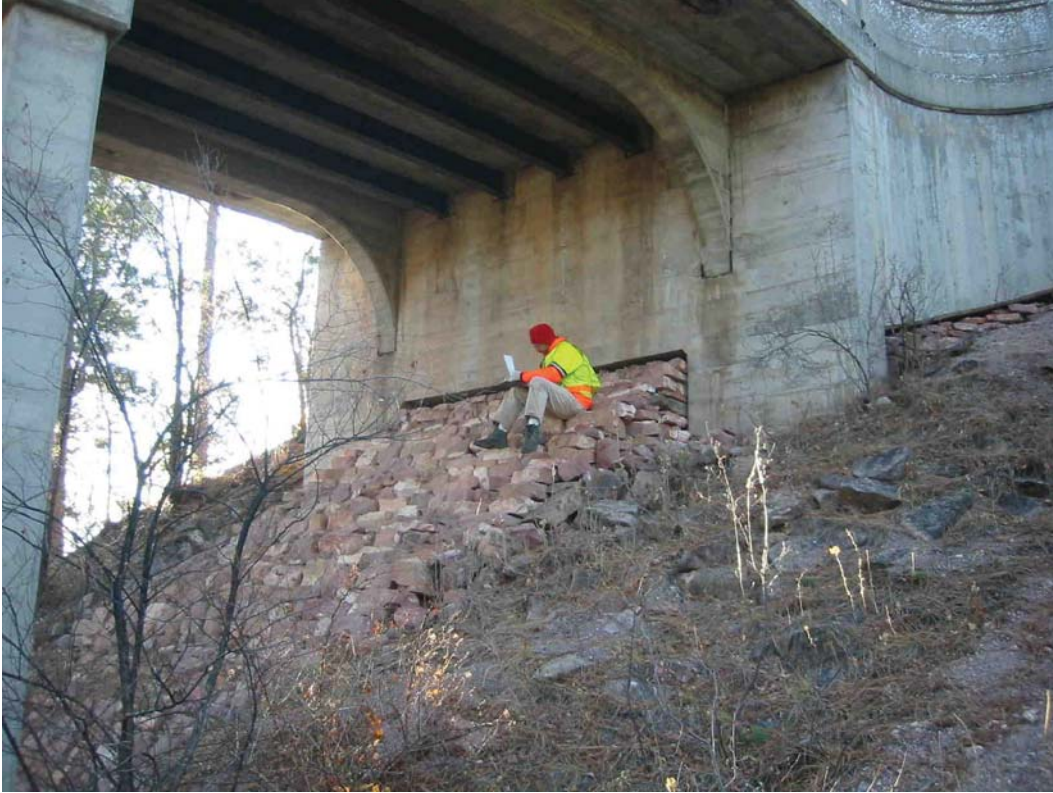
WICA\_0012\_1.318\_L\_1.jpg

<b>Wall ID:</b>	WICA-0012-1.318-L		
<b>Route Name:</b>	NORTH ENTRANCE ROAD (STATE HIGHWAY 87)		
<b>Inspection Date:</b>	November 15, 2006	<b>Approximate Year Built:</b>	1929
<b>*Wall Rating:</b>	94	<b>Maintenance Action:</b>	No Action

<b>Element (Weighting Factor)</b>	<b>Narrative</b>	<b>Condition Rating (0 - 10)</b>
PERFORMANCE 8.00	Very good condition and performance.	10
WALL FOUNDATION MATERIAL 8.00	Steep, erosion susceptible soil foundation. Probably shallow depth to bedrock	8
STONE MASONRY 8.00	Strong, unweathered rock, showing no signs of cracking or degradation. Mortar is sound, durable, and shows little or no signs of cracking or deterioration. Lower, older wall is sound and shows no signs of distress.	10
DOWNSLOPE 0.50	In-place rock	10
LATERAL SLOPE 0.50	In-place rock	10
ROAD/SIDEWALK/SHOULDER 0.50	No distress	10

<b>Failure Consequence:</b>	LOW
<b>Recommendation Narrative:</b>	None
<b>Repair Cost:</b>	\$0

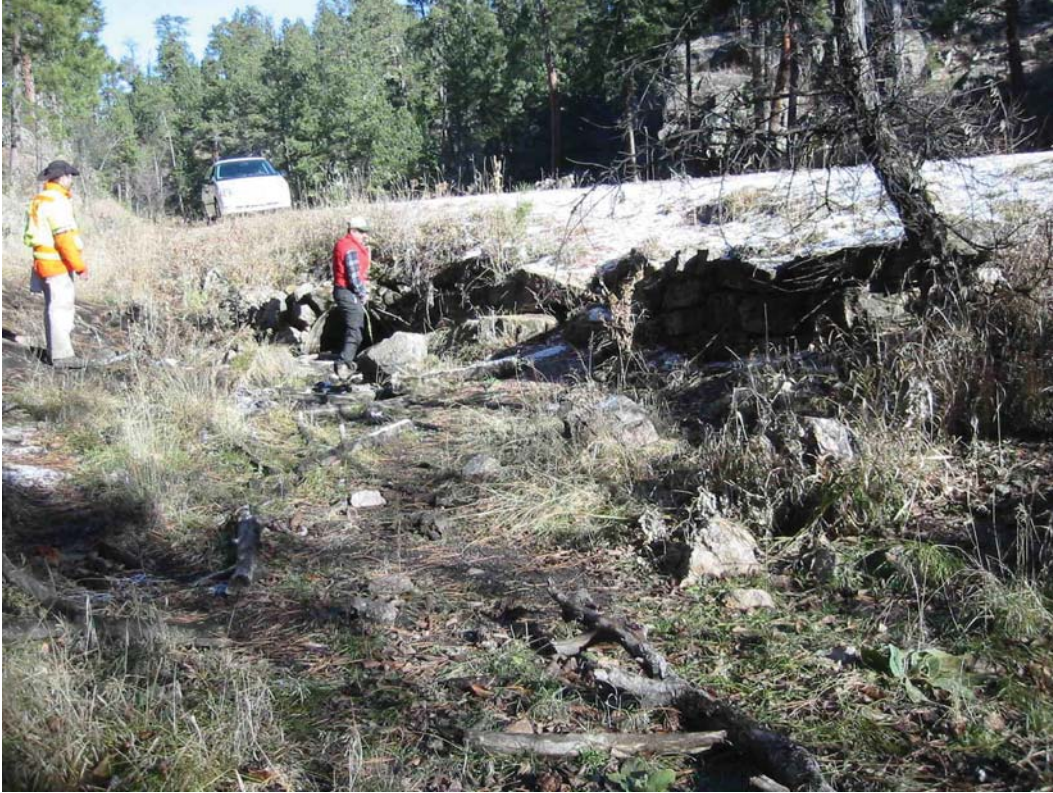
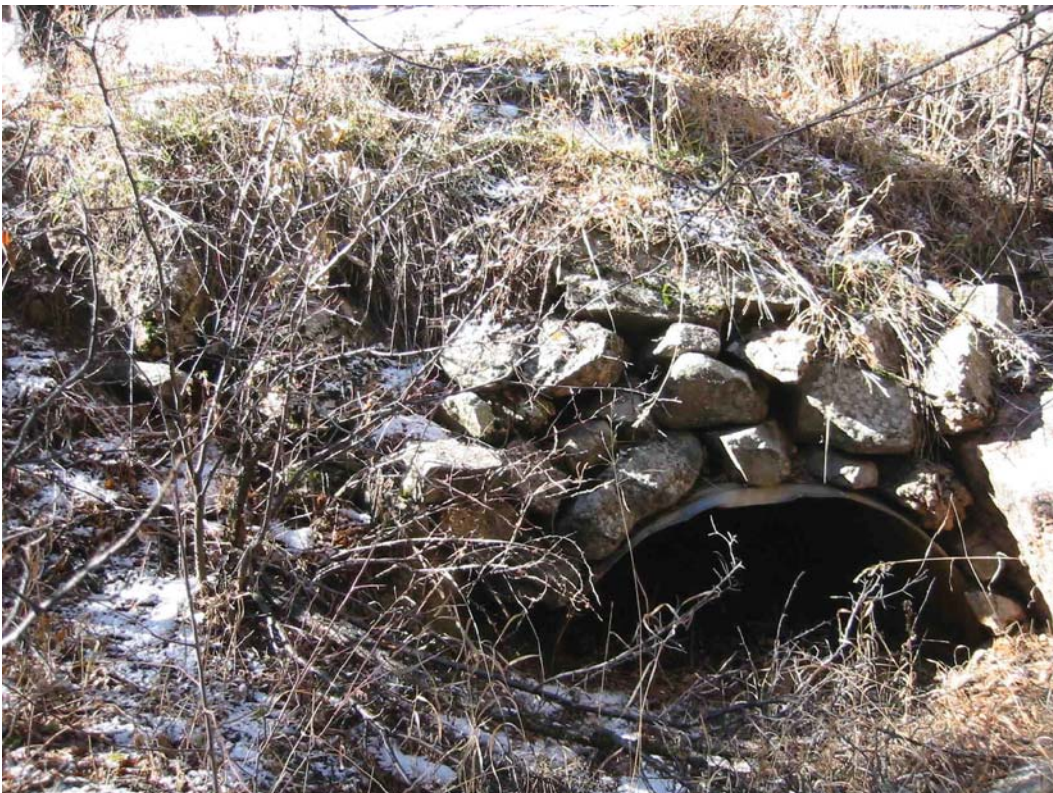
<b>Wall ID:</b>	WICA-0012-3.478-L		
<b>Route Name:</b>	NORTH ENTRANCE ROAD (STATE HIGHWAY 87)		
<b>Inspection Date:</b>	November 15, 2006	<b>Approximate Year Built:</b>	1935
<b>*Wall Rating:</b>	69	<b>Maintenance Action:</b>	Repair Elements

<b>Element (Weighting Factor)</b>	<b>Narrative</b>	<b>Condition Rating (0 - 10)</b>
PERFORMANCE 8.00	Likely repaired via stone replacement in the past. Poor wall condition not currently effecting roadway.	5
WALL FOUNDATION MATERIAL 8.00	Some foundation stones loose. Mostly in good condition.	9
PLACED STONE 8.00	Stones generally loose. Many missing/dislodged stones. Some slope erosion where stones are missing	6
CULVERT 0.50	Bottom and sides rusting out. Not adversely effecting wall.	8
VEGETATION 0.50	Vega on and in wall. Some adding to stability. Larger shrubs may be loosening wall stones	8
LATERAL SLOPE 0.50	Stable road fill	10
ROAD/SIDEWALK/SHOULDER 0.50	No distress	10
UPSLOPE 0.50	Stable, no distress.	10

<b>Failure Consequence:</b>	LOW
<b>Recommendation Narrative:</b>	North end of wall around culvert (headwall): Remove and replace 65sf of wall. Re-use existing stone. 65sf*\$75/sf = \$4875. South end of wall: Replace and reset stones as needed. Labor: 3 days for 2 person crew. Equipment: Backhoe 3 days, Possible dump truck
<b>Repair Cost:</b>	\$11,175

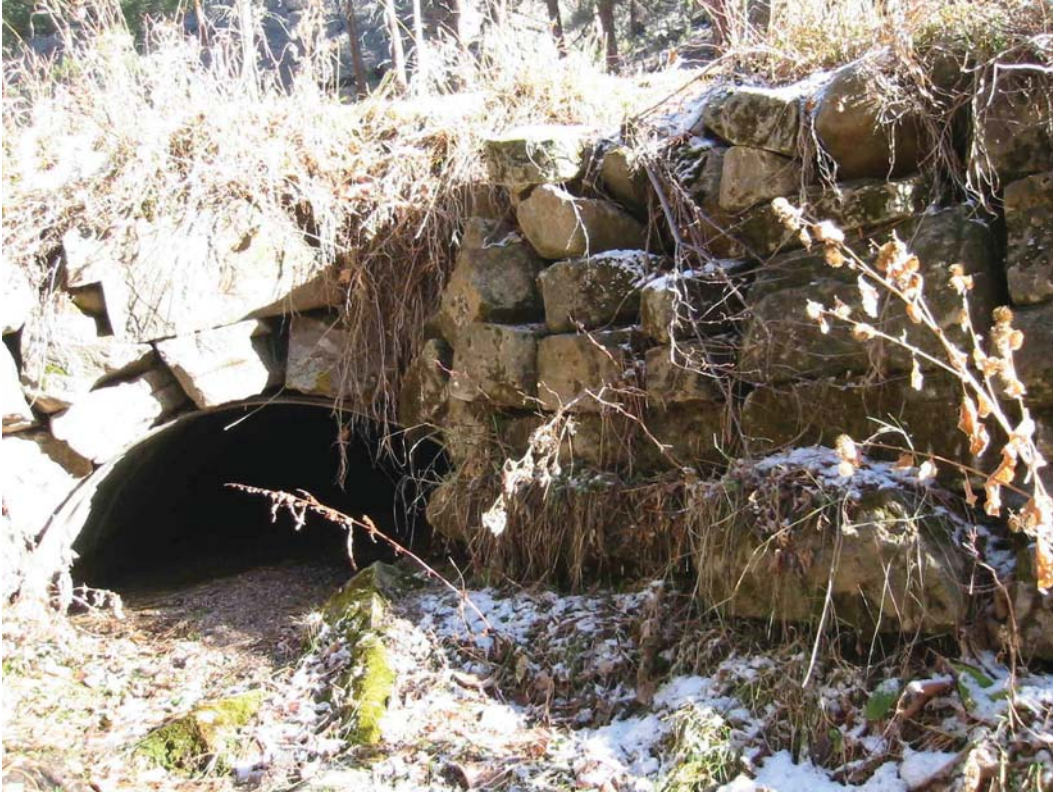
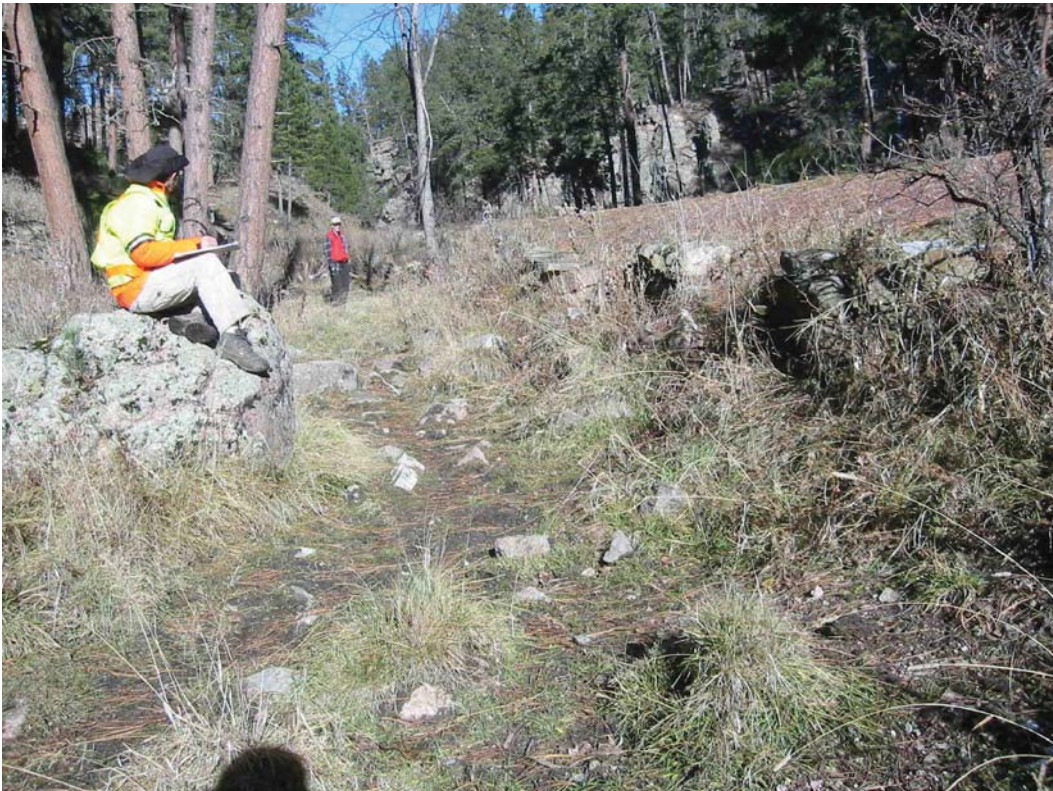
<b>Wall ID:</b>	WICA-0012-3.666-L		
<b>Route Name:</b>	NORTH ENTRANCE ROAD (STATE HIGHWAY 87)		
<b>Inspection Date:</b>	November 15, 2006	<b>Approximate Year Built:</b>	1930
<b>*Wall Rating:</b>	60	<b>Maintenance Action:</b>	Replace Wall

<b>Element (Weighting Factor)</b>	<b>Narrative</b>	<b>Condition Rating (0 - 10)</b>
PERFORMANCE 8.00	Wall failure impacting road edge and causing fill subsidence	4
WALL FOUNDATION MATERIAL 8.00	Erosion at culvert outlet causing minor undermining.	7
STONE MASONRY 8.00	Stones generally loose in wall face. Many stones missing. Animal traffic (Bison) causing stone loss.	6
CULVERT 0.50	Rusted, 1/2 to 2/3 full. Minimal effect on wall stability	9
LATERAL SLOPE 0.50	Stable road fill, settling slightly at road edge.	9
UPSLOPE 0.50	Stable, no distress.	10
VEGETATION 0.50	Vegetation on and above wall face. Likely adding to stability.	10
ROAD/SIDEWALK/SHOULDER 1.00	Over steepened shoulder/foreslope and pavement edge cracking along most of wall length.	7

<b>Failure Consequence:</b>	LOW
<b>Recommendation Narrative:</b>	Remove and replace wall salvaging all existing stone in the wall and nearby stone that has fallen from the face. Any new stone used should be similar in character to existing stone. Although not part of this WO, consider replacing the culvert at the sam
<b>Repair Cost:</b>	\$19,125

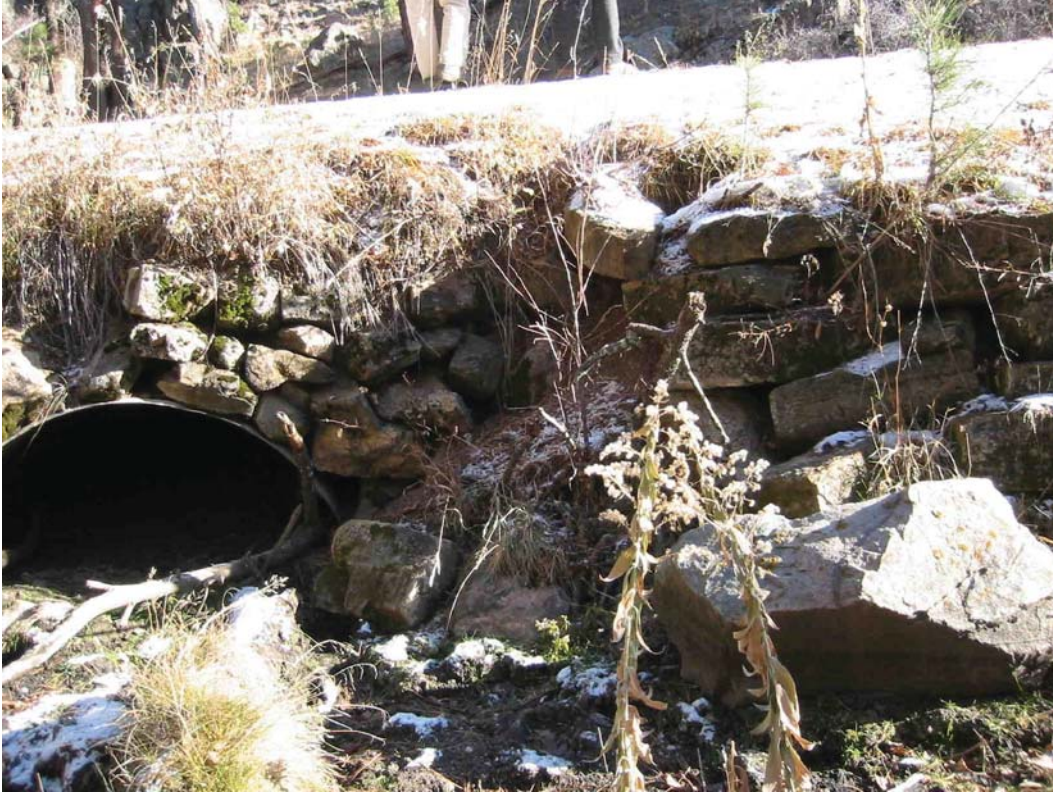
WICA\_0012\_3.748\_R\_1.jpg

<b>Wall ID:</b>	WICA-0012-3.748-R		
<b>Route Name:</b>	NORTH ENTRANCE ROAD (STATE HIGHWAY 87)		
<b>Inspection Date:</b>	November 15, 2006	<b>Approximate Year Built:</b>	1935
<b>*Wall Rating:</b>	94	<b>Maintenance Action:</b>	Maintenance

<b>Element (Weighting Factor)</b>	<b>Narrative</b>	<b>Condition Rating (0 - 10)</b>
PERFORMANCE 8.00	Good condition.	10
WALL FOUNDATION MATERIAL 8.00	No distress.	10
PLACED STONE 8.00	Minor voids in wall face	8
CULVERT 0.50	3.5'X5' elliptical. Minor rusting.	9
LATERAL SLOPE 0.50	Stable road fill	10
ROAD/SIDEWALK/SHOULDER 0.50	No distress	10
UPSLOPE 0.50	Good condition.	10

<b>Failure Consequence:</b>	LOW	
<b>Recommendation Narrative:</b>	Place chinking stones in minor voids in wall face as needed. Use stones salvaged on site. Labor: 6hrs*1crew = 6hrs. Material: Incidental to labor. 6hrs*\$40/hr = \$240 Used CESS extra labor cost. Use \$500 minimum WO cost	
<b>Repair Cost:</b>	\$500

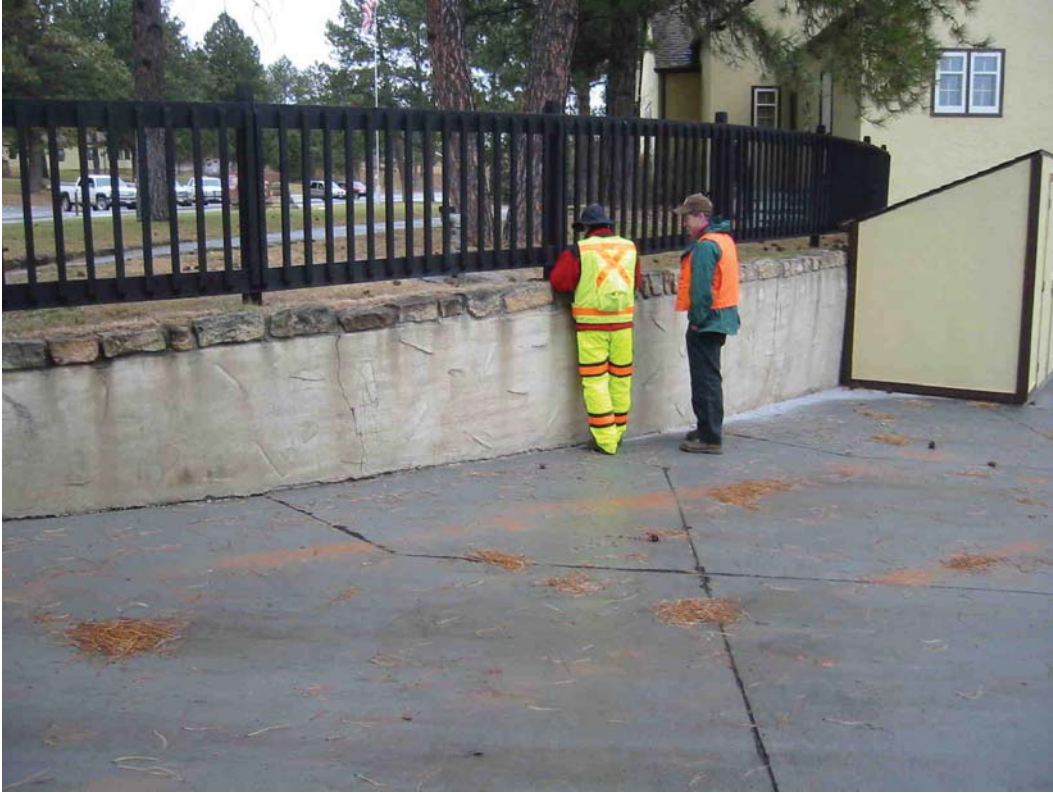
**WICA\_0900\_0.000\_P1\_1.jpg**

<b>Wall ID:</b>	WICA-0900-0-P1		
<b>Route Name:</b>	VISITOR CENTER PARKING		
<b>Inspection Date:</b>	November 14, 2006	<b>Approximate Year Built:</b>	1979
<b>*Wall Rating:</b>	97	<b>Maintenance Action:</b>	No Action

<b>Element (Weighting Factor)</b>	<b>Narrative</b>	<b>Condition Rating (0 - 10)</b>
PERFORMANCE 8.00	Very good condition.	10
WALL FOUNDATION MATERIAL 8.00	No distress	10
CONCRETE 8.00	Bulged and irregular face but probably built that way (virtually no other distress that would indicate post construction distortion). Two full height cracks in surface grout that appear to penetrate into wall.	9
ROAD/SIDEWALK/SHOULDER 0.50	no distress	10
TRAFFIC BARRIER/FENCE 0.50	No deflection	10

<b>Failure Consequence:</b>	LOW
<b>Recommendation Narrative:</b>	None
<b>Repair Cost:</b>	\$0

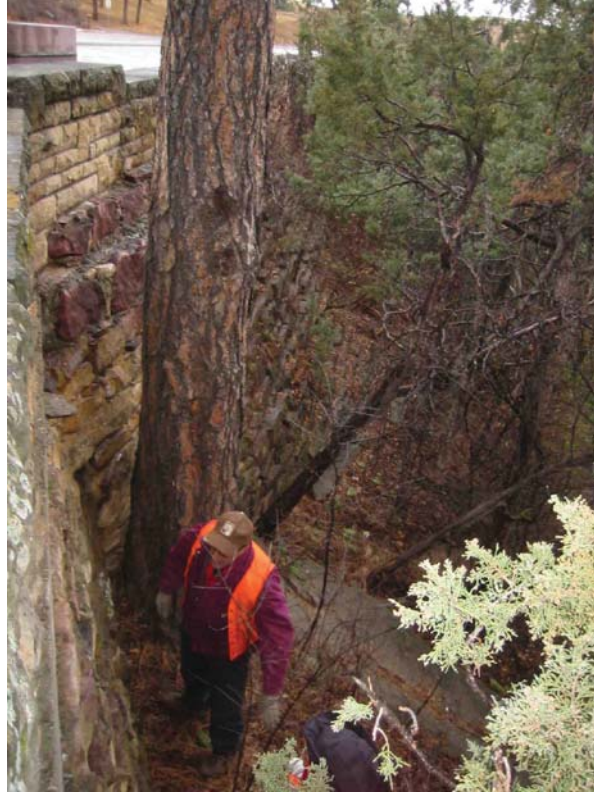
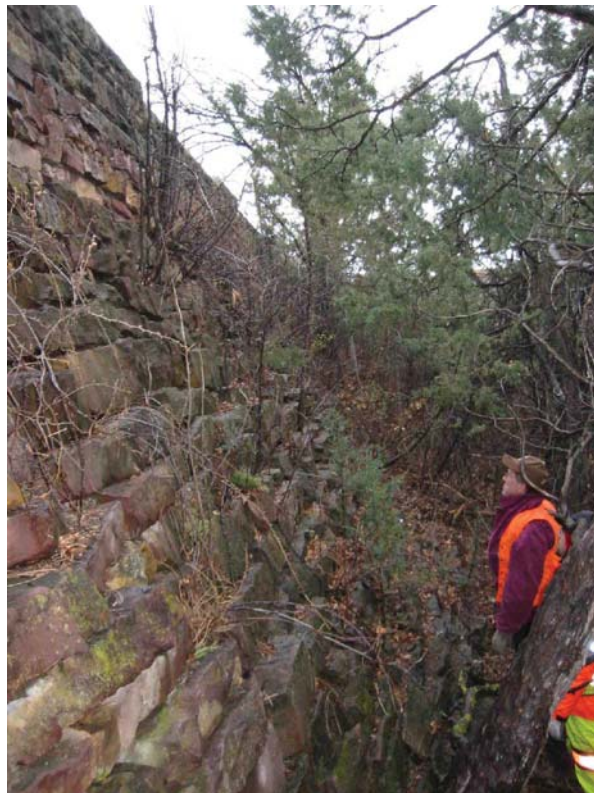
<b>Wall ID:</b>	WICA-0900-0-P2		
<b>Route Name:</b>	VISITOR CENTER PARKING		
<b>Inspection Date:</b>	November 14, 2006	<b>Approximate Year Built:</b>	1935
<b>*Wall Rating:</b>	69	<b>Maintenance Action:</b>	Repair Elements

<b>Element (Weighting Factor)</b>	<b>Narrative</b>	<b>Condition Rating (0 - 10)</b>
PERFORMANCE 8.00	Evidence of repair to foundation, upper wall, culvert and spillway.	7
WALL FOUNDATION MATERIAL 8.00	Previous sloughing likely. Evidence of concrete repairs. Toe is steep.	7
STONE MASONRY 8.00	Large voids in grout in several areas. Missing chinking in dry laid portions of wall. Face bulged near 12" culvert in upper portion of south end of wall.	7
DOWNSLOPE 0.50	No distress. Steep but well vegetated	8
WALL DRAINS 0.50	6" pipe drains present. 12" culvert w/concrete spillway. Drains in good condition, spillway breaking up but currently functional.	8
ROAD/SIDEWALK/SHOULDER 0.50	7.5 ft concrete sidewalk in good condition	10
VEGETATION 1.00	Small juniper and other brush growing from wall face. Beginning to dislodge wall stones	6

<b>Failure Consequence:</b>	MODERATE
<b>Recommendation Narrative:</b>	Remove vegetation from wall face. Rechink large voids in dry laid stone. Repoint/fill large voids in mortared stone. Use stone chinking material consistent with existing stone face. Masonry labor: 2 person crew for 4 days = 64hrs.
<b>Repair Cost:</b>	\$3,600
