# ZION WIP Report

## NPS Retaining Wall Inventory Program Zion National Park

**Federal Lands Highway  
Road Inventory Program**

**Data Collection Date: December 2006  
Report Date: October 2015**

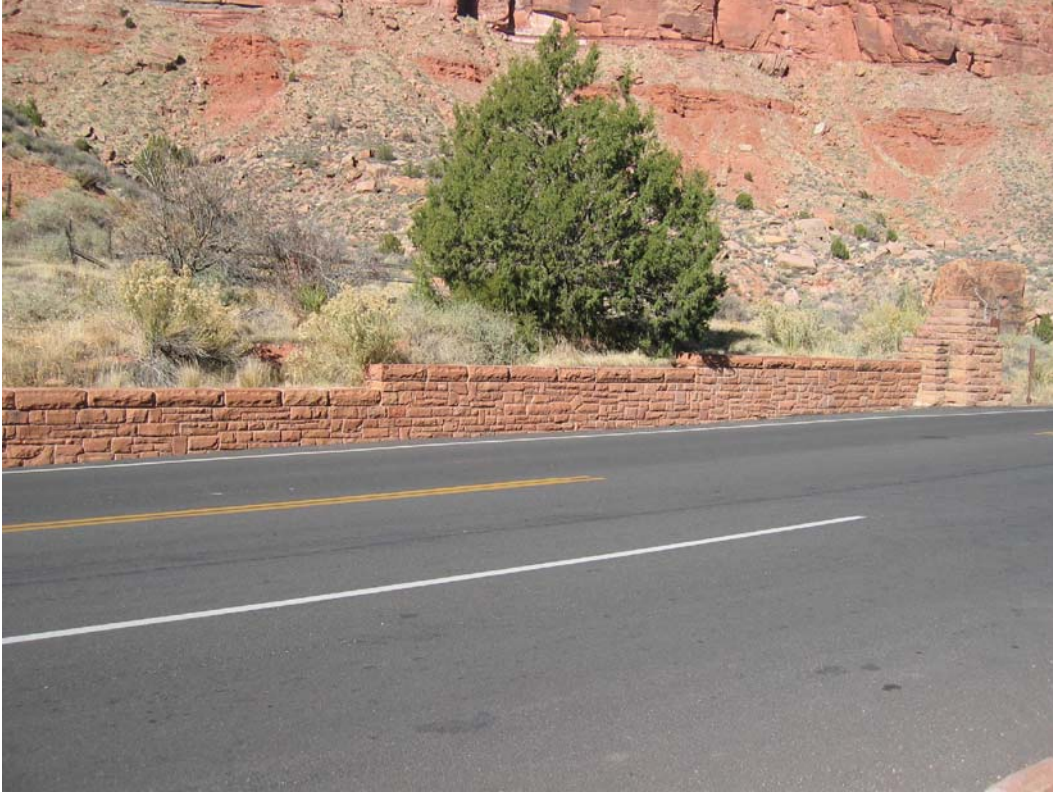
ZION\_0010\_0.058\_L\_1.jpg

<b>Failure Consequence:</b>	LOW
<b>Recommendation Narrative:</b>	None
<b>Repair Cost:</b>	\$0

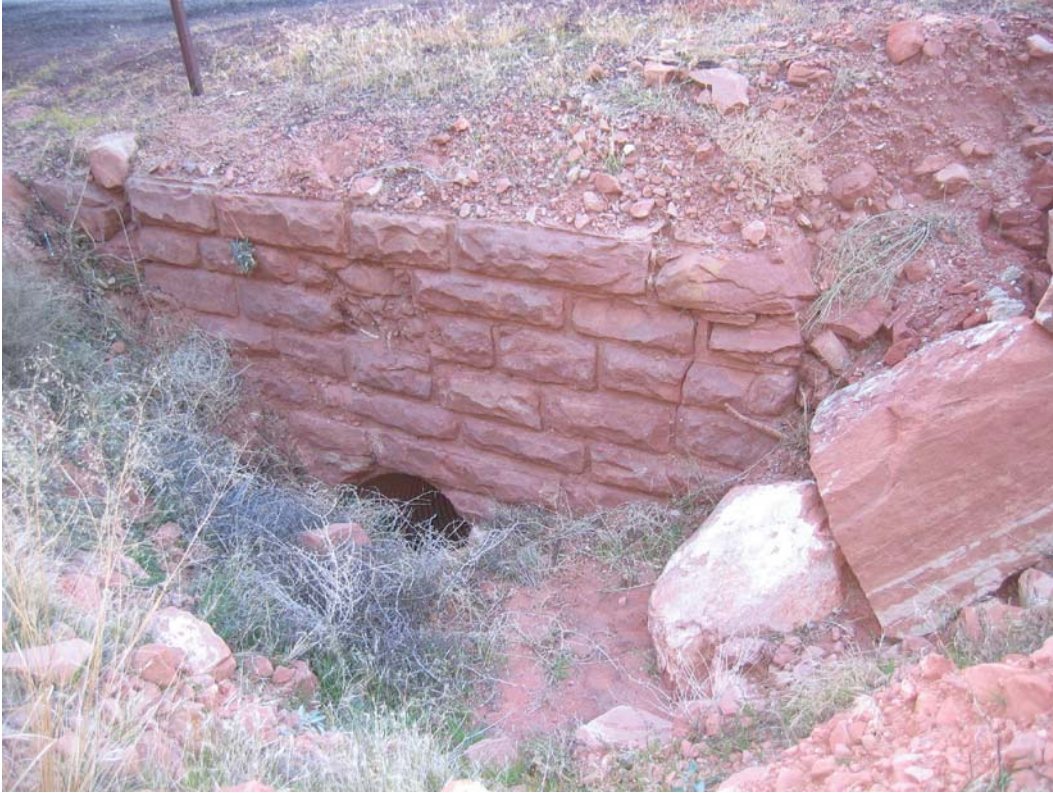
ZION\_0010\_2.598\_R\_1.jpg

<b>Wall ID:</b>	ZION-0010-2.598-R		
<b>Route Name:</b>	ZION-MT CARMEL HIGHWAY		
<b>Inspection Date:</b>	December 06, 2006	<b>Approximate Year Built:</b>	1930
<b>*Wall Rating:</b>	84	<b>Maintenance Action:</b>	Repair Elements

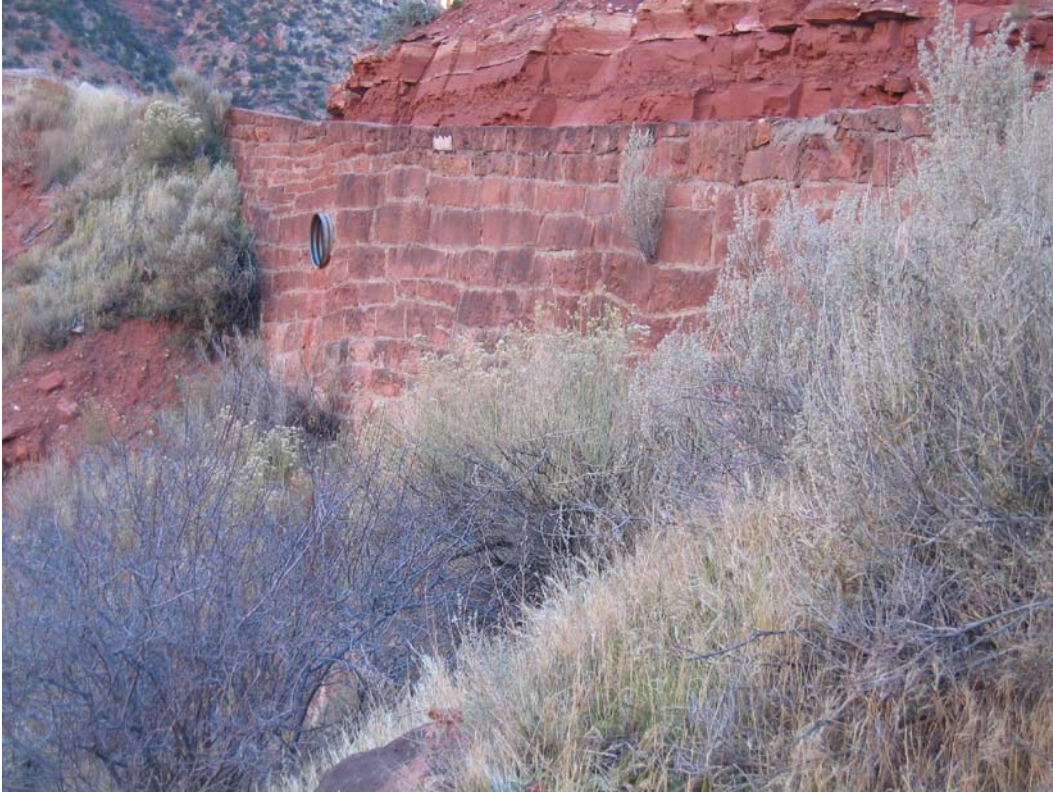
ZION\_0010\_2.645\_L\_1.jpg

<b>Wall ID:</b>	ZION-0010-2.645-L		
<b>Route Name:</b>	ZION-MT CARMEL HIGHWAY		
<b>Inspection Date:</b>	December 06, 2006	<b>Approximate Year Built:</b>	1930
<b>*Wall Rating:</b>	88	<b>Maintenance Action:</b>	Maintenance

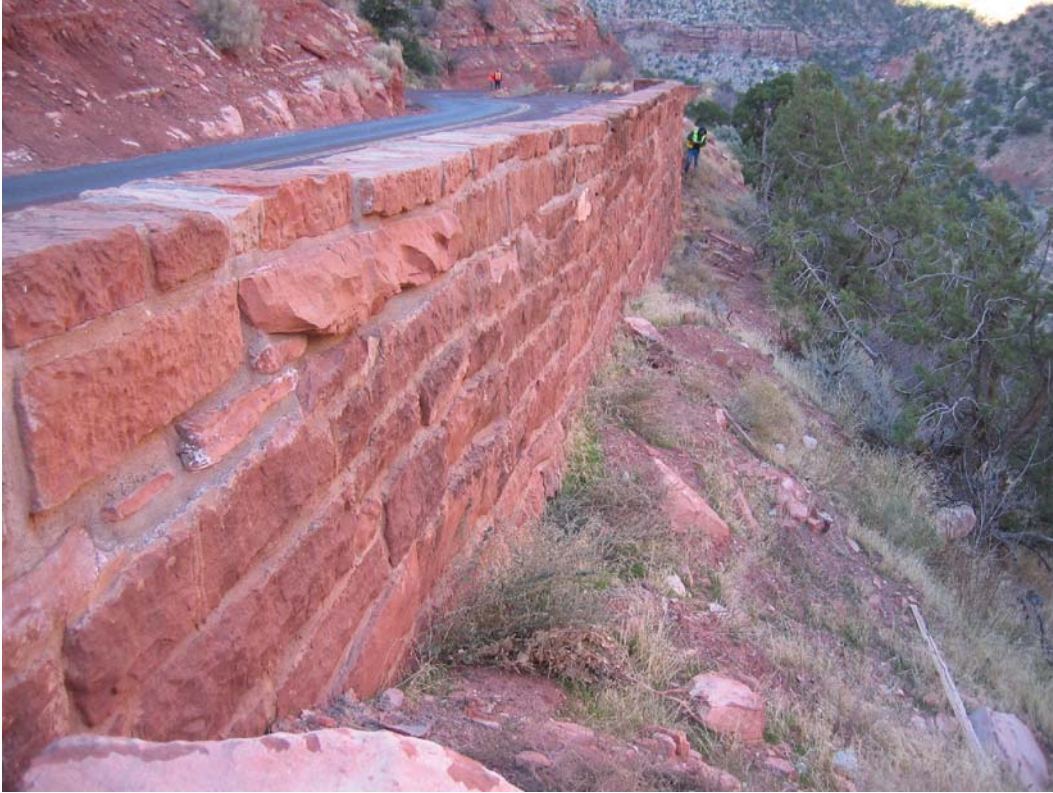
**ZION\_0010\_2.810\_L\_1.jpg**

<b>Wall ID:</b>	ZION-0010-2.810-L		
<b>Route Name:</b>	ZION-MT CARMEL HIGHWAY		
<b>Inspection Date:</b>	December 06, 2006	<b>Approximate Year Built:</b>	1930
<b>*Wall Rating:</b>	92	<b>Maintenance Action:</b>	No Action

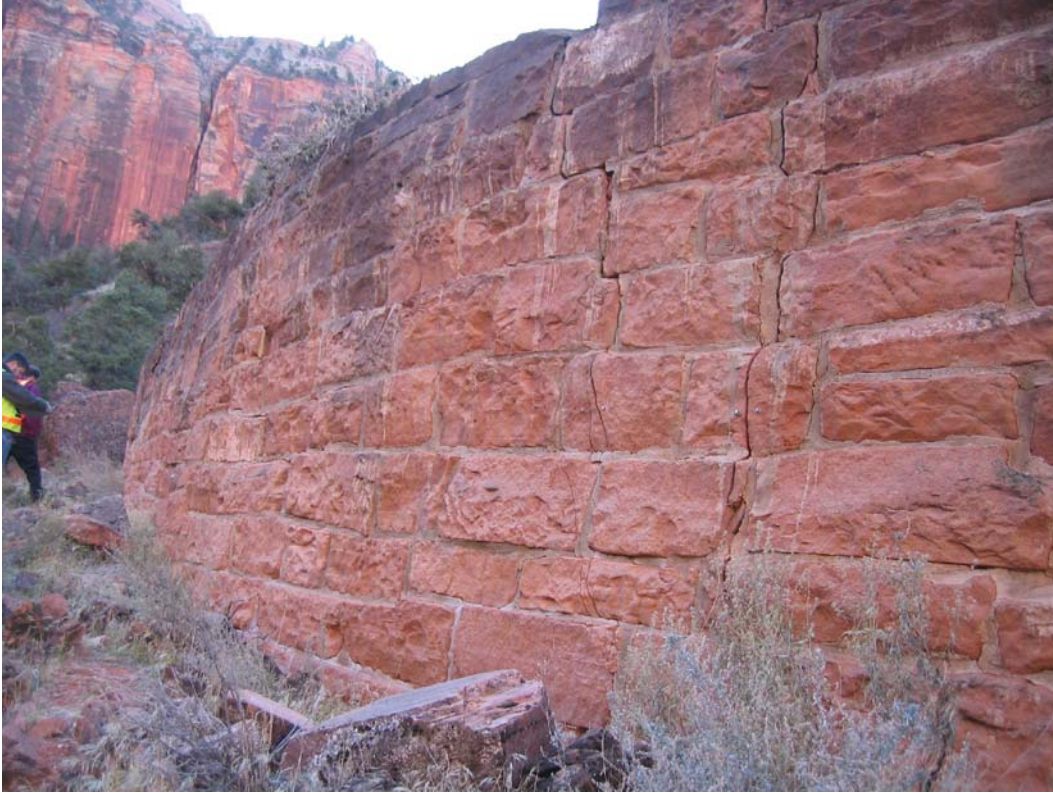
**ZION\_0010\_3.355\_L\_1.jpg**

<b>Wall ID:</b>	ZION-0010-3.355-L		
<b>Route Name:</b>	ZION-MT CARMEL HIGHWAY		
<b>Inspection Date:</b>	December 06, 2006	<b>Approximate Year Built:</b>	1930
<b>*Wall Rating:</b>	74	<b>Maintenance Action:</b>	No Action

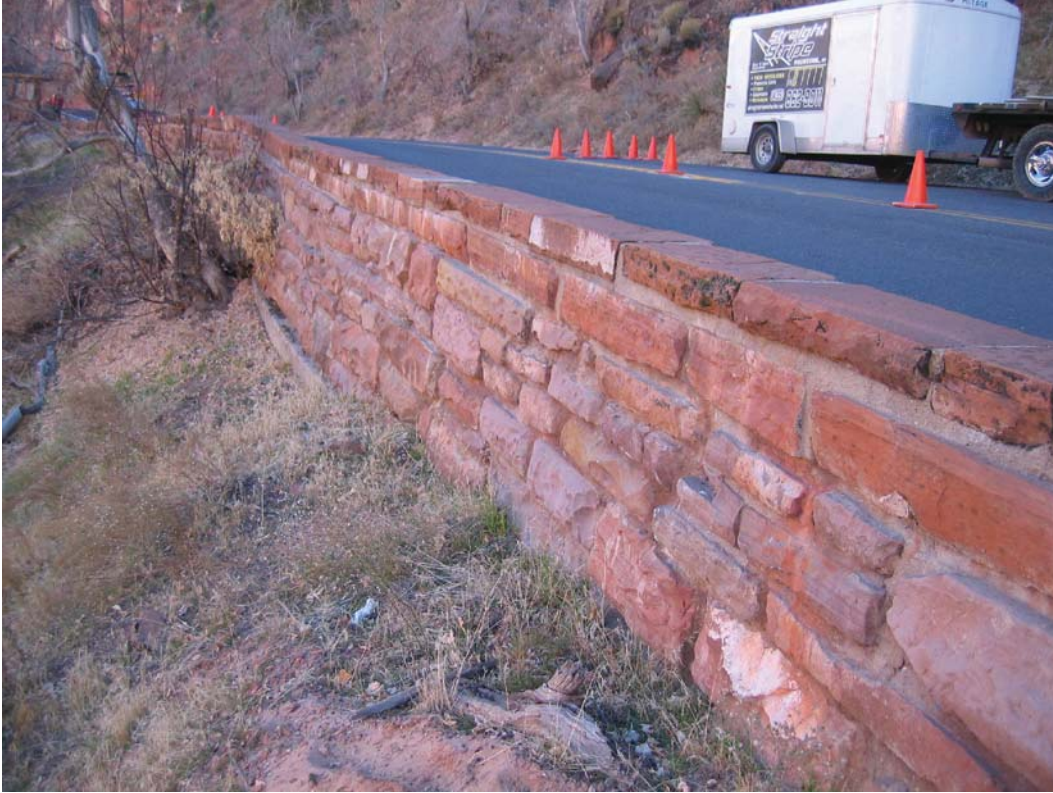
**ZION\_0010\_4.853\_L\_1.jpg**

<b>Wall ID:</b>	ZION-0010-4.853-L		
<b>Route Name:</b>	ZION-MT CARMEL HIGHWAY		
<b>Inspection Date:</b>	December 06, 2006	<b>Approximate Year Built:</b>	1930
<b>*Wall Rating:</b>	97	<b>Maintenance Action:</b>	No Action

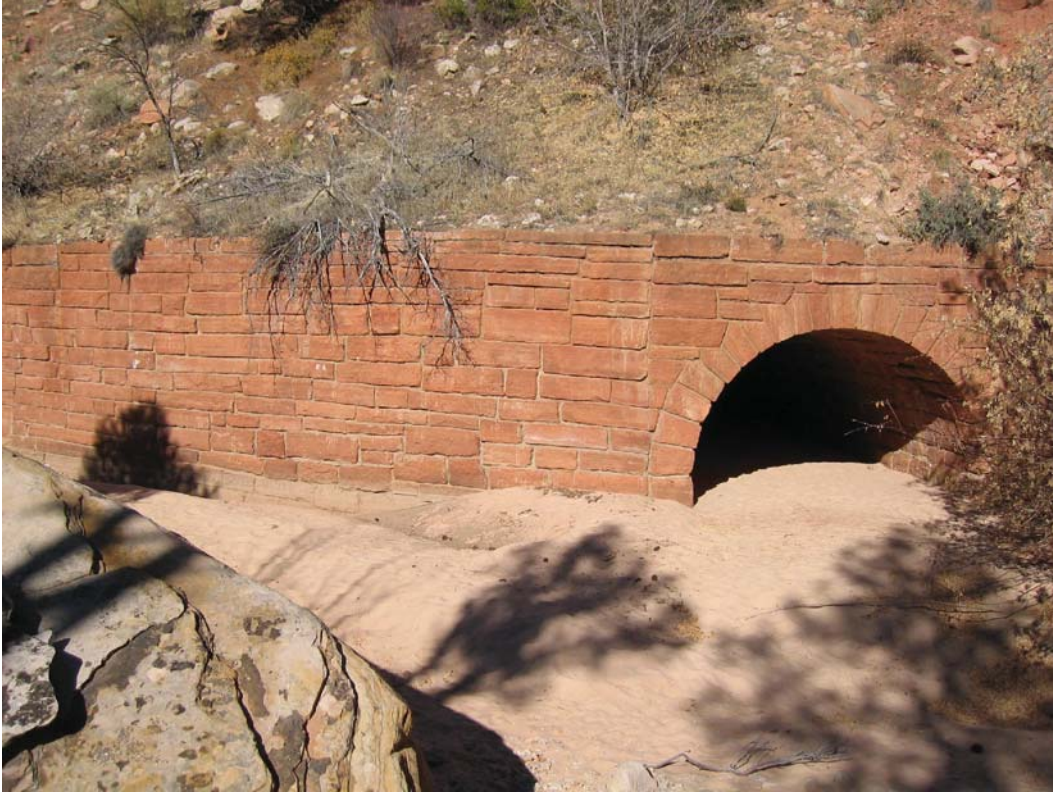
**ZION\_0010\_6.512\_R\_1.jpg**

<b>Wall ID:</b>	ZION-0010-6.512-R		
<b>Route Name:</b>	ZION-MT CARMEL HIGHWAY		
<b>Inspection Date:</b>	December 06, 2006	<b>Approximate Year Built:</b>	1930
<b>*Wall Rating:</b>	100	<b>Maintenance Action:</b>	No Action

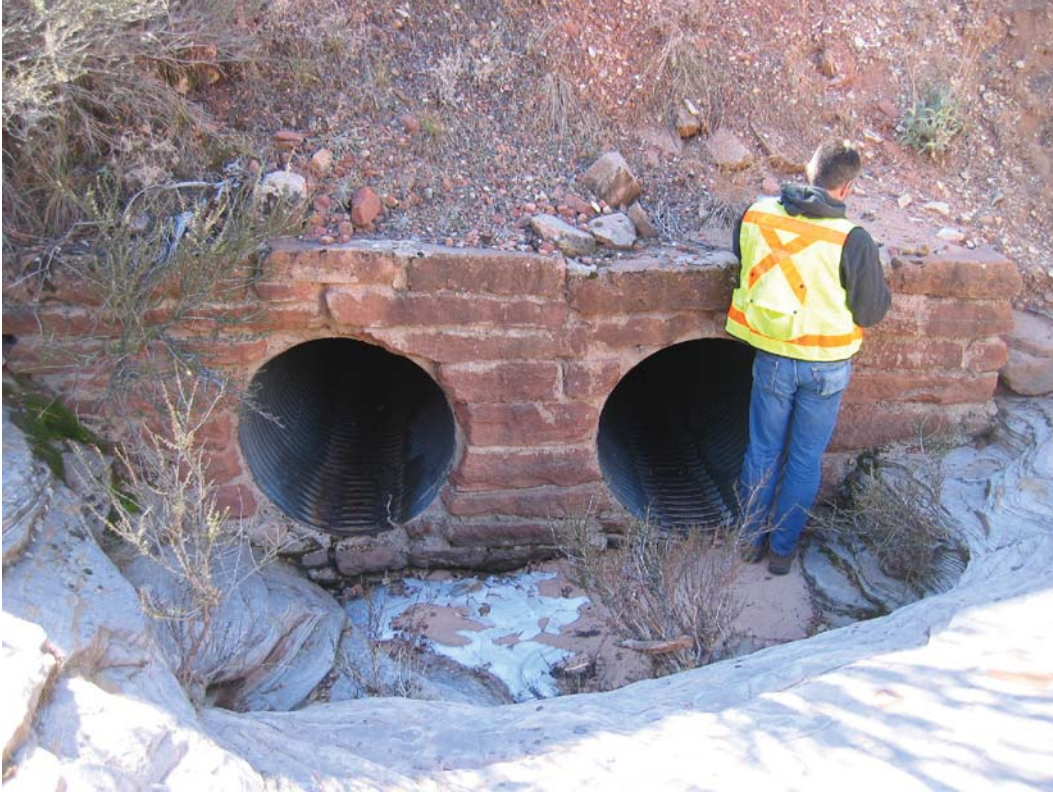
**ZION\_0010\_6.548\_L\_1.jpg**

<b>Wall ID:</b>	ZION-0010-6.548-L		
<b>Route Name:</b>	ZION-MT CARMEL HIGHWAY		
<b>Inspection Date:</b>	December 06, 2006	<b>Approximate Year Built:</b>	1930
<b>*Wall Rating:</b>	94	<b>Maintenance Action:</b>	Repair Elements

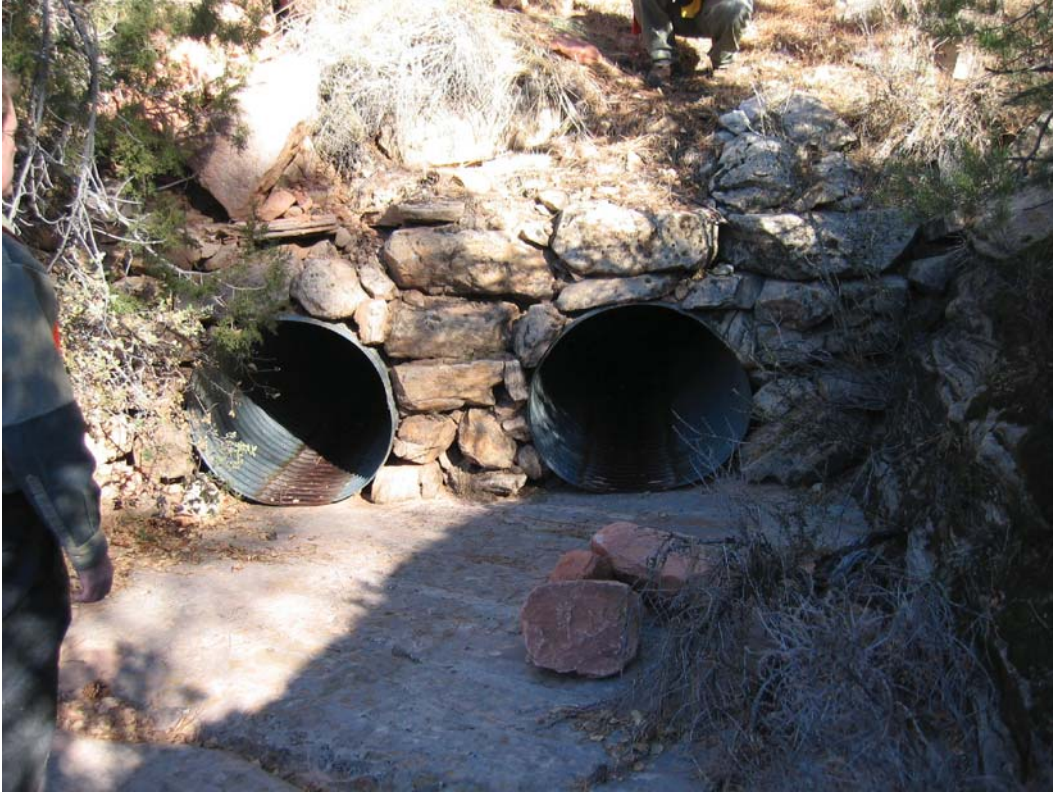
**ZION\_0010\_6.552\_R\_1.jpg**

<b>Wall ID:</b>	ZION-0010-6.552-R		
<b>Route Name:</b>	ZION-MT CARMEL HIGHWAY		
<b>Inspection Date:</b>	December 06, 2006	<b>Approximate Year Built:</b>	1930
<b>*Wall Rating:</b>	98	<b>Maintenance Action:</b>	No Action
