**The Road Inventory  
of  
Abraham Lincoln Birthplace  
National Historic Site  
ABLI-5540**

**Road Inventory Program**

Prepared By:  
Federal Highway Administration  
Eastern Federal Lands Highway Division  
Cycle 3

# Abraham Lincoln Birthplace National Historic Site in Kentucky

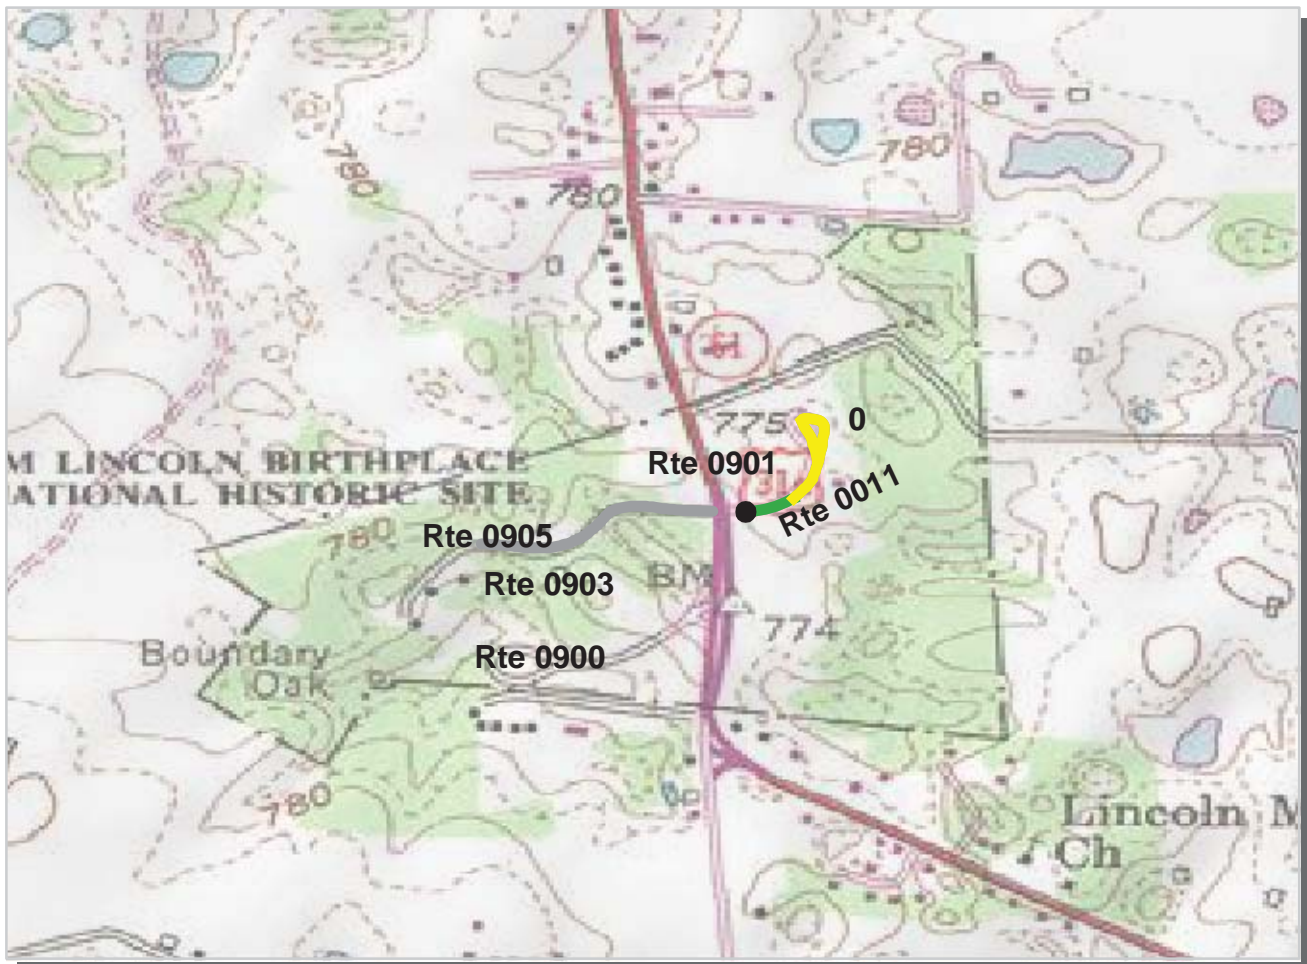
**ROUTE: 0011 Picnic Loop**

Section Number	0				
Section Length (mi)	0.19				
AADT	**				
SADT	**				
ADT Date	**				
<b>Cross Section Information</b>					
Number of Lanes	2				
Paved Width (ft)	19				
Lane Width (ft)	9				
Shoulder Width (ft)	0				
<b>Roadway Condition Information</b>					
PCR (Pavement Condition Rating)	77				
RCI (Roughness Condition Index)	75				
SCR (Surface Condition Rating)	77				
Alligator Cracking Index	100				
Rutting Index	85				
Patching Index	100				
Transverse Cracking Index	95				
Longitudinal Cracking Index	96				
Shoulder Condition Rating	N/A				
Drainage Condition Rating	GOOD

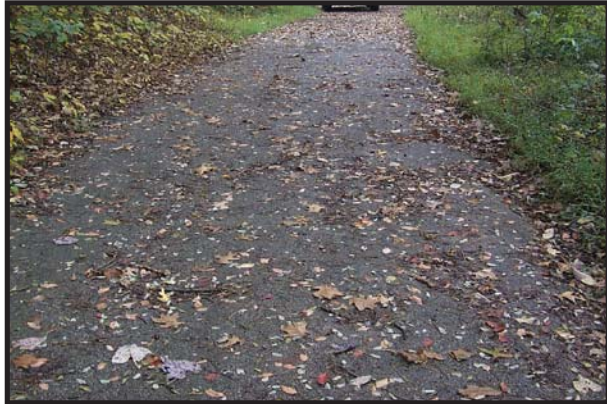
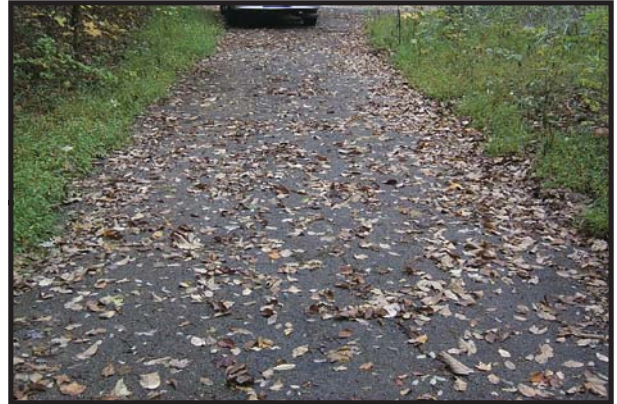
## Route 0403

Route	Length (mi)	Width (ft)	Area (sq ft)	Lane Miles *	Condition / PCR	Surface Type
0403	0.04	10.00	1901	0.03	GOOD / 90	AS

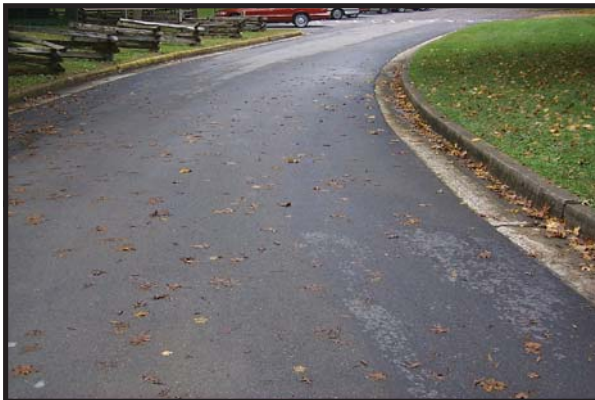
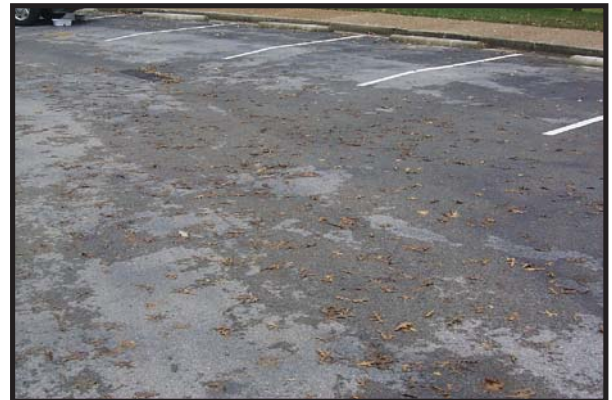
## Route 0900

Route	Public / NonPublic	Date Visited	Area (sq ft)	Lane Miles *	Surface Type	Condition / PCR
0900	Public	10/26/2002	48347	0.83	AS	GOOD / 90

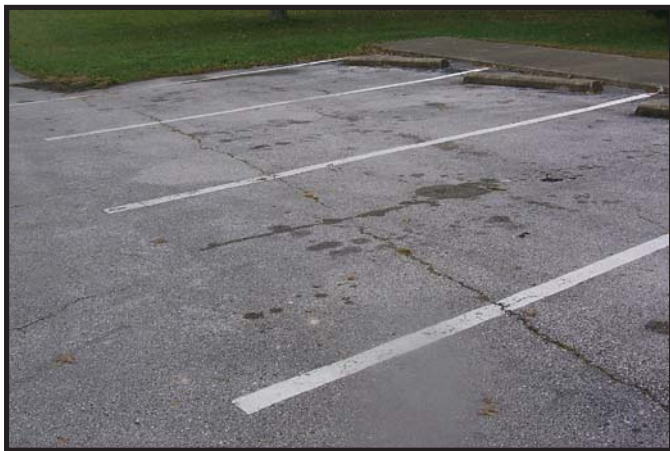
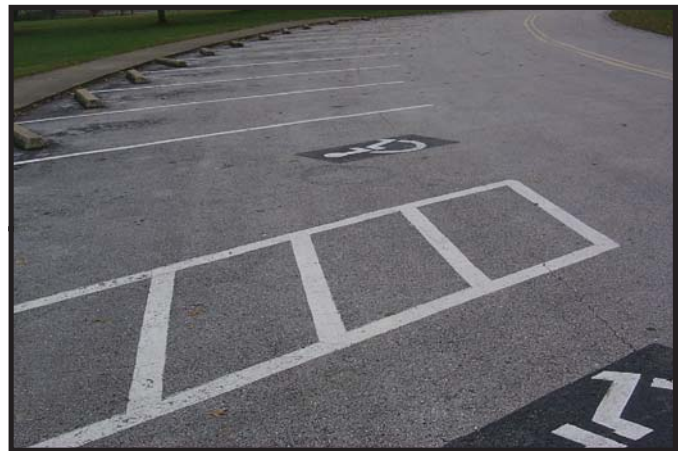
## Route 0901

Route	Public / NonPublic	Date Visited	Area (sq ft)	Lane Miles *	Surface Type	Condition / PCR
0901	Public	10/26/2002	6962	0.12	AS	FAIR / 73

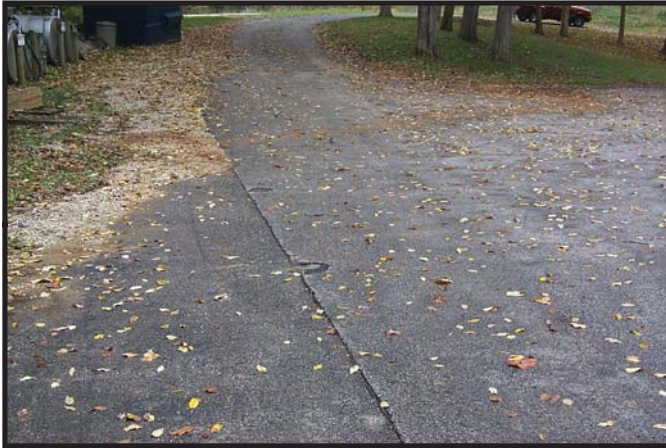
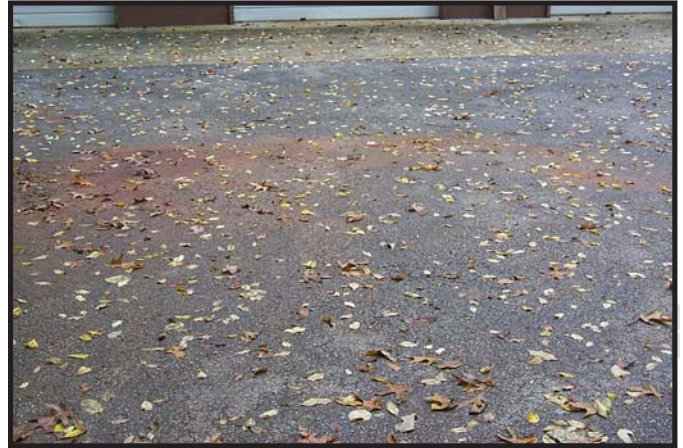
## Route 0903

Route	Public / NonPublic	Date Visited	Area (sq ft)	Lane Miles *	Surface Type	Condition / PCR
0903	NonPublic	10/26/2002	6792	0.12	AS	FAIR / 73

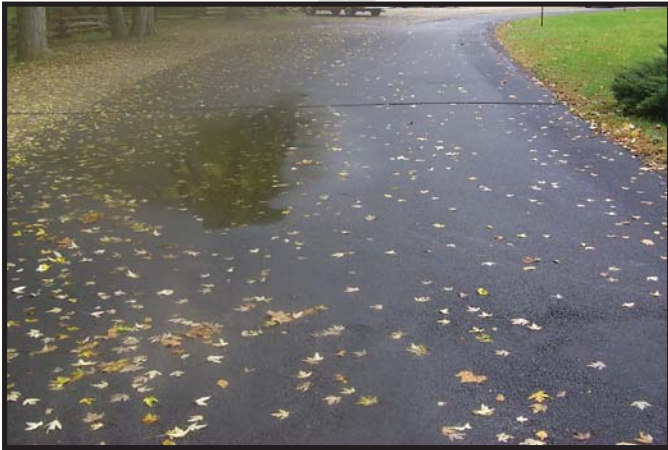
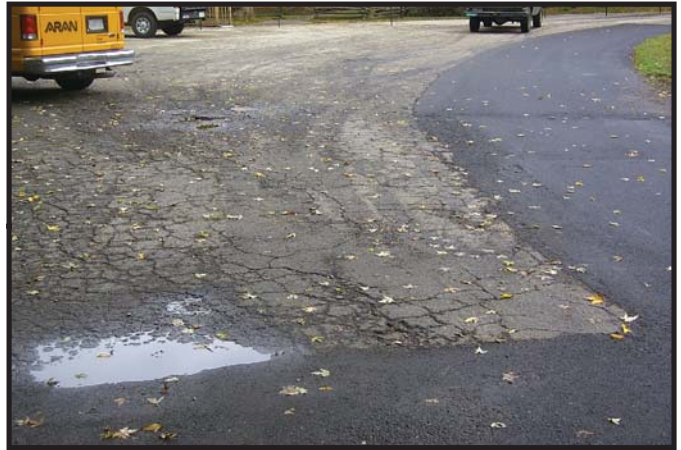
## Route 0904

Route	Public / NonPublic	Date Visited	Area (sq ft)	Lane Miles *	Surface Type	Condition / PCR
0904	Public	10/26/2002	14124	0.24	AS	POOR / 45

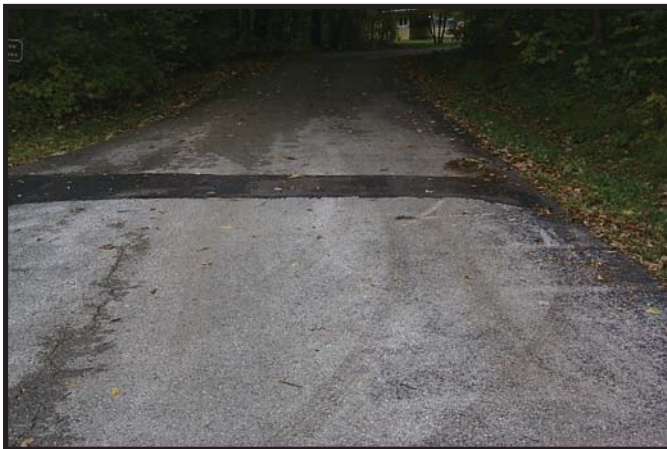
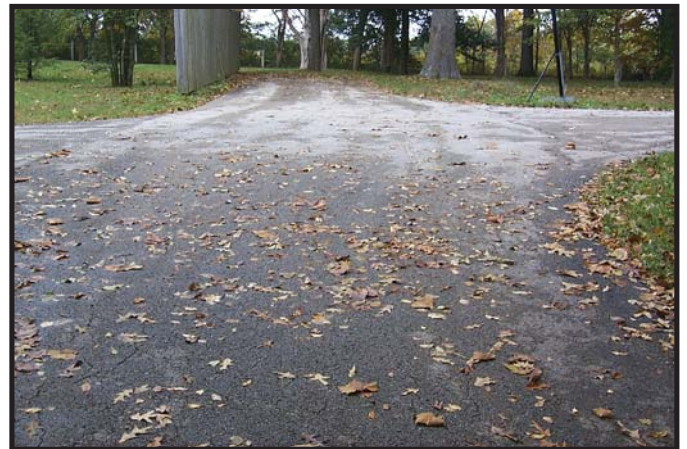
## Route 0905

Route	Public / NonPublic	Date Visited	Area (sq ft)	Lane Miles *	Surface Type	Condition / PCR
0905	NonPublic	10/26/2002	5281	0.09	AS	FAIR / 73
