# The Road Inventory of Agate Fossil Beds National Monument AGFO - 6710

## Road Inventory Program

Prepared By:  
Federal Highway Administration  
Eastern Federal Lands Highway Division  
Cycle 3

# Agate Fossil Beds National Monument in Nebraska

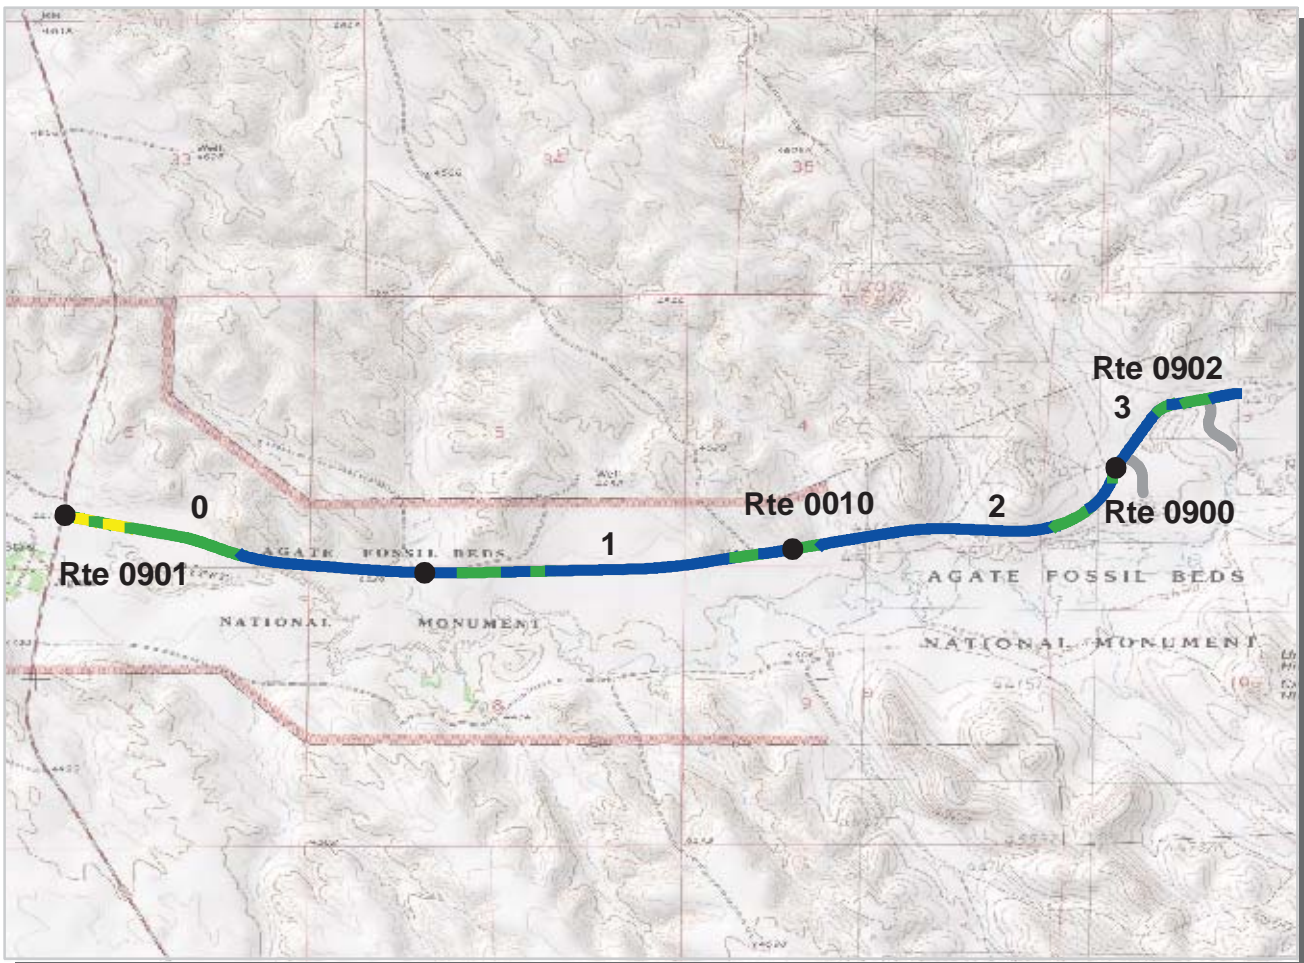
ROUTE: 0010 River Road

PCR    Poor ■    Fair ■    Good ■    Excellent ■  
 (<=60)    (61 - 84)    (85 - 94)    (95 - 100)

Section Number	0	1	2	3	
Section Length (mi)	1.00	1.00	1.00	0.48	
AADT	**				
SADT	**				
ADT Date	**				
<b>Cross Section Information</b>					
Number of Lanes	2	2	2	2	
Paved Width (ft)	20	20	20	20	
Lane Width (ft)	10	10	10	10	
Shoulder Width (ft)	8	8	7	6	
<b>Roadway Condition Information</b>					
PCR (Pavement Condition Rating)	91	97	96	95	
RCI (Roughness Condition Index)	99	99	99	96	
SCR (Surface Condition Rating)	88	96	94	94	
Alligator Cracking Index	100	100	100	100	
Rutting Index	88	97	95	96	
Patching Index	100	100	100	99	
Transverse Cracking Index	99	99	99	98	
Longitudinal Cracking Index	99	100	100	100	
Shoulder Condition Rating	GOOD	GOOD	GOOD	GOOD	
Drainage Condition Rating	GOOD	GOOD	GOOD	GOOD

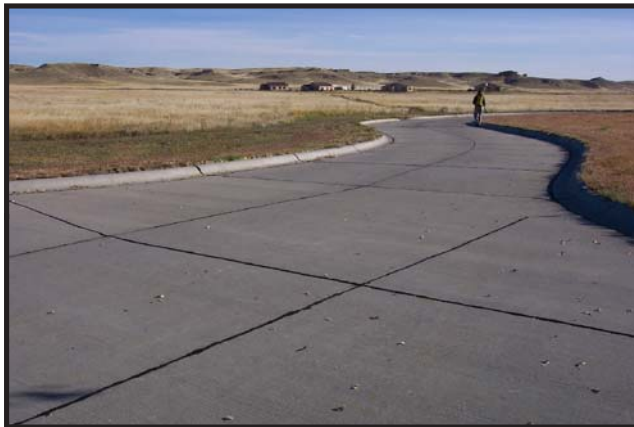
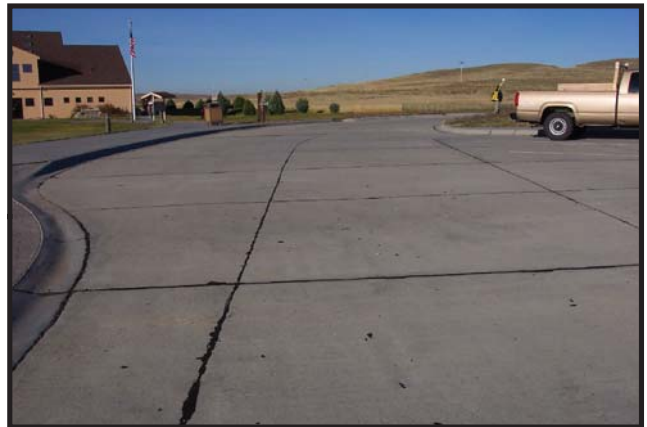
Route	Public / NonPublic	Date Visited	Area (sq ft)	Lane Miles *	Surface Type	Condition / PCR
0900	Public	10/3/2003	42152	0.73	CO	FAIR / 73

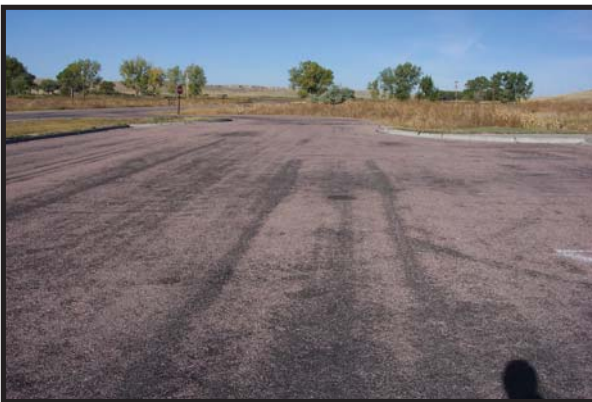
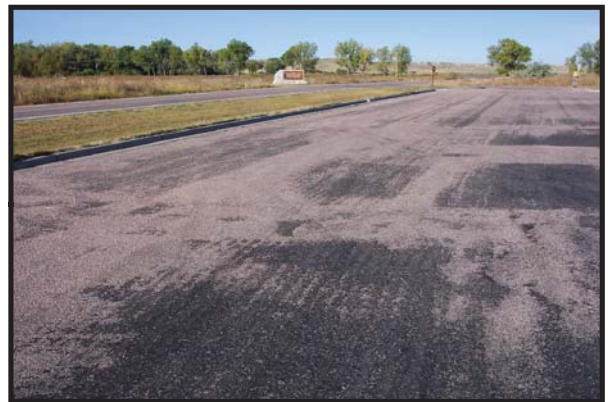
## Route 0901

Route	Public / NonPublic	Date Visited	Area (sq ft)	Lane Miles *	Surface Type	Condition / PCR
0901	Public	10/3/2003	15871	0.27	OC	FAIR / 73

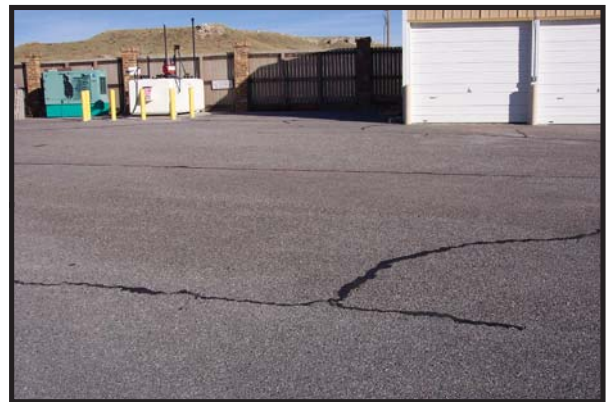
## Route 0902

Route	Public / NonPublic	Date Visited	Area (sq ft)	Lane Miles *	Surface Type	Condition / PCR
0902	NonPublic	10/3/2003	25698	0.44	OC	FAIR / 73
