# The Road Inventory of Allegheny Portage Railroad National Historic Site ALPO - 4130

## Road Inventory Program

Prepared By:  
Federal Highway Administration  
Eastern Federal Lands Highway Division  
Cycle 3

# Allegheny Portage Railroad National in Pennsylvania

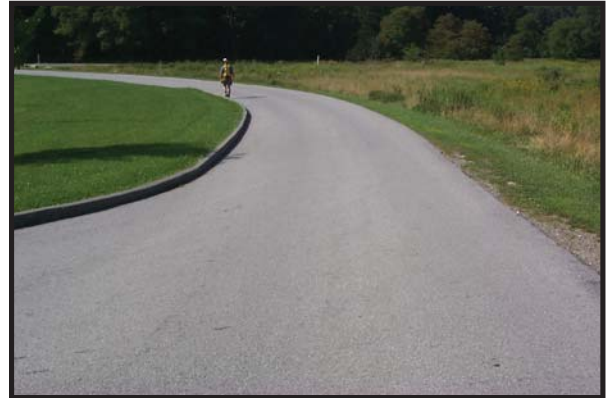
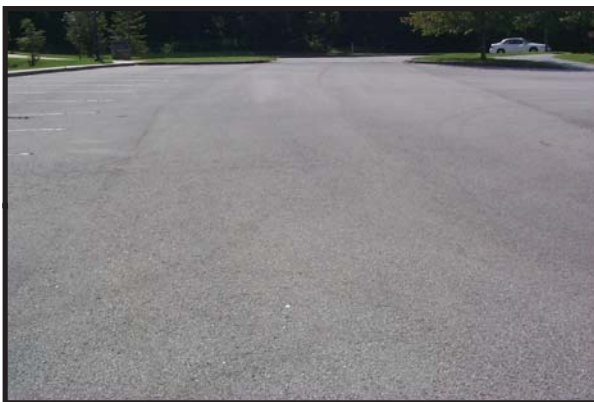
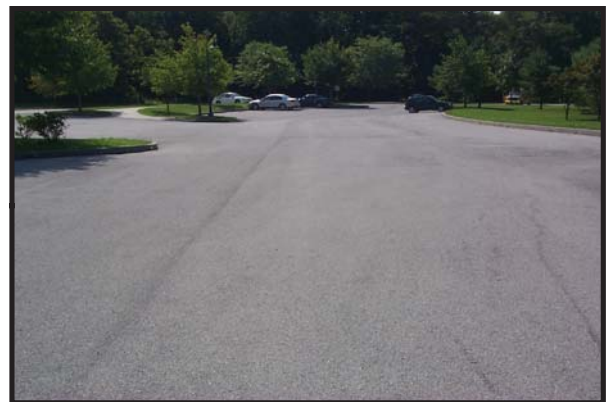
Route	Public / NonPublic	Date Visited	Area (sq ft)	Lane Miles *	Surface Type	Condition / PCR
0900	Public	8/25/2001	58335	1.00	OC	FAIR / 73

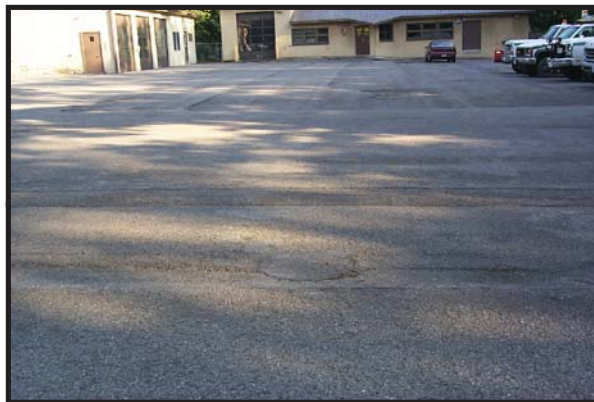
## Route 0901A

Route	Public / NonPublic	Date Visited	Area (sq ft)	Lane Miles *	Surface Type	Condition / PCR
0901A	NonPublic	8/25/2001	22027	0.38	AS	FAIR / 73

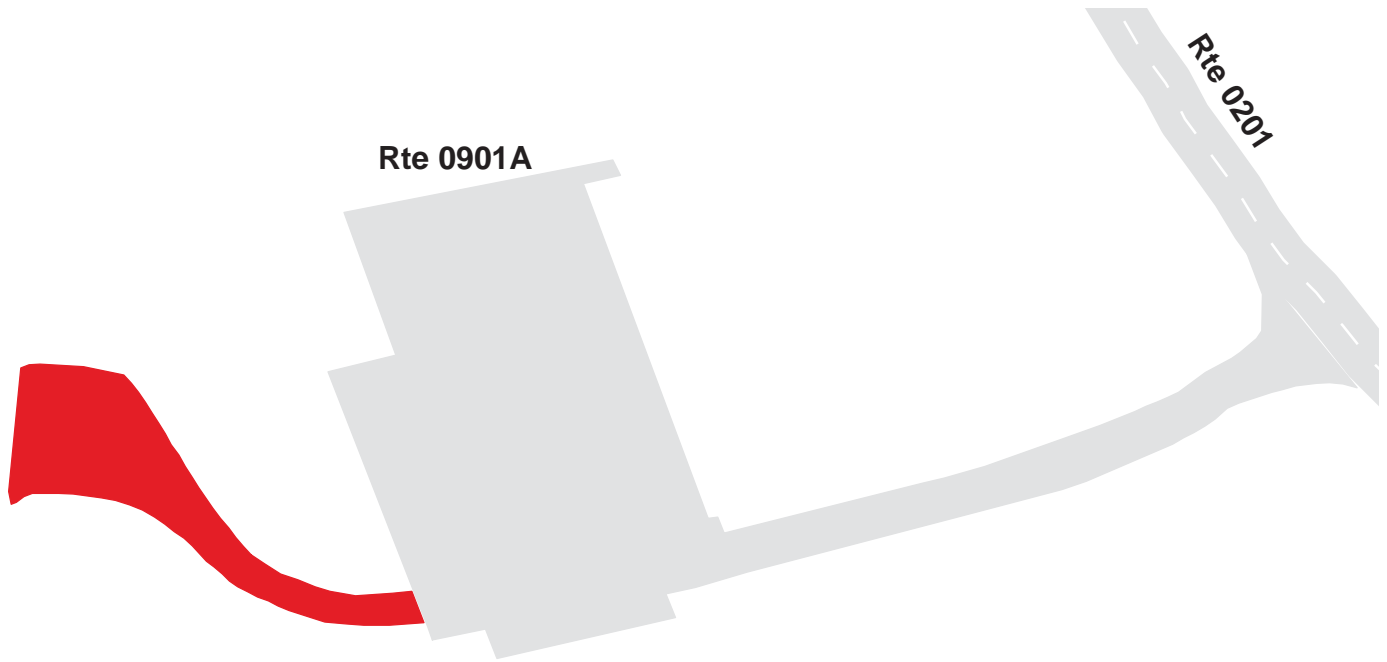
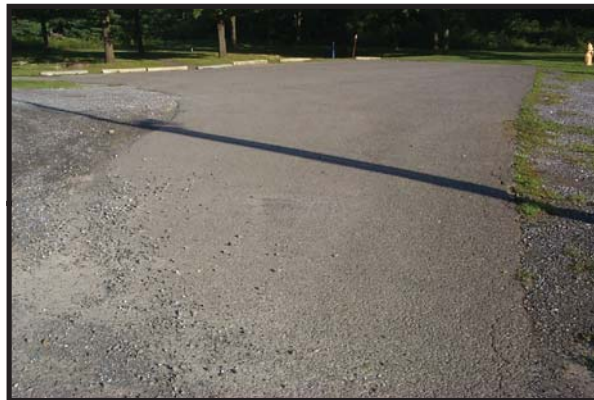
## Route 0902

Route	Public / NonPublic	Date Visited	Area (sq ft)	Lane Miles *	Surface Type	Condition / PCR
0902	NonPublic	8/25/2001	4044	0.07	AS	FAIR / 73

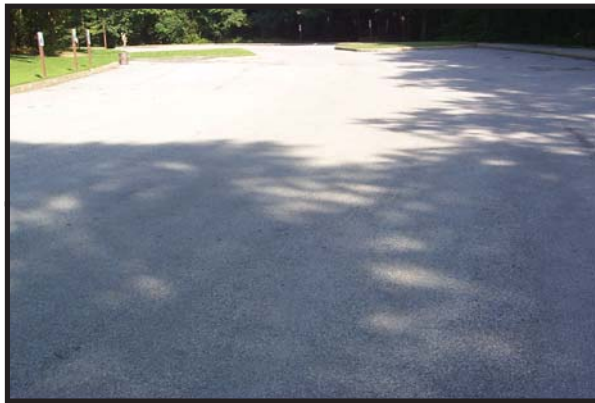
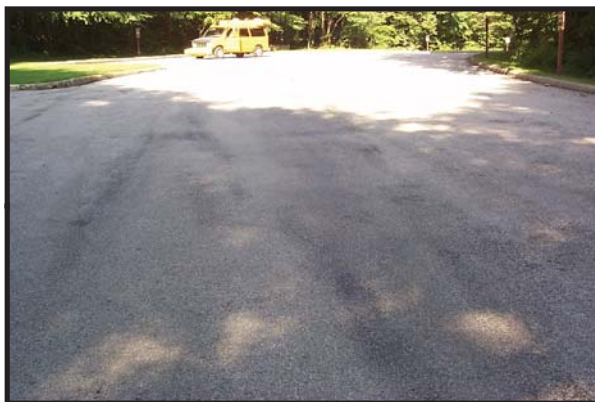
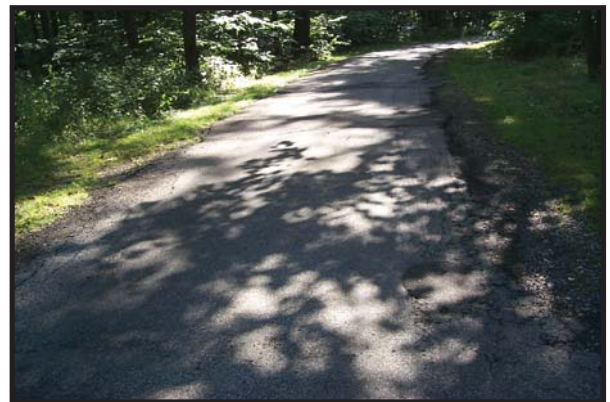
## Route 0903

Route	Public / NonPublic	Date Visited	Area (sq ft)	Lane Miles *	Surface Type	Condition / PCR
0903	Public	8/25/2001	60062	1.03	OC	GOOD / 90
