The Road Inventory of Amistad National Recreation Area AMIS - 1700

Road Inventory Program

Prepared By:
Federal Highway Administration
Eastern Federal Lands Highway Division
Cycle 3

Amistad National Recreation Area in Texas

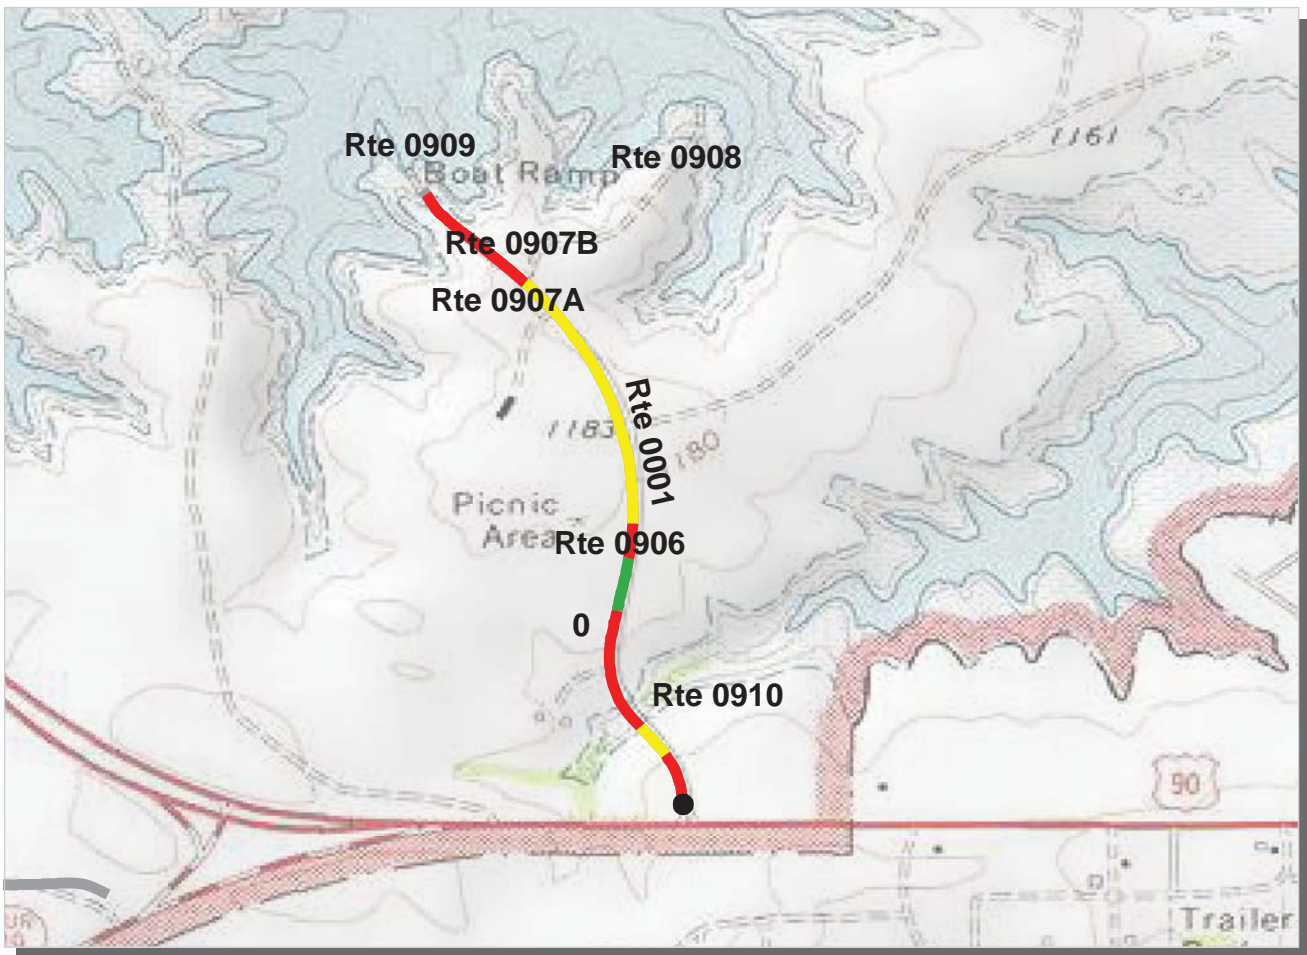
ROUTE: 0001 Diablo East Entrance Road **TOTAL LENGTH: 0.79 Miles**

Section Number	0				
Section Length (mi)	0.79				
AADT	**				
SADT	**				
ADT Date	**				
Cross Section Information					
Number of Lanes	2				
Paved Width (ft)	21				
Lane Width (ft)	11				
Shoulder Width (ft)	0				
Roadway Condition Information					
PCR (Pavement Condition Rating)	59				
RCI (Roughness Condition Index)	76				
SCR (Surface Condition Rating)	51				
Alligator Cracking Index	100				
Rutting Index	53				
Patching Index	100				
Transverse Cracking Index	99				
Longitudinal Cracking Index	99				
Shoulder Condition Rating	N/A				
Drainage Condition Rating	N/C

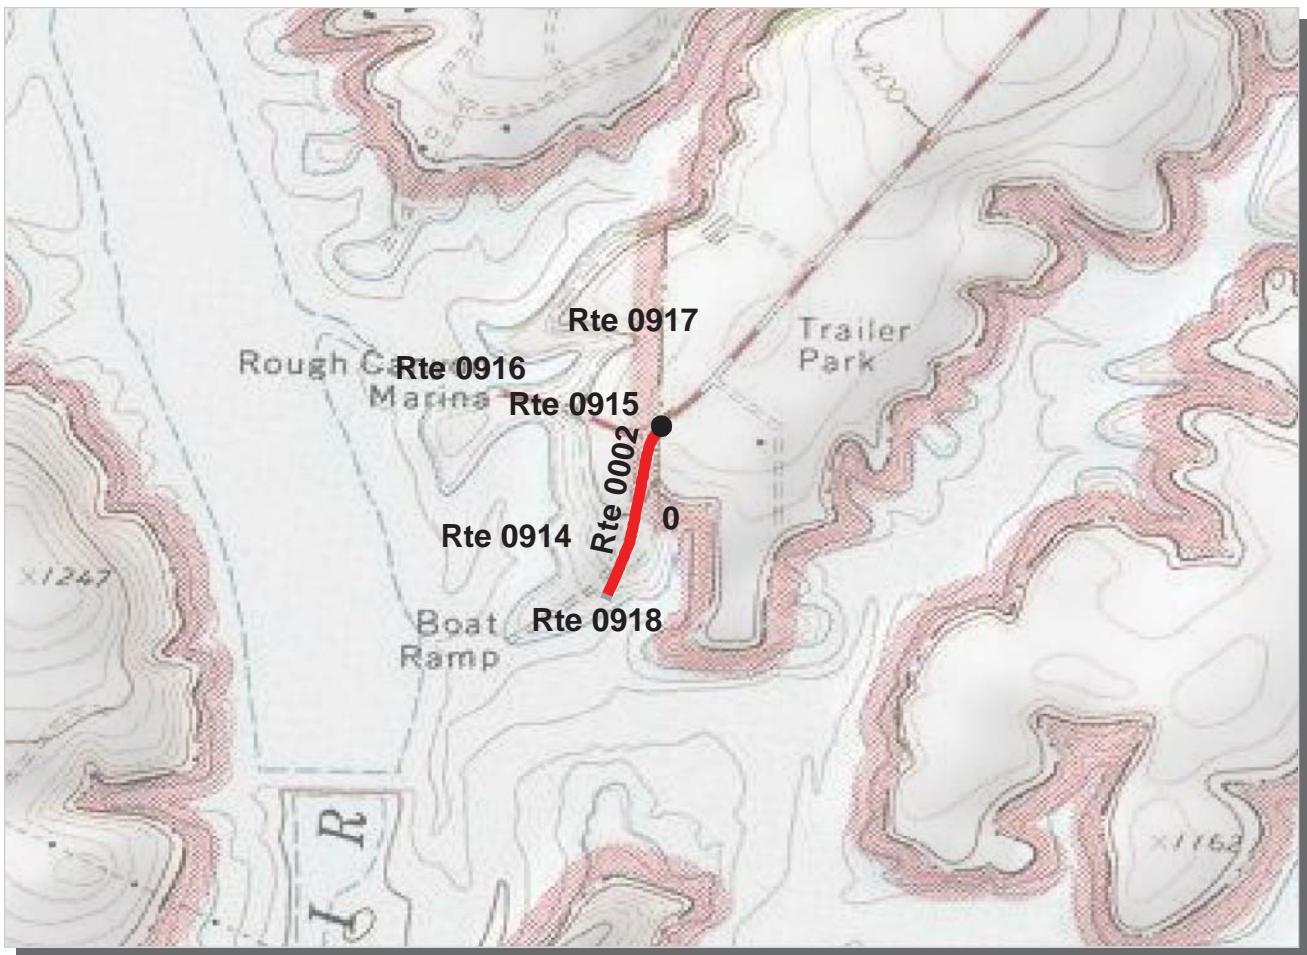
ROUTE: 0002 Rough Canyon Entrance Road **TOTAL LENGTH: 0.21 Miles**

Section Number	0				
Section Length (mi)	0.21				
AADT	**				
SADT	**				
ADT Date	**				
Cross Section Information					
Number of Lanes	2				
Paved Width (ft)	22				
Lane Width (ft)	11				
Shoulder Width (ft)	0				
Roadway Condition Information					
PCR (Pavement Condition Rating)	35				
RCI (Roughness Condition Index)	56				
SCR (Surface Condition Rating)	32				
Alligator Cracking Index	100				
Rutting Index	34				
Patching Index	100				
Transverse Cracking Index	99				
Longitudinal Cracking Index	98				
Shoulder Condition Rating	N/A				
Drainage Condition Rating	N/C

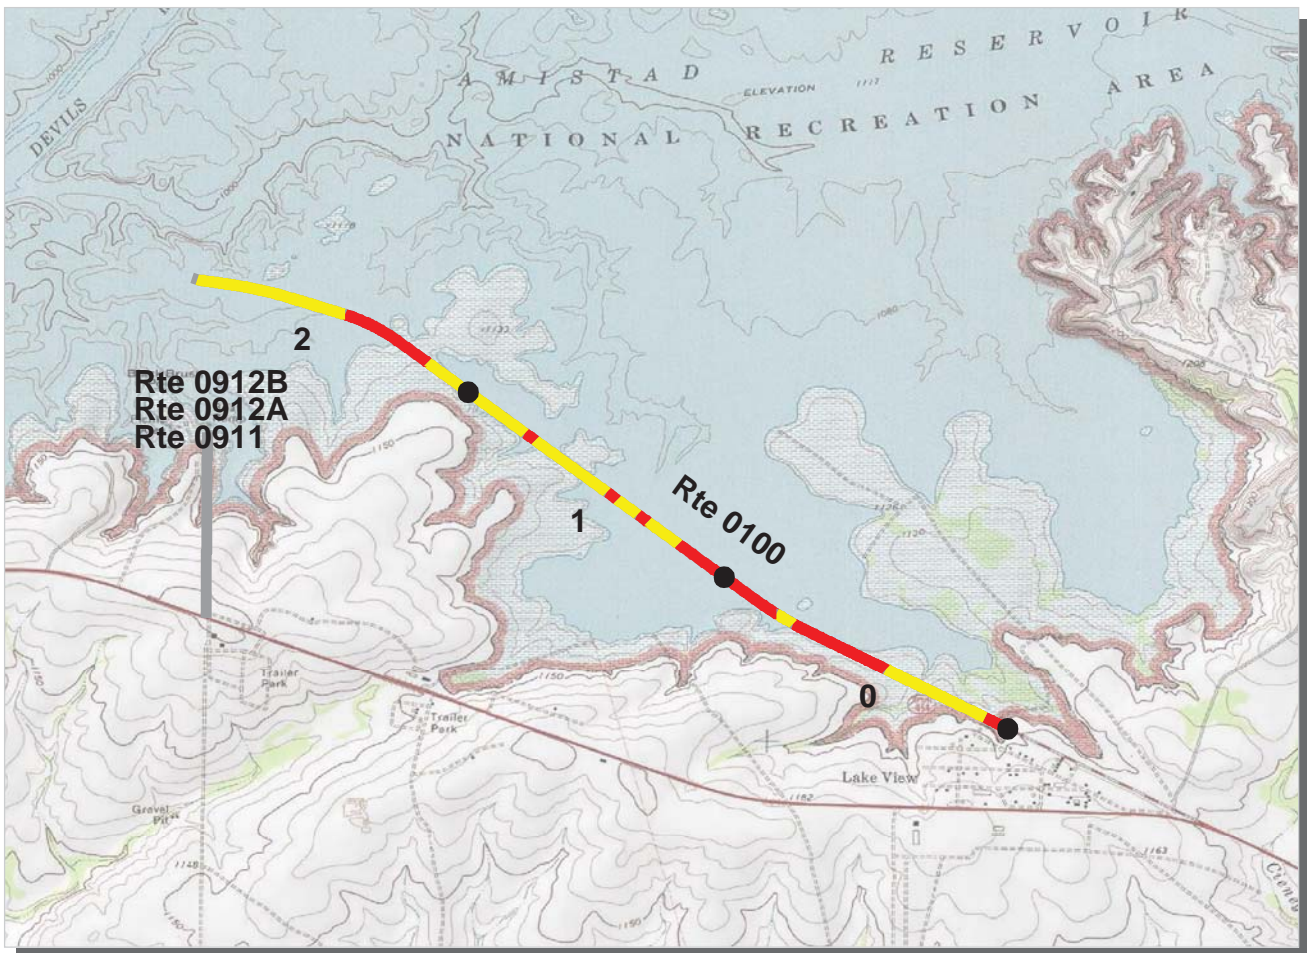
ROUTE: 0100 Spur 454 **TOTAL LENGTH: 2.93 Miles**

Section Number	0	1	2		
Section Length (mi)	1.00	1.00	0.93		
AADT	**				
SADT	**				
ADT Date	**				
Cross Section Information					
Number of Lanes	2	2	2		
Paved Width (ft)	25	28	25		
Lane Width (ft)	14	14	14		
Shoulder Width (ft)	0	0	0		
Roadway Condition Information					
PCR (Pavement Condition Rating)	51	60	60		
RCI (Roughness Condition Index)	75	89	98		
SCR (Surface Condition Rating)	37	41	37		
Alligator Cracking Index	94	97	100		
Rutting Index	45	54	50		
Patching Index	100	100	100		
Transverse Cracking Index	97	95	91		
Longitudinal Cracking Index	95	93	94		
Shoulder Condition Rating	N/A	N/A	N/A		
Drainage Condition Rating	N/C	N/C	N/C

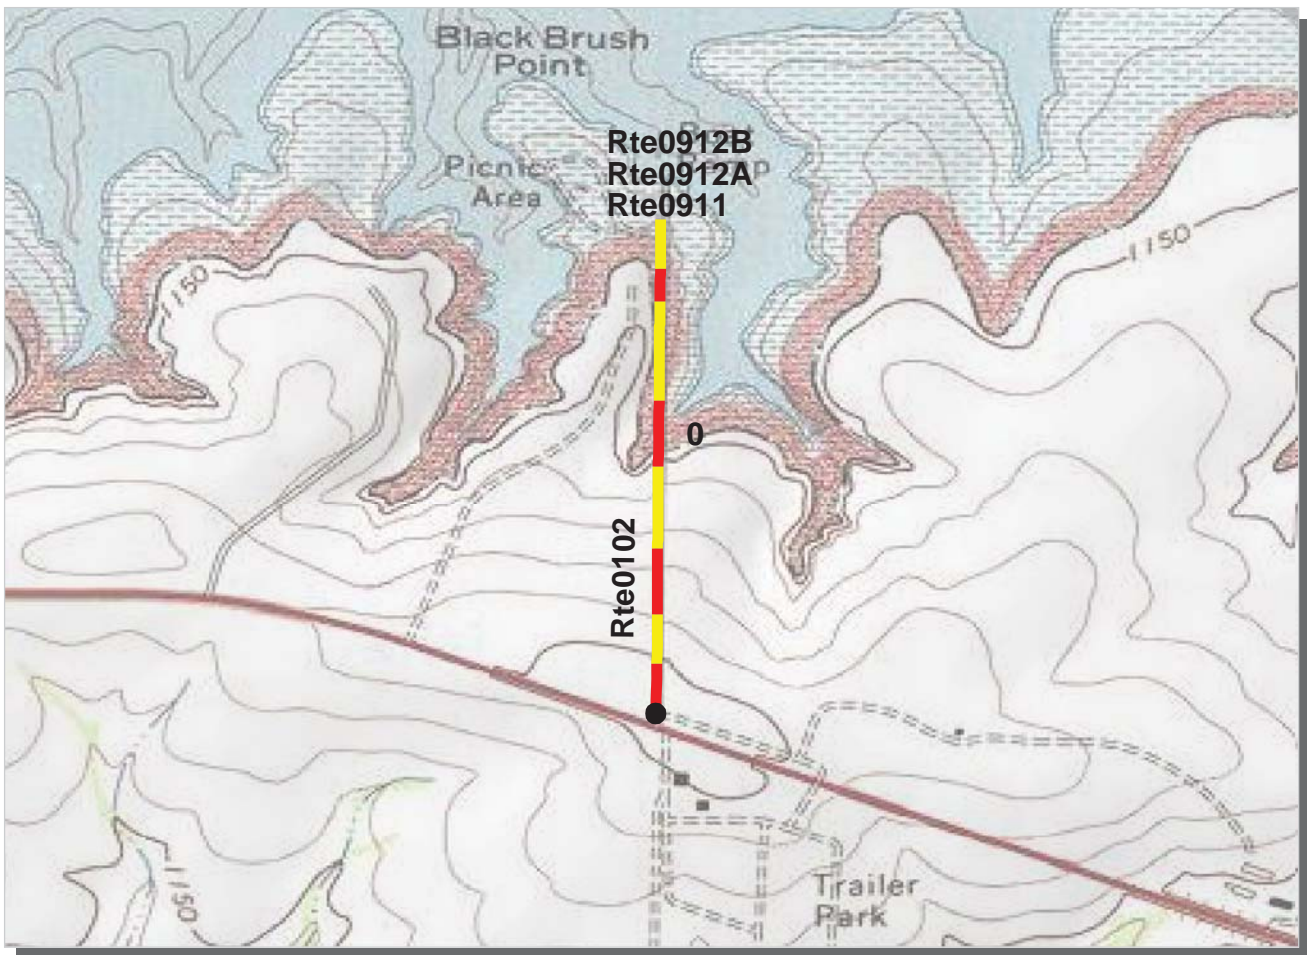
ROUTE: 0102 Blackbrush Road **TOTAL LENGTH: 0.62 Miles**

Section Number	0				
Section Length (mi)	0.62				
AADT	**				
SADT	**				
ADT Date	**				
Cross Section Information					
Number of Lanes	2				
Paved Width (ft)	21				
Lane Width (ft)	11				
Shoulder Width (ft)	0				
Roadway Condition Information					
PCR (Pavement Condition Rating)	59				
RCI (Roughness Condition Index)	83				
SCR (Surface Condition Rating)	49				
Alligator Cracking Index	100				
Rutting Index	49				
Patching Index	100				
Transverse Cracking Index	99				
Longitudinal Cracking Index	99				
Shoulder Condition Rating	N/A				
Drainage Condition Rating	N/C

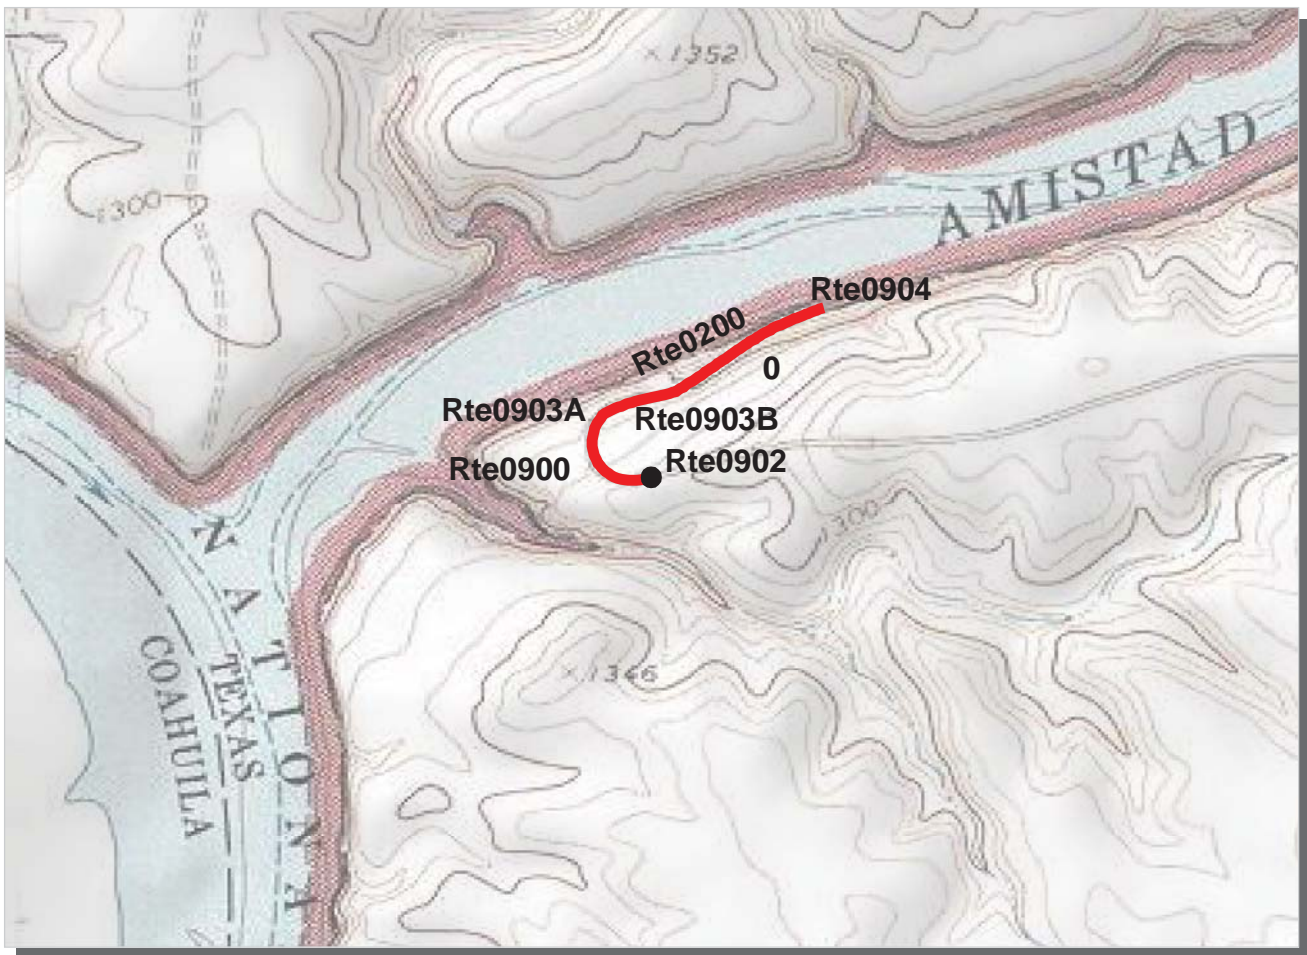
ROUTE: 0200 Pecos District Road **TOTAL LENGTH: 0.39 Miles**

Section Number	0				
Section Length (mi)	0.39				
AADT	**				
SADT	**				
ADT Date	**				
Cross Section Information					
Number of Lanes	2				
Paved Width (ft)	20				
Lane Width (ft)	10				
Shoulder Width (ft)	0				
Roadway Condition Information					
PCR (Pavement Condition Rating)	35				
RCI (Roughness Condition Index)	59				
SCR (Surface Condition Rating)	18				
Alligator Cracking Index	85				
Rutting Index	22				
Patching Index	100				
Transverse Cracking Index	100				
Longitudinal Cracking Index	100				
Shoulder Condition Rating	N/A				
Drainage Condition Rating	N/C

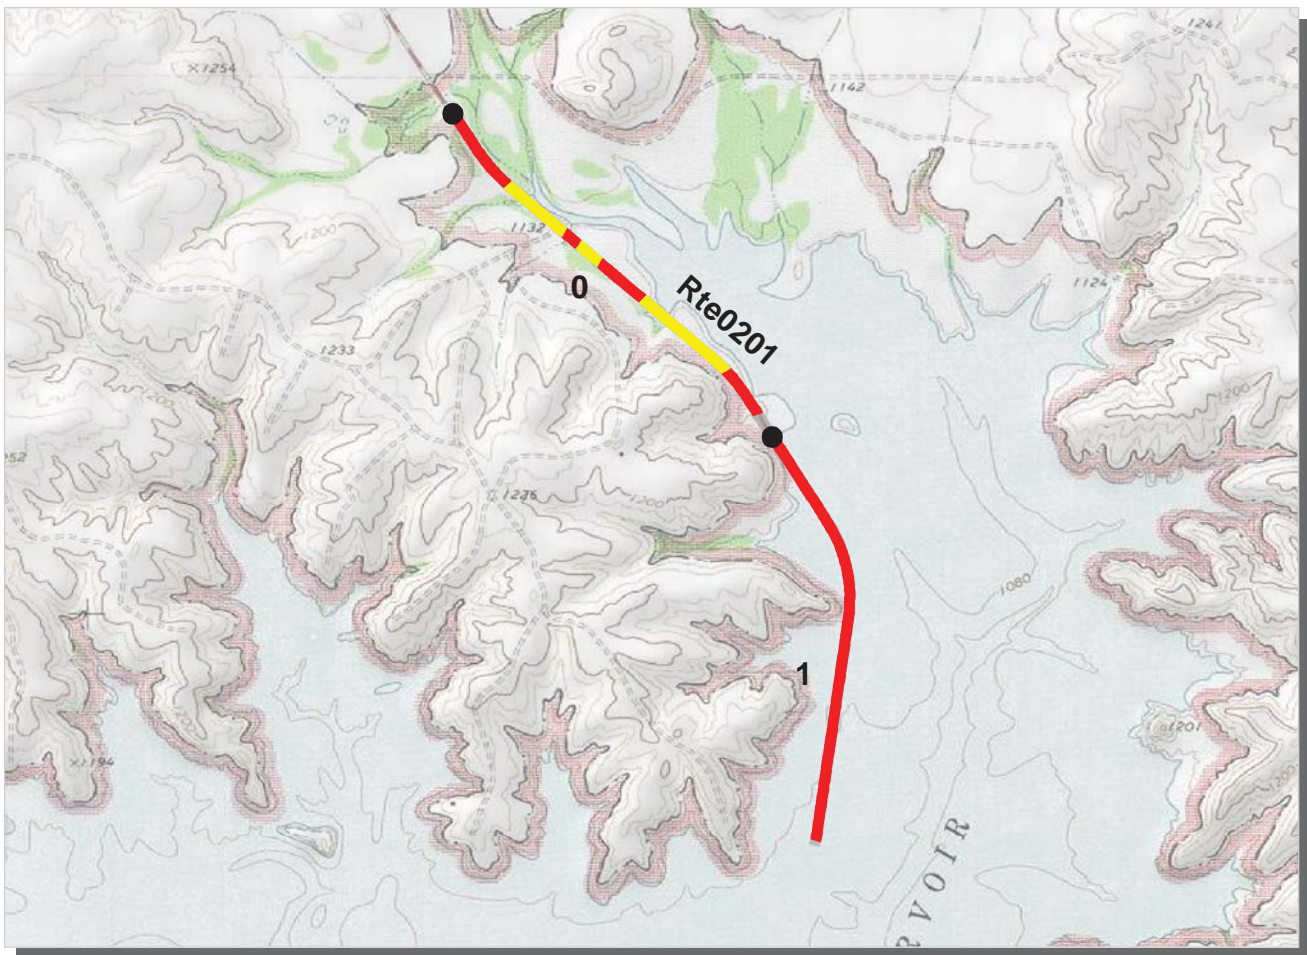
ROUTE: 0201 Spur 406

Section Number	0	1			
Section Length (mi)	1.00	0.99			
AADT	**				
SADT	**				
ADT Date	**				
Cross Section Information					
Number of Lanes	2	2			
Paved Width (ft)	26	22			
Lane Width (ft)	13	13			
Shoulder Width (ft)	0	0			
Roadway Condition Information					
PCR (Pavement Condition Rating)	59	35			
RCI (Roughness Condition Index)	92	91			
SCR (Surface Condition Rating)	37	3			
Alligator Cracking Index	100	50			
Rutting Index	38	49			
Patching Index	100	99			
Transverse Cracking Index	99	78			
Longitudinal Cracking Index	99	91			
Shoulder Condition Rating	N/A	N/A			
Drainage Condition Rating	N/C	N/C

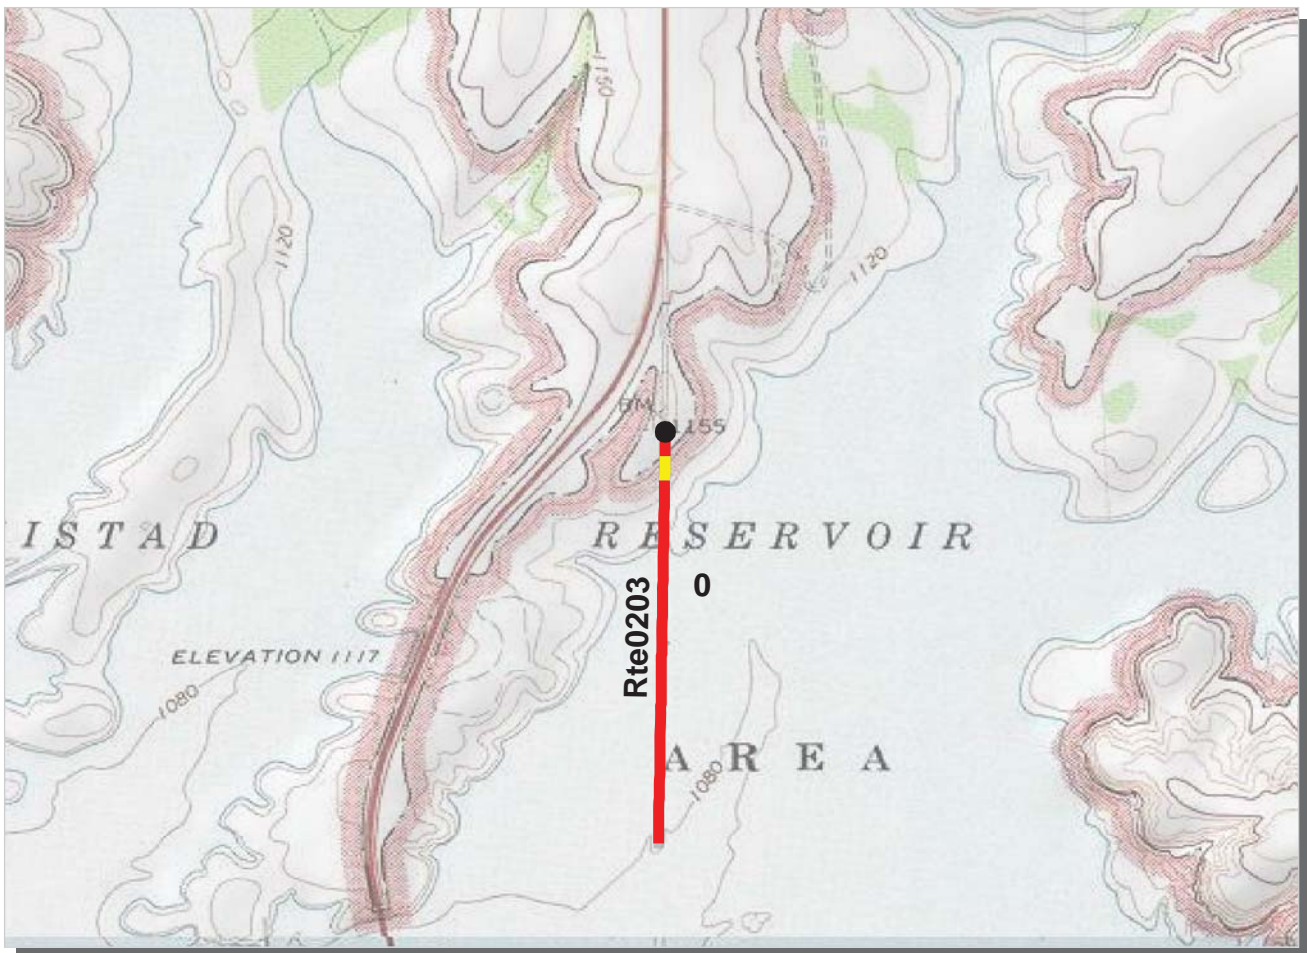
ROUTE: 0203 Spur 277 North

Section Number	0				
Section Length (mi)	0.69				
AADT	**				
SADT	**				
ADT Date	**				
Cross Section Information					
Number of Lanes	2				
Paved Width (ft)	20				
Lane Width (ft)	10				
Shoulder Width (ft)	0				
Roadway Condition Information					
PCR (Pavement Condition Rating)	36				
RCI (Roughness Condition Index)	86				
SCR (Surface Condition Rating)	8				
Alligator Cracking Index	52				
Rutting Index	38				
Patching Index	100				
Transverse Cracking Index	92				
Longitudinal Cracking Index	95				
Shoulder Condition Rating	N/A				
Drainage Condition Rating	N/C

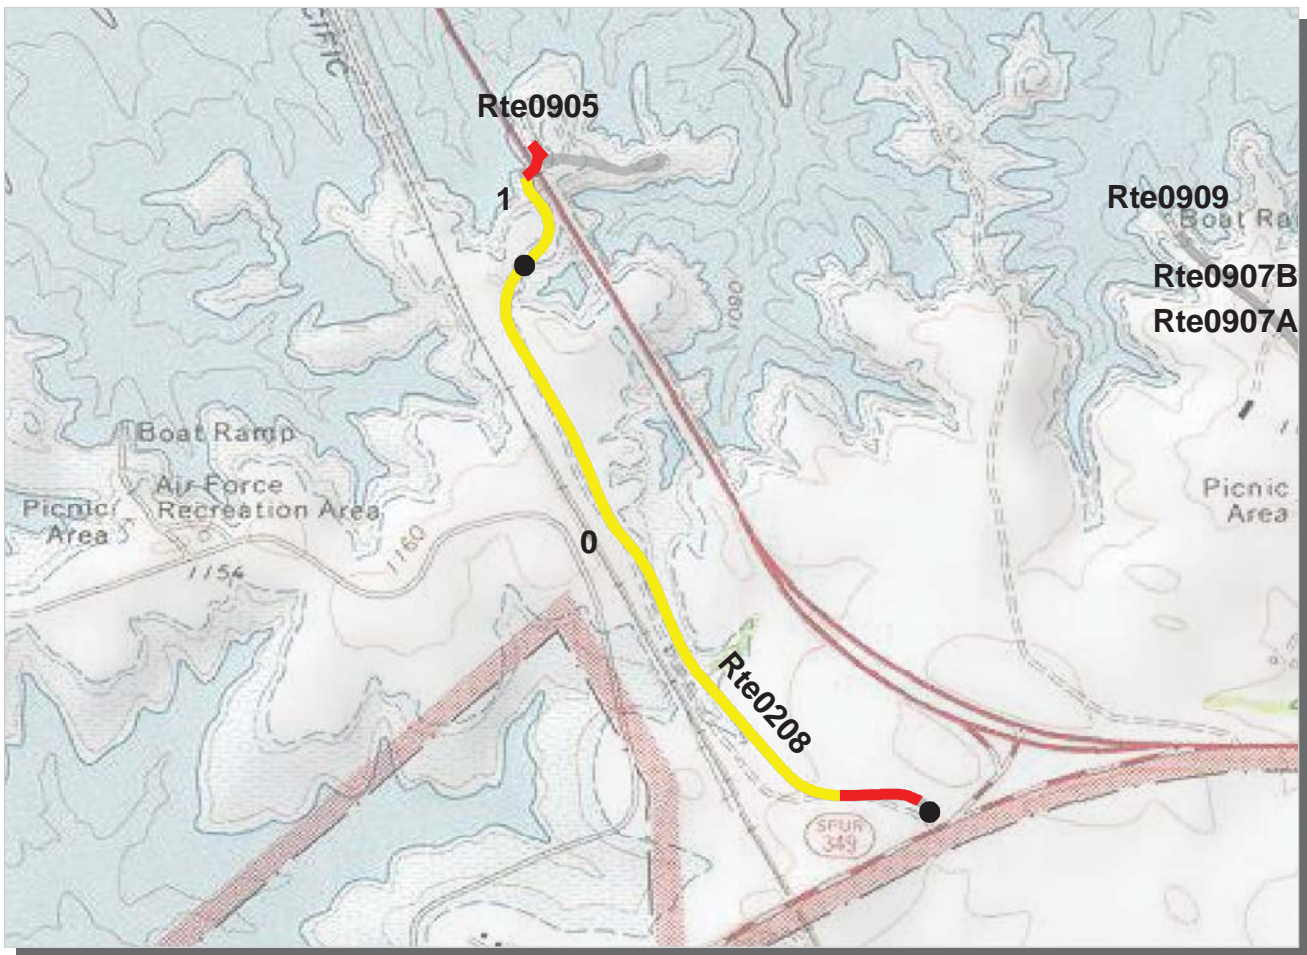
ROUTE: 0208 Governors Landing Road **TOTAL LENGTH: 1.24 Miles**

Section Number	0	1			
Section Length (mi)	1.00	0.24			
AADT	**				
SADT	**				
ADT Date	**				
Cross Section Information					
Number of Lanes	2	2			
Paved Width (ft)	21	22			
Lane Width (ft)	10	10			
Shoulder Width (ft)	2	2			
Roadway Condition Information					
PCR (Pavement Condition Rating)	66	55			
RCI (Roughness Condition Index)	100	86			
SCR (Surface Condition Rating)	46	34			
Alligator Cracking Index	100	100			
Rutting Index	46	34			
Patching Index	100	100			
Transverse Cracking Index	100	99			
Longitudinal Cracking Index	99	100			
Shoulder Condition Rating	N/C	N/C			
Drainage Condition Rating	N/C	N/C

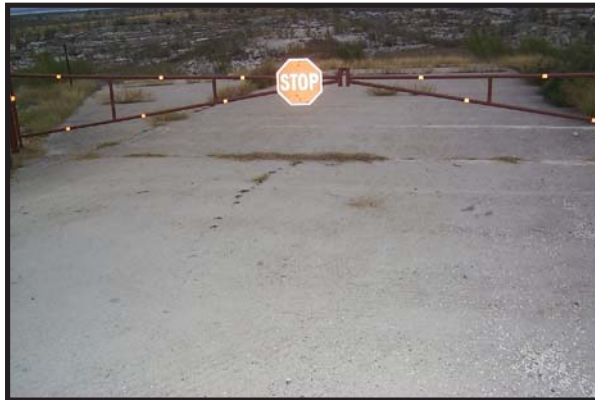
Route 0912B

Route	Public / NonPublic	Date Visited	Area (sq ft)	Lane Miles *	Surface Type	Condition / PCR
0912B	Public	12/15/2001	16999	0.29	CO	POOR / 45

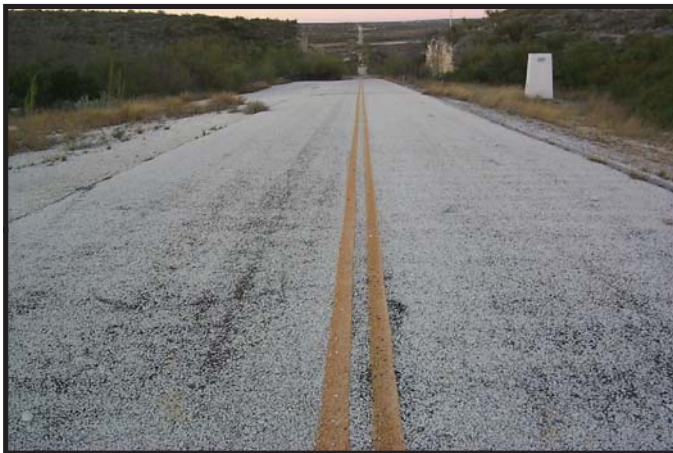
Route 0913B

Route	Public / NonPublic	Date Visited	Area (sq ft)	Lane Miles *	Surface Type	Condition / PCR
0913B	NonPublic	12/16/2001	16996	0.29	CO	POOR / 45
