# The Road Inventory of Andersonville National Historic Site ANDE – 5100

## Road Inventory Program

Prepared By:  
Federal Highway Administration  
Eastern Federal Lands Highway Division  
Cycle 3

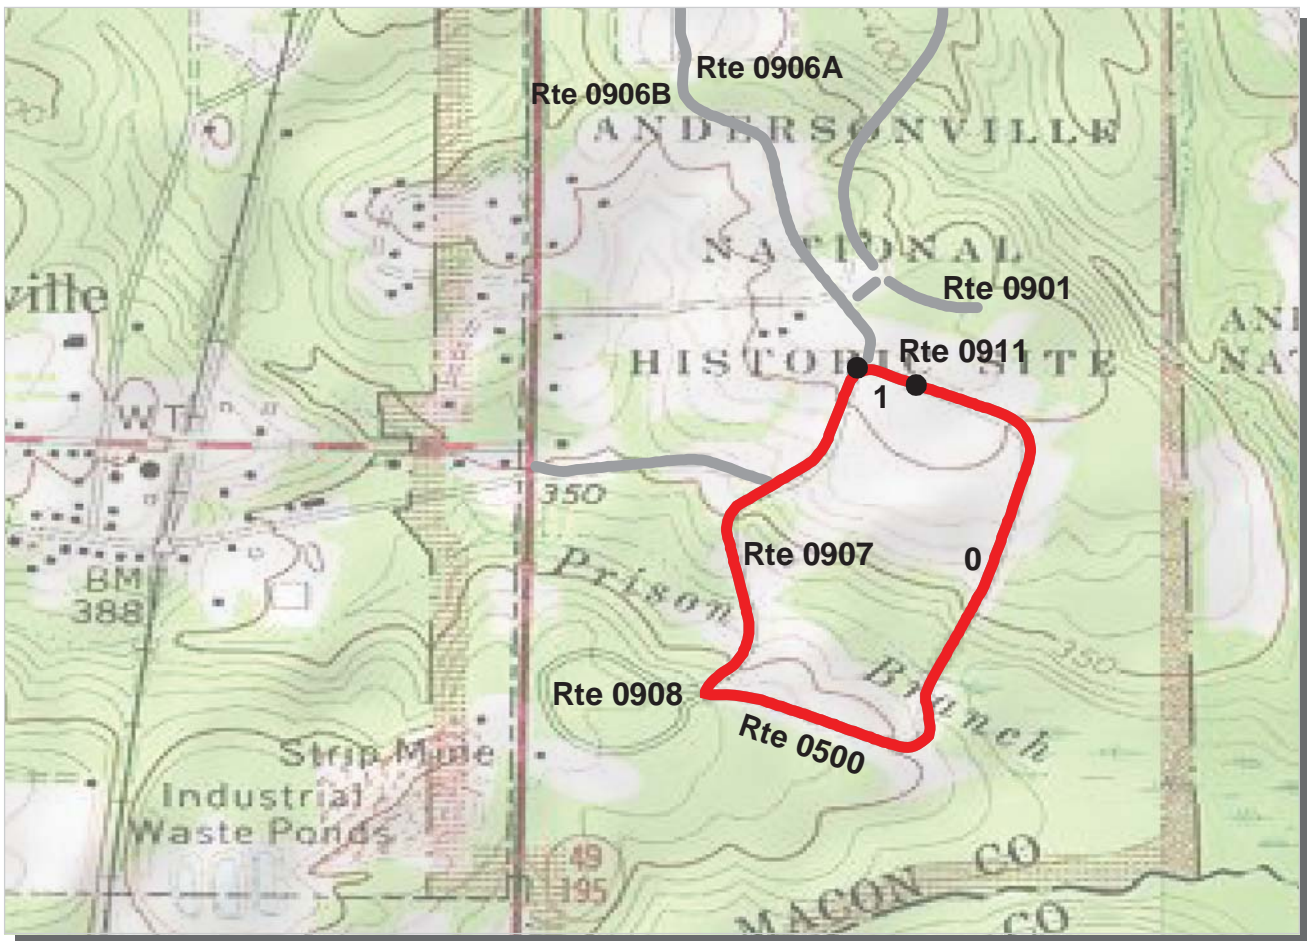
**ROUTE: 0500 Perimeter Road** **TOTAL LENGTH: 1.07 Miles**

Section Number	0	1			
Section Length (mi)	1.00	0.07			
AADT	**				
SADT	**				
ADT Date	**				
<b>Cross Section Information</b>					
Number of Lanes	1	1			
Paved Width (ft)	14	14			
Lane Width (ft)	14	14			
Shoulder Width (ft)	6	6			
<b>Roadway Condition Information</b>					
PCR (Pavement Condition Rating)	35	14			
RCI (Roughness Condition Index)	90	100			
SCR (Surface Condition Rating)	4	4			
Alligator Cracking Index	99	100			
Rutting Index	6	7			
Patching Index	100	100			
Transverse Cracking Index	96	97			
Longitudinal Cracking Index	99	99			
Shoulder Condition Rating	N/A	N/A			
Drainage Condition Rating	N/C	N/C

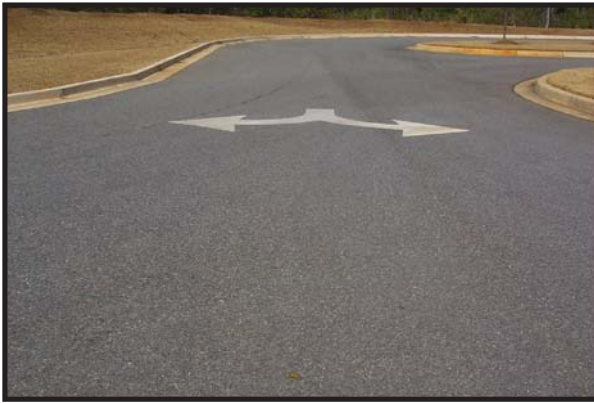
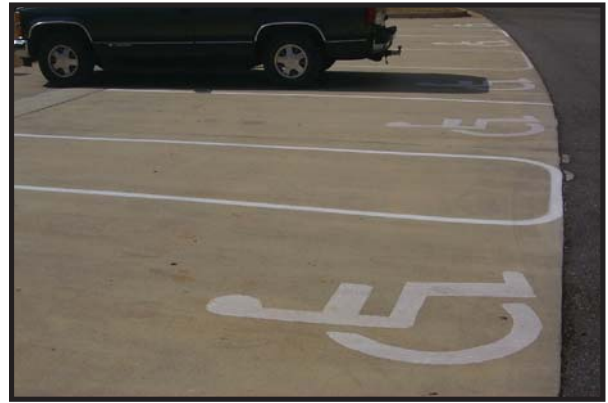
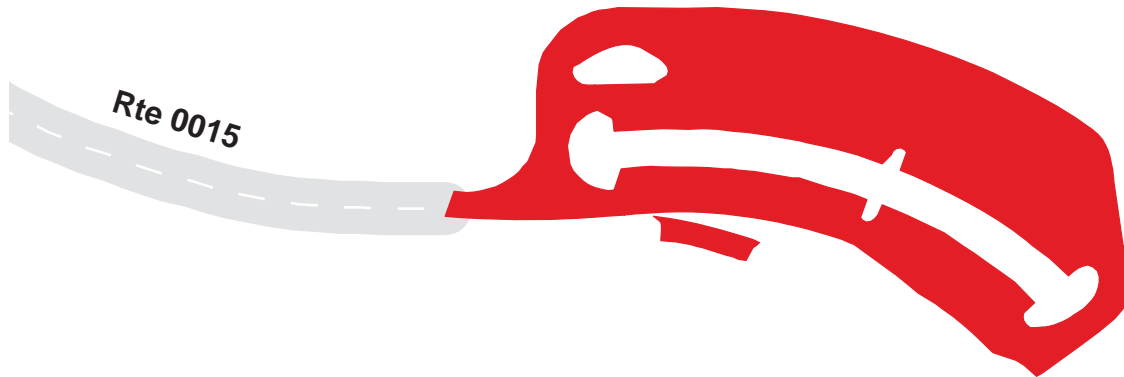
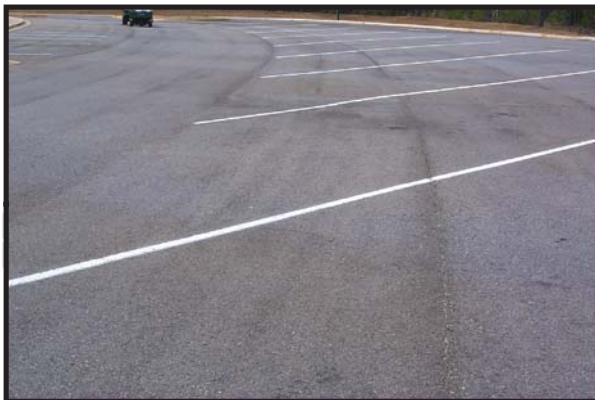
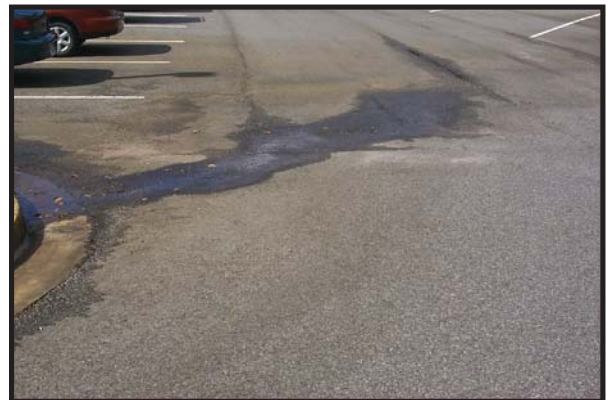
## Route 0901

Route	Public / NonPublic	Date Visited	Area (sq ft)	Lane Miles *	Surface Type	Condition / PCR
0901	Public	2/24/2003	65614	1.13	AS	GOOD / 90

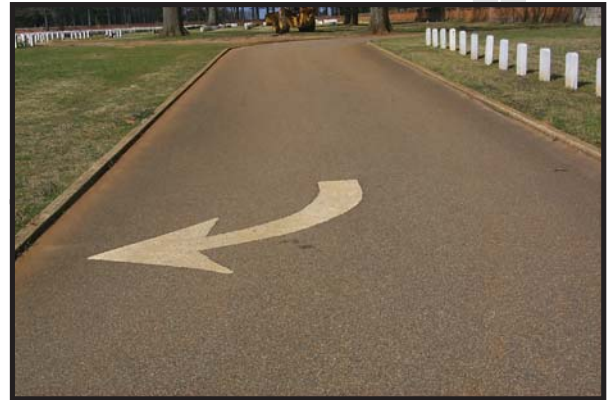
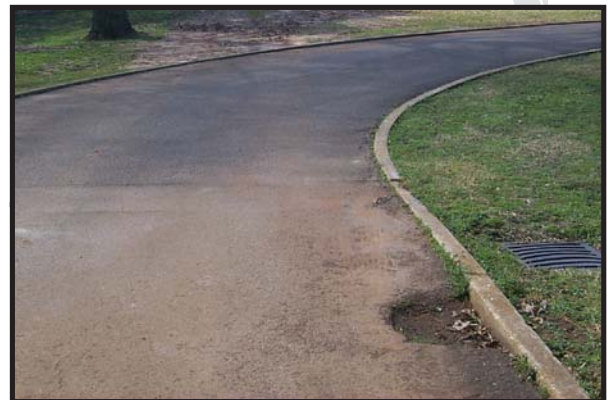
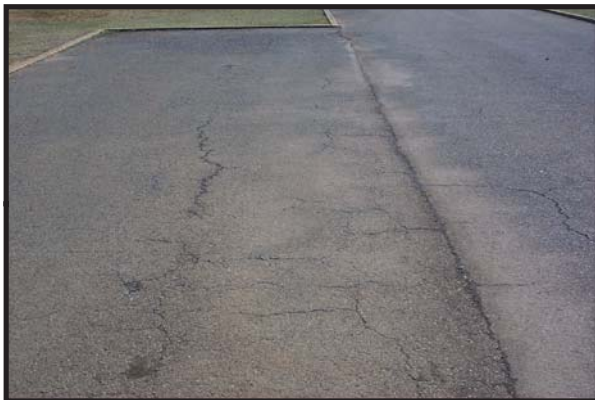
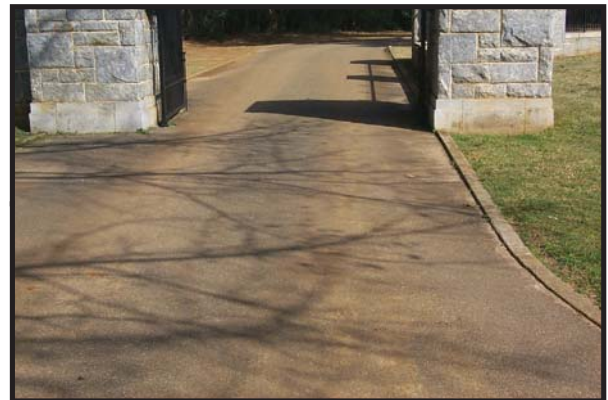
## Route 0902

Rostrum Parking  
From Route 0016

Route	Public / NonPublic	Date Visited	Area (sq ft)	Lane Miles *	Surface Type	Condition / PCR
0902	Public	2/24/2003	19082	0.33	AS	GOOD / 90

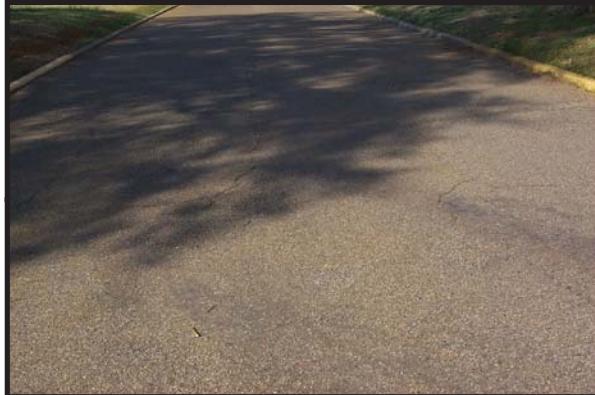
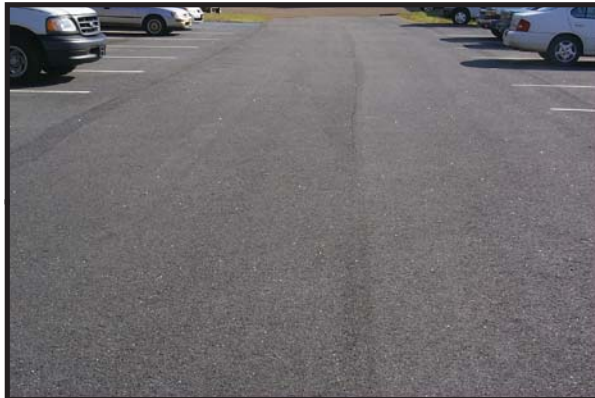
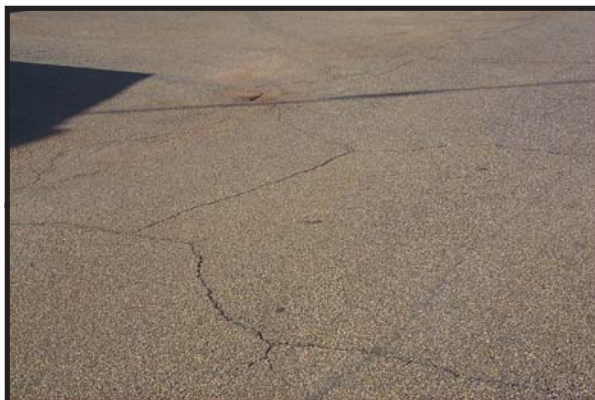
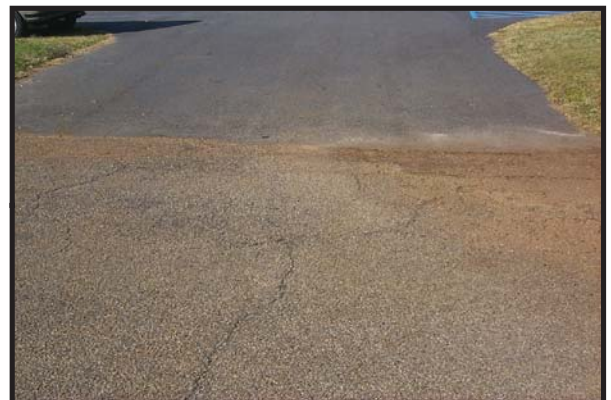
## Route 0903

Route	Public / NonPublic	Date Visited	Area (sq ft)	Lane Miles *	Surface Type	Condition / PCR
0903	NonPublic	2/24/2003	14370	0.25	AS	FAIR / 73

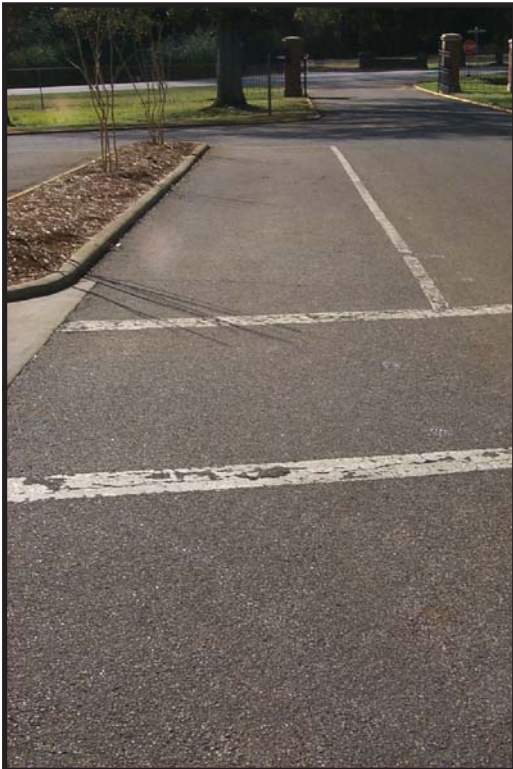
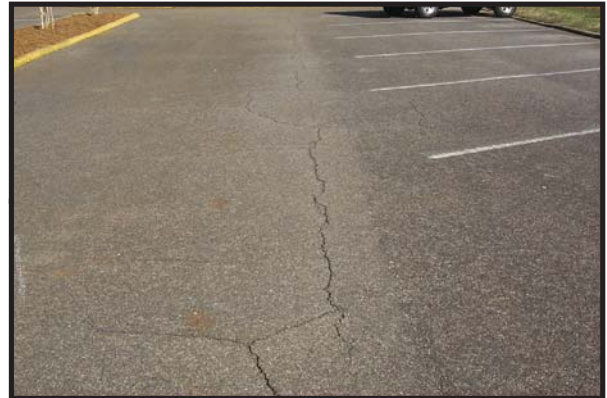
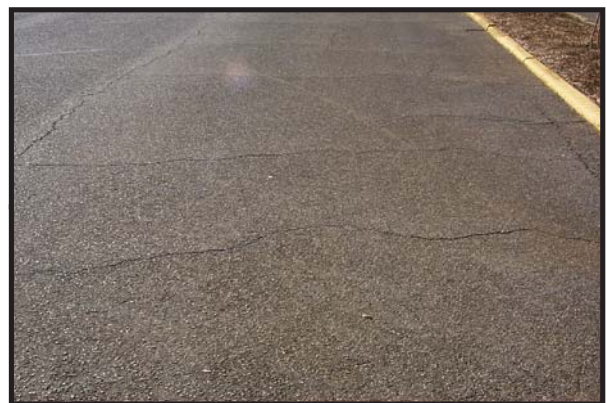
## Route 0904

Route	Public / NonPublic	Date Visited	Area (sq ft)	Lane Miles *	Surface Type	Condition / PCR
0904	Public	2/24/2003	7170	0.12	AS	FAIR / 73

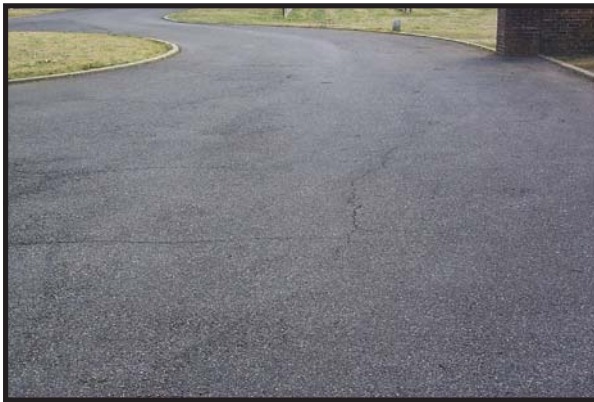
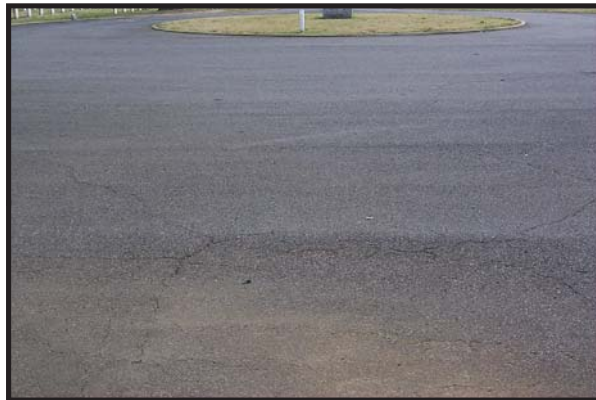
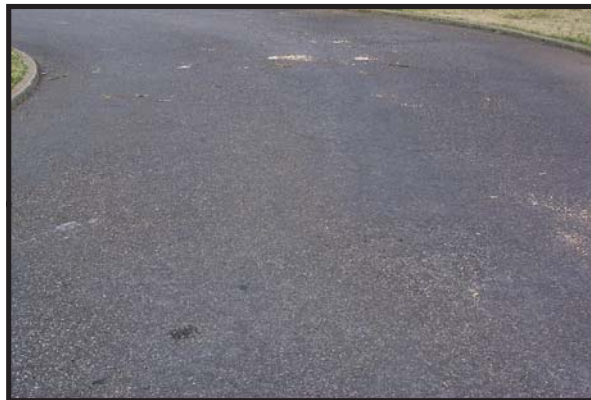
## Route 0905

Route	Public / NonPublic	Date Visited	Area (sq ft)	Lane Miles *	Surface Type	Condition / PCR
0905	Public	2/24/2003	8720	0.15	AS	FAIR / 73

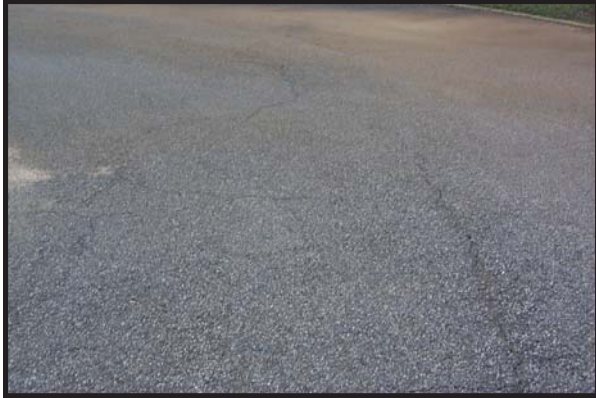
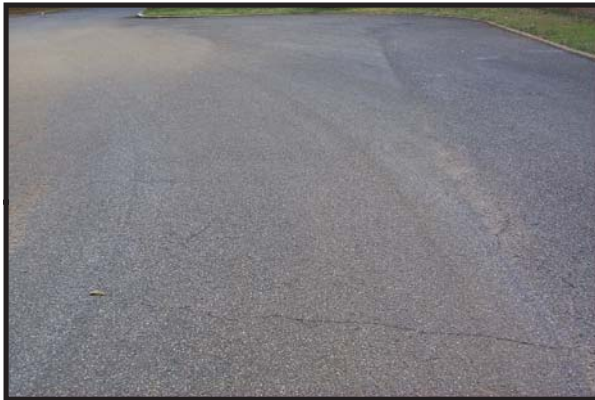
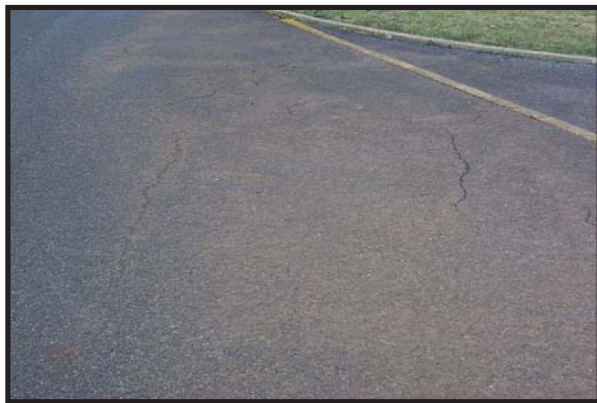
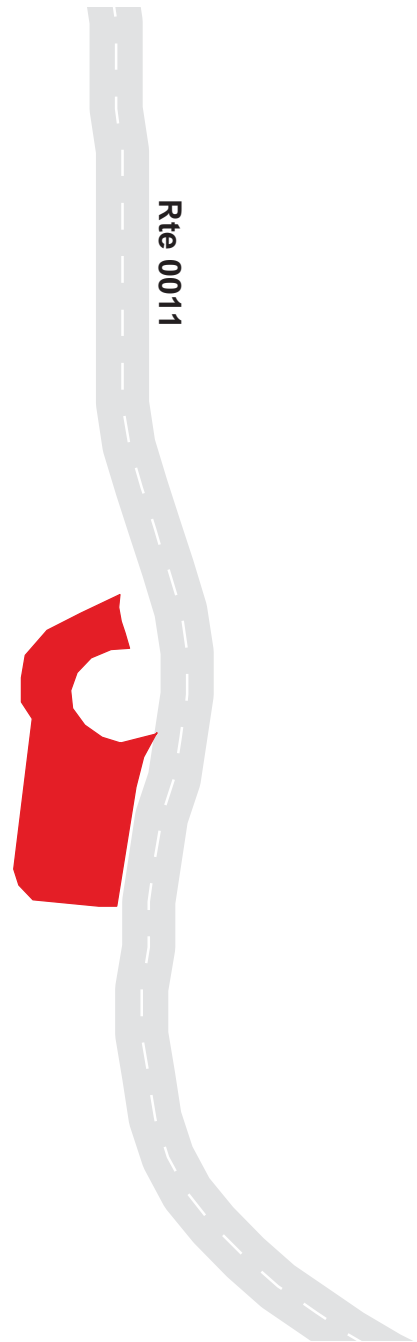
## Route 0906B

Route	Public / NonPublic	Date Visited	Area (sq ft)	Lane Miles *	Surface Type	Condition / PCR
0906B	Public	2/24/2003	4093	0.07	AS	GOOD / 90

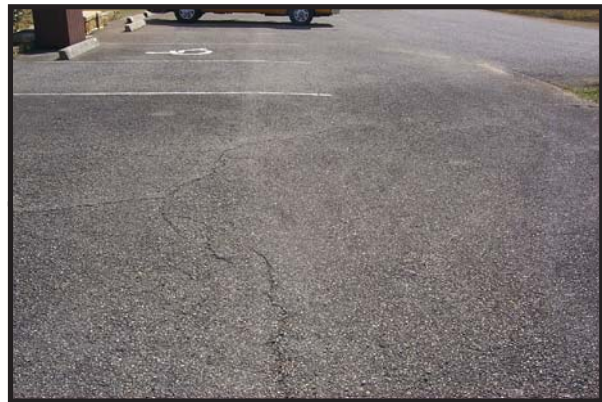
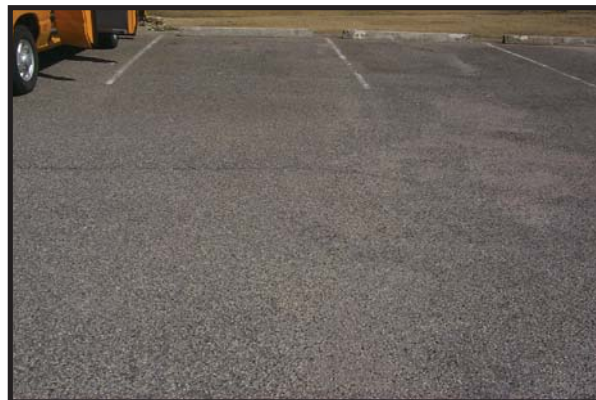
## Route 0907

Route	Public / NonPublic	Date Visited	Area (sq ft)	Lane Miles *	Surface Type	Condition / PCR
0907	Public	2/24/2003	3738	0.06	AS	FAIR / 73

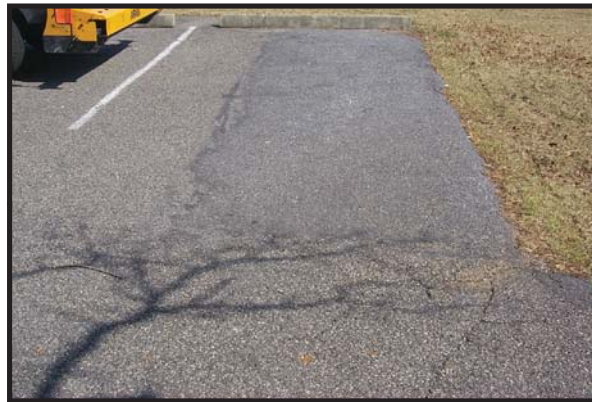
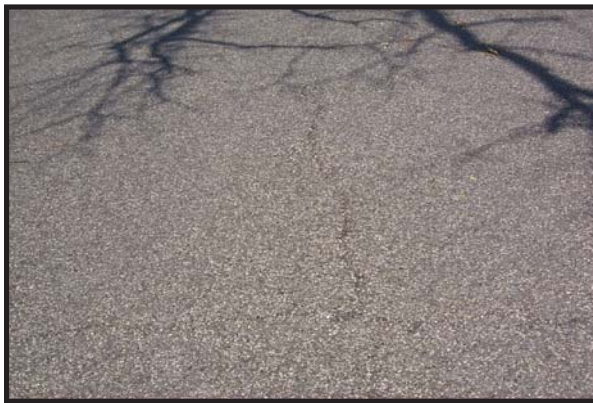
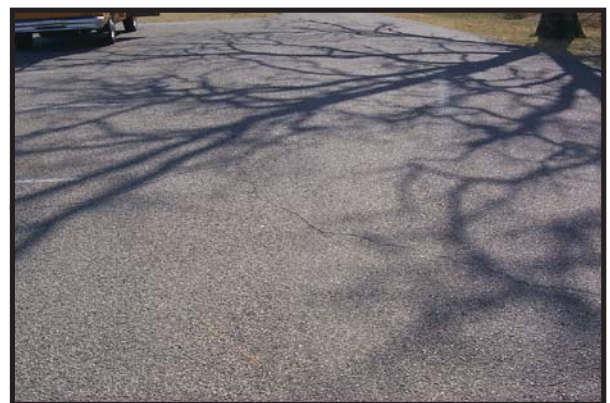
## Route 0908

Route	Public / NonPublic	Date Visited	Area (sq ft)	Lane Miles *	Surface Type	Condition / PCR
0908	Public	2/24/2003	6020	0.10	AS	GOOD / 90

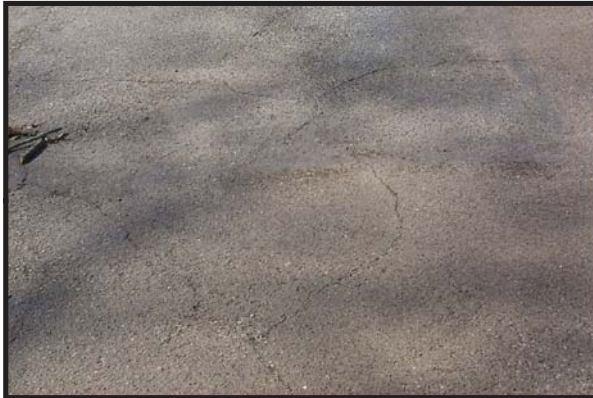
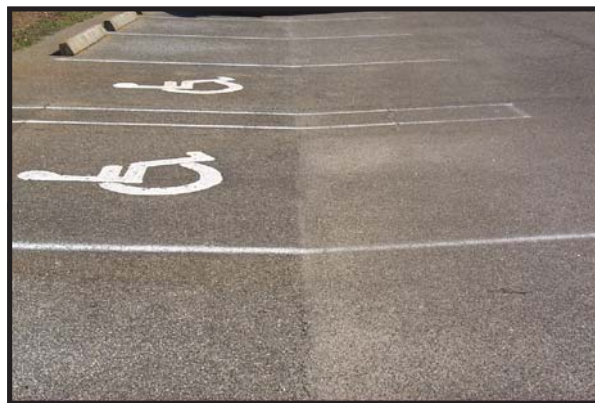
## Route 0911

Route	Public / NonPublic	Date Visited	Area (sq ft)	Lane Miles *	Surface Type	Condition / PCR
0911	Public	2/24/2003	2987	0.05	AS	GOOD / 90
